INSULATING HERITAGE MASS MASONRY BUILDINGS FROM THE INTERIOR

A Condensed Best Practice Guide
to Mitigate Risk of Freeze-Thaw Damage

November 2022

Public Services and
Procurement Canada

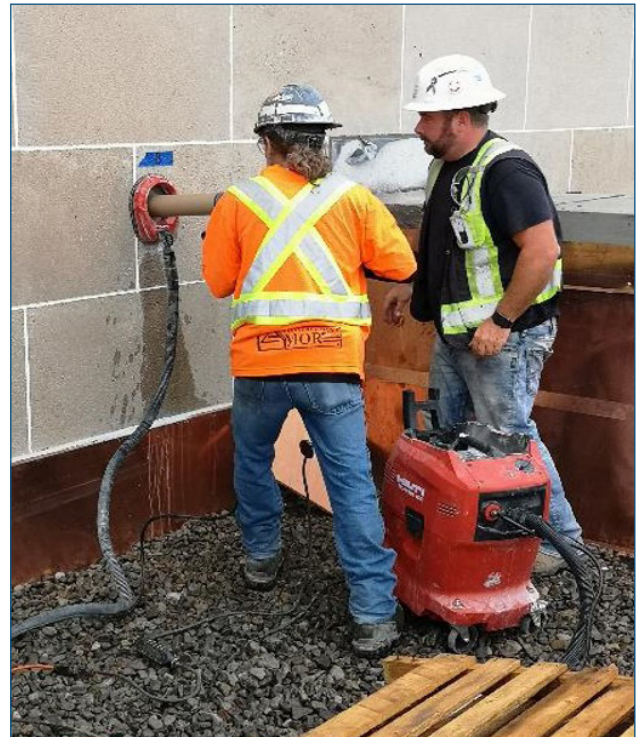
Figure 8: Material sampling being completed at West Memorial Building [4]

Material sampling and testing was completed for the West Memorial Building rehabilitation project to create hygrothermal and energy models. 30 core samples of the limestone masonry with varying exposure conditions were harvested from 10 different locations throughout the building. The stone cores were sent to a laboratory where the stone's properties were established (see page

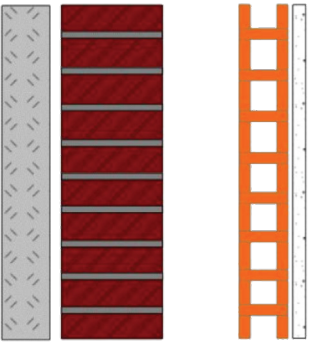
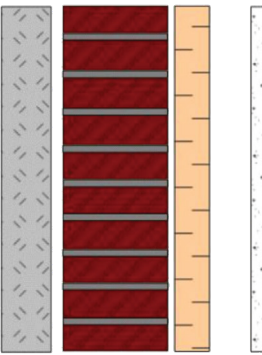
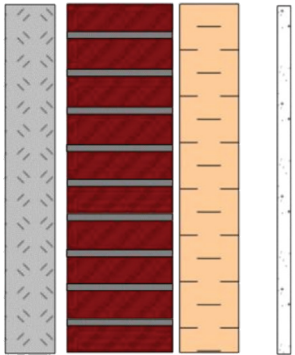
<p>Scenario C1</p>	<p>Scenario C2</p>	<p>Scenario C3</p>
<ul style="list-style-type: none"> ▪ 100mm limestone ▪ 200mm brick ▪ 150mm air space ▪ 100mm terracotta tile ▪ 15mm plaster 	<ul style="list-style-type: none"> ▪ 100mm limestone ▪ 200mm brick ▪ 50mm medium density, closed cell spray polyurethane foam (R-12) ▪ 92mm stud cavity ▪ 13mm gypsum drywall 	<ul style="list-style-type: none"> ▪ 100mm limestone ▪ 200mm brick ▪ 100mm medium density, closed cell spray polyurethane foam (R-24) ▪ 92mm stud cavity ▪ 13mm gypsum drywall

Figure 13: Example - Three wall retrofit scenarios with varying levels of interior insulation to be considered using hygrothermal analysis for the West Memorial Rehabilitation Project [4]

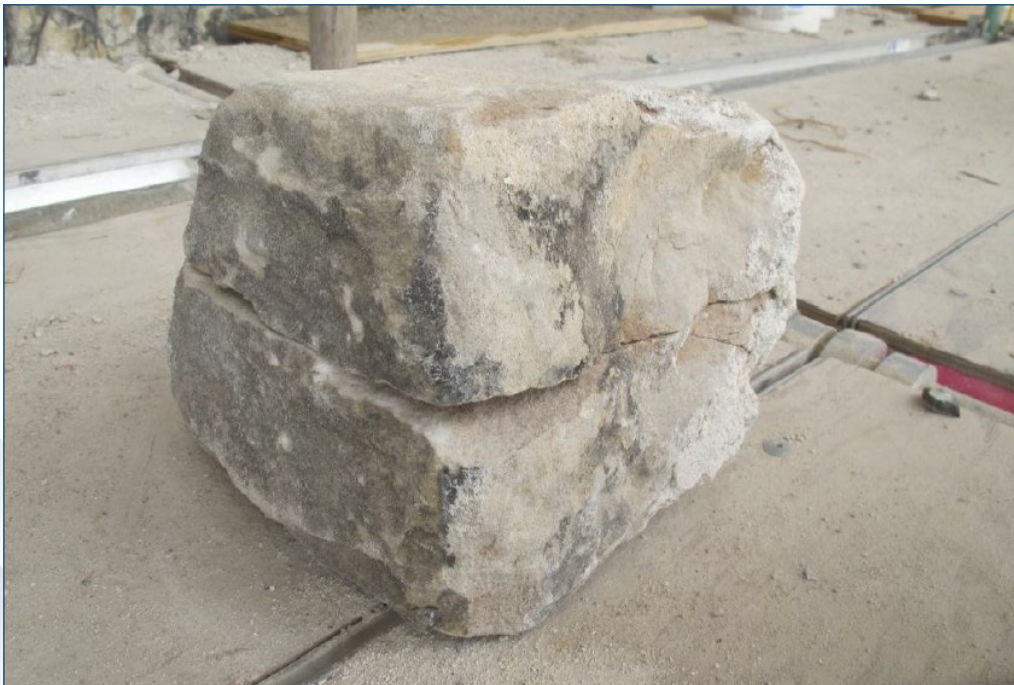
Figure 15: Cracked masonry unit due to freeze-thaw damage [2]

Materials with a W_f higher than their S_{crit} have the potential to experience freeze-thaw damage. In this case, the material can achieve a moisture content under the normal field conditions, which could cause damage in a freeze-thaw cycle.

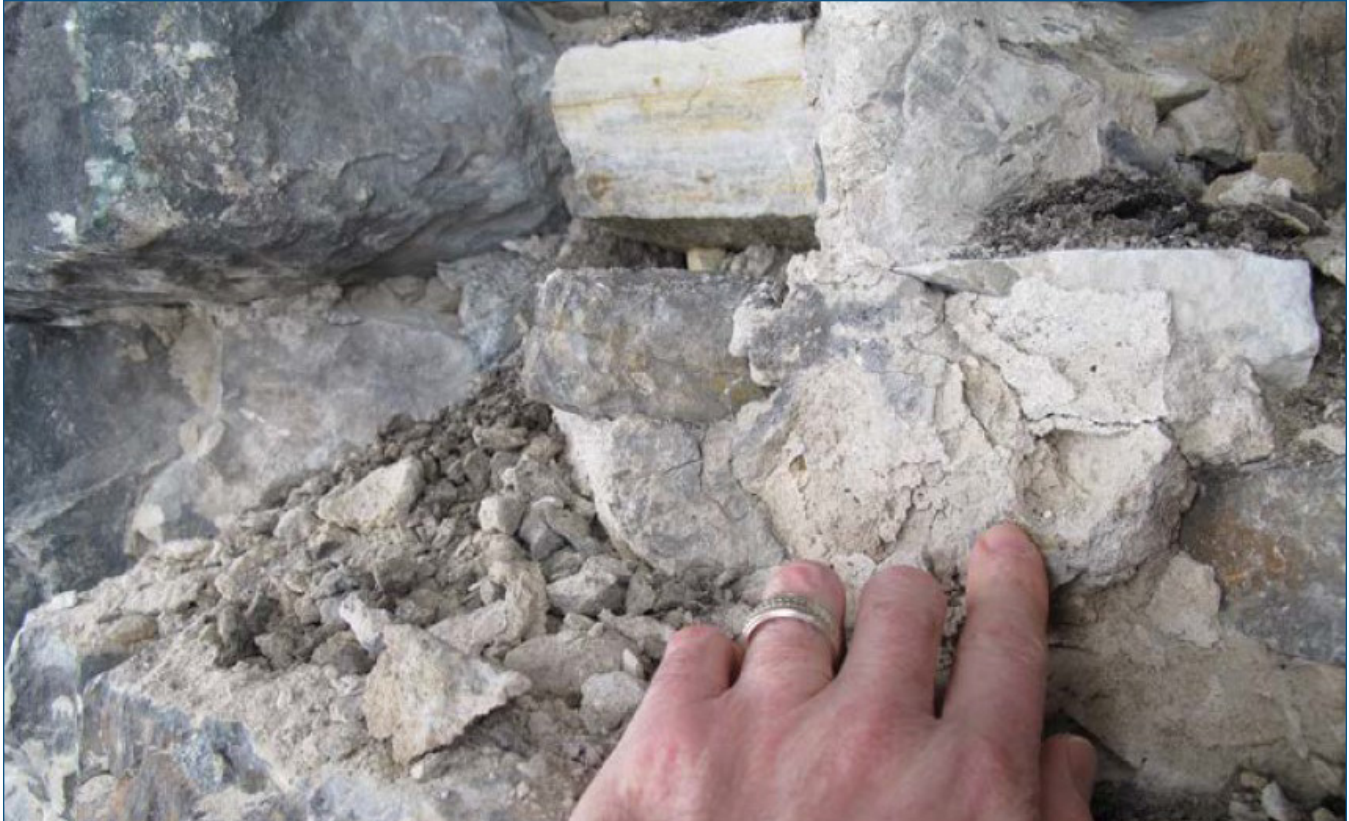
Figure 16: Cracked masonry unit due to freeze-thaw damage [2]

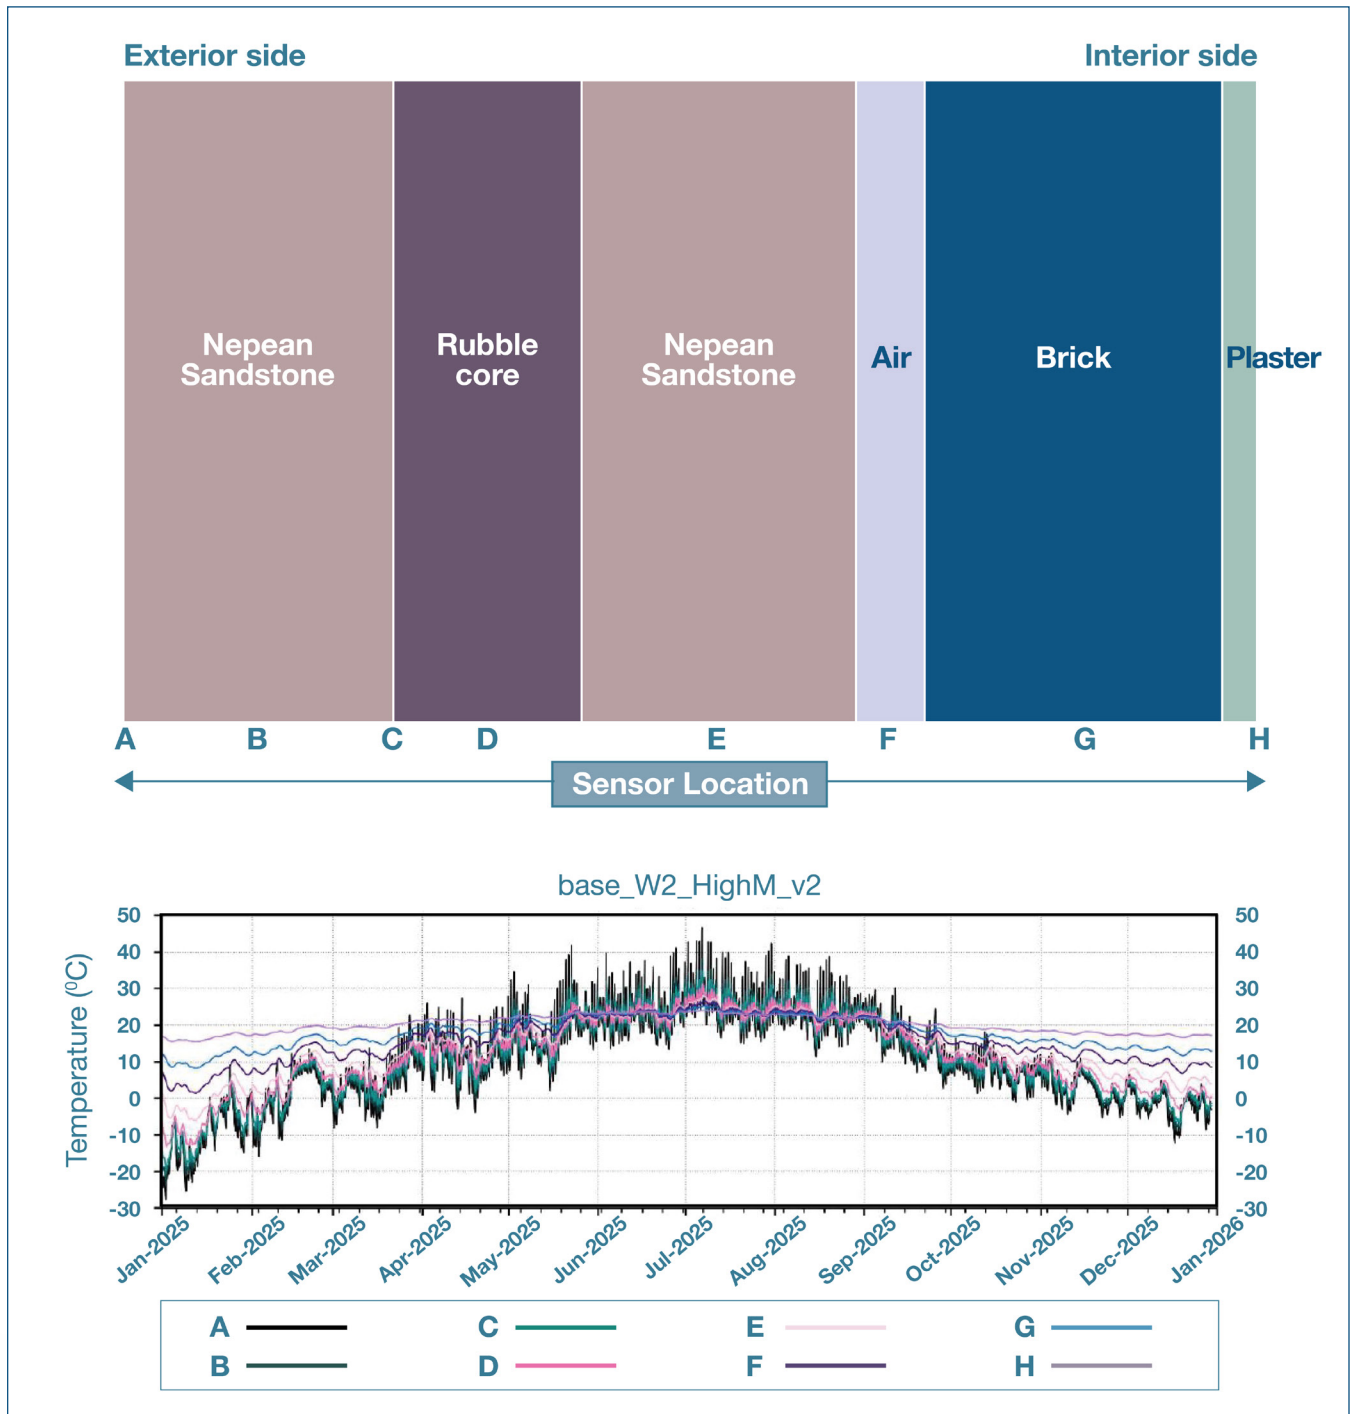
Figure 17: Example of the location of wall sensors in a hygrothermal model at East Block [6]

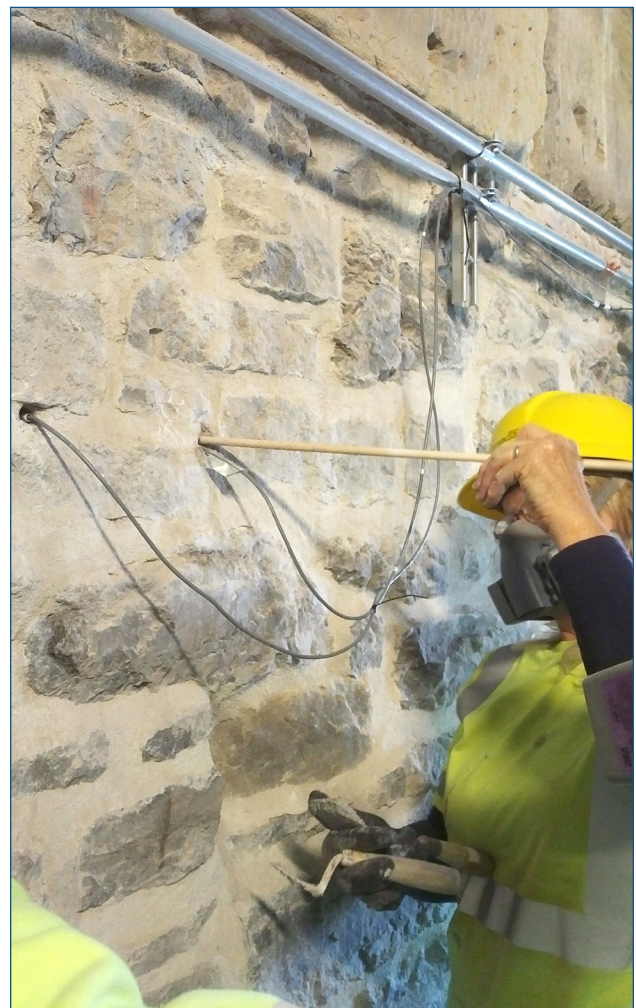
Figure 19: Monitoring sensors being installed in a masonry wall [2]

For the collection of data, sensors should be shielded from solar radiation and be installed in a minimum of two locations:

1. At the interior air/interior wall interface
2. Near the exterior stone components (in a void space if present)

At minimum, sensors should detect the moisture content, relative humidity and temperature. Sensors should be installed on the interior and exterior of the wall and throughout the building envelope. At each location in the measurement site, three sensors of each type should be installed for increased reliability and verification. The data collected from these sensors is only reliable if the sensor has been calibrated to a calibration standard. Calibration should occur every year. Certifications for all sensors and data acquisition systems used for the monitoring should be provided as part of the program.

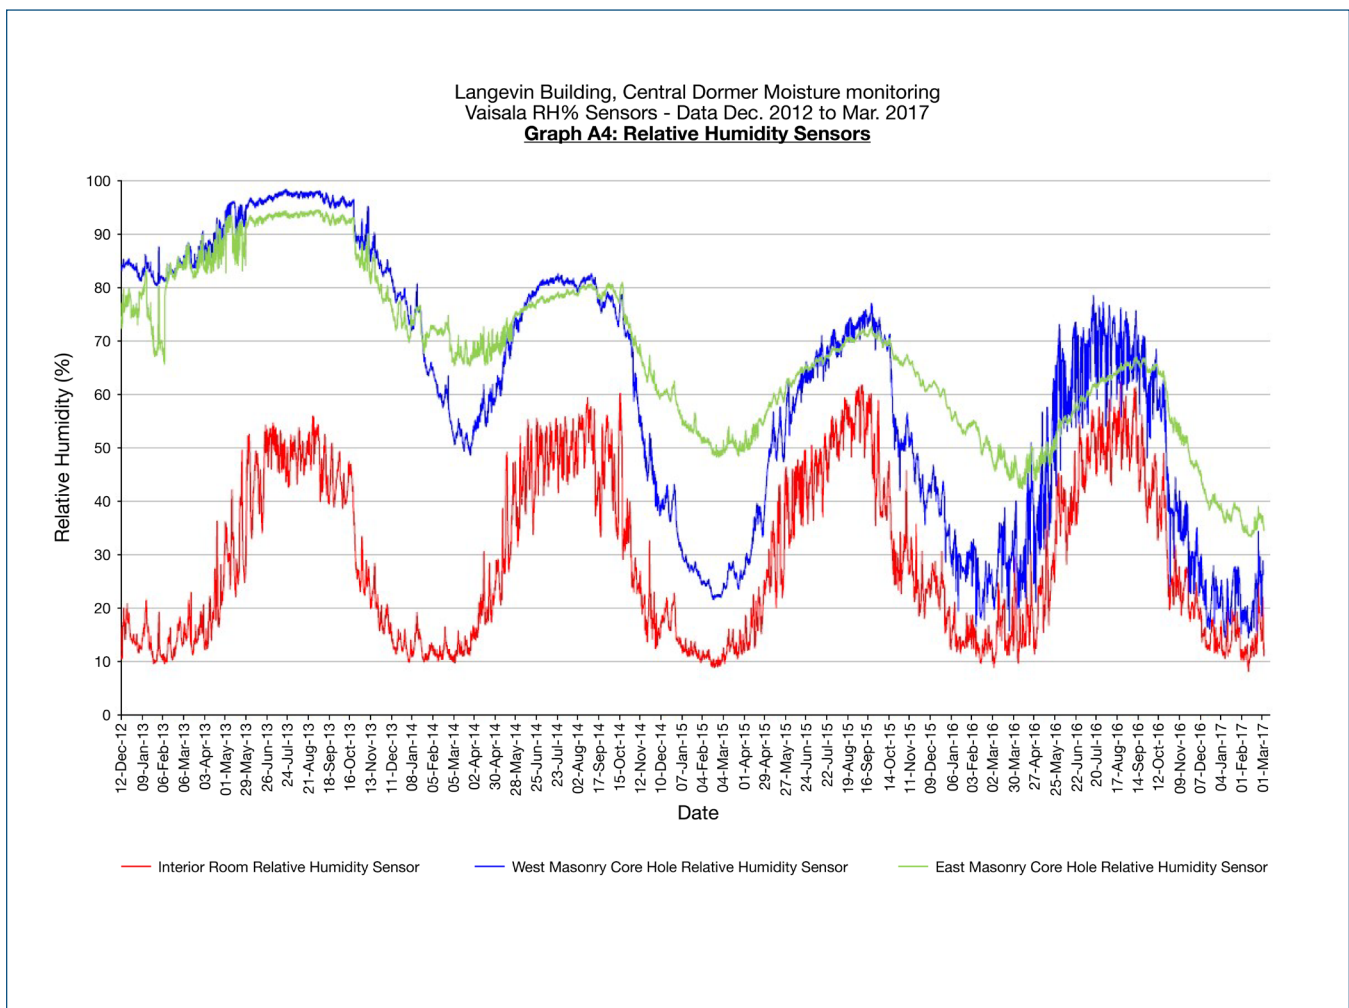
Figure 20: Graph monitoring the relative humidity sensors at 80 Wellington St, formerly known as the Langevin Building [7]

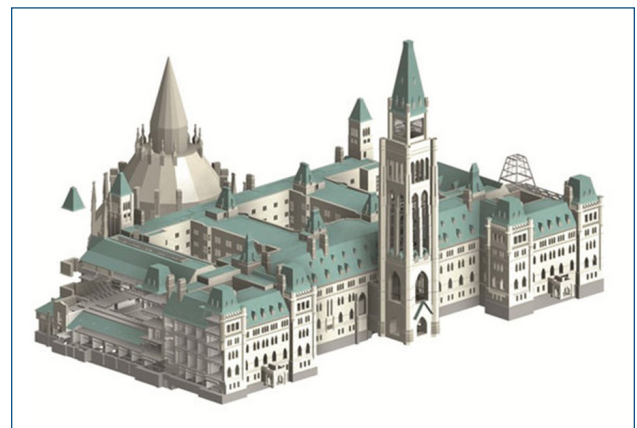
Figure 22: The Centre Block Building Information Model created from laser scans [9]

- i. Air-tightness of heritage buildings
- ii. Advanced wind-driven rain analysis using computational fluid dynamics
- iii. 3D laser scanning when building drawings are not available
