Research Summary – Evaluation of Current Tank Car TC128B Steel Weld Performance

Transportation of Dangerous Goods | Scientific Research Division

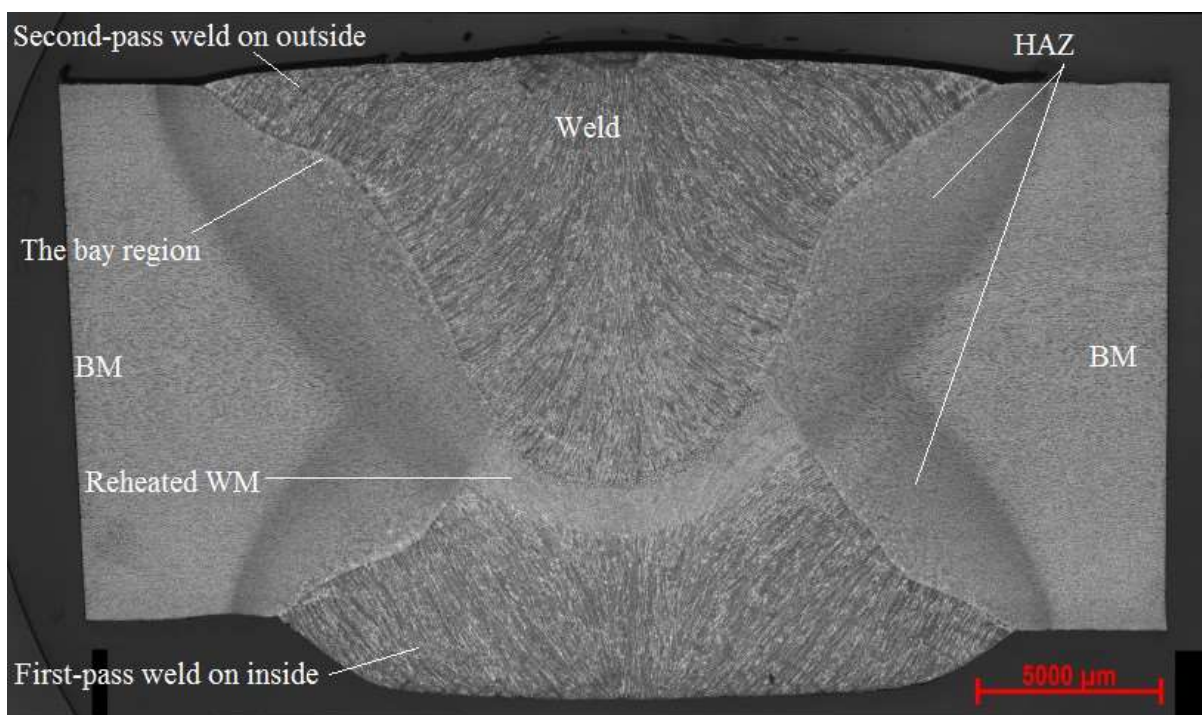
Figure 1: Macrograph of a TC128B circumferential weld

is also often more brittle than the BM in dynamic tests meaning that it is more likely to fracture during an impact. The welding process also creates a Heat Affected Zone (HAZ) in the BM adjacent to the weld, which due to the heating and cooling cycle of the weld, will perform differently than the BM and WM. A macrograph showing the cross-section of a TC128B weld is shown in Figure 1.

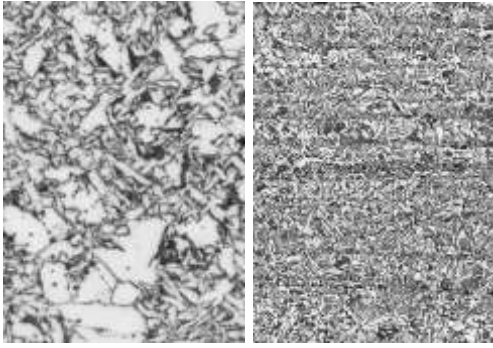
Figure 2: Coarse WM centerline microstructure (left) and fine grain BM microstructure (Right).

The microstructure of the WM and HAZ was consistent with expected results. The weld centerline has a coarse-grained structure, as shown in Figure 2. Coarse grain structure is undesirable because it can reduce a materials ductility though it is usually unavoidable in welds.

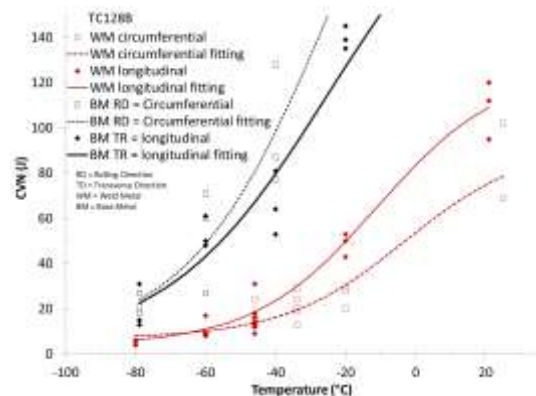
Figure 3: Charpy transition curve of TC128B weld and base metal

CVN testing was used to measure the toughness of the BM, and of longitudinal and circumferential welds. CVN measures the amount of energy a pre-notched sample absorbs during an impact. Tests were conducted at temperatures from -80 °C to 23 °C. The results are shown in Figure 3. These curves are referred to as Charpy transition curves because they show how the material transitions from high toughness and ductility at higher temperatures to brittle, low toughness at low temperatures. This behavior occurs in all steels. CVN values of WM were

significantly lower than those of BM and HAZ specimens. The initial test results at -34 °C (29J, 13J, 24J), did not meet the benchmark of AAR specification requirements for pressure tank cars (M-1002) of an average of 20.3 J and a minimum of 13.6 J. The subsequent retest (20 J, 19 J, 20 J) also did not meet the retest specification. M-1002 is a manufacturing specification and does not include provisions for performing Charpy tests on in-service or ex-service welds but was used for comparison as there is no alternative in-service test. Also, this weld specification criteria applies to pressure tank cars, not the non-pressure tank car tested in this study, as there currently is no similar standard for non-pressure tank cars. However, the results indicate that Charpy testing is important for tank cars in low-temperature climate applications.

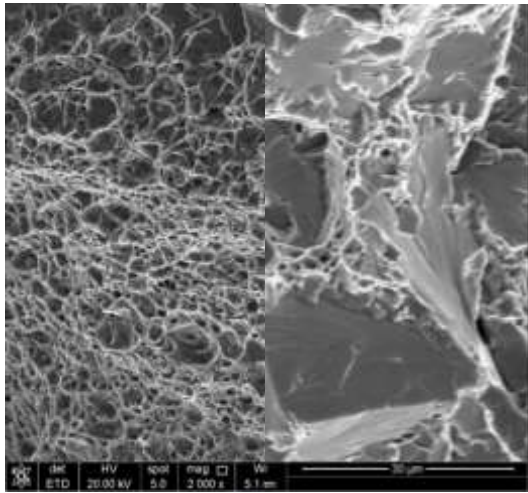
Figure 4: SEM fractographs of ductile fracture (left) and brittle cleavage initiation (right) in Charpy WM specimens tested at 25 and -46 °C.

The fracture surfaces of two Charpy specimens were examined using SEM, one tested at 25 °C with CVN=69 J, and another tested at -46 °C with CVN=13 J. The specimen with CVN=69 J showed approximately 35% ductile and 65% brittle fracture. The 13 J specimen displayed cleavage fracture with no discernible ductility (Figure 4). The SEM fractography examinations indicate that low TC128B WM toughness was associated with weld

microstructural constituents and/or inclusions, and not weld flaws.
