TP 15513E

Assessment of ACFM NDT for Use on Tank Cars

National Research Council Canada
Automotive and Surface Transportation

Project: A1-017746
Report number: AST-2021-0008

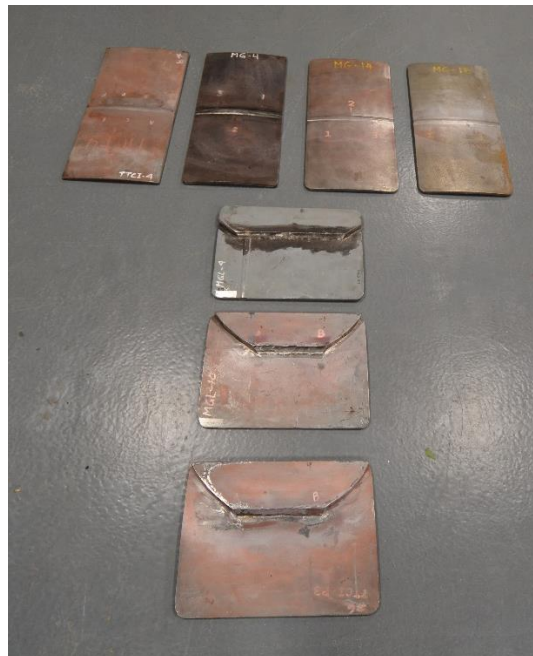
Figure 1 – Defect specimen overview

Specimens from top to bottom, left to right, TTCI-4, MG-4, MG-14, MG-18, MLG-4, MGL-10 & TTCI-P3

These test specimens have pre-determined flaws induced from either electro-discharge machining (EDM) or induced fatigue cracks of various directions and sizes which provided a baseline for the inspectors and technique comparison. Details of the flaws contained within the specimens were provided by the FRA and are listed below in Table 1.

Seven defect specimens (Figure 1) were utilized for the evaluation. These master gauge test panels are representative tank car panels of both structural weld types used in older tank car construction (butt and fillet welds). The defect specimens are part of the defect library owned by the United States Federal Railroad Administration (FRA) and stored at the Transportation Technology Center Inc. (TTCI) to provide calibration artifacts for NDT evaluations and were manufactured of tank car materials representative of ASTM A515, Grade 70 Steel. They were provided to NRC on loan for this evaluation through the FRA and TTCI.

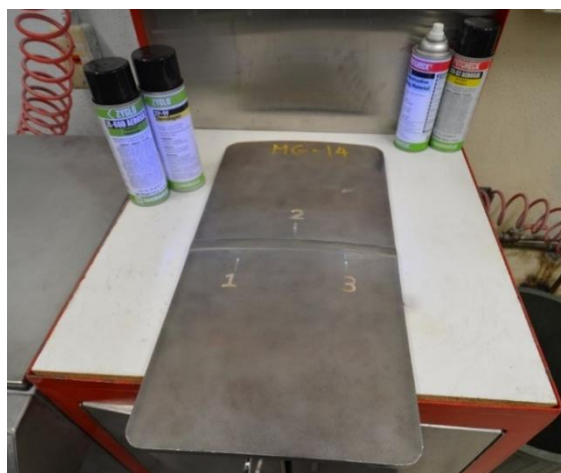
Figure 3 – Liquid penetrant inspection on defect specimen

Figure 3 depicts a defect specimen during the liquid penetrant inspection. Please note an aerosol version of the penetrant was used for testing.

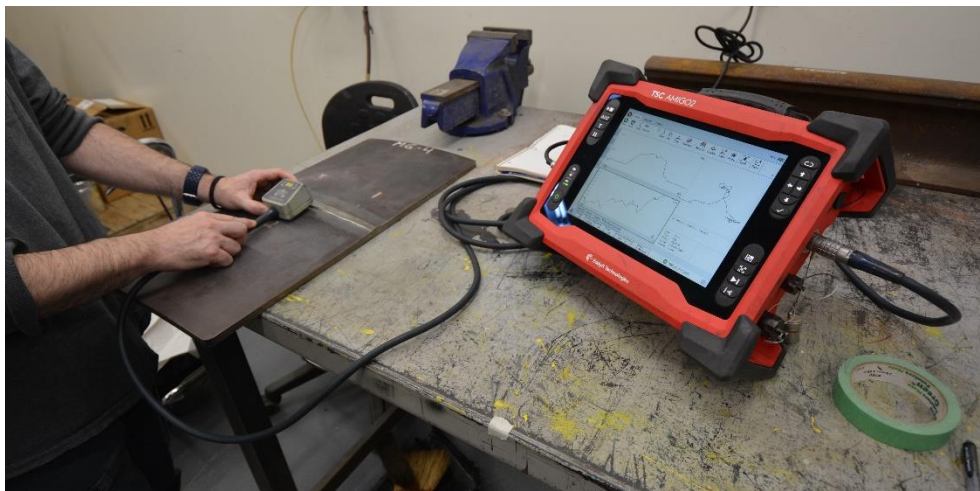
Figure 9 – ACFM inspection on defect specimen

The ACFM procedures were developed and approved by Eddyfi Technologies [12]. The procedures were reviewed by NRC prior to the approval. Figure 9 depicts a defect specimen during the ACFM inspection.

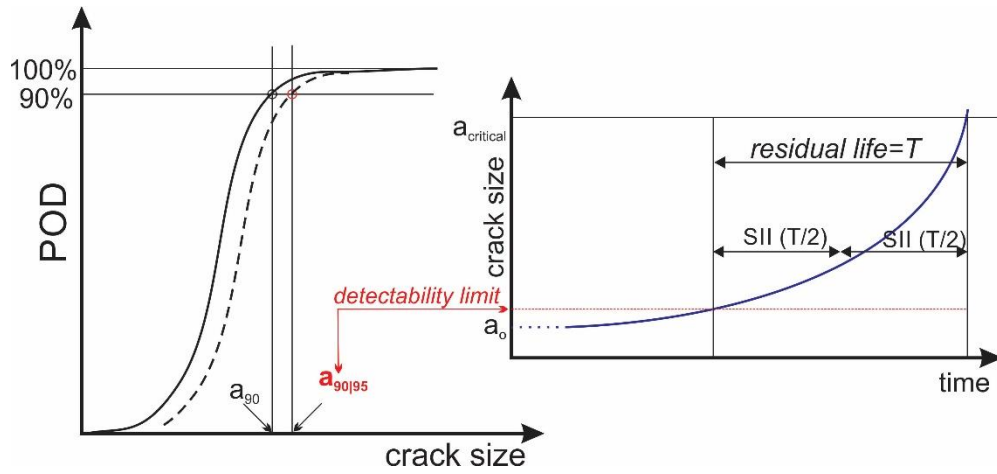
Figure 10 – Example of a POD curve [9]

The $a_{90|95}$ value is also used for comparing different NDT techniques or procedures. The figure below shows an example POD curve and its use in damage tolerance life management: the $a_{90|95}$ value as input to fatigue crack growth in order to determine safe inspection intervals.

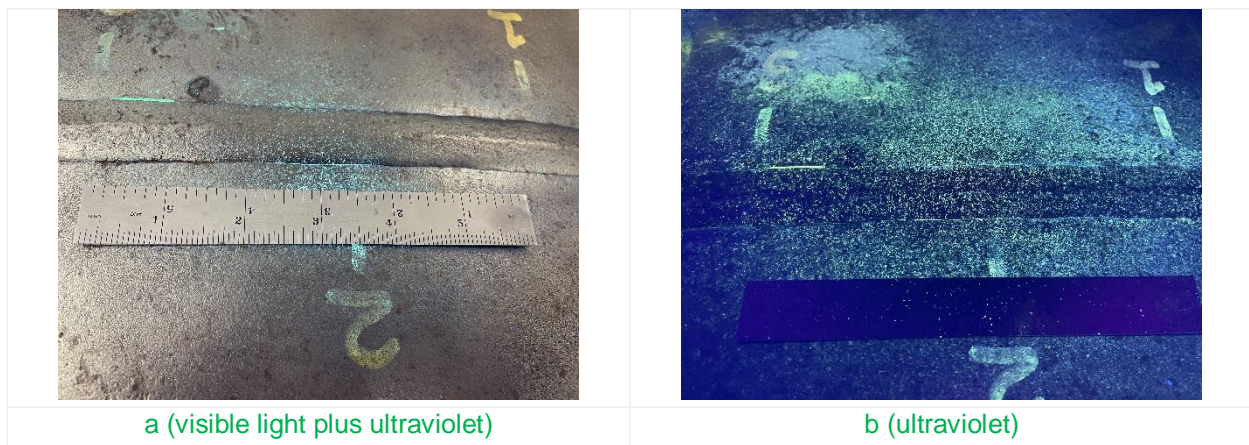
Location No.	Indication length	Comments
1	no indication	
2	29 mm	Toe of the weld
3	34 mm	Toe of the weld

Figure 18 – PT indications of specimen MG-18 at location #2

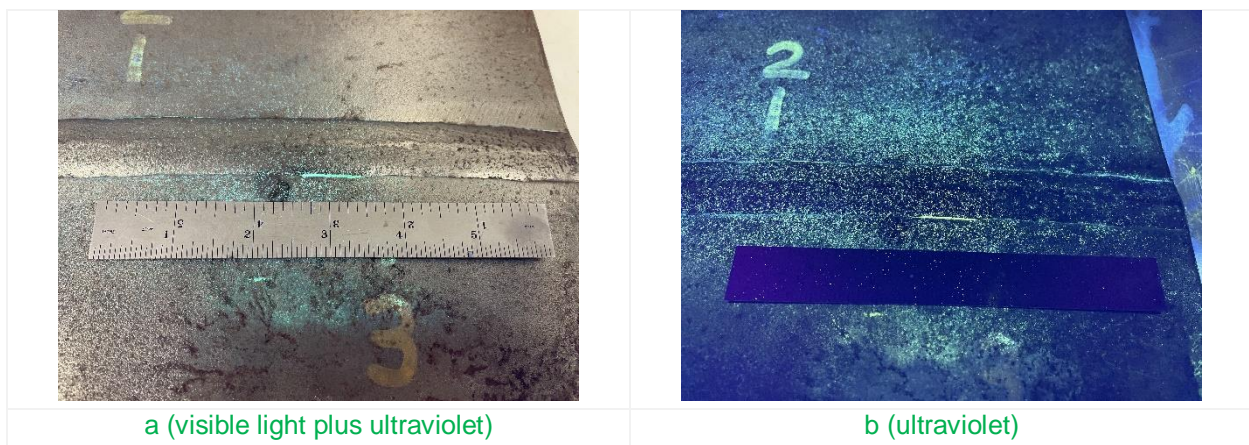
Figure 19 – PT indications of specimen MG-18 at location #3

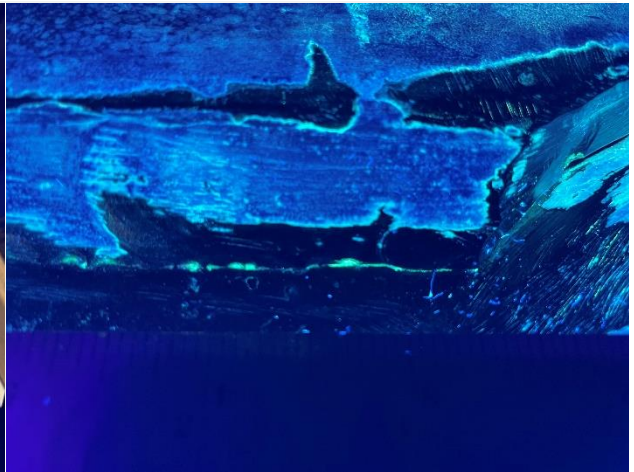
Location No.	Indication length	Comments
A	7 mm	Toe of the weld
B	27 mm	Toe of the weld

a (visible light plus ultraviolet)

b (ultraviolet)

Figure 27 – PT indications of specimen TTCi-3 at location B
