# EVALUATION AND ANALYSIS OF SUBSTANDARD LITHIUM-ION BATTERIES BY UN 38.3 TESTING

**By: Henry Lu**  
**Contributors: Ian Whittal, Kiran Shoib**  
RDIMS # 19007970

Transport  
Canada

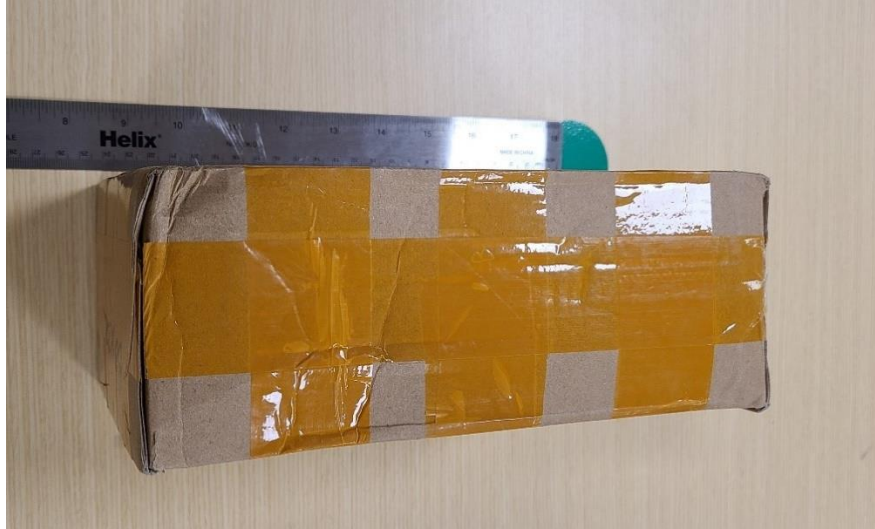
Sixteen packages (16/44, 36%) had suffered some form of damage upon receipt by the contractor. Most packages that received damage had dents and loose packing tape as observed in Figure 1.

Figure 1: B6 Package (Box B6-1) is dented and appears to be retaped. Similar damage was observed for packages for A1, A3, A5, B1, B3, C1, C2, C3, C4, and C5.

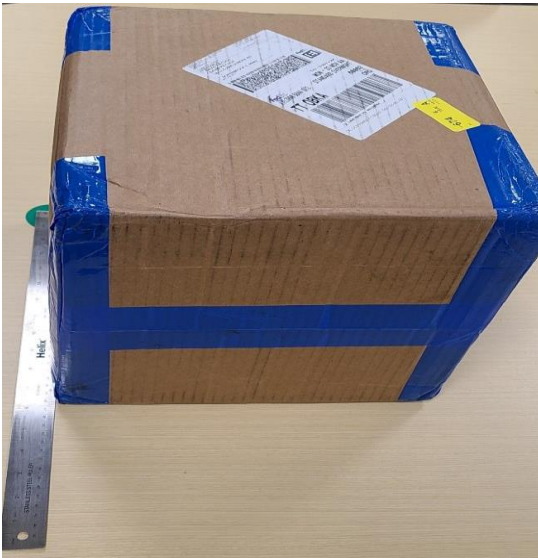
Figure 3: Box B4-1 Is missing a UN3480 label, only the pictured marking was available

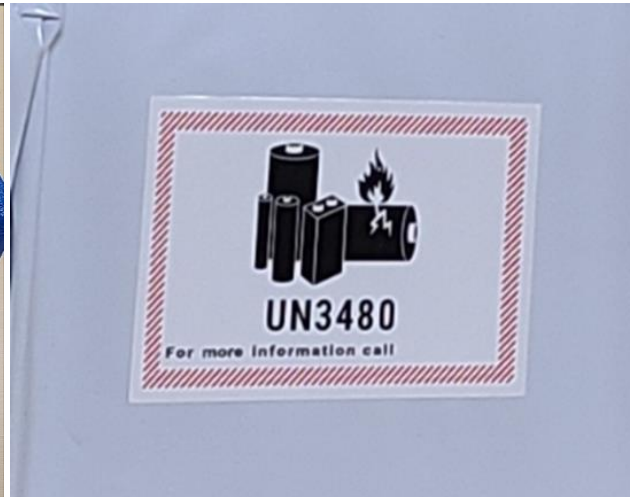
Figure 4: Box B4-1 internal packaging UN3480 label is missing a phone number

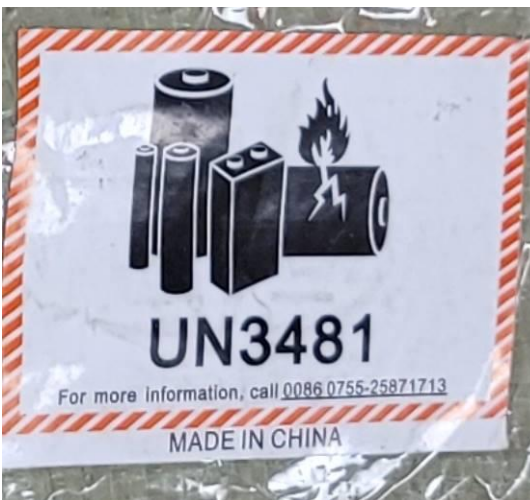
Figure 5: Box A4-1 with a UN3481 label

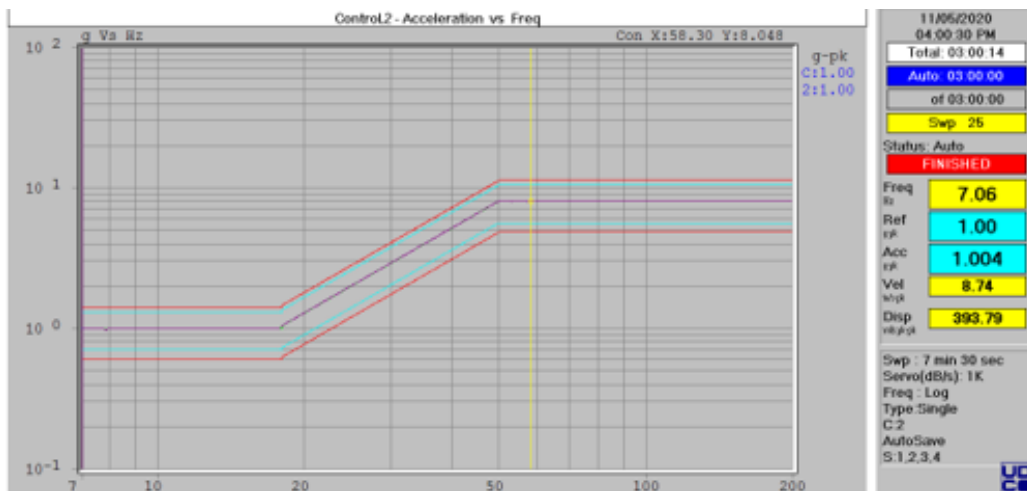
Vibration plots [Figure 8] show no difference in the parameters with tests that had compliant results and non-compliant results. This extends to all batteries that failed T.3 Vibration testing.

Figure 8: Acceleration vs. Frequency graph for (top) A1 Set A OEM and (bottom) A2 replacement. The set control – indicated with the purple line– show tests with both compliant and non-compliant batteries experience the same test parameters.

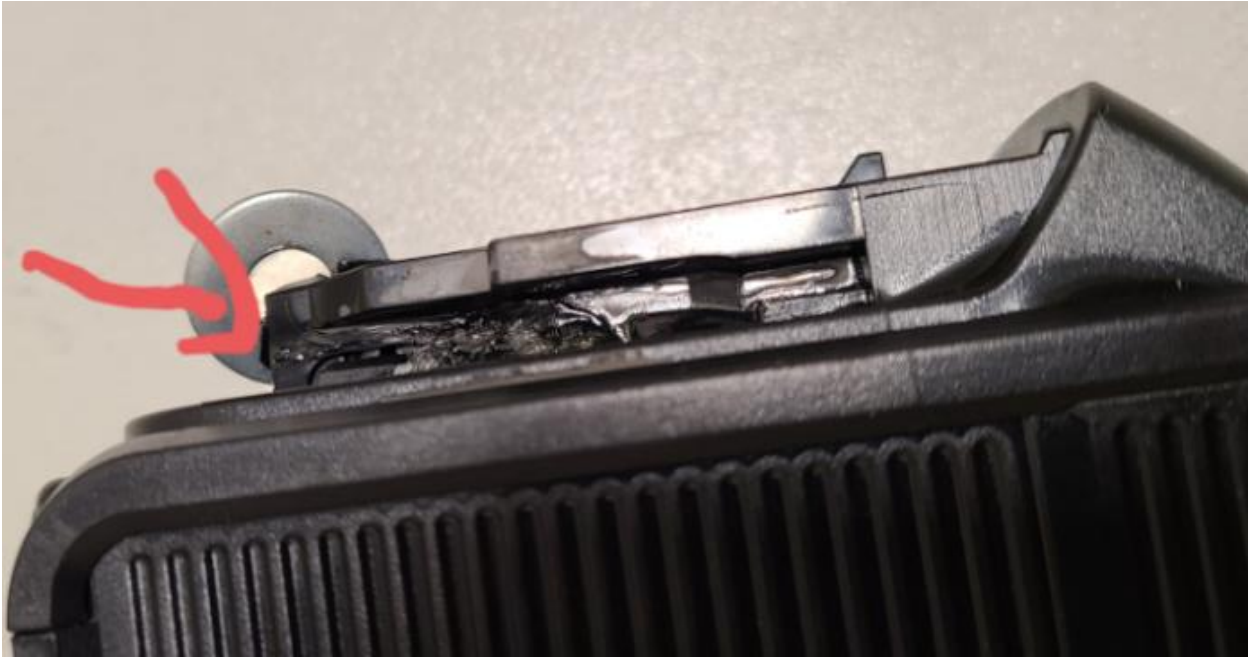
The battery remained intact with no disassembly and no fire within six hours of the test. However, the plastic around the thermocouple and battery case terminals warped due to the rise in temperature [Figure 9]. Although this sample was less than a degree above the limit of 170°C for this test [Figure 10], it is still considered a non-compliant result. The max temperature for batteries that passed this test tended to be around 60°C, with the A1 OEM example [Figure 11]. Also of note is that other standards such as UL 2054 (Standard for Household and Commercial Batteries) have a temperature limit of 150°C for a very similar short circuit test.

Figure 9: A2 Sample 5 T.5. - Melting of the plastic case due to the heat generated during the test

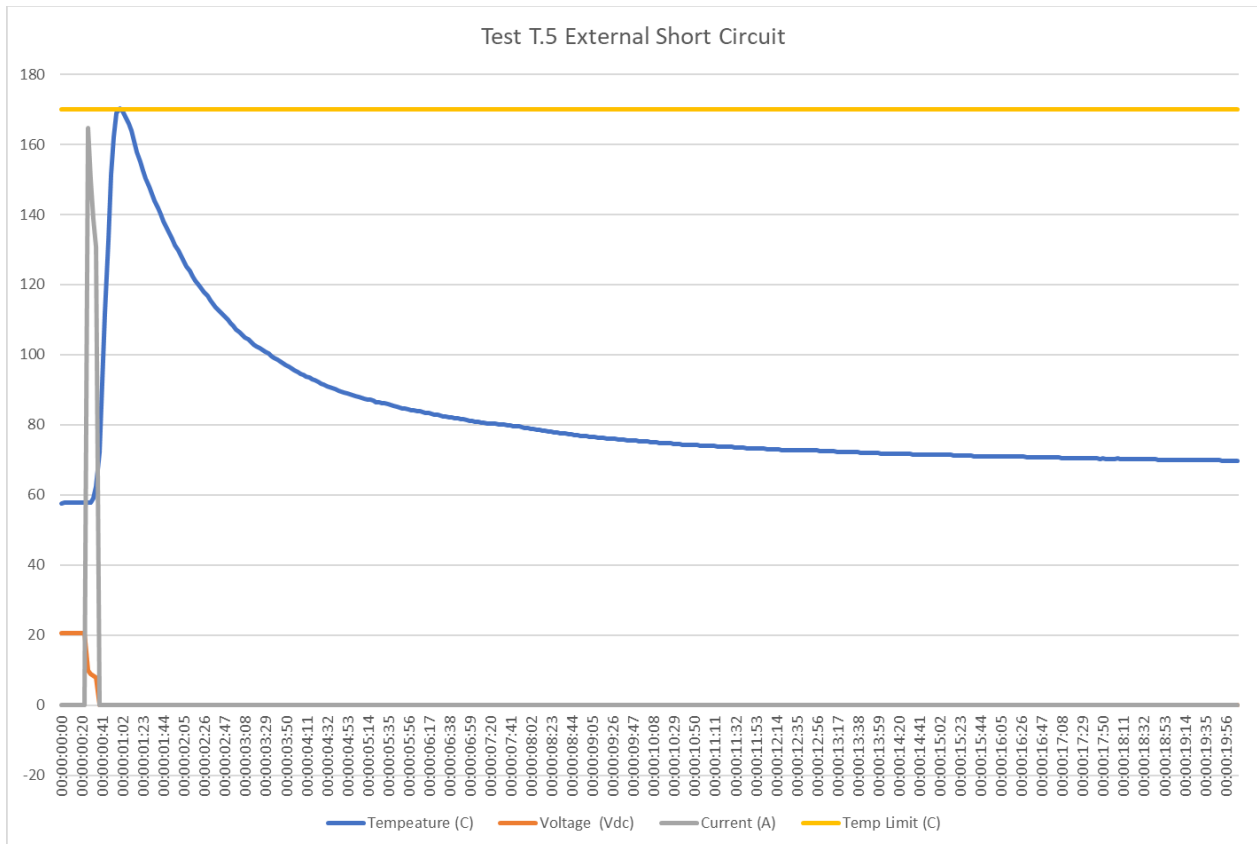
Figure 10: A2 Sample 4 Test T.5 failure with temperature rising past 170C

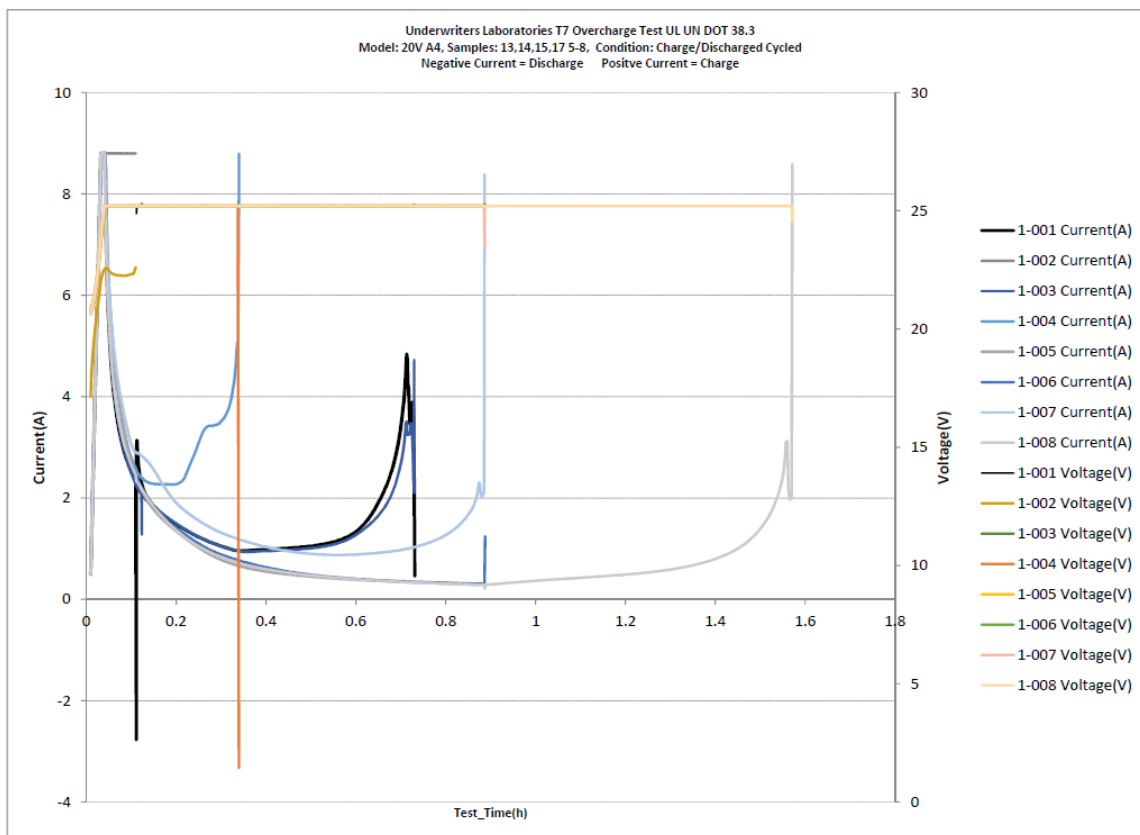
Figure 12 shows the overcharge causing the current to rise and lead to subsequent failure, while Figure 13 shows what a passing test would look like with B1 OEM sample.

Figure 12: A4 Samples failing with current continuing to rise with overcharge

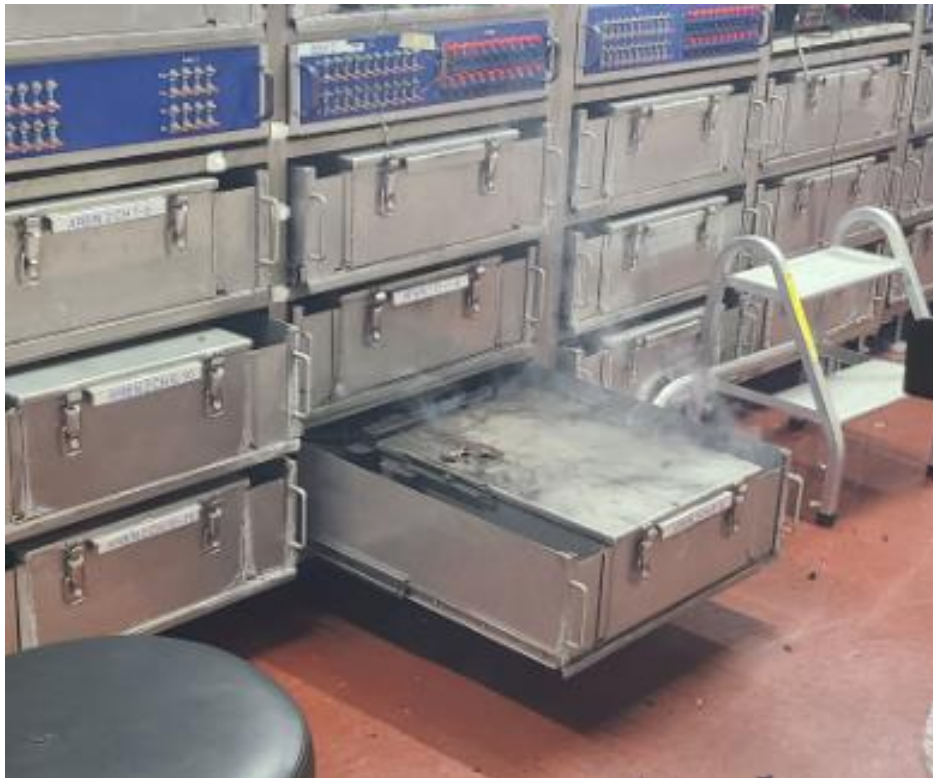
Photographs of the exploded batteries [Figure 14, Figure 15] were taken to show the extent to the failure. A lot of smoke was present with most of the cells charred.

Figure 14: A4 Samples releasing a heavy amount of smoke after catching fire and exploding during the T.7 overcharge test

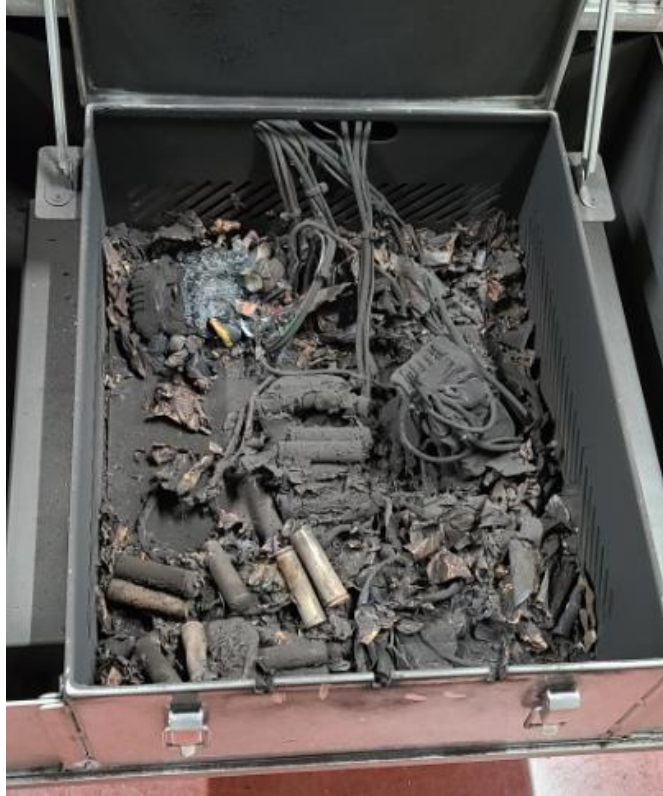
Figure 15: A4 Samples showing charring during the T.7 overcharge test

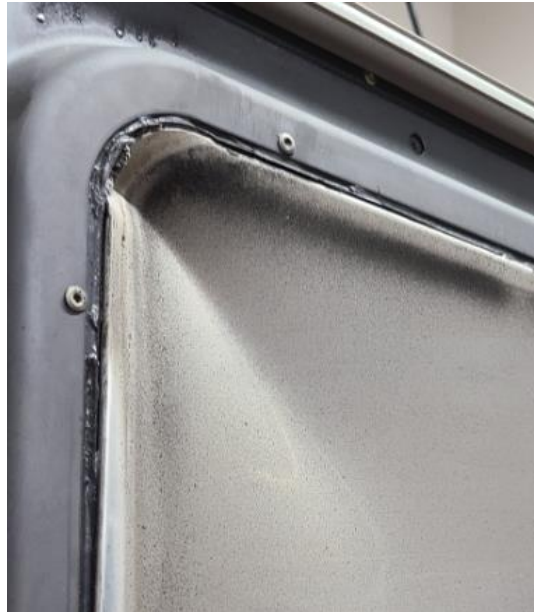
Figure 17 shows the extent of the explosion and fire. A sample from each A4 package and both charge conditions resulted in severe failure. One cell/battery built up enough energy and exploded during the test with such force to dent the door of the explosion proof oven. The failure also had very audible popping noises during the test.

Figure 17: One A4 battery exploded with such force it dented the door of the explosion proof oven.

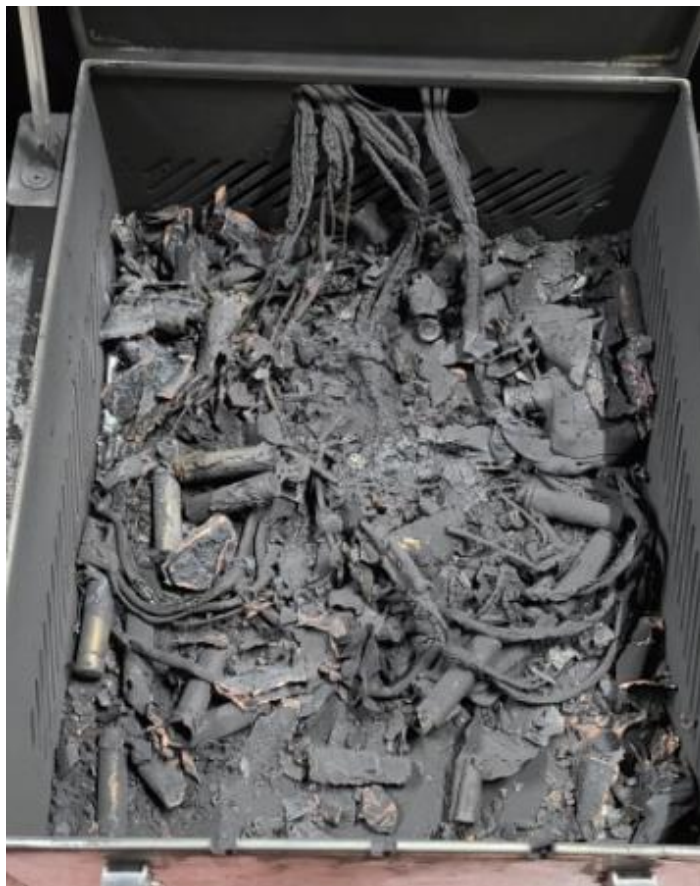
Like A4, the fire and explosion left a lot of char and debris in the test chamber [Figure 18]. The voltage-current graph shows the spike in voltage/drop in current at the time of failure [Figure 19].

Figure 18: B2 Sample 13, 14, 15, 16 – T.7 photographs showing a lot of debris from the explosion

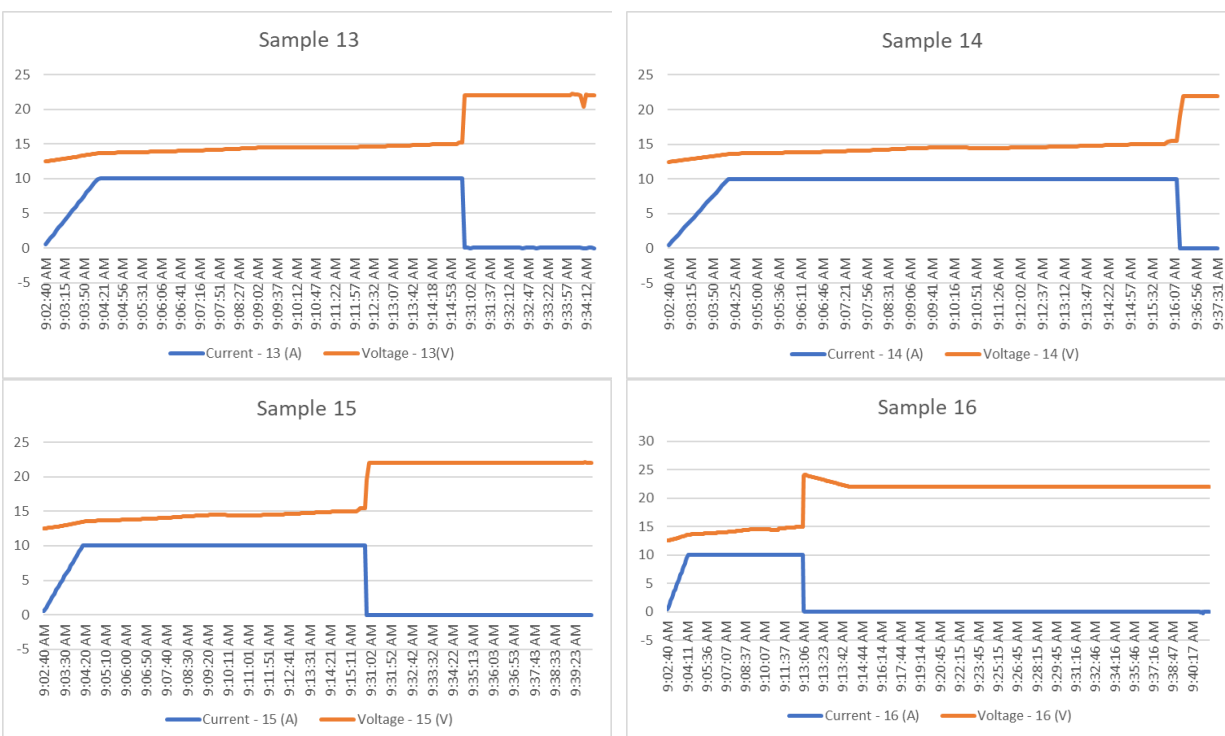
Figure 19 : B2 Sample 13,14,15,16 – T.7 Voltage-Current Graphs
