# Aircraft Takeoff Test Program for Winter 2001-02: Testing to Evaluate the Aerodynamic Penalties of Clean or Partially Expended De/Anti-Icing Fluid

Prepared for  
**Transportation Development Centre**

**Transport Canada  
Civil Aviation**

November 2002  
Final Version 1.0

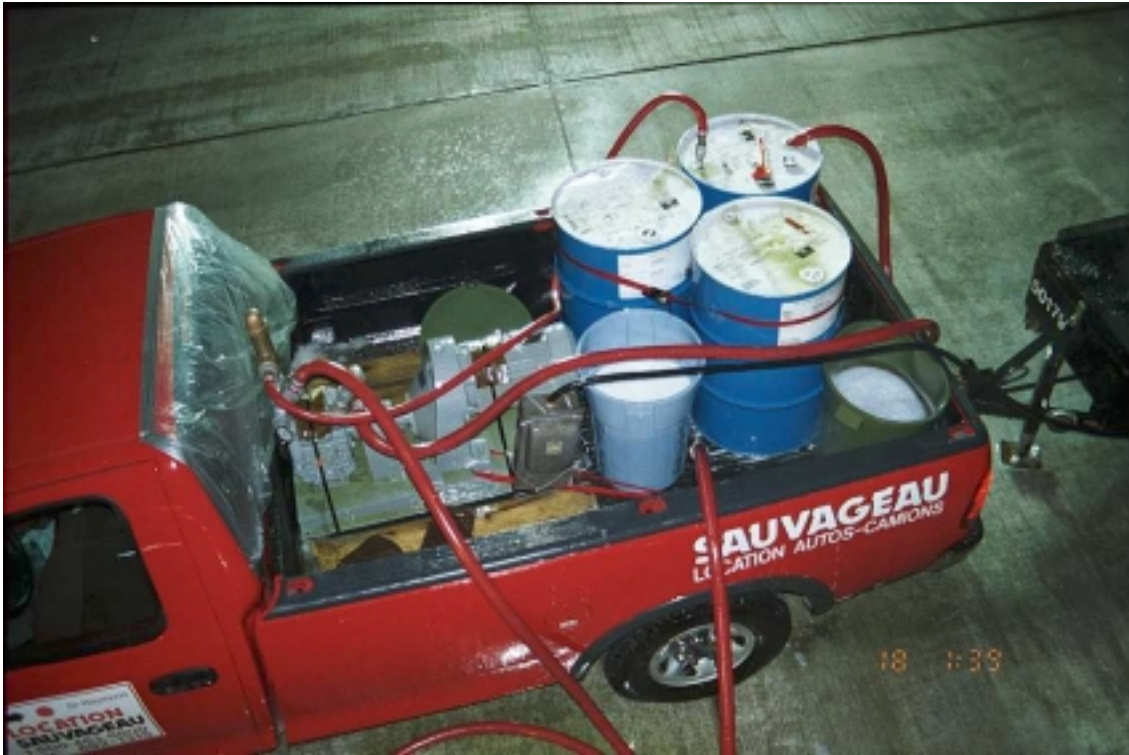
Photo 2.11: Mobile Type IV Fluid Sprayer Unit

The mobile sprayer system weighs approximately 315 kg (not including the generator) and can be easily transported with a pickup truck although a winch is required for loading (see Photo 2.11). The generator required for previous tests with the mobile sprayer was a large portable unit mounted on its own trailer as shown in Photo 2.12.

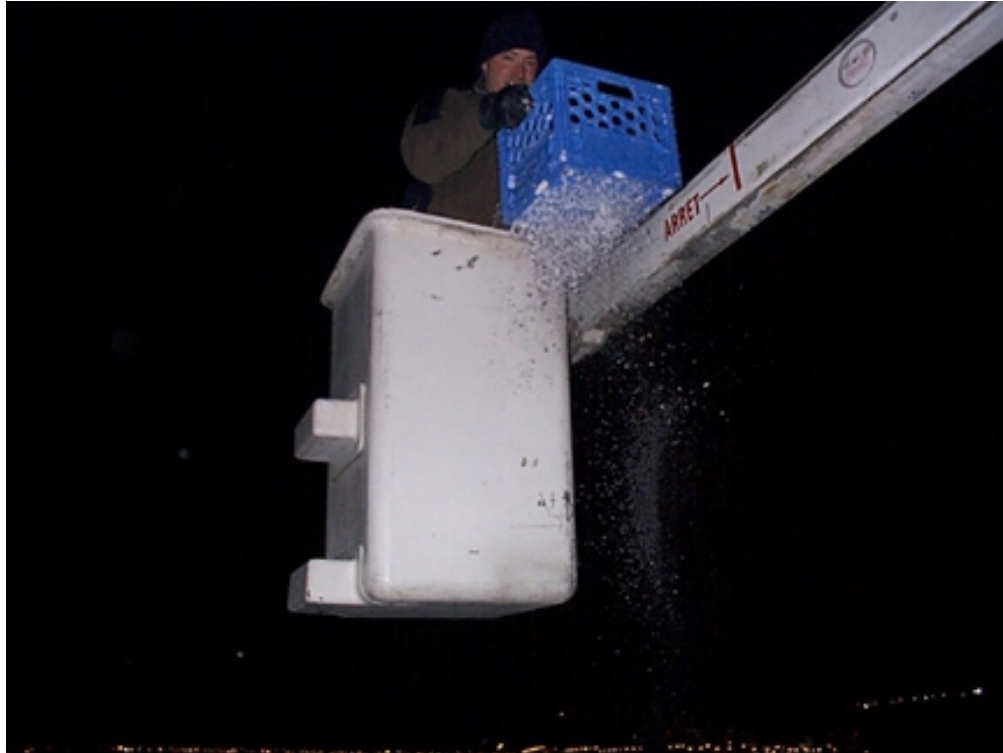
Photo 2.13: Snow Sifter Used in Snow Calibration Tests

Calibration tests with the snow sifter were conducted at the central deicing facility at Dorval Airport using the Lockheed JetStar wing (see Photo 2.13). Rate pans were placed at several locations on the wing to determine whether the desired rate of precipitation over the entire wing surface (approximately 25 g/dm<sup>2</sup>/h) could be obtained. A known weight of snow was placed in the sifter, and the sifter was provided to an operator in a boom truck.

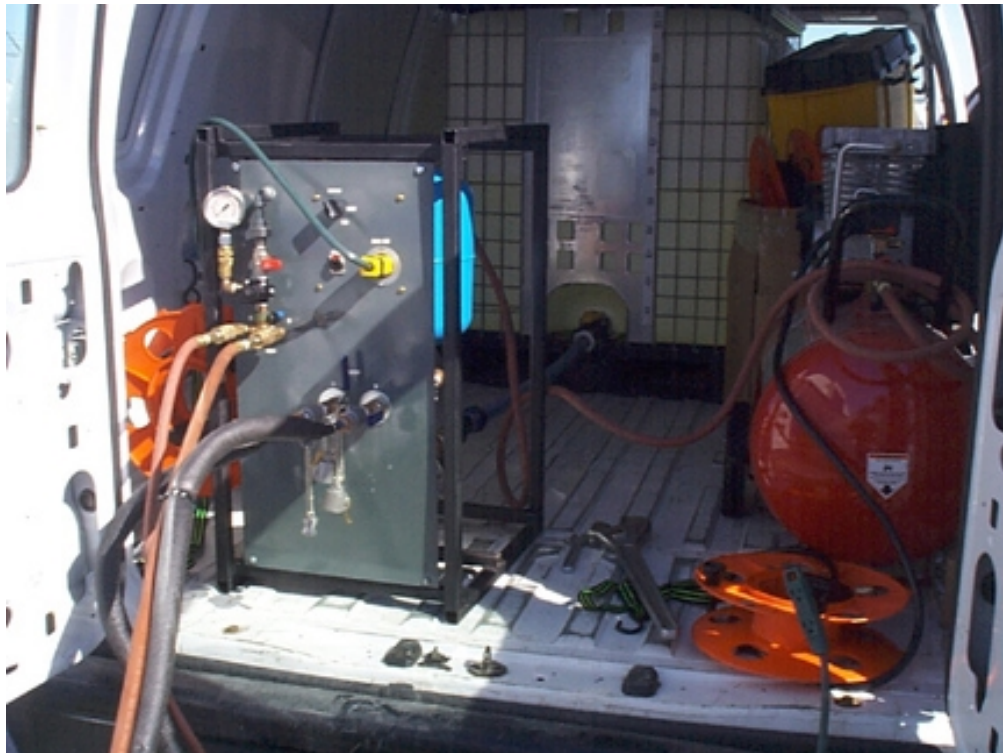
Photo 2.14: Freezing Rain Sprayer in Rental Van

System controls and the overall system installation in the rented van are shown in Photos 2.14. The freezing rain sprayer equipped with the spray hoses is shown in Photo 2.15.

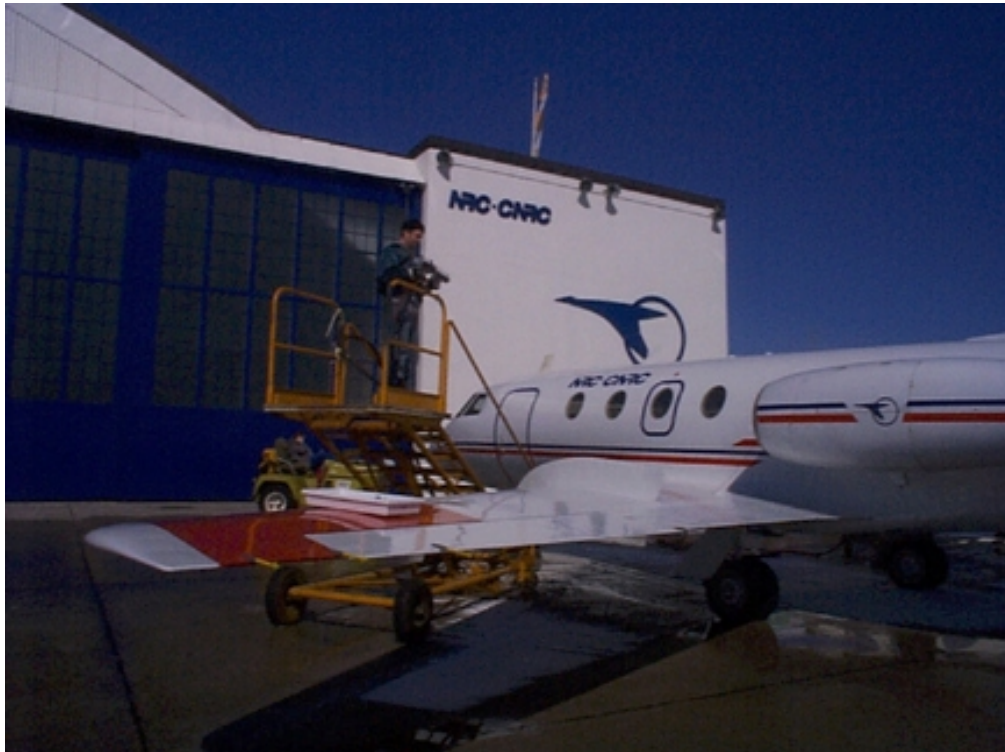
Photo 2.16: Calibration Tests with Freezing Rain Sprayer at NRC

Evaluation tests of the freezing rain sprayer were conducted at the NRC Flight Research Laboratory on March 7, 2002, using the Falcon 20 as a test bed (see Photo 2.16). These tests demonstrated that rates typical of freezing rain could be achieved using the portable unit, provided the wind conditions were adequately low. Because the spray bars are hand-held and manipulated by an operator to provide coverage over the surface of the wing, the rates and consistency of coverage may be operator dependent. For this reason, it is important that spray personnel are familiar with the operation of the spray apparatus prior to testing.

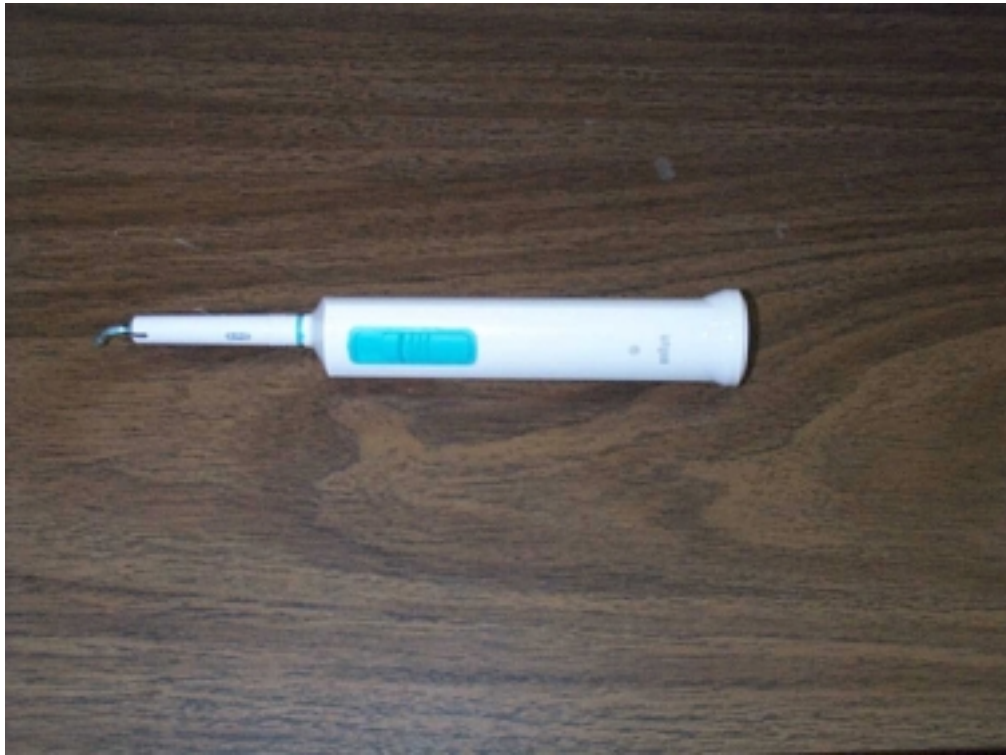
Photo 2.17: Device Used to Test Adherence

During the 1997-98 study characterising the nature of aircraft anti-icing fluids during the process of contamination, a qualitative method of determining the extent of adhesion failure dimensionality and degree of bonding was developed (refer to Transport Canada report, TP13317E, *Characteristics Of Aircraft Anti-Icing Fluids Subjected To Precipitation* (6)). This method was based on the use of an electric dental floss device (Photo 2.17).

In operation (Photo 2.10), a thread of "floss" was spun by the device. A floss segment extended radially about 3 to 4 mm from the tip of the unit, and upon spinning could carve out a circle (if adhesion had occurred) with a radius of 3 to 4 mm on a failed surface element. In a layer of non-adhered fluid, the force of the spinning floss was sufficient to expose the surface of the test plate.

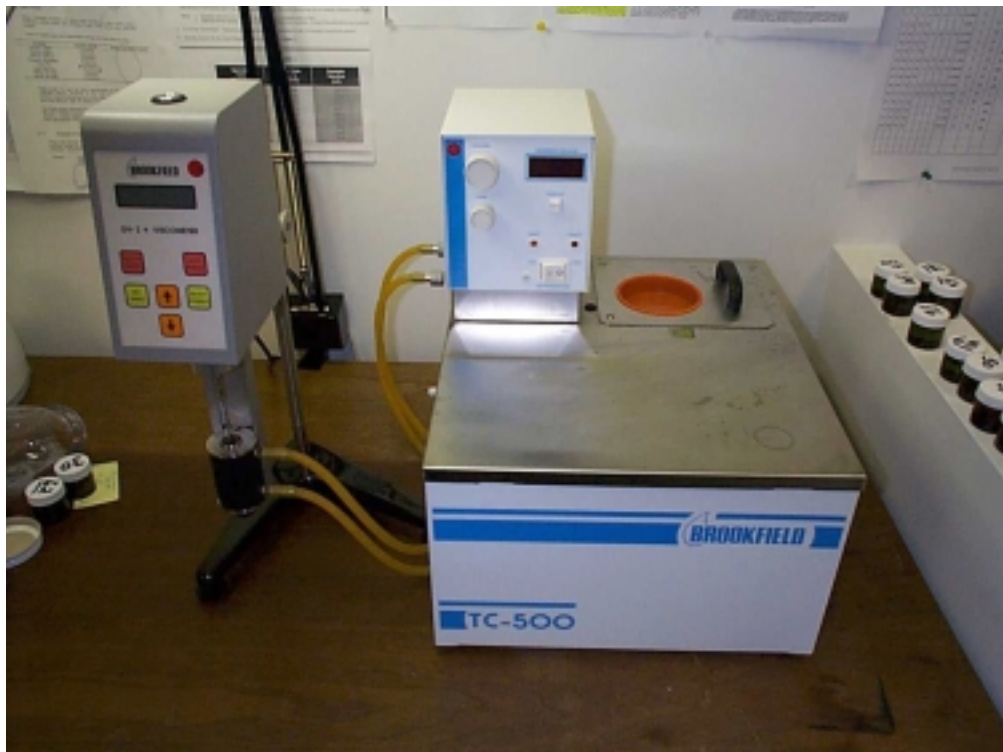
Photo 2.18: Brookfield Digital Viscometer Model DV-1+ and Temperature Bath

Fluid samples for viscosity tests were gathered from various points within the wing test area and were stored in small wide-mouth glass bottles with screw caps. Viscosity measurements of these samples were carried out using a Brookfield viscometer (Model DV-1+ , Photo 2.18) fitted with a thermostatted re-circulating fluid bath and microsampling option.

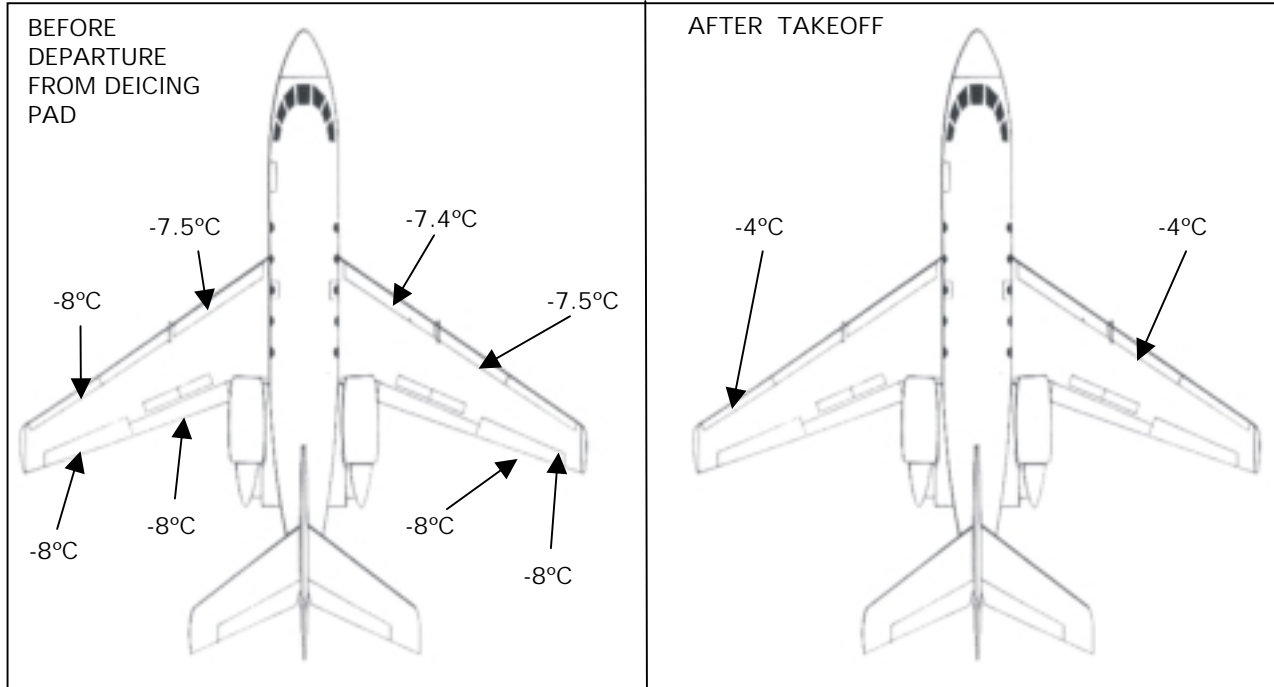
Figure 4.1: Wing Skin Temperatures (°C) – March 6, 2002 – Run 1, Before/After Takeoff Run

Prior to the departure of the Falcon 20 from the deicing pad, the wing temperatures ranged from -7.4°C to -8°C (see Figure 4.1). The ambient air temperature at the start of testing was -8°C.

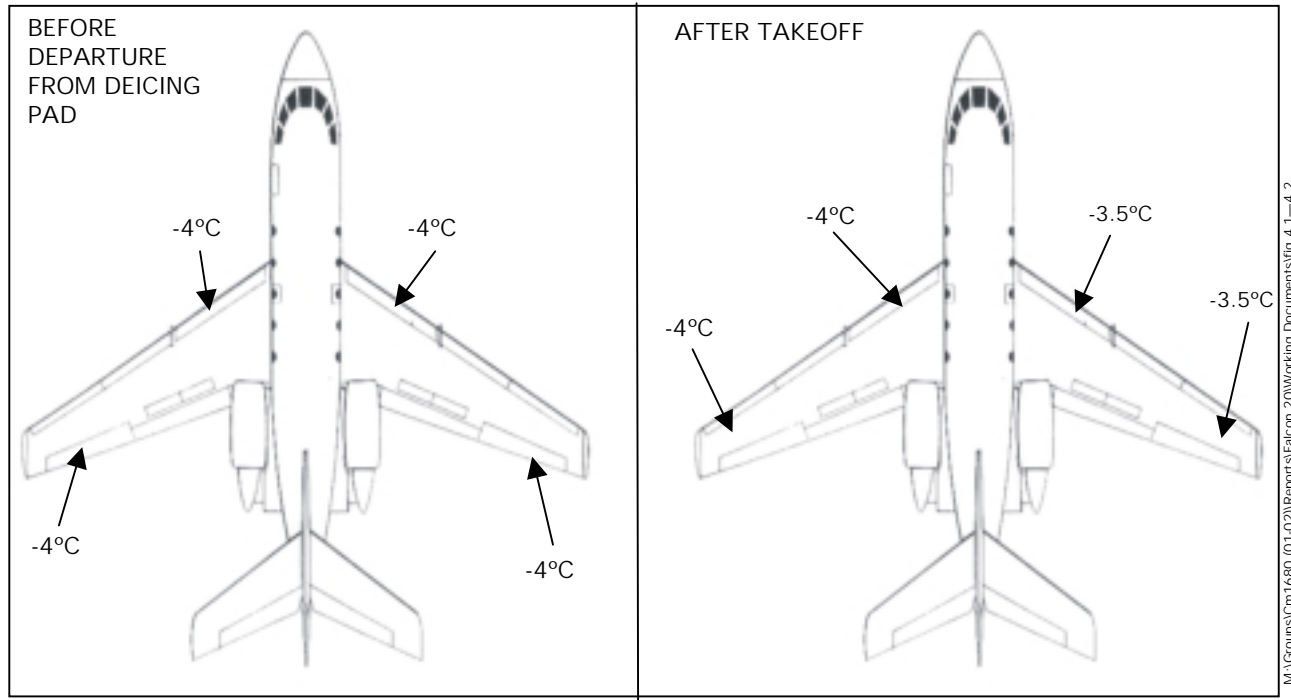
Figure 4.2: Wing Skin Temperatures ( $^{\circ}\text{C}$ ) – March 6, 2002 – Run 2, Before/After Takeoff Run

Prior to the departure of the Falcon 20 from the deicing pad, the wing surface temperature was  $-4^{\circ}\text{C}$  (see Figure 4.2). The ambient temperature at the start of testing was  $-7^{\circ}\text{C}$ .

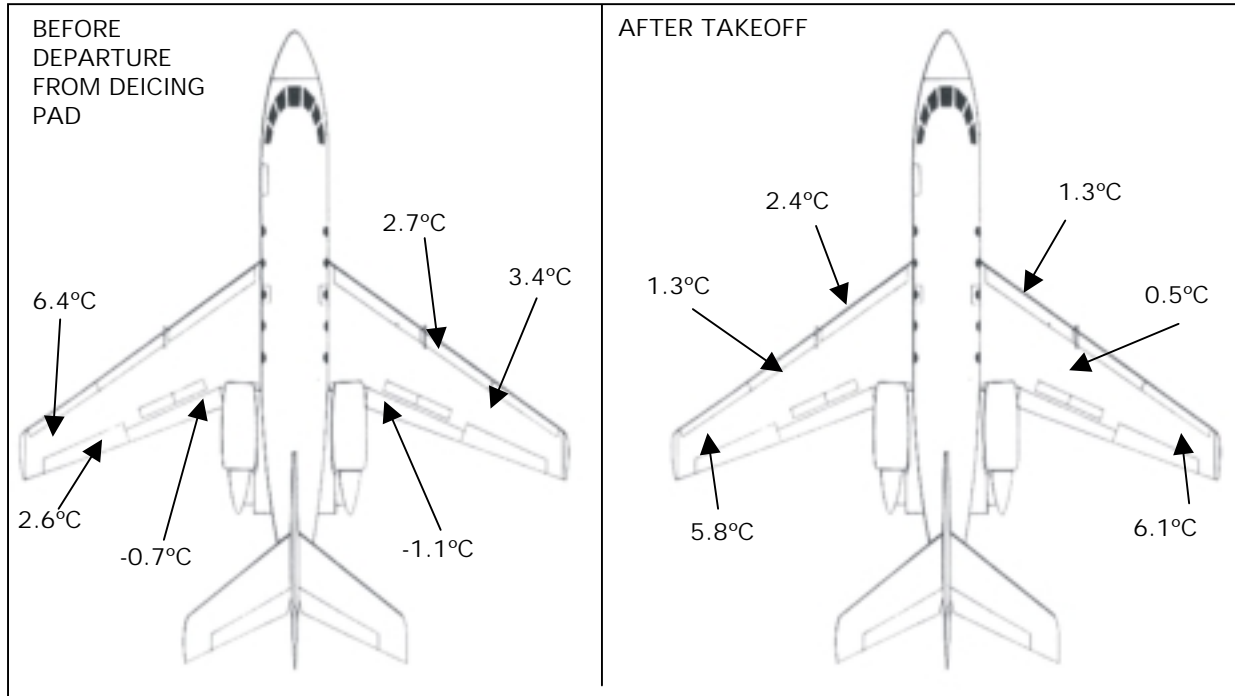
Figure 4.5: Wing Skin Temperatures (°C) – March 6, 2002 – Run 5, Before/After Takeoff Run

The temperatures of the Falcon 20 wing ranged from 6.4°C to -1.1°C prior to the departure of the aircraft from the deicing pad. The sun was poking through the broken cloud layer and warmed the wing (see Figure 4.5). The ambient temperature at the start of testing was -3°C.

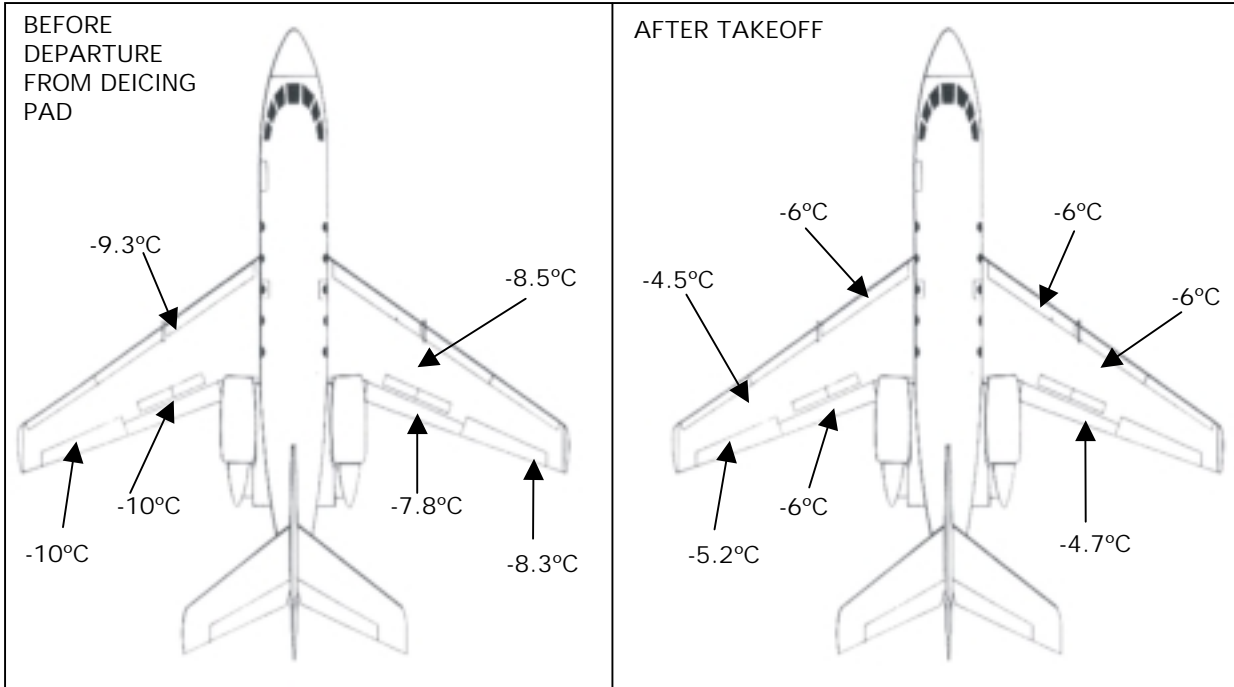
Figure 4.6: Wing Skin Temperatures ( $^{\circ}\text{C}$ ) – March 11, 2002 – Run 1, Before/After Takeoff Run

The wing temperatures prior to takeoff run ranged from  $-7.8^{\circ}\text{C}$  to  $-10^{\circ}\text{C}$  (see Figure 4.6). The ambient temperature at the start of testing was  $-11^{\circ}\text{C}$ .

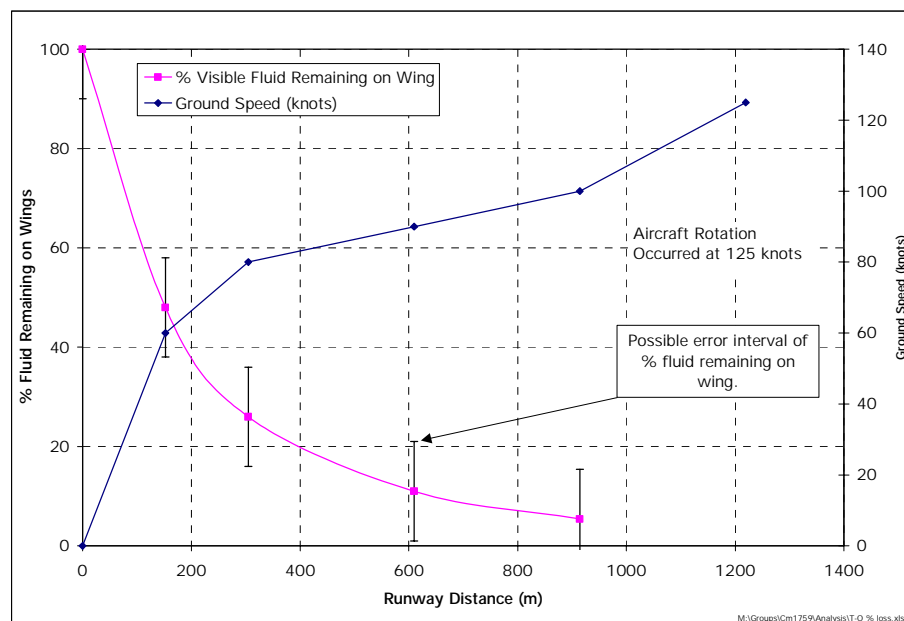
Figure 4.13: Fluid Remaining on the Wings of the Falcon 20 During the Takeoff Run

Figure 4.13 shows that when the aircraft reached 80 knots of ground speed, approximately 75 percent of the Type IV fluid on the wing had been removed. This occurred in the first 305 metres (1000 ft.) of the takeoff run. In the following 610 metres (2000 ft.) of runway, an additional 20 percent of the fluid had come off the wing. This scenario may be significantly different, however, for other aircraft. The Falcon 20 was light, carried no cargo, and had very little fuel on board. Furthermore, the Falcon 20 requires a shorter takeoff run than larger, heavier aircraft. While the fluid present on the wings of a larger aircraft would undoubtedly begin to shear off at speeds similar to those shown in Figure 4.13, it would take these larger and heavier aircraft more time and runway length to attain these ground speeds, thus altering the patterns of glycol dispersal over the runway. Also, aircraft size and wingspan would affect the dispersal patterns since some portion of the fluid would be carried by the vortices generated by the different aircraft.

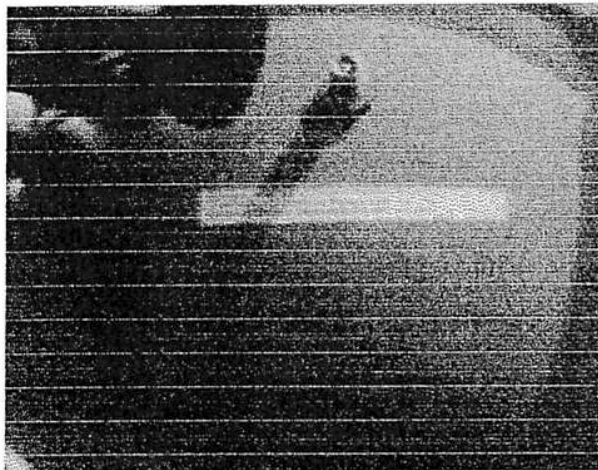
According to manufacturer specifications, the water pressure reservoir air pre-charge should be verified at regular intervals and set to 18 psi of air pressure. Water pressure tank air inlet is located on top of the tank and is a standard car wheel valve type.

*Fig.16 Water pressure tank air inlet*

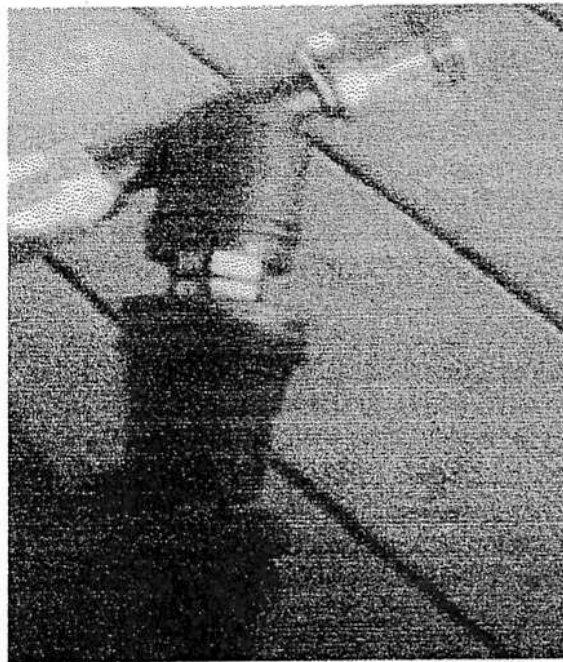
The objective of the three-year test program with the Falcon 20 research aircraft is to ascertain the aerodynamic penalty on the aircraft due to the presence of partially expended anti-icing fluid on the wings of the aircraft. Fluid diluted by snow and freezing rain will be examined as part of this research program. For 2001-02 testing, only one method of fluid dilution was required, although APS also investigated methods for simulating snow using the NCAR artificial snowmaker.
