# Ice Detection Sensor Capabilities for End-of-Runway Wing Checks: Phase 2 Evaluation

**Transportation Development Centre**

**Transport Canada**

August 2000

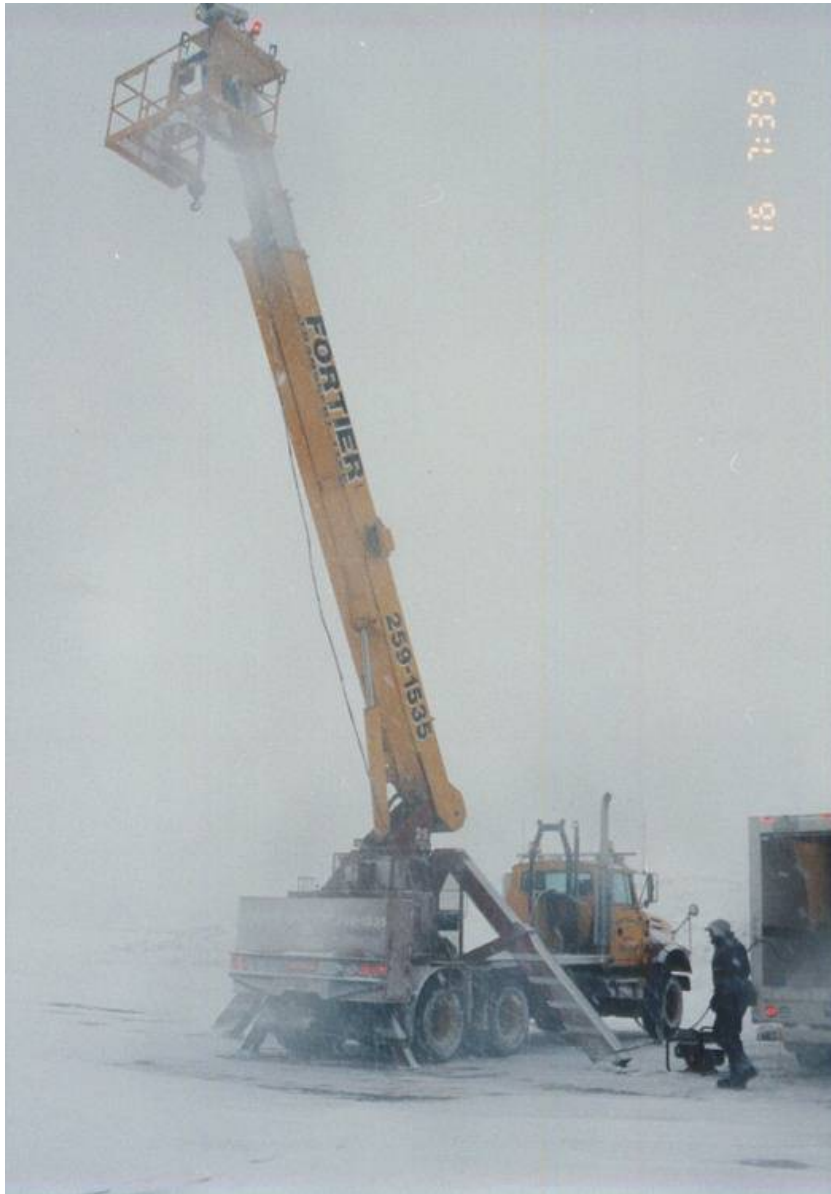
Photo 2.1  
Mobile Crane with Sensor Installed

height (up to 18 m or 60 ft.) at the test location. A suitable crane was located and arrangements were made to have the crane and operator available at short notice based on forecasted weather conditions. For each test, the crane was delivered to the APS test site for installation of the GIDS system on the truck boom. Photo 2.1 shows the mobile crane positioned for testing, with the mast extended and the sensor camera installed. Photo 2.2 shows the sensor camera installation on the crane bucket in more detail. A comprehensive description of the crane and sensor installation is given in the equipment section.

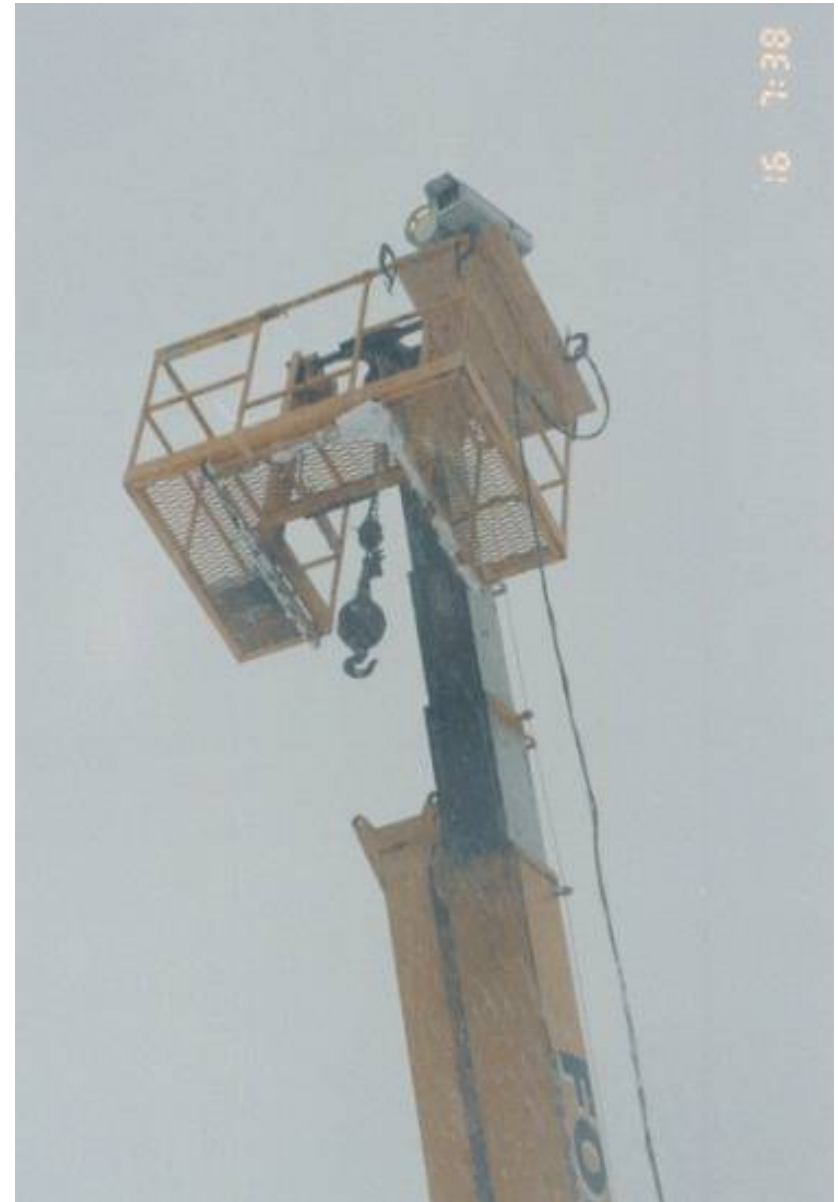
Photo 2.2  
Sensor Installation on Bucket

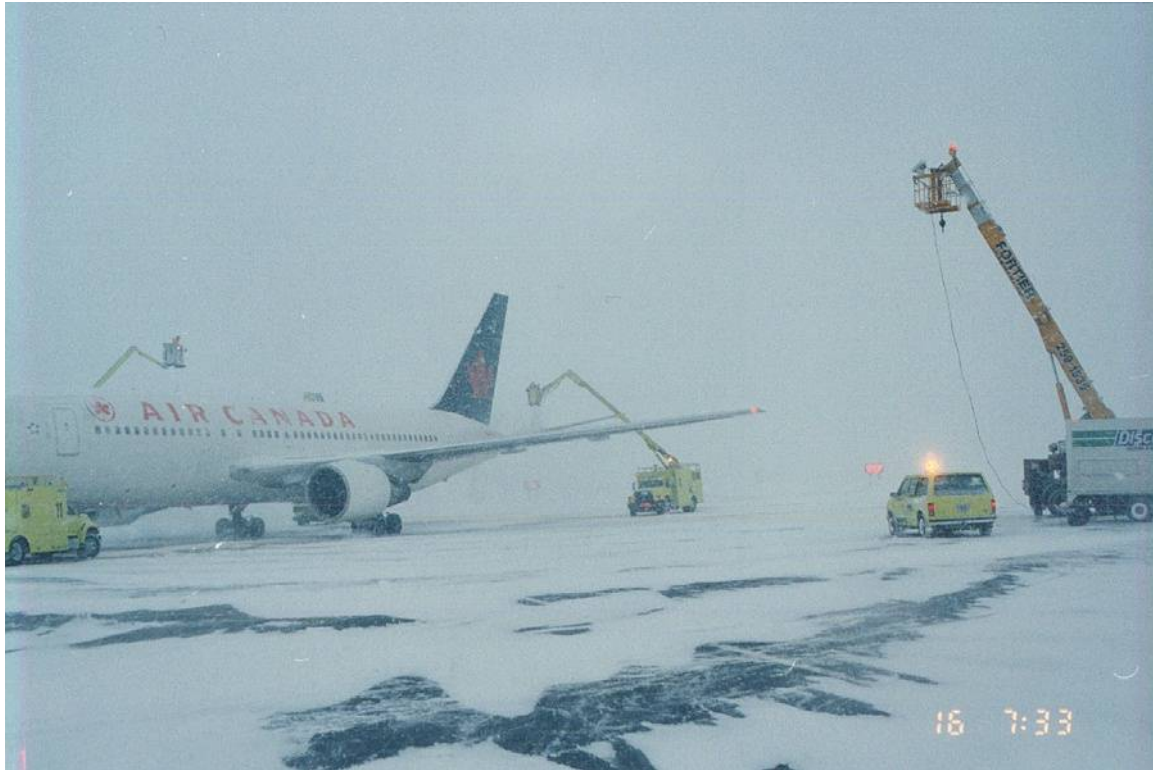
Photo 2.3  
Mobile Crane and Cube Van at CDF Pad 1

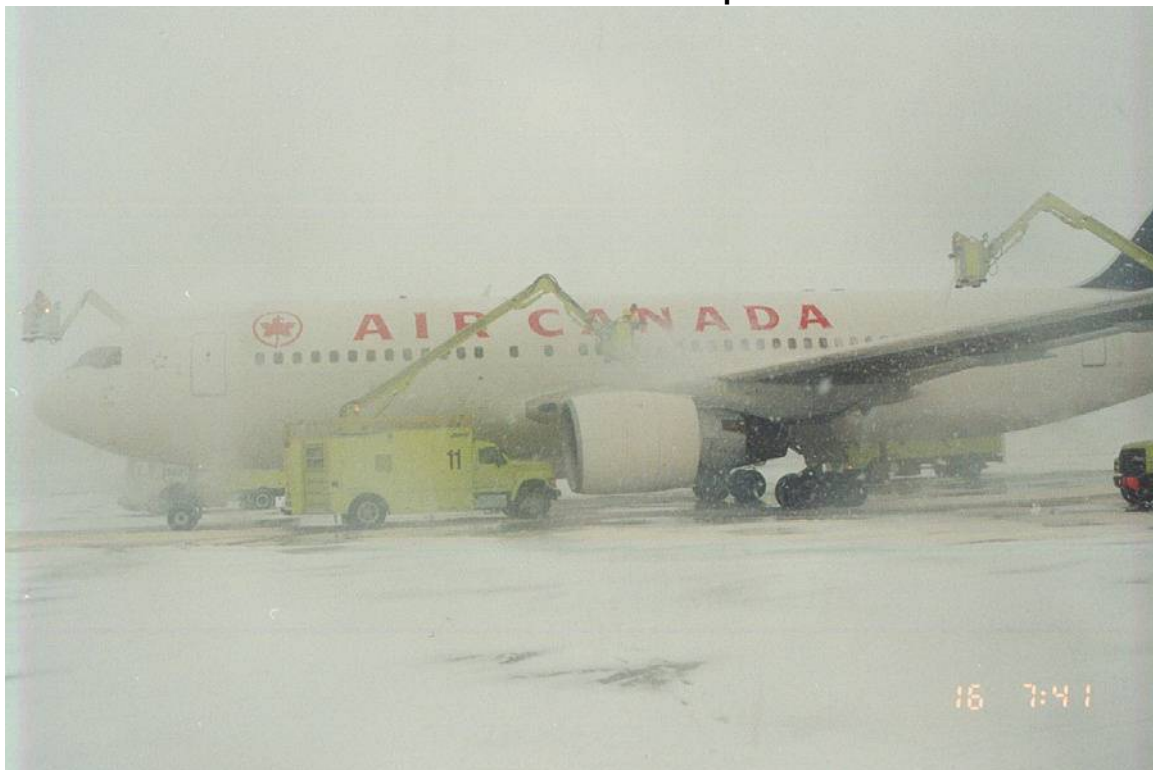
Photo 2.4  
Aircraft on Pad 1 Viewed from Open Cube Van

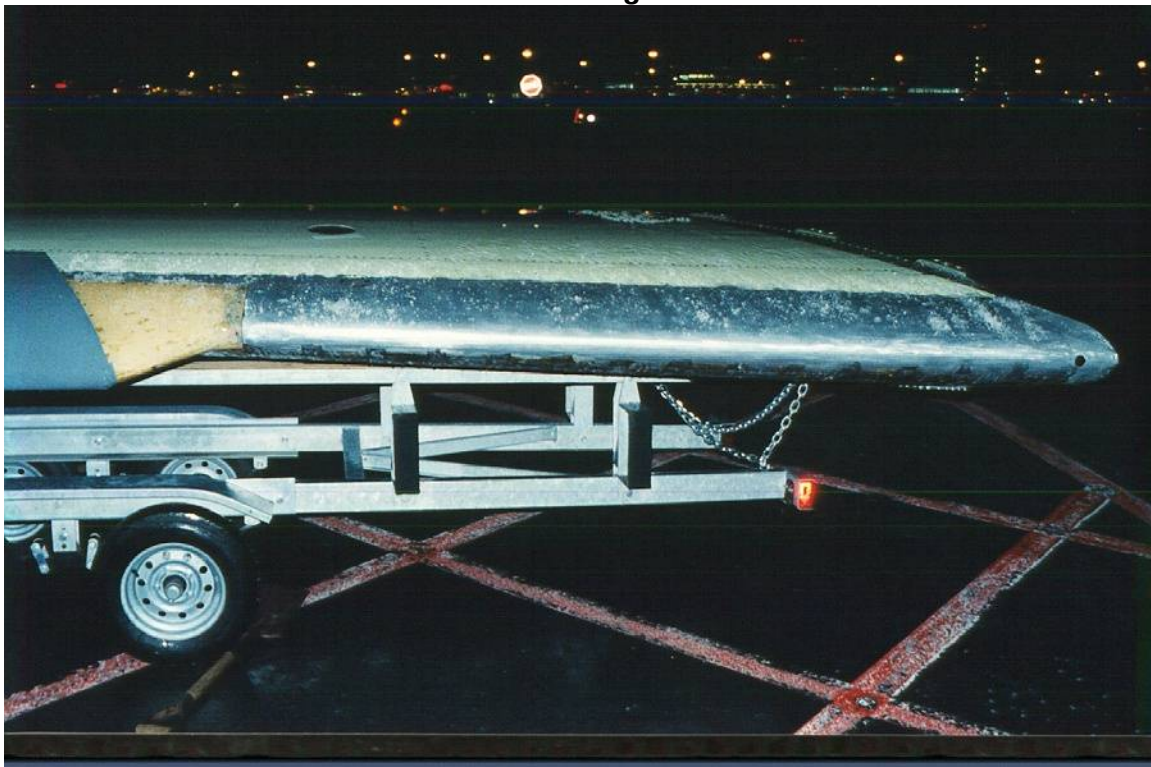
Photo 2.6  
JetStar Test Wing on Trailer

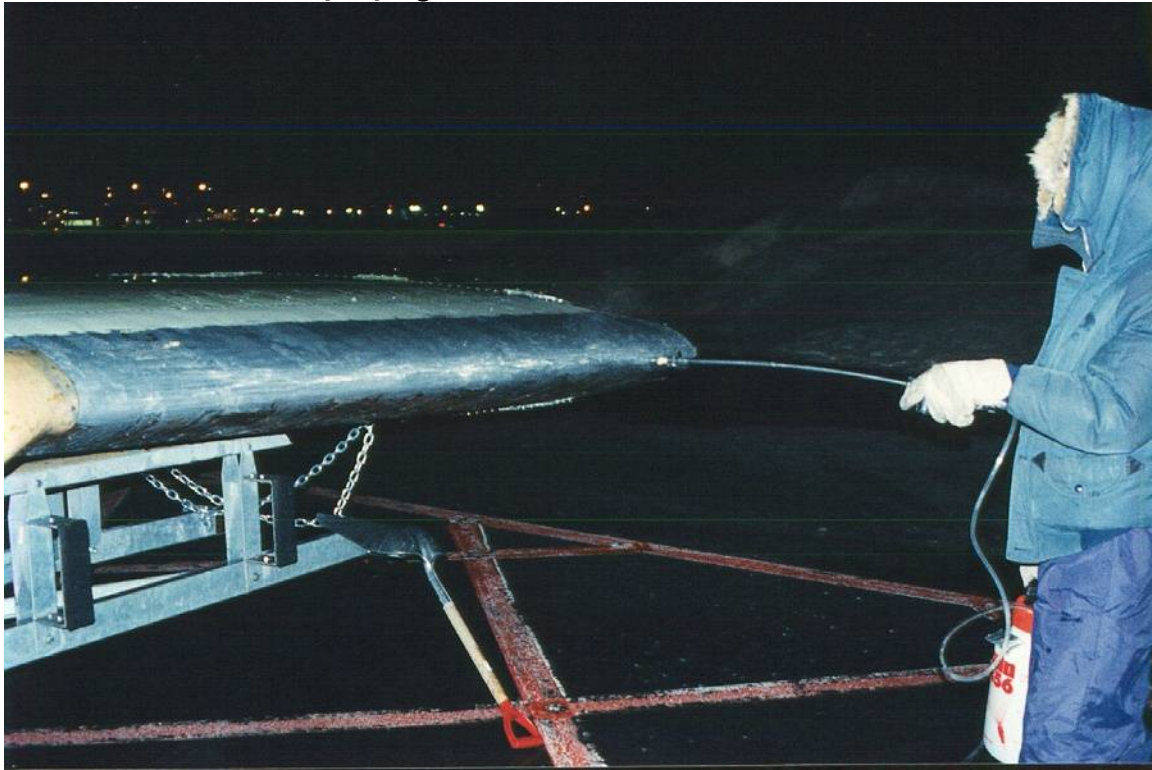
Photo 2.7  
Spraying Water Mist to Form Ice Film

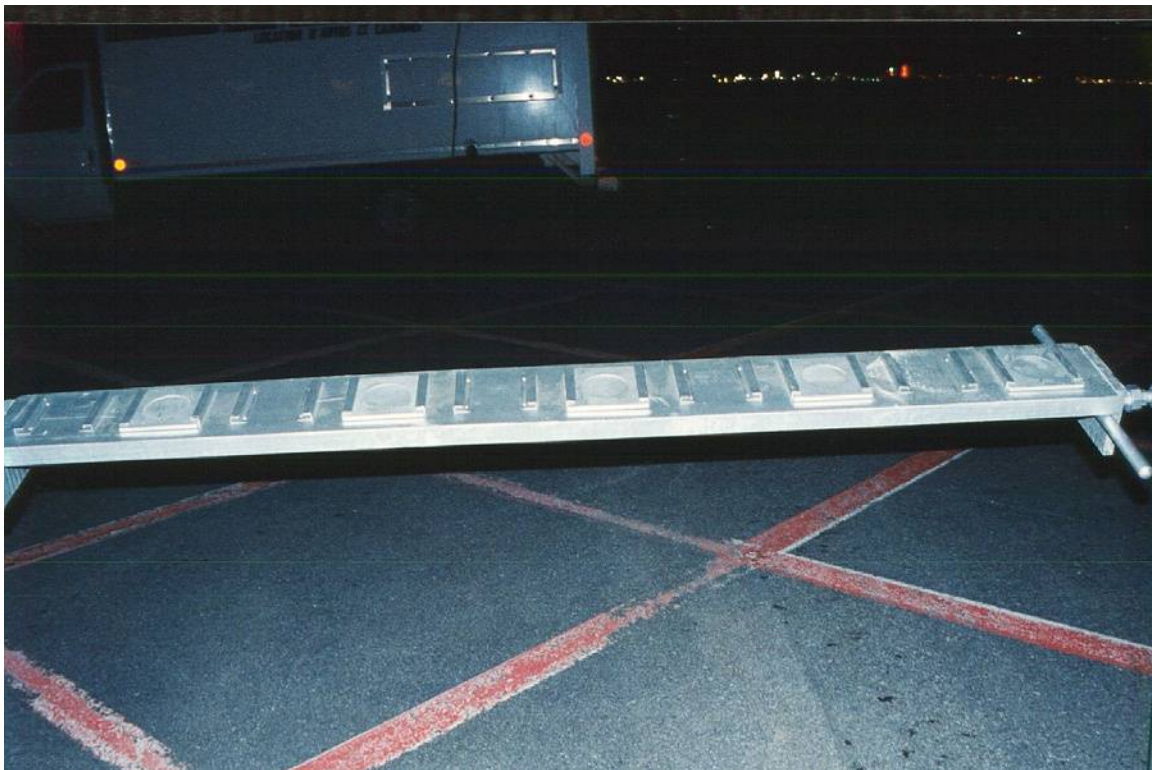
Photo 2.8  
Stand for FAA Ice Detection Plates

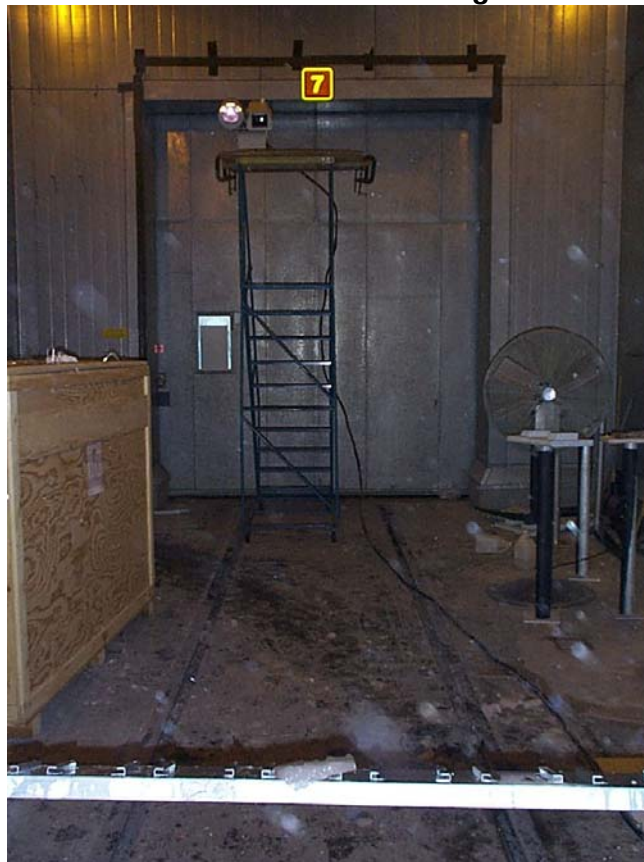
Photo 2.10  
Sensor Mounted on Rolling Stair

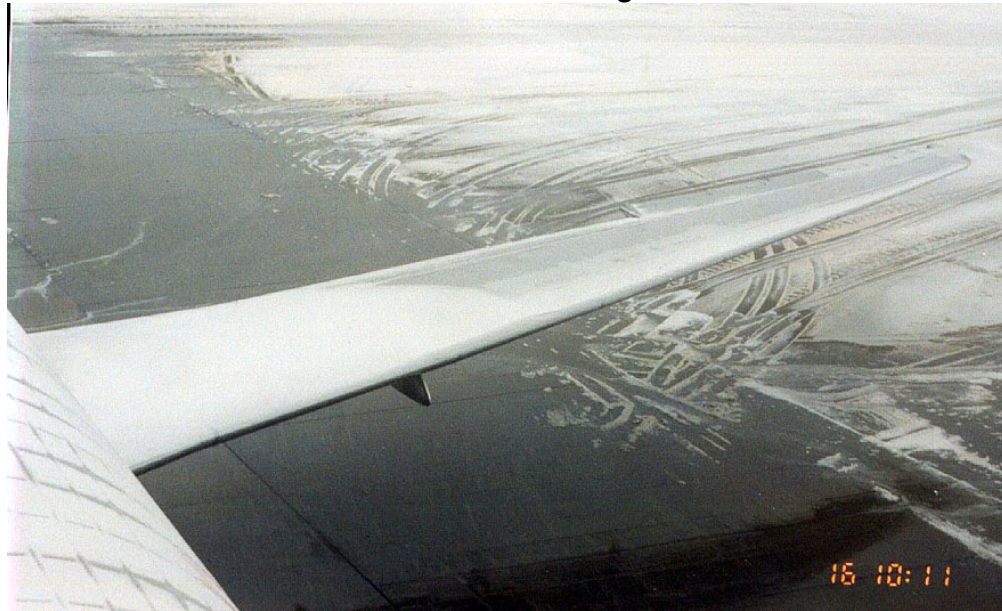
Photo 3.1  
Photo of Snow on Wing MD-80

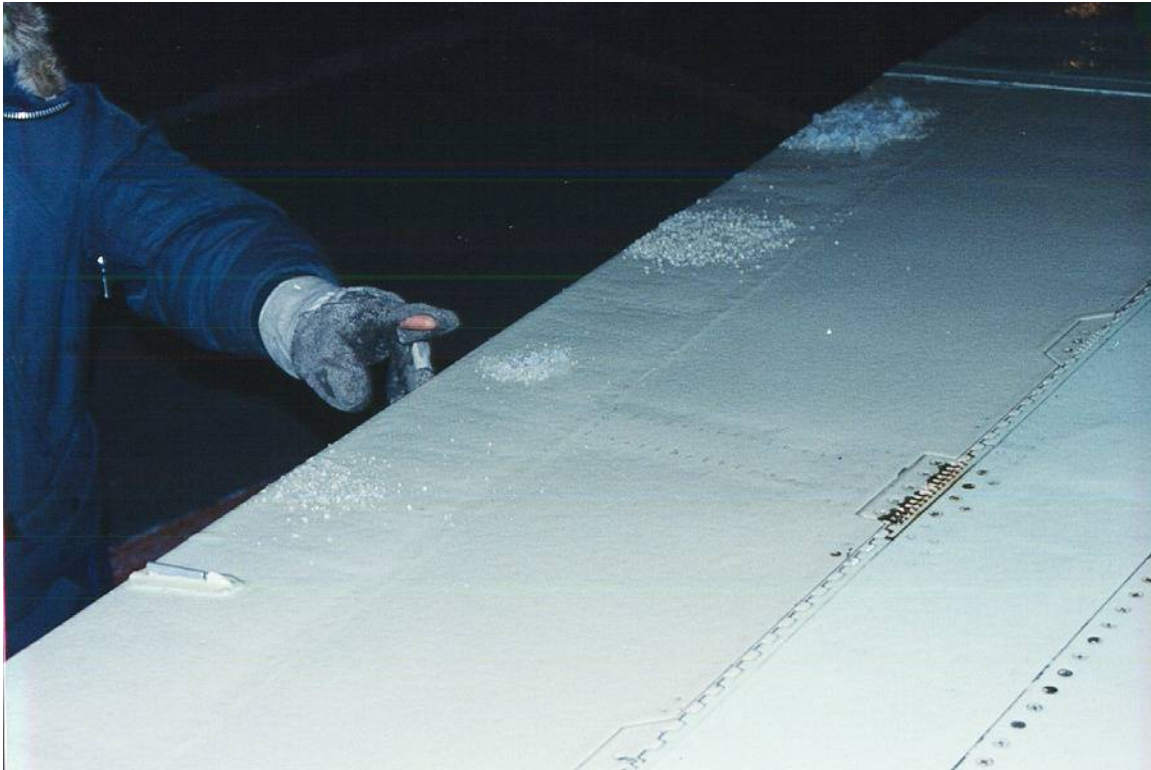
Photo 3.6  
Granular Snow Patches on Aileron

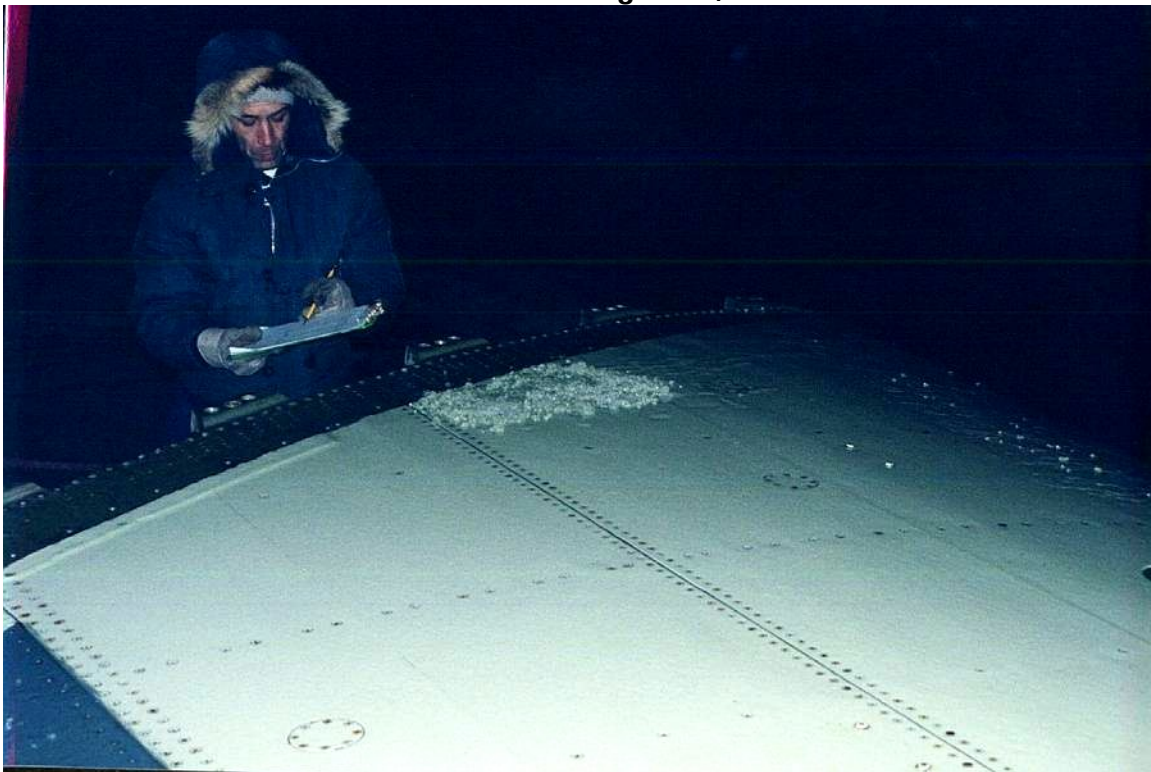
Photo 3.7  
Granular Snow Patch at Wing Root, 10+ mm Thick

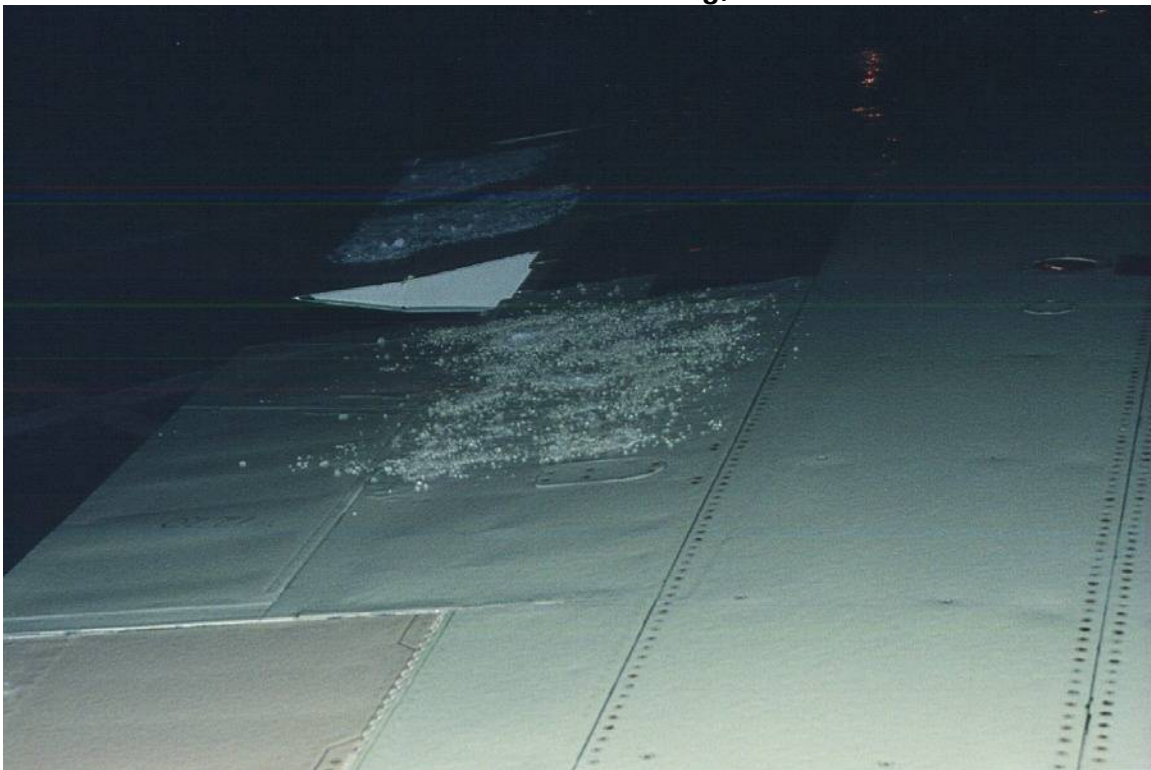
Photo 3.9  
Granular Snow Patch on Main Wing, 10+ mm Thick

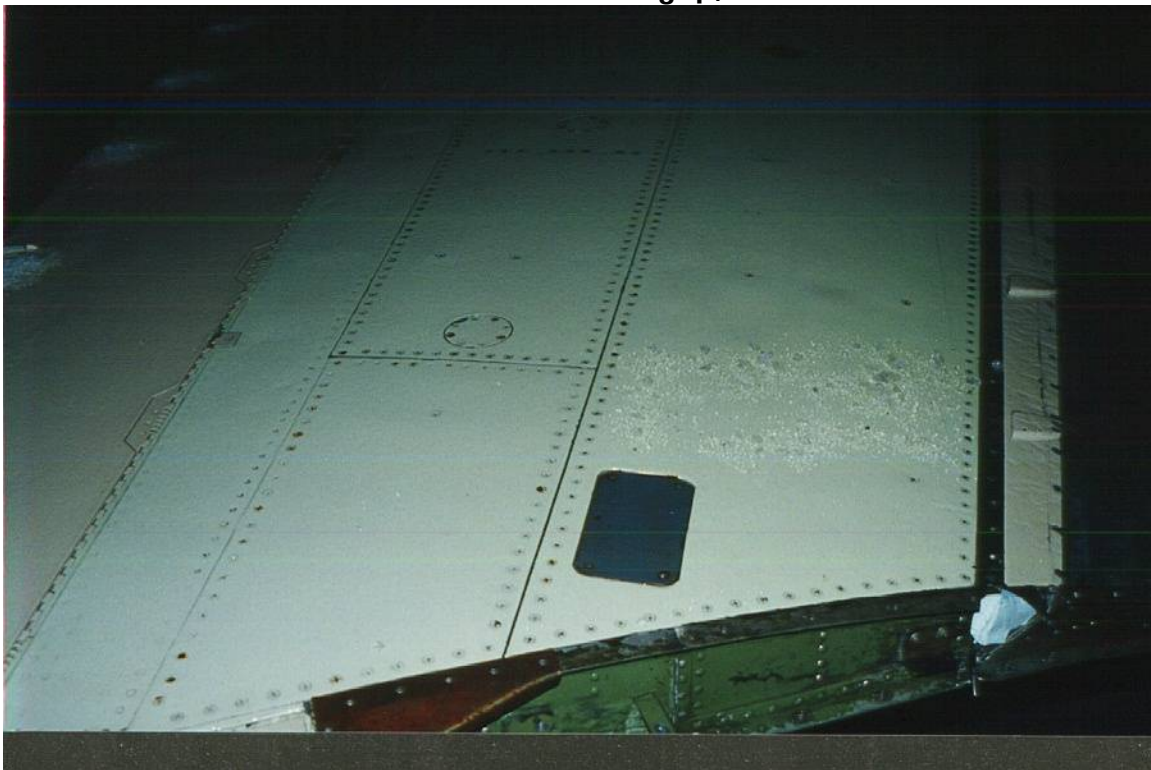
Photo 3.11  
Granular Snow Patch Near Wingtip, 10+ mm Thick

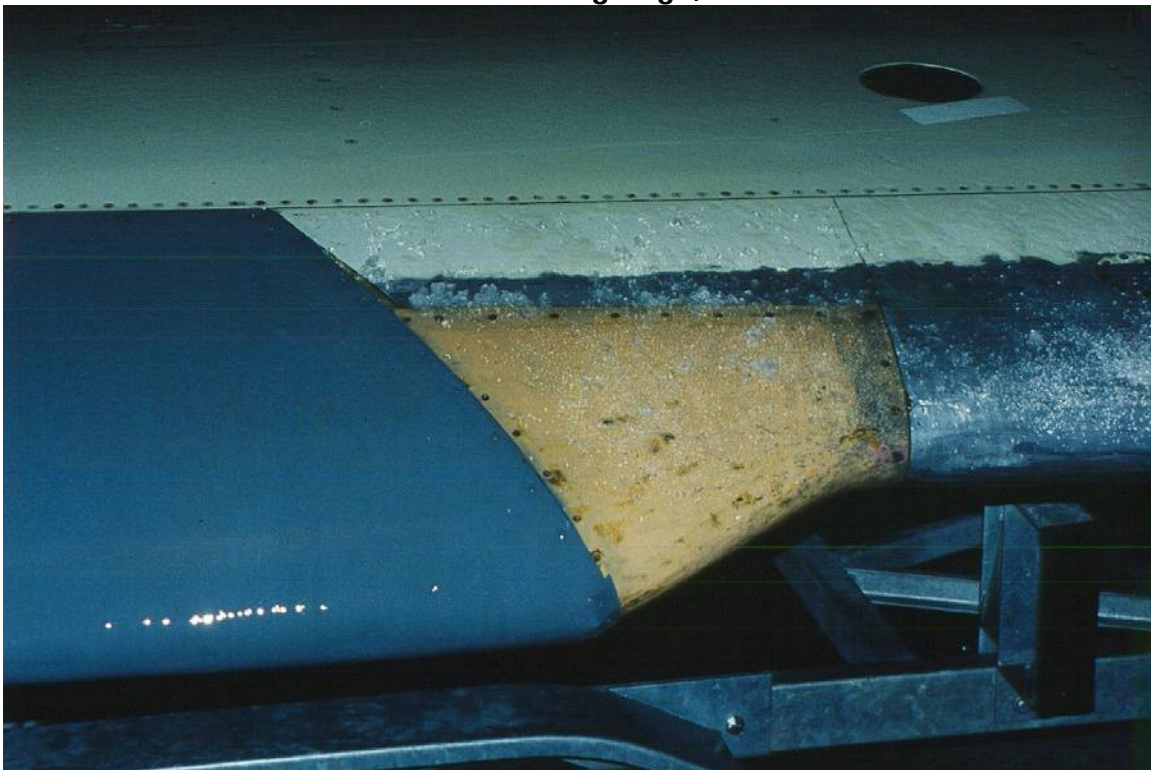
Photo 3.13  
Granular Snow on Leading Edge, 10+ mm Thick

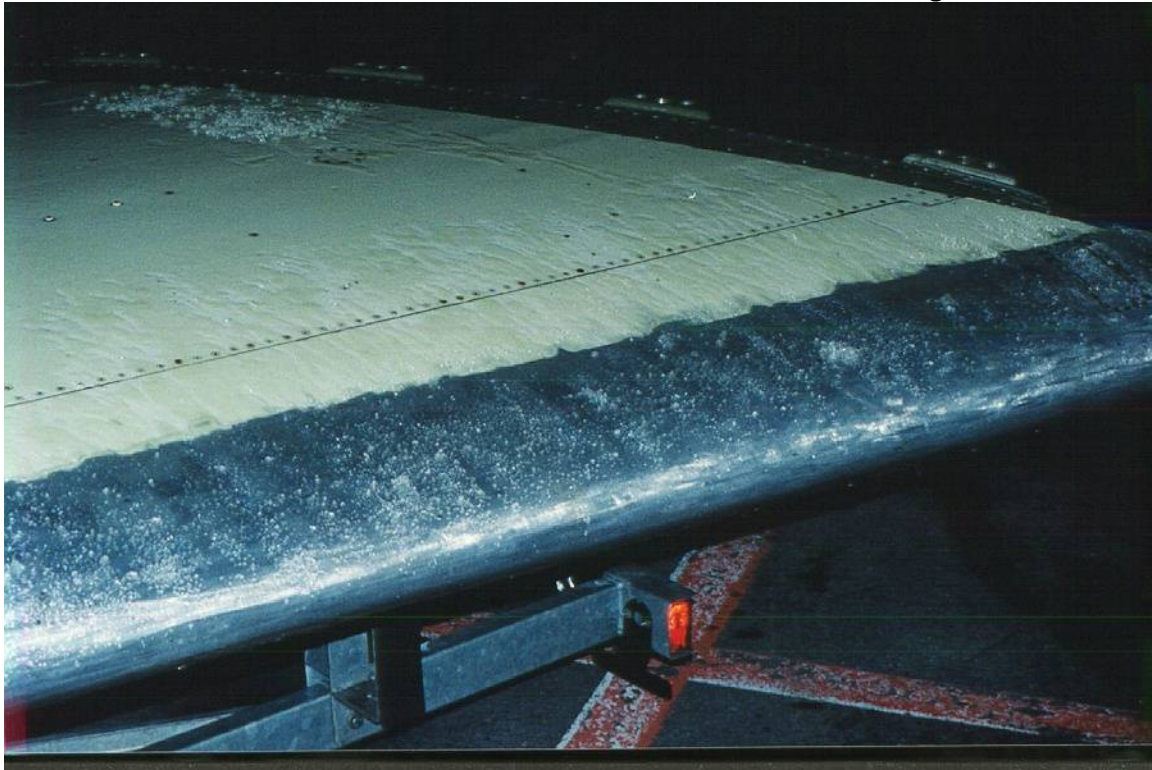
Photo 3.14  
Remnants of Granular Snow Patch on Main Wing

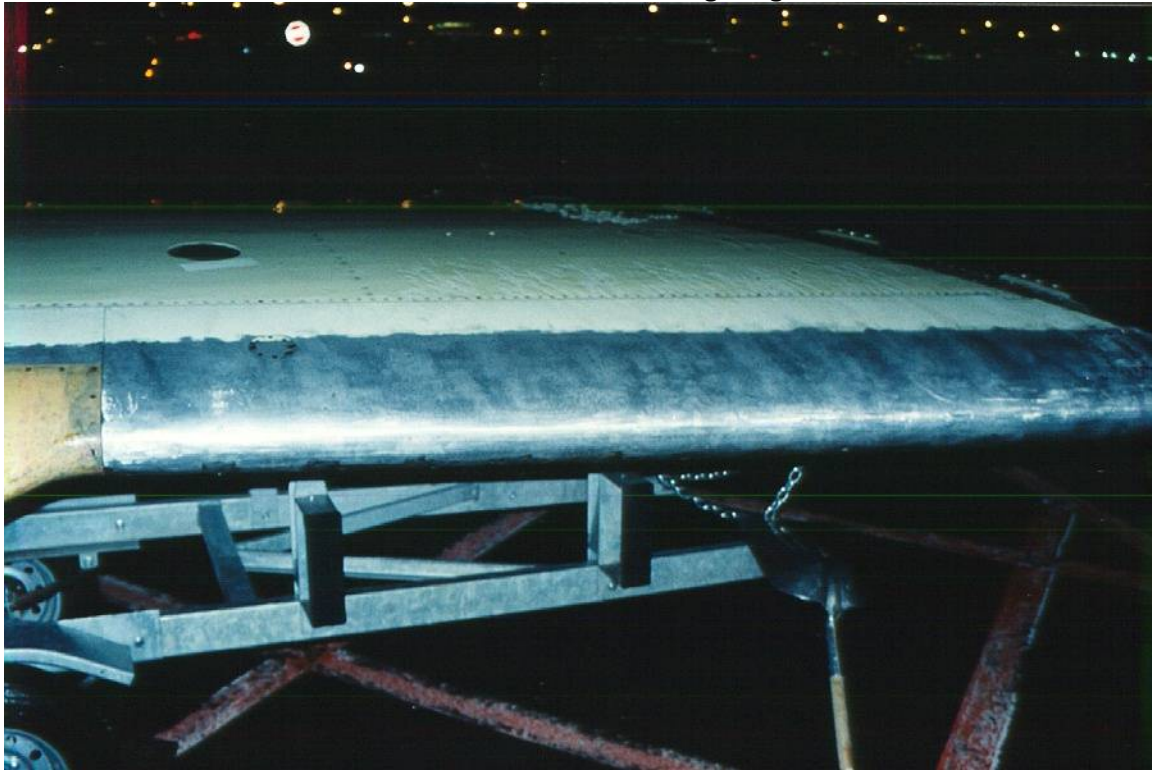
Photo 3.16  
Thin Ice Film on Leading Edge

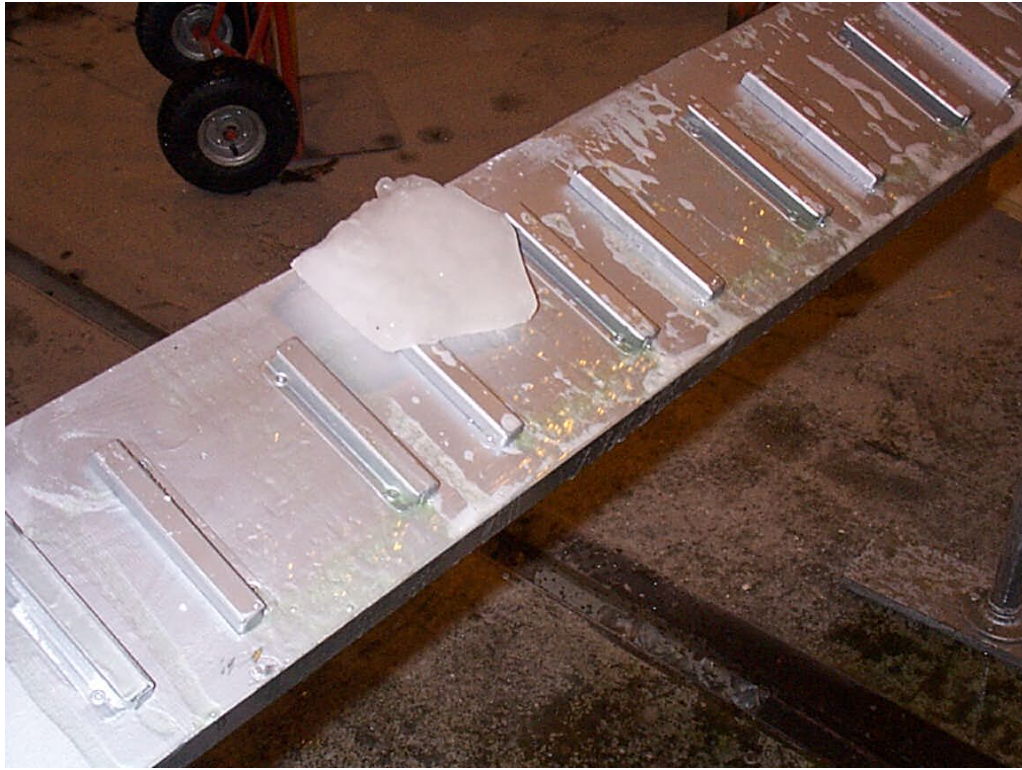
Photo 4.1  
Block of Ice on Test Stand

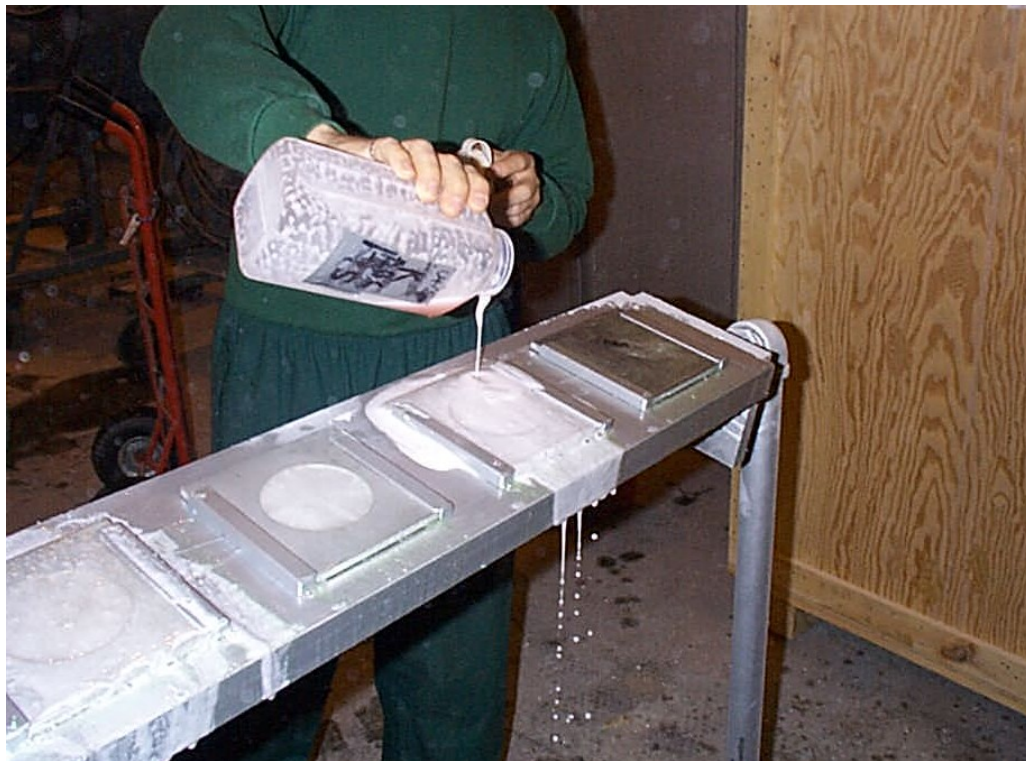
Tests were also performed to examine the impact of fluid foam on the sensor's response, as shown in Photo 4.2. Two Type I fluids, Octoflo EG and UCAR 55A, were shaken to produce foam. The foam was then poured on the test plates. The sensor correctly identified clean surfaces and ice-covered surfaces under the fluid foam.

Photo 4.2  
Fluid Foam Test

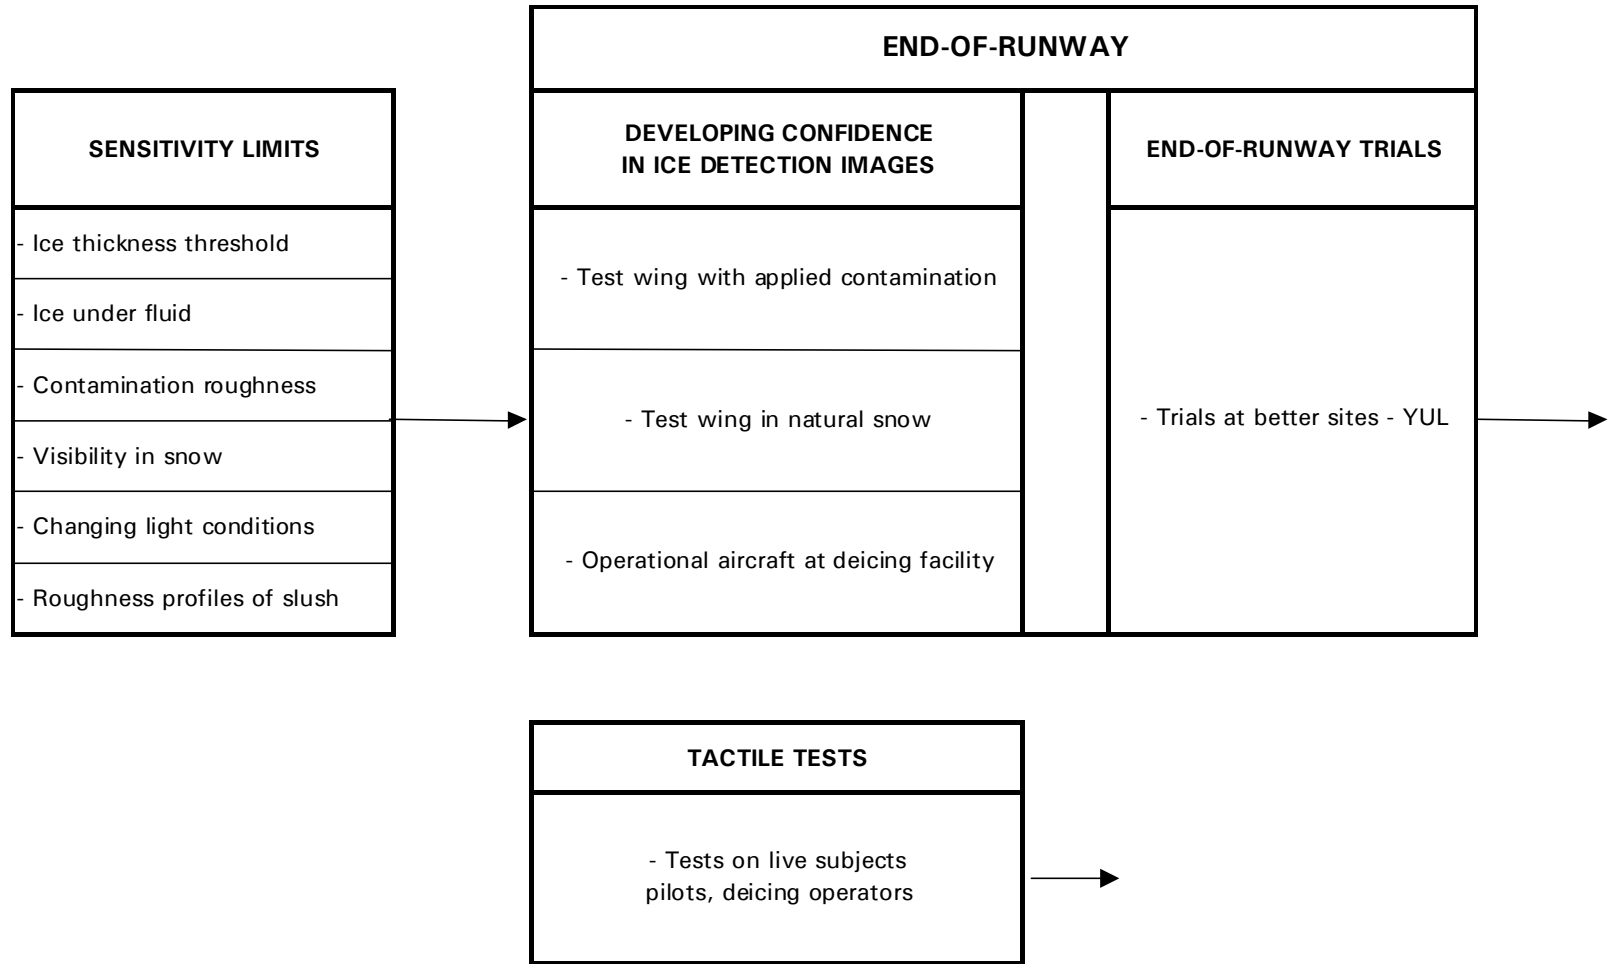
FIGURE B-1  
 REMOTE ICE DETECTION SENSORS  
 OVERALL PROGRAM

Elements 1 and 2 are addressed in a separate project. This procedure addresses elements 3 and 4. Initially, only element 3 (Phase 1 of this procedure) is approved for test.
