Aircraft Full-Scale Test Program for the 1998/99 Winter

Michael Chaput,
Medhat Hanna,
Elio Ruggi and
Jeff Mayhew

October 1999

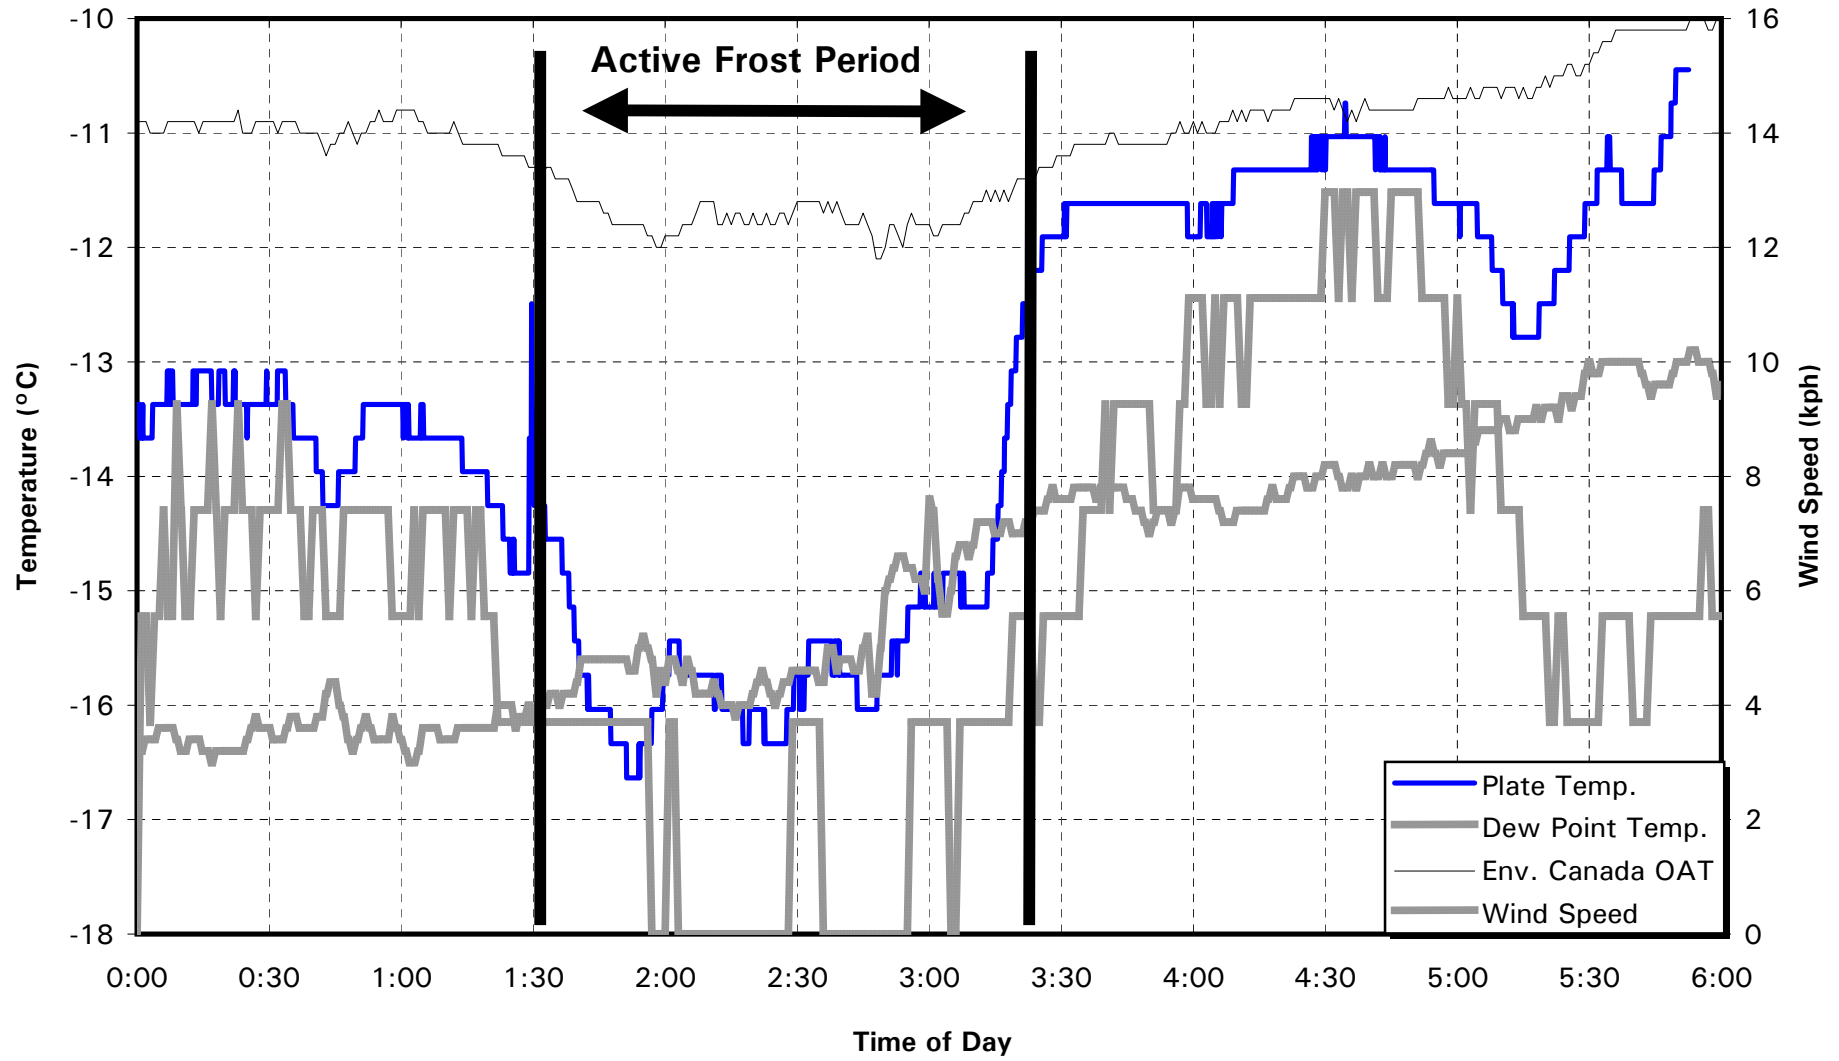
FIGURE 3.2
Meteorological Profile of Test Session
February 14-15

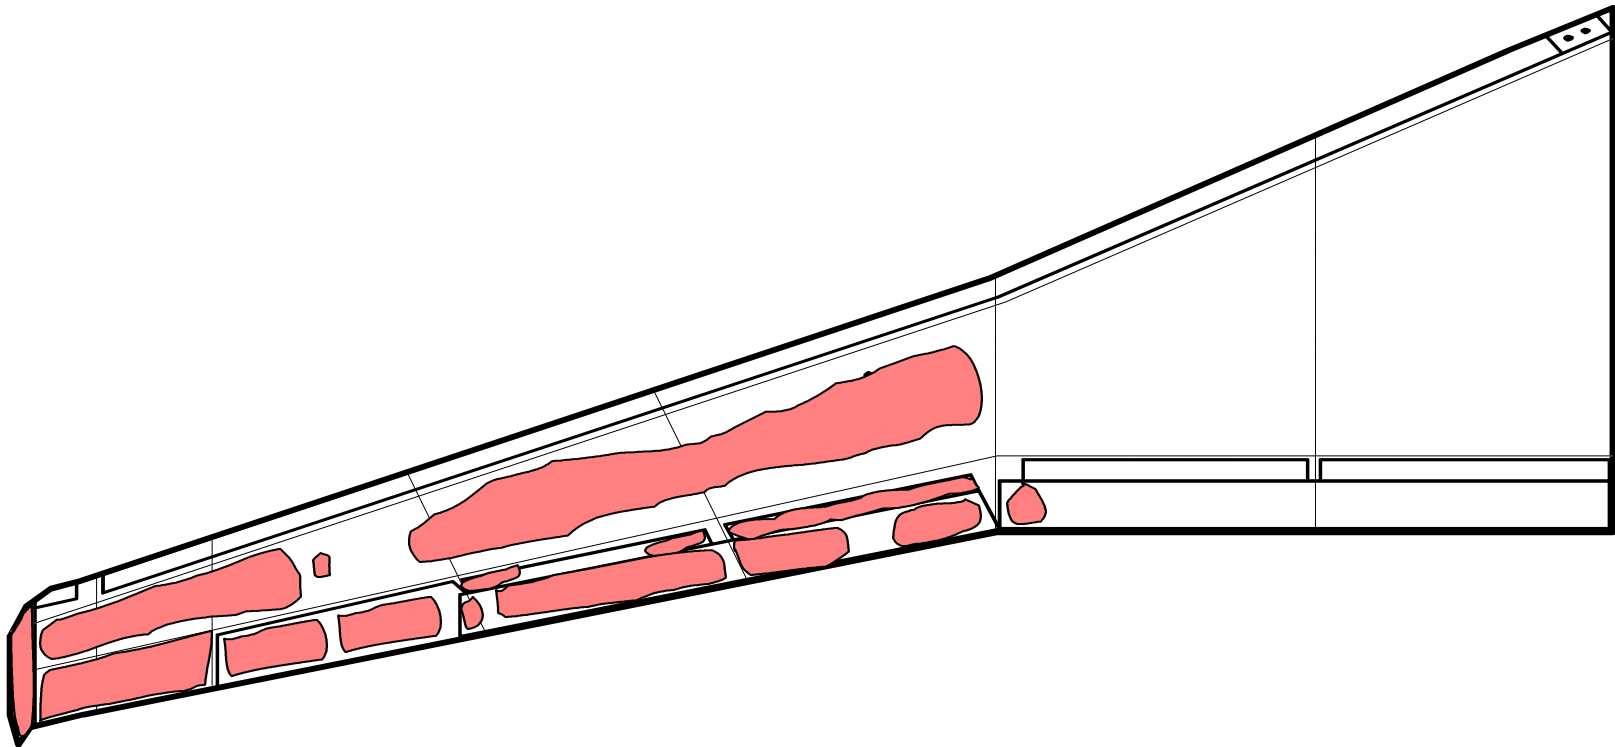
FIGURE 3.3
FROST PATTERN ON CL-65 PORT WING (ID # 1)

December 5, 1998 - 4:00 AM

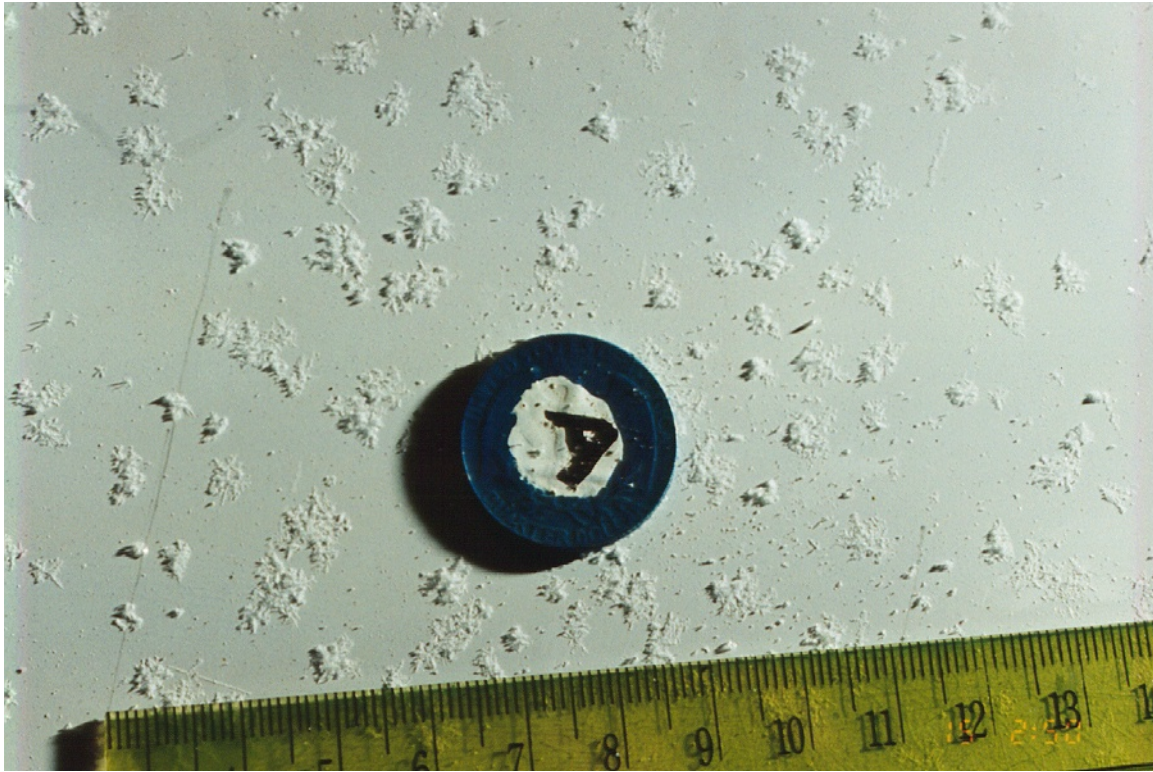
Figure 3.4
Plan Photo of Frost Formation on RJ Aileron

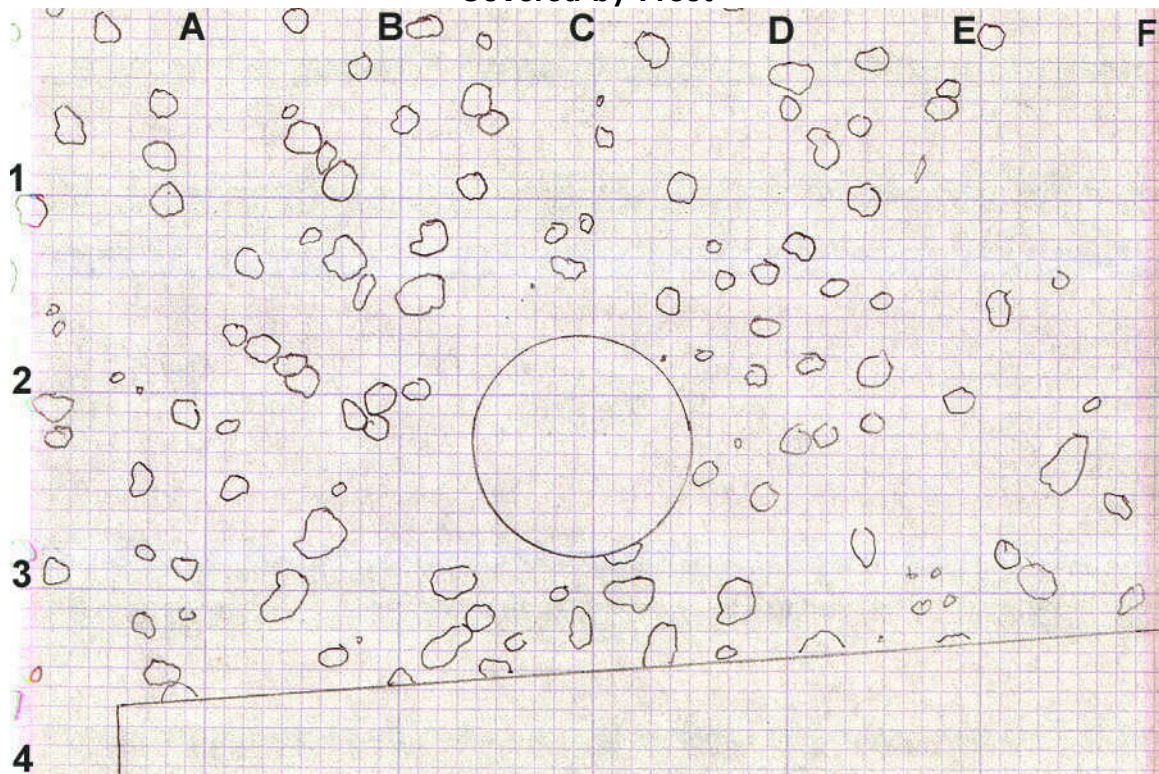
Transparent Grid used to Determine Frost Sizes and Surface Area Covered by Frost

Each large square represents 25.4mm (1 inch).

The average density of frost peaks per square centimetre in each of the wing sections was also calculated using the transparent grid.

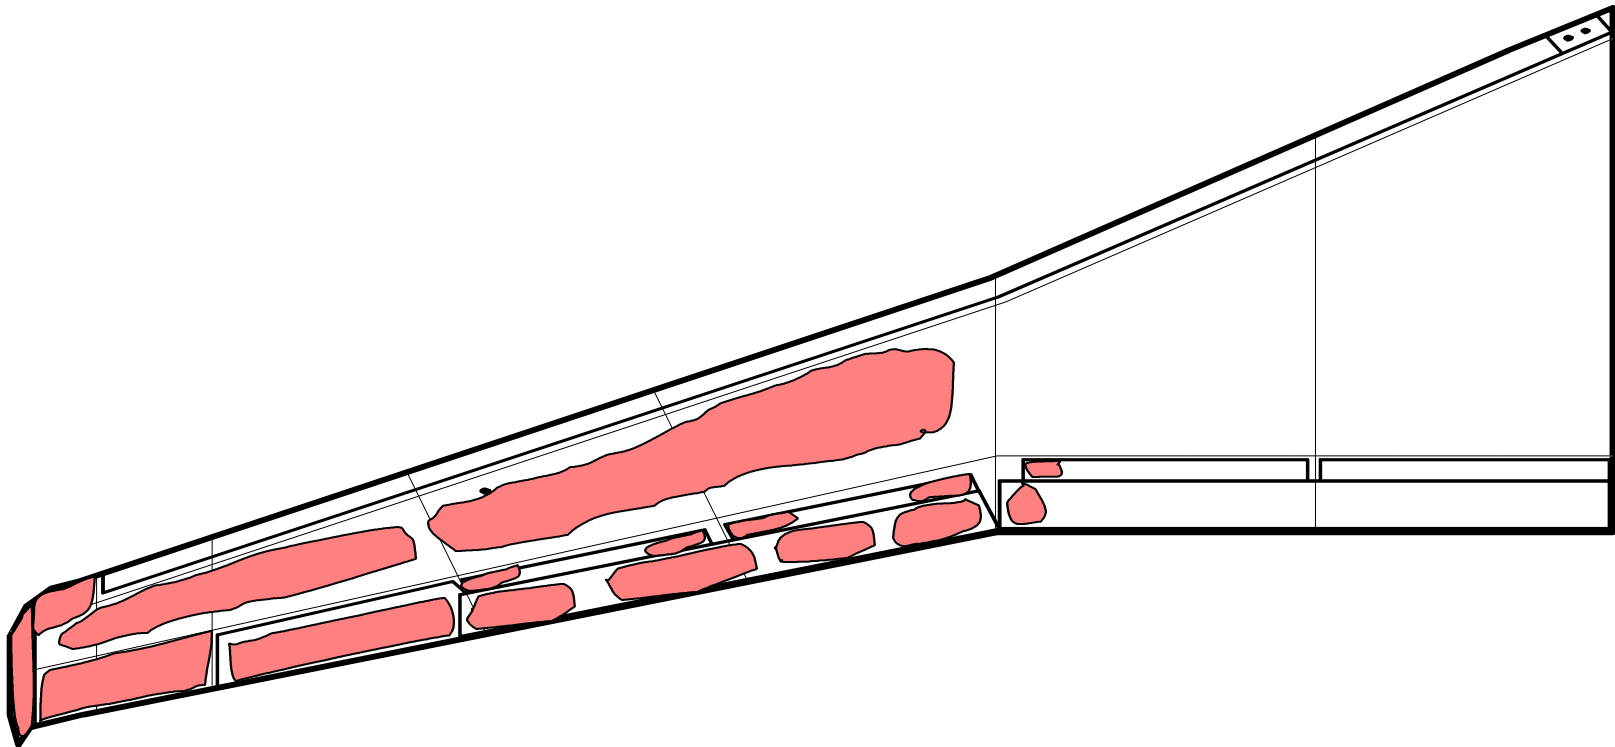
FIGURE 4.5
FROST PATTERN ON CL-65 PORT WING (ID # 3)

February 15, 1999 - 2:40 AM

Another overnighing aircraft was selected by APS personnel for test purposes on February 15, 1999. The frost development patterns observed during this test (ID#3) are shown in Figure 4.5. A much lighter frost had formed on the wing surface than those observed in the two previous frost tests. Although lighter in deposition, the patterns of development were similar to the previous tests, with the heaviest accumulation on the trailing edge outboard of the aileron (see Photo 4.8). No frost was detected on the leading edge (see Photo 4.9) or on the inboard mid-wing section.

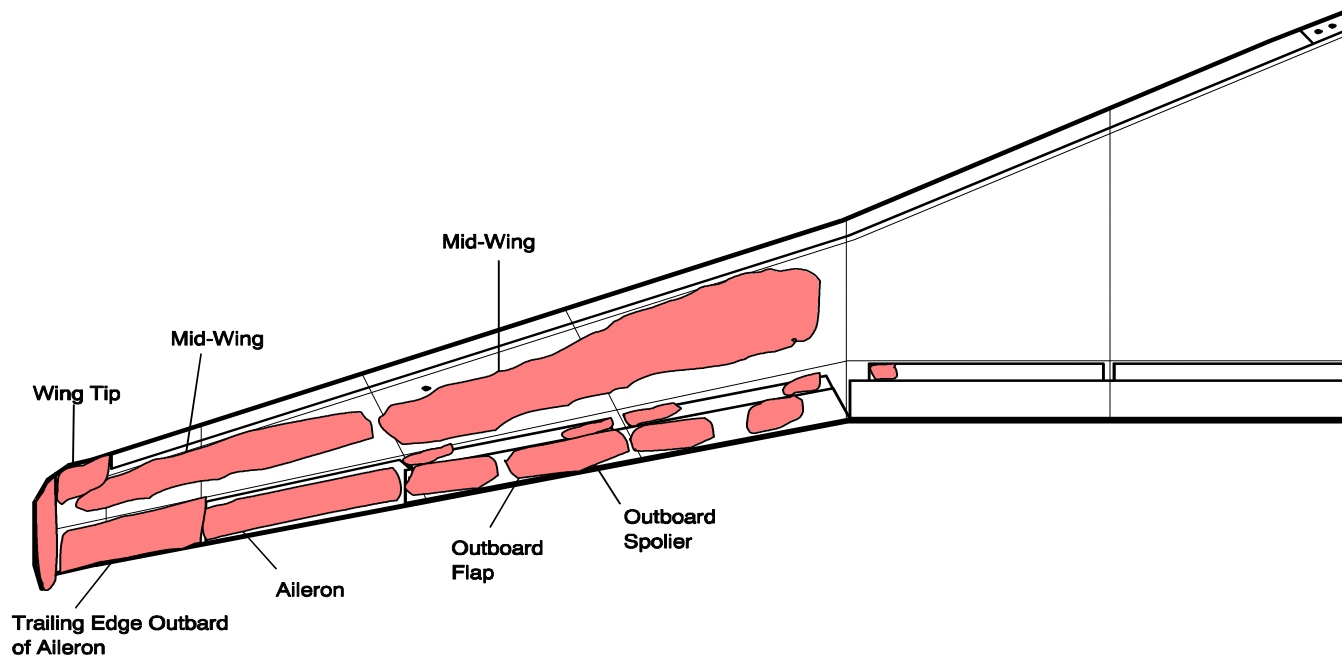
TABLE 4.1
FROST DIAMETER, HEIGHT, SURFACE AREA COVERAGE, AND DENSITY
ON A CL-65 WING (ID # 3)

Wing Section	Average Frost Diameter (mm)	Surface Area Covered	Average Frost Height (mm)	Density Peaks/cm ²
Aileron	4	12%	0.2	2
Outboard Spoiler	3	9%	< 0.2	2
Outboard Flap	1	6%	< 0.2	4
Mid-Wing	3	8%	< 0.2	2
Wing Tip	5	80%	0.5	NA
Mid-Wing	3	7%	< 0.2	2
Trailing Edge Outboard of Aileron	> 5	94%	0.5 - 0.8	NA

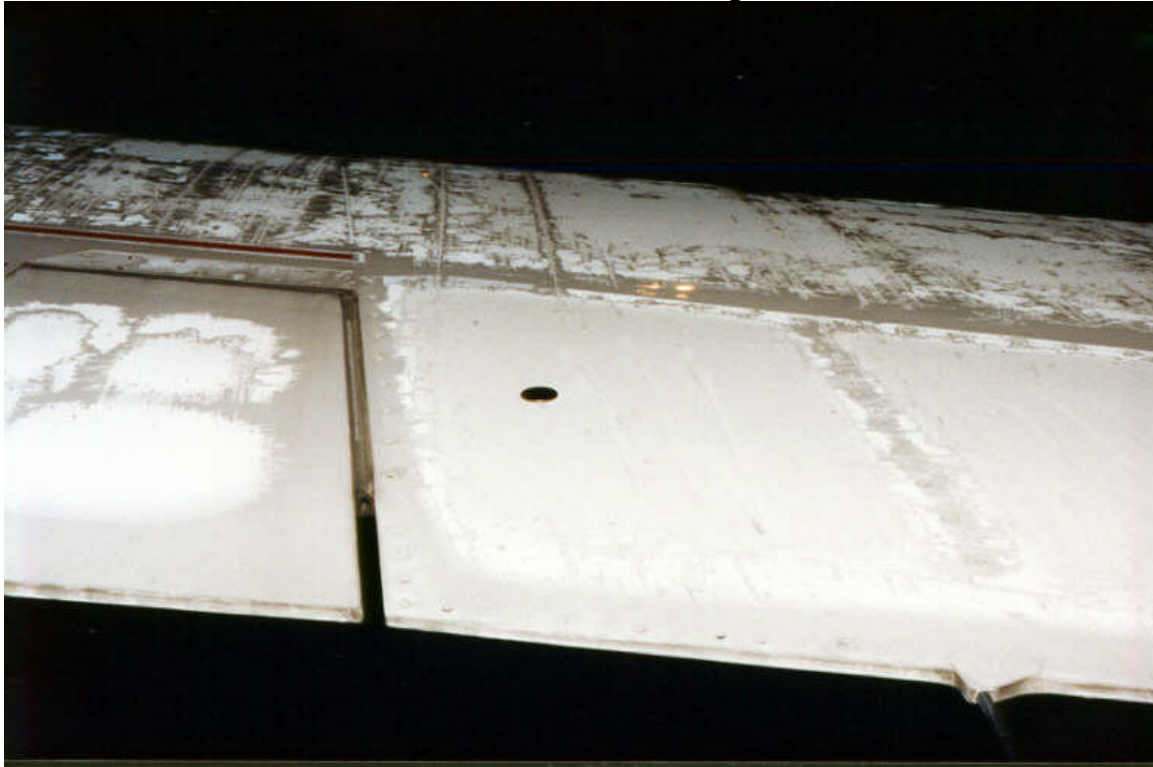
Photo 4.3

Heavy Frost Accumulation on the Aileron and Trailing Edge Outboard of the Aileron of the Starboard Wing (ID# 1)

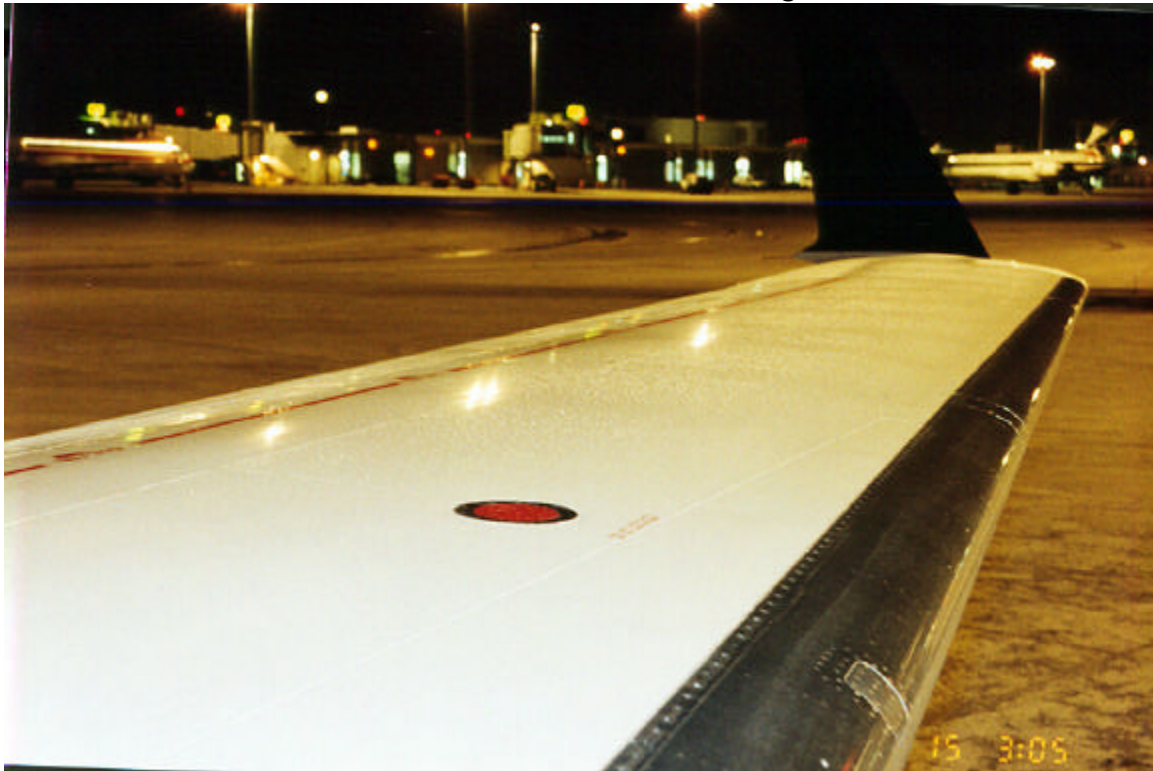
Photo 4.9
Frost Accumulation on the Port Wing (ID# 3)

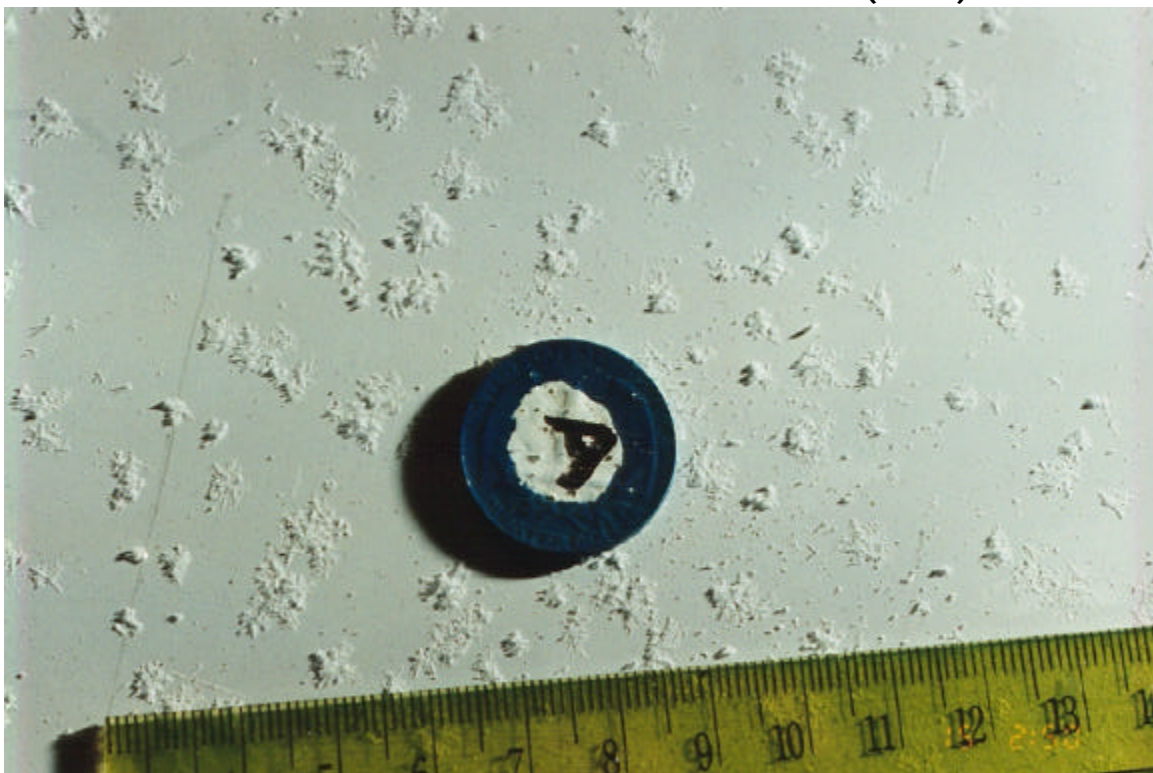
Photo 4.10
Plan Photo of Frost Formation on the Aileron (ID# 3)

Photo 4.10 was used in the determination of frost diameter and surface area coverage on the CL-65 aileron. In this case, the average frost diameter was 4 mm and the surface area coverage was 12 percent. Photo 4.11 is an overall shot of the frost formation on the aileron.

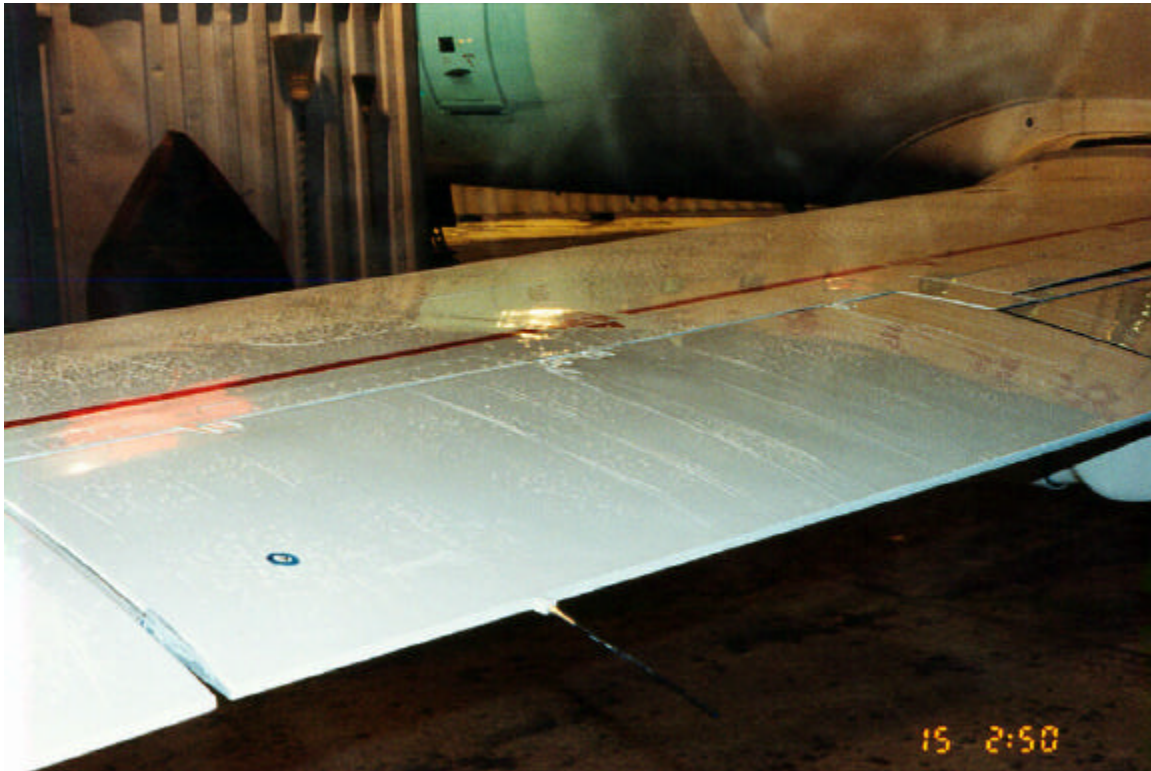
Photo 4.11
Overall Photo of the Frost Formation on the Aileron (ID# 3)

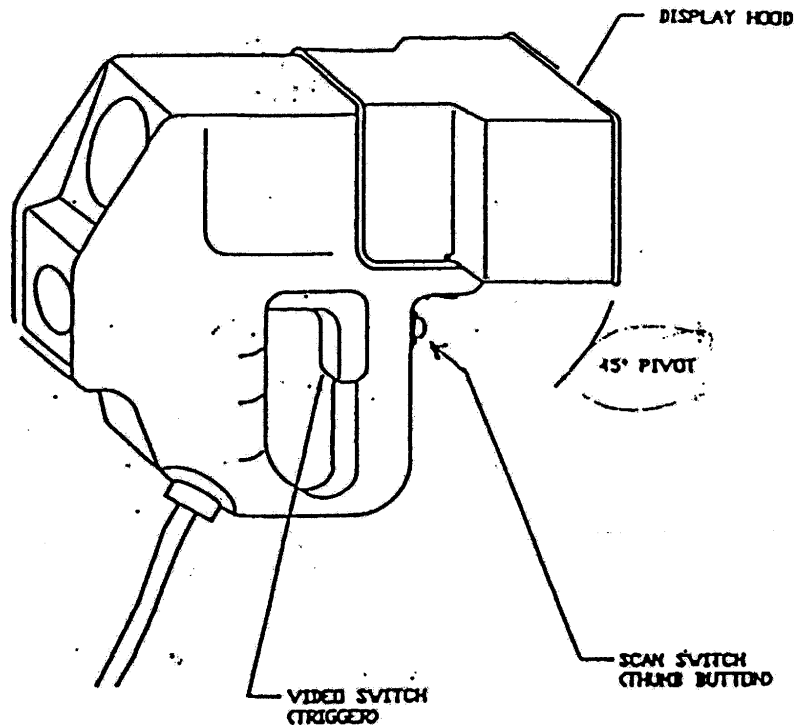
Figure -2 ID-1H SENSOR MODULE A HAND-HELD VIDEO SCANNING UNIT.

- Video Switch (trigger)
- Scan Switch
- Adjustable Display Screen and Hood

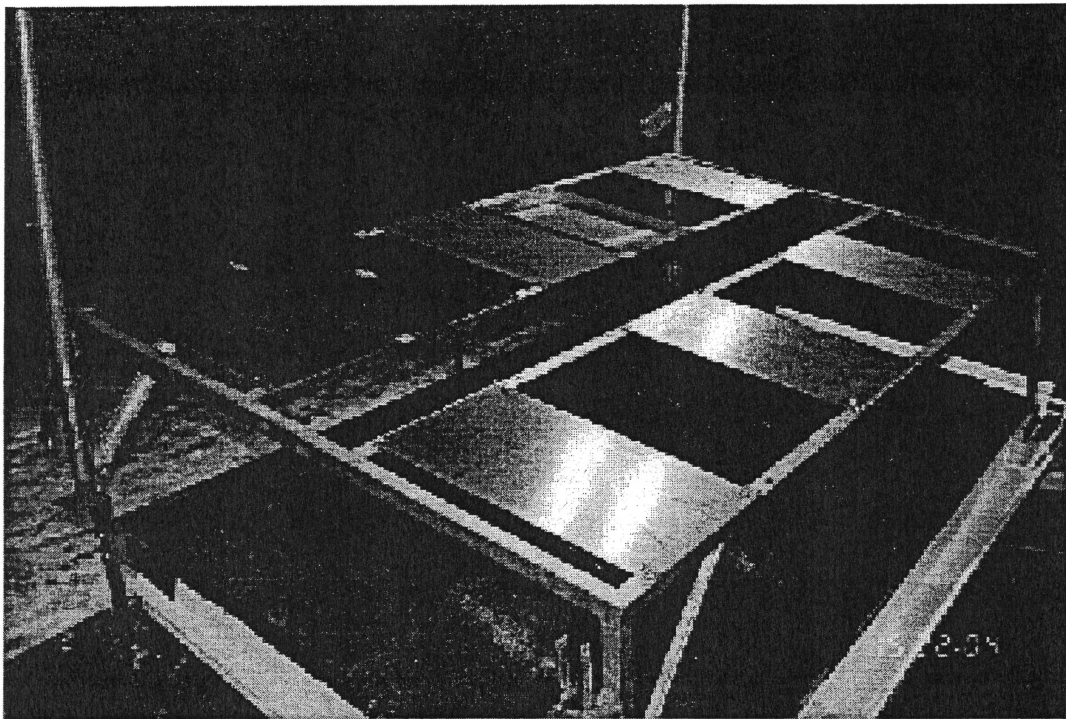
Photo 2.0
Two Adjacent "Lighted Plates" On Test Stand

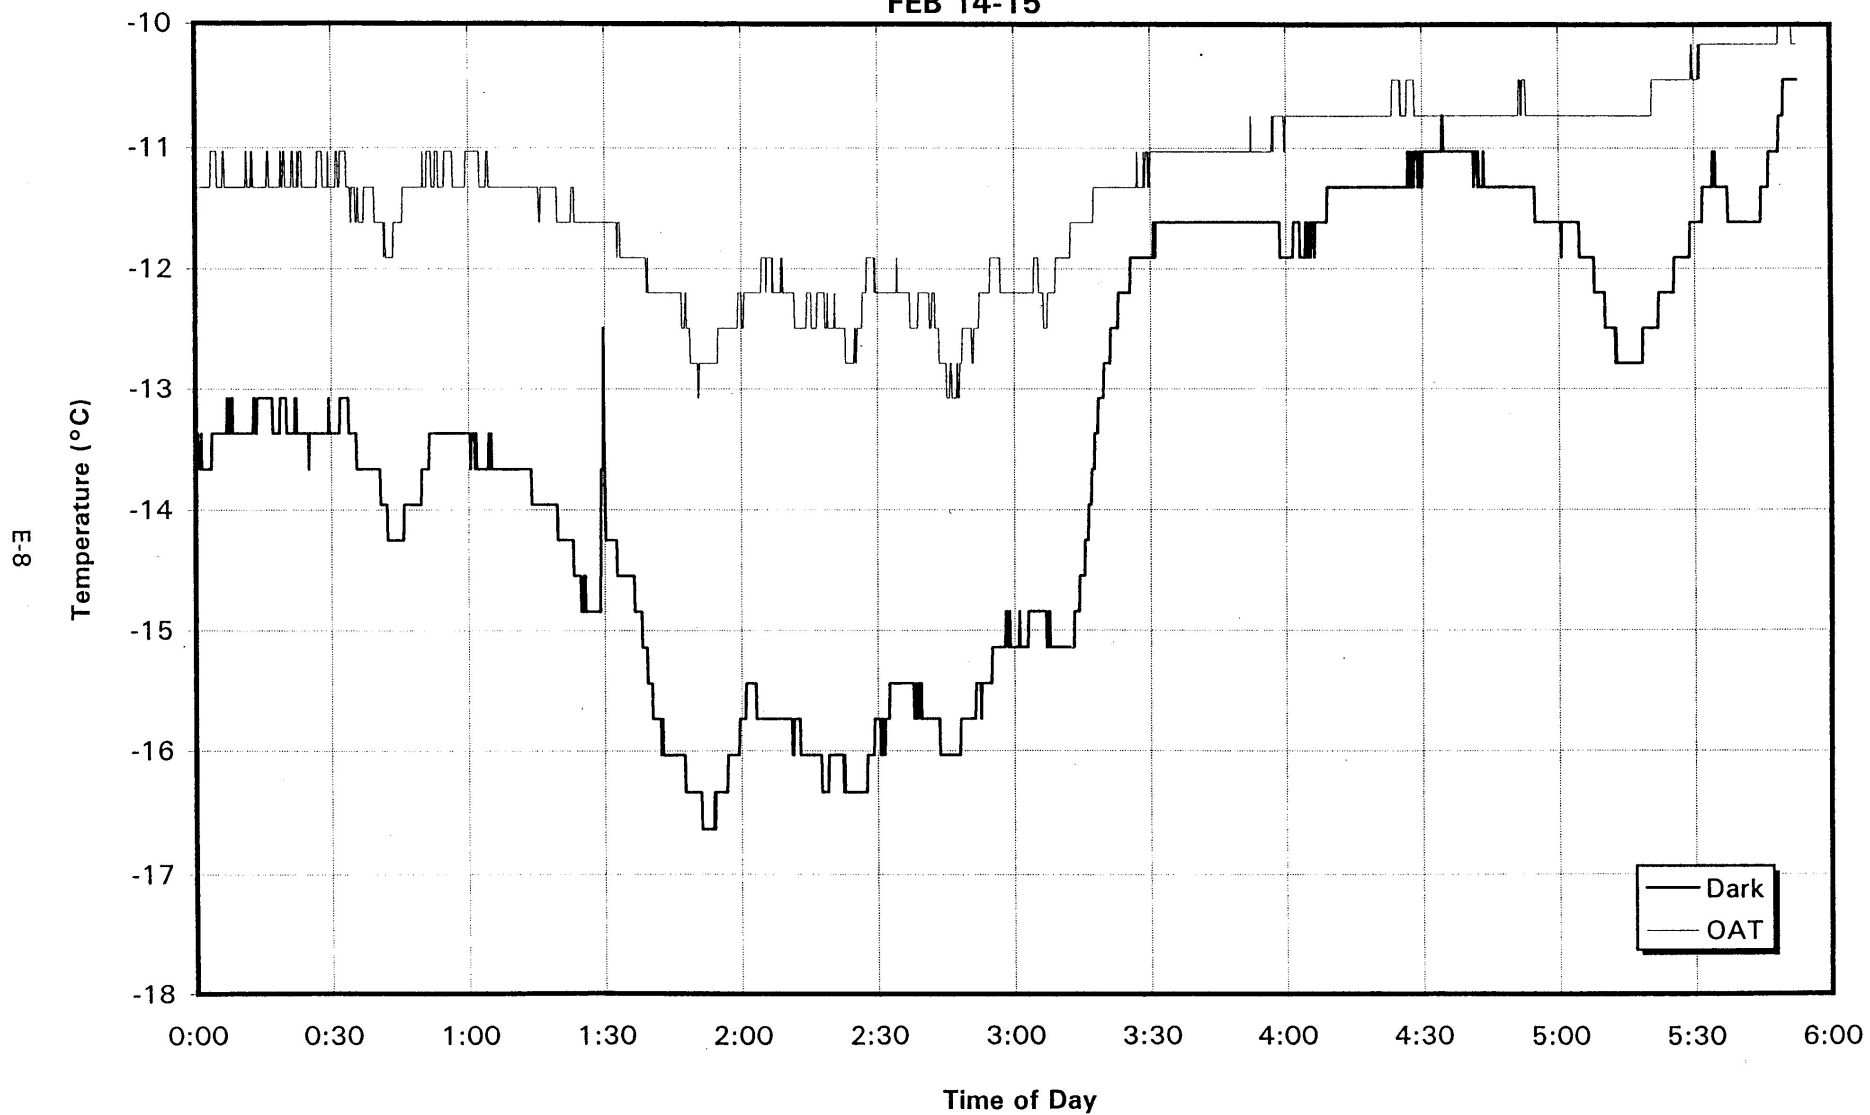
Unlighted Plate Surface Temperature vs OAT

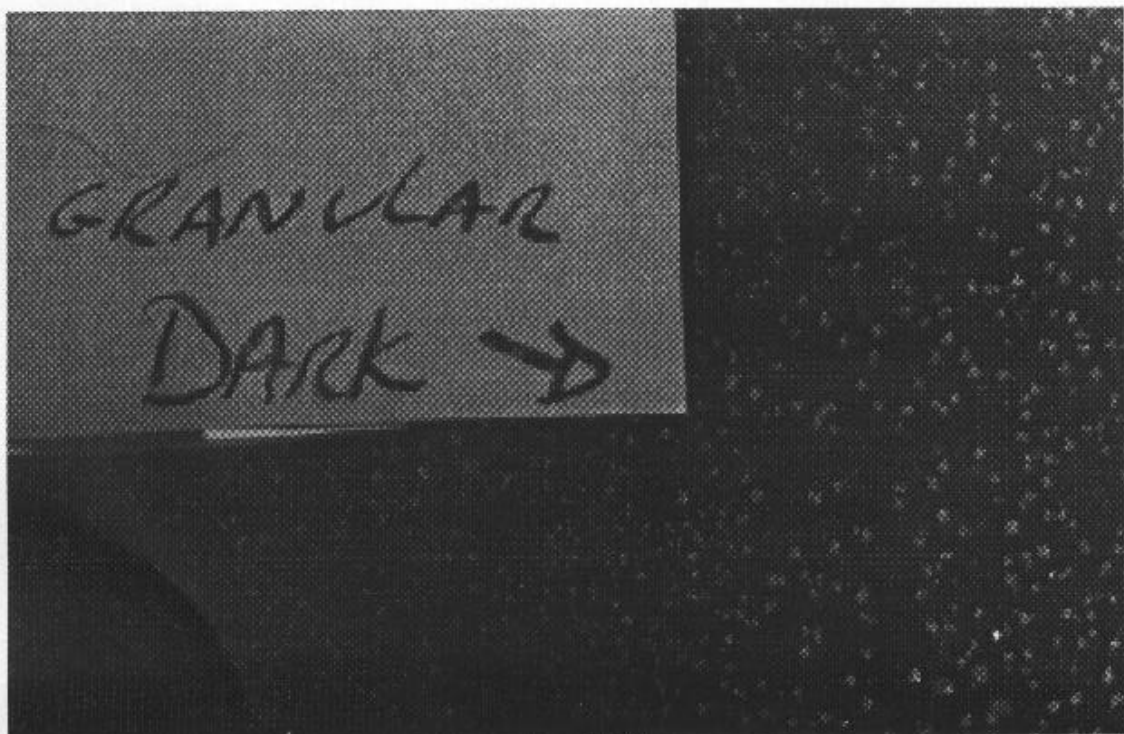
Photo 4.1
Granular Shaped Frost Formation on "Dark Plate"
