# Contaminated Aircraft Takeoff Test for the 1997/98 Winter

**Transportation Development Centre**

Transport Canada

December 1998

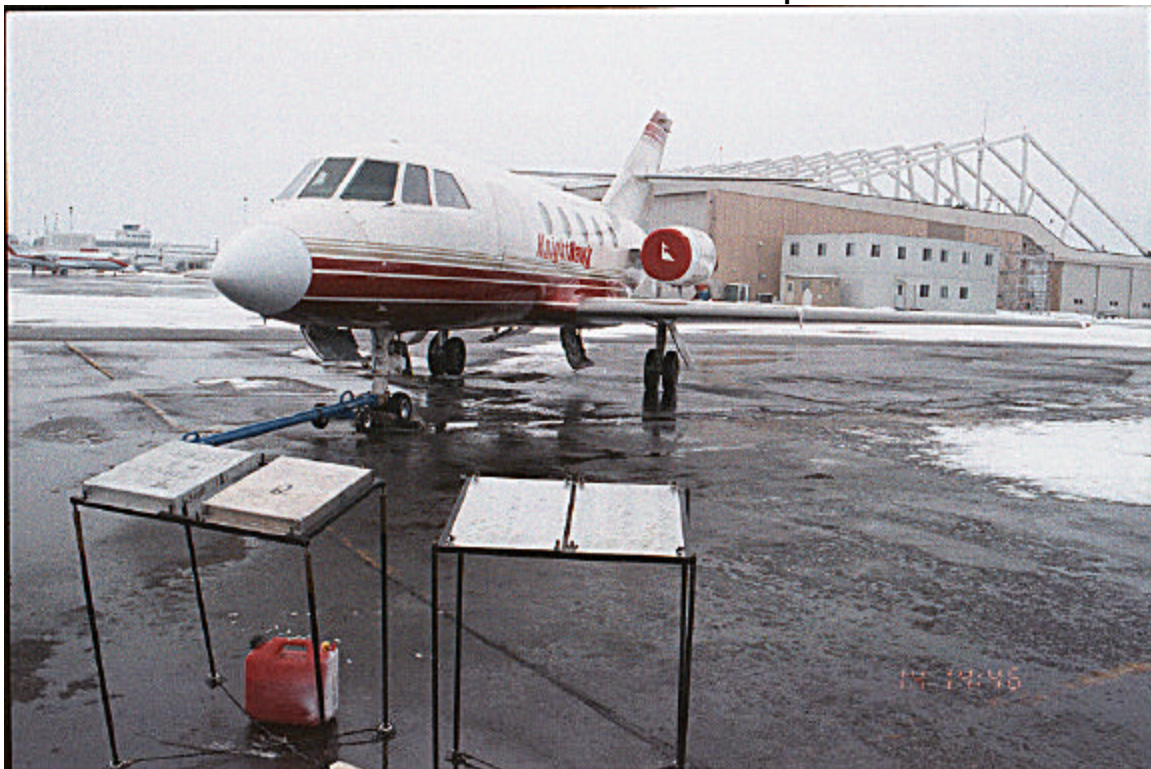
Photo 2.2  
Falcon 20D Static Test Setup

Equipment used was the same as defined in the program to determine fluid failure patterns on full-scale aircraft<sup>1</sup>. A portable plate-stand (Photo 2.2) was used for simultaneous flat plate tests.

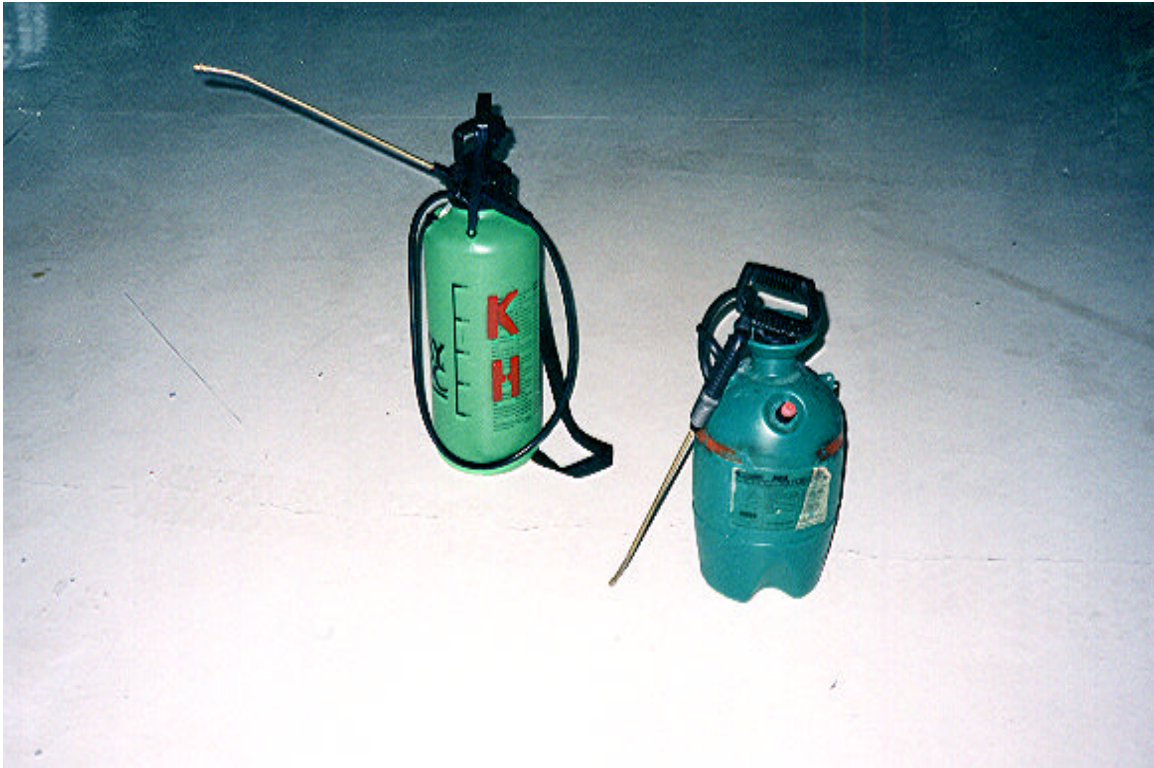
Photo 2.3  
Falcon 20D Static Test Spray Equipment

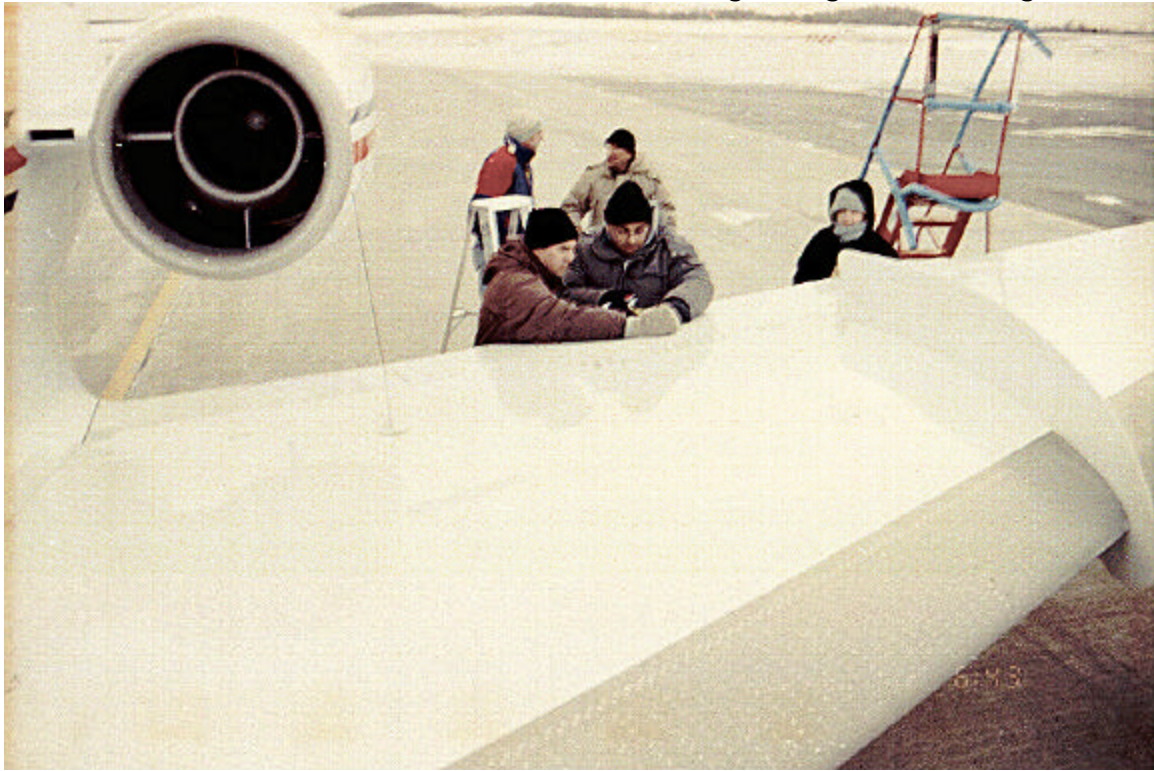
Photo 2.5  
NRC Falcon 20D Fluid Thickness Measuring (Wing Fence at Right)

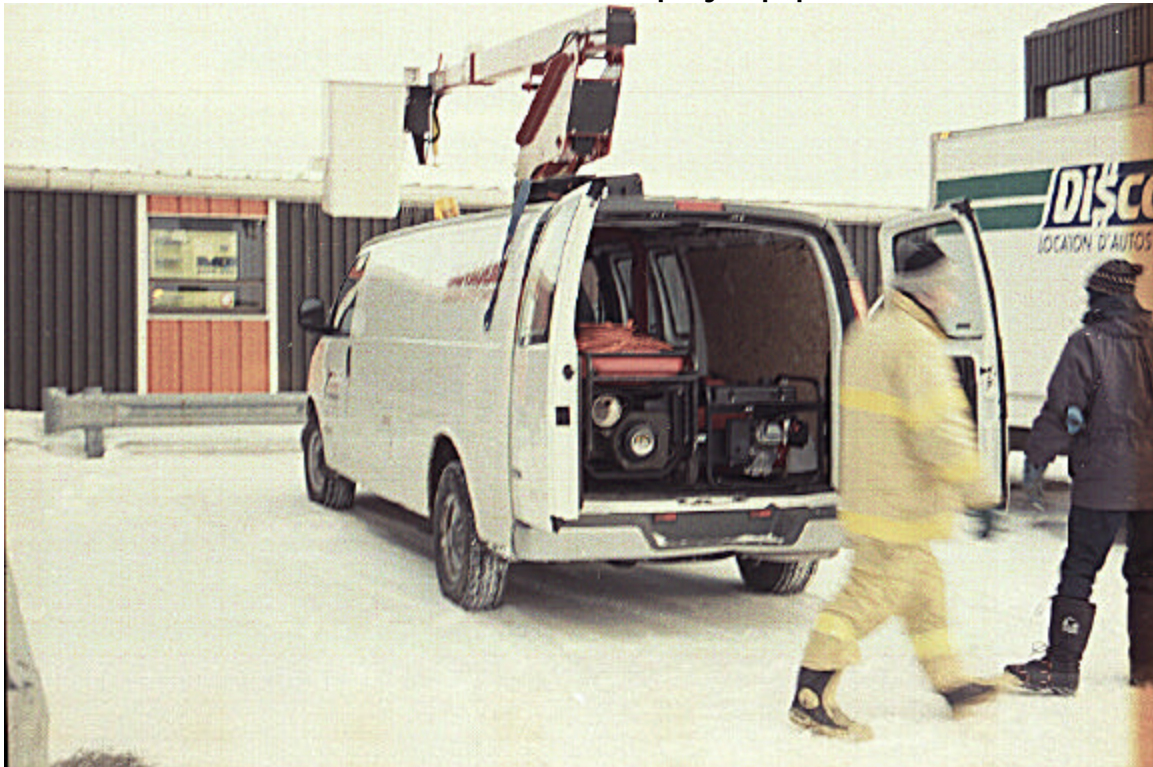
Photo 2.6  
Boom Truck with Water Spray Equipment

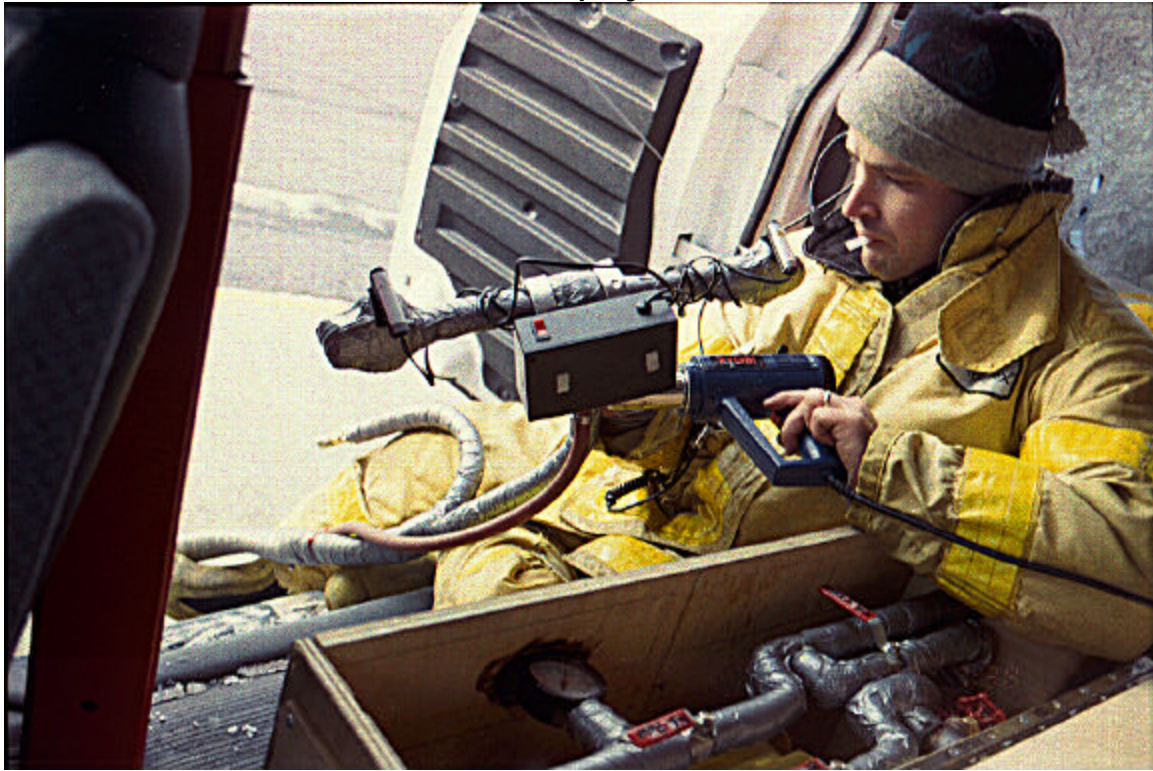
Photo 2.7  
Water Spray Bar

Evaluation trials conducted at the APS test site prior to the aircraft tests demonstrated that rates typical of freezing rain could be achieved using the portable unit. As the spray bar was hand-held and manipulated by an operator to provide coverage over the desired area, rates and consistency of coverage were operator dependent. For these trials, a single operator was used who developed a satisfactory level of skill. Calm wind conditions were necessary in order to achieve satisfactory coverage.

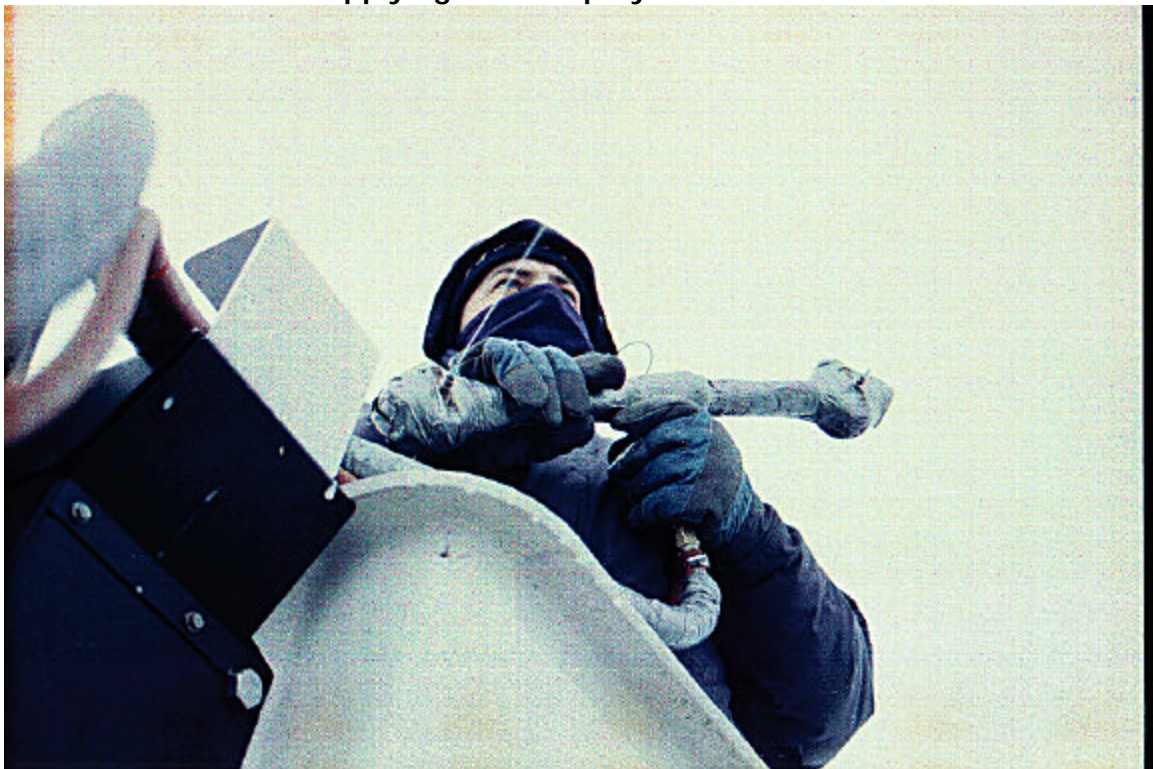
Photo 2.8  
Applying Water Spray from Bucket

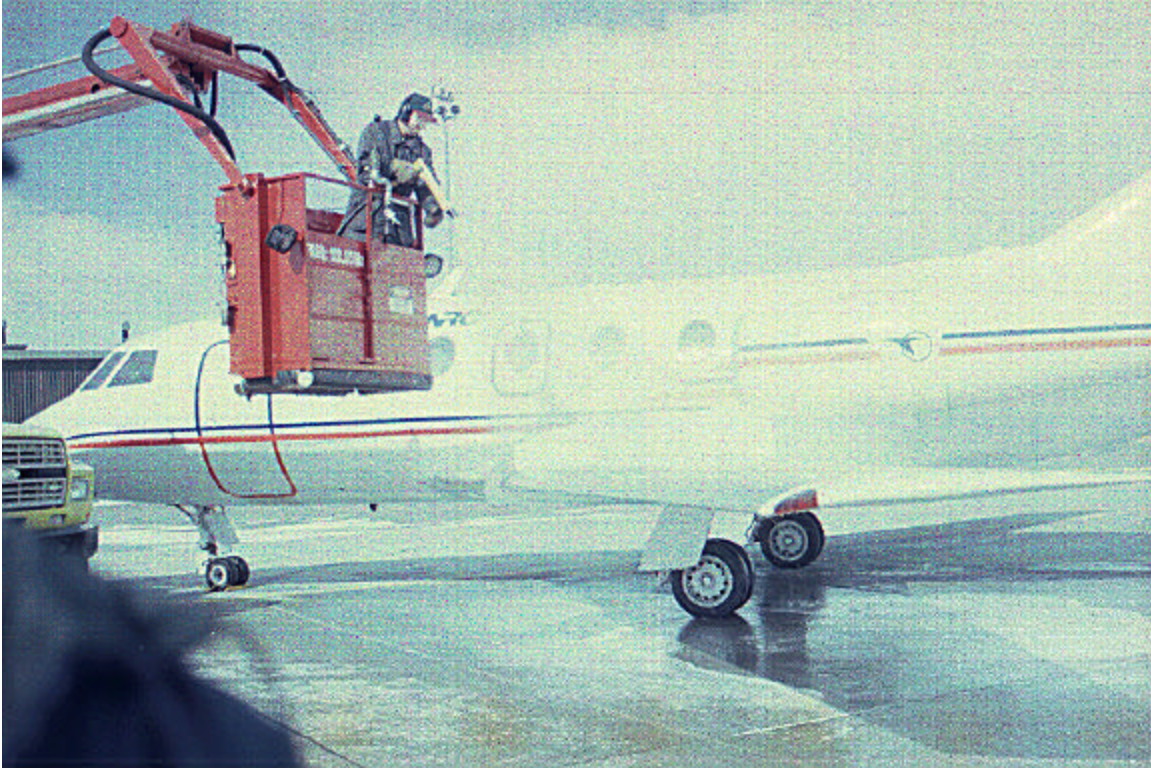
Photo 2.9  
Spraying Type IV Fluid

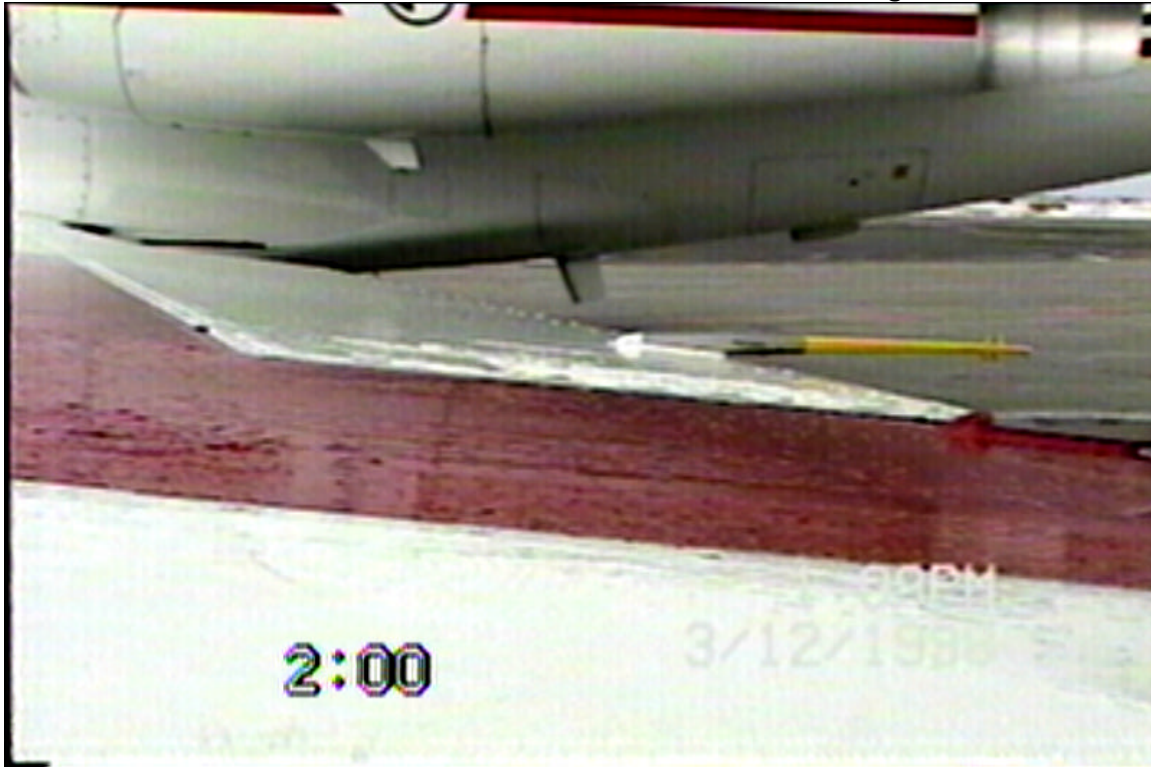
Photo 4.1  
Run 1 (Initial Failure) Ice on Outboard Aileron - Following Takeoff Run

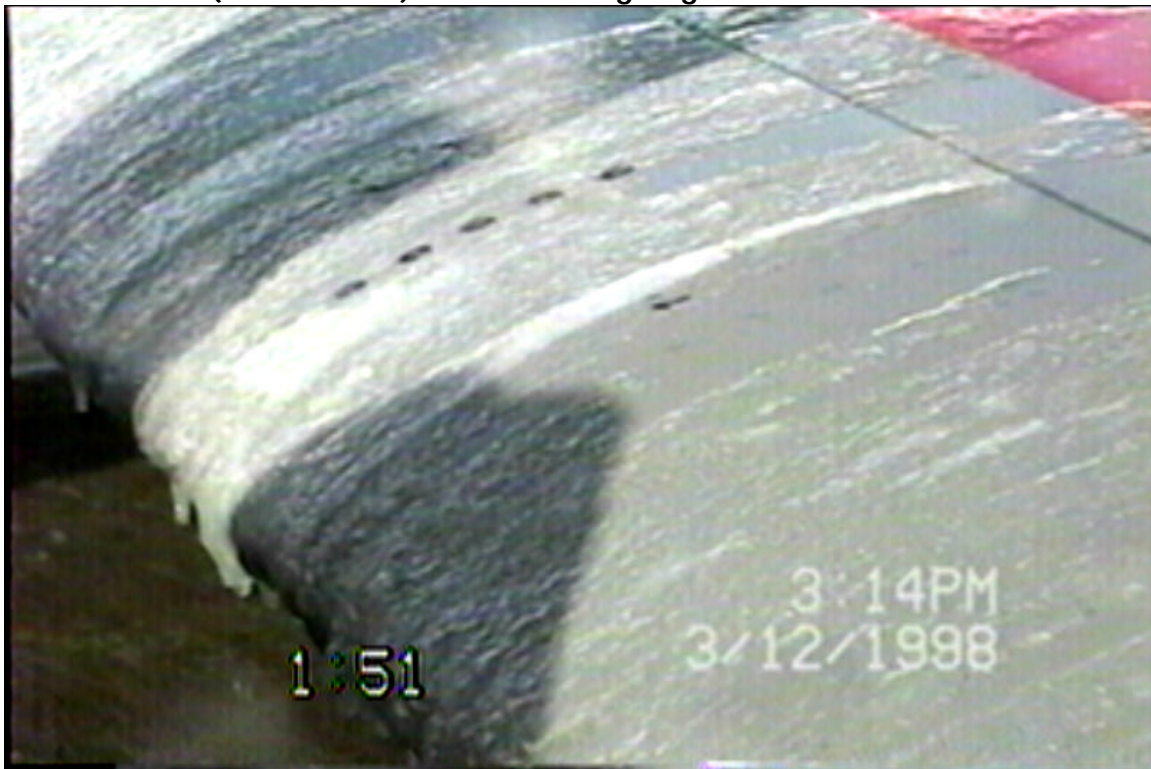
Photo 4.2  
Run 3 (33% Failure) Ice on Leading Edge - Prior to Takeoff Run

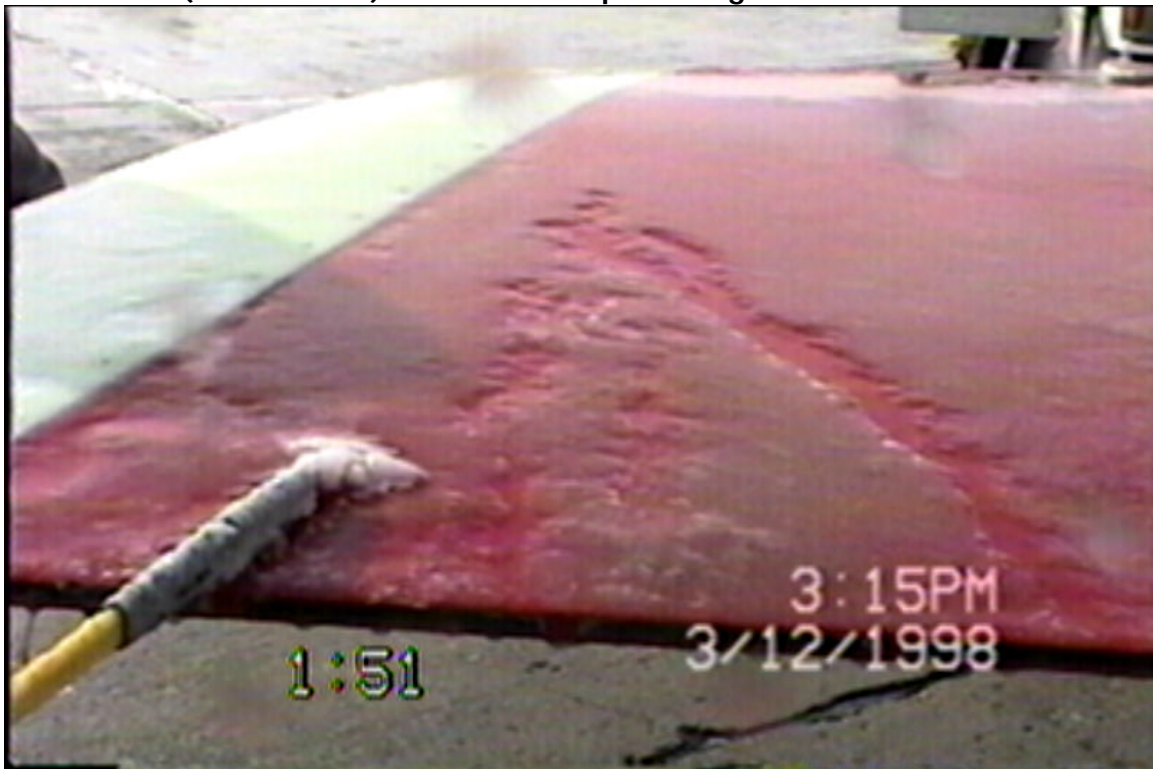
Photo 4.6  
Run 3 (33% Failure) Slush Over Top of Wing - Prior to Takeoff Run

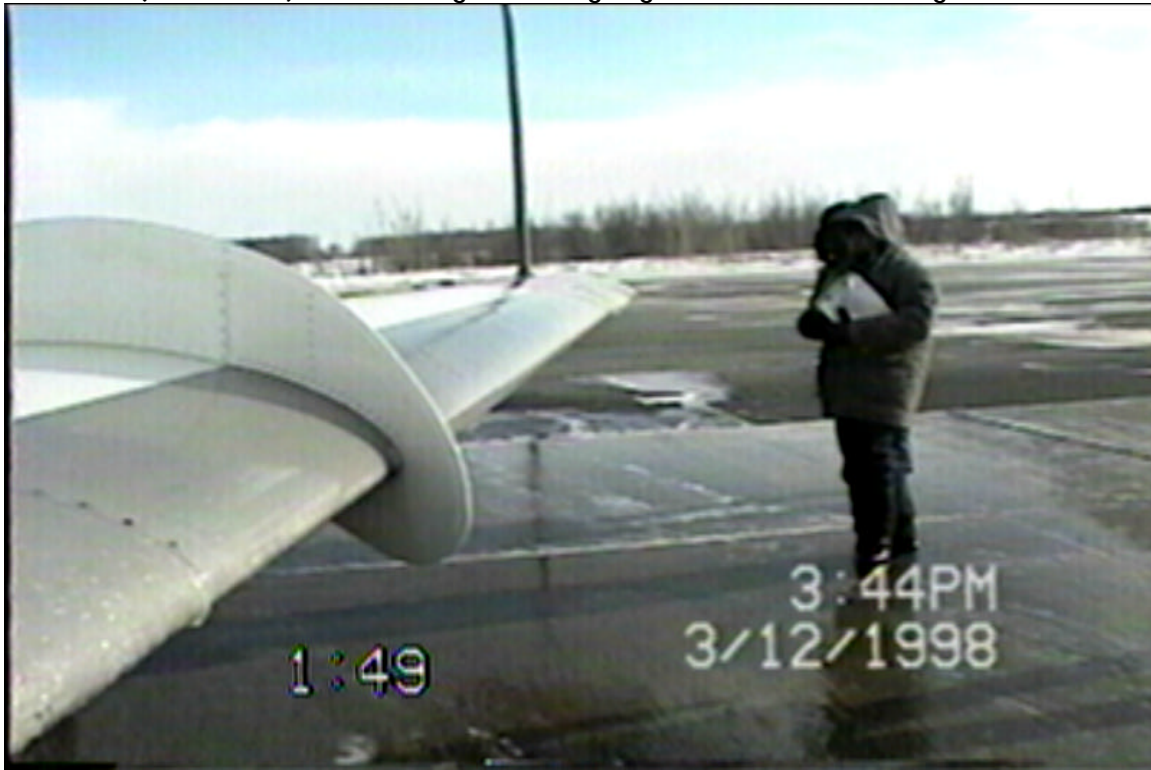
Photo 4.7

Run 3 (33% Failure) Ice Remaining on Leading Edge Inner Chord - Following Takeoff Run

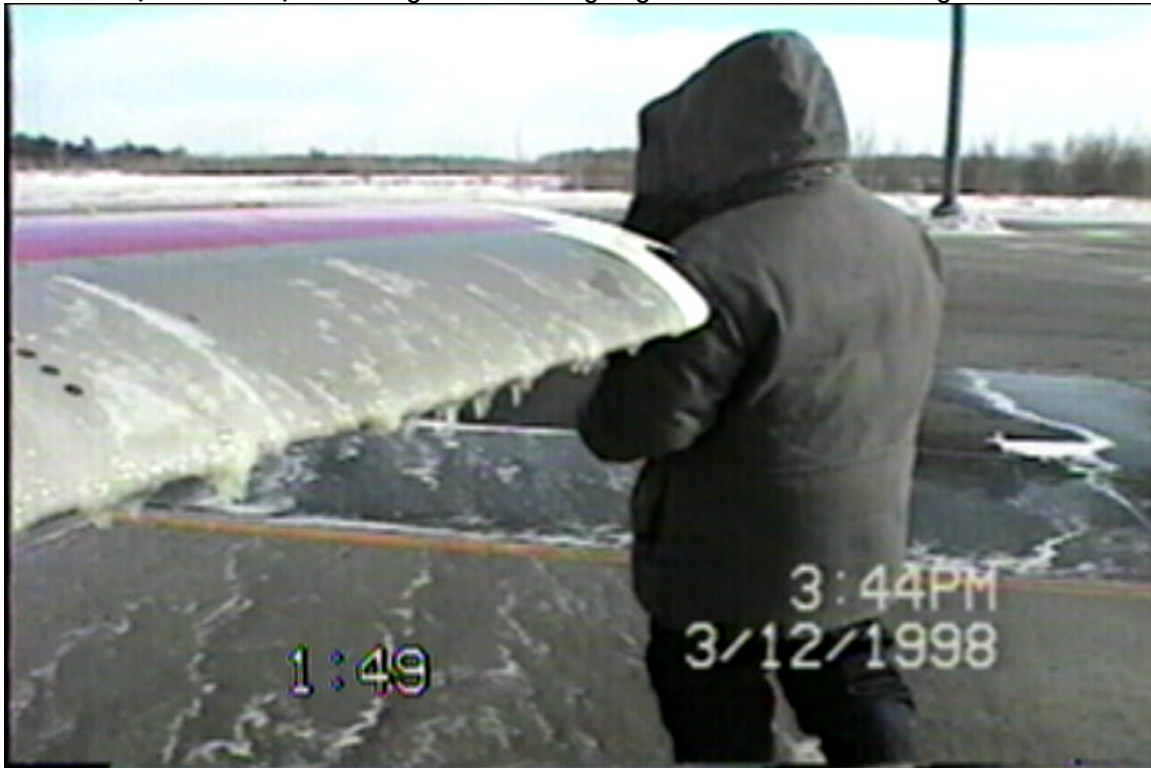
Photo 4.8

Run 3 (33% Failure) Remaining Ice on Leading Edge Outer Chord - Following Takeoff Run

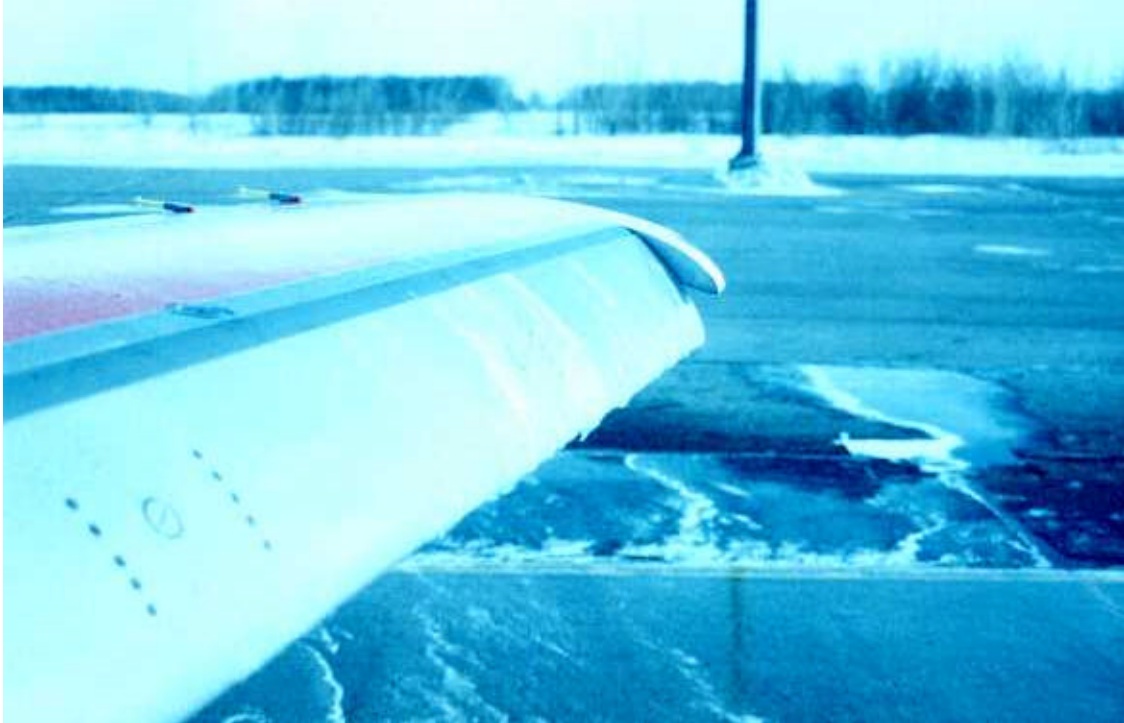
Photo 4.9  
Run 3 (33% Failure) Ice on Extended Leading Edge Slat – Following Takeoff Run
