# Aircraft Full-Scale Test Program for the 1996/97 Winter

Prepared for  
**Transportation Development Centre**  
on behalf of  
**Civil Aviation**

**APS AVIATION INC.** **APS**

December 1997

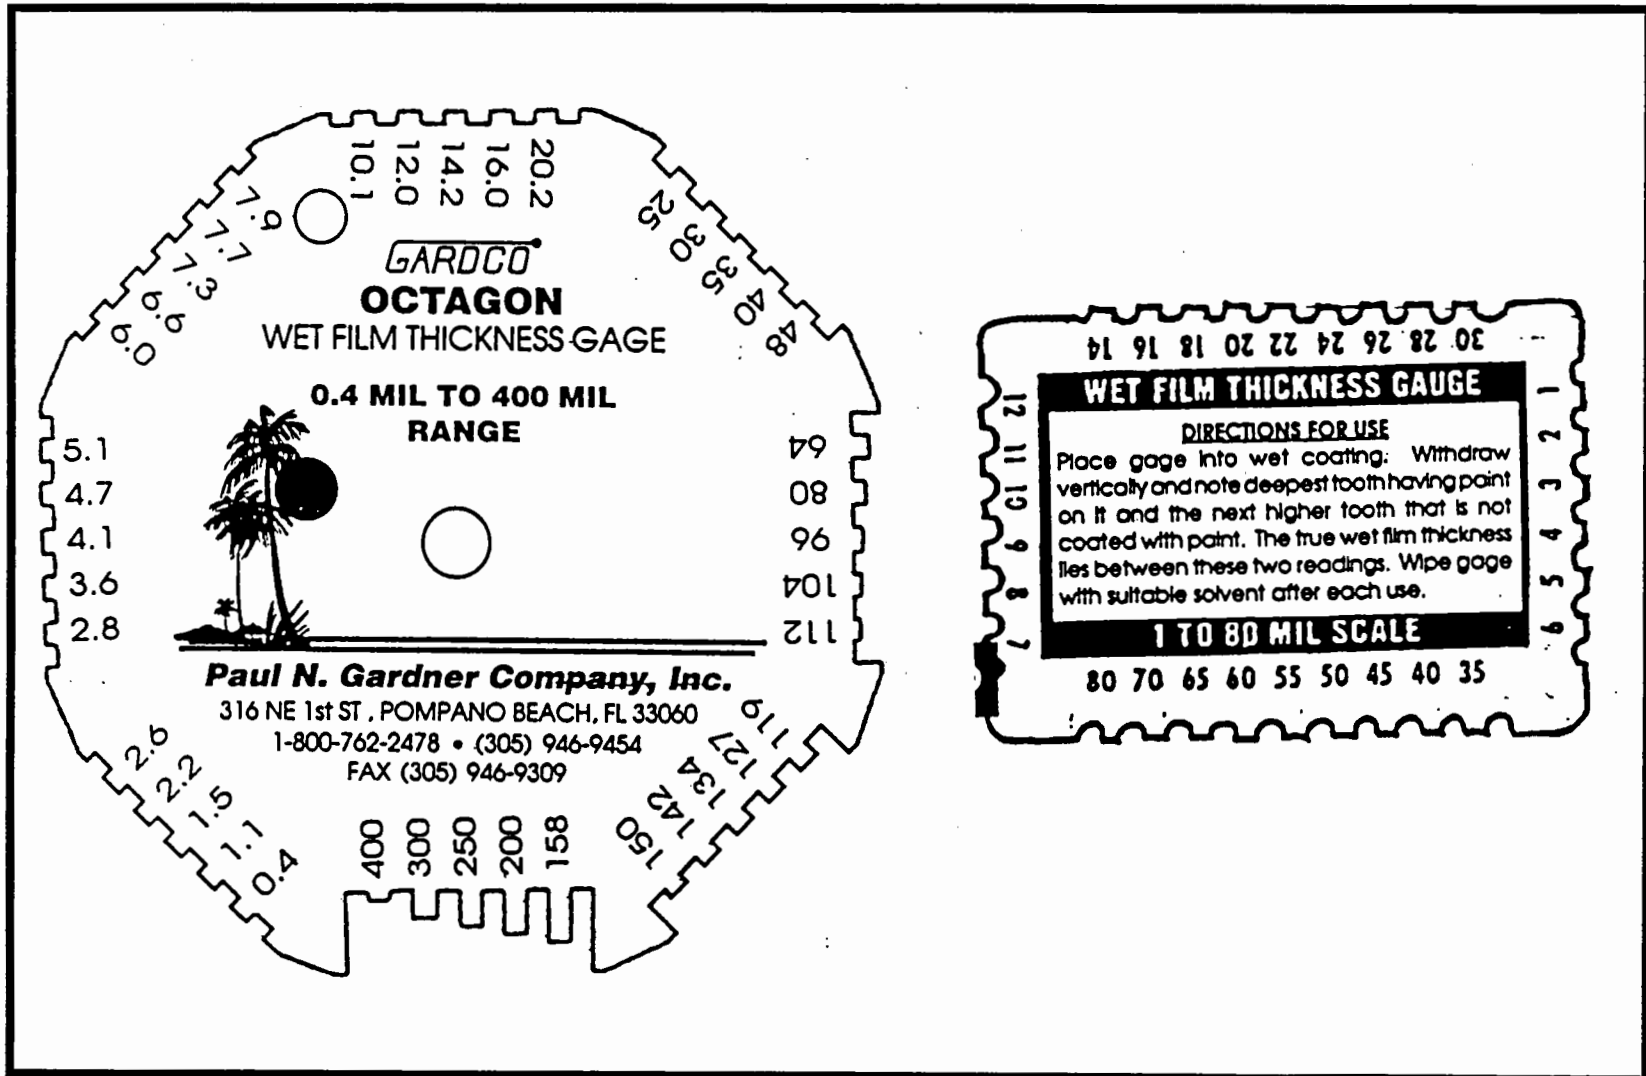
FIGURE 2.6  
**WET FILM THICKNESS GAUGES**

A complete equipment list for fluid thickness tests may be found in Appendix B, Procedures for Conducting Tests on Jet Aircraft, and Appendix C, Procedure for Conducting Tests on Propeller Aircraft.

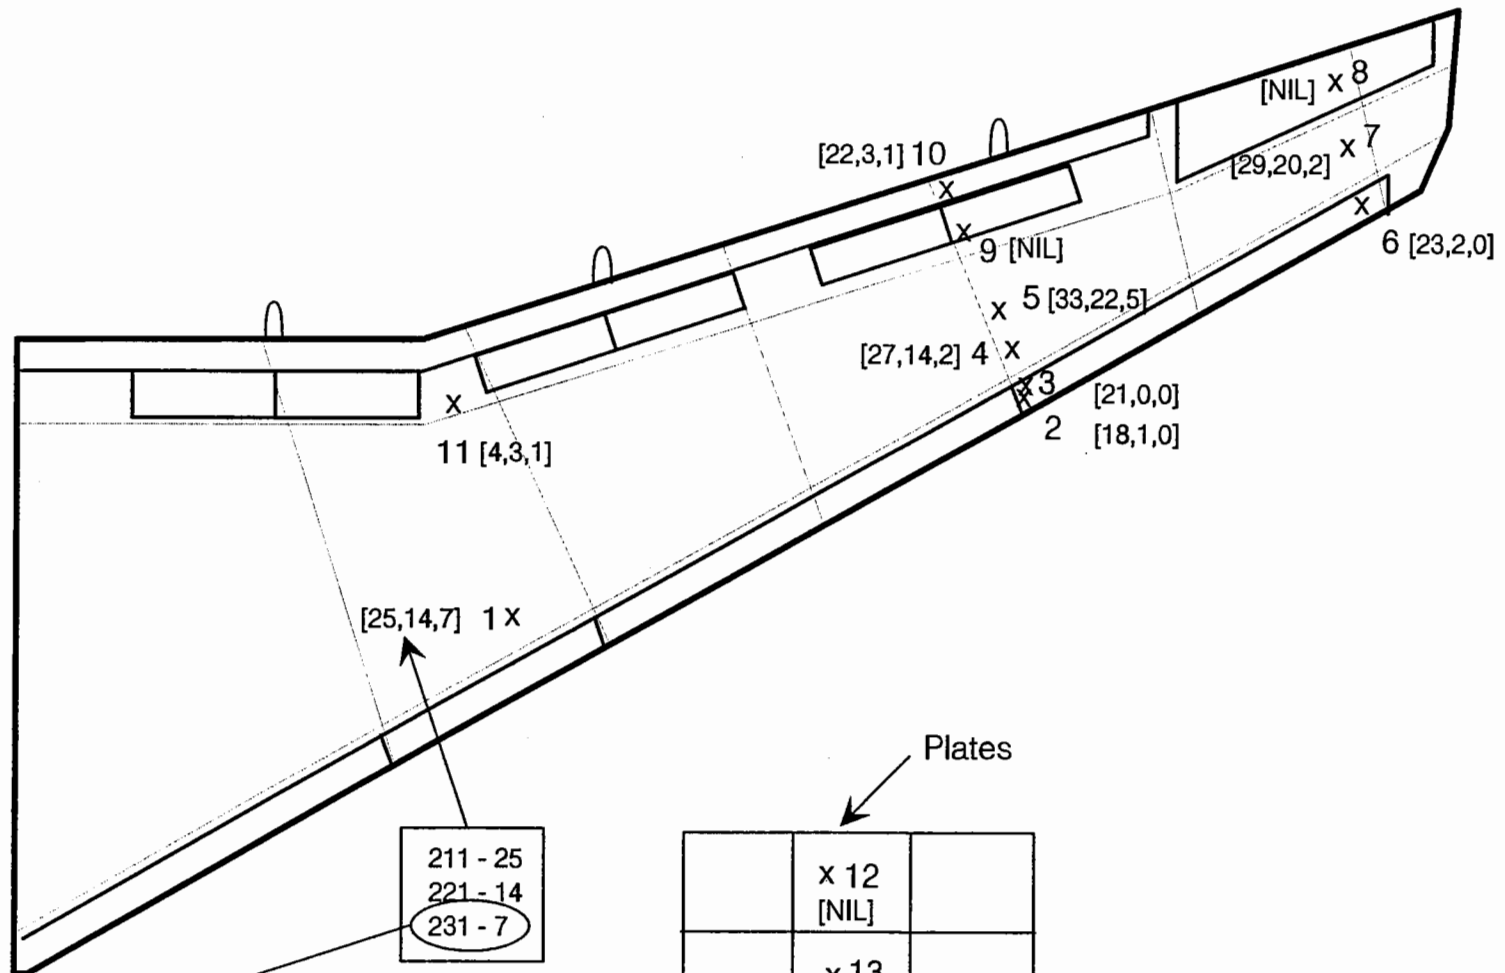
FIGURE 3.6  
 BRIX MEASUREMENTS FOR ID 24

**Example:** 231 - 7  
 2 - Run number  
 3 - Cycle number  
 1 - Sample location  
 7 - Brix measurement

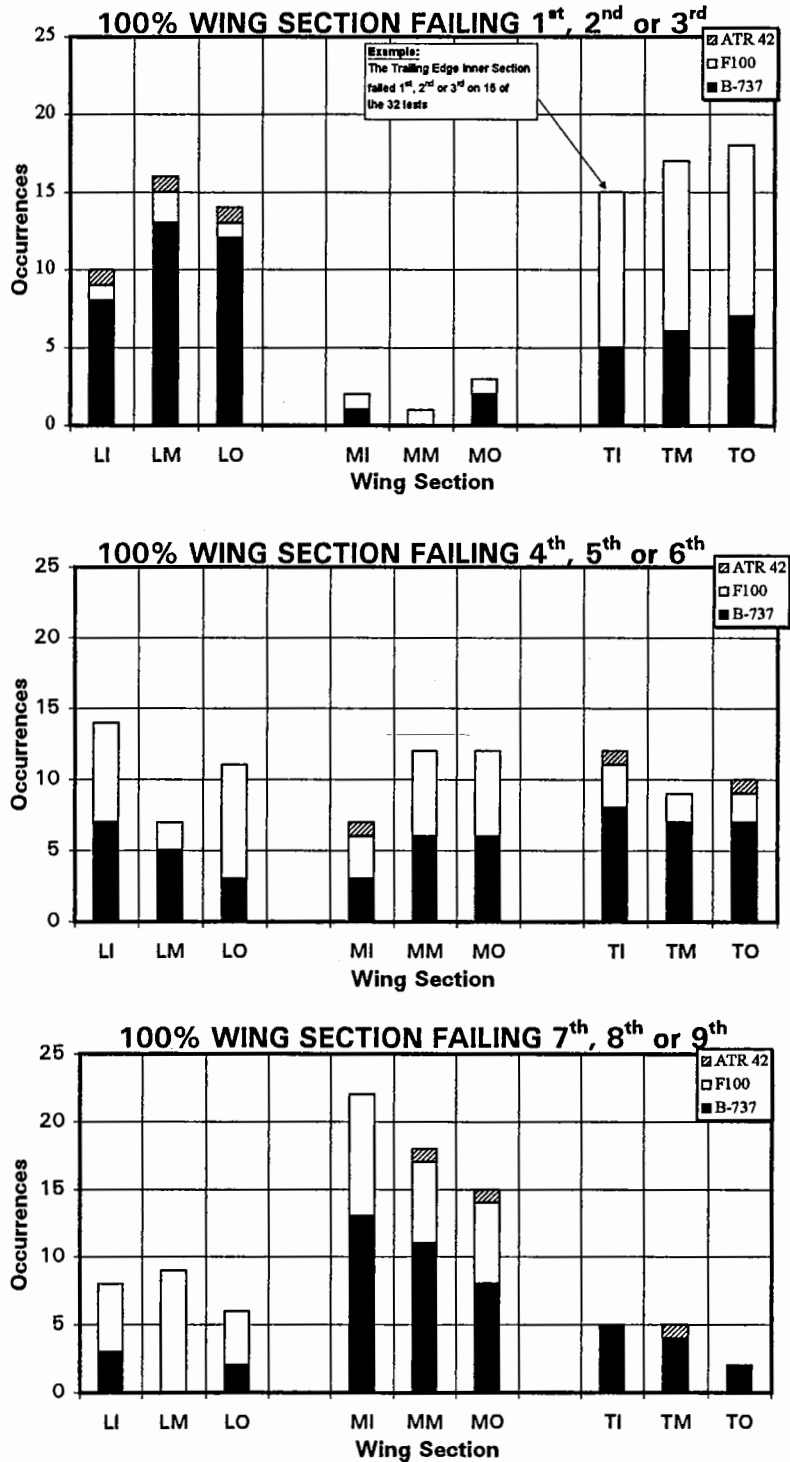
FIGURE 3.15  
**TABULATION OF FAILURE PATTERNS ON WING\*  
 BY AIRCRAFT TYPE**

\* Based on a 100% section failure  
 \* 32 Tests

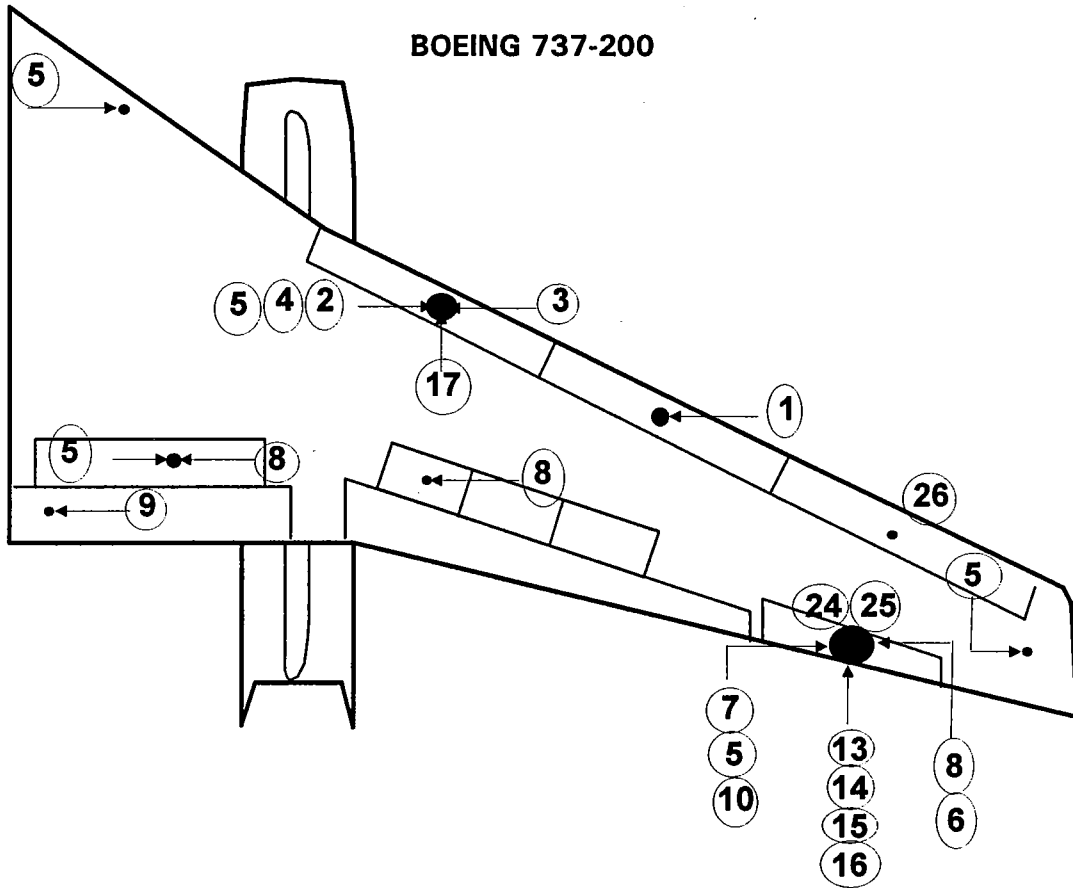
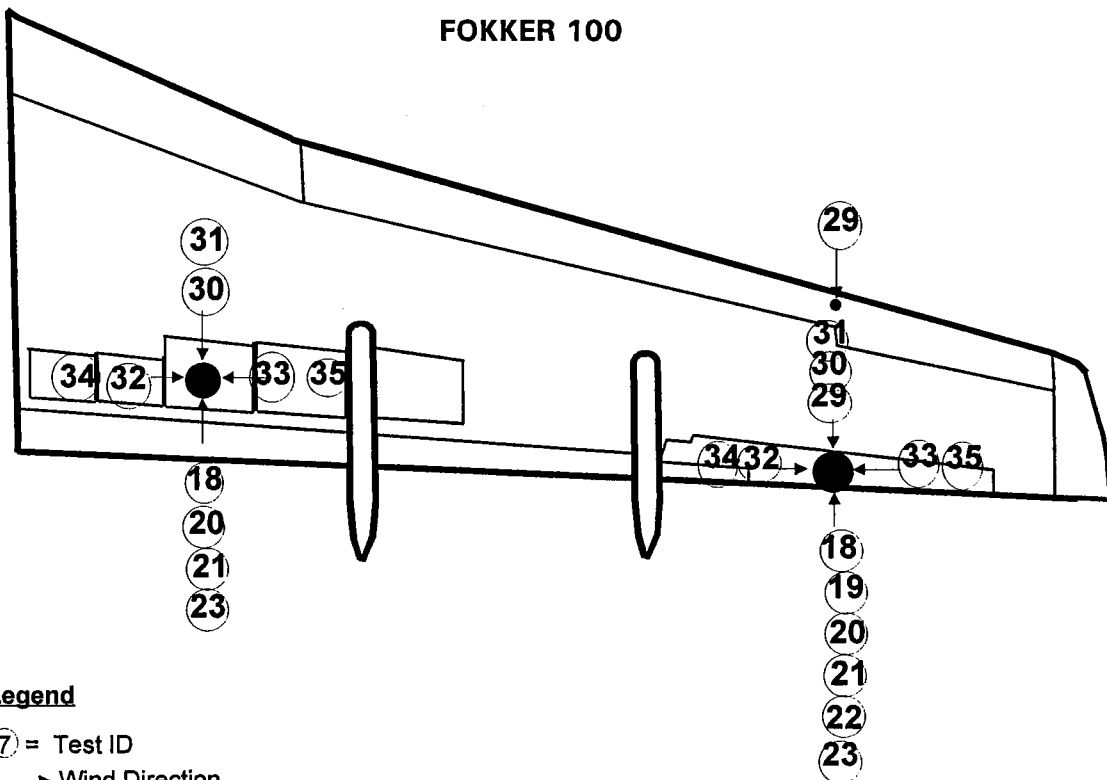
FIGURE 3.16  
**LOCATION OF FIRST FAILURE BY TEST ID**

⑦ = Test ID

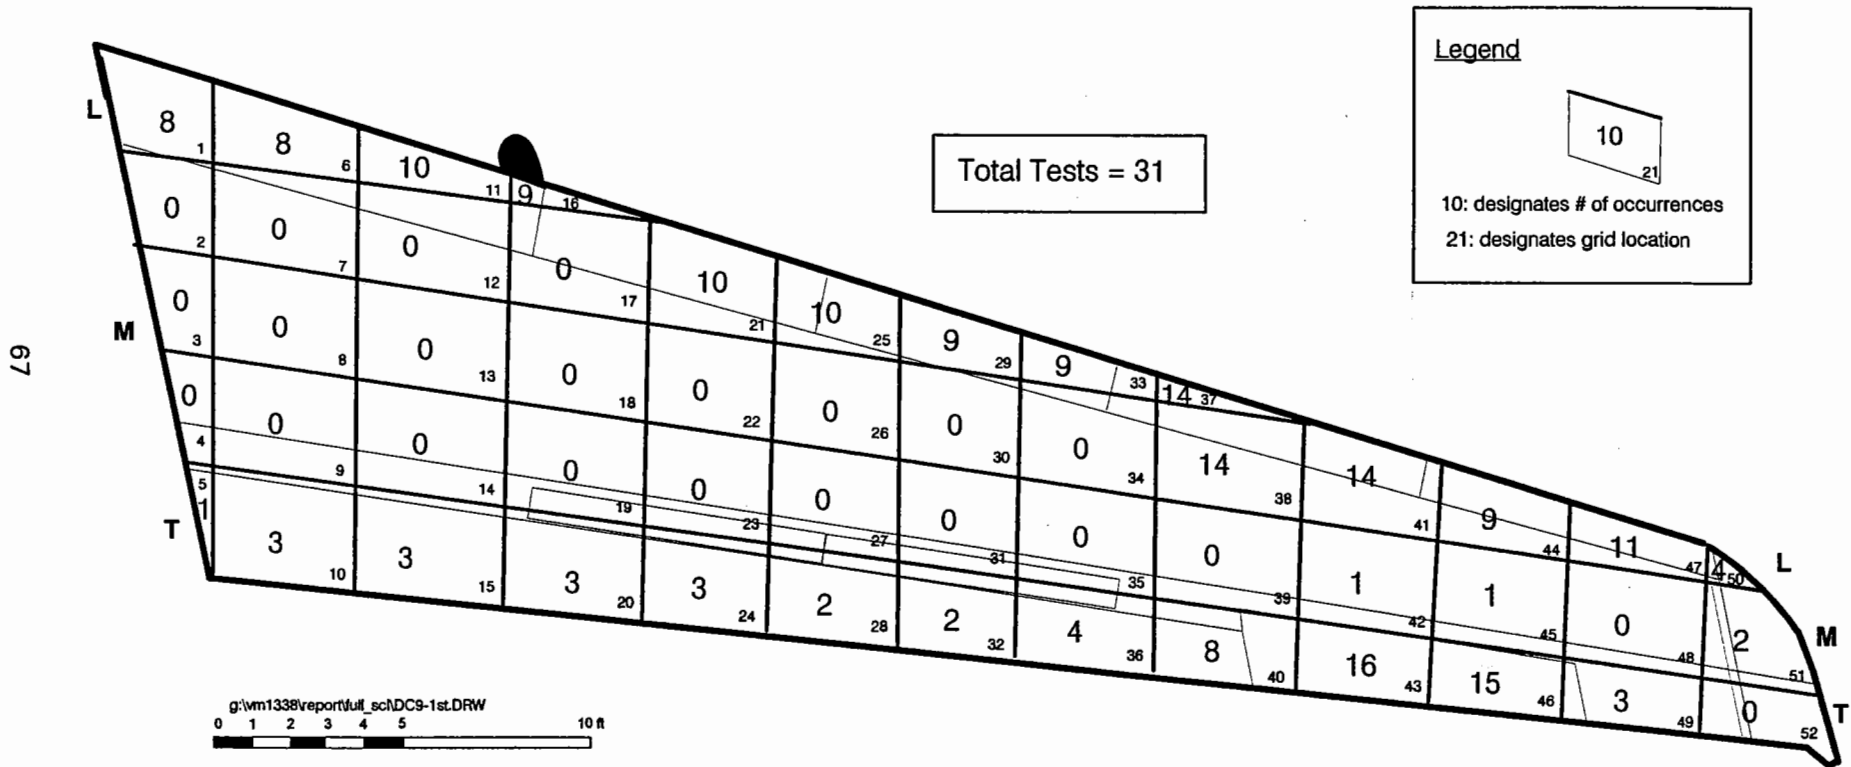
**FIGURE 3.19**  
**OCCURRENCES OF FIRST WING FAILURE BY WING GRID LOCATION**  
 McDONNELL DOUGLAS DC-9 Series 30

**Note:** Occurrence was counted when any amount of failure was present in the grid

The wing representative surface is aircraft specific, and should be positioned in an area where early failures consistently occur. For the Boeing 737 and McDonnell Douglas DC-9 tested, the representative surface locations were inappropriate. For the Fokker 100 tested, the current position is valid, provided that the visibility from the cabin is unobstructed by the flap fairing. Since failures initiate on the leading and trailing edges, inclusion of these surfaces as part of the representative surface should also be considered.

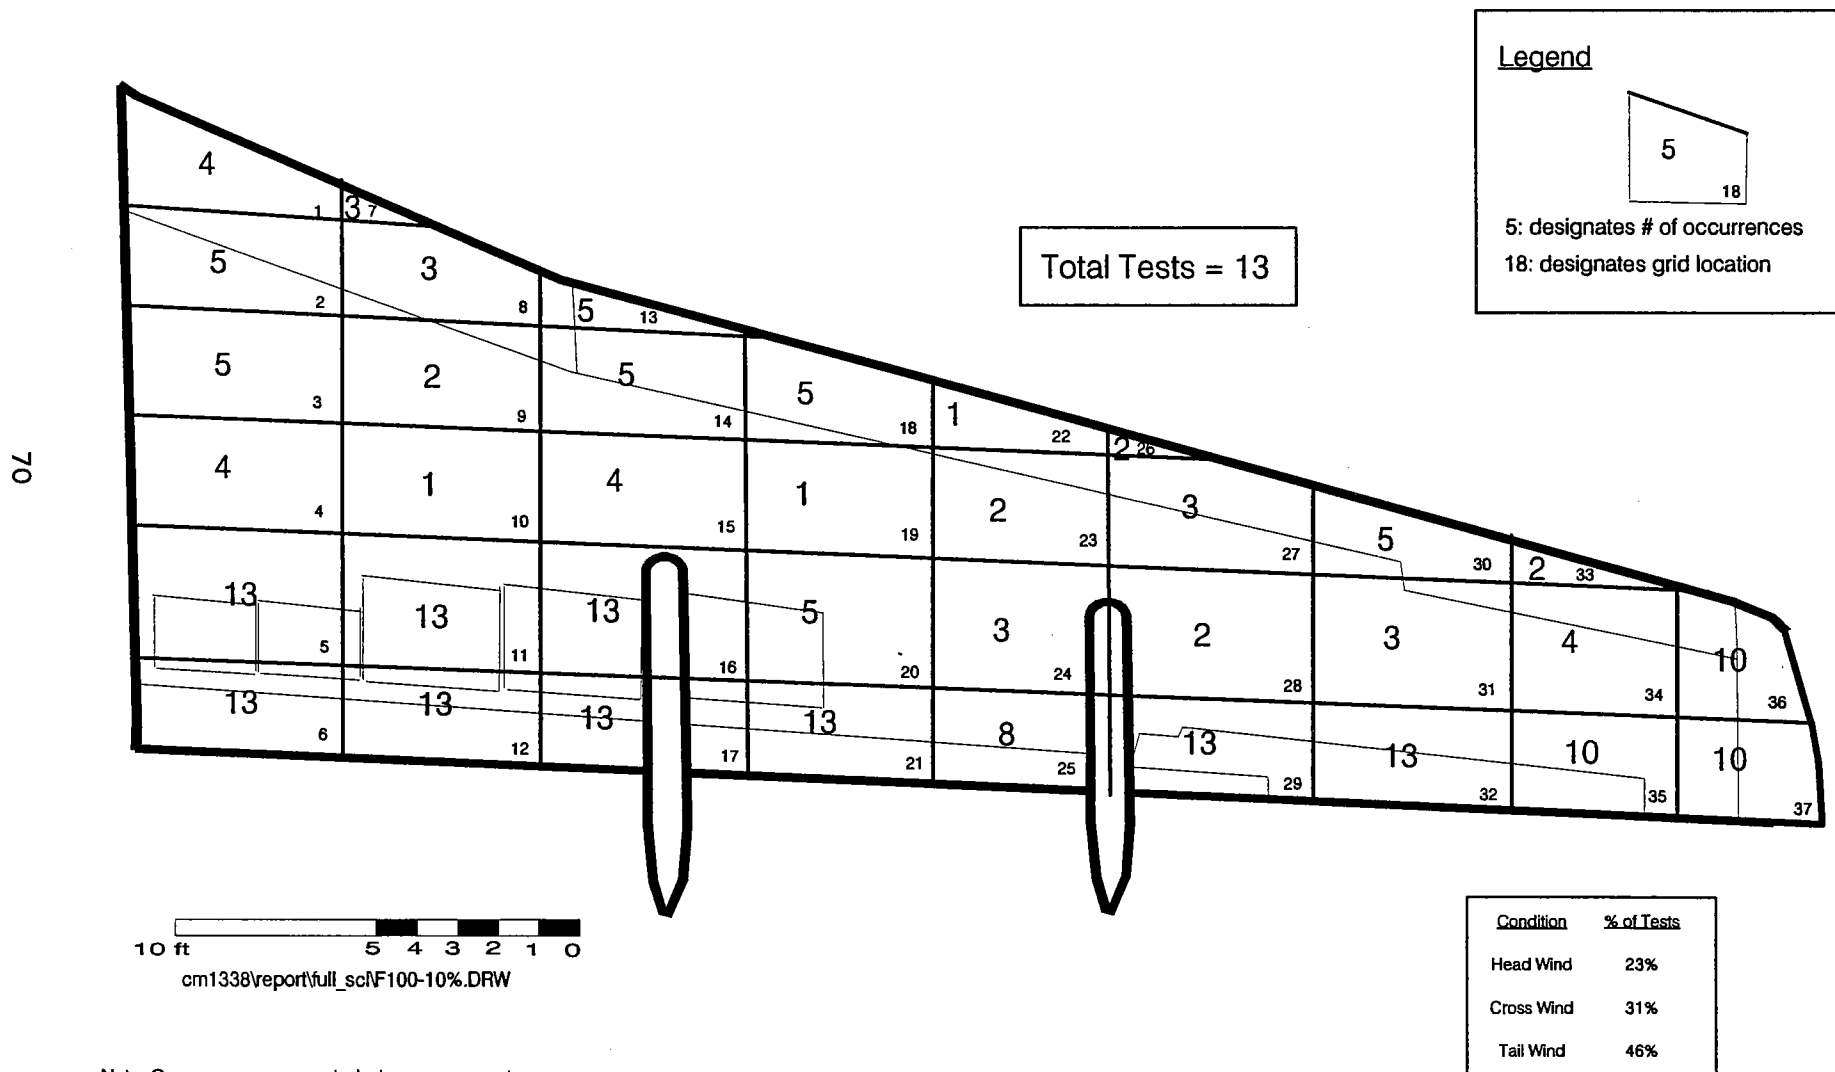
FIGURE 3.21  
**OCCURRENCES OF FAILURE BY WING GRID LOCATION**  
**10% WING FAILURE LEVEL**  
**FOKKER 100**

**Note:** Occurrence was counted when any amount of failure was present in the grid

Results of the full-scale tests with Type I fluid confirm that flat plate holdover times are approximately equivalent to the time it takes for fluid failure to progress to 10% of the entire wing's surface area. In tests using Type IV fluids, when the fluid application is uniform and in accordance with fluid manufacturer's guidelines, the same correlation is observed between flat plate and wing surface failures.

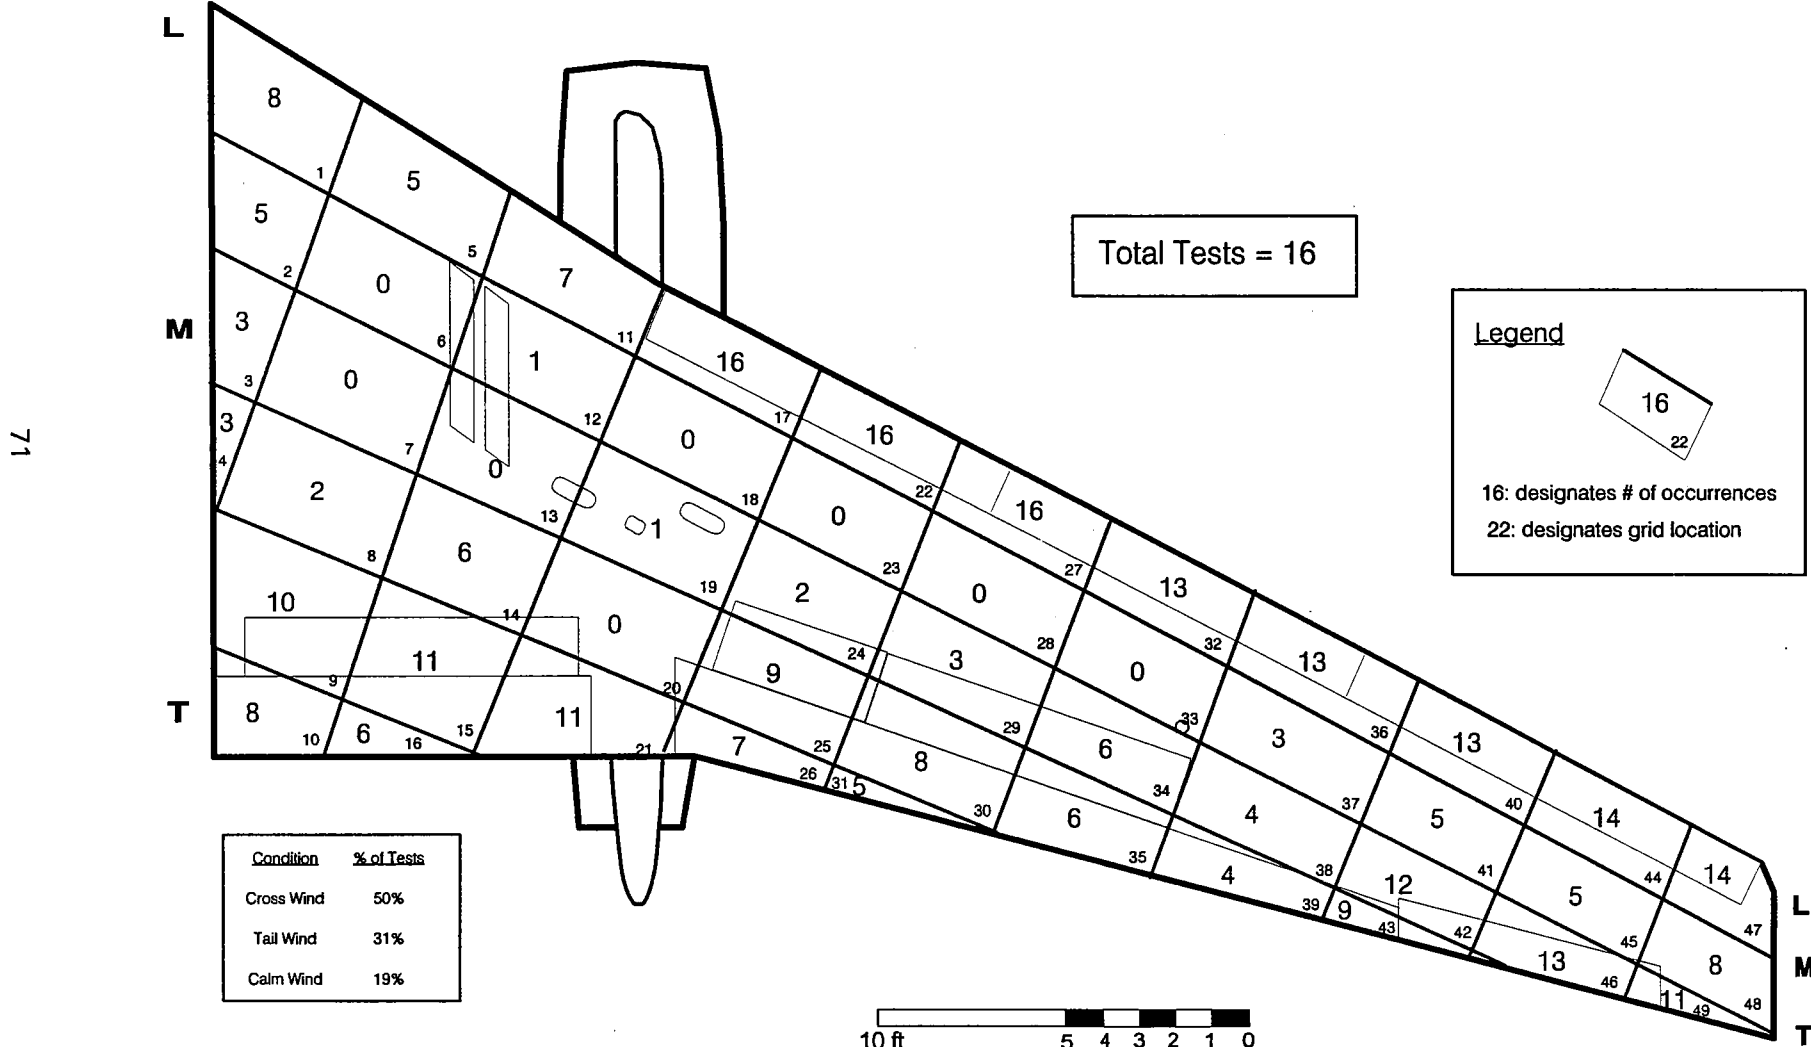
**FIGURE 3.22**  
**OCCURRENCES OF FAILURE BY WING GRID LOCATION**  
**10% WING FAILURE LEVEL**  
**BOEING 737-200**

Note: Occurrence was counted when any amount of failure was present in the grid

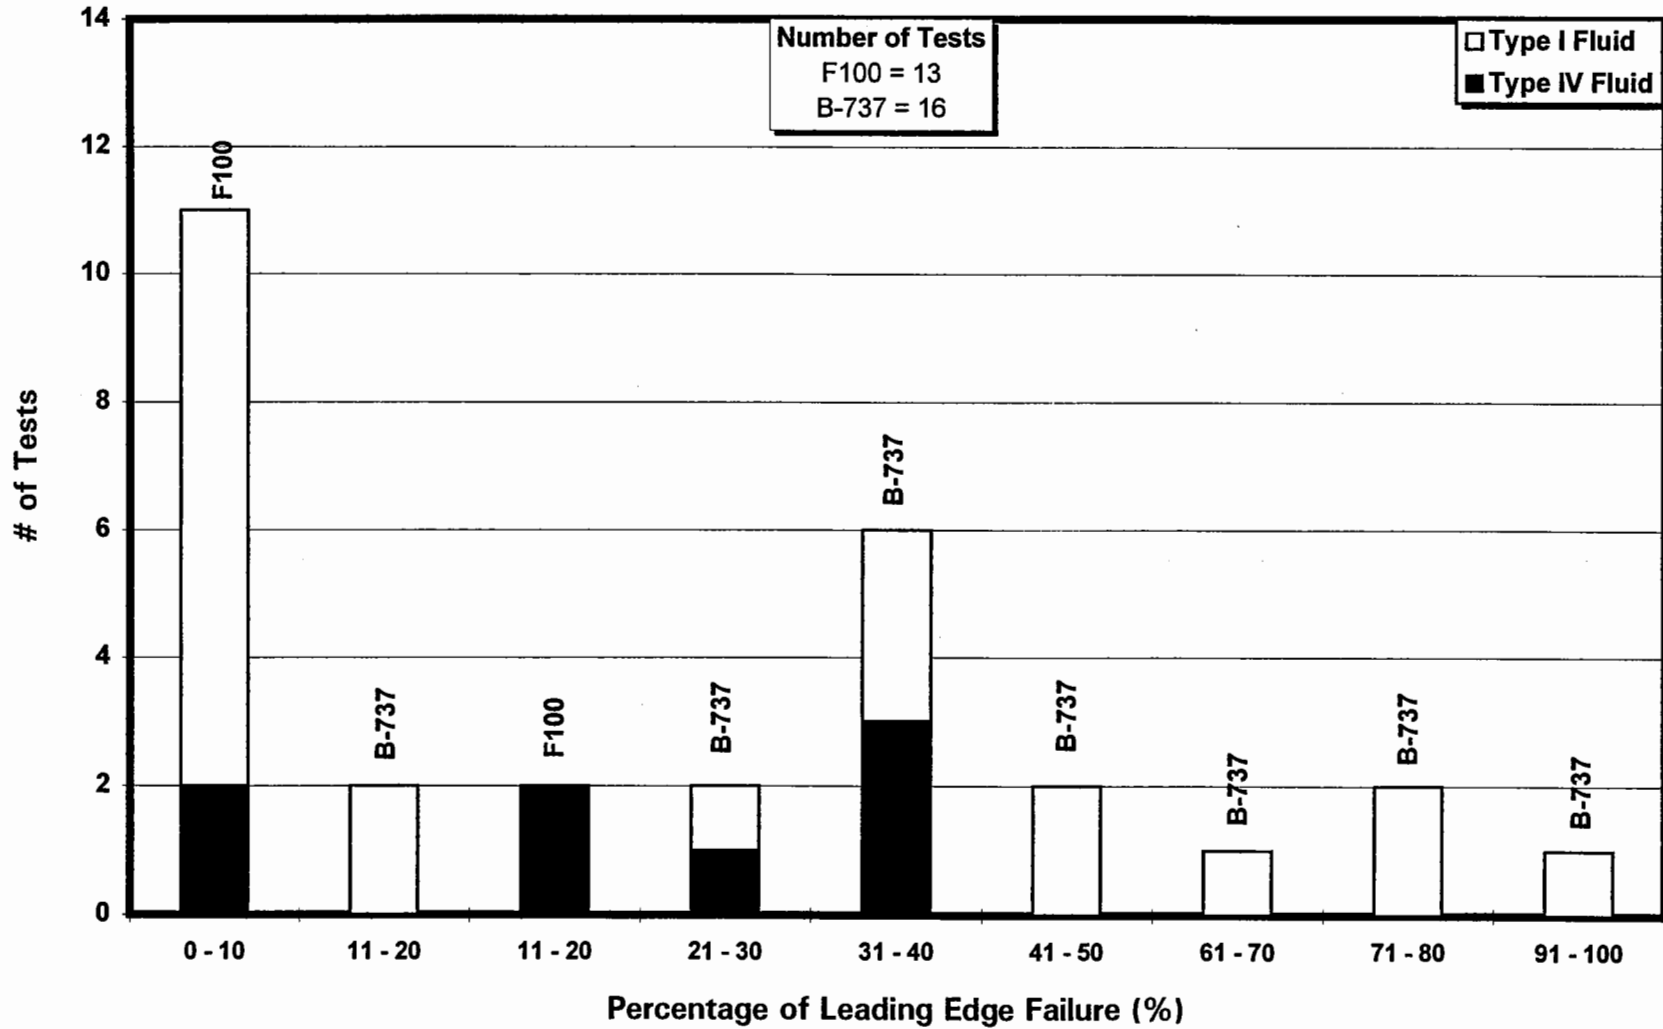
FIGURE 3.24

## PERCENTAGE OF LEADING EDGE FAILURE AT 10% WING FAILURE

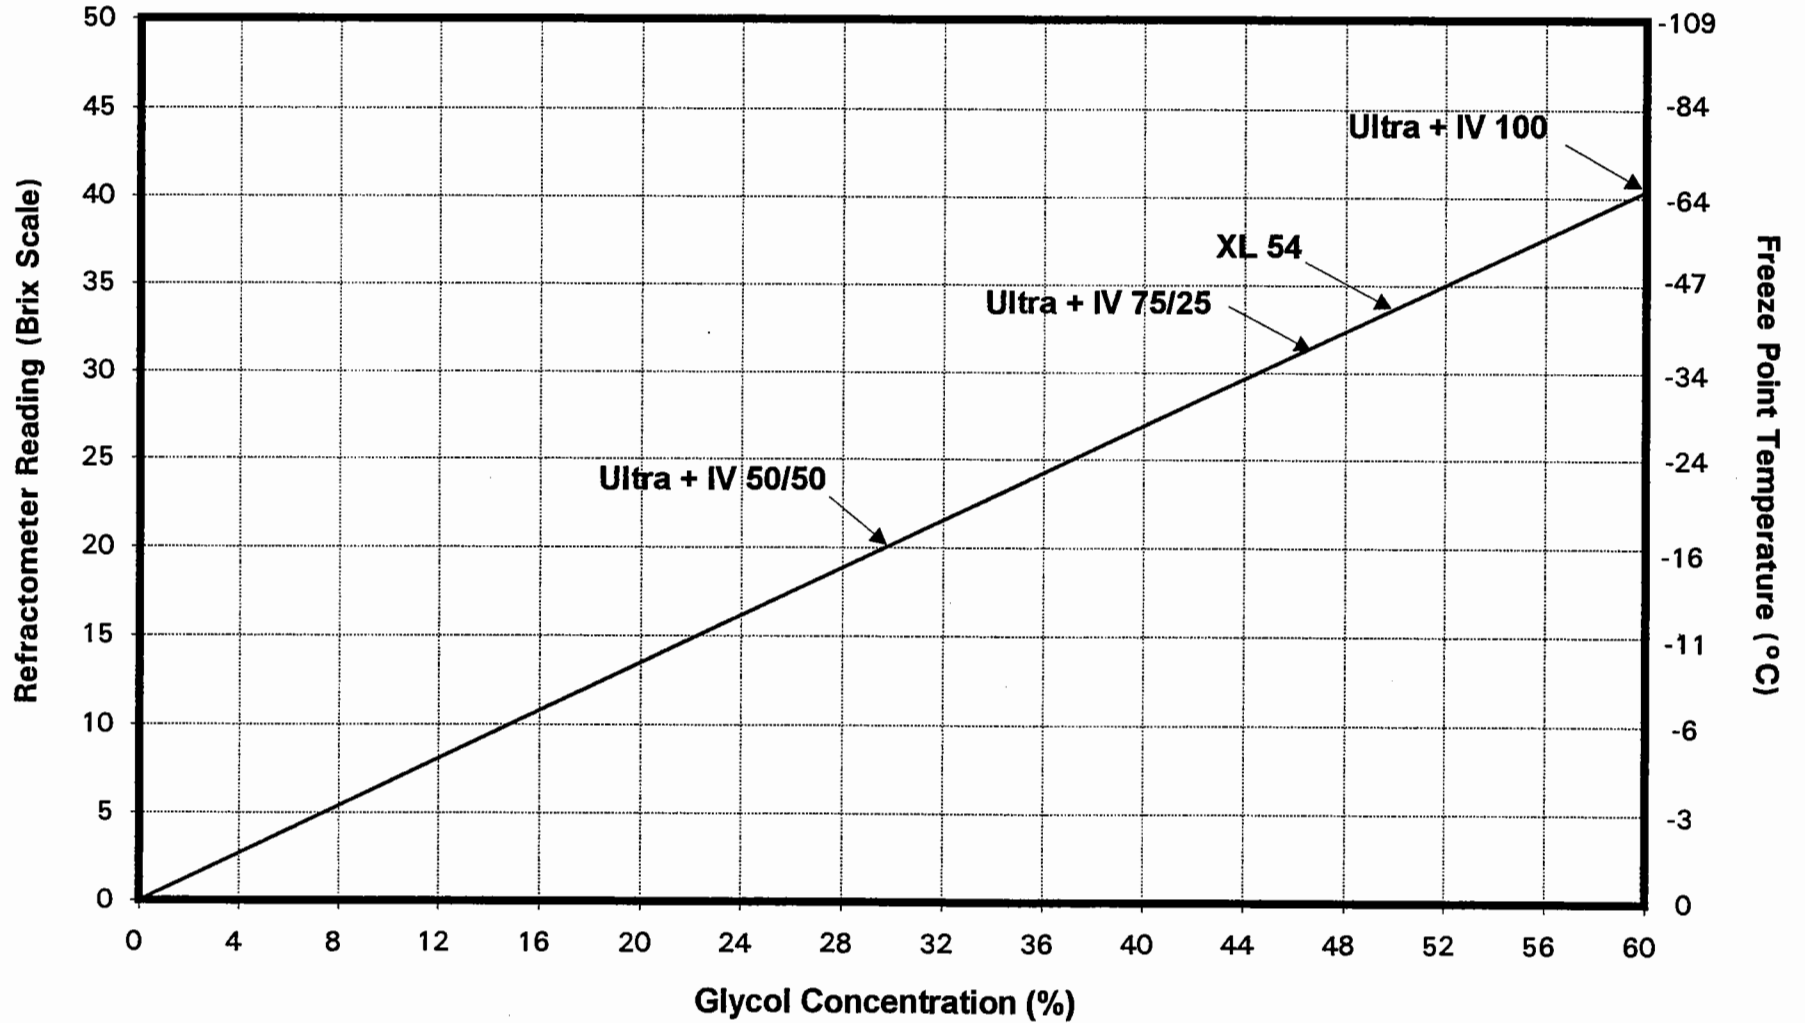
### BRIX vs GLYCOL CONCENTRATION OF UNION CARBIDE ADF AND ULTRA +

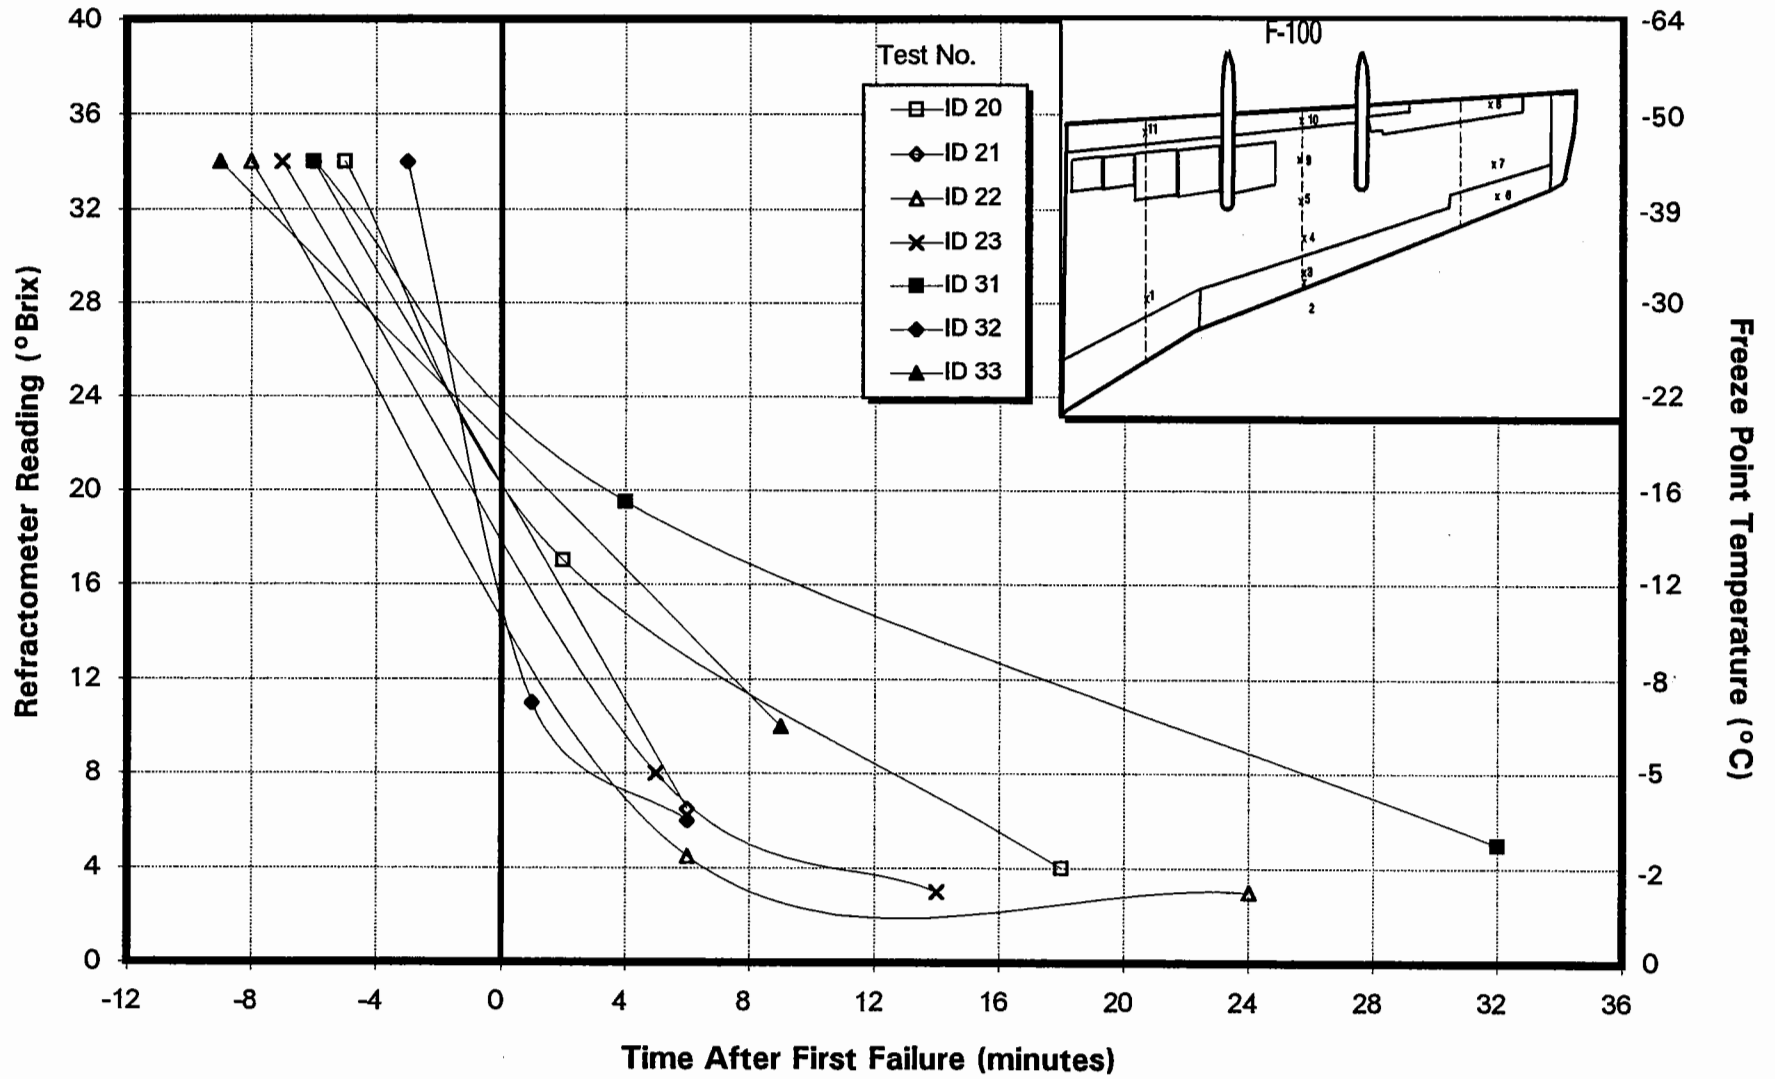
**FIGURE 3.26**  
**REFRACTOMETER READINGS OF WING SAMPLES**  
**RELATIVE TO FIRST FAILURE**  
**FOKKER 100 TYPE I, LOCATION # 10**

two subsequent samples from ID # 20 were taken 2 and 18 minutes following first failure and had Brix values of 17° and 4°, respectively. The line joining the points intercepts the first failure line at 20° Brix. The other curves on the chart represent the sample data collected at the same sample location during the course of the different tests (test ID are indicated for each curve). Using this information, it is possible to determine the fluid freeze point range at sample location # 10 for this fluid and aircraft type. All the curves in Figure 3.26 intercept the first failure line between 15° and 24° Brix which corresponds to a temperature range from -11 to -23°C. As a result, this would be the expected Brix value range of Type I XL54 fluid at sample location # 10 for Fokker 100 tests at the time first failure occurs anywhere on the wing. This Brix range could also be converted to percentage of water using Figure 3.25. In this case, the Brix range of 15° to 24° corresponds to 64% to 78% of water in these samples.

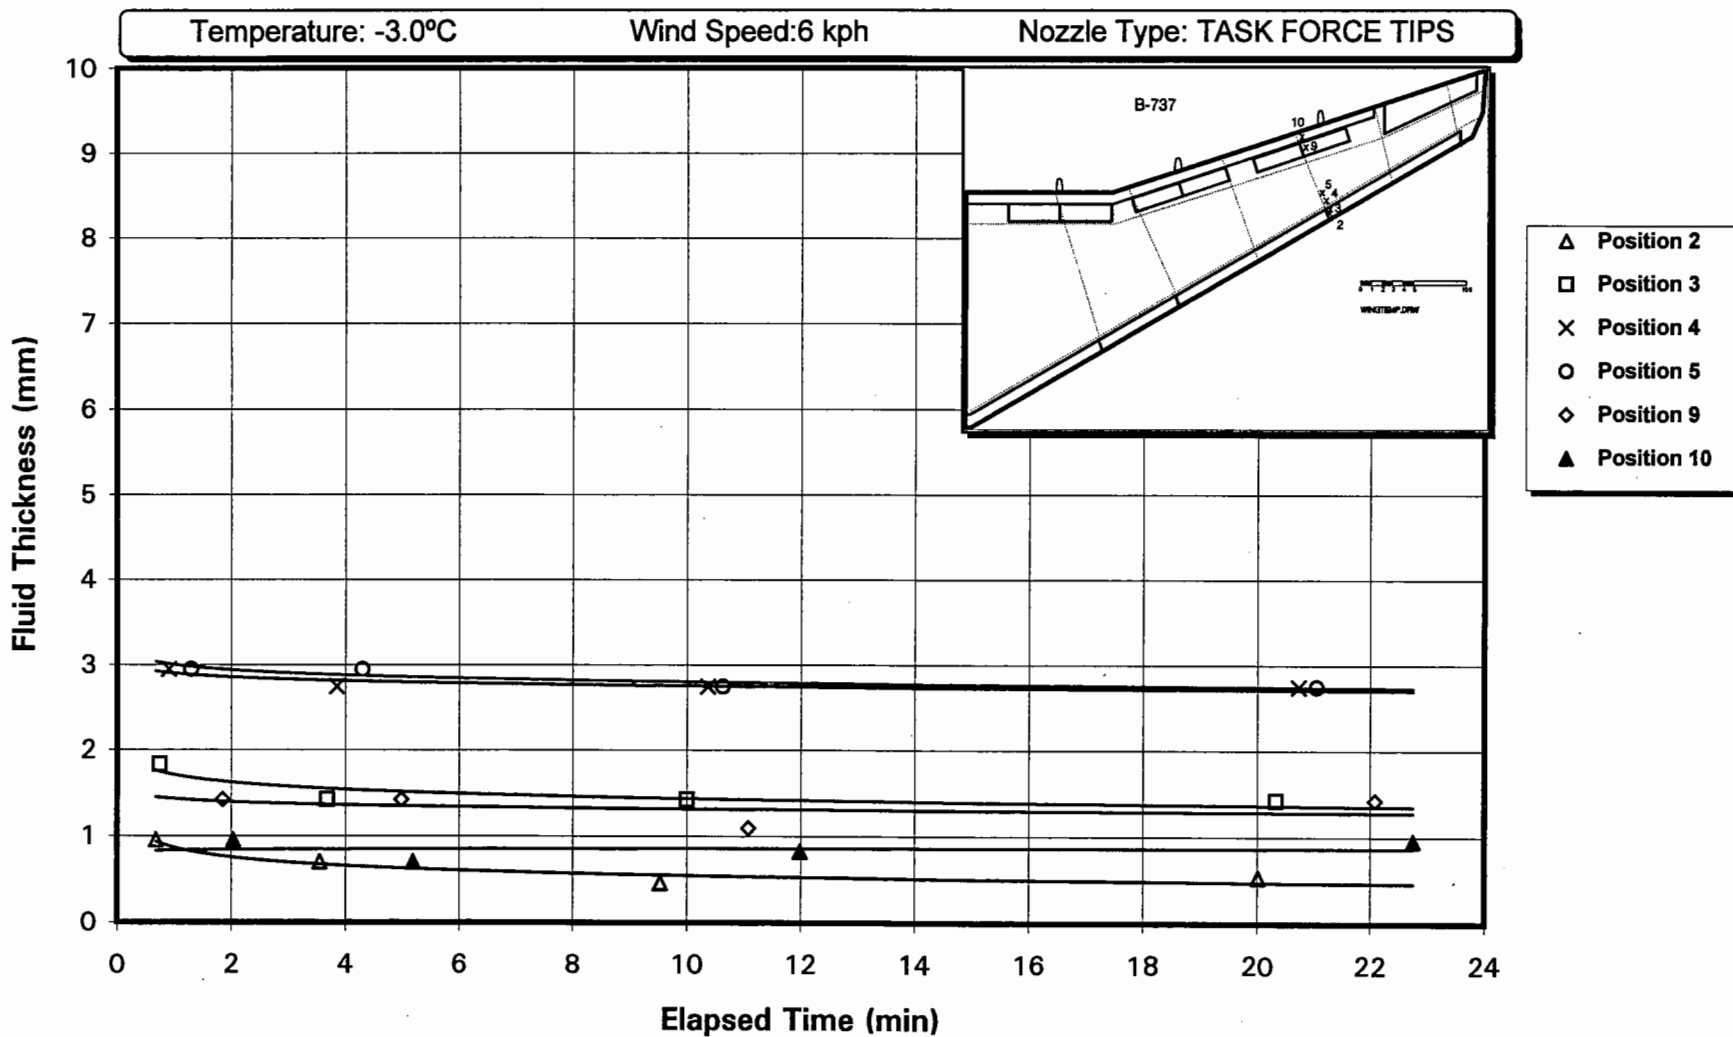
**FIGURE 3.29**  
**TYPE IV FLUID THICKNESS (STABILIZED) PROFILE - NO PRECIPITATION**  
**ULTRA + OVER XL54 ON BOEING 737 WING, ULTRA + ON PLATES**  
 ID# T11 - February 21, 1997

1st FLUID: XL54 TYPE I / 100 LITRES  
 2nd FLUID: ULTRA TYPE IV / 50 LITRES

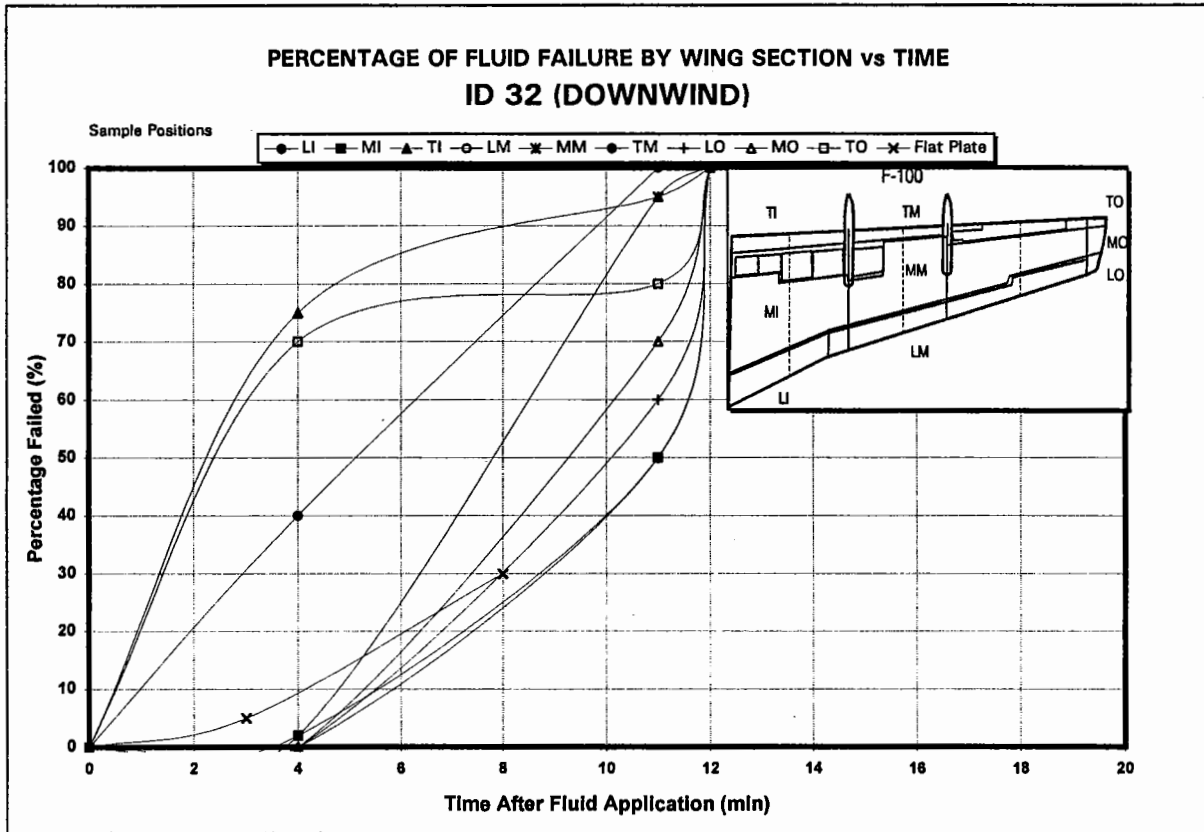
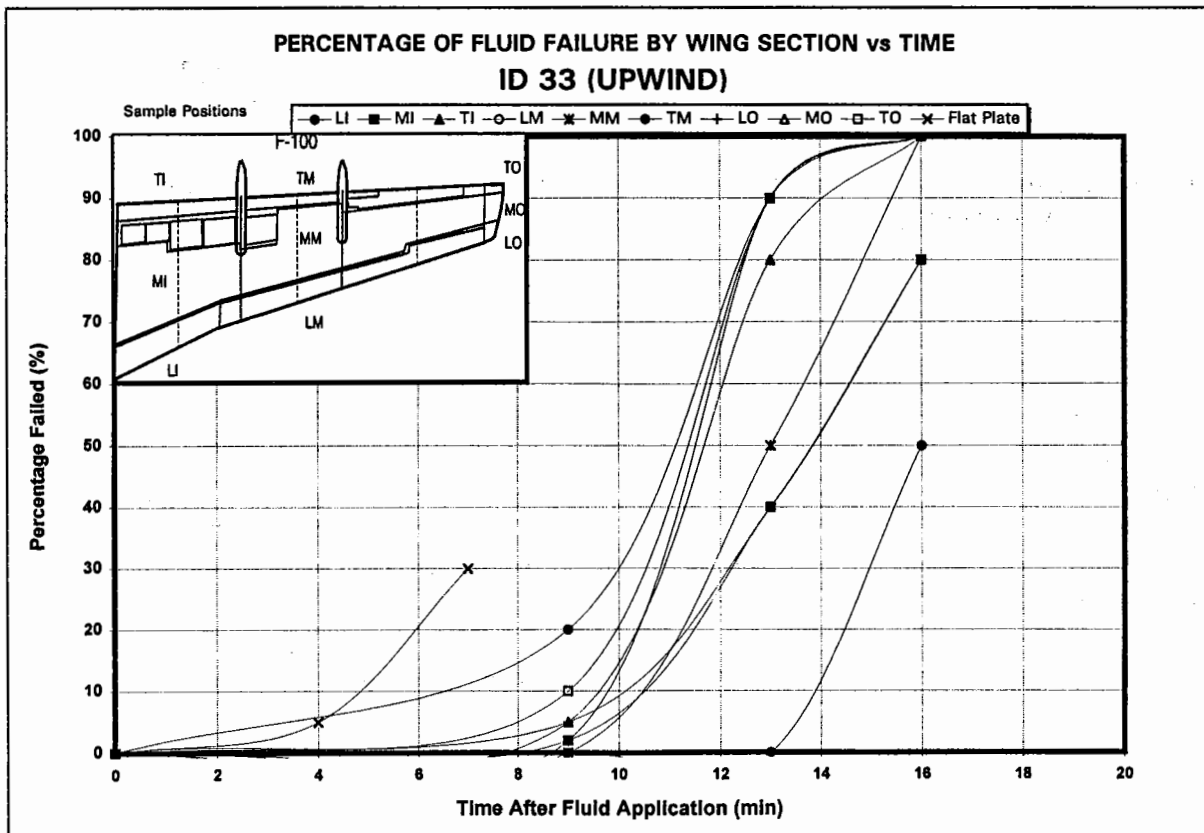
## EXAMPLE OF THE PROGRESSION OF FAILURE OF RELATED DOWNWIND AND UPWIND WINGS

- The effect of wind direction on the progression of failure was observed. In crosswind conditions, the downwind wing always fails prior to the upwind wing. The actual patterns of failure were similar for a Fokker 100 but differed for a Boeing 737. In tailwind conditions, first wing failure occurs on the trailing edge, while in headwind conditions, leading edge failure is always present at the time of first failure.

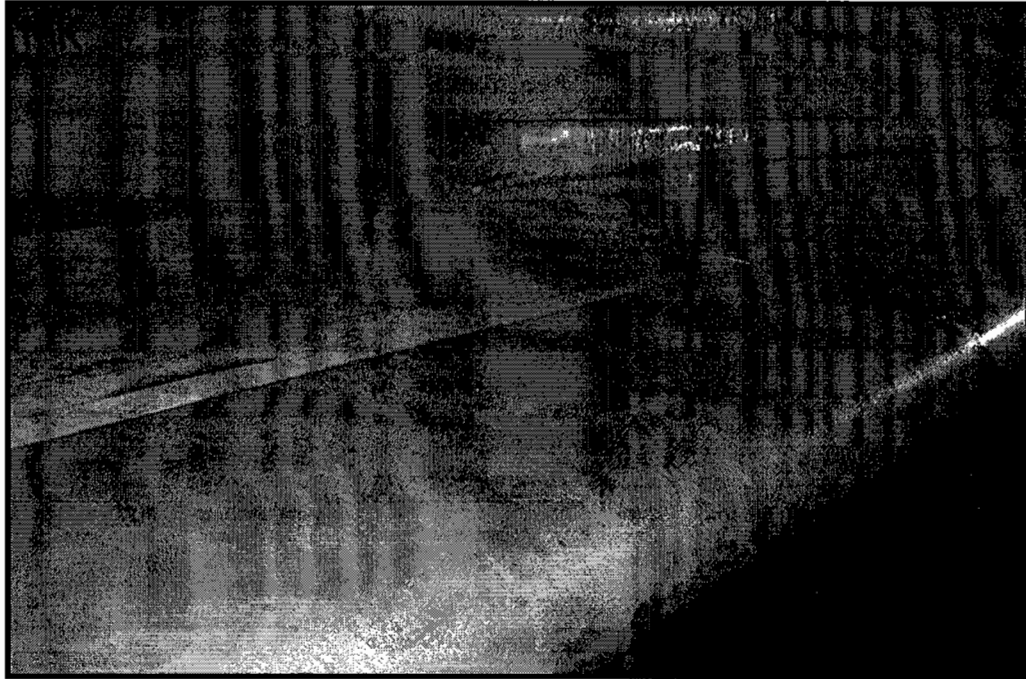
**Photo 4.1**  
**McDonnell Douglas DC-9 Wing Surface During**  
**Freezing Rain Tests at Dorval (Feb. 28, '96)**

**Prior to Failure (Type IV Fluid)**

**After Failure (no fluid was applied)**

The top photograph in Photo 4.1 shows the condition of the fluid on the wing prior to failure. The green dye of the Ultra fluid provided confirmation at the start of the test that fluid was present. The bottom photograph was taken on the opposite wing, which was not protected with fluid. Ice on the wing surface occurred soon after the freezing rain started. The detection of ice in this photo is difficult, due to a lack of contrast between any two areas on the wing surface. Although the wing has failed, this lack of contrast could lead to the false belief that there is fluid on the wing, when viewing the surface from a distance.
