# Aircraft Full-Scale Test Program for the 1996/97 Winter

Prepared for  
**Transportation Development Centre**  
on behalf of  
**Civil Aviation**

**APS AVIATION INC.** **APS**

December 1997

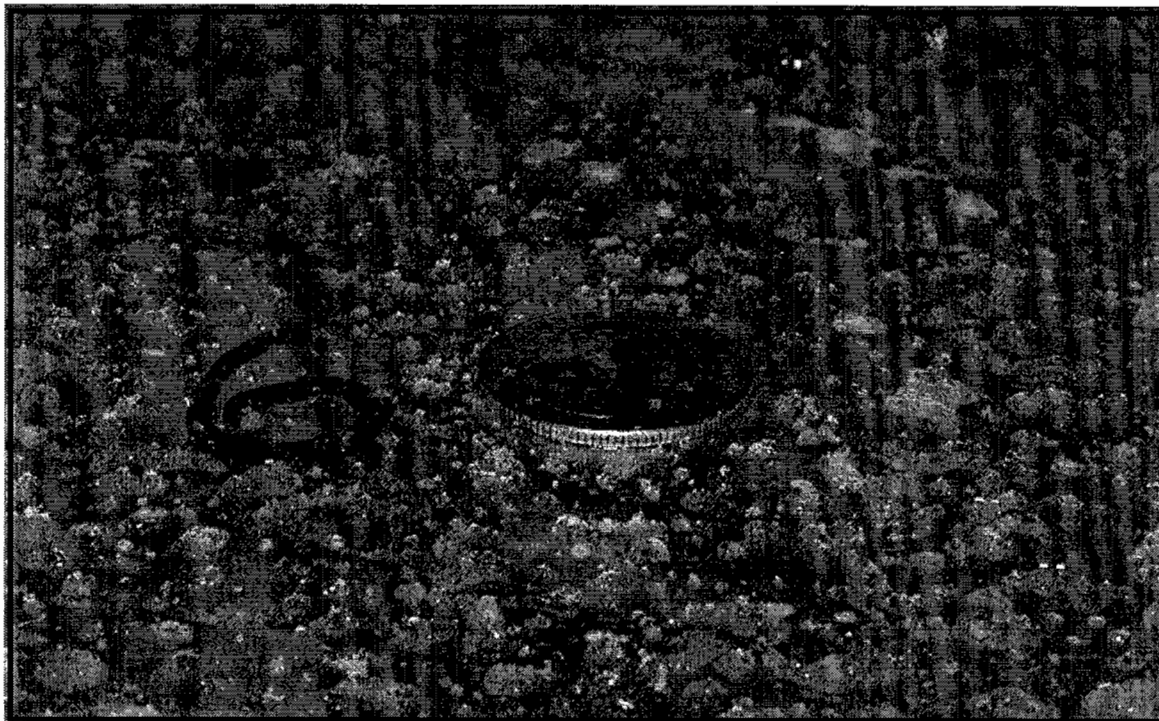
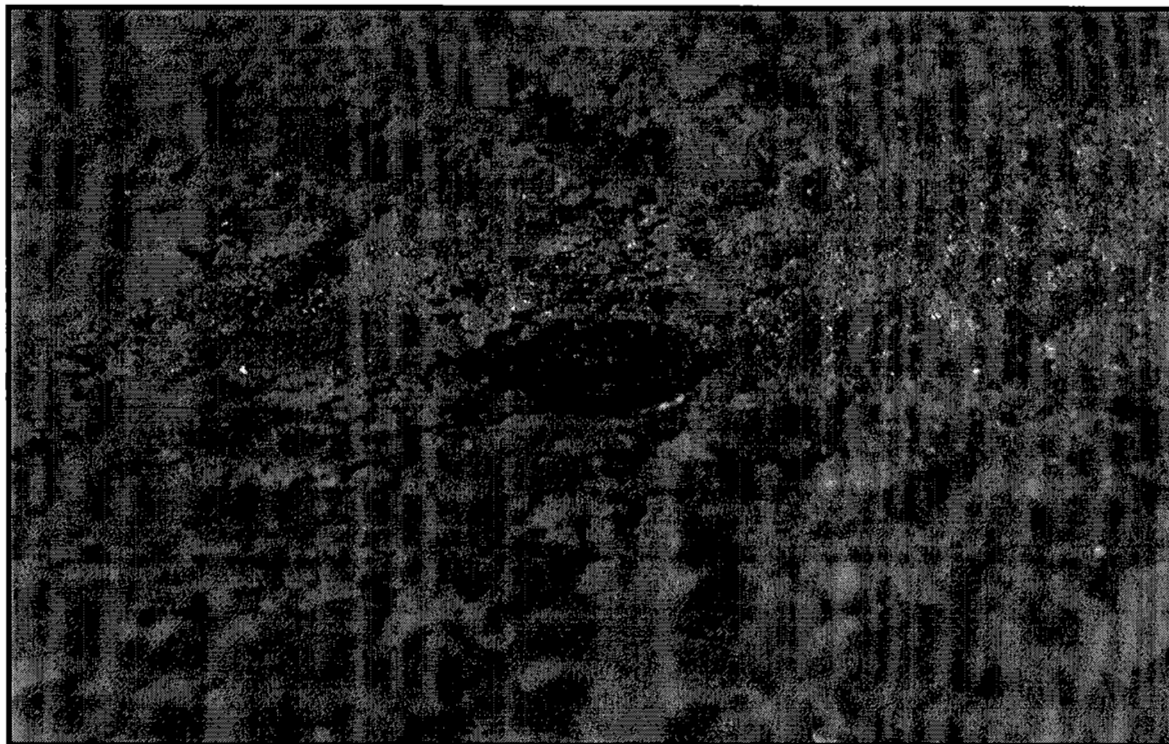
# Photo 4.6 Comparison of Type I and Type IV Failure

## Detailed View of Type I Failure

ID # 33, March 6, 1997, Fokker 100, 20 kph, t = 3:42AM, failure occurred at 3:40 at this leading edge location

## Detailed View of Type IV Failure

ID # 34, March 6, 1997, Fokker 100, t = 4:11AM, 10% wing failure time was 4:10AM, mid-wing, location 4
