Feasibility of Enhancing Visibility of Contamination on a Wing

Phase 1

APS AVIATION INC. **APS**

October 1996

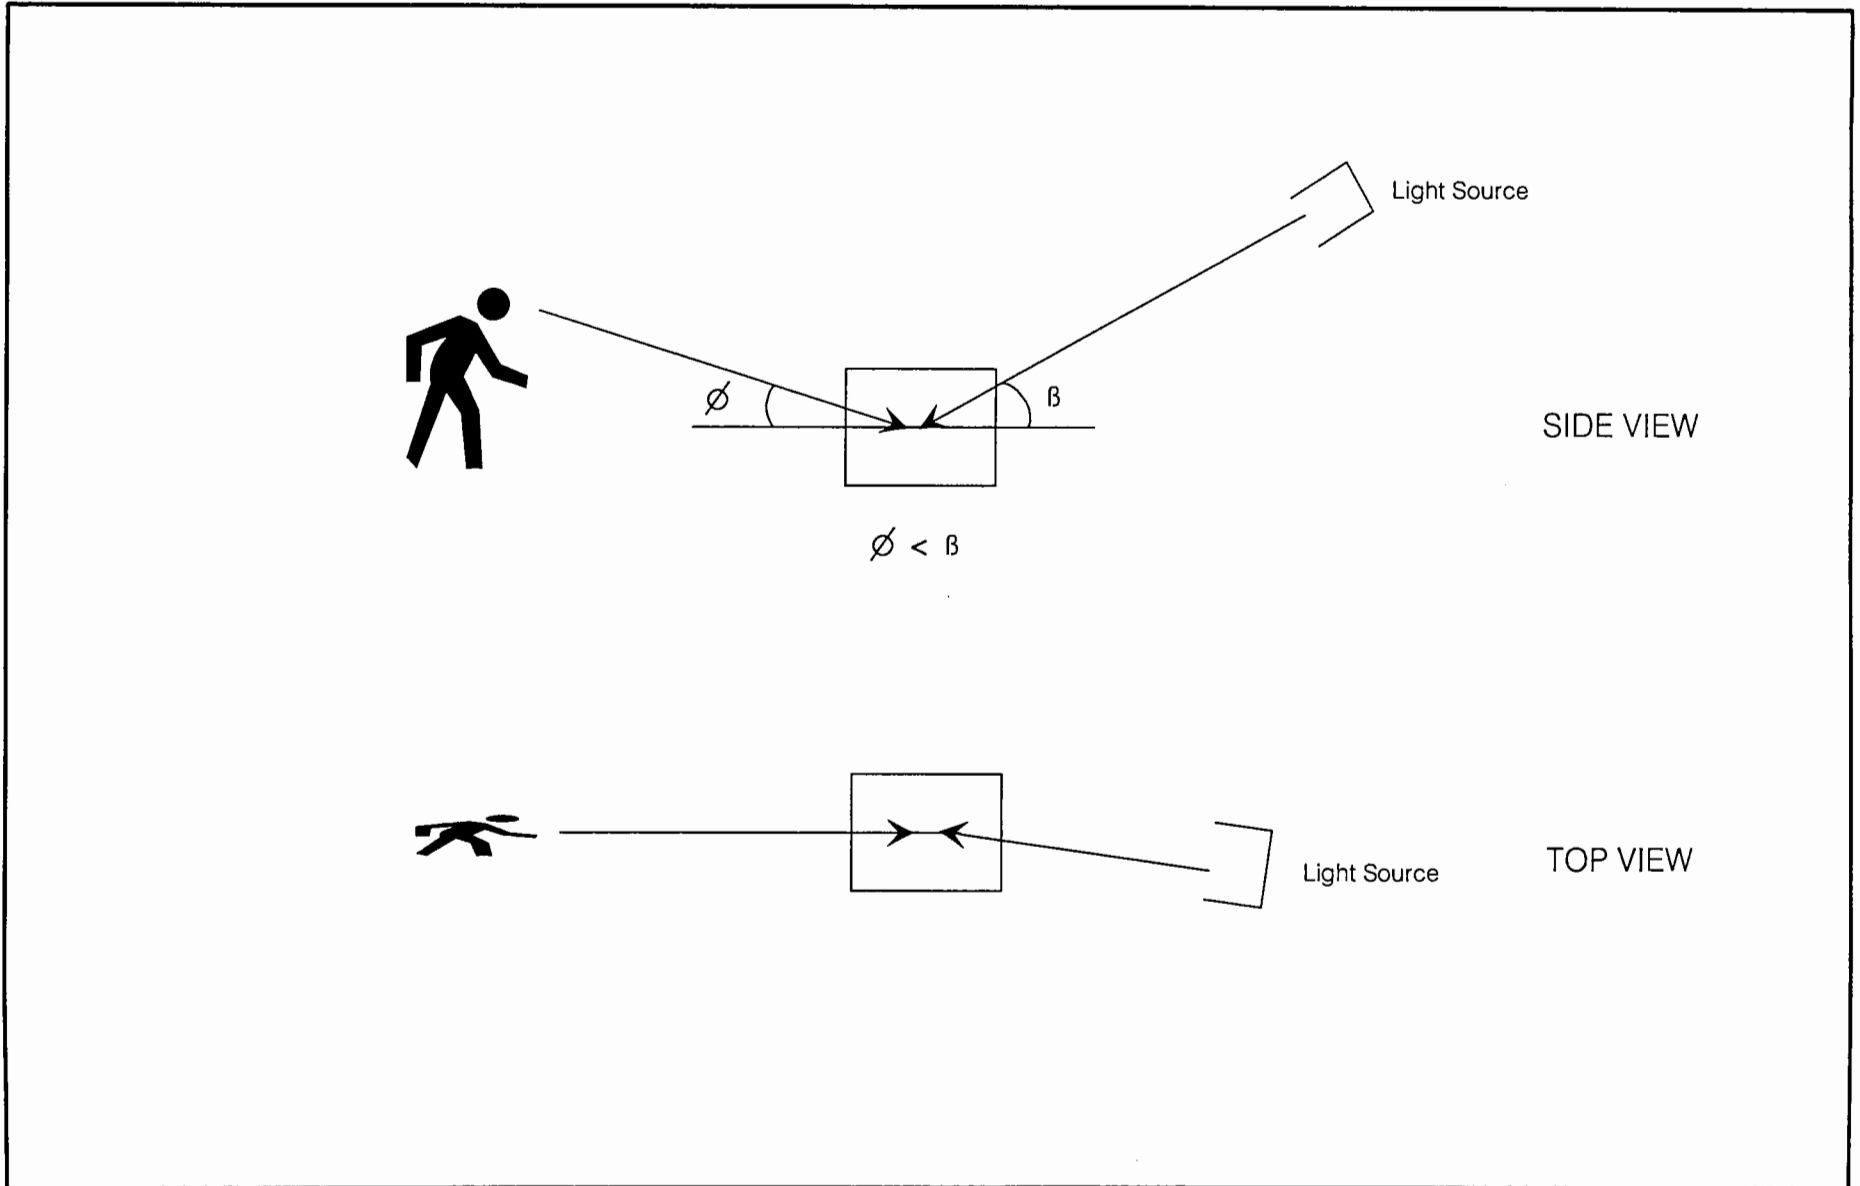
FIGURE 3.1
LOCATION OF LIGHT SOURCE FOR BEST VIEW OF LOSS OF GLOSS
INDICATION OF FAILURE

Under test conditions in which "loss of gloss" criteria applied, as in cases of wet precipitation, it was observed that best visibility of failure was achieved when the camera was pointed slightly off 180° from the light source, with the source of light being somewhat higher (giving a higher angle of incidence) than the camera. Figure 3.1 provides a sketch illustrating this setup. Views of the same failure case by an observer or camera located near the source of light resulted in a quite different result.
