Effects of internal ditching on waterfowl  
use of a forty-acre slough at Kindersley,  
Saskatchewan. Saskatoon, 1959.

The Effects of Internal Ditching on Waterfowl Use of a  
40-acre Slough at Kindersley, Saskatchewan

Alex Dzubin

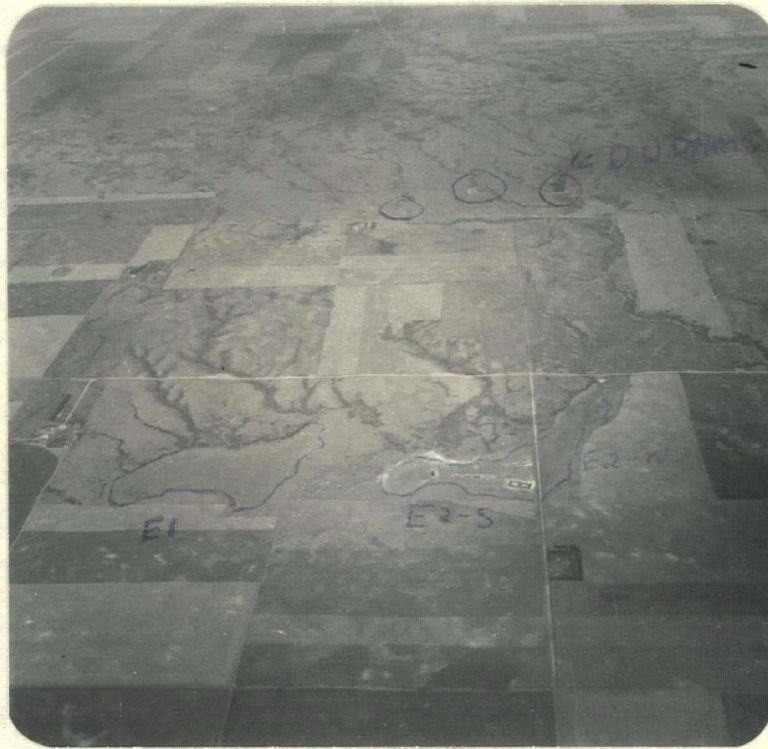
PLATE I - Aerial photo of the centre part of Canadian Wildlife Service Study Area showing ditched pothole in centre of plate with unditched portion north of road. Pothole E1 is the depression to the left of pothole E2. The nesting cover is seen along the sides of the coulees.

Birds utilize the various water areas for feeding, loafing and waiting areas and fly onto the uplands to nest. Nesting cover consists of extensive masses of buckbrush (Symphoricarpos) and Rose (Rosa) which grow in the coulees and around the sloughs. (Plate 1)

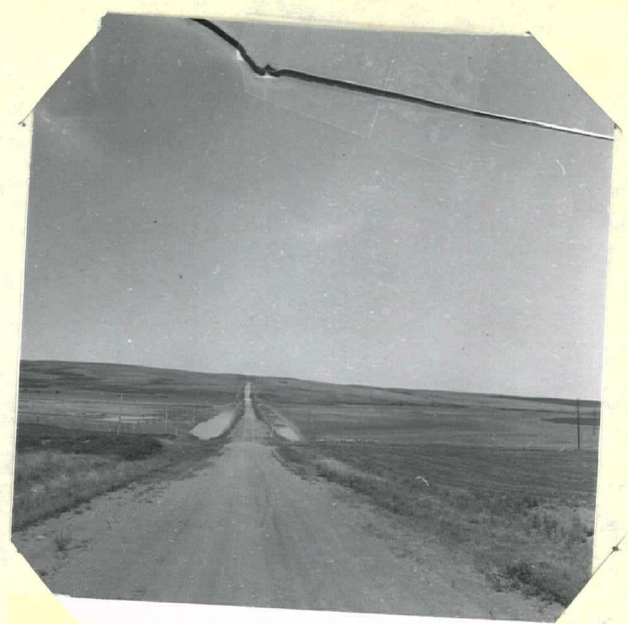
PLATE 2 - Ditches along road grade between north and south portions of pothole E2 - the ditched area is at the left. (Looking West)

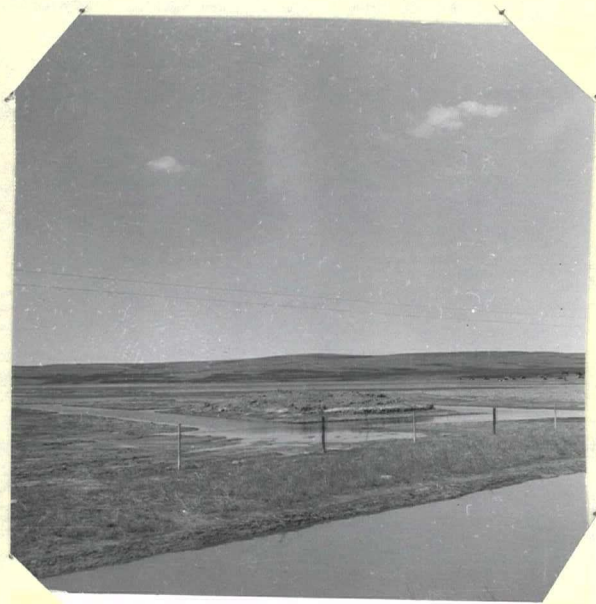
PLATE 3. First island with ditch fill on centre to promote growth. (Looking South-west)

The ditches consisted of A) two islands 54' x 87' and 84' x 58' surrounded by 20'-22" water. Material from the ditches was scattered on one of the islands and removed from the other. (Plates 3 and 4)

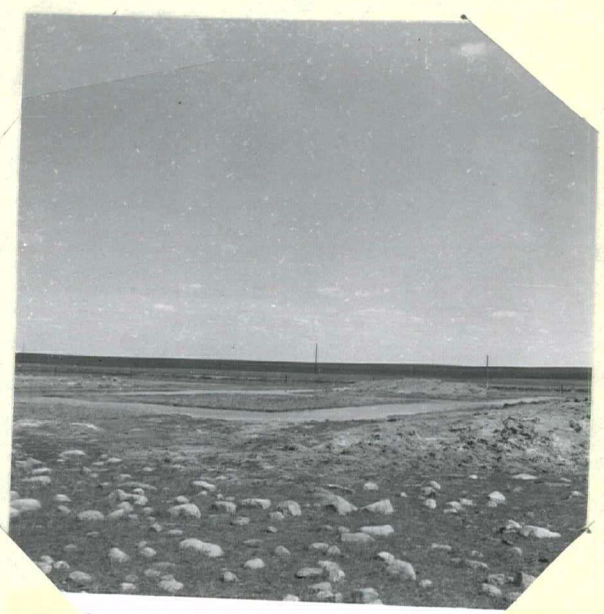
PLATE 4 - Second island with ditch fill removed to one side. Cover mostly of saltwort and wild barley. (Looking North-west)

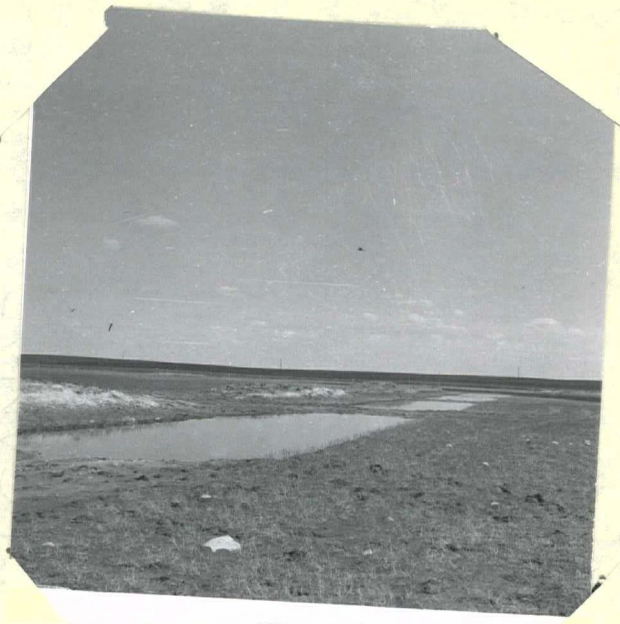
PLATE 5 - Series of 4 short ditches with fill removed to one side. (Looking North)

B) four ditches 65' - 70' x 21' strung out in a north south direction and some 32'-41' apart. (Plate 5)

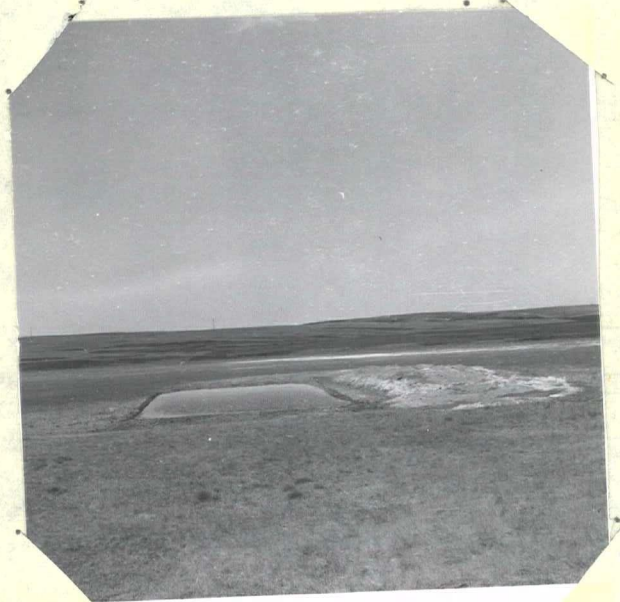
PLATE 6 - The large "dugout-type" ditch. (Looking West)

C) one large dugout type excavation 100' x 40'. (Plate 6)

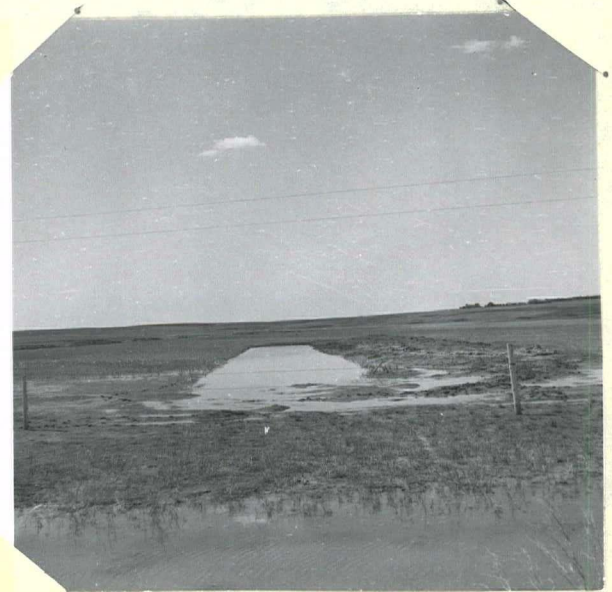
PLATE 7 - The "long-ditch". (Looking South)

D) one long ditch 217' x 20'. (Plate 7)
