GRANULAR AGGREGATE RESOURCES,
ANDOVER (N.T.S. 21J/12)
AND
FLORENCEVILLE (N.T.S. 21J/5)

GARTNER LEE ASSOCIATES LIMITED

OPEN FILE REPORT 81-2

MARCH, 1981

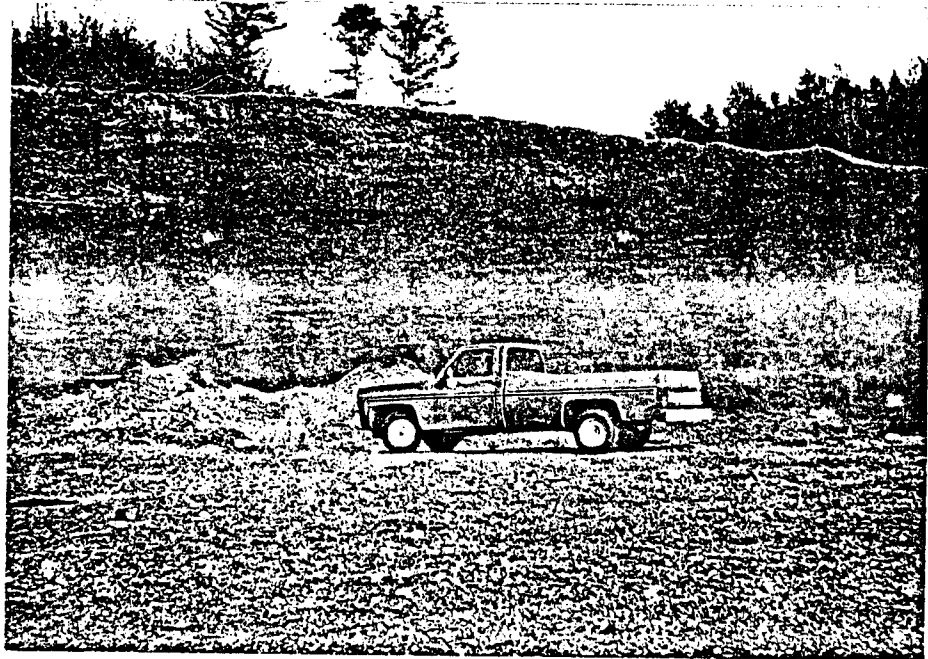
PHOTO 4

Well laminated sandy gravel outwash deposit at Location 22.
The pit face is 8 m in height.

Smaller outwash deposits are present along several of the smaller stream valleys in the area. The Big Presque Isle Stream has several terraced outwash deposits along its valley that have been used as aggregate sources. A substantial area of outwash exists north of the valley at Tracey Mills (Locations 54 and 55). Two levels of outwash are present here in an abandoned outwash channel which apparently drained into the Big Presque Isle Stream. Another similar but much less well developed channel deposit flanks the present Meduxnekeag River in the southwest corner of the map area (Location 85). A new pit has been opened in an outwash deposit along Monquart Stream (Location 22, Photo 4).

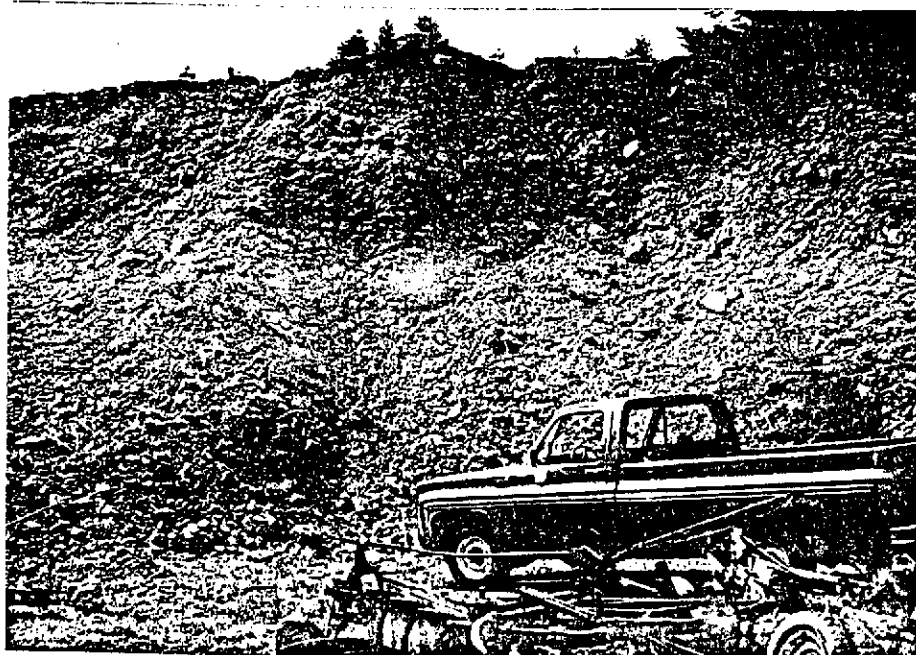
PHOTO 6

Coarse esker sediments at Location 20.
Pit face is 12 m in height.

Numerous kames and kame-like deposits were noted in the present survey. These deposits often lack a distinct geomorphic form and are therefore difficult to distinguish from bedrock landforms - especially when forested. It is possible that detailed local explorations may reveal more of these features, particularly in wooded areas. Field observations indicate that the larger these features are, the more likely they are to contain good quality aggregate. The larger features (Locations 1 and 2, 13, 17, and 46) have all produced sizeable amounts of aggregate. Several smaller deposits (Locations 18, 19, 20, 21, 45 and others, Photo 6) have produced some material but exposures indicate

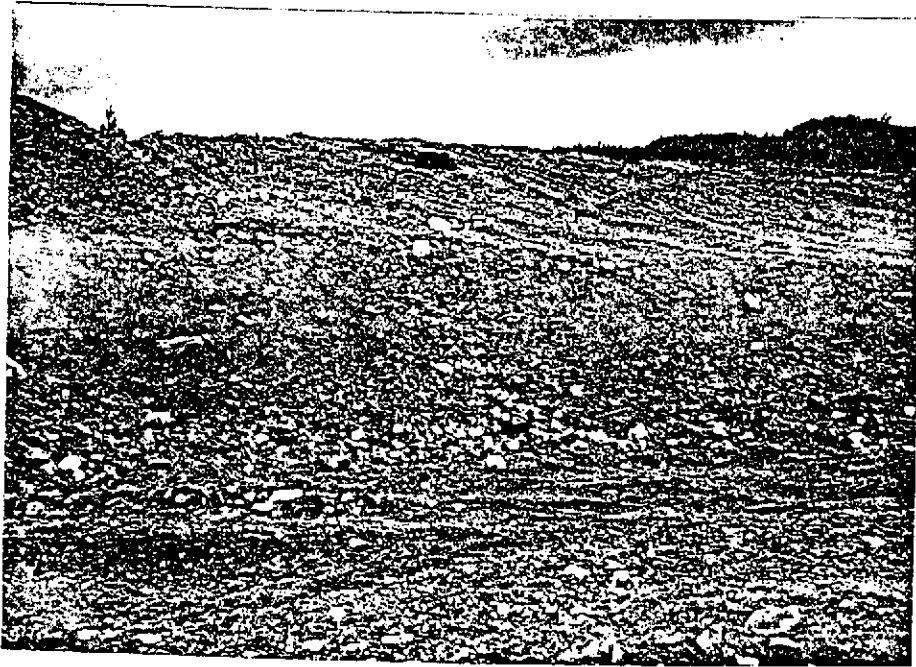
PHOTO 7

Ablation Materials in a small pit at Location 45.
Total thickness of materials is 4 m.

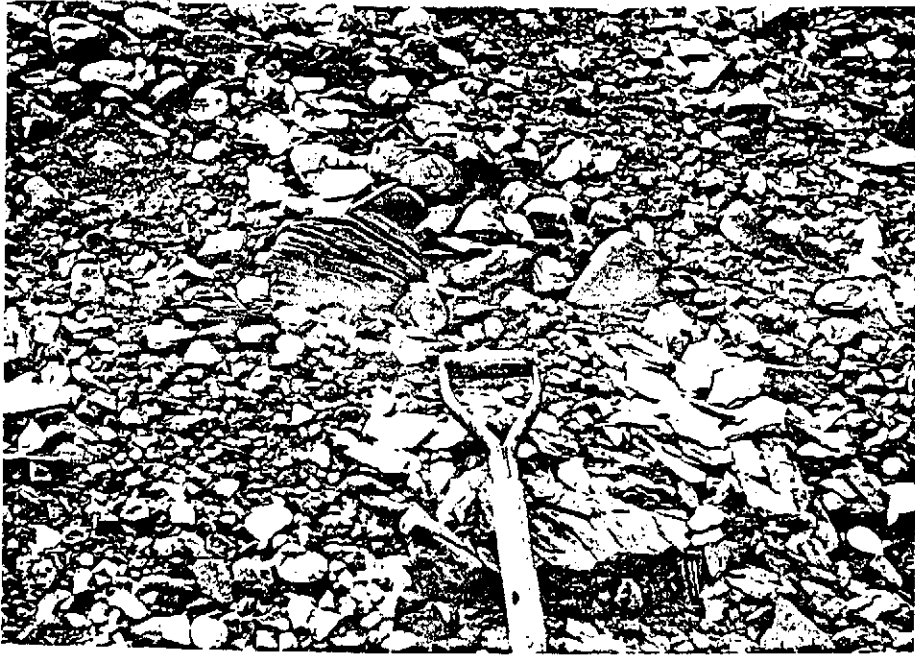
PHOTO 8

Weathering of deleterious shale and phyllite particles in an aggregate deposit.

The composition of the individual pebbles in the aggregate has a profound effect on the **performance** of an aggregate. Ideally all clasts should be hard, strong, uncoated and resistant to both chemical and physical weathering. In practice, there are always some clasts that are considered "unsound" - they are likely to provide unsatisfactory performance and so weaken any structure or road surface they are used in (Photo 8).

susceptible to abrasion and will break down when exposed to repeated freeze-thaw cycles (Photo 8). They also exhibit a preference to platy or rod shaped particle shapes. Chert, which is often found with limestone, commonly breaks down when exposed to moisture. Badly weathered pieces of any rock lithology are also classified as being unsound.
