# Operational Fund Year-End Report 2023-24

## Salmon Habitat Restoration Center of Expertise

September 26, 2024

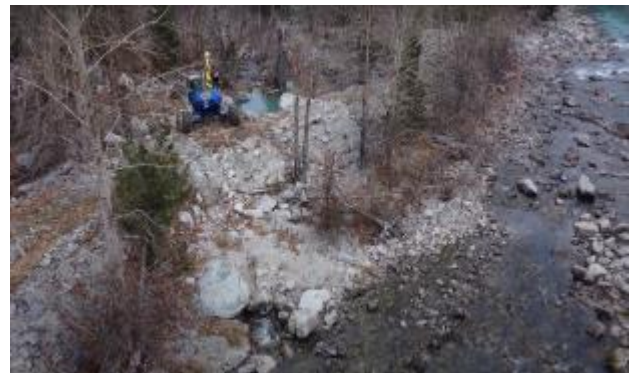
Figure 1: Downstream view of the Bluenose off-channel site prior to 2024 restoration works (photo taken February 5, 2024).

This project was carried out in February 2024 and involved construction services and monitoring. Specifically, the Bluenose off-channel river intake was removed, the berm separating the channel from Bridge River was breached, and a new 25-m connector channel was created to directly connect the mainstem Bridge River to the Bluenose off-channel habitat (Figure 2).

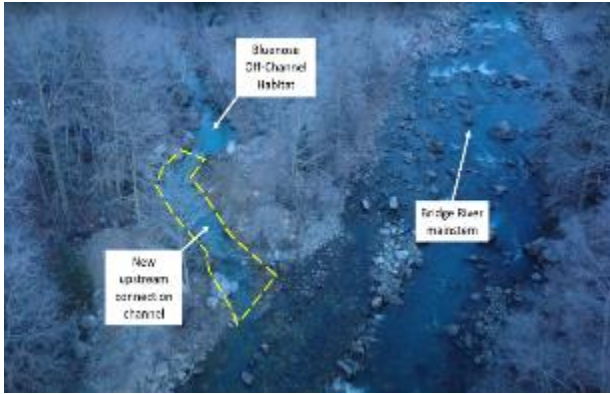
Figure 2: View downstream of the newly constructed connection channel (dashed yellow line) for the Bluenose off-channel project site adjacent to the Bridge River mainstem (photo taken February 7, 2024)

and improved habitat conditions in approximately 1000 m<sup>2</sup> of existing side channel habitat. Xwísten has documented COSEWIC Endangered Middle Fraser Summer Steelhead spawning in the new connector channel during early project monitoring.

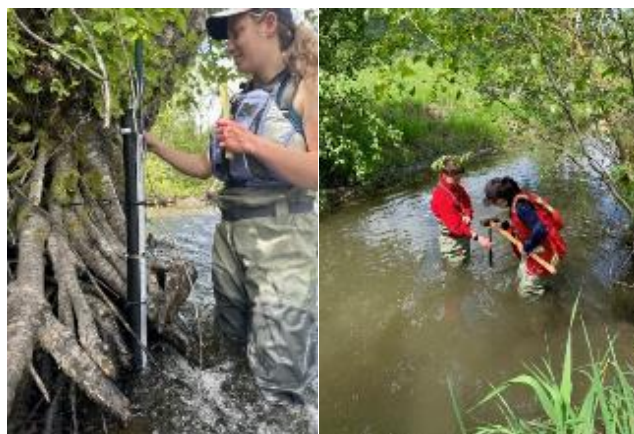
Figure 1: The BC Interior restoration team installing monitoring equipment in Raft River (left) and the Pawloff Channel (right).

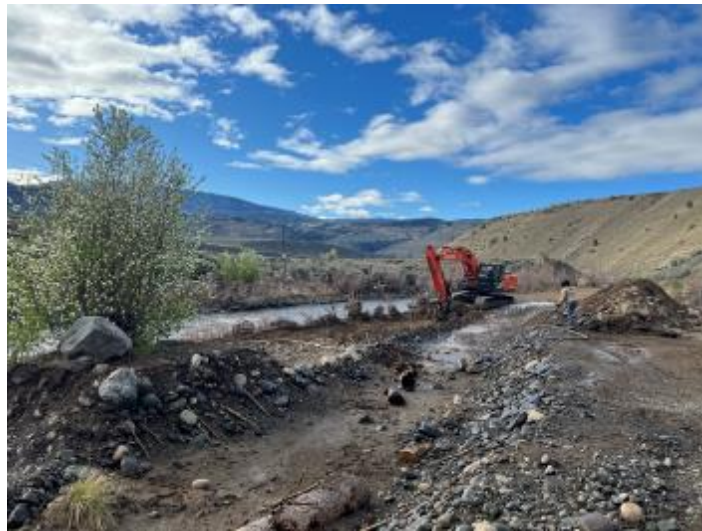
Figure 1: Excavator constructing a low bench.

A low-bench floodplain was excavated at a berm originally constructed to protect an irrigation intake channel (Figure 1). The low bench was designed to be inundated at a 2-year bankfull flood flow, and designed to widen bankfull width, reduce bed erosion, and encourage natural recruitment of cottonwoods and willows. Cottonwood stakes were planted along the low bench.

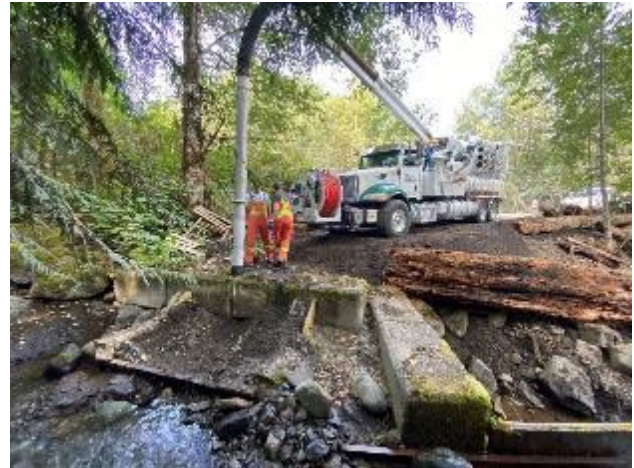
Figure 1. Maintenance for the existing intake using a vacuum truck to remove accumulated bedload.

Deer Creek is a steep tributary to the Chilliwack River with high bedload, thus the current intake is prone to clogging and requires substantial maintenance to provide consistent flows to the habitat complex (Figure 1).

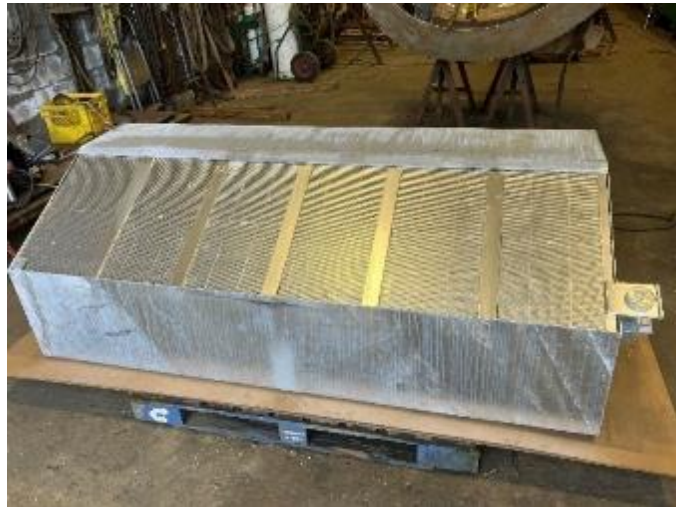
Figure 2. The newly fabricated intake for Deer Creek.

The project objective is to replace a non-functional intake on Deer Creek with a new, innovative intake that will require less maintenance from sediment clogging, and will maintain consistent flows to the spawning channel and rearing pond complex.

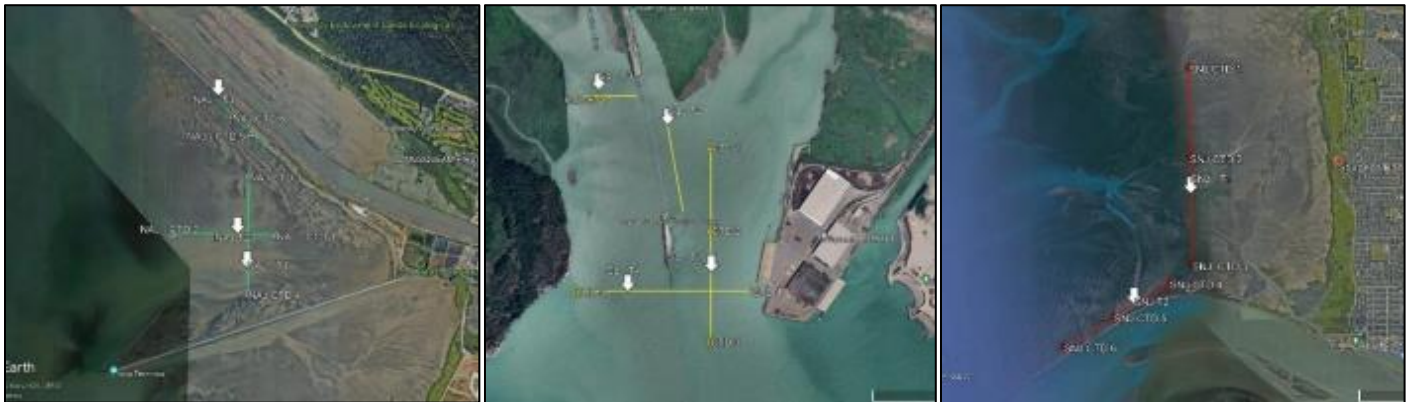
Figure 1. Sampling locations at the North Arm Jetty (left), Steveston North Jetty (middle), and Squamish Jetty (right).

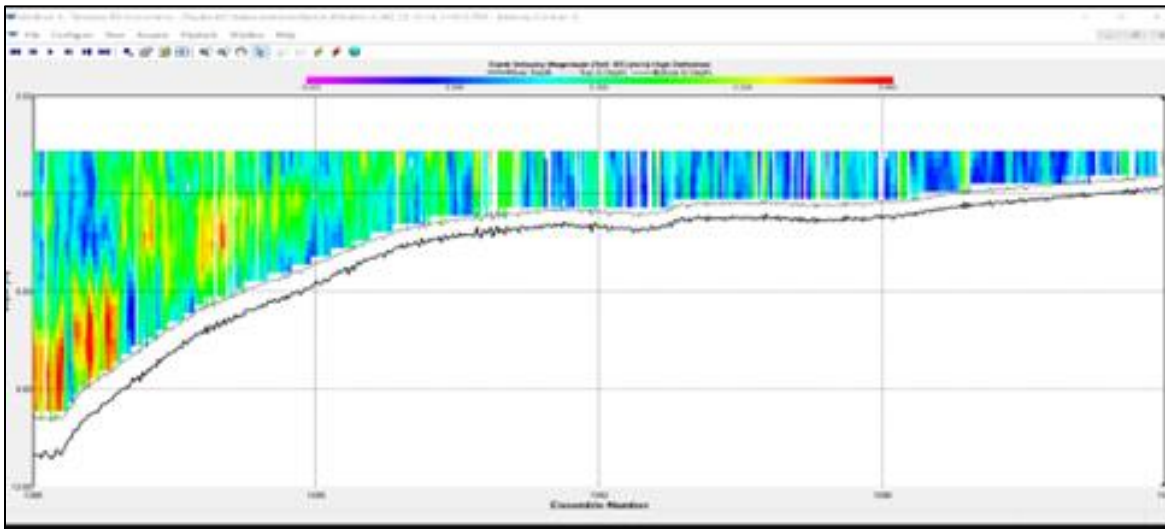
Figure 2. Example of velocity profile across the Squamish River Estuary from south to north.

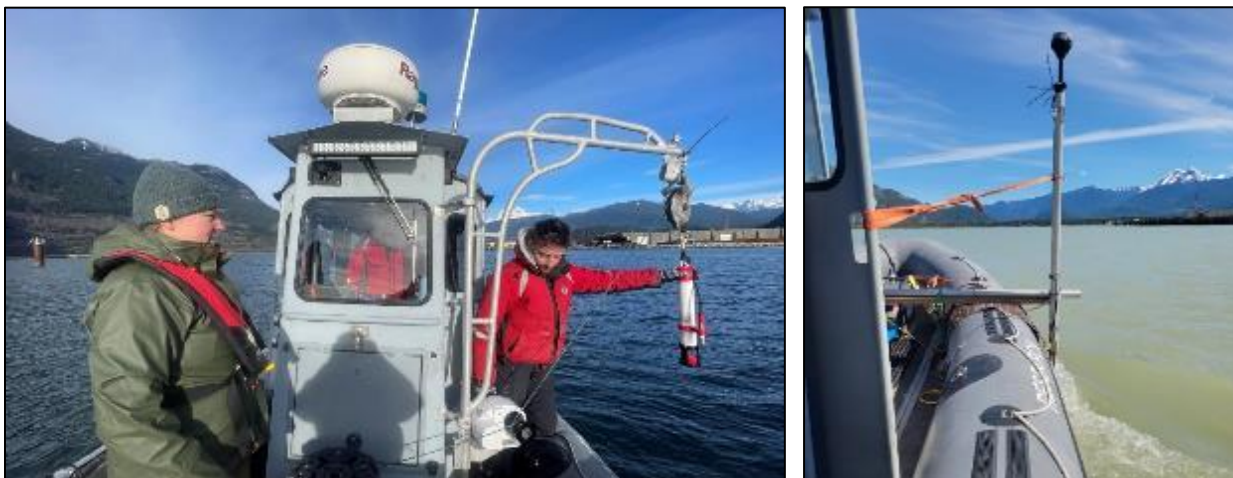
Figure 3. CTD profile cast and selection (left), and ADCP set up (right).

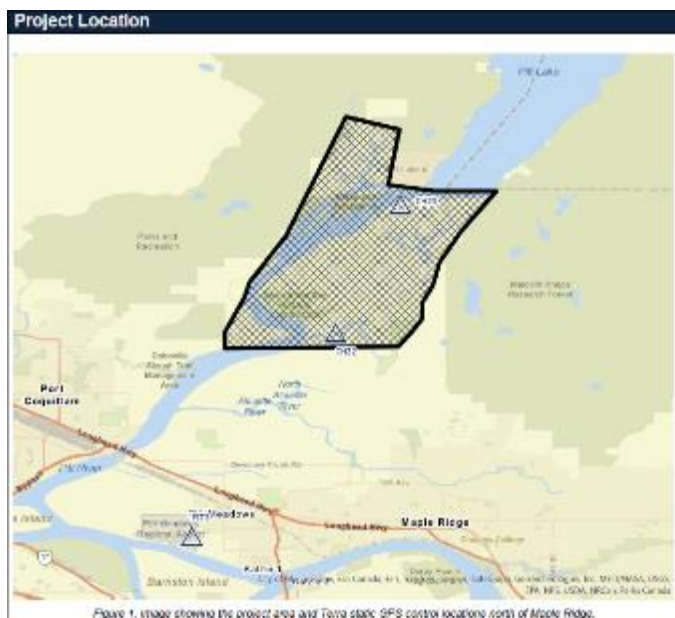
Figure 1. Image showing the project area and Terra static GPS control locations north of Maple Ridge. Figure 1. Project area within which LiDAR and aerial imagery were collected.

Project outputs include LiDAR, a DEM and ortho-imagery covering 43.2 km<sup>2</sup> of the Pitt River and historic floodplain including Pitt-Addington Marsh, Widgeon Slough, and Addington-Point Marsh.

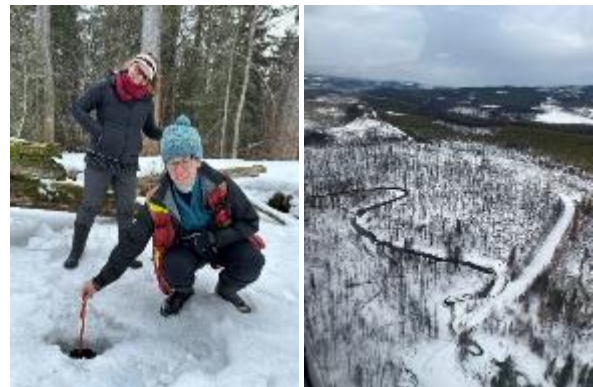
Figure 1. Measuring water and ice depth at a priority creek mouth (left) and Pinkut Creek Fire 2023 (right).

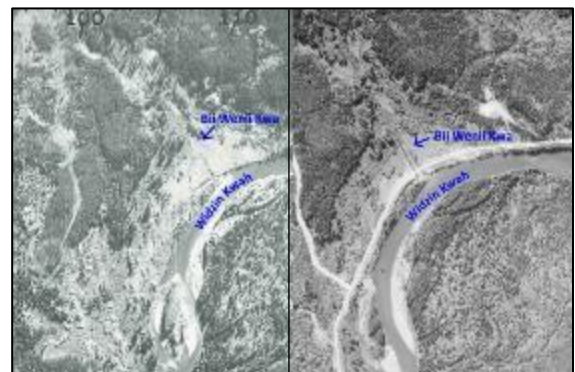
Figure 1. Bii Wenii Kwa - Left: 1949 aerial imagery, flow at the confluence appears to occupy 2-3 channels. Right: mid-1950s, channelization at the confluence with all channels consolidated to one.

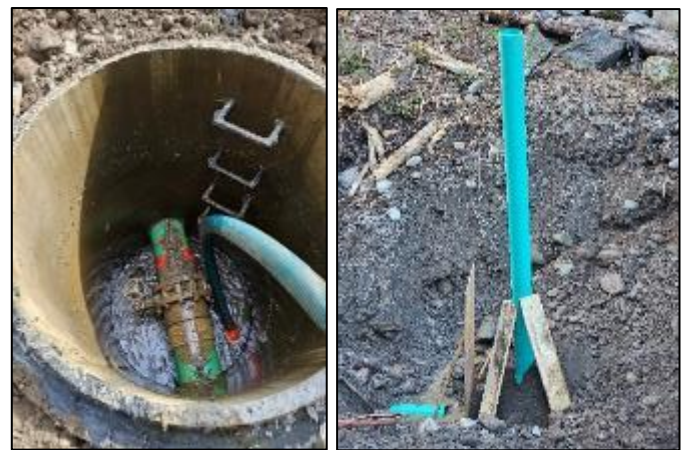
Figure 1. Partially excavated flooded manhole with broken valve (left). Buried replacement valve with new access pipe (right).

The intake screen was removed and a bladder was used to plug the intake. The broken valve was excavated and replaced, along with sections of broken pipe (Figure 1). Access to the new valve was improved by replacing the confined space concrete manhole with a pipe and long metal key. The valve and pipes were reburied and reinforced with a rip rap wall (Figure 2).

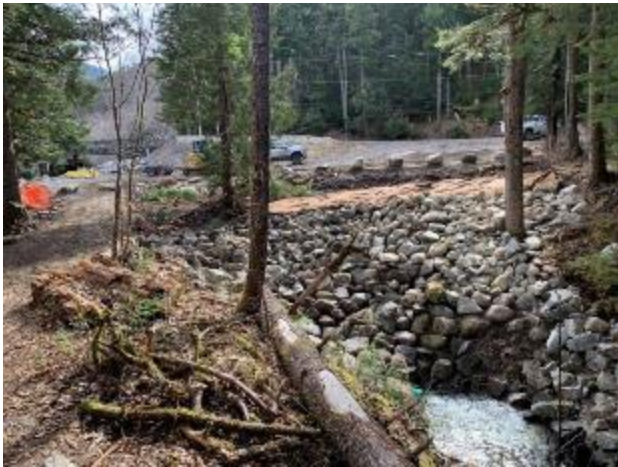
Figure 2. View of rip rap wall, exit pipe and valve access pipe.

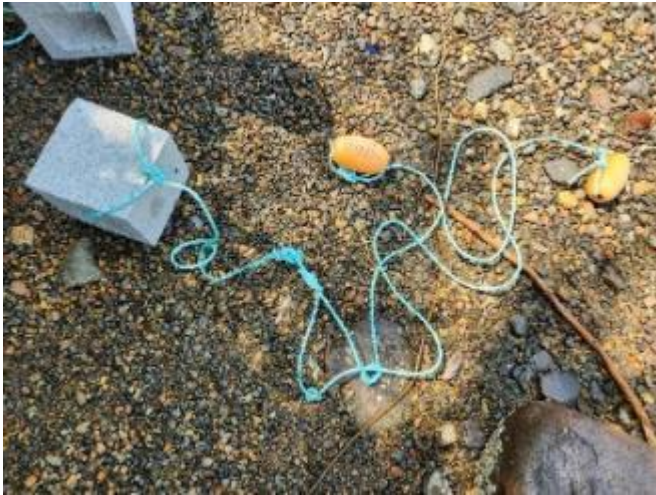
Figure 1. BuDS set-up.

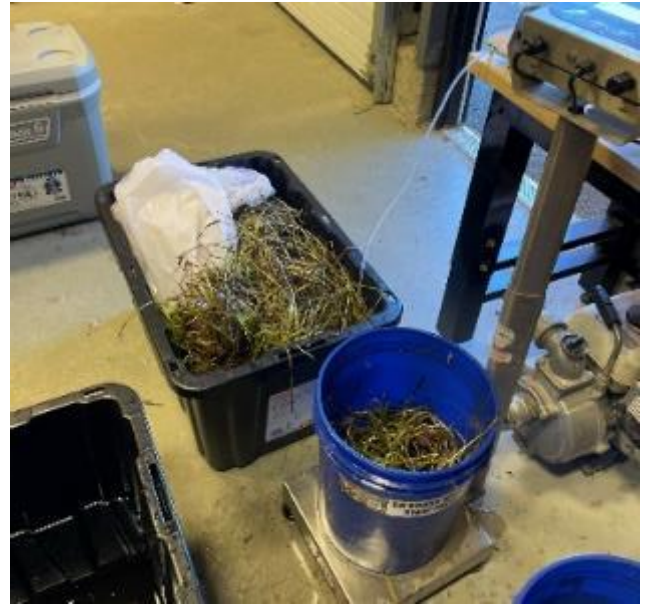
Figure 4. Weighing and bagging the harvested reproductive eelgrass shoots.

All reproductive shoots were weighed and divided equally among the BuDS sets (Figure 4), plus one additional set. This extra set was needed to estimate germination rate under controlled conditions. The divided shoots were placed into mesh onion bags for deployment (4-mm mesh, Figure 5). Reproductive shoot net bag deployment was carried out either by small metal Jon boat (using oars, electric motor or 5hP gas motor), kayak or stand-up paddleboard (SUP), with the net bags transported in a tote of sea water.

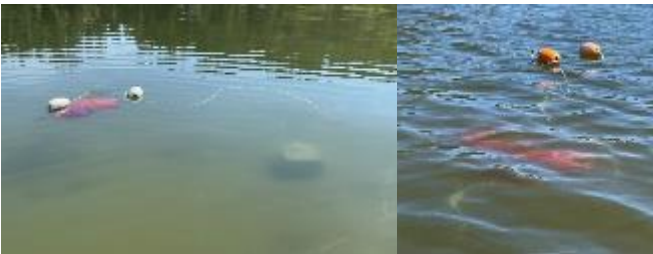
Figure 2. BuDS set method at surface (left) and 1.5 m depth BuDS set (right).

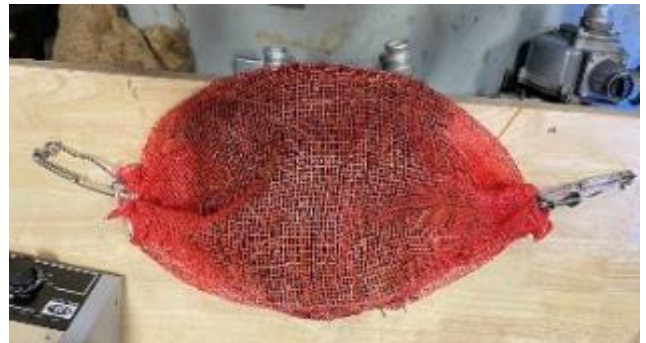
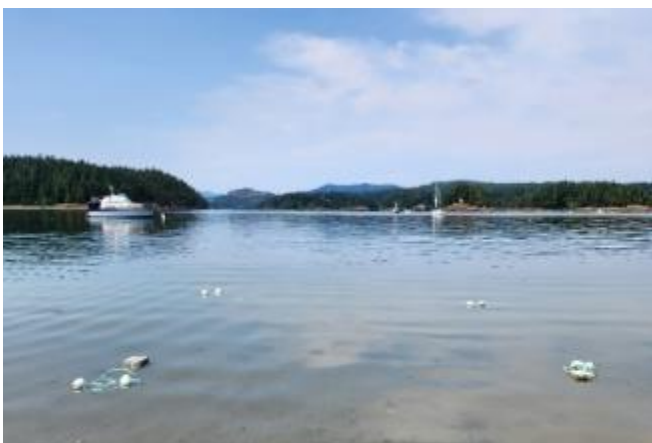
Figure 5. Mesh bag ready for deployment.

Figure 3. Four BuDS sets in 5-m X 5-m plots

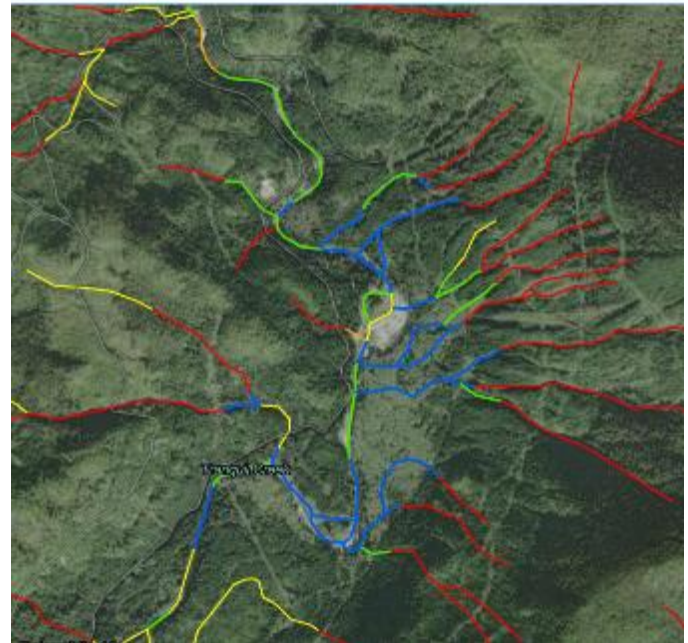
Figure 1. Existing beaver dam capacity in Tranquil Creek. Blue = 15-40 dams/km, Green = 5-15 dams/km, Yellow = 1-5 dams/km, Orange = 0-1 dams/km, Red = 0 dams/km.

Two existing GIS-based spatial modelling tools were adapted for use in West Coast Vancouver Island watersheds to assess condition and recovery potential of watersheds. The Beaver Restoration Assessment Tool (BRAT) was used to evaluate where within a watershed beavers could be used as an agent for restoration and stream conservation. The Riparian Condition Assessment Toolbox (R-CAT) was used to assess a watershed's riparian condition and opportunities for recovery. This mapping is being used to guide future process-based restoration implementation.

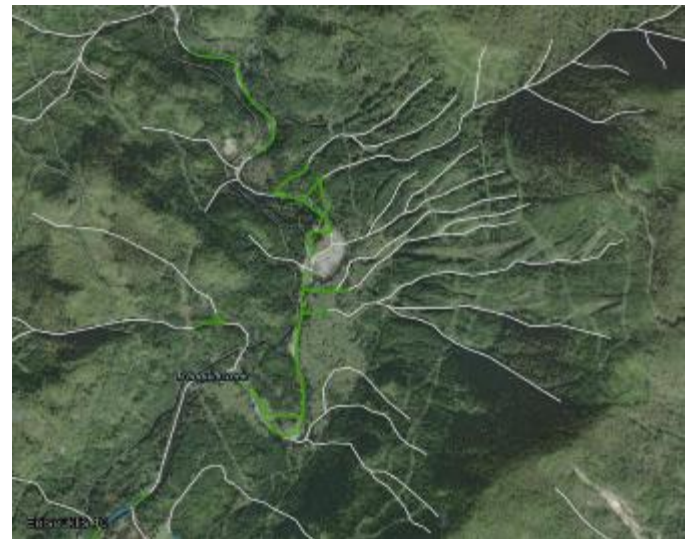
Figure 2: Reaches of Tranquil Creek with high recovery potential (green) using beaver-based restoration options.
