Radio Tracking Chinook Salmon to Determine Migration Delay at Whitehorse Rapids Dam

T.R. Cleugh and L.R. Russell

**Fisheries & Marine Service
Manuscript Report No. 1459**

HABITAT PROTECTION DIVISION
DEPARTMENT OF FISHERIES AND OCEANS
1090 WEST PENDER STREET
VANCOUVER, B.C. V6E 2P1

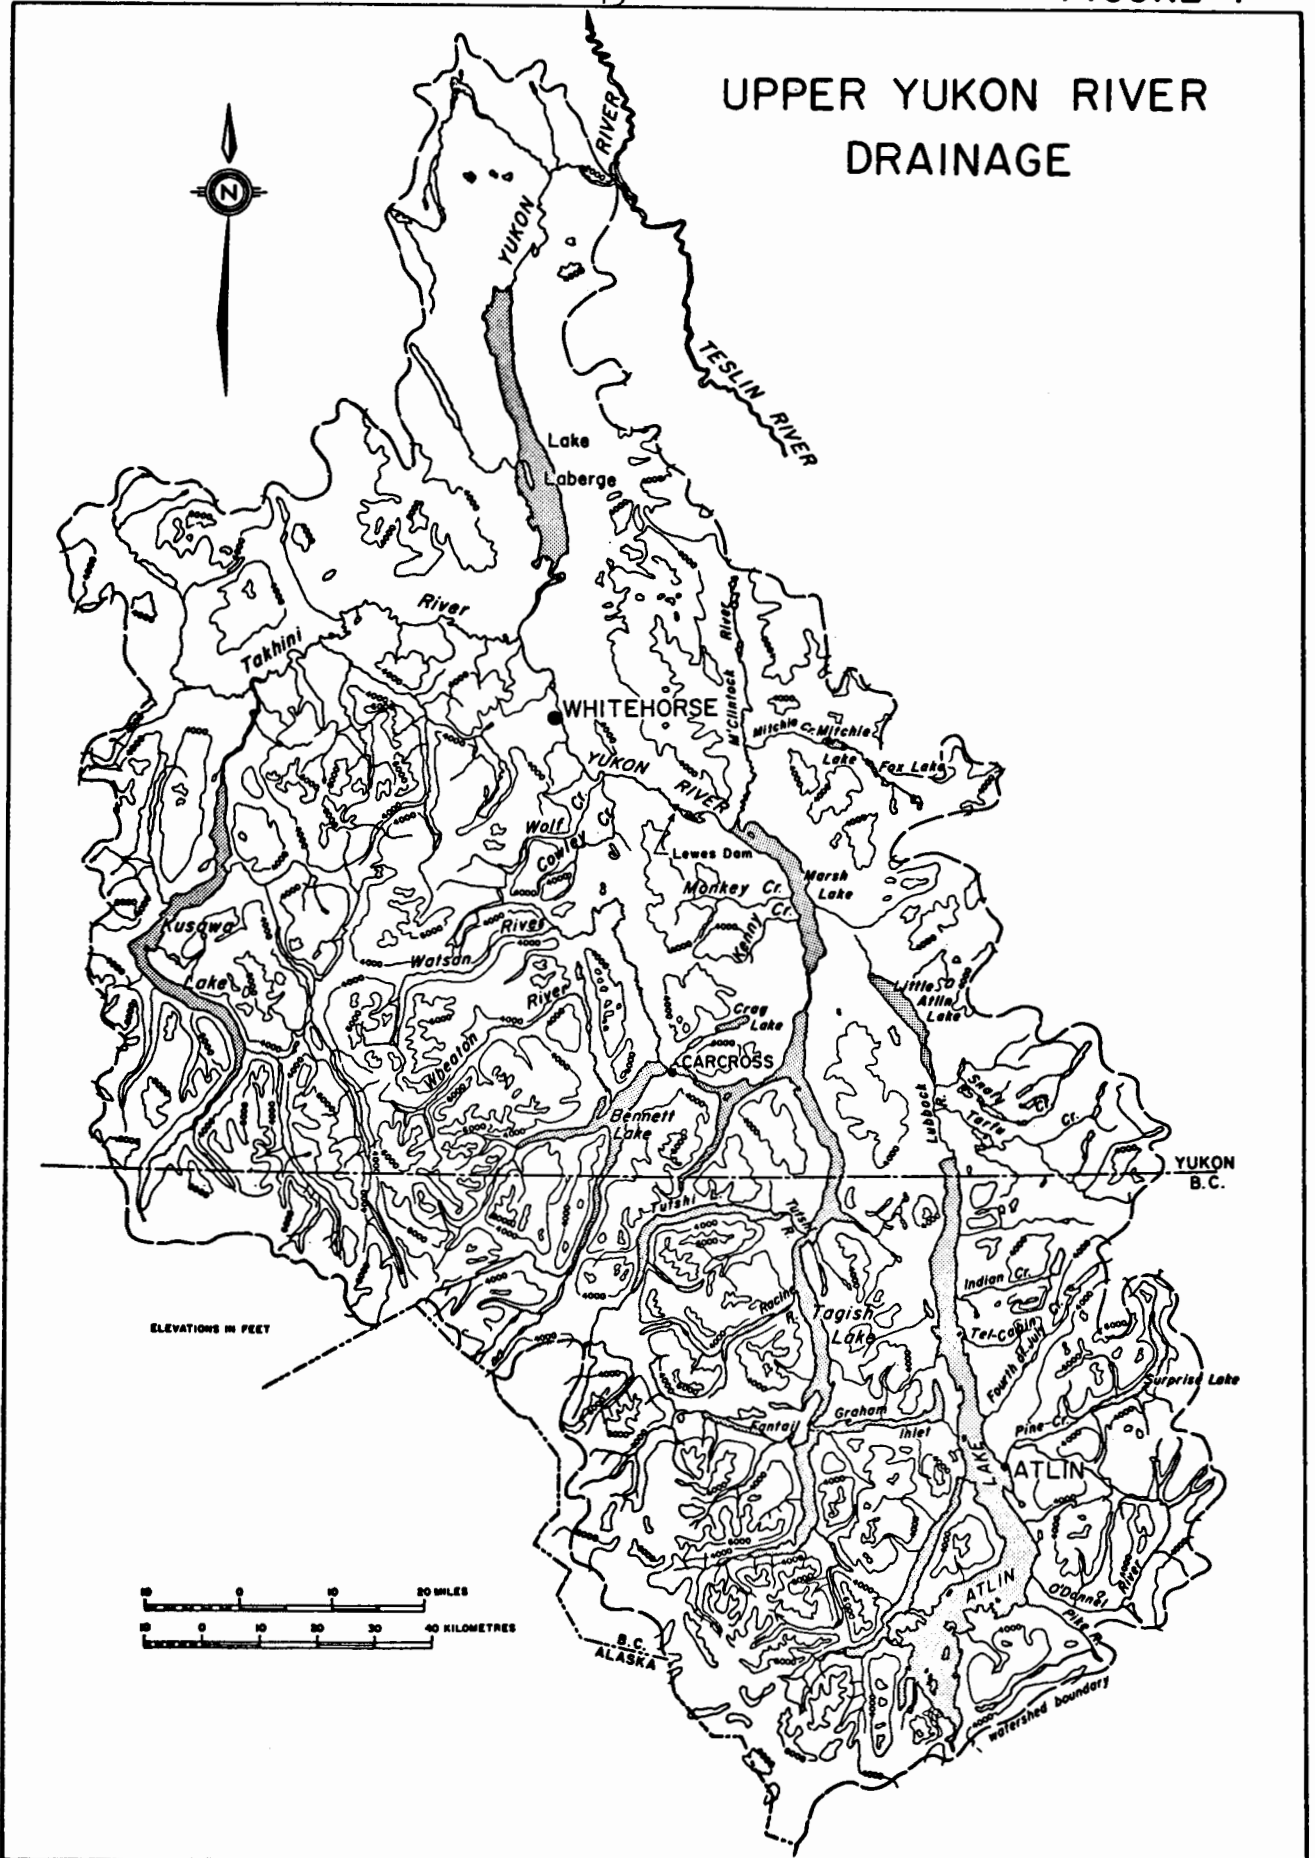
The helicopter survey (number 9 above) consisted of flights over all known or potential stream spawning grounds. Since Michie Creek was the only known spawning area it was surveyed twice; the remaining streams were surveyed once. The streams surveyed (see Figure 4) in order of observation were:

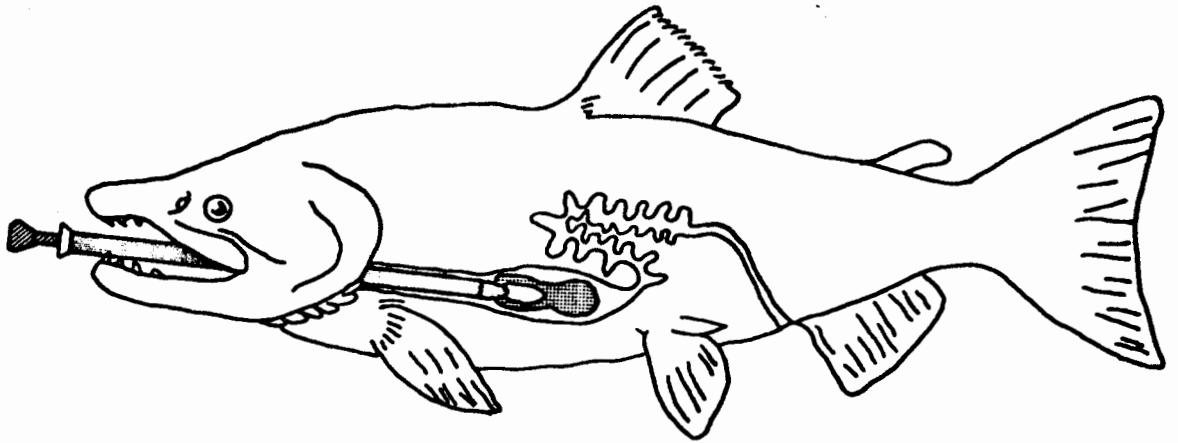
A. Sonic tag is placed in the anterior of stomach.

Tagging was accomplished by pushing the radio tag (coated with dental acrylic plastic) into the anterior of the fish's stomach

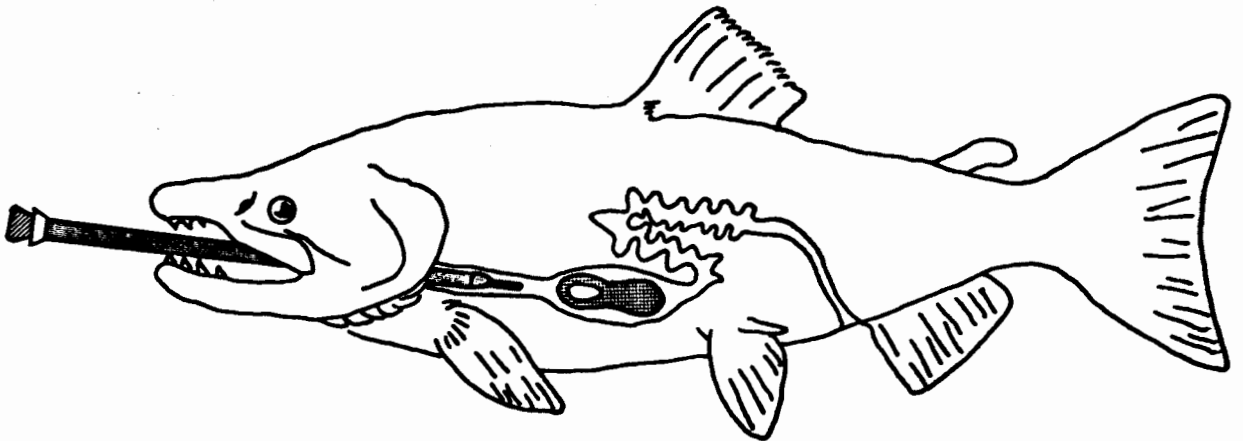
B. Sonic tag is released and injector withdrawn.

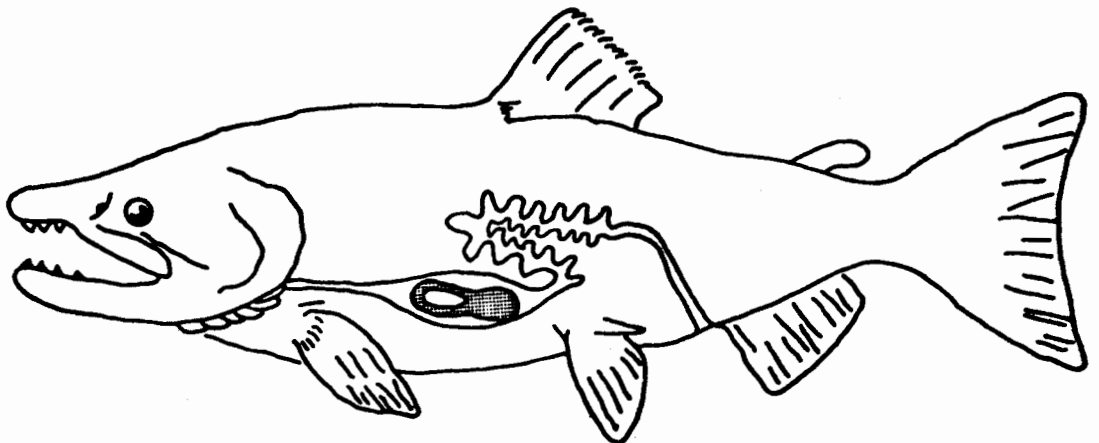
C. Sonic tag in place.
