**GEOLOGICAL SURVEY OF CANADA  
OPEN FILE 8736**

**Understanding plateau landslides: current research  
in the Thompson River valley, Interior Plateau,  
British Columbia (2013-2020)**

**D. Huntley, P. Bobrowsky, D. Rotheram-Clarke, R. MacLeod, R. Cocking, and J. Joseph**

**2020**

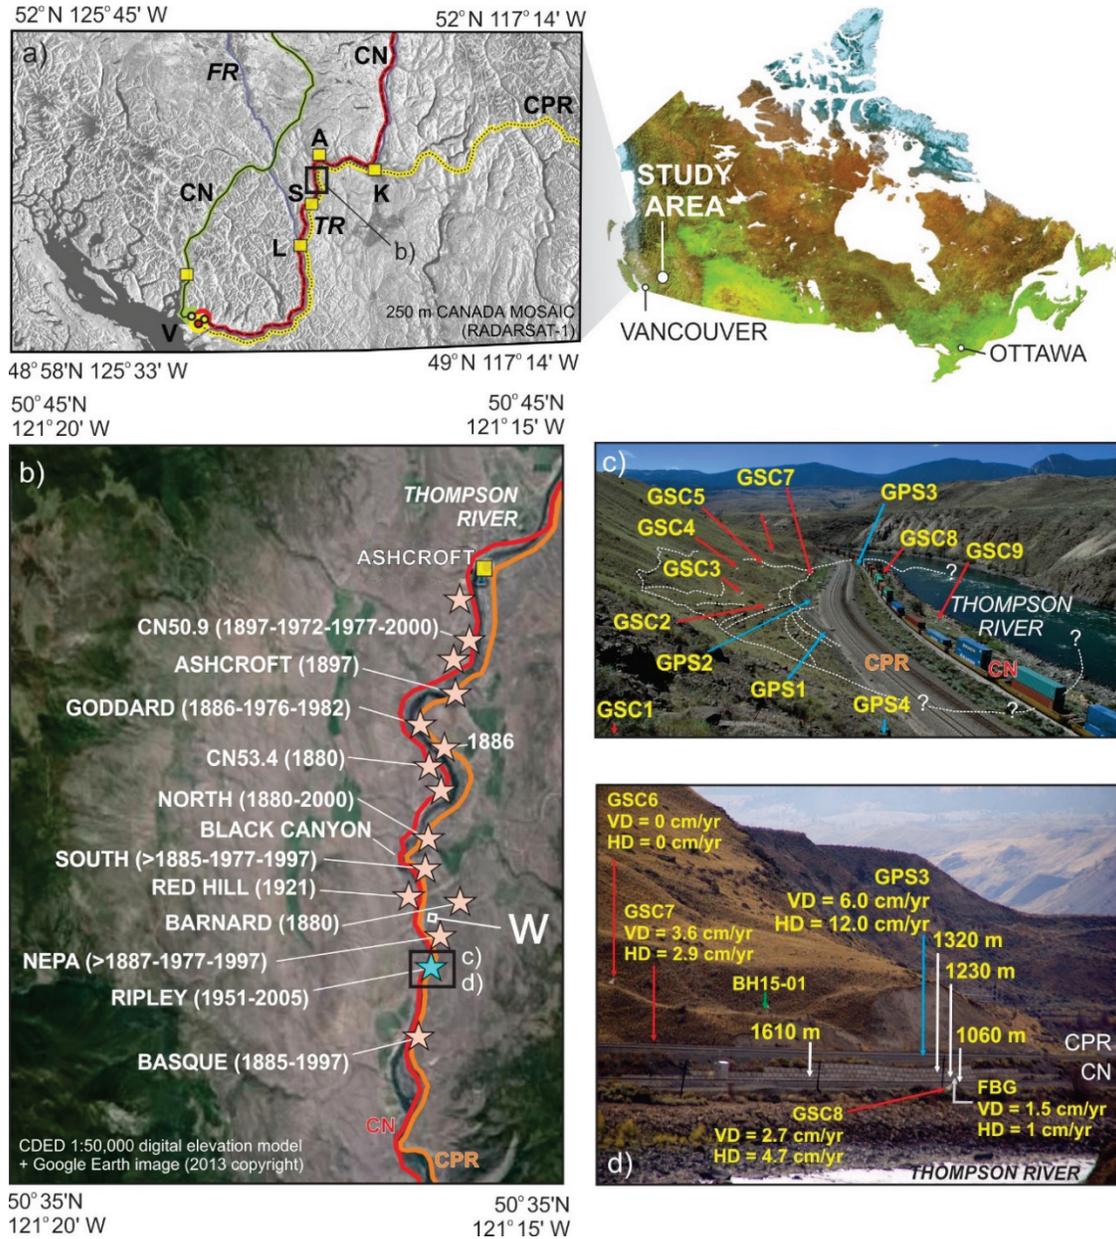
**Figure 1-1** The study area. a) Rail transportation corridors (solid green, red and yellow lines) in southwestern British Columbia with location of the Thompson River valley area of interest: **A** – Ashcroft; **K** – Kamloops; **L** – Lytton; **S** – Spences Bridge; **V** – Vancouver; **FR** – Fraser River; **TR** - Thompson River (solid blue lines). b) Landslides of the Thompson River valley, with location of Ashcroft, the railway transportation corridor and Ripley Landslide test site; **w** – weather station location. c) Overview of the Ripley Landslide test site highlighting the location of GNSS monitoring stations (GPS1-4), InSAR corner reflectors (GSC1-9), and the monitored retaining wall dividing the CN and CPR tracks - view to south (NRCan photo 2020-290); d) South flank of landslide with sagging retaining wall separating CN and CPR tracks with displacement vectors for FBG, GNSS and InSAR stations; strain points detected by BOTDR (white arrows and distance in metres from datum); **VD** – vertical displacement; **HD** – horizontal displacement detected by FBG (grey arrow with displacement values expressed as mm/yr); and location of BH15-01 (green arrow) (NRCan photo 2020-291).

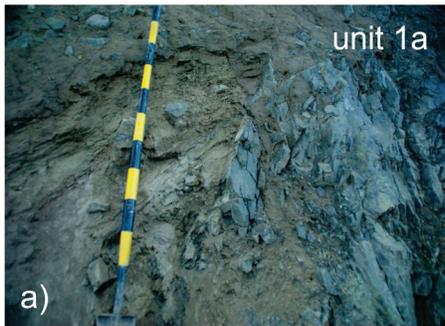
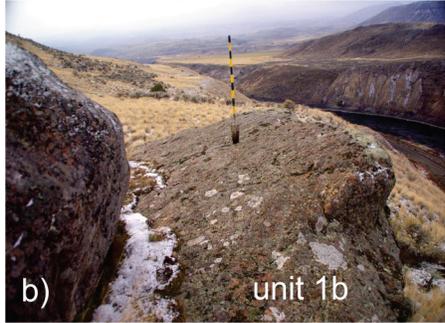
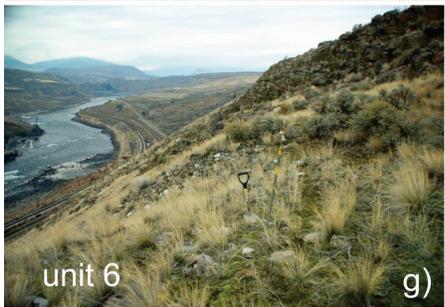
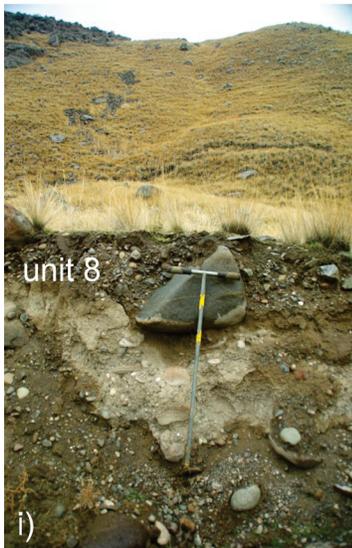
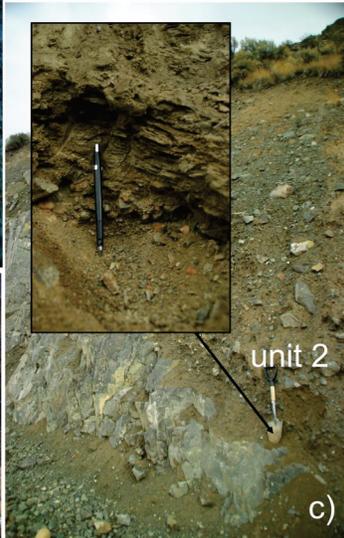
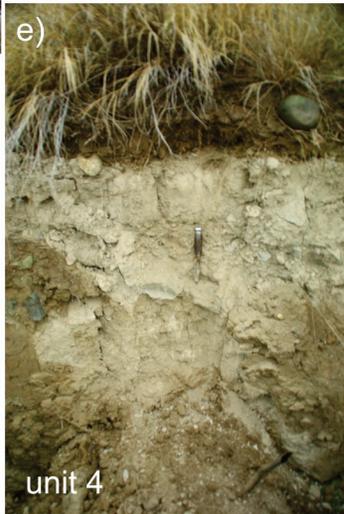
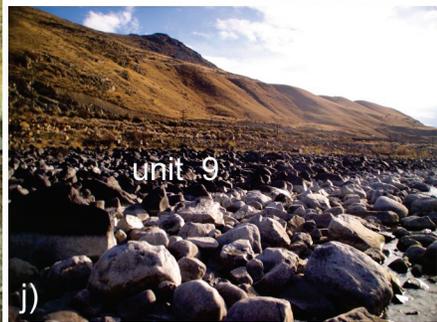
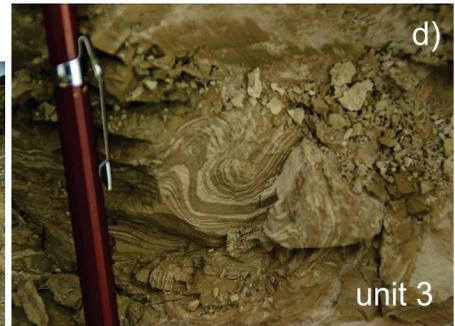
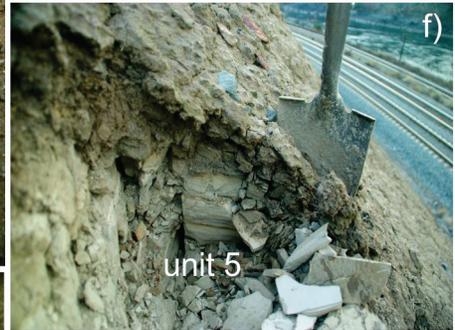
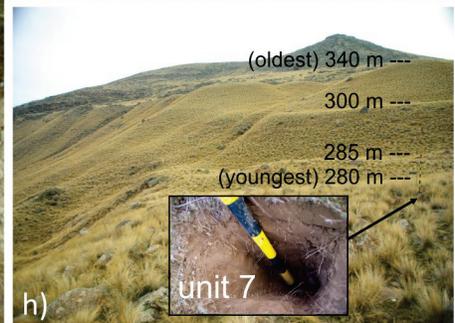
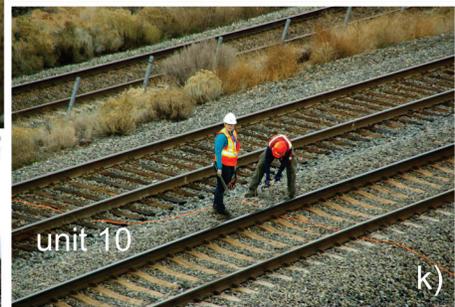
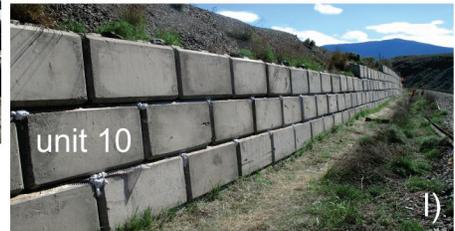
**Figure 2-1** Hydrogeological units of Ripley Landslide – see also **Table 2-1** (Huntley and Bobrowsky 2014; Huntley et al. 2020a) a) Unit 1a- andesite: fine-grained crystalline igneous rock with dominant fractures 040°/076°/E (278 m elevation), 074°/50°/NNW, 136°/78°/W, 178°/28°/E (NRCan photo 2020-292). b) Unit 1b - rhyolite and pyroclastic volcanic rock: strike/dip/dip-direction 104°/18°/E (350 m elevation) (NRCan photo 2020-293). c) Unit 2 – colluvial sediments: interbedded clast-supported diamicton, sand and gravel overlying fractured bedrock (unit 1), ca. 276 m elevation (NRCan photo 2020-294). d) Unit 3 - glaciolacustrine sediments: rhythmically interbedded clay, silt and sand with rare dropstones; sub-till (unit 4) soft-sediment indicates glacial deformation, ca. 278 m elevation (NRCan photo 2020-295). e) Unit 4 – lodgement till: massive, matrix-supported diamicton overlain by a veneer of hillslope colluvium (unit 8) exposed in headscarp; at 280 m elevation (NRCan photo 2020-296). f) Unit 5 - glaciolacustrine sediments: interbedded silt and clay overlying till (unit 4), silt-rich beds appear lighter; bedding-parallel fissility and vertical slope relaxation fractures formed in exposed in railway embankment (NRCan photo 2020-297). g) Unit 6 - glaciofluvial sediments: cobble gravel and sand; moderately steep slope (25° - 32°) is gullied and drains a 340 m - 350 m elevation terrace abutting against bedrock (unit 1b) (NRCan photo 2020-298). h) Unit 7 - alluvial fan sediments: silt, sand and gravel deposited on outwash and till as terraced fans with slopes up to 12°; indicate falling base-levels in the Thompson River valley during early Holocene (NRCan photo 2020-299). i) Unit 8 - colluvial sediments: erratic boulders, glaciofluvial cobbles and sand remobilized by debris fall, soil creep and surface runoff on slopes ranging from 25° slope above the headscarp to 12° across the main slide body; on steeper portions of the slope (up to 32°), talus blocks are derived from frost shattered rhyolite and volcaniclastic rock (NRCan photo 2020-300). j) Unit 9 - alluvial floodplain sediments: boulders, cobbles and sand, sparse vegetation growth dominated by horsetails indicating zone of seepage across the landslide toe (NRCan photo 2020-301). k) Unit 10 - anthropogenic features: boulder-rich track ballast overlying alluvial floodplain on the landslide toe; CN (top left) and CPR tracks (centre) (NRCan photo 2020-302); l) Unit 10 - lock-block retaining wall separating CPR (above left) and CN tracks (right) (NRCan photo 2020-303).

| Stratigraphic unit | Geological notes |
|---|---|
| Unit 8 | Colluvial sediments (post-glacial): erratic boulders, glaciofluvial cobbles and sand remobilized by debris fall, soil creep and surface runoff on slopes ranging from 25° slope above the headscarp to 12° across the main slide body; on steeper portions of the slope (up to 32°), talus blocks are derived from frost shattered rhyolite and volcanoclastic rock – see <b>Figure 2-1 i</b> |
| Unit 5 | Glaciolacustrine sediments (glacial retreat phase): interbedded silt and clay overlying till (unit 4), silt-rich beds appear lighter; bedding-parallel fissility and vertical slope relaxation fractures formed in exposed in railway embankment – see <b>Figure 2-1 f</b> |
| Unit 2 | Colluvial sediments (glacial retreat-phase): interbedded clast-supported diamicton, sand and gravel overlying fractured bedrock (unit 1) (ca. 276 m elevation) – see <b>Figure 2-1 c</b> |
| Unit 1a | Fine-grained crystalline andesite with dominant fractures 040°/076°/E, 074°/50°/NNW, 136°/78°/W, 178°/28°/E (278 m elevation) – see <b>Figure 2-1 a</b> |

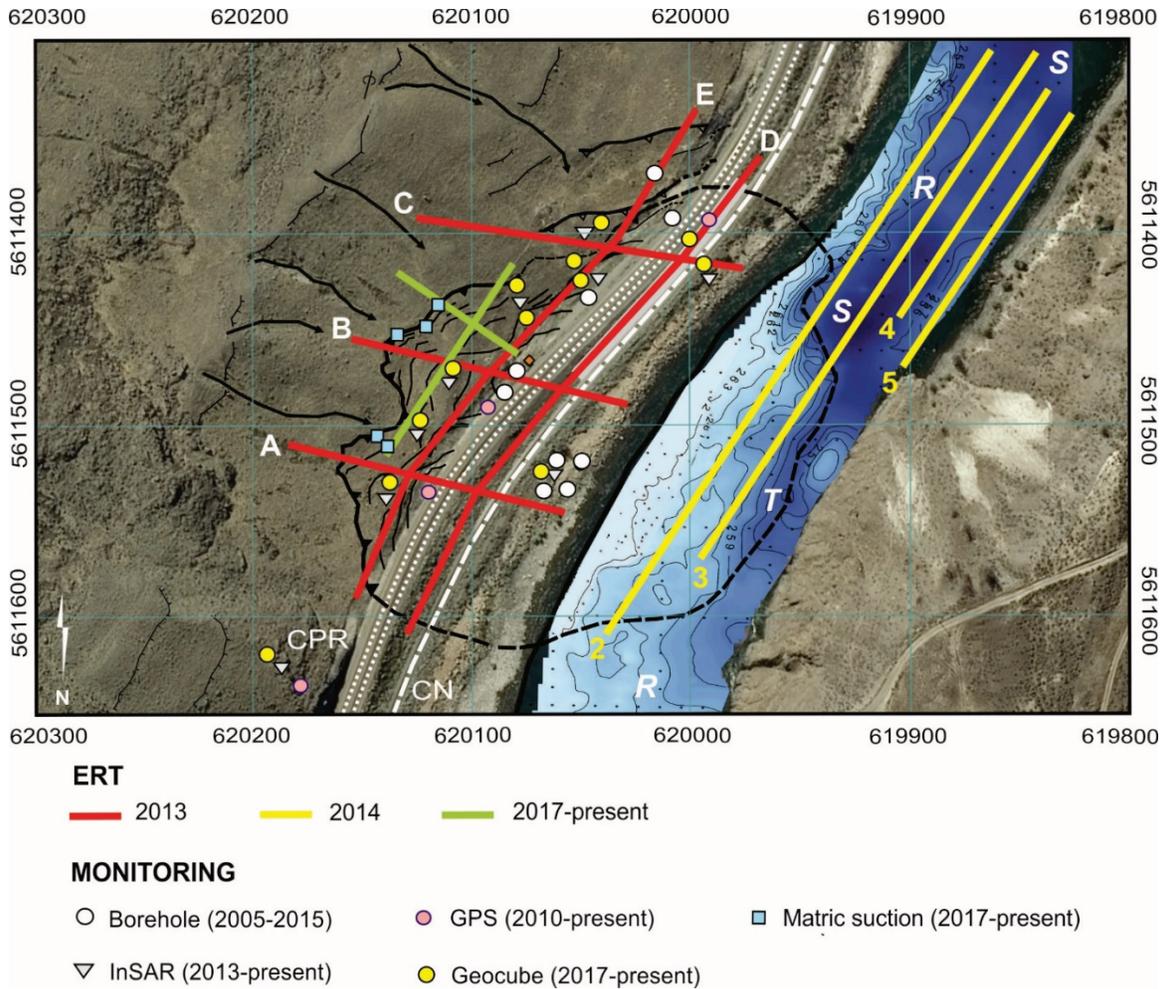
**Figure 2-2** Geophysical transects for November 2013 (red lines), November 2014 (yellow lines), and PRIME installation, beginning in November 2017 (green lines); other monitoring components shown include positions of logged boreholes (2005-2015), InSAR corner reflectors (2013 - present) and permanent GNSS stations (2010 - present). CPR signals bungalow – orange triangle. Ripley Landslide boundary - solid black lines with downslope teeth; tension cracks – thin solid black lines; projected extension - dashed black lines; gullies (with drainage direction) - solid black arrows; post-glacial terraces - solid lines with downslope ticks. Thompson River bathymetry grades from dark blue (250 m elevation) to white (263 m elevation) at the landslide toe (Huntley et al. 2017a). Channel morphology: *R* – riffle (bedrock high); *T* – thalweg scour (glacial sediments in bedrock basin at landslide toe); *S* – scour pool (glacial sediments in bedrock basin at landslide toe). Projections of geophysical results require that UTM grid north is oriented to the bottom of the figure; grid squares are 100 m x 100 m.

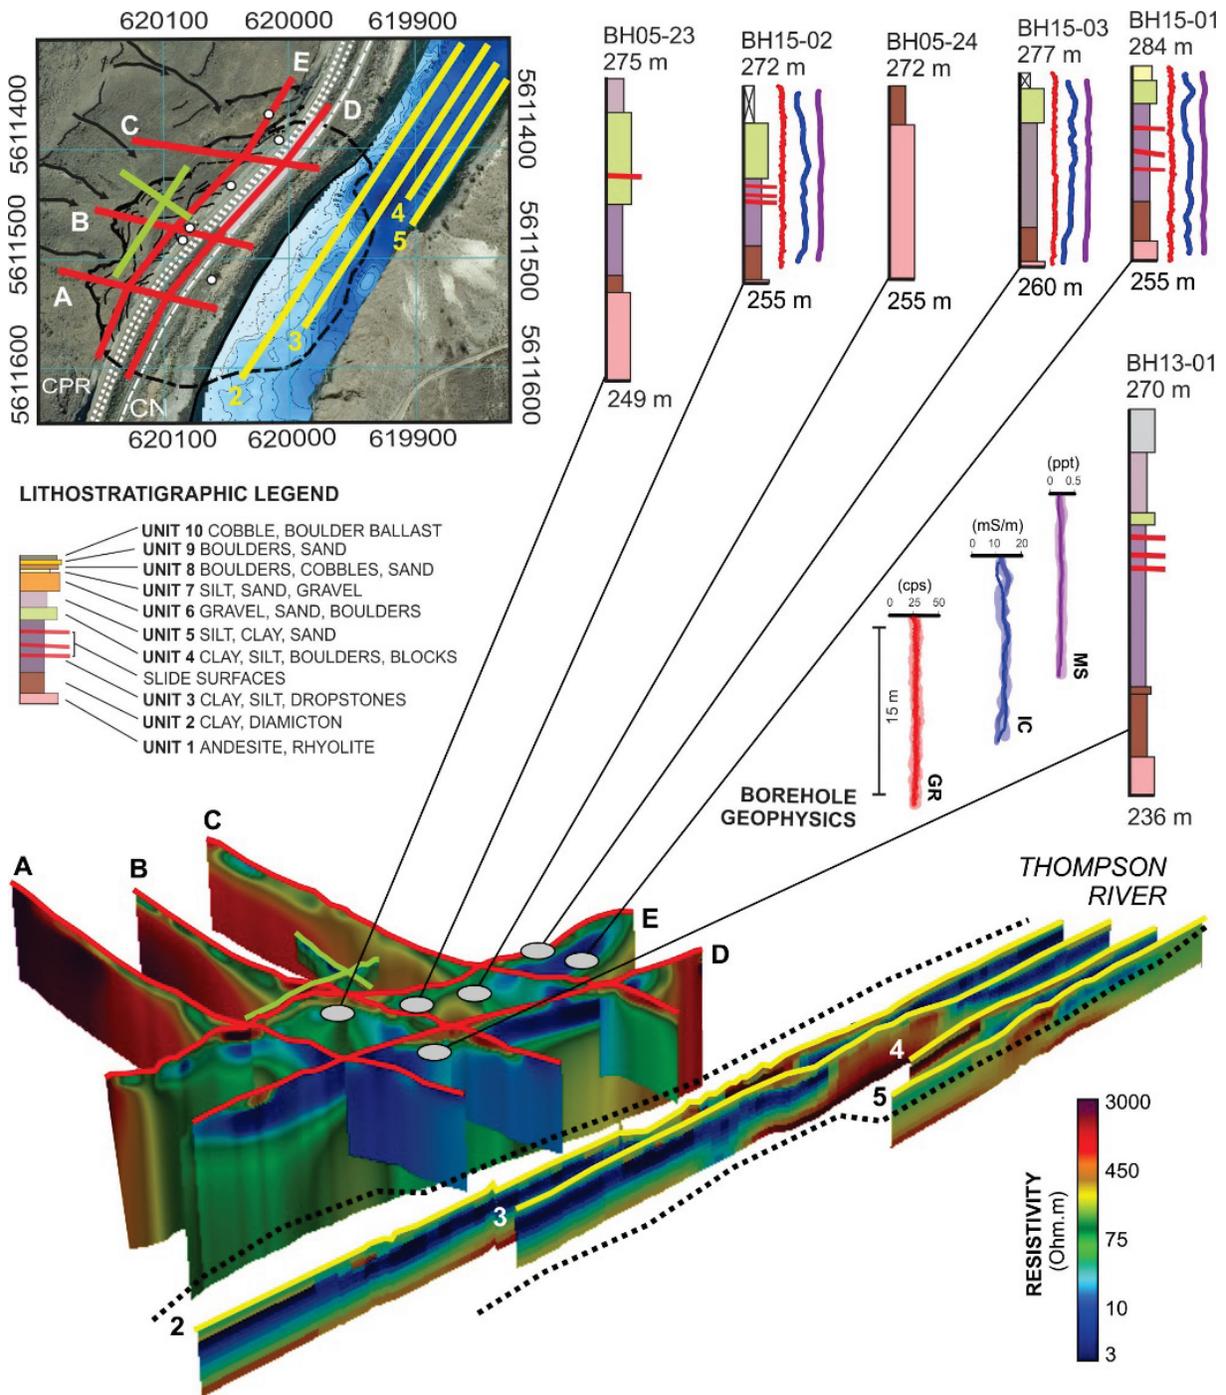
**Figure 2-3** Terrestrial ERT pseudosections (red transect lines A, B, C), waterborne ERT pseudosections (yellow transect lines 2, 3, 4, 5) and PRIME installation (green transect lines). Location of boreholes shown in relation to transect lines. Gamma radiation measured in counts per second (cps), induced conductivity measured in milliSiemens/m (mS/m) and magnetic susceptibility in parts per thousand (ppt). Also shown, location of elevated terrain conductivity readings located on submerged slide toe. Landslide extent (approximate) shown as dashed black lines on inset map.

Downhole natural GR levels, IC, and MS surveys of boreholes BH15-01, BH15-02, and BH15-03 (**Figure 2-3**) provide further insight into the sub-surface thickness of earth materials, depth to bedrock, groundwater conditions and failure mechanisms of the landslide. East of the CP tracks, the Mount Sopris MGX logging tool encountered 15 m to 17 m of glacial deposits overlying basal bedrock in the boreholes (**Figure 2-4**). West of the CN tracks, boreholes show approximately 30 m of till and clay-rich glaciolacustrine sediments overlying bedrock (**Figure 2-4**). These observations corroborate the terrestrial and waterborne geophysics results indicating the main landslide body is located over a  $>20$  m deep bedrock basin underlying the modern Thompson River. Natural GR logs show a relatively constant response (**Figure 2-3**), interpreted to indicate the predominance of clays in the glacial deposits. Minor changes in readings throughout the borehole reflect small variations in sand, clay and silt content, and levels of uranium, thorium, and potassium in granitic and arkosic dropstones (units 2 and 3) and erratics (in unit 4) directly adjacent to boreholes. The IC logs show an initial progressive, but subtle rise in conductivity values (**Figure 2-3**) corresponding to an increase in clay content with depth. High conductivity zones may indicate clay horizons in silt- and boulder-rich till (unit 4). At depth, conductivity levels fall in response to a lower clay content at depth (unit 3), decreasing porosity in stiff to hard silt-clay diamicton (unit 2), and electrically resistive bedrock intersected in the bottom of boreholes (unit 1). The MS logs show a consistently low response (**Figure 2-3**) indicating a very low ferromagnetic mineral content in the surrounding glacial deposits (units 2 to 5). The slight decrease in MS apparent near the base of each borehole corresponds to the intersection of unconsolidated glacial deposits with fractured, weathered andesite bedrock (**Table 2-1**).

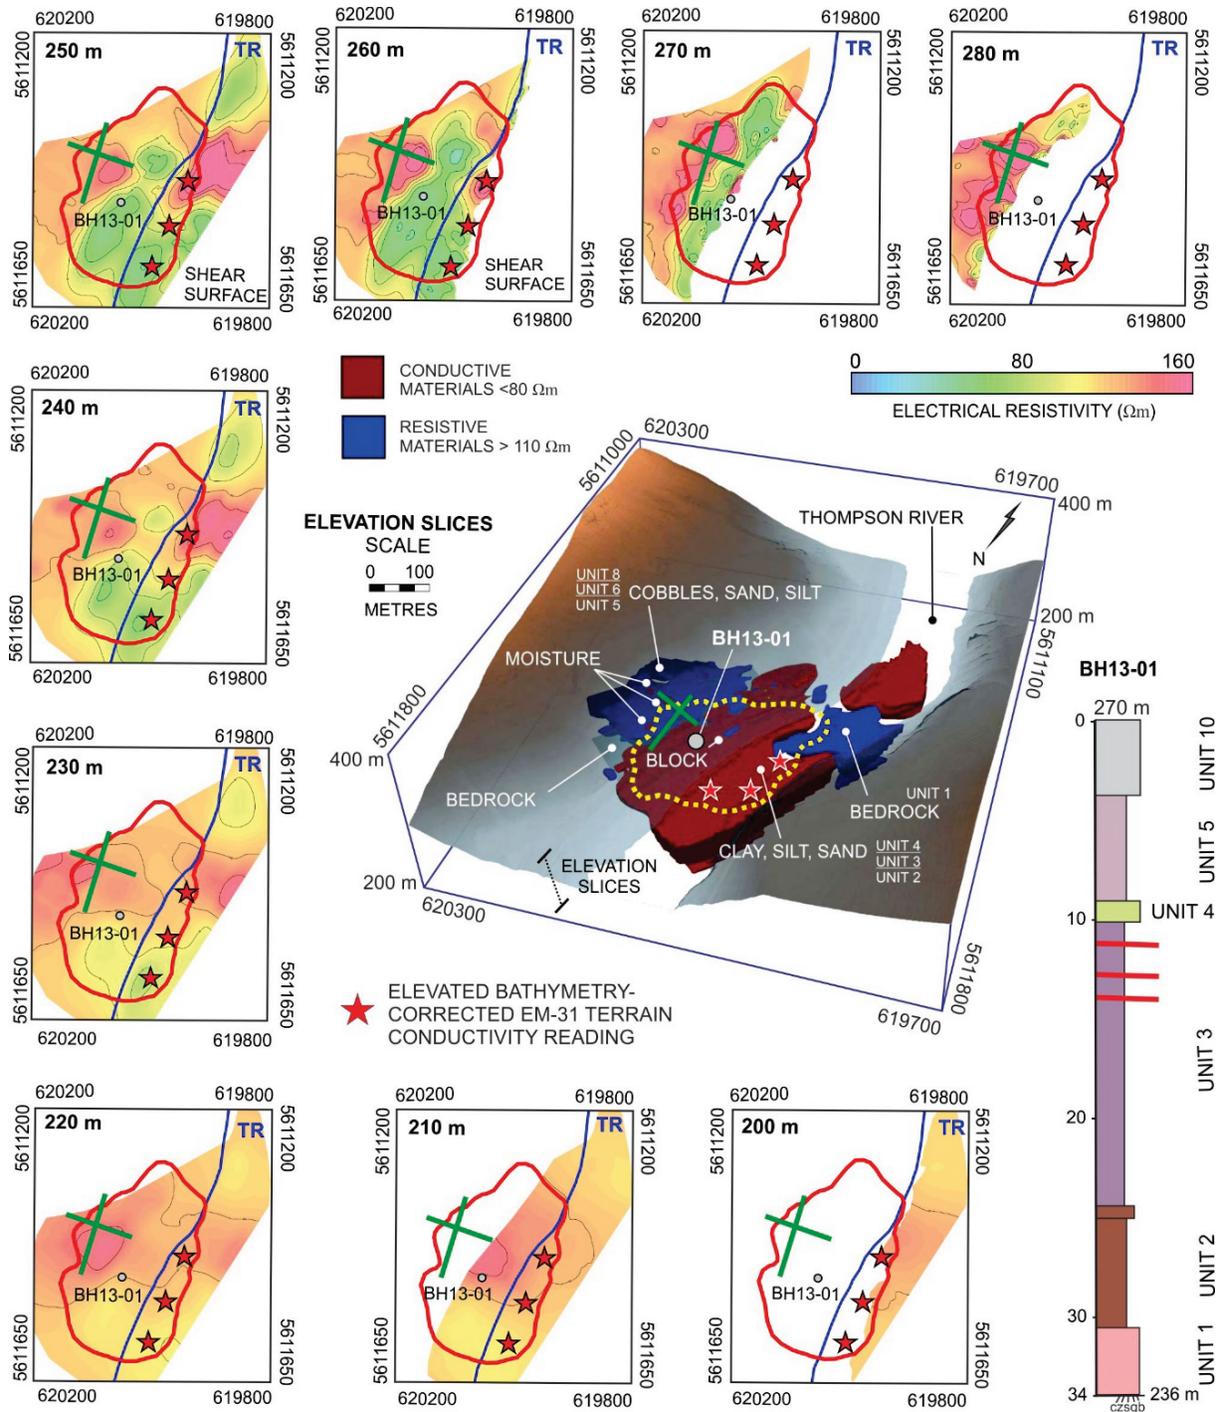
**Figure 2-4** Electrical resistivity tomographic depth slices of Ripley Landslide. Location of BH13-01 shown; graphic log captures changes in hydrogeological units at depth near the centre of the slide body. Solid blue line – east bank of Thompson River (TR). Solid green line - PRIME array. Red stars indicate elevated bathymetry-corrected EM terrain conductivity interpreted as artesian groundwater discharge zones exposed by river erosion. Data processing by Frontier Geosciences Inc.

Combined terrestrial and waterborne 2D ERT datasets are visualized as a pseudo-3D model of resistivity values using ParaView® software (**Figure 2-4**). Pseudo-3D models capture resistivity, soil moisture and groundwater conditions in surficial deposits and bedrock for the fall seasons of 2013 and 2014 (**Figure 2-3** and **Figure 2-4**). This representation is interpretation-oriented, with the selection of resistivity thresholds at  $80 \Omega\text{m}$  and  $110 \Omega\text{m}$  determined by observations of earth materials, and their hydrogeological properties at surface, and in logged boreholes. Competent bedrock (unit 1, **Figure 2-1 a**) has a high resistivity value,  $>110 \Omega\text{m}$  (**Figure 2-4**). Weathered bedrock and colluviated fine-grained beds at the base of unit 2 (**Figure 2-1 b**) are moderately resistive ( $80 \Omega\text{m}$  to  $110 \Omega\text{m}$ ). Overlying areas with low resistivity values ( $<80 \Omega\text{m}$ ) are correlated with the oldest Pleistocene glaciolacustrine sediments, units 2 and 3 (**Figure 2-1 c, d**). Unit

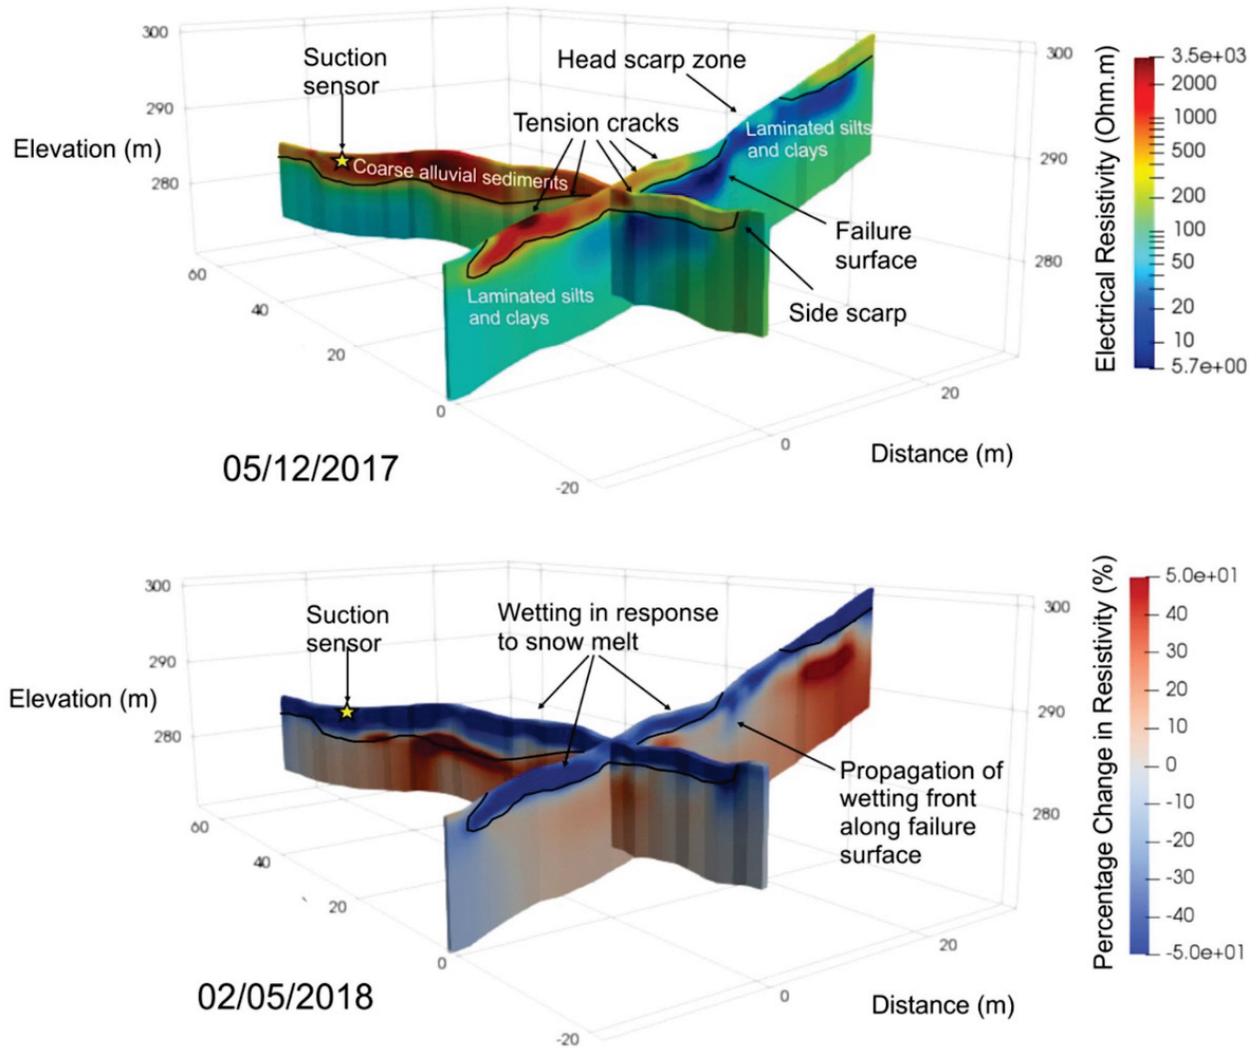
**Figure 2-5** Electrical resistivity tomographic images generated from the PRIME data collected on the Ripley landslide. The baseline image (December 05, 2017) highlights the lithological units present on site and shows key geomorphological features including failure surfaces and tension cracks. The image from May 02, 2018 shows the percentage change in resistivity from the baseline image, highlighting changes that took place following the onset of snowmelt on the site. Yellow stars mark suction sensor locations. The suction sensors (yellow star) are located at 0.3 m, 0.6 m, 0.9 m, 1.2 m and 2 m below the surface.

The PRIME system provides new insight into the hydrogeological structure and function of the slope, imaging surface tension cracks >0.5 m-wide, and 1 m-deep penetrating units 8 and 4, and extending to landslide failure planes in units 2 and 3 (**Figure 2-5**). Field suction-resistivity relationships were established by relating the resistivity of the head scarp as revealed by the PRIME data with sensor data from the head scarp. The daily average soil suction is plotted alongside the daily average resistivity of the cells in the resistivity model corresponding with the suction sensor depth. The location of the suction sensor is shown in **Figure 2-2** and **Figure 2-5**. Although readings of the soil suction sensors for a range of depths up to 2 m below the surface are averaged, results are dominated by the sensor at 0.3 m depth with the largest magnitude of suctions. Results reflect the non-linear relationship of soil suction with moisture content, and dependence of resistivity on moisture. Generally in winter, resistivity and suction increase as moisture content decreases (**Figure 2-6**). A deviation from this trend is observed mid-January when daily resistivity was higher than expected. This is likely due to localized freezing at the surface resulting in increased resistivity, which is supported by the weather station data showing temperatures below 0°C around this time (**Figure 2-6**). Therefore, there is an increase in resistivity despite effective rainfall being positive during this period, which is usually associated with decreased resistivity. Large decreases in surface resistivity (>50%) from March to May are due to an increase in moisture content accompanying snowmelt and intense, short-duration precipitation events. Temperatures are consistently above 0°C by this time, and despite a negative weekly effective rainfall during this season (**Figure 2-6**), the additional moisture resulting from snowmelt is sufficient to increase the moisture content of the slope. The propagation of the wetting front along the failure plane is clearly shown in **Figure 2-5**, indicating that the headscarp acts as a major conduit for the flow of percolating groundwater over this interval.

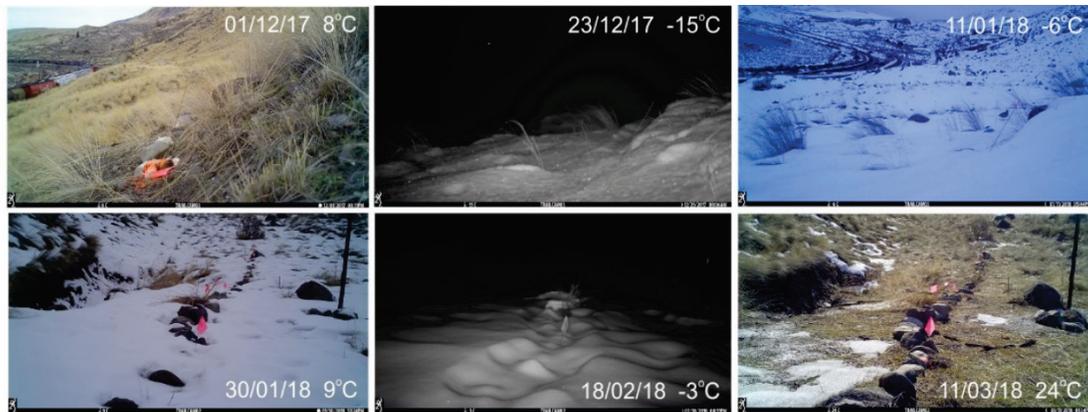
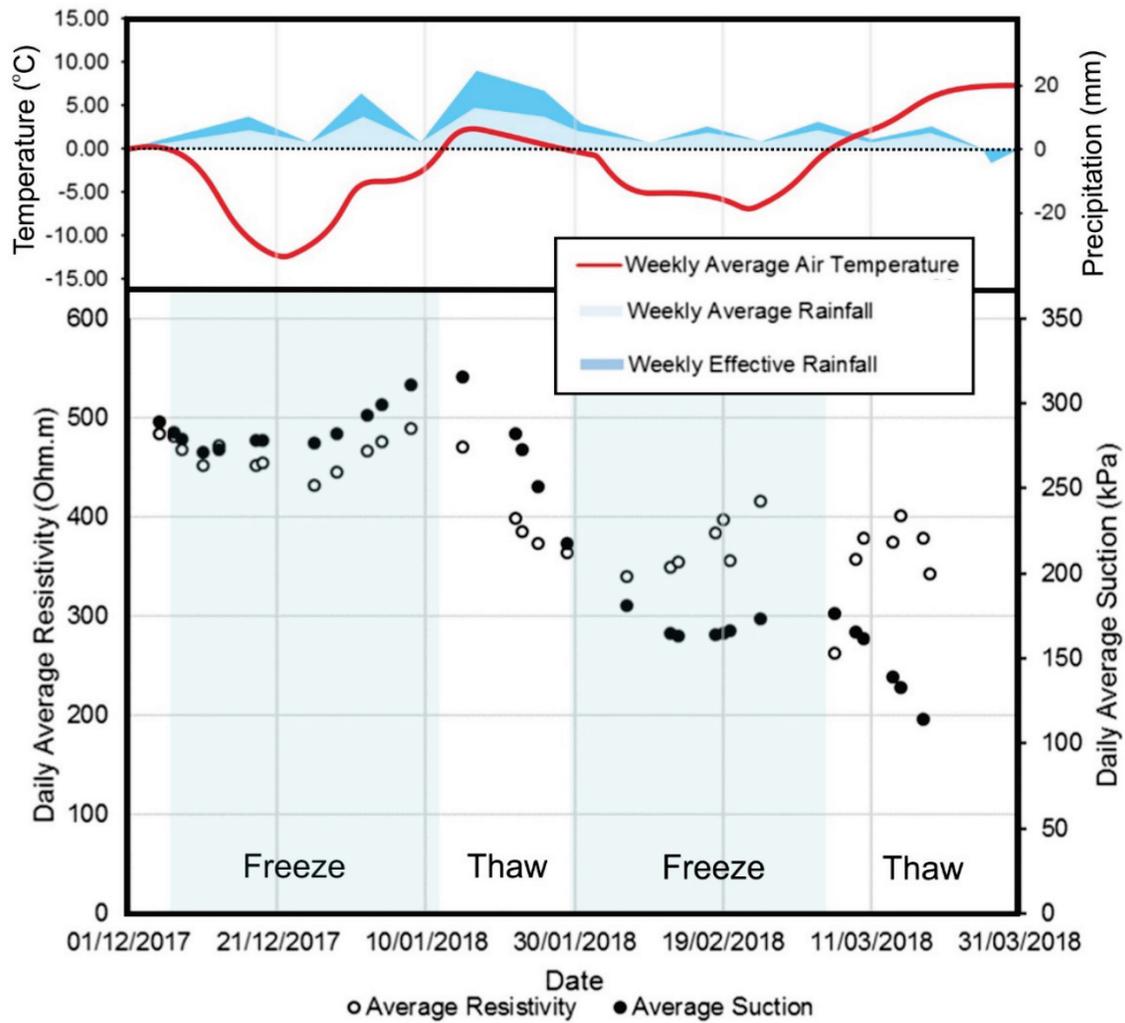
**Figure 2-6** Ripley Landslide ground conditions from December 2017 to March 2018, with the relationship between resistivity and suction for the head scarp. The average daily resistivity is the average resistivity of cells of the PRIME model (**Figure 2-5**) proximal to the suction sensors (within 1 m distance). Suction sensors located at 0.3 m, 0.6 m, 0.9 m, 1.2 m, and 2 m below the surface; **Figure 2-5** shows the location relative to the PRIME ERT lines. Weather data recorded at the GSC climate monitoring station (**Figure 2-7**).

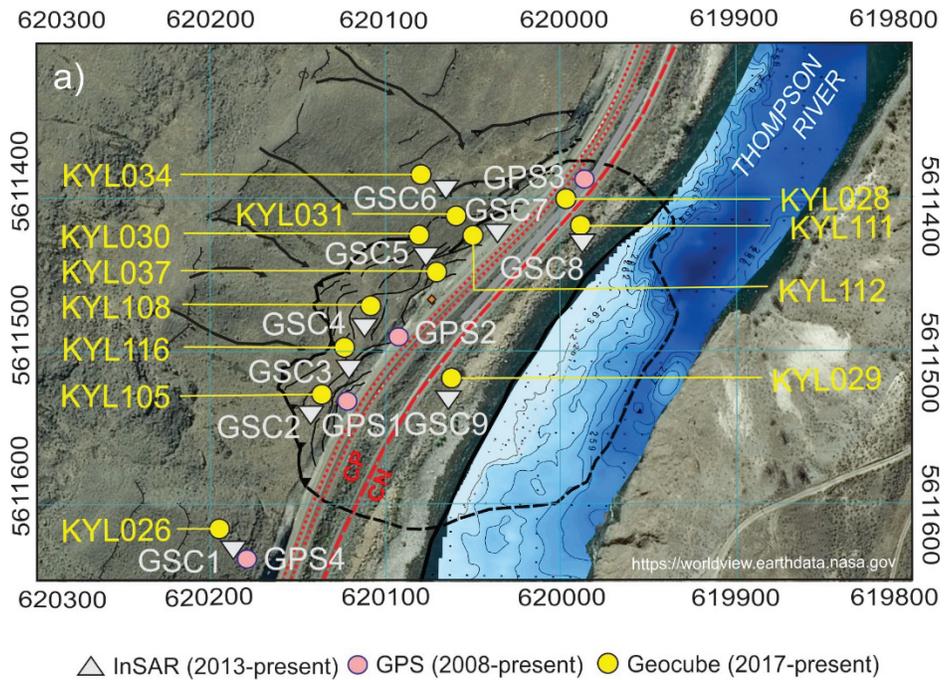
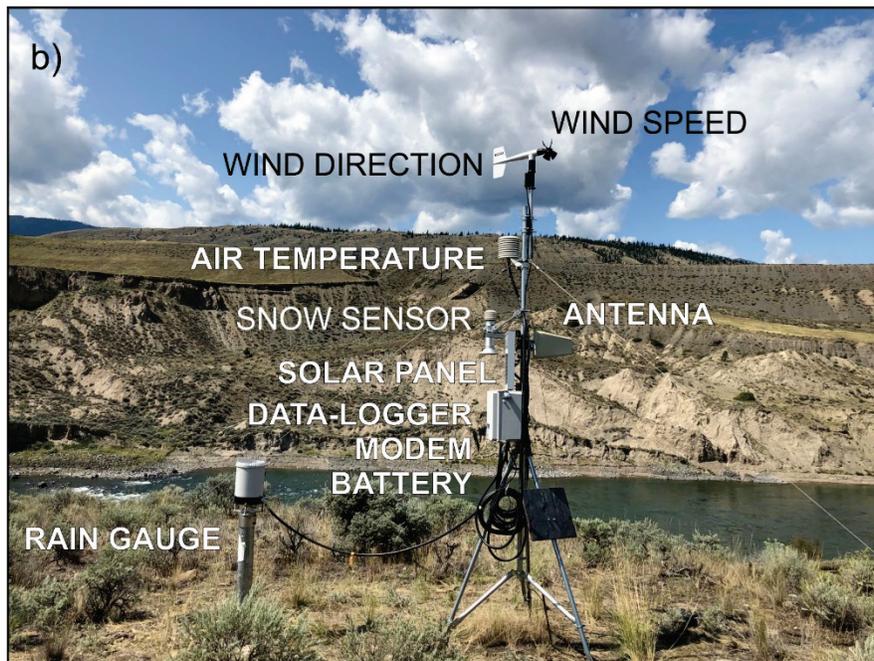
**Figure 2-7** a) Plan view of the test site highlighting the location of GNSS monitoring stations (GPS1-4), InSAR corner reflectors (GSC1-9) and Geocubes™ (KYL026 to KYL116). Railway infrastructure: Canadian National track - red dashed line; Canadian Pacific tracks – red dotted lines; monitored lock-block retaining wall dividing the CN and CPR tracks - light grey solid line. Bathymetry derived from GPR and single-beam acoustic depth soundings (modified from Huntley et al. 2017a). b) Weather station installed in 2016, and continuously recording climate variables since; see Figure 1c for location (NRCan photo 2020-304).

Rigorous change detection requires an accurate and precise elevation model to serve as a reference base map. In 2008, CPR installed four permanent GNSS monuments trackside across the landslide (**Figure 2-2; Figure 2-7 a**). These monuments record cumulative annual displacements >10 cm/yr to <60 cm/yr, with peak movement in winter (Macciotta et al. 2014; Hendry et al. 2015); and captured the 2017 displacement event, recording 47 cm/yr at the north end of the slide, and 52 cm/yr on the lock-block retaining wall. Two areas of maximum displacement recorded by the GNSS stations coincide with maximum displacement indicated by the InSAR corner reflectors (**Table 2-5**). The larger zone spans the CN and CPR tracks between GSC3 to GSC5, GPS1 and GPS2, and GSC9. A smaller zone is centred on GSC7, GPS3, and GSC8 at the south end of the landslide near the lock-block retaining wall (**Figure 2-7 a**).

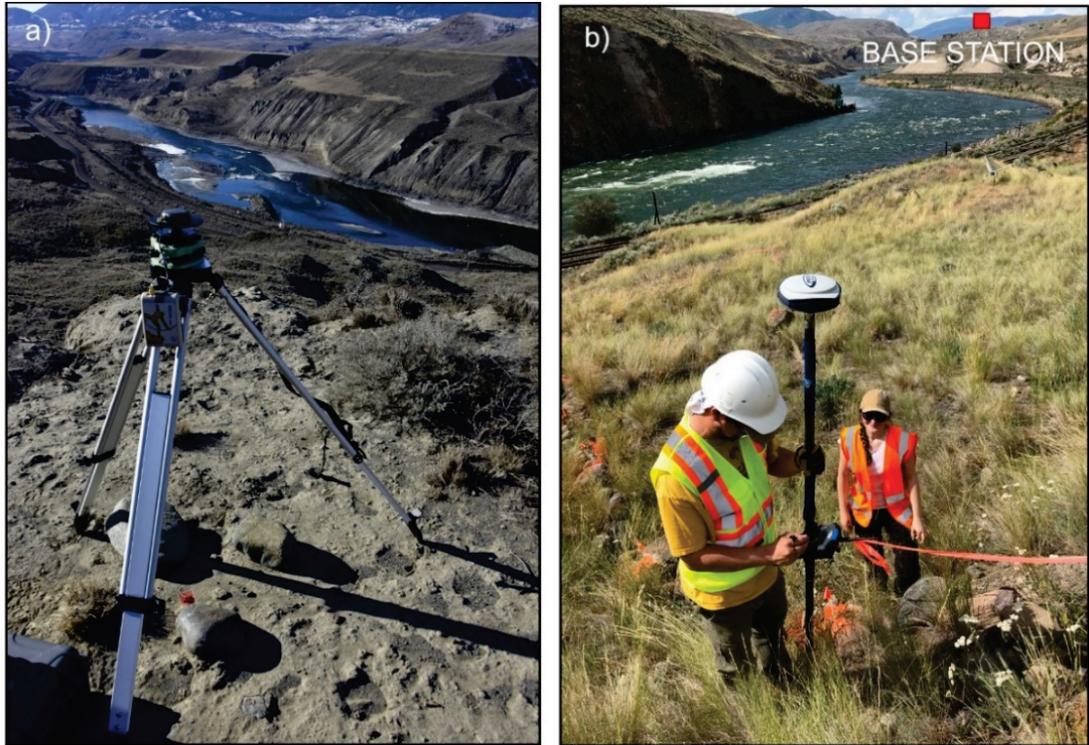
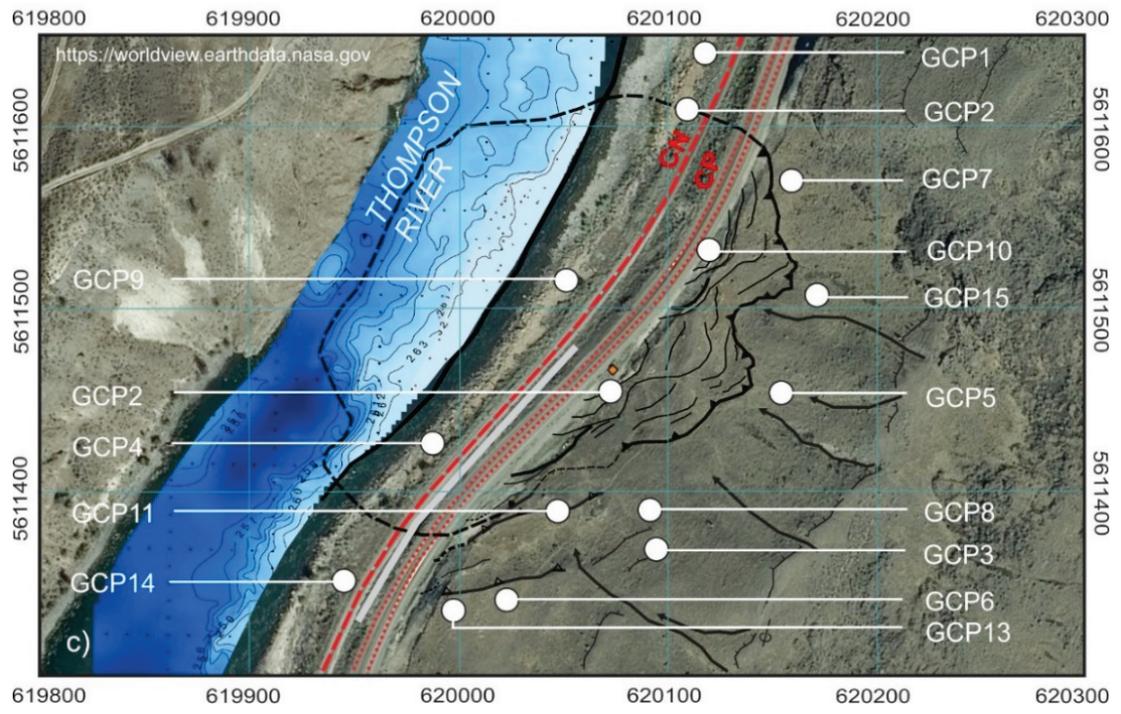
**Figure 2-8** a) Base station at South Slide, with EOS Arrow Gold base unit positioned over the prime GCP (March 2019) (NRCan photo 2020-305); b) Trimble Spectra SP-80 RTK GNSS head and Spectra TSC3 Ranger handheld computer (NRCan photo 2020-306); c) distribution of ground control points (GCPs) on and adjacent to Ripley Landslide. Note, grid north is to the top of the map.

In 2016, permanent ground control points (GCP) were established across the slope, using stable boulders and anthropogenic features on, and adjacent to the landslide (**Figure 2-8 a**). Subsequently, positional data were referenced using the North American datum (NAD83) and Universal Transverse Mercator (UTM) Zone 10. From 2016 to 2017, surveys used RTK-GNSS receivers: Ashtech NovAtel DL-V3, EOS Arrow Gold, and Trimble R10 GNSS units. After 2018, surveyed points were positioned using two Spectra Precision SP-80 receivers (**Figure 2-8 b**). Under optimal conditions, at least ten Global Positioning Systems (GPS), and Globalnaya Navigazionnaya Sputnikovaya Sistema (GLONASS) satellites were visible, and typically between 14 and 17 satellites were accessible. A reference base station was established on a stable post-glacial terrace near Black Canyon, 3 km north the Ripley Landslide (**Figure 2-1 c**). The absolute position of the station was determined from a post-processed RINEX file using the Canadian Spatial Reference System (CSRS) Precise Point Positioning (PPP) tool after a nine-hour occupation. Reported absolute positional accuracy was 0.8 cm horizontally and 1.3 cm vertically (95% sigmas), and used for all surveys (**Figure 2-8 a**). All GNSS positioning data were reviewed, corrected for antenna laybacks, heights and edited for erroneous data points during the data processing (Huntley et al. 2017a; Huntley et al. 2020c, in review).

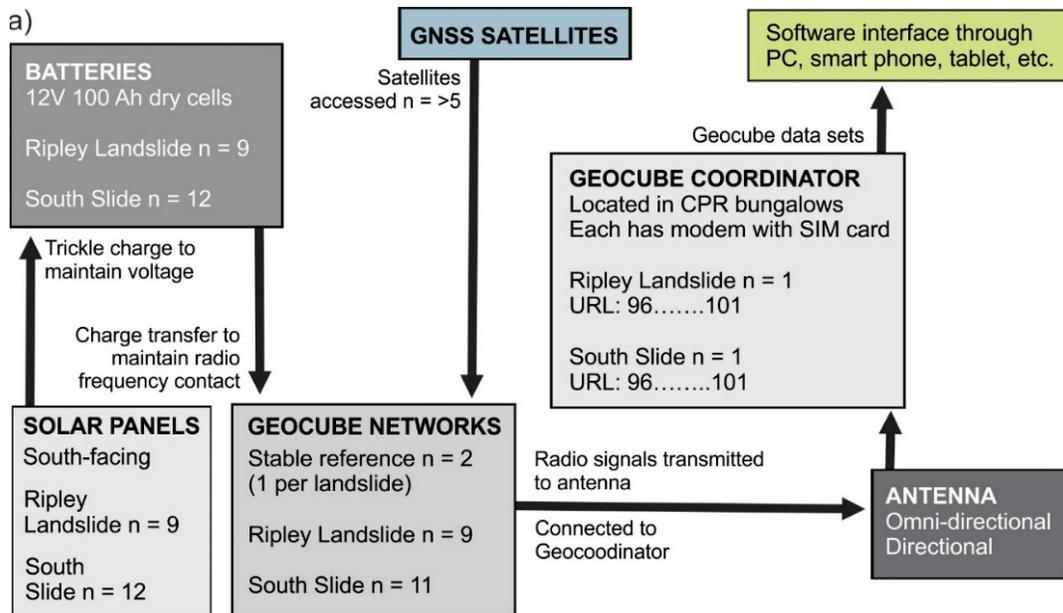
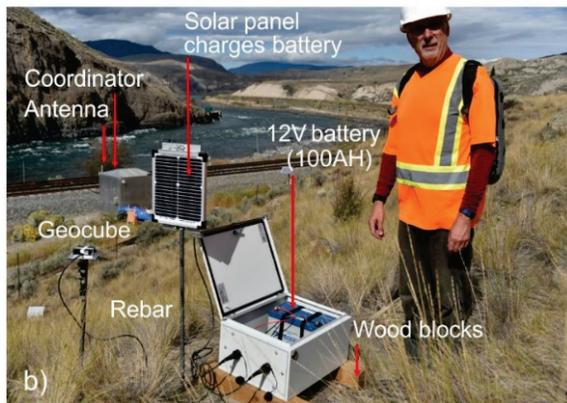
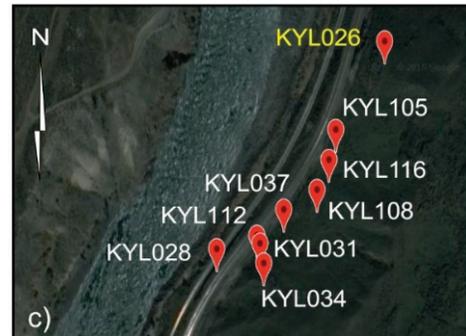
**Figure 2-9** Geocubes™ installation: a) schematic of Geocube™ system; b) components installed on the unstable slope (NRCan photo 2020-307); c) Geocube™ network installed at Ripley Landslide (yellow text label is stable reference position).

Repeat RTK-GNSS surveys generates point position data across much of the slide body. However, this method provides limited information on the seasonal variation in displacement rates and amounts. Different GNSS (d-GNSS) monuments installed by CPR provide continuous, near-real-time monitoring of surface displacement, but only at three trackside locations (**Figure 2-7 a**). Starting in 2016, a high-resolution (millimetric) Geocube (GeoKylia)™ GNSS network was installed at Ripley Landslide to address both issues of spatial and temporal coverage (Macciotta et al. 2017; Rodriguez et al. 2018; Holmes et al. 2020, in press; Huntley et al. 2020, in review). This monitoring system comprised twelve small, rugged, single-frequency d-GNSS transmitter-receivers with directional antennas (Geocube™) that relayed geospatial data to a Geocoordinator unit hosting a proprietary operating system developed and provided by Ophelia Sensors in France. A 3G network modem with an omnidirectional antenna provided internet access to the Geocoordinator (**Figure 2-9 a**).

For installation, at each monitoring location (**Figure 2-9 b**), a 1 m length of steel rebar was first driven into the soil to a maximum depth of 75 cm. A Geocube™ was mounted on an aluminum plate and attached to the rebar by means of pipe clamps and adhesive tape. An alternative mounting approach was to attach the plate and Geocube™ to a nearby InSAR corner reflector. The second method ensured Geocubes™ had a wide horizon to receive satellite signals. Units were levelled by using spacing washers and a locking nut; then oriented in the line-of-sight with the antenna side pointing toward the Geocoordinator. Care was taken to ensure that each d-GNSS antenna had their line-of-sight cleared of vegetation. A second, 1.5 m length of rebar was driven to a maximum depth of 75 cm to allow the mounting of a 50 cm<sup>2</sup> solar panel. The mount was angled to allow solar panels maximum exposure to the sun when oriented facing south (**Figure 2-9 b**). For Ripley Landslide, one Geocube™ was installed on stable terrain adjacent to stations GSC1 and GPS4: a bedrock outcrop that confined the landslide in the northeast (**Figure 2-7 a**); the remaining eleven were positioned across the slide body to capture spatial variation in displacement (**Figure 2-9 c**). Radio signals were reflected by anthropogenic obstacles between the coordinator, reference site, and Geocubes™ (e.g., rolling stock, tracks, and lock-block retaining wall).

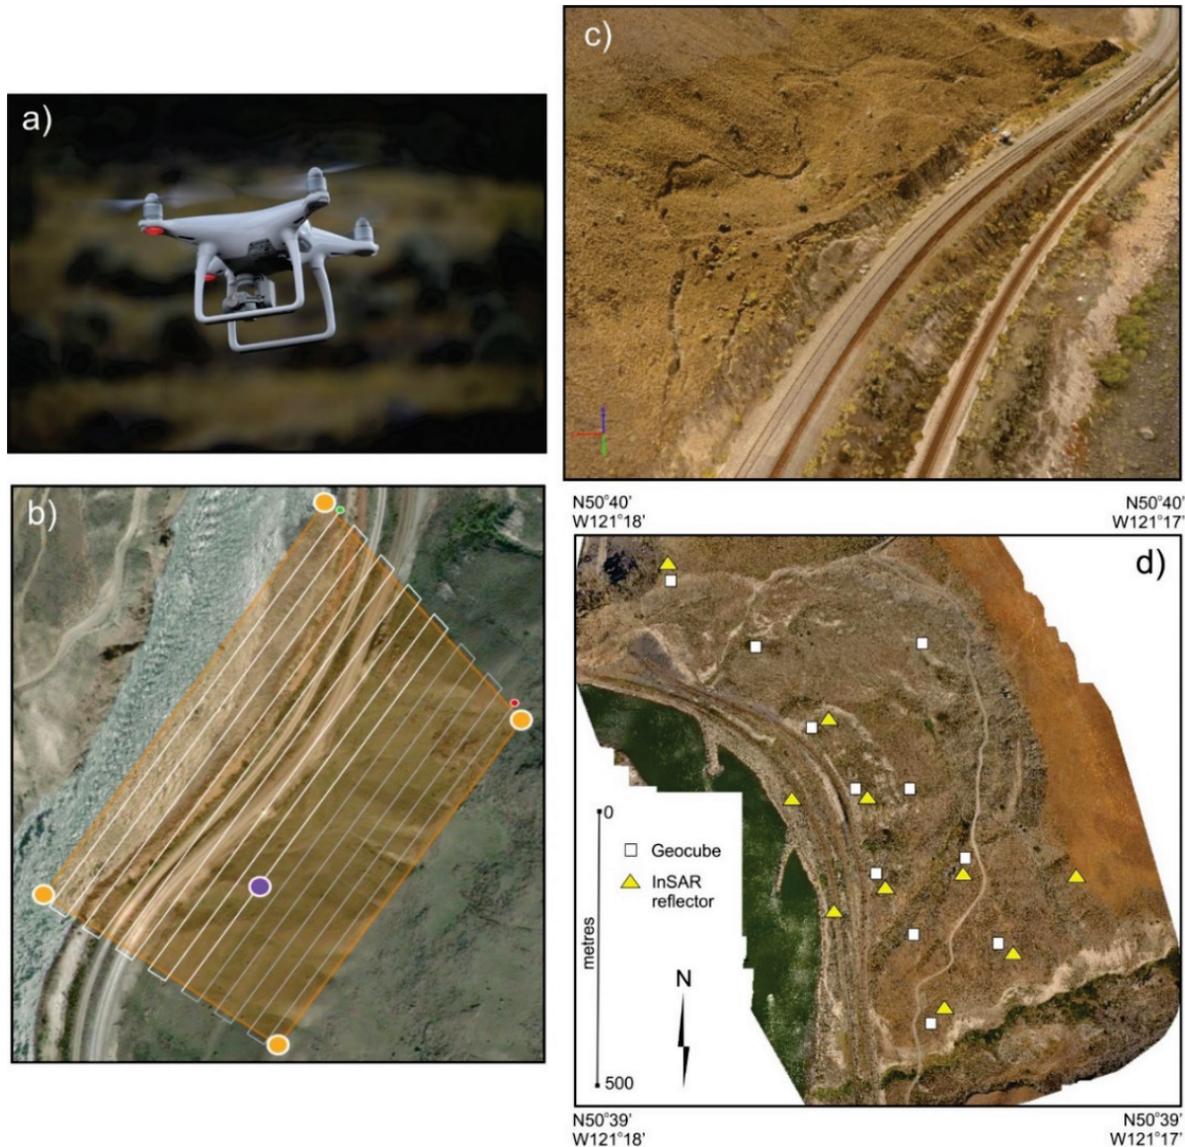
**Figure 2-10** a) DJI Phantom 4 UAV (GSC photo 2020-308); b) Programmed flight plan for Ripley Landslide September 2019 survey, north to top of scene (image: P. Skrivanos); c) DSM of Ripley Landslide generated by SfM software (September 2016), view to south; d) DSM of South Slide generated by SfM software, showing location of InSAR corner reflectors and Geocubes™ (September 2017).
