**GEOLOGICAL SURVEY OF CANADA  
OPEN FILE 8736**

**Understanding plateau landslides: current research  
in the Thompson River valley, Interior Plateau,  
British Columbia (2013-2020)**

**D. Huntley, P. Bobrowsky, D. Rotheram-Clarke, R. MacLeod, R. Cocking, and J. Joseph**

**2020**

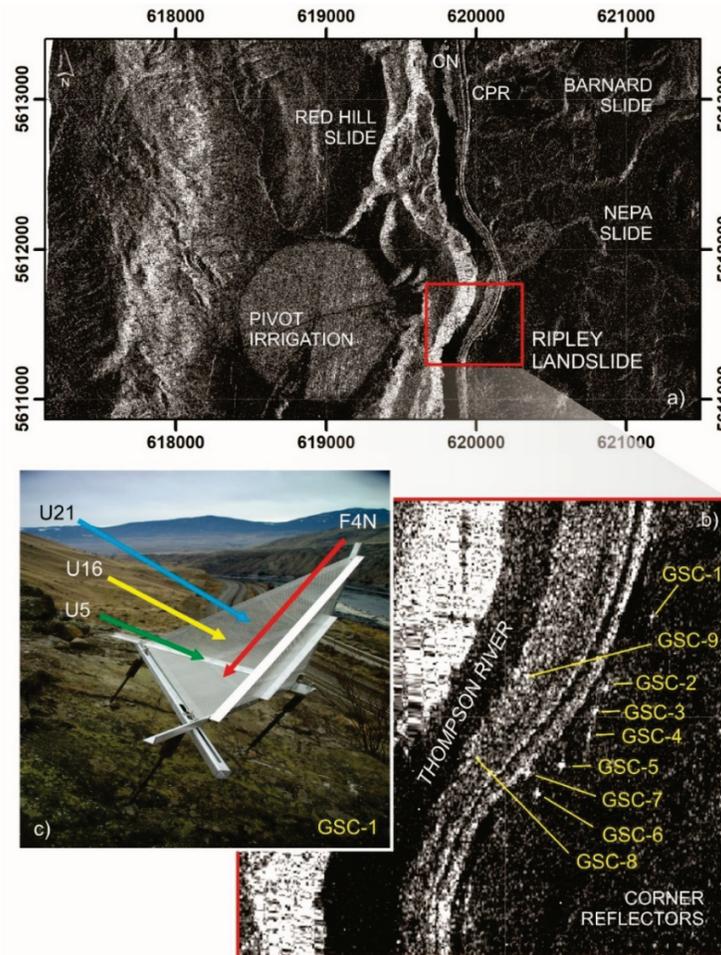
**Figure 2-11** a) Regional orthorectified RADARSAT-2 SAR amplitude image, showing Ripley Landslide in relation to other slow-moving landslides and major anthropogenic features in the Thompson River valley; b) orthorectified amplitude image of Ripley Landslide, showing trihedral corner reflectors (GSC-1, master stable reflector on bedrock); c) stable trihedral corner reflector (GSC-1) showing diagrammatic Ultrafine beam paths for three descending nodes along an azimuthal line-of-sight of  $280^\circ$  (U5  $34^\circ$ , U16  $42^\circ$ , and U21  $45^\circ$ ), interferograms were generated from a stack of U21 images; corner reflectors are not oriented to utilize the ascending node along an azimuthal line-of-sight of  $088^\circ$  (F4N  $44^\circ$ ) (NRCan photo 2020-309).

PCI Geomatica (2018) was used to create a series of interferograms from a stack of U21 Ultrafine RADARSAT-2 images (**Figure 2-11 a**). The stack has an average incident angle of  $45.4^\circ$ , and was acquired with a right-looking geometry from descending orbital passes east of the study site. Reliable InSAR targets were identified from the stack of SAR imagery by examining the degree of phase stability over time for every resolution cell within the study area (**Figure 2-12**). By considering only targets with persistent scatterer characteristics, and correcting for phase change contributions caused by orbital position errors, topography and atmospheric effects, a time series of deformation for each target was recovered with possible measurement accuracies of several mm (cf. Henschel et al. 2015). The trihedral corner reflectors (**Fig. 2-11 b, c**) installed on site served as highly coherent artificial InSAR targets. Submillimeter accuracy of corner reflector time series' has been demonstrated experimentally (Ferretti et al. 2007). For stack pre-processing, SAR imagery was co-registered with a geo-coded DEM derived from airborne LiDAR. Temporary coherent targets were identified across scenes. Multi-master interferograms were created (minus winter scenes) with atmospheric effects removed. Signal enhancement included proprietary partner pixel searching and adaptive filtering. Network processing included: unwrapping, displacement rates, and height error estimation by 3vGeomatics (Pon et al. 2020).

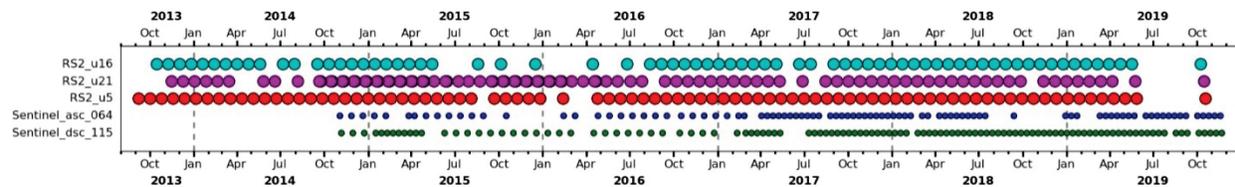
**Figure 2-12** Raster coverages of SENTINEL-1 and RADARSAT-2 scenes used in comparison by 3vGeomatics (Pon et al. 2020).

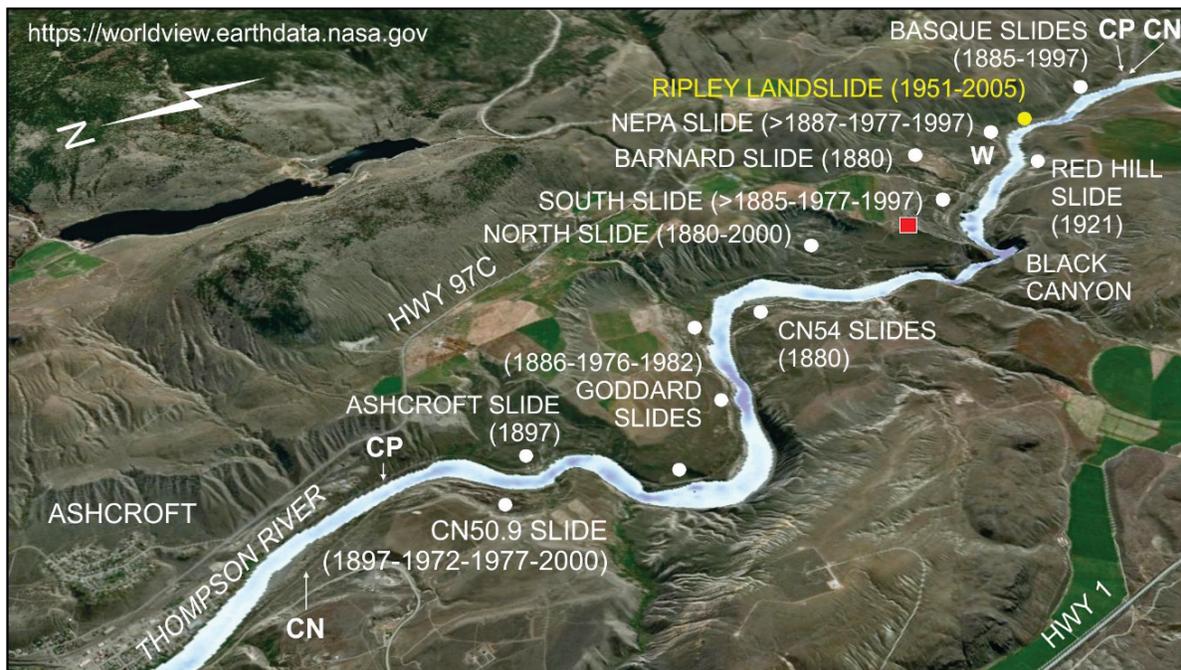
**Figure 2-13** Bathymetry and landslide history of the Thompson River valley (after Clague and Evans 2003), showing location of Ashcroft and railway transportation corridor in relation to the Ripley Landslide test site (yellow text and dot); prime ground control point, survey base station (red square); weather station (**W**). Bathymetric survey by Young and Slater (2017).

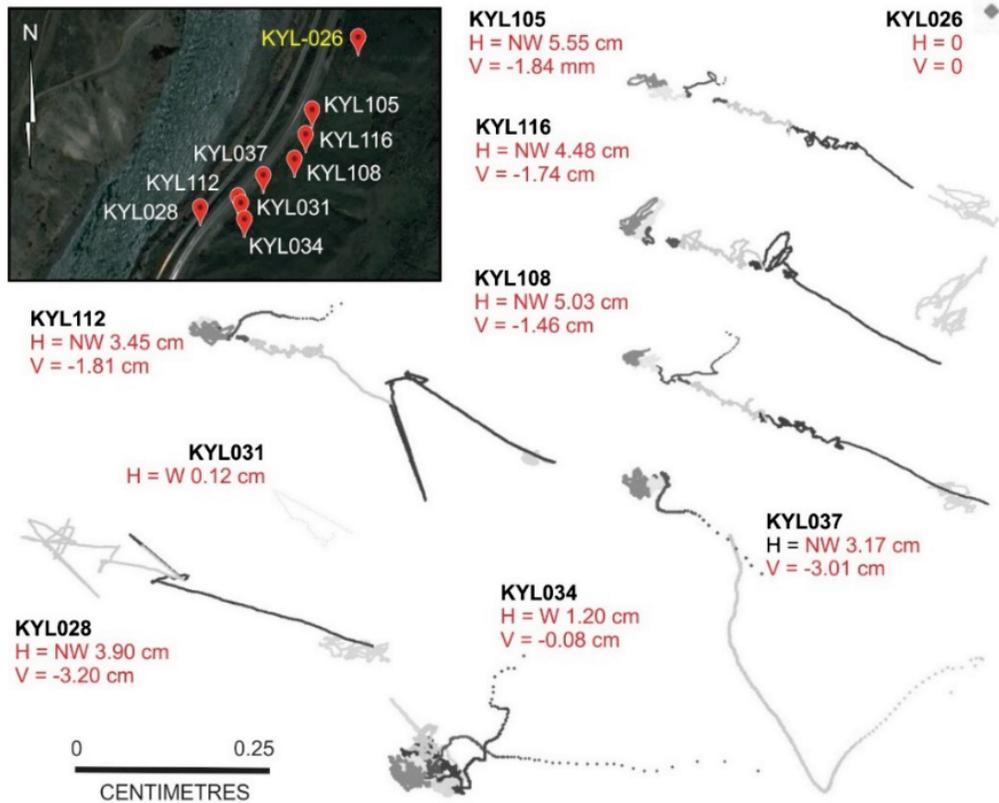
**Figure 2-14** Unfiltered displacement trends of Ripley Landslide Geocube™ network. Google Earth image showing active units from December 2018 and provisional results for the November 2018 to June 2019 observation period.

Geocubes™ displacement results from November 2018 to June 2019 are discussed here. Eight units installed across Ripley Landslide were active to some degree, and recording 3D displacement during this time interval (**Figure 2-6; Figure 2-14**). Three units were not active due to wildlife damage or low battery charge (KYL029, KYL030, KYL111). Geocube™ location data (X - longitude, Y - latitude, Z – height above sea level) collected over the eight month-long observation trial were imported into an ArcGIS Geodatabase. Geocube™ tracks are plotted as points, grey-shaded from light to dark according to date (per month) from exported individual Shapefiles (**Figure 2-14**).

body, KYL-00112 is located in a graben toward the southern margin of the slide. While experiencing only 34.40 mm of horizontal movement NW, the Geocube dropped 15.54 mm in elevation. On the lock-block retaining wall, KYL-00028 recorded 39.01 mm of horizontal movement NW, and experienced 24.94 mm vertical downward displacement over the observation period (**Figure 2-15**). Above the southern head scarp, KYL-00034 captured 12.00 mm of horizontal movement to W, while dropping in height by 1.44 mm. These small displacement values may be an indication of developing instability upslope of the active headscarp.

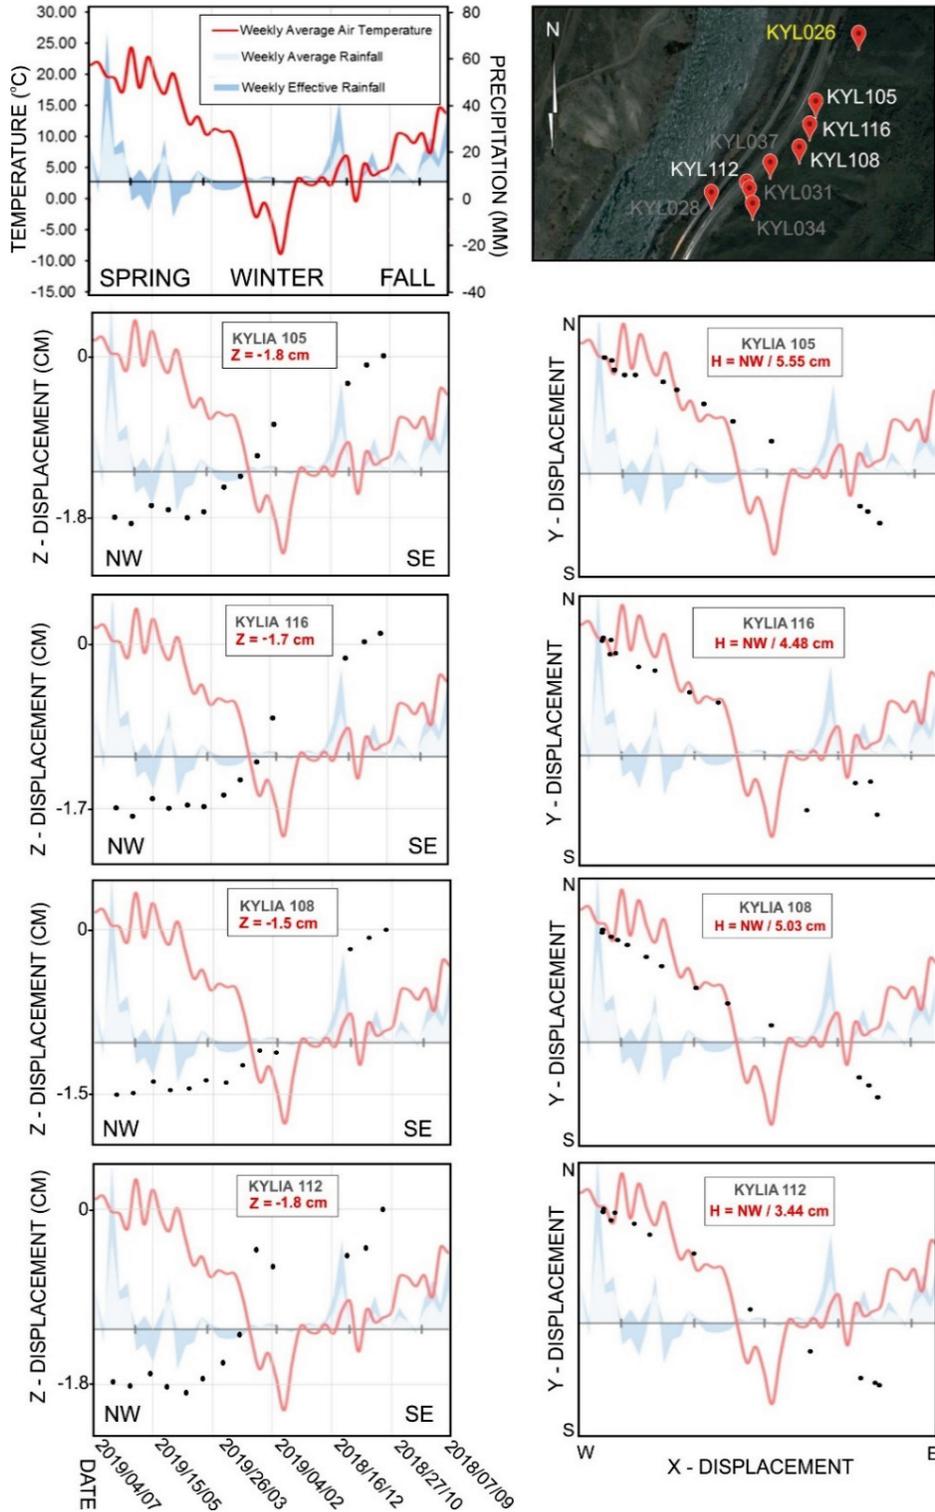
**Figure 2-15** Geocube™ displacement results: Z - vertical amounts (cm) and X,Y - horizontal displacements trends for the period September 07, 2018 to June 04, 2019; superimposed are rainfall and temperature data from Thomson Valley weather station (adapted from Holmes et al. 2020, in press). Note that these graphical representations read right to left to represent the displacement trends across Ripley Landslide.

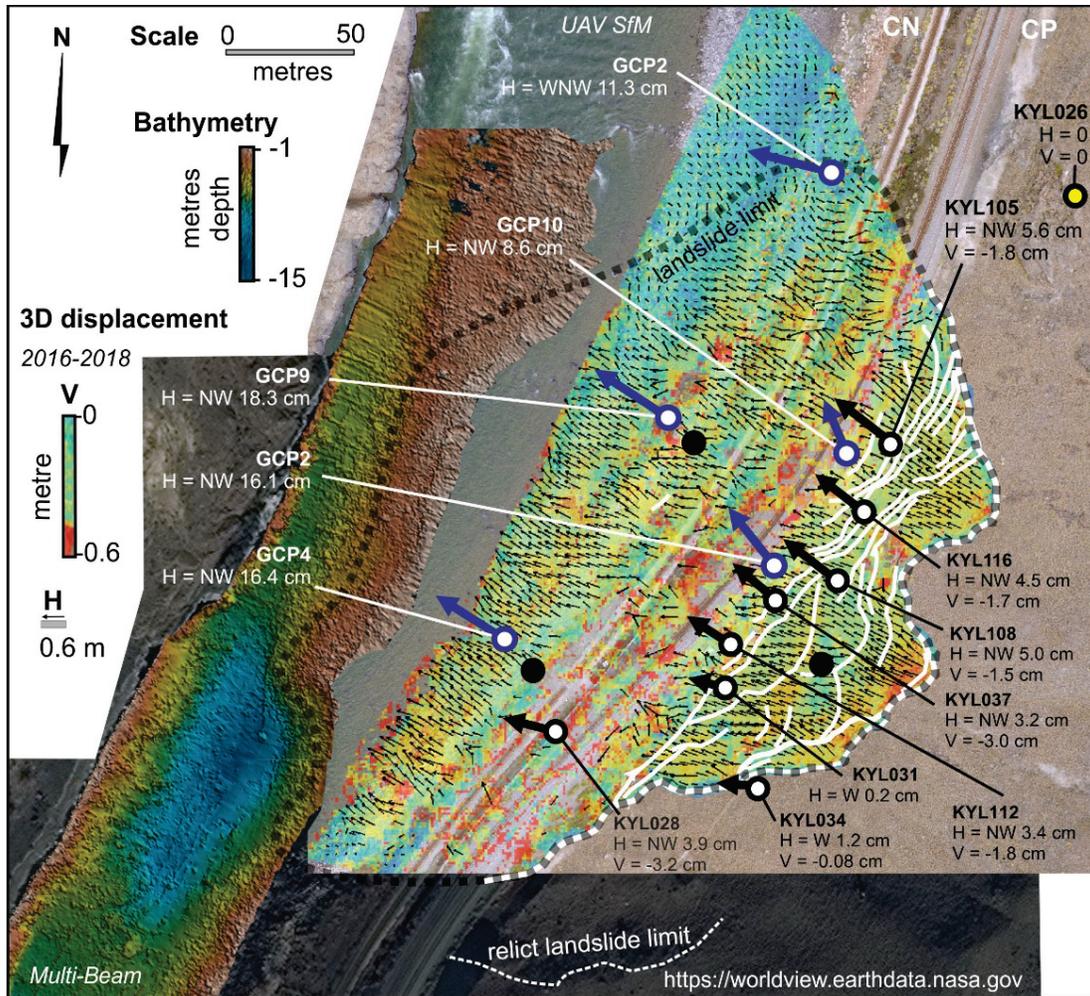
**Figure 2-16** Surface displacement data derived from UAV overflights in 2016 and 2018 and multi-beam bathymetry data collected in 2018; plotted with Geocube displacement data (November 2018 to June 2019). Figure also merges multibeam bathymetry data of Thompson River with an outline of Ripley Landslide mapped from a WorldView-2 image of the study site. Stable Geocube – yellow dot; active Geocube – black and white dot; inactive Geocube – black dot. Active GCP – blue and white dot.

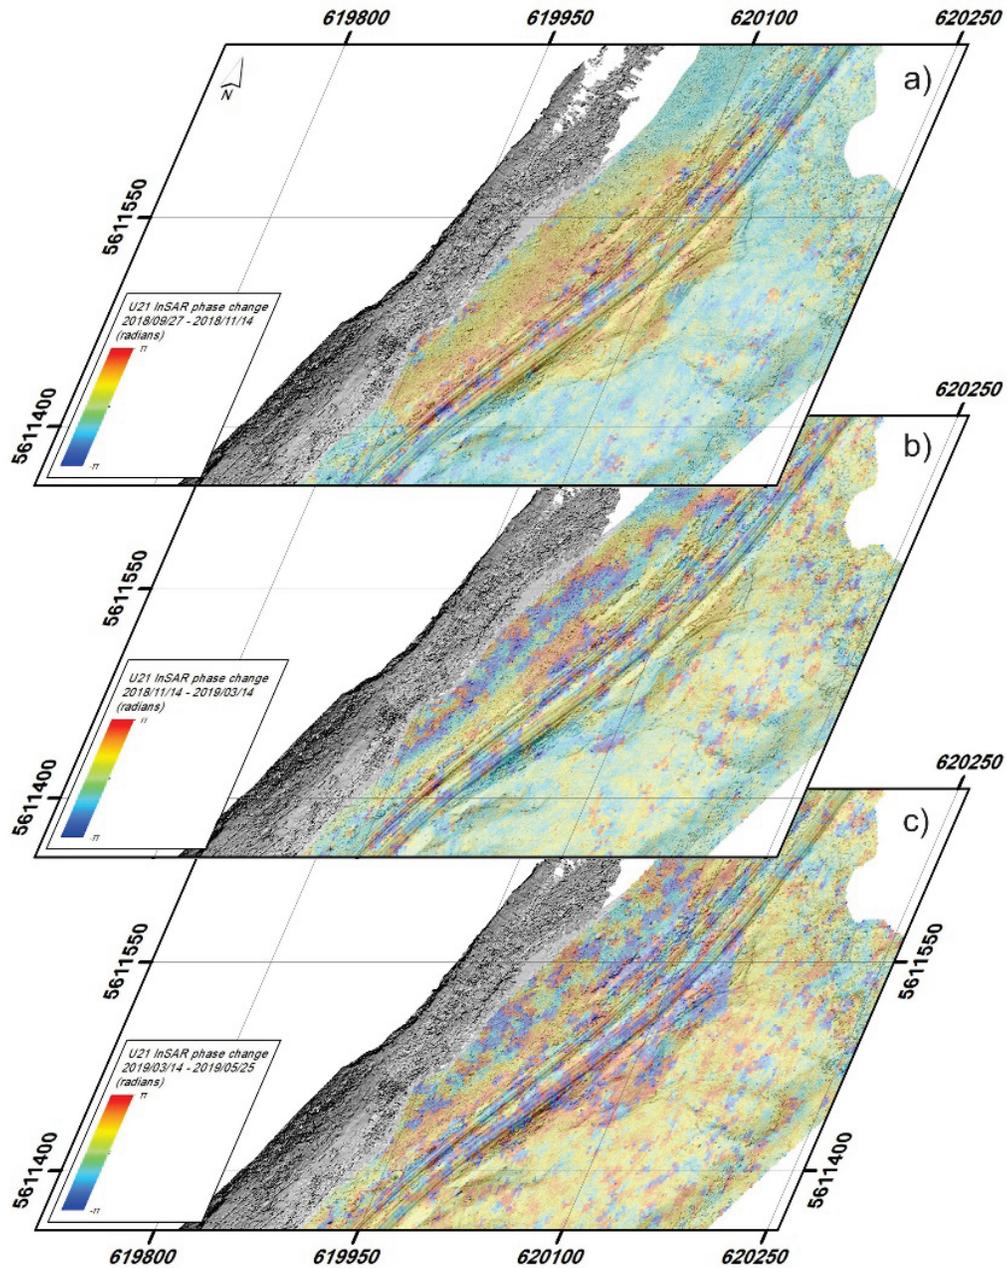
**Figure 2-17** Ripley Landslide interferograms for: a) September - November 2018; b) November 2018 - March 2019; c) March 2019 - May 2019.

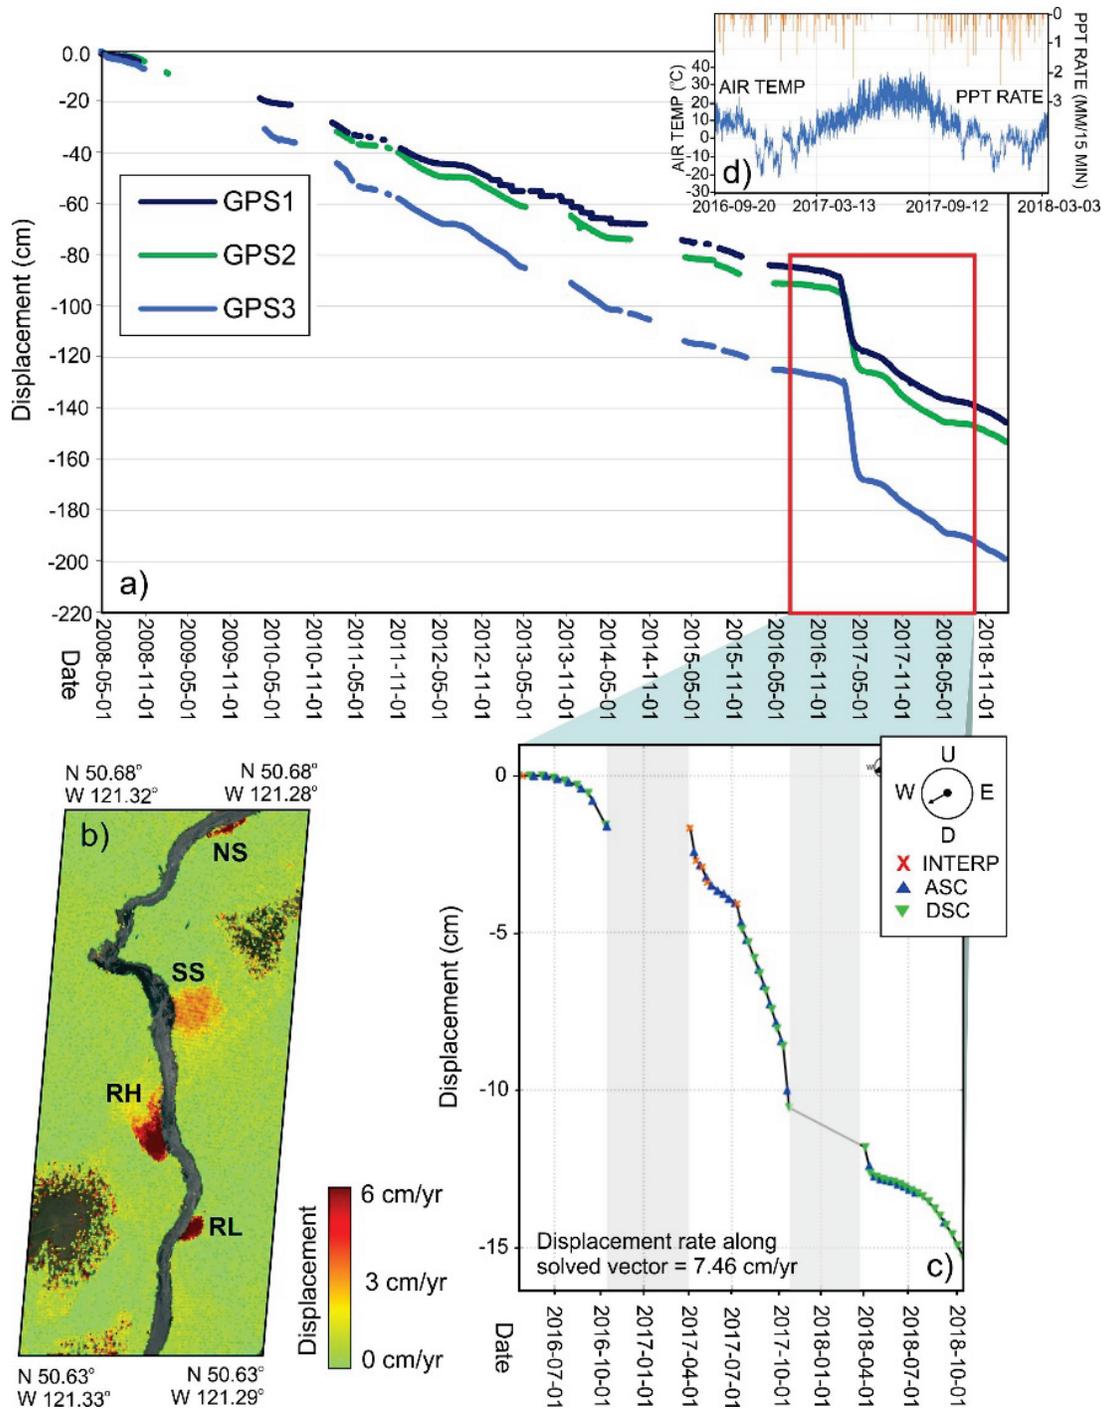
**Figure 2-18** Long term change detection monitoring at Ripley Landslide: a, b) InSAR average and 1D LoS displacement rates calculated using temporary coherent targets identified across RADARSAT-2 scenes from July 2016 to October 2018. Multi-master interferograms were created (minus winter scenes, W) with atmospheric effects removed, and signal enhancement including pixel searching and adaptive filtering (Pon et al. 2020). c) Vertical displacement (cm) trackside from May 2008 to January 2019 recorded by GPS1 (-145 cm), GPS2 (-155 cm) and GPS3 (-200 cm); see Fig. 2 for location of GNSS monuments (GNSS data courtesy of D. Wong, CPR). d) Air temperature and precipitation rate recorded at Thompson Valley weather station (**Figure 2-7 b**).

InSAR results from 2013 to 2015 indicate similar magnitudes and spatial-temporal patterns of displacement as recorded by GNSS and UAV surveys (**Figure 2-18 a**; Huntley et al. 2017b; Journault et al. 2018; Huntley et al. 2020b, in press; Huntley et al. 2020, in review). Ground movement concentrated within the centre of the sliding mass averages 39 mm/year, with fastest displacements detected upslope from the railway tracks, and on the southern flank of the landslide. Average and maximum line of sight (LoS) displacement rates (equivalent to the downslope direction for the west-facing test site) of InSAR corner reflectors and other

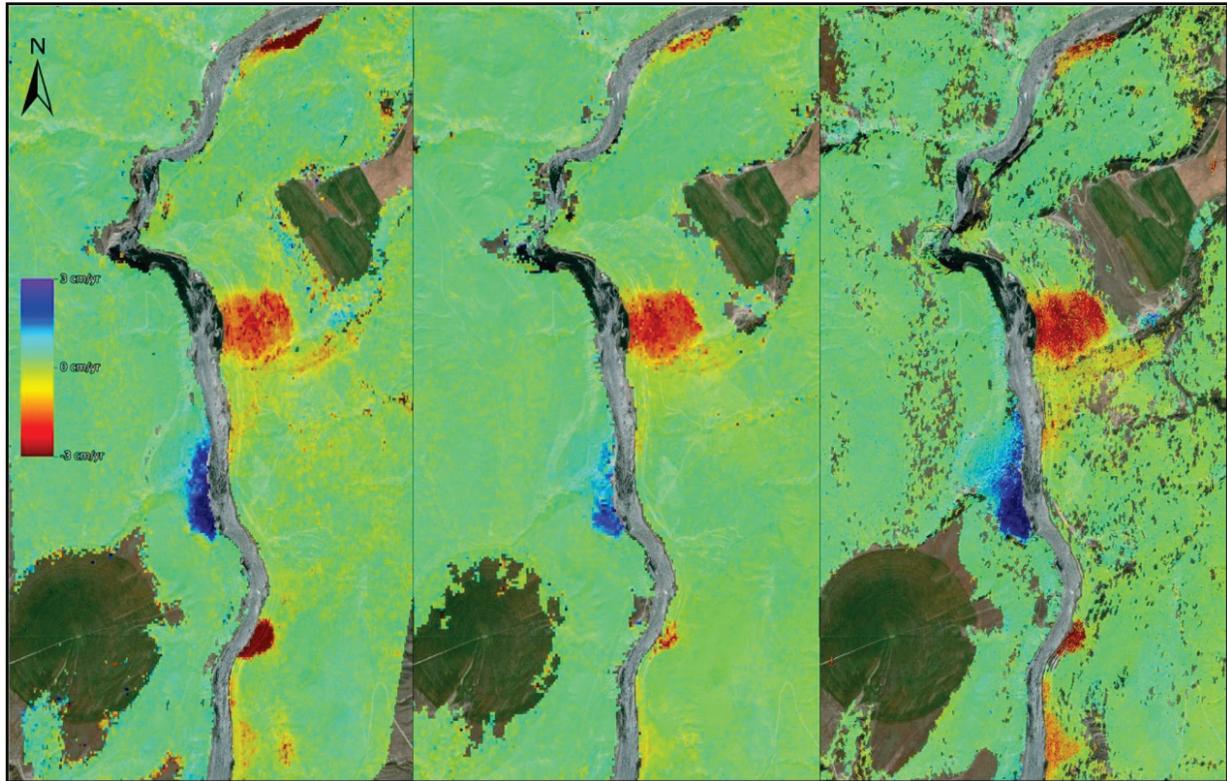
**Figure 2-19** Raster comparisons of 1D line-of-sight (LoS) time-series for descending orbits of SENTINEL-1 and RADARSAT-2. Every measurable pixel within this area will have displacement rates assigned. Point coverage for the results (time series) based on displacing areas defined using the signal-to-noise ratio for each pixel (Pon et al. 2020).

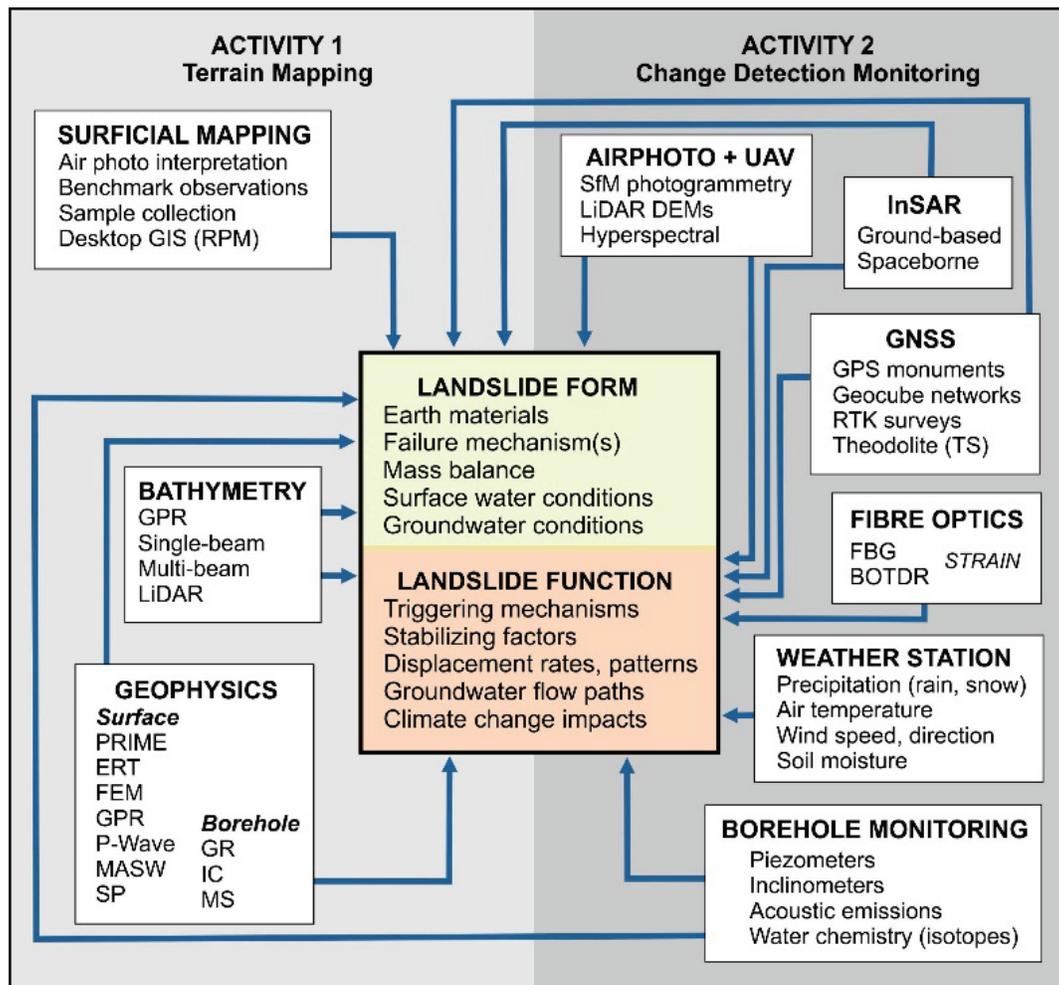
**Figure 3-1** Understanding plateau landslide systems through terrain mapping and change detection monitoring based on R&D experience in the Thompson River valley (2013-2020).
