# FINAL REPORT

## Transit Bus Research

Suzanne Tylko, Kathy Tang (Innovation Centre, Transport Canada)

**Date:** 2022-12-19

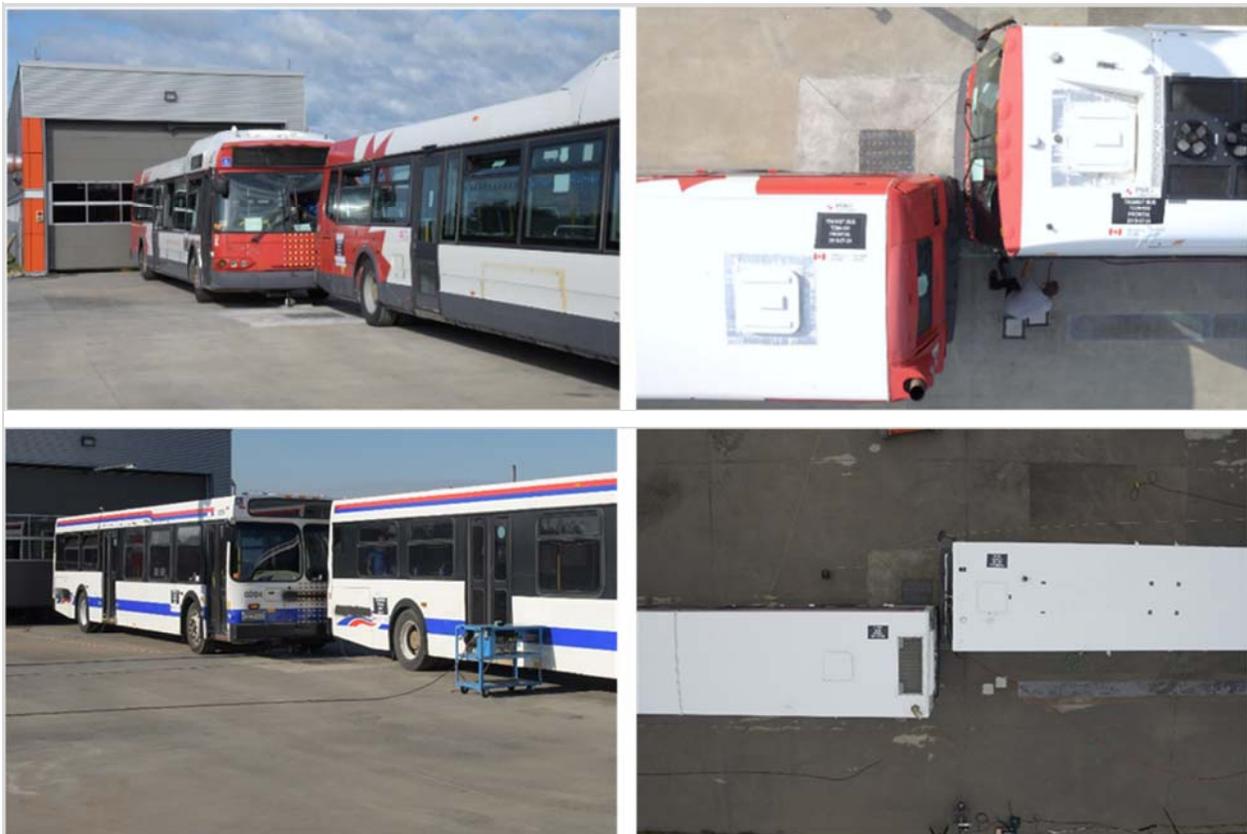
**Figure 1: Front and top view of vehicle alignment for Test 1 and Test 2 (top) Test 3 and Test 4 (bottom).**

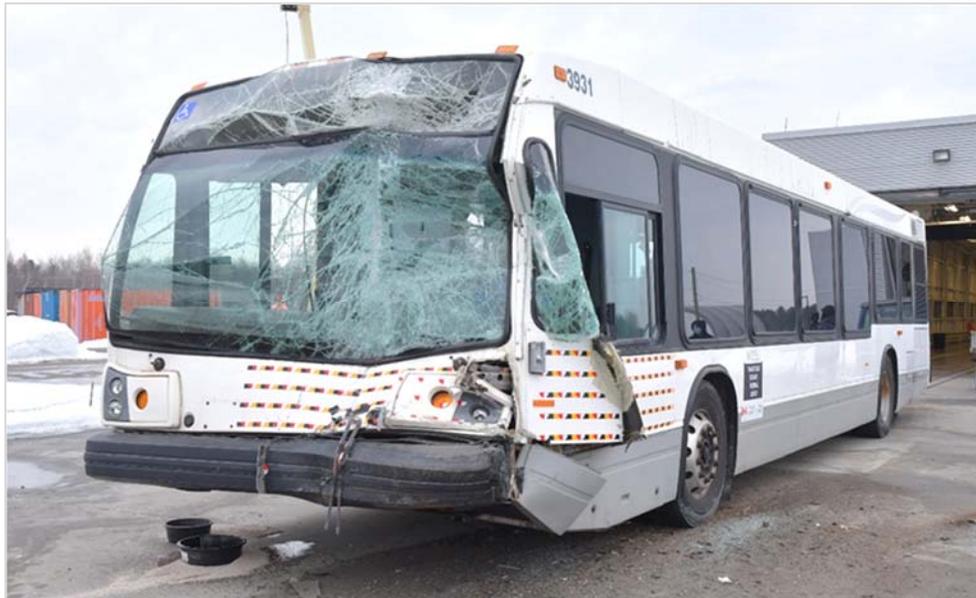
**Figure 6: Post test photo of Striking Vehicle in Test 5.**

The resulting damage to the striking vehicle can be seen in Figure 6. The A-pillar/windshield frame of the striking bus was displaced rearward into the occupant compartment. The front body panel of the bus was also displaced rearward, along with the bumper. The bumper was deformed primarily where it met with the right edge of the target bus. No major rearward displacement was visually observed along the side of the bus or underneath the front. The frame surrounding the driver's sliding window does not appear to be displaced.

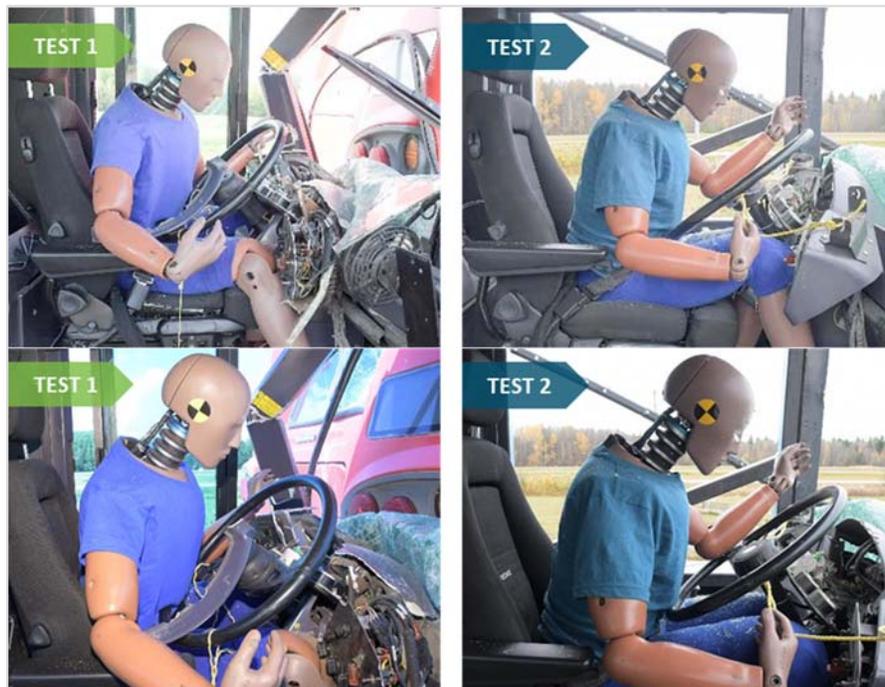
**Figure 16: Final position of dummy in the driver seat following Test 1 (left) and Test 2 (right).**

In the lateral views of the videos for Test 1, the dummy pelvis was displaced rearward by the intruding structures. The extent of the intrusion and the concurrent rearward displacement were not observed for Test 2. Post-test photos of the driver in Figure 16 illustrate the difference in the final position of the dummy relative to the steering wheel and instrument panel. In Test 1 (upper left photo), there is no gap between the pelvis and the seat back and the knee joint is on the seat cushion, whereas in Test 2 (upper right photo), there is a visible gap between the pelvis and the seat back, and the knee joint is forward of the seat cushion. In the post-test close-up views of Test 1 (lower left photo), the steering wheel is wedged into the space between the rib cage and the dummy abdomen while in Test 2 (lower right photo), only the shirt of the dummy is in contact with the steering wheel. As noted previously, there are no sensors in this region of the dummy to quantify the loading.

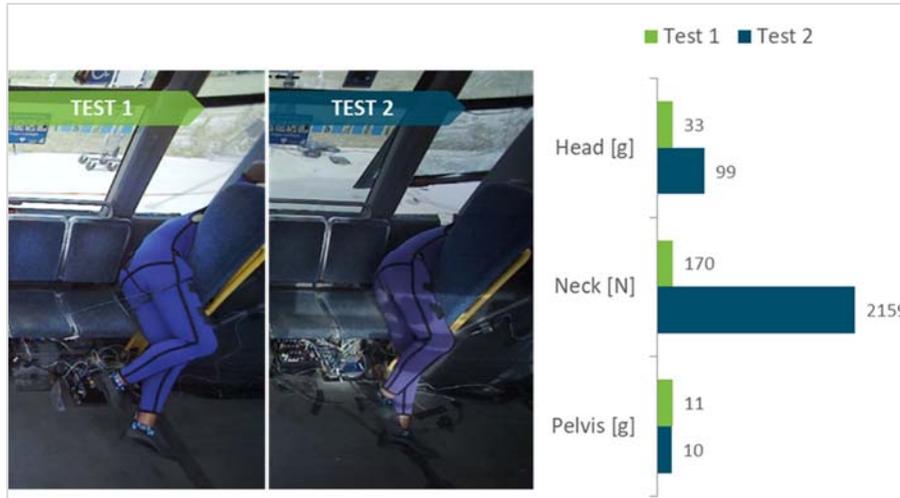
Figure 17: Freeze frames at peak head excursion for the dummy seated in Position A in Tests 1 and 2 (left panel) and the peak head, neck, and pelvis responses (right panel).

Figure 17 presents a freeze frame image of the WorldSID 50<sup>th</sup> side impact dummy at the moment of peak head excursion for Test 1 and Test 2. In both tests, the dummy was displaced vertically and projected in an upright seated posture towards the front of the bus until the motion of the pelvis and upper legs were stopped by the upholstered barrier. The upper body continued to move towards the front of the bus in the space between the upholstered barrier and the window. In Test 1, the upper body did not extend as far forward as in Test 2, and the torso of the dummy rebounded out of the space. In Test 2, the head extended further forward, impacted a rigid panel located behind the driver seat, and remained trapped between the barrier and the window. The dummy head and neck responses confirmed that the impact of the head was more severe in Test 2.

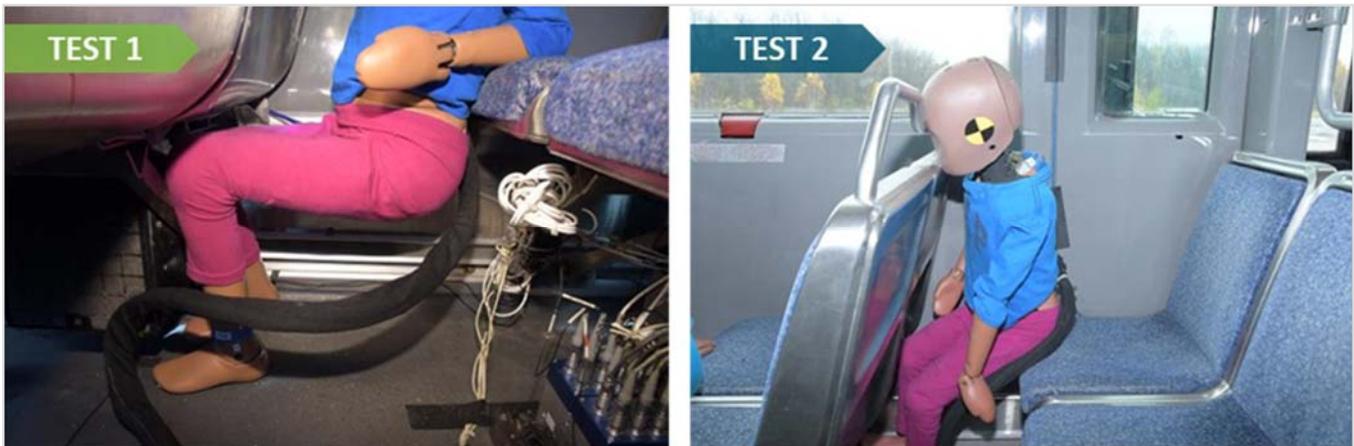
**Figure 21: Post-test photos illustrating postures of the six-year-old Hybrid III dummy in Position G.**

The dummies were sometimes found in positions that were not at all representative of what would be expected of a human child. Figure 21 presents the post-test images for the child sized dummy in position G following Tests 1 and 2.

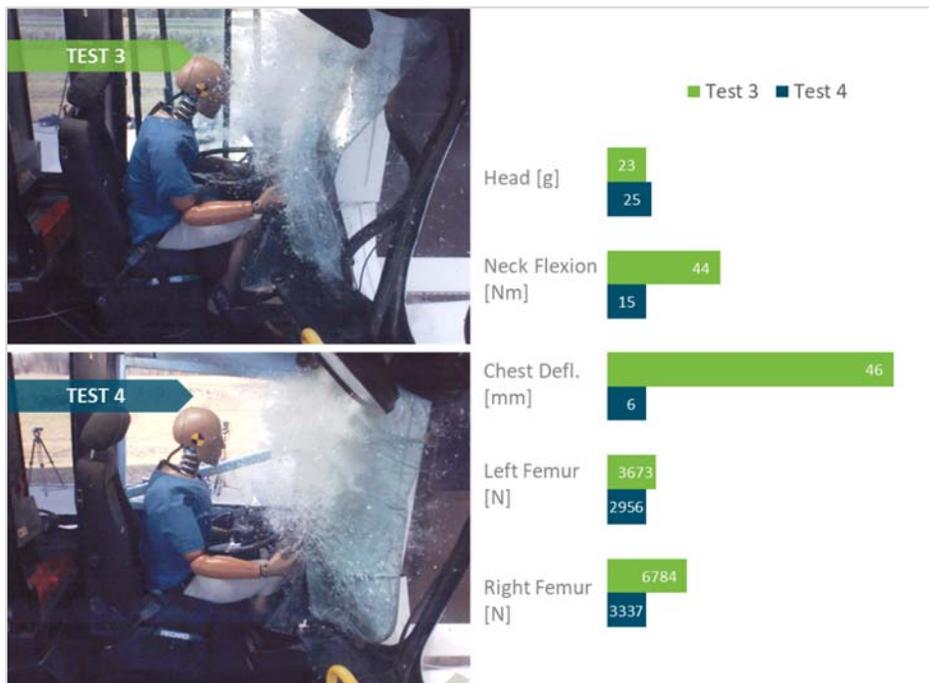
Figure 23: Freeze frames at 95 ms of the dummy in the driver location for Tests 3 and 4 (left panel) and the peak head, neck, pelvis, and femur responses (right panel).

Figure 23 presents freeze-frame images of the 50<sup>th</sup> percentile dummy at 95 ms, just before the view is obstructed by glass shards, peak responses for the driver in Test 3 and Test 4 are shown in the panel to the right. The dummy was restrained only by the lap belt. The head and torso rotated forward as the dummy translated forward in the seat. In both tests, the instrument panel and steering wheel were displaced into the driver space but there was no impact with the dummy head. This is corroborated by the peak accelerations of the head which were 23 g and 25 g in Test 3 and 4, respectively. In Test 3, the lower rim of the steering wheel loaded the dummy at the sternum contributing to a peak chest deflection of 46 mm. In Test 4, however, the lower rim of the steering wheel loaded the abdomen well below the instrumentation of the thorax resulting in a peak chest deflection of only 6 mm.

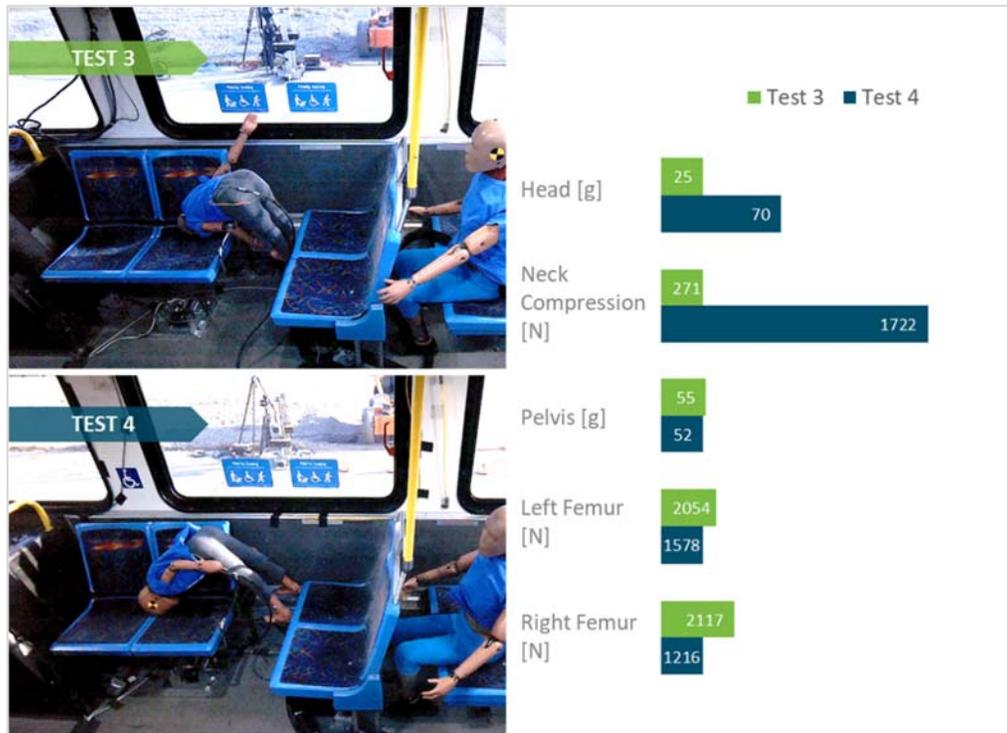
**Figure 25: Freeze frames at the time of head contact (left panel) of the dummy seated in Position B in Tests 3 and 4 and the peak head, neck, pelvis, and femur responses (right panel).**

Figure 25 presents freeze-frames and responses for the Hybrid III 6-year-old dummy seated in Position B (non-struck side of the bus). In both tests the dummy translated forward until the knees struck the edge of the side-facing seat. In Test 3 and Test 4 the dummy was pitched over the arm rest of the side-facing seat. In Test 3 the trajectory of the dummy was interrupted by the interaction between the dummy pelvis and the arm rest, and the dummy was eventually ejected from the seat into the aisle. In Test 4, the dummy pelvis cleared the arm rest of the side-facing seat, the head impacted the separation between the side-facing seats and remained in the position shown in the bottom freeze frame of Figure 25. The peak head acceleration for this dummy was 70 g and the peak neck compression was of the order of 1700 N.

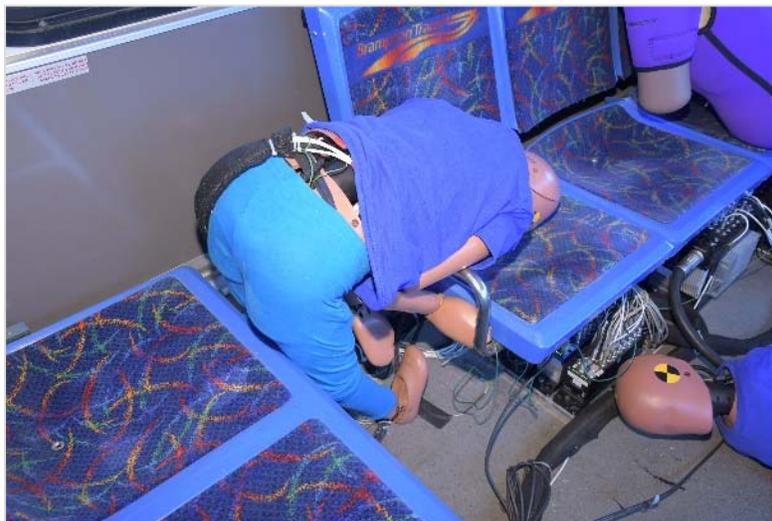
Figure 27: Photo of final position in Test 3.

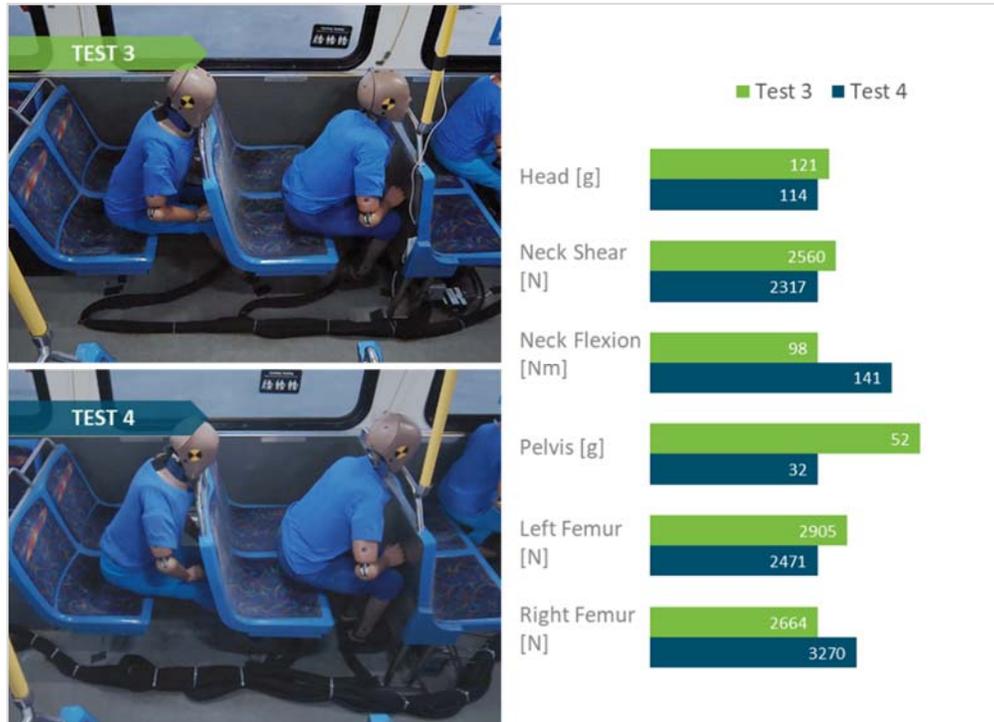
**Figure 28: Freeze frames of the dummy seated in Position E and G (left) for Tests 3 and 4 (left panel) and the peak head, neck, pelvis, and femur responses for position E (right panel).**

Figure 28 presents freeze-frames of the 5<sup>th</sup> percentile dummy positioned in E (row 2, left side of bus) and in G (row 3, left side of bus) for Test 3 and Test 4. In Test 3 the dummies located in positions E and G, translated forward until the knees struck the seatback of the seat directly in front. At the time of knee impact, the legs of the dummy seated in E were flexed with the feet immediately below the lower legs, the head and torso then pivoted forward until the face of the dummy collided with the handrail atop the seat in front. In position G (immediately behind E), the feet extended further forward, below the seat in front. The pelvis translated upwards causing the head and neck to be displaced upwards above the handrail, eventually coming to rest with the neck on the hand rail. The motion of the dummy seated in position D, across the aisle was comparable to the dummy in position E.

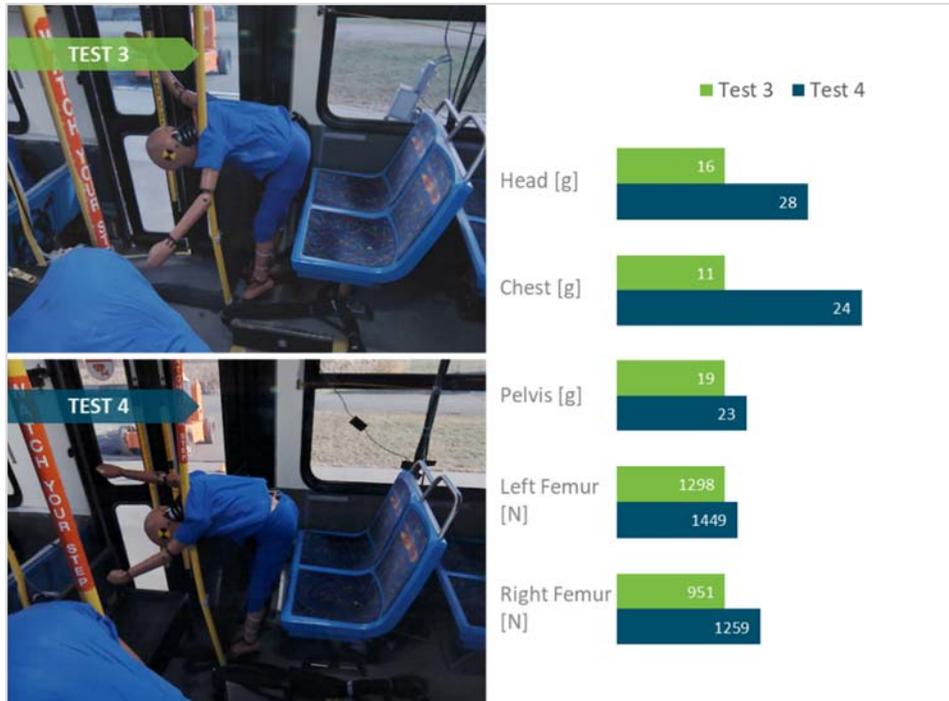
Figure 33: Freeze frames of the dummy seated in Position J in Tests 3 and 4 at the time of peak head excursion (left panel) and the peak head, chest, pelvis, and femur responses (right panel).

Figure 33 presents freeze-frames of the Hybrid III ten-year-old dummy placed in Position J. In both Tests 3 and 4, the knees of the dummy impacted the barrier. As the dummy pivoted over the barrier the left shoulder impacted the vertical hold bar. The panel flexed but did not break. As shown in Figure 34 the dummy in both tests came to rest suspended by the neck.

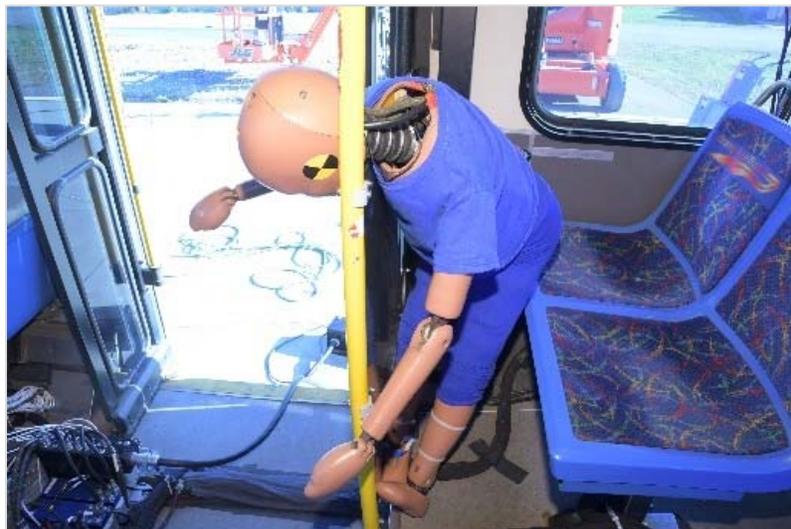
Figure 34: Photo of post test position for the dummy seated in location J.

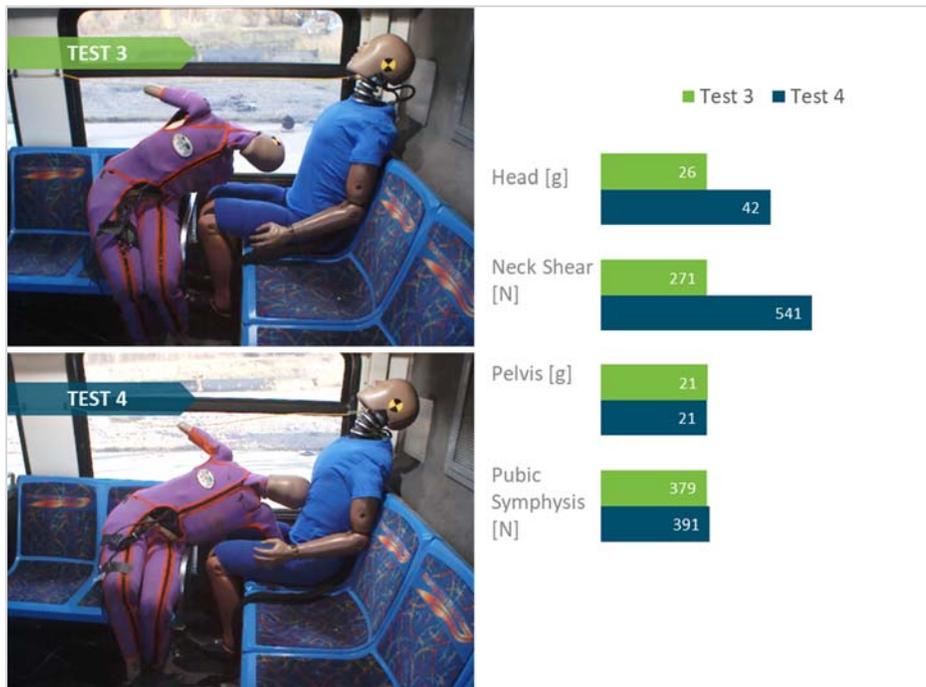
The side-facing 5<sup>th</sup> percentile WorldSID (WS 5<sup>th</sup>) side impact dummy in the side facing rear row seat of the target bus was projected rearward. In both tests, shown in Figure 35, the dummy impacted the armrest with the left hip while the unrestrained upper body continued rearward.

**Figure 35: Freeze frame of the dummy seated in the target vehicle, Position K in Tests 3 and 4 (left panel) and the peak head, neck, and pelvis responses (right panel).**

In Test 3, the 5<sup>th</sup> percentile side impact dummy was ejected from the seat and travelled towards the dummy seated in the rearmost position. The head of the WS 5<sup>th</sup> impacted the forward edge of the rearmost seat (adjacent to the Hybrid III 50<sup>th</sup>) before falling on the floor of the bus while in Test 4, the dummy contacted the Hybrid III 50<sup>th</sup> chest before falling to the floor.

In Test 3 and Test 4 the pelvis of 50<sup>th</sup> percentile dummy positioned in the rearmost forward-facing row of the Target Vehicle remained in place. The dummy moved towards the seatback, where only its head and neck were unsupported. The freeze frames in Figure 35 show a small increase in the hyperextension of the neck in Test 4.

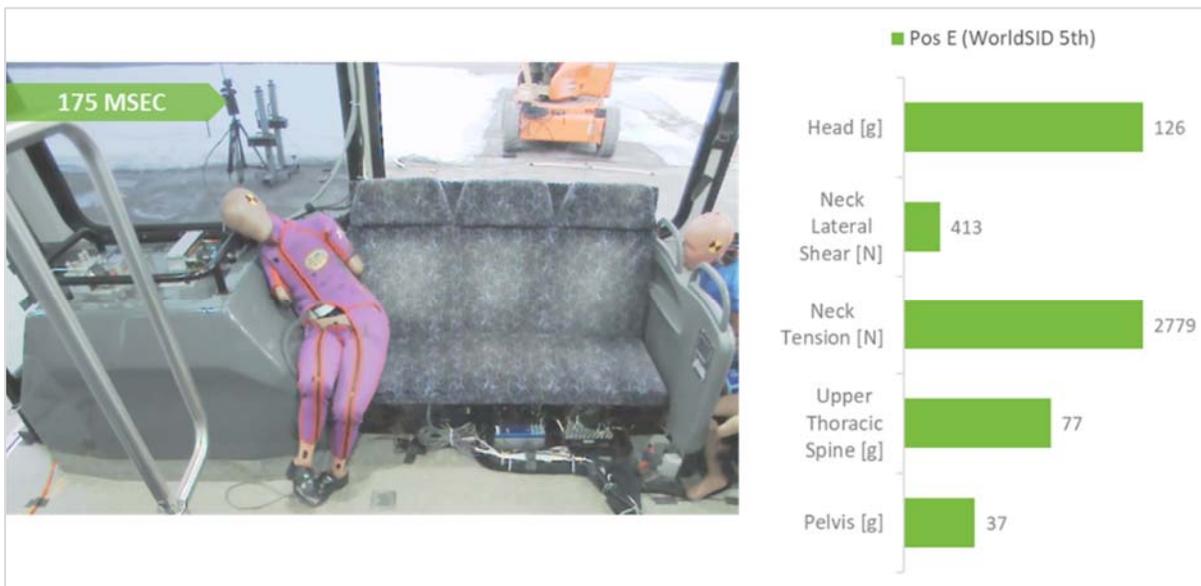
Figure 39 illustrates head contact with the rails of the luggage rack. Peak head resultant acceleration was 126 g with a calculated 3 ms acceleration clip of 116 g.

**Figure 39: Freeze frame of the dummy seated at the front of the non-struck side of the bus, in Test 5 (left panel) and the peak head, neck, chest, and pelvis responses (right panel).**

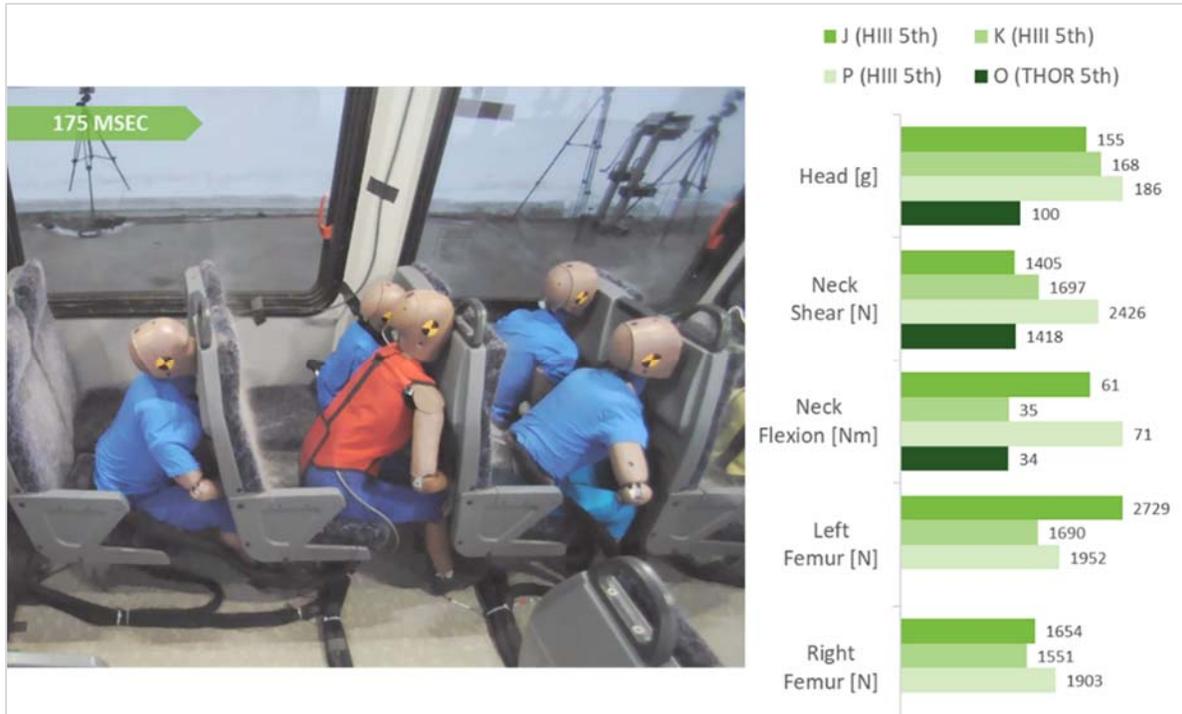
Figure 42: Freeze frame of the dummies impacting seat in front in Test 5 (left panel) and the peak head, neck, and femur responses (right panel).

Figure 41 to Figure 44 illustrate the interactions that occurred between different types and sizes dummies and the seat in front for both sides of the bus. Head impacts into the seat in front were observed in all seating locations on the lower level of the bus. The two dummies that were placed at the upper level rotated over the seats in front.

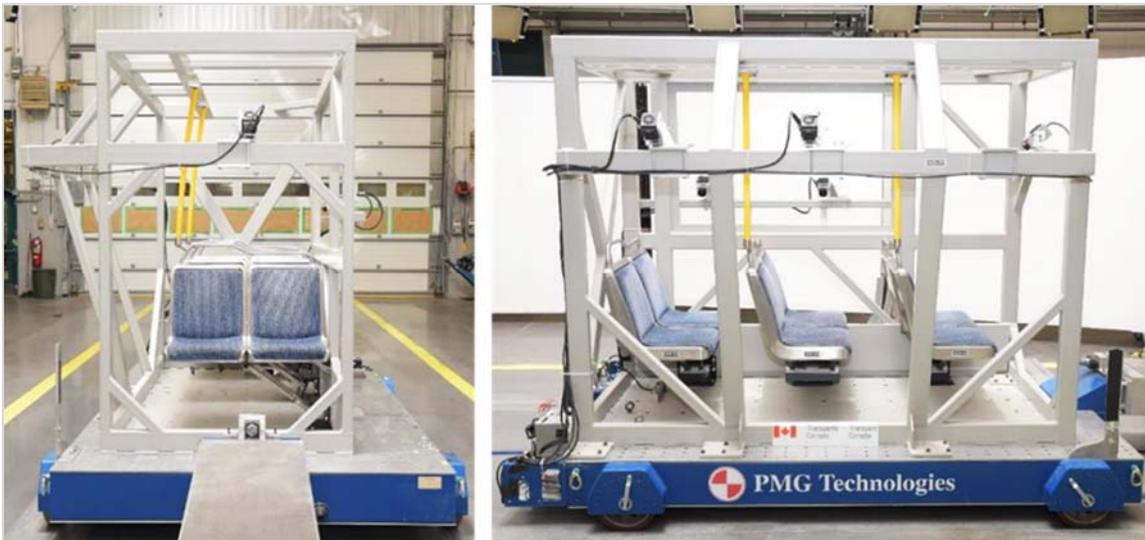
**Figure 46: Front and side views of the bus buck attached to the deceleration sled bed.**

The advantages that sled testing can offer—reproducibility and low incremental cost—are contingent on the fact that the buck, provided it is sufficiently rugged, can withstand repeated use without damage or wear. To ensure that the frame would be sufficiently rugged, the frame was constructed with 2"x4" steel tubes, the back of the frame was braced by additional 2"x4" tubes, and the joints were braced with 2"x2" tubes and 3/8"-thick plates.

The frame was designed and fabricated to allow experimentation with different seat configurations, seat types and interior structures. While the seats currently installed are from the OC Transpo New Flyer buses, other bus seat models may be attached instead. The spacing between rows of seats can be varied, and vertical posts can also be replaced or moved along the length of the buck.
