# A Practical Guide to Corrosion of Atmospheric Corrosion Resistant Steel Bridges Exposed to De-icing Salt: Understanding Micro-Climate Effects

# **A Practical Guide to Corrosion of Atmospheric Corrosion Resistant Steel Bridges Exposed to De-icing Salt: Understanding Micro-Climate Effects**

Nafiseh Ebrahimi, Marc-Oliver Gagné, Alban Morel and Danick Gallant

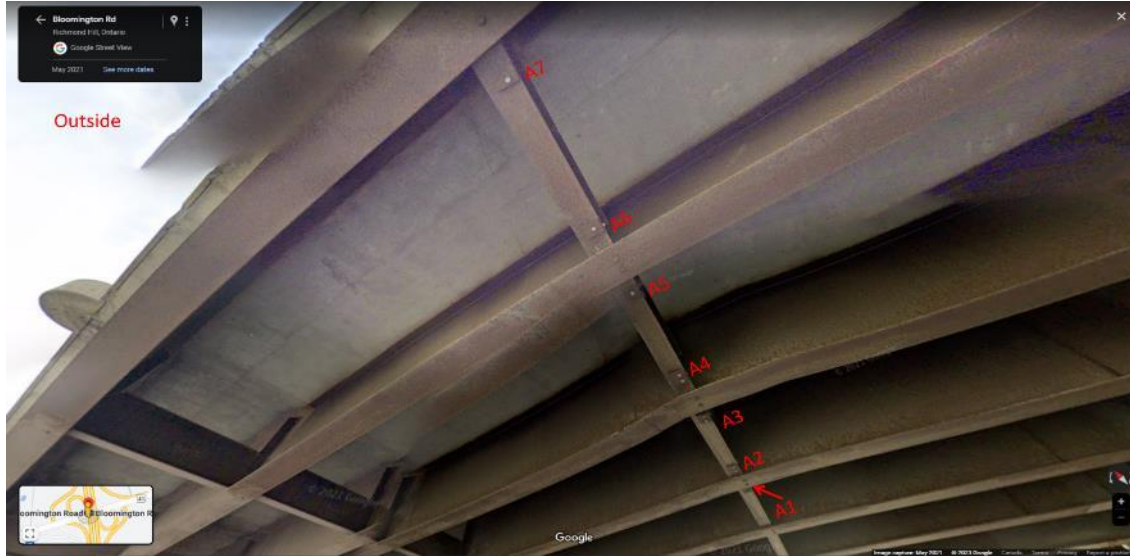
Figure 4-2. Steel plate samples installed under the Hwy 404 and Bloomington Road overpass [13].

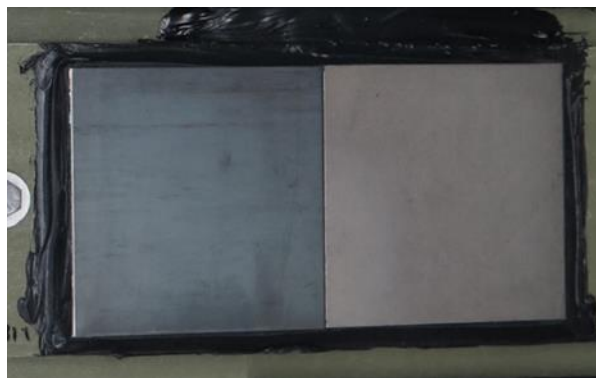
*Figure 5-5. Typical surface condition of the bare weathering steel materials utilized in the monitoring array, illustrating the 2.0 mm (left) and 1.18 mm (right) variants.*

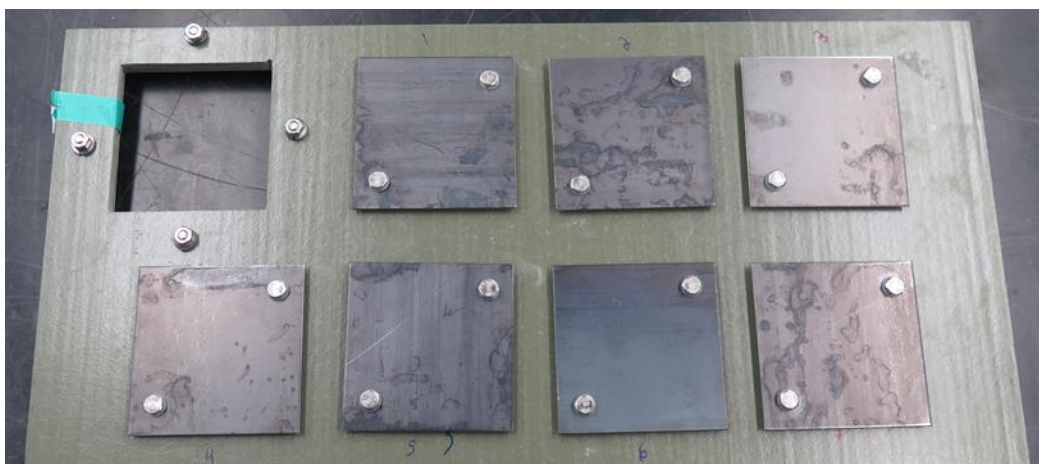
*Figure 5-8. Configuration of the weathering steel mass-loss coupons mounted on the side rail plate. This physical array implements the staggered exposure matrix designed to systematically evaluate the influence of discrete seasonal environmental variations on the structural corrosion kinetics.*

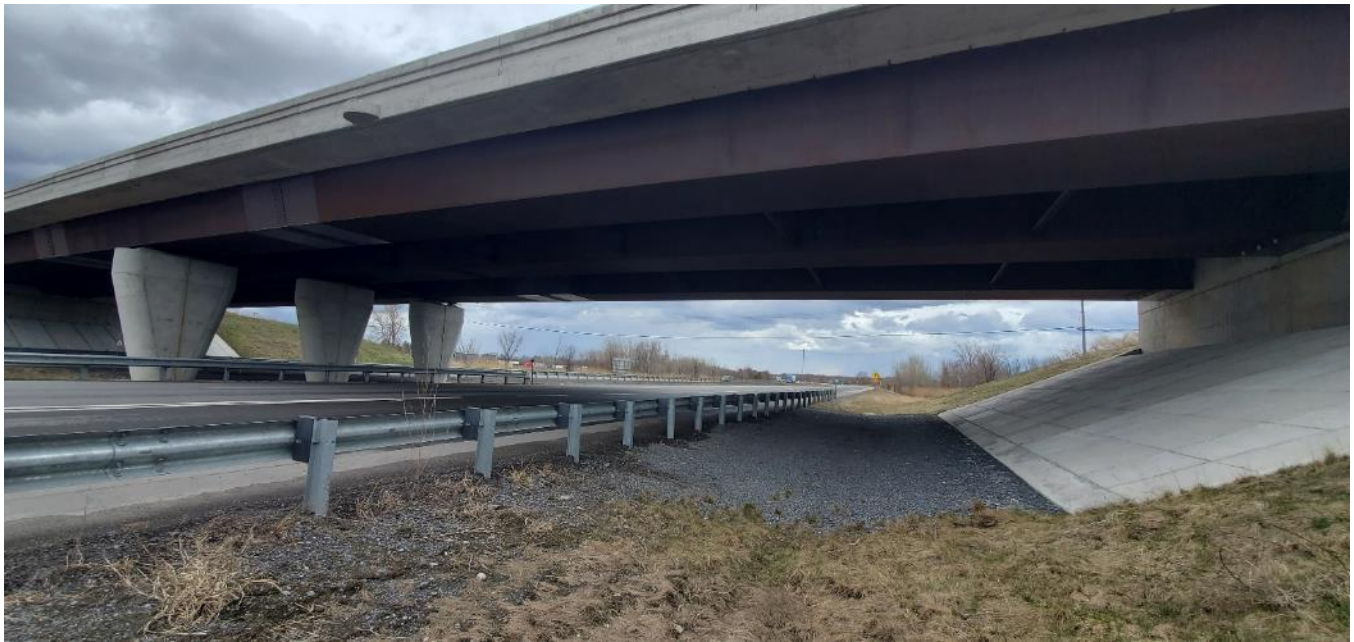
*Figure 5-13. Field perspective of the Highway 401 Underpass at County Road 2 & County Road 34 I/C. The image illustrates the primary installation environment, featuring weathering steel girders and reinforced concrete piers. Sensor plates are strategically distributed across these structural elements, including the abutment (right), the central piers, and the girder webs over the traffic lanes, to capture varying degrees of exposure to roadway splash and aerosolized de-icing salts.*

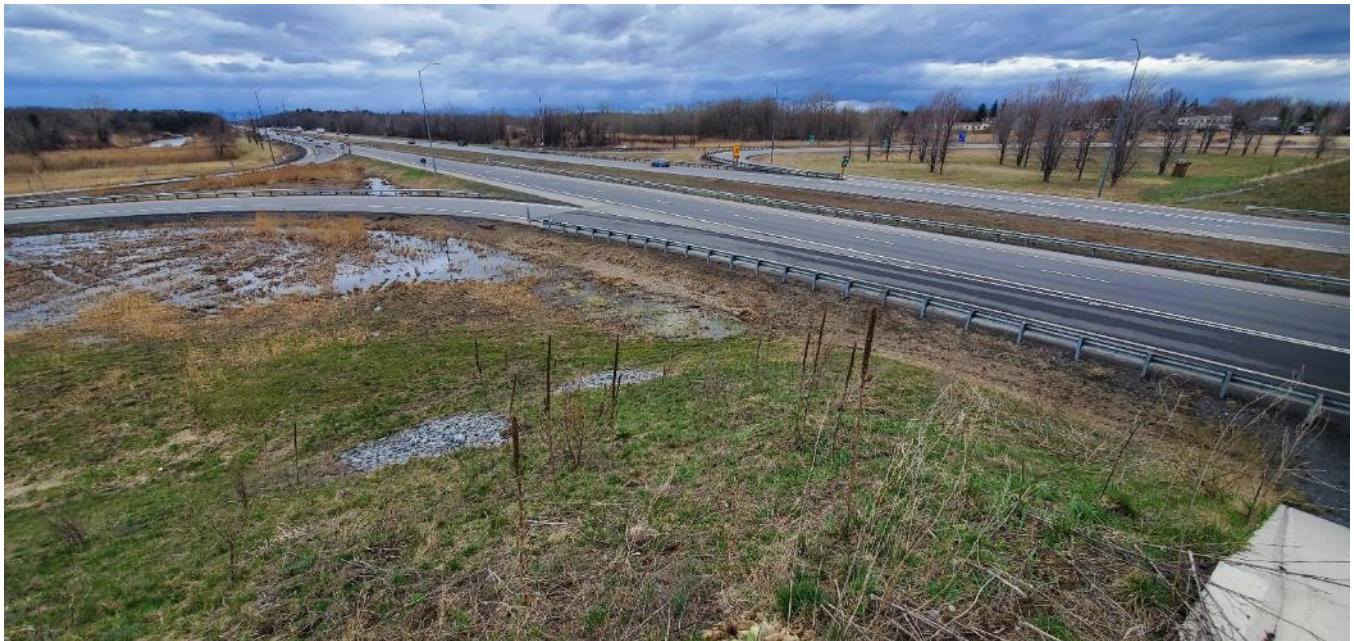
*Figure 5-15. Panoramic view of the Highway 401 entry ramp and main corridor from the monitoring site.*

In **Figure 6-15**, the view from the bridge structure highlights the acceleration lane and the heavily traveled Highway 401 corridor, which serves as a major transportation artery through Ontario. The close proximity of the structural monitoring sites to this high-speed traffic flow ensures that the sensor arrays are consistently exposed to "splash-and-spray" zones. During the winter months, vehicles traversing these ramps and main lanes aerosolize runoff containing high concentrations of chloride-based de-icing salts. This transport mechanism delivers aggressive ions directly to the bridge's weathering steel girders and concrete supports, creating the high-corrosivity micro-climate for which its effect is monitored in real-time via the thickness loss and galvanic current sensors.

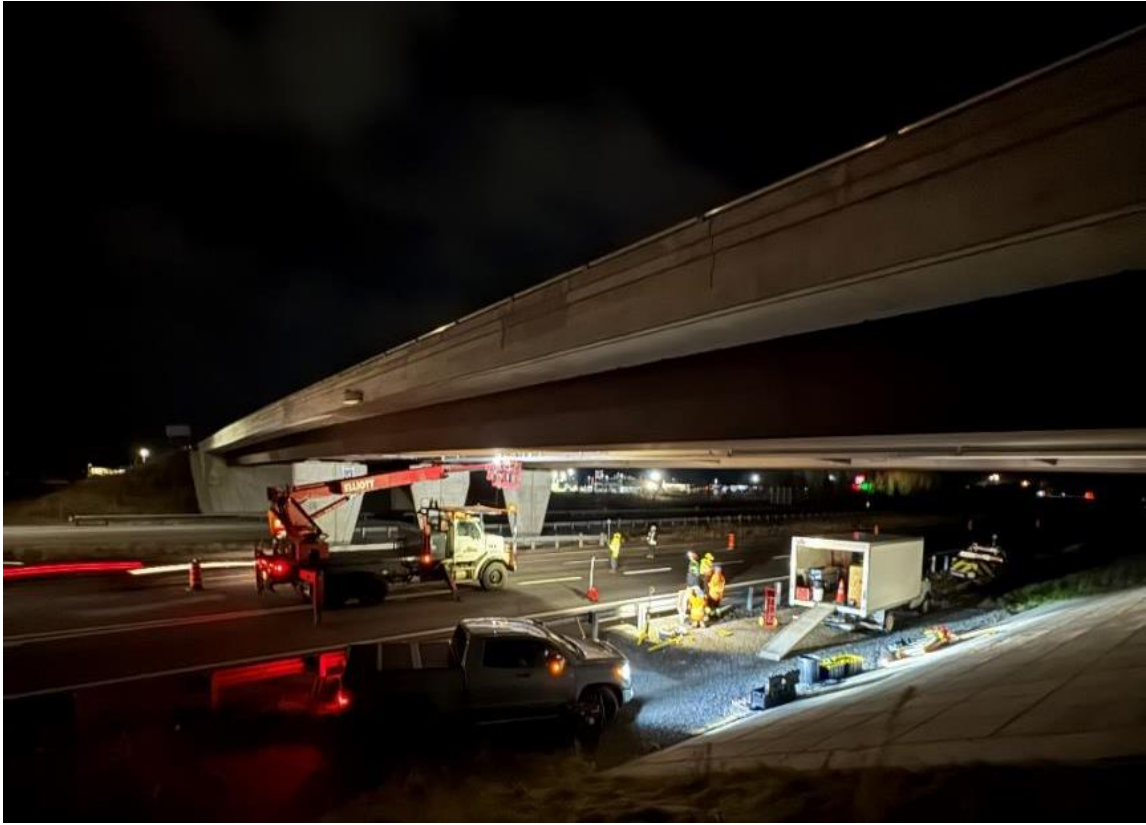
*Figure 5-17. Overview of the nighttime field operations, illustrating the Highway 401 lane closure and the vehicles utilized for the transport and deployment of monitoring instrumentation.*

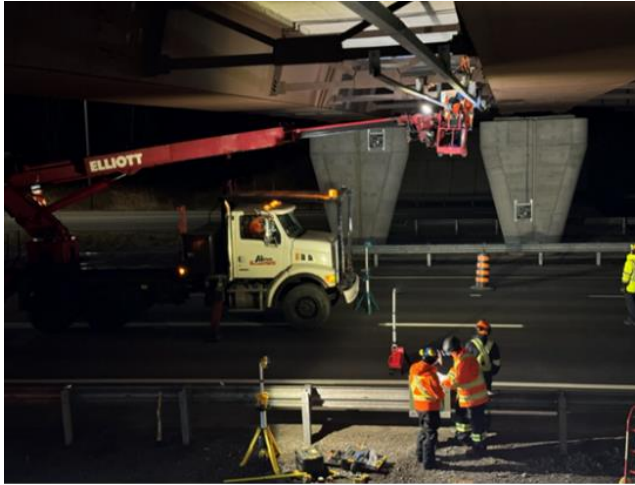
Figure 5-18. Field photographs documenting the nighttime installation work to secure specimen plates at various locations on the bridge. **Top left:** workers in a mobile elevated work platform are being raised towards the superstructure between box girders; **Top right:** workers in a basket mount a specimen plate on a pier, close to the girder; **Bottom left:** workers in a basket attach specimen plates over the slow lane, with another worker assisting and managing wiring and safety perimeter on the ground.

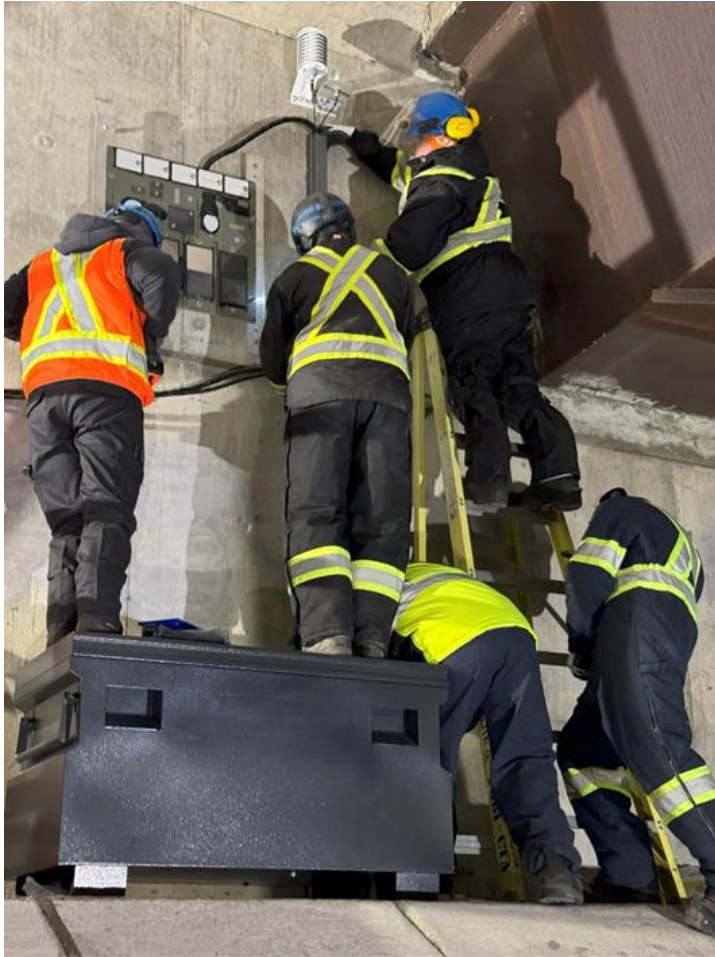
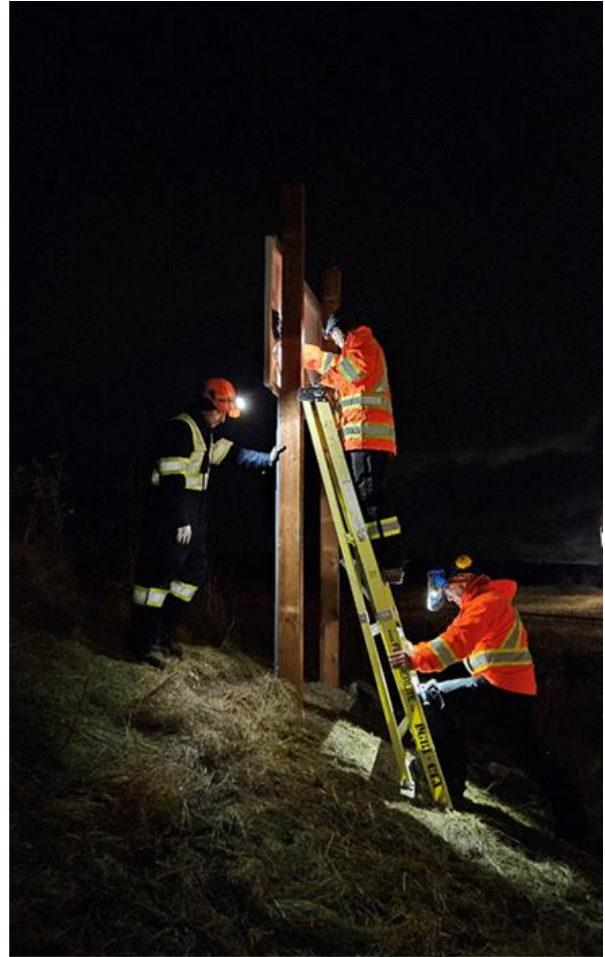
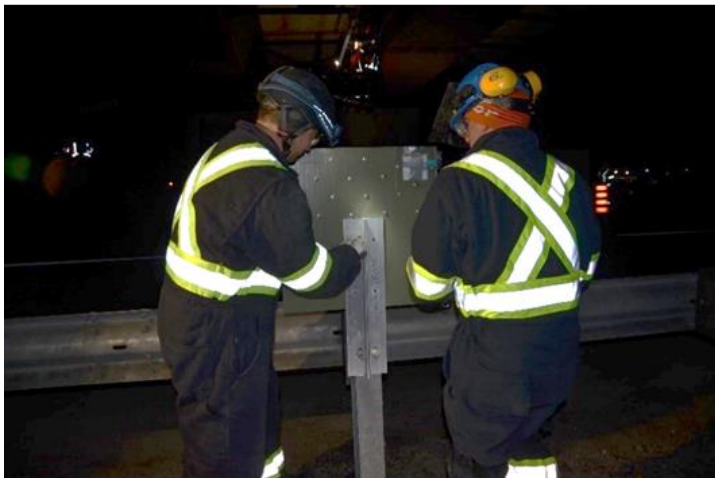
Figure 5-19. Final commissioning of the key system components. **Top left:** installation of Plate 1 on the abutment wall along with the integrated T/RH sensor; **Top right:** deployment of the solar panel array on the embankment. **Bottom left:** mounting of the WS mass-loss specimen holder on the side rail's post.

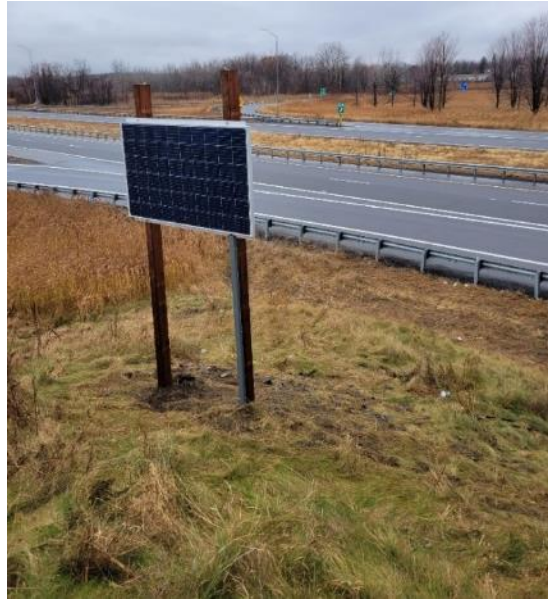
*Figure 5-20. View of the autonomous solar power system. The panel is mounted on a rigid support structure on the south-facing embankment to provide a continuous renewable energy source for the bridge's remote monitoring and data transmission instrumentation.*

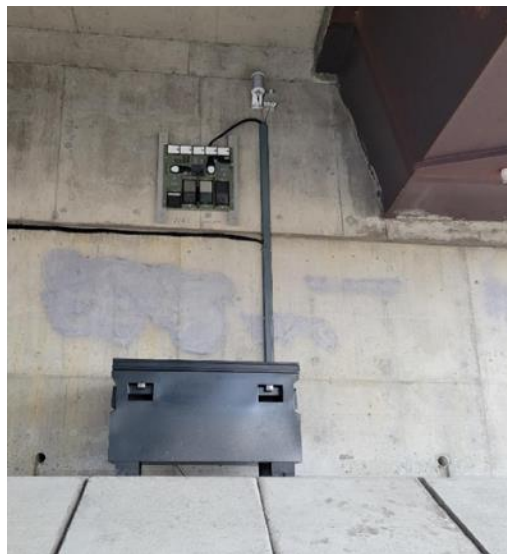
*Figure 5-21. Detailed view of the right abutment wall. This installation includes Plate 1, positioned vertically to serve as a baseline monitoring site, and an integrated T/RH sensor for local atmospheric data collection. On the flat surface against the abutment wall is positioned the weather-resistant enclosure that houses the system batteries and the main datalogging hardware. Cables are neatly routed and protected, ensuring long-term structural monitoring and continuous data transmission from this central hub.*

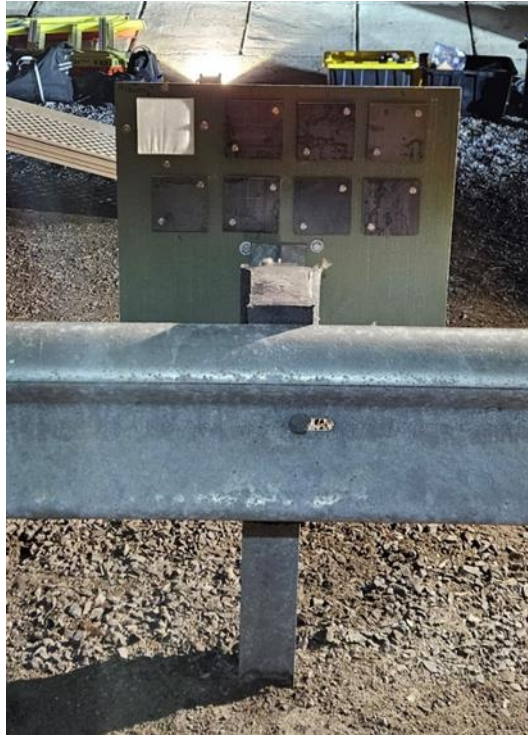
*Figure 5-22. Close-up view of the mounting plate secured to the rail post. This station holds a series of weathering steel (WS) mass-loss coupons, specifically configured to monitor the corrosive impact of seasonal variations and roadway splash at the structure's exterior boundary.*

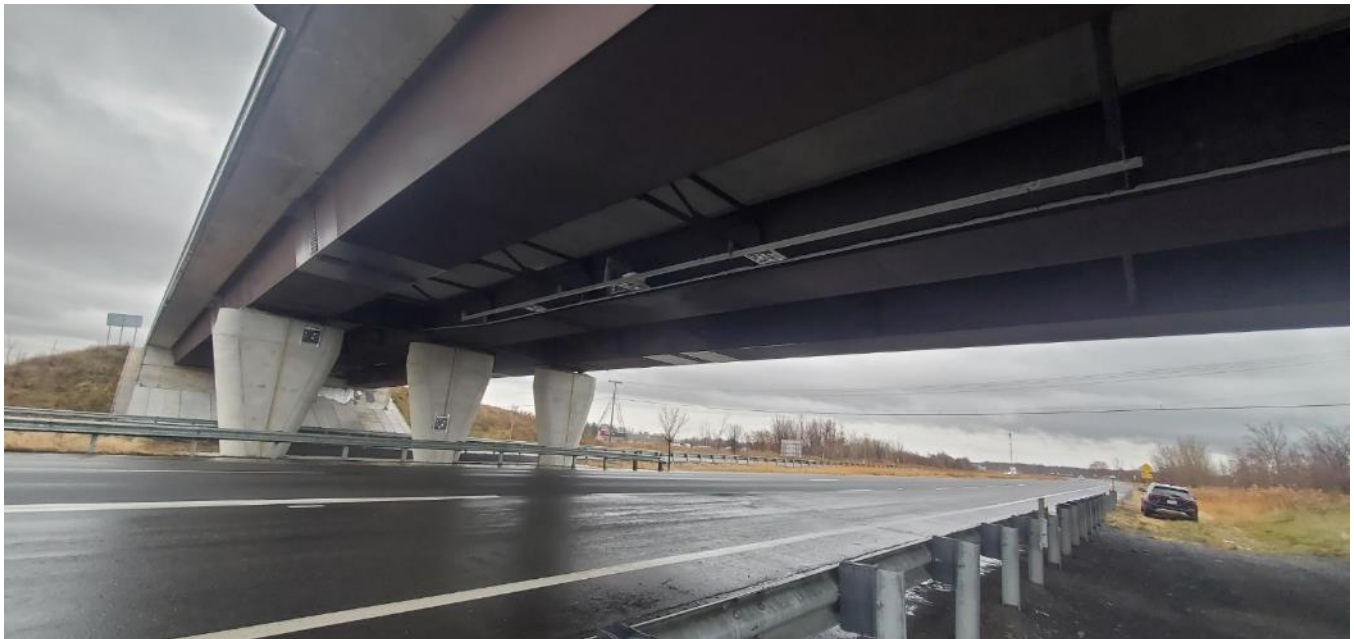
*Figure 5-23. Wide-angle view of the structural monitoring system in place after the final day of installation. The image captures the sensor plates mounted across the concrete piers and the weathering steel box girders.*

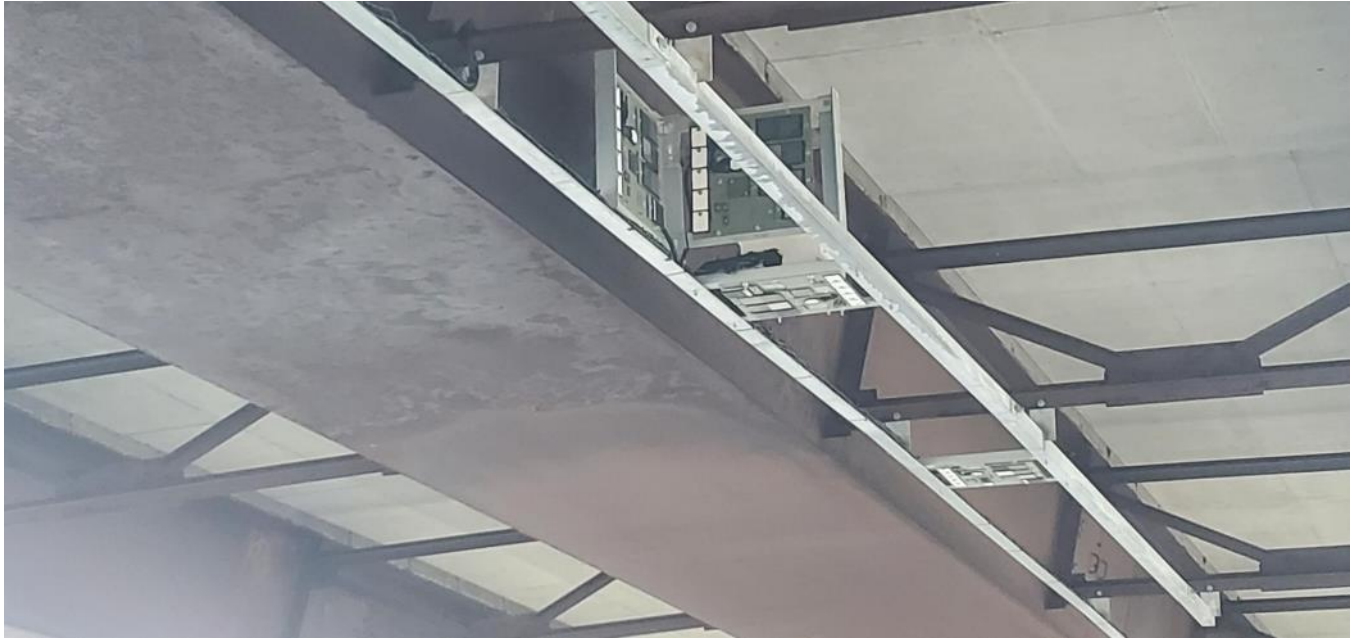
*Figure 5-24. Detailed view of the monitoring stations installed on the primary mounting rail over the acceleration lane and #2 middle lane. In the foreground, the Plate 3 cluster evaluates the influence of orientation on corrosion rates above the #2 middle lane: Plate 3.1 faces downwards, Plate 3.2 is mounted vertically and parallel to traffic, and Plate 3.3 is mounted vertically and perpendicular to traffic, directly facing oncoming flow. In the background, at the farthest extent of the rail, Plate 2 is positioned to monitor the micro-climate specifically associated with the acceleration lane.*

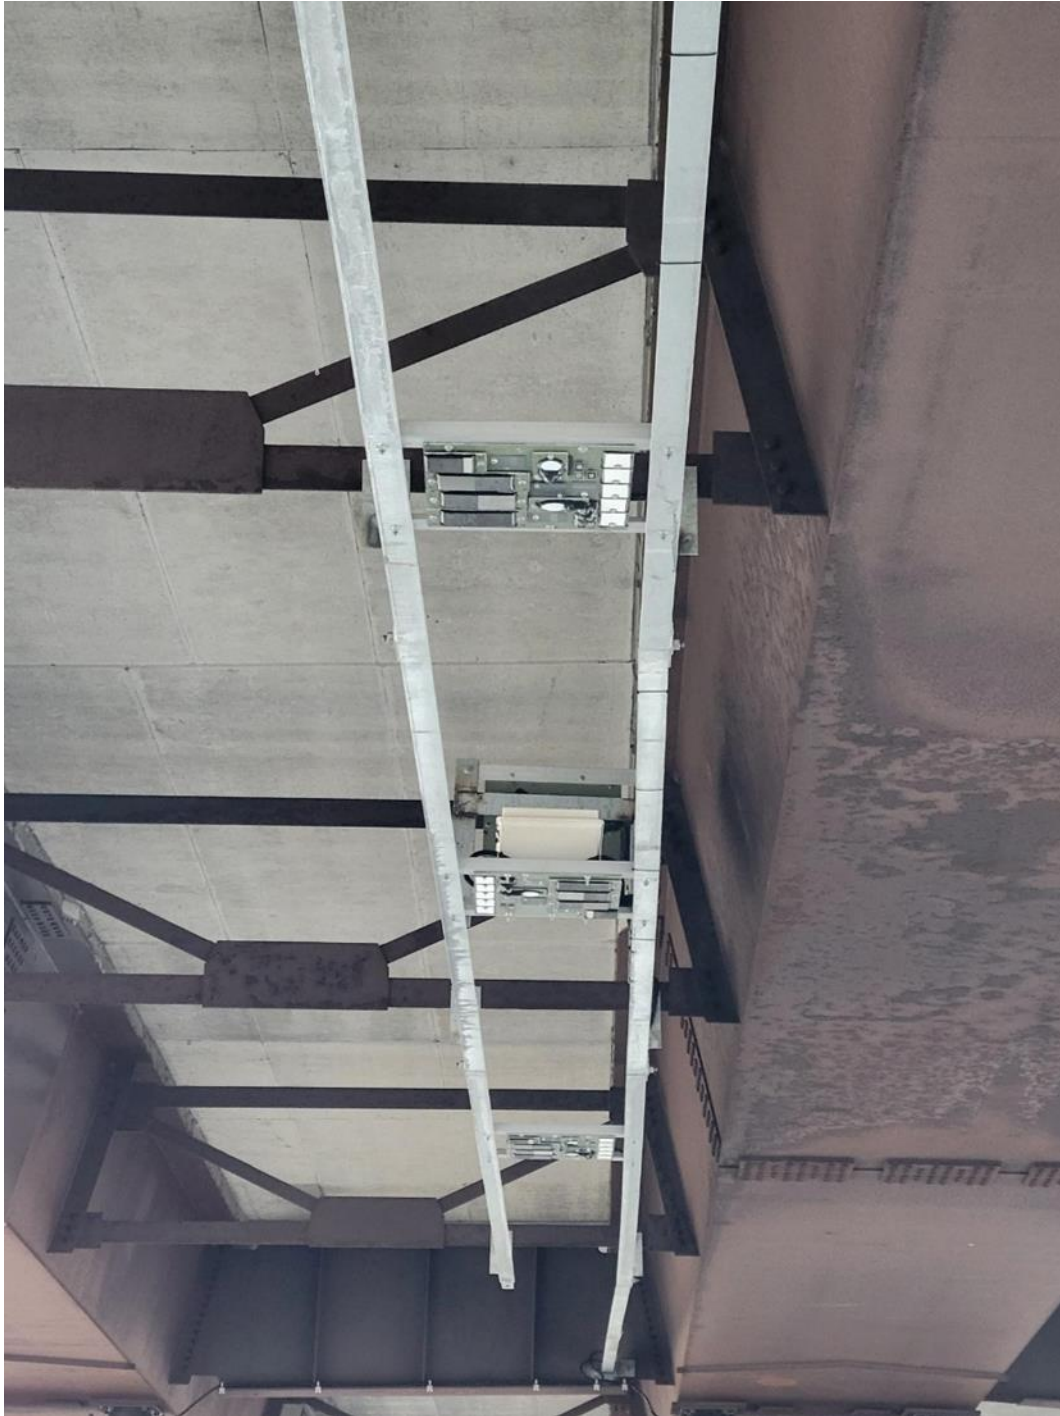
*Figure 5-25. Interior longitudinal view of the mounting rail system spanning the primary bridge girders. The image illustrates the sequential positioning of the instrumentation stations from front to back (top to bottom of photograph): Plate 2 (situated above the acceleration lane), the Plate 3 cluster (above the #2 middle lane), and Plate 4 (at the farthest extent above the #1 left lane). This alignment ensures that the monitoring network covers the full width of the traffic-induced spray.*

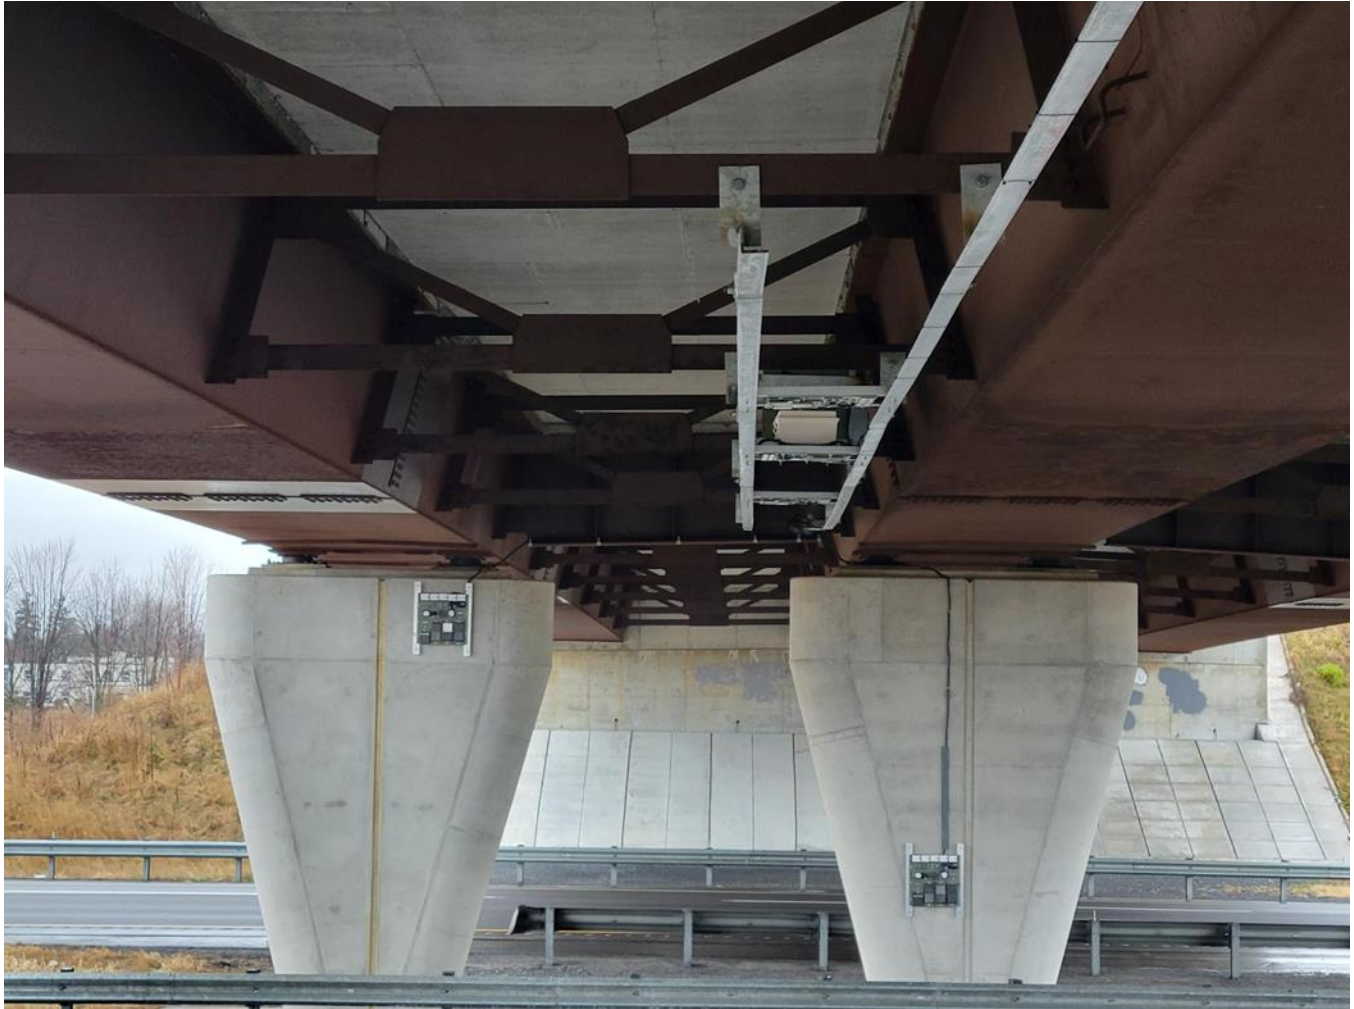
*Figure 5-26. Interior view of the bridge superstructure highlighting the instrumentation mounted on the reinforced concrete support piers. Plate 5 is installed on the lower section of the second pier (right), positioned at a standardized "splashing height" to monitor high-intensity roadway runoff. Plate 6 is secured to the upper section of the first pier (left), near the girder interface, to evaluate the corrosivity of the environment at a higher elevation. The central mounting rail and its associated over-lane sensor clusters are also visible, illustrating the vertical and horizontal distribution of the monitoring network.*

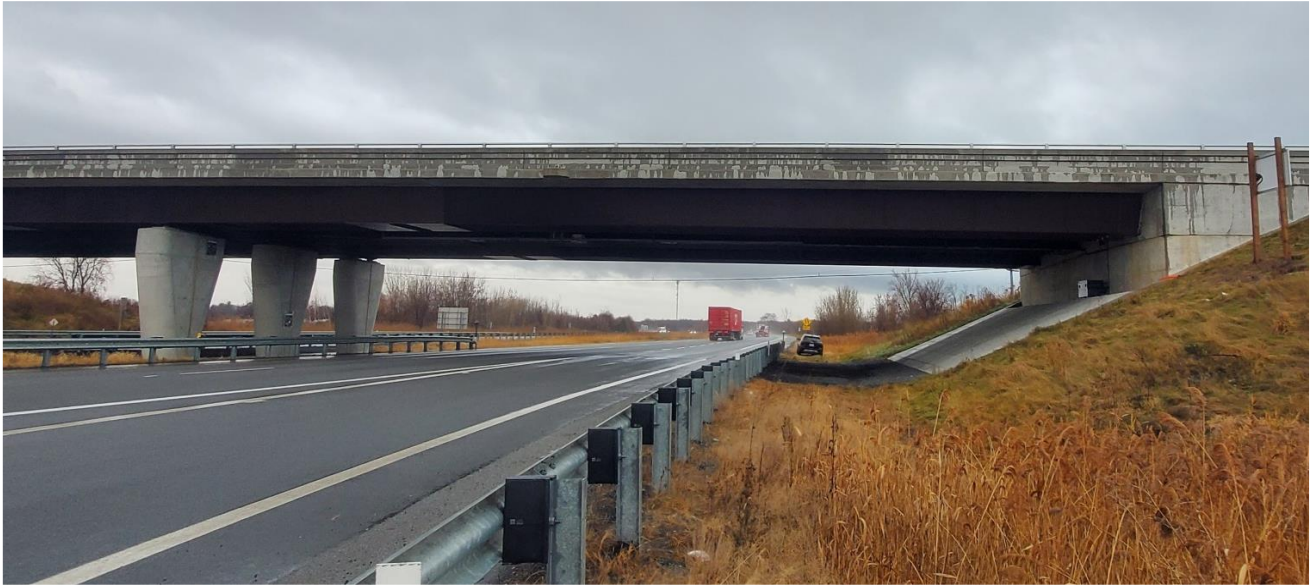
Figure 5-54. (a) Overview photograph of the monitored bridge structure and (b) corresponding spatial corrosivity map illustrating the thickness loss across various micro-climates after 12 months of exposure. The schematic in

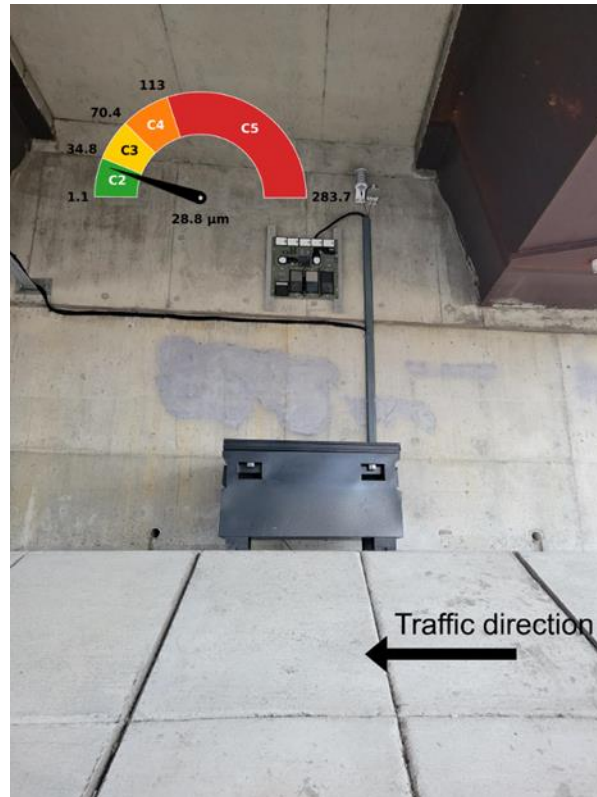
Figure 5-55. In-situ monitoring results for the weathering steel sensor installed on the Right abutment wall (panel 1).

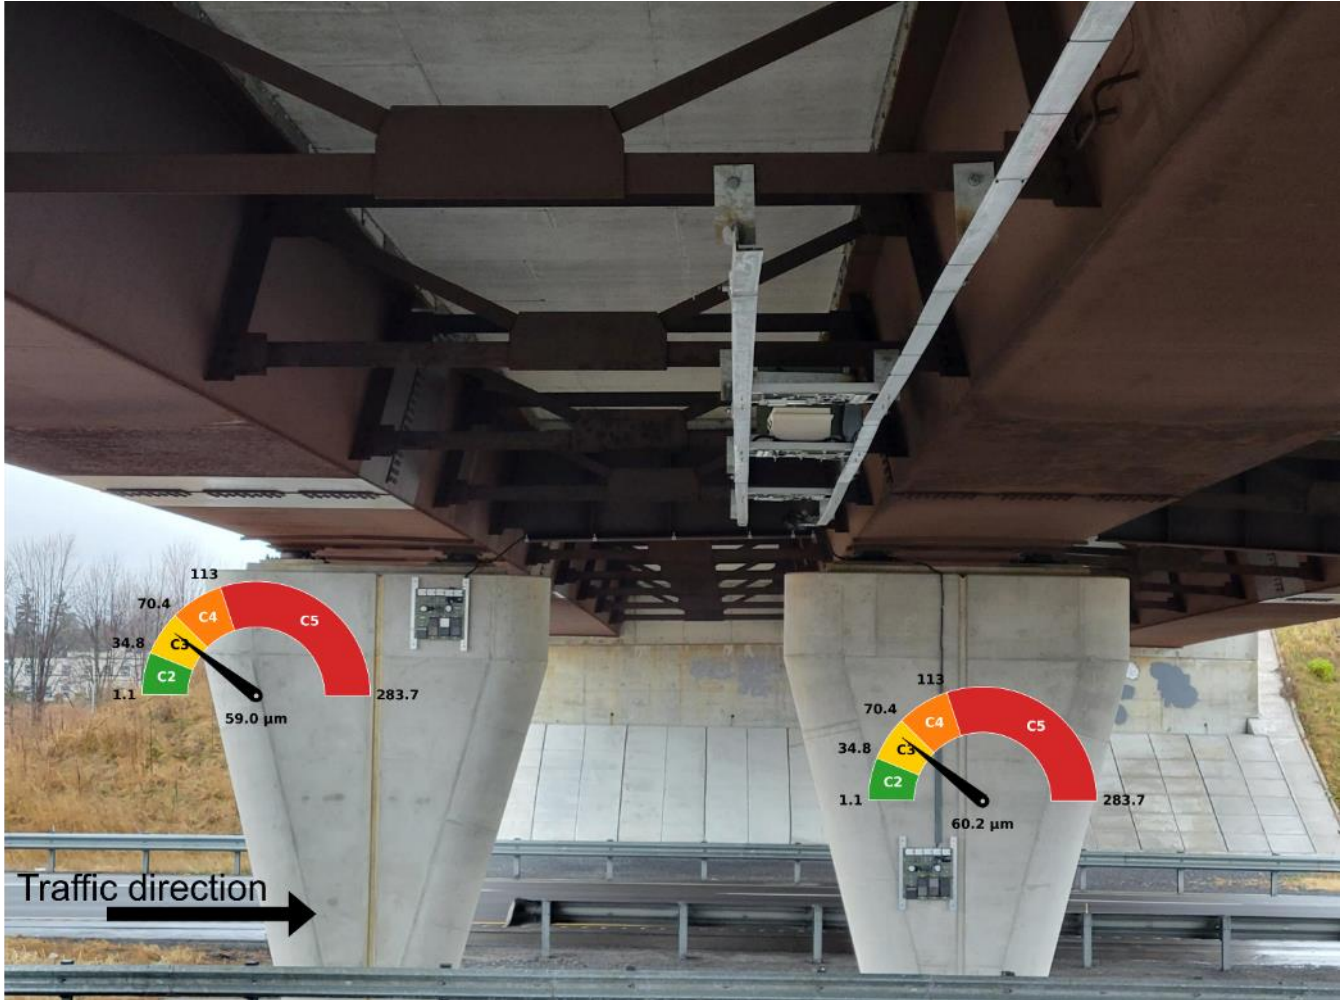
Figure 5-57. In-situ monitoring results for the weathering steel sensors installed on the bridge piers (panels 5 and 6).
