**GEOLOGICAL SURVEY OF CANADA
OPEN FILE 7897**

**EXAMPLES OF COMMON LANDSLIDE TYPES
IN CANADA**

**Canadian Technical Guidelines and Best Practices related
to Landslides: a national initiative for loss reduction**

O. Hungr and J. Locat

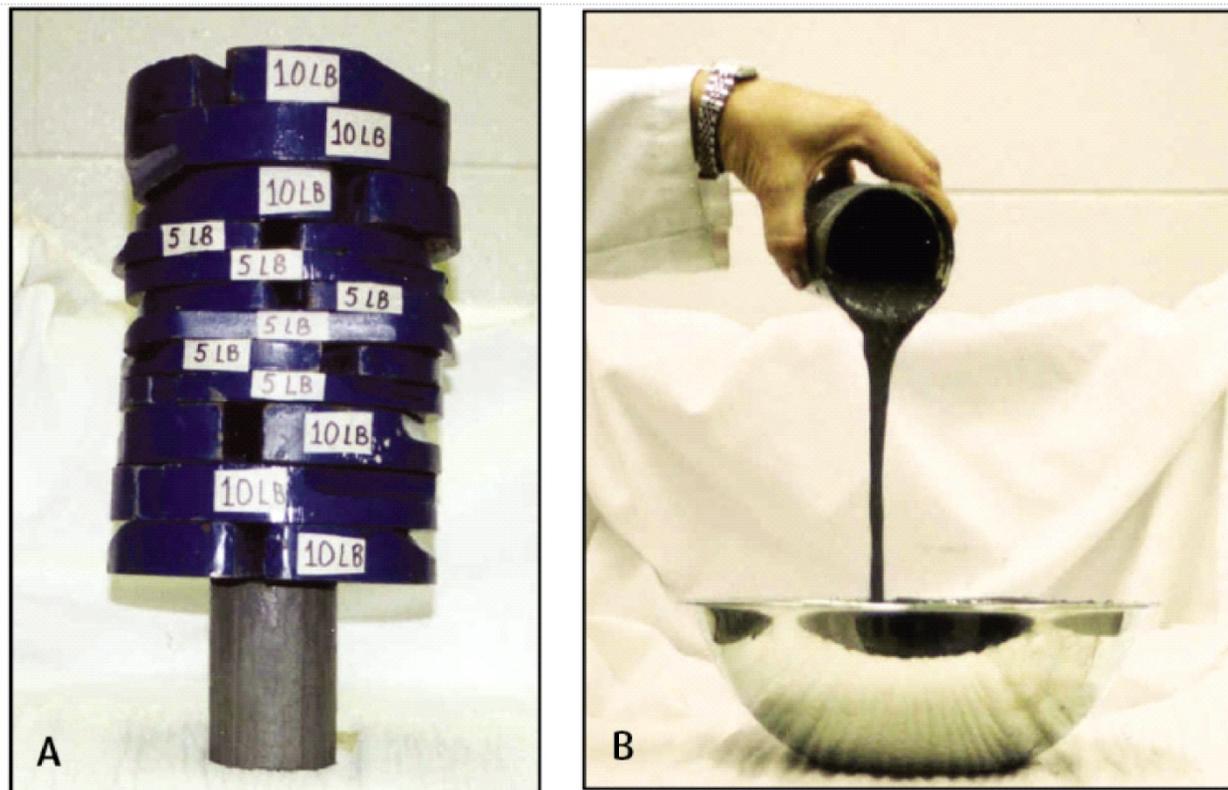
Figure 1. Demonstration of the sensitivity of Lake Champlain Sea clay: a) intact sample; b) remolded sample (photo Ministère des Transports de Québec (MTQ), used with permission).

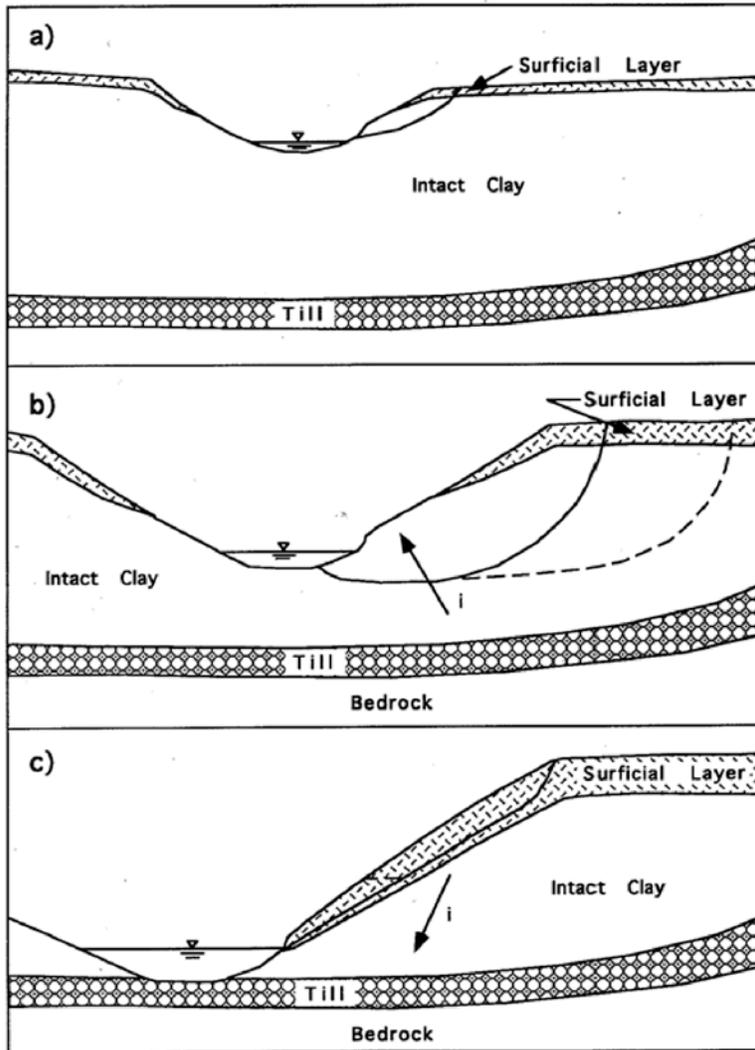
Figure 2. Stages of valley formation in marine clay deposits: a) early phase, b) intermediate phase, c) advanced phase. ('i' is hydraulic gradient) (Lefebvre, 1996).

In most sedimentary basins, thick marine clay is often underlain by glaciofluvial sediments or more permeable tills (Locat, 1995). Such stratigraphic sequences favour the development of high hydraulic gradients as shown by the valley formation process described by Lefebvre (1996; Figure 2). The most critical condition occurs where the high hydraulic gradient (i) is directed upwards near the toe of the slope (Figure 2b). The initial landslide often occurs as a slide, typically a shallow or deep rotational slide that can develop into a large flow or spread, or a combination of both. The resulting landslide can involve a large volume of material that can mobilize within minutes (Demers et al., 1999; Demers et al., 2008).

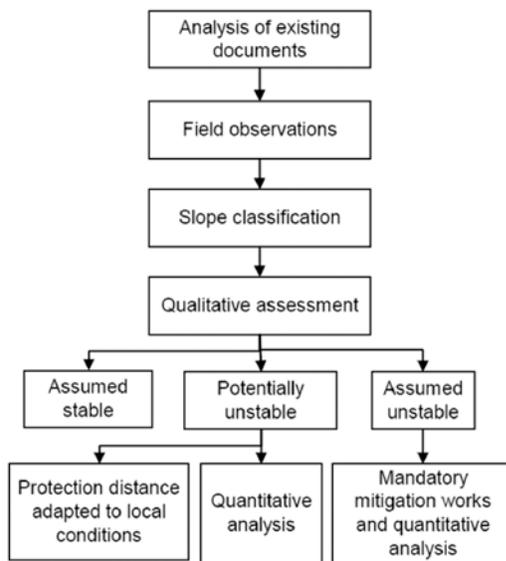
Figure 3. General approach to the overall assessment of the stability of a slope (Lefebvre et al., 2008).

Before addressing specific analyses, the general approach to the overall slope stability analysis, as proposed by Lefebvre et al. (2008), is reviewed (Figure 3). The approach integrates field observations with slope classification to optimize the information provided by the morphology and landslide history of an area. Then, based on this preliminary analysis, the stability can be qualitatively assessed and further studies and treatment considered. In this context, the long term stability of the eroded slope is critical. That is, over time the slope will come to equilibrium (factor of safety approaches 1.0), with the slope forming processes (Locat, 2001).

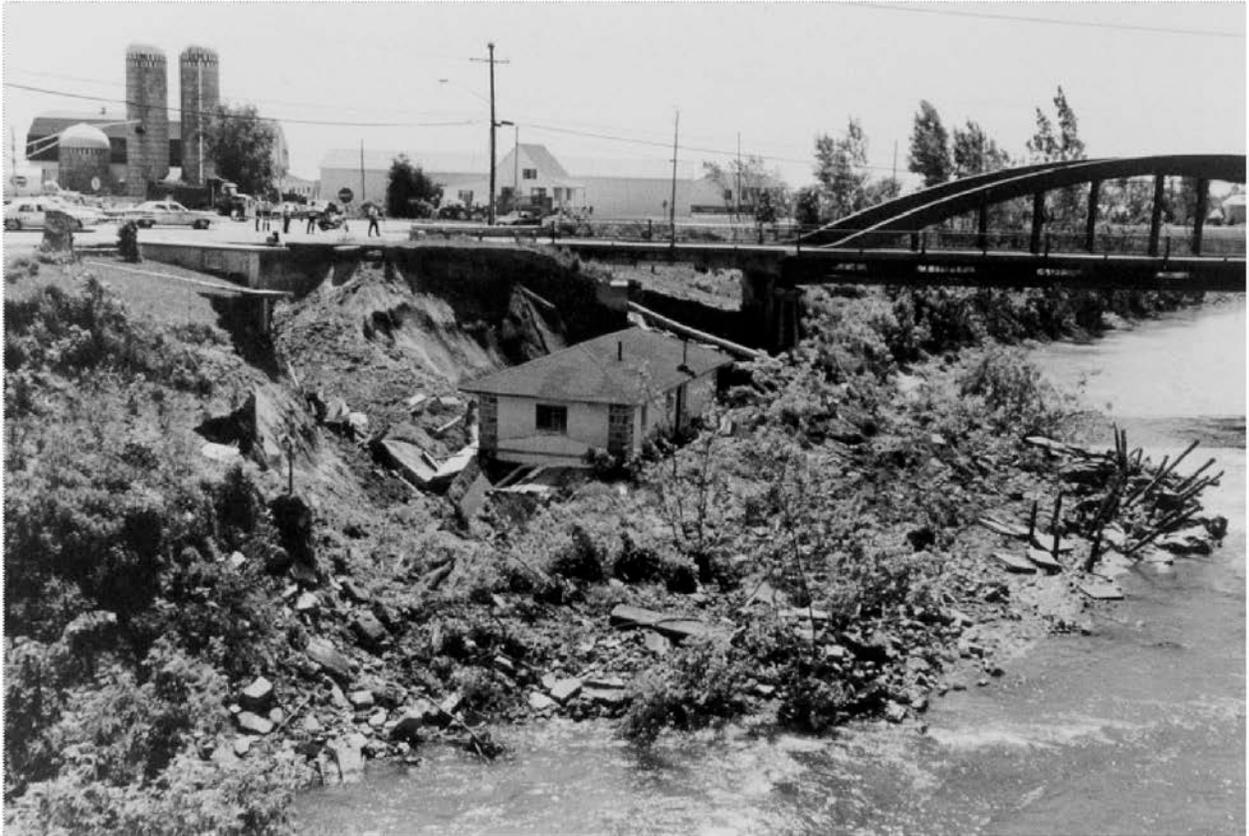
Figure 4. Maskinongé landslide, QC (Demers et al., 1999).

First time slides were analyzed in detail by Demers et al. (1999), using the 1989 Maskinongé landslide as an example (Figure 4). They concluded that, with time, there is a gradual strength reduction along the failure plane, that is, the plane that gives the lowest factor of safety. They

also demonstrated the potential of the cone penetration test (CPTU) to define a zone of reduced strength. As discussed previously, the porewater pressure distribution in the slope should be investigated and analyzed.

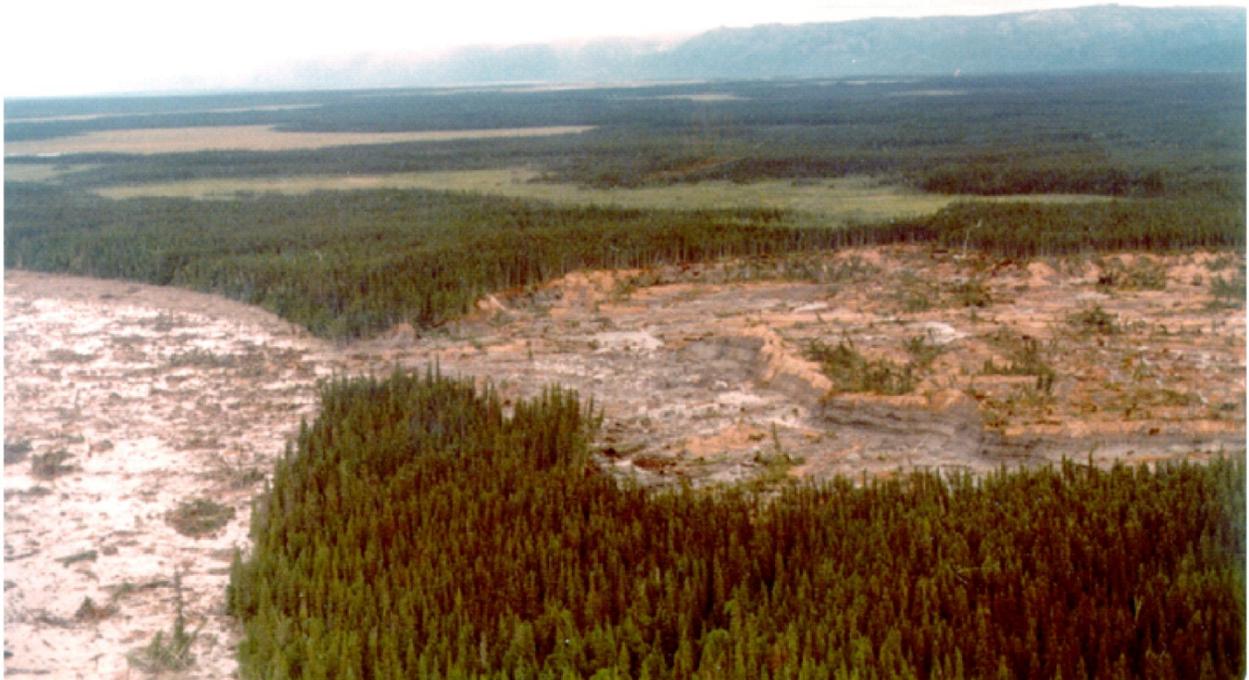
Figure 5. Kenamu landslide, NL (photo: unknown source).

Examples of this type of landslide are the 1971 Saint-Jean-Vianney landslide in Quebec (Tavenas et al., 1971) and the 1993 Lemieux landslide in Ontario (Evans and Brooks, 1994). An example from Labrador is the 1984 Kenamu landslide which shows typical bottle-neck morphology (Figure 5).

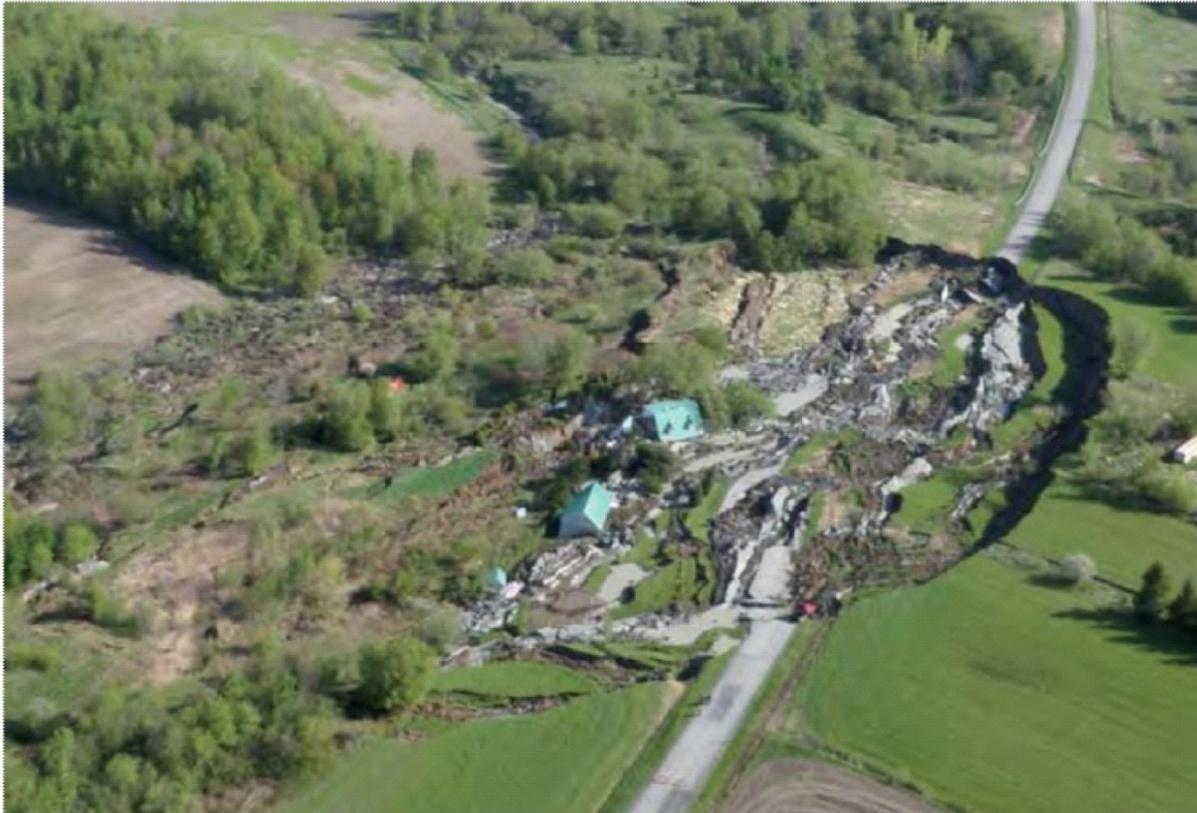
Figure 6. St. Jude landslide, QC (Locat et al. 2012b).

given slope. However, recent work by Locat (2012) shows two main prerequisite properties of the clay for the initiation of a progressive failure leading to a spread: (i) a strain softening behavior, and (ii) a high sensitivity. A higher degree of over-consolidation also favors the development of progressive failure. Typical examples of spreads are the 1978 Rigaud landslide (Carson, 1979), the 1975 Ste-Ambroise landslide (1975), the 1989 St-Liguori landslide (Ouehb, 2007) and the 2010 St. Jude landslide (Figure 6).

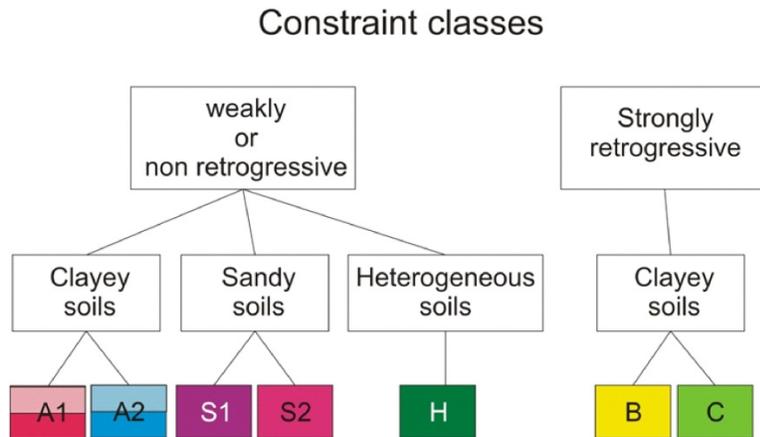
Figure 7. Constraint zones for sensitive clay in Quebec. A1 indicates clayey soil with slopes $> 20^\circ$ with or without erosion and slopes $> 14^\circ$ with a stream at the base; A2 indicates clayey soil with slopes $> 14^\circ$ without a stream at the base; the dark colours represent the slope while the light colours represent the protection zone; S1 and S2 indicate sandy soil slopes with or without a stream at the base ; H indicates a heterogeneous soil slopes with or without a stream at the base; B and C are clayey soil forming a flat band of terrain behind unit A, B for slopes with erosion and C for slopes without signs of erosion (source: MTQ, used with permission).

Constraint maps also include soil types and the potential for landslide retrogression which are then organized into zones integrating the susceptibility classes. Figure 7, an example, shows seven classes of constraints that integrate the various elements described previously.

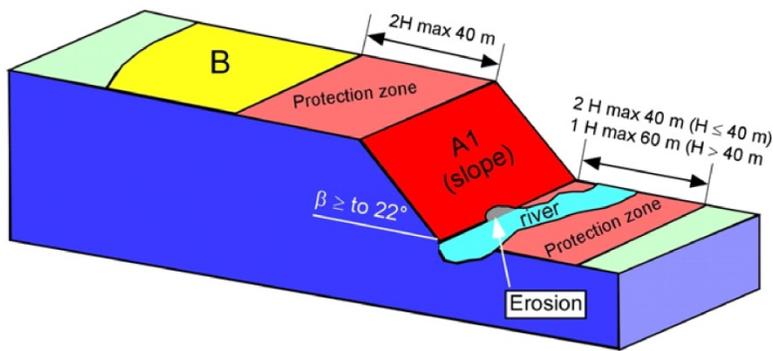
Figure 8. Example of protection zones in sensitive clay (Bilodeau et al., 2005, symbols are defined in Figure 7).

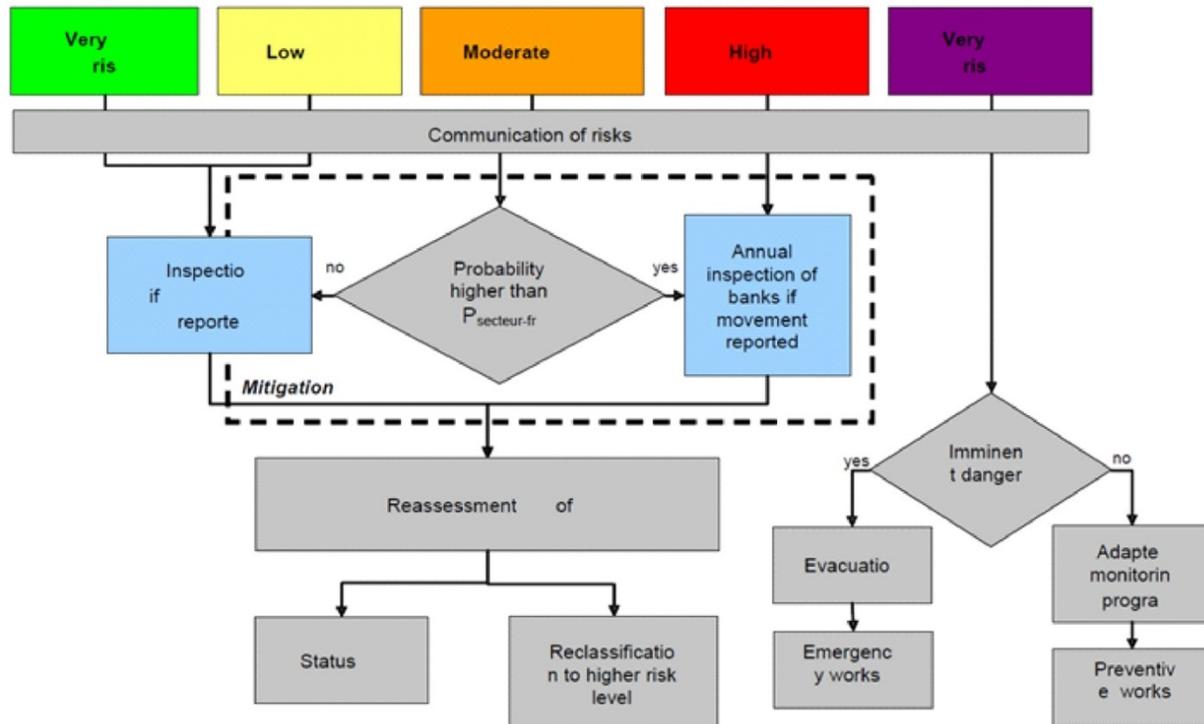
Figure 9. Flow chart showing the approach proposed to manage risks from large retrogressive landslides in sensitive clay (Thibault et al., 2008).

Thibault et al. (2008) has summarized mitigation related to large retrogressive landslides in sensitive clay; whereas Demers et al. (2008) summarized the administrative aspects. Figure 9 is a flow chart of the approach to manage risks in an area that has been previously investigated and for which susceptibility and constraint maps exist. Figure 9 also indicates that, as the risk increases, mitigation may be necessary to reduce the risk to acceptable levels by either removing the elements at risk or reducing the hazard by some form of remediation.

According to Thibault et al. (2008), the approach considers three actions. The first action is linked to communicating the risk to the various stakeholders, including authorities and residents, so that they are aware of the situation, the measures to be applied and the respective roles. For example, residents are informed about how to be vigilant and to look for features such as tension cracks and erosion features. The second action looks at managing the risk by preparing monitoring plans. The third action considers further actions needed when the risk level requires immediate mitigation.

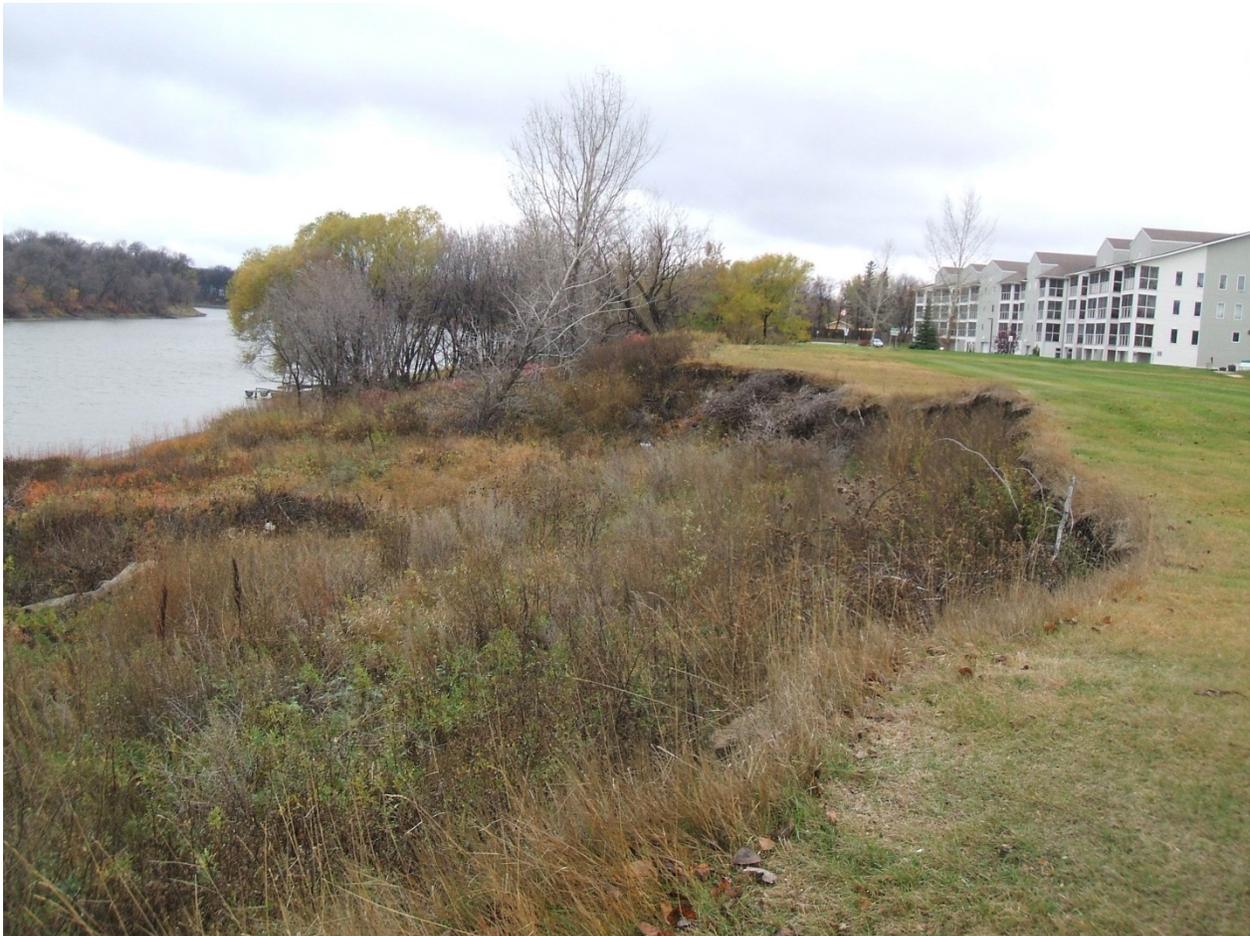
Figure 10. Typical rotational slide, with headscarps identified, in lacustrine clay along a Winnipeg, MB, river bank (photo A. James, used with permission).

Although the river banks in Winnipeg do not exceed 15 m in height, they experience frequent rotational slides (e.g. Figure 10). Baracos and Graham (1981) identified 40 individual landslide areas in downtown Winnipeg. The river banks are being undermined by erosion on the outside of the sinuous river meanders. Annual floods submerge the banks and create high porewater pressures that trigger landslides by rapid drawdown when the flood waters recede. Local stability analyses routinely use residual strength on circular or non-circular pre-sheared surfaces. Stable slopes are in the order of 1 (V) to 8 (H).

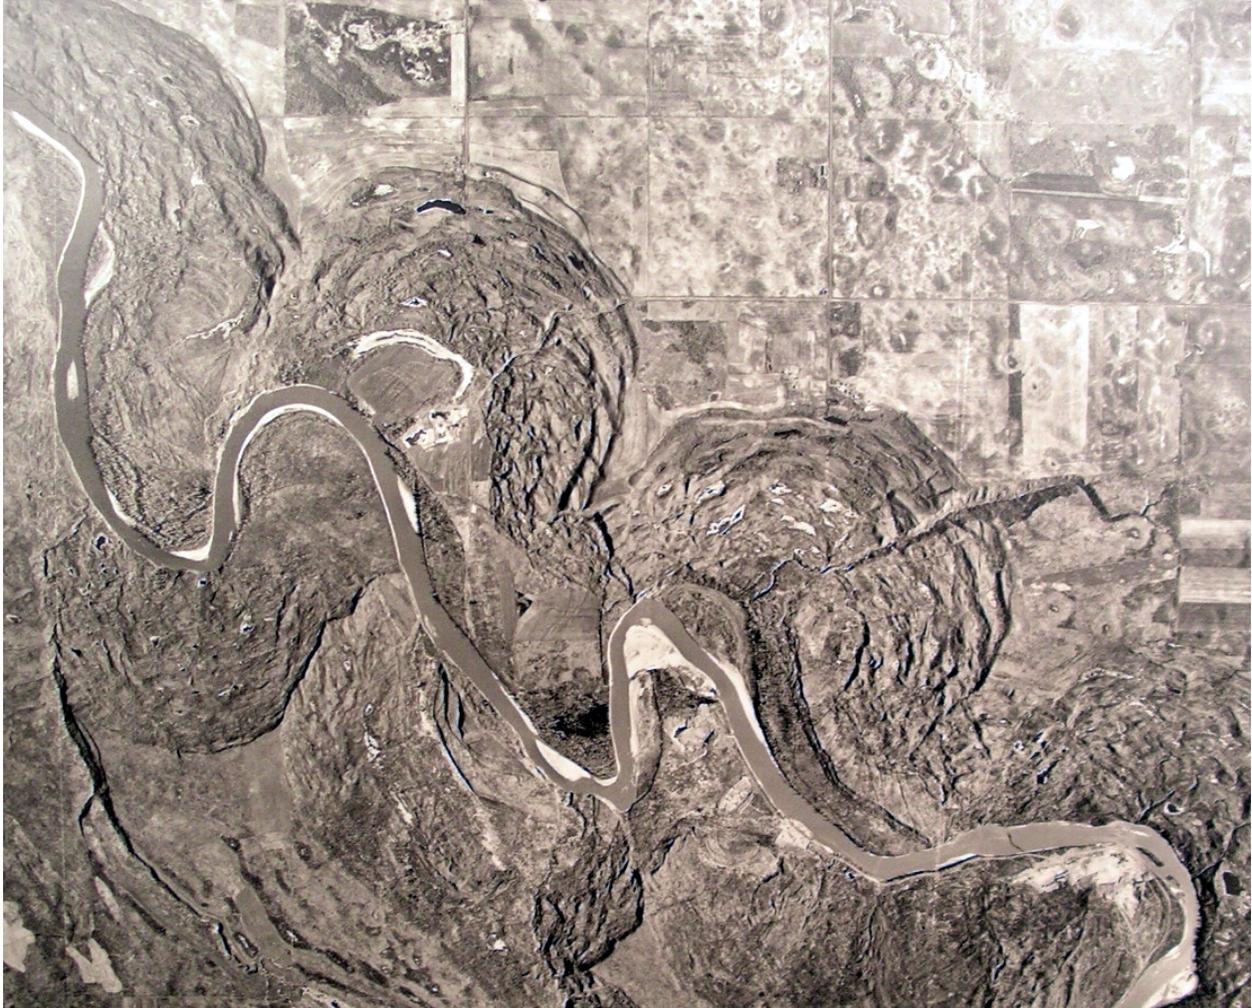
Figure 11. Retrogressive, multiple, rotational slides in lacustrine clay in Saskatchewan; width of image depicts approximately 3 km across (Government of Canada airphoto A5511-68, 1968).

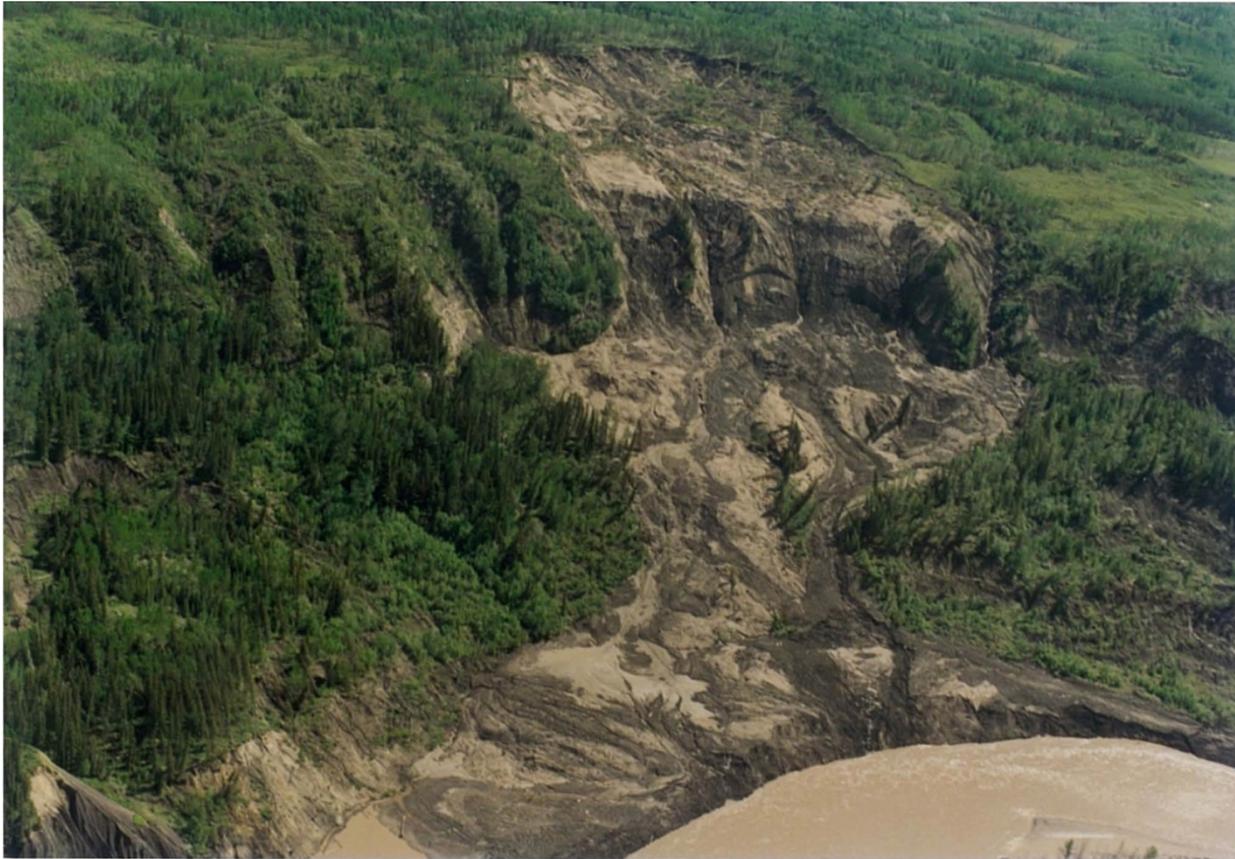
Figure 12. A large flow in Lake Peace clay, north-eastern BC; landslide depletion zone is on top of a bedrock scarp. The scar is approximately 300 m wide and 600 m long (photo D. Moore, used with permission).

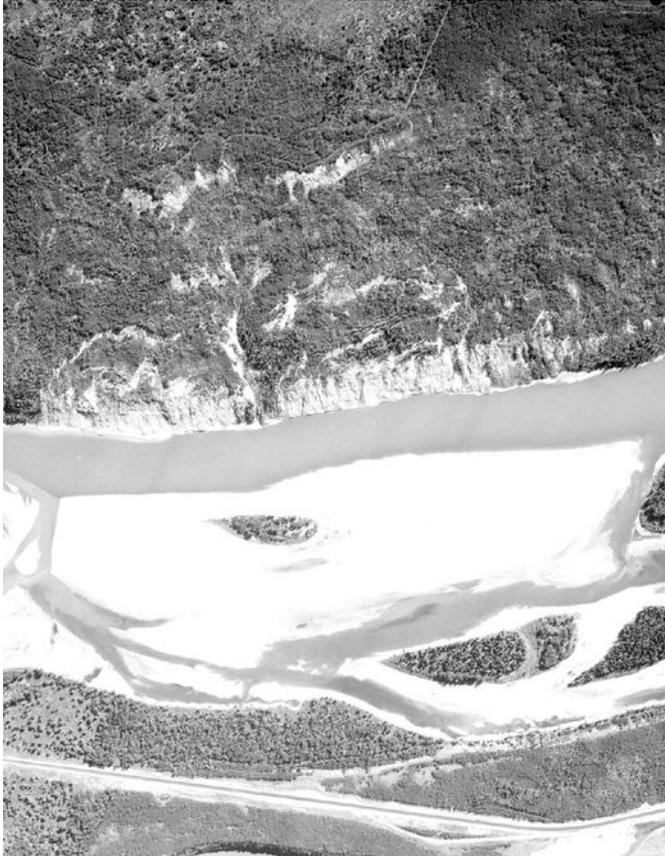
Figure 13. Pre-Attachie landslide airphoto, Peace River, BC (airphoto BC 7279-070 taken 1970).

In the area of the Attachie landslide, the entire overburden column has long been subject to compound slides, seated on weak layers in the Lake Mathews deposits. Numerous scarps and tension cracks and grabens, visible on pre-1973 airphotos, indicate that the entire slope had

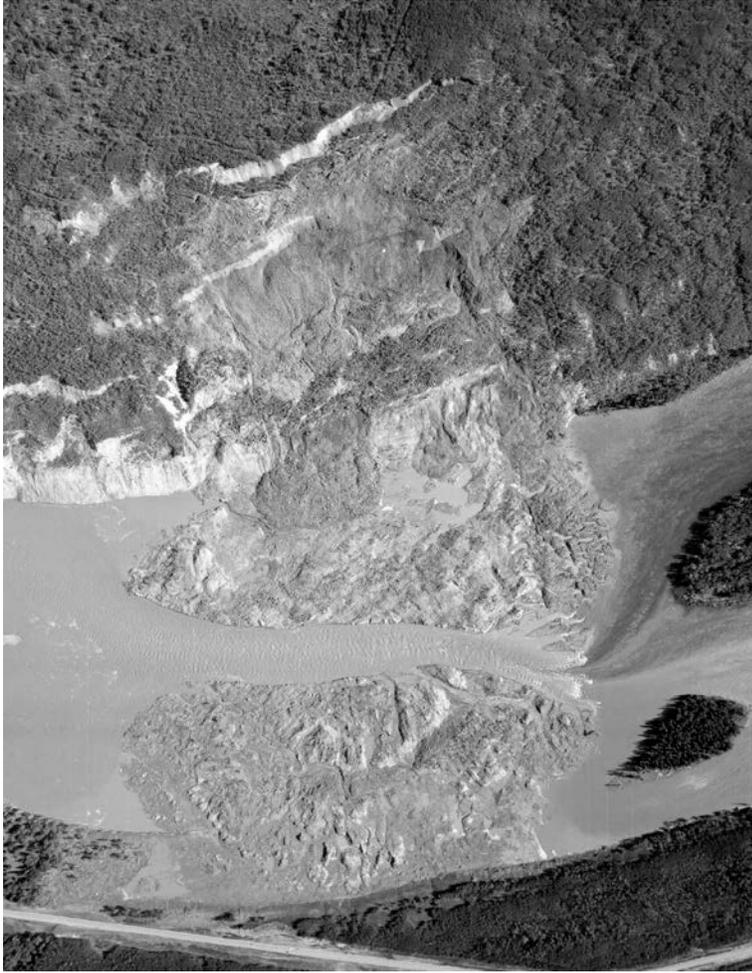
Figure 14. Attachie landslide, BC; width of the image depicts approximately 1.8 km (airphoto BC 5529-075 taken 1973).

The clay and silt involved in the Attachie landslide was over-consolidated, stiff and with low sensitivity comprising illite and kaolinite mineralogy. The till, forming about 50% of the landslide debris, was very dense and during the event broke into angular blocks resembling fragmented weak rock (Fletcher et al., 2002). The landslide may have been triggered by intense surface water infiltration, during a spring with unusually thick snow cover.

The volume of the landslide is remarkable and its extreme mobility is very difficult to explain. The soil was insensitive, weak and heavily deformed prior to the landslide, all conditions that would typically be expected to lead to ductile landslide behavior. The current explanation is that loose silty material accumulated in the extensive crack systems on the disturbed slope, softened and formed a mixture of brittle soil blocks, surrounded by a liquefied matrix (Fletcher et al., 2002). Based on its behavior, the landslide can be termed a flow, although it formed in material that would normally not be considered susceptible to this mode of movement. Overburden landslides with these characteristics are rare in the Peace River Valley and no comparable example is known.

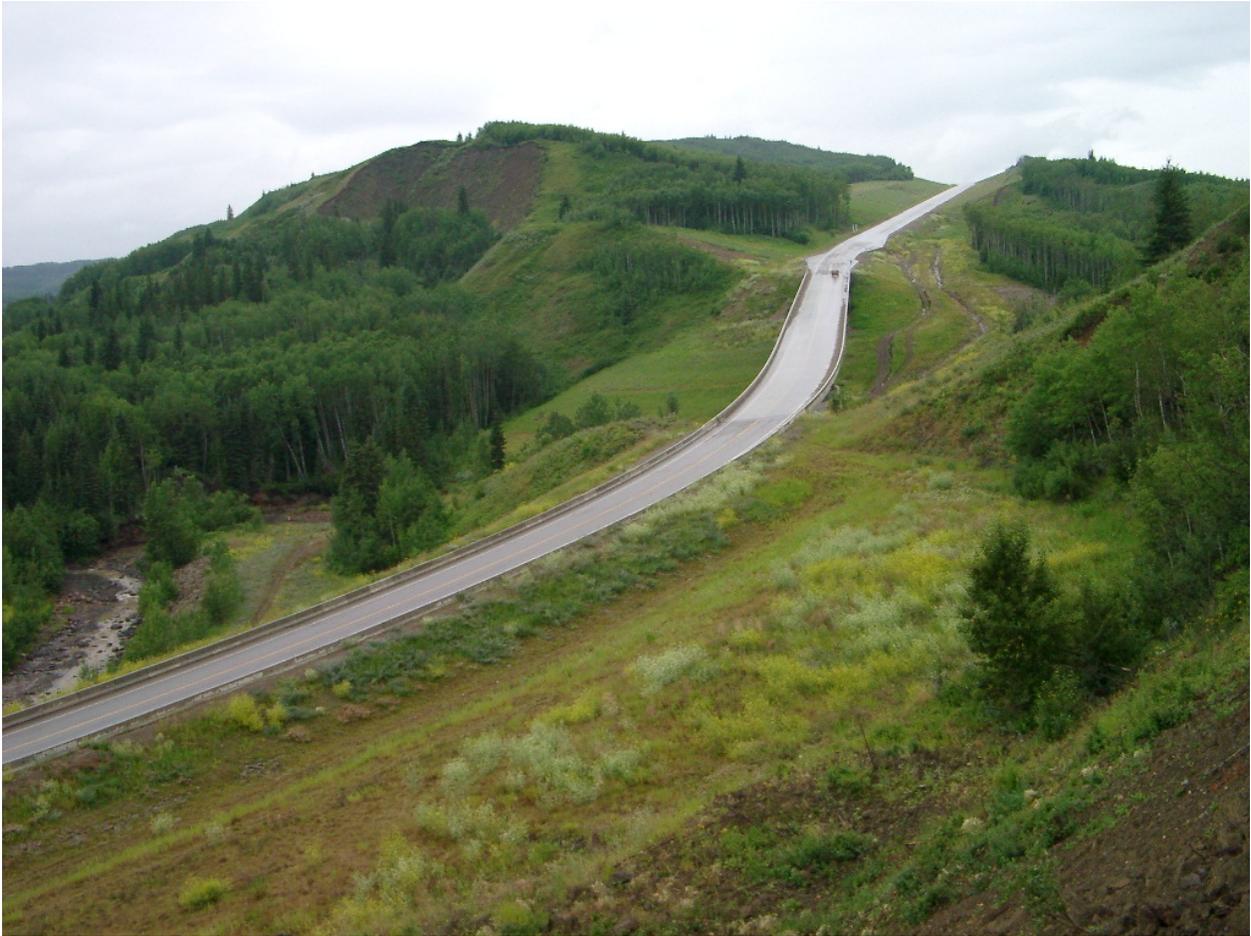
Figure 15. Compound slide on the Beaton River, BC; landslide in the upper left corner is one of several in the area that appear to utilize the same weak surface (photo O. Hungr).

Although not hazardous to life, the slow-moving compound slides in the over-consolidated glaciolacustrine clay in the Peace River valley create a major constraint on development – an important area of oil, gas and hydroelectric resources. A classic example of such a slow moving landslide on the Beatton River was partially re-activated by road construction excavations in the 1990s (Polysou et al., 1998). The new road traverses the landslide over a length of several kilometres without problems, because it was mostly constructed so as to avoid increasing the load on the inactive body of the landslide. However, a bridge approach close to a tributary of the Beatton River necessitated a deeper cut (Figure 15). The landslide responded with slow displacements of several metres, mostly horizontal in direction. A very well-defined compound rupture surface was identified from inclinometer observations. The basal part of the rupture surface lies on a weak over-consolidated clay layer, pre-sheared to a residual friction of 9° . The landslide was stabilized by installing approximately 90, 1500 mm diameter steel piles, 20 to 30 m deep, filled with concrete. The piles intersected the pre-sheared sliding surface and stopped the sliding by lateral support. The cost of the stabilization was \$2.38 million (1998 dollars), and movements have been reduced to an insignificant rate (Polysou et al., 1998). The same pre-sheared weak surface forms the base of several smaller landslides in the vicinity of the same bridge, on both sides of the river.

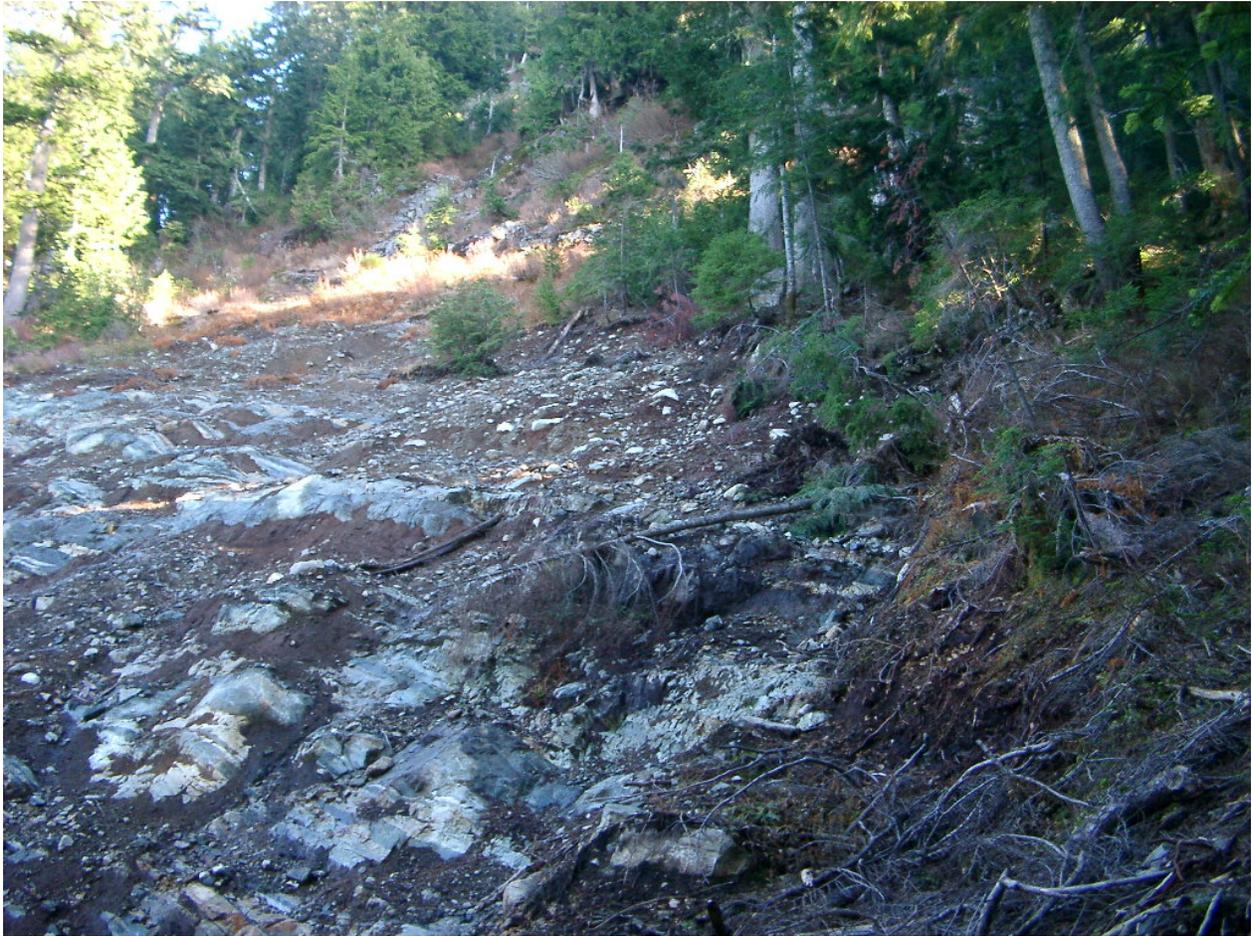
Figure 16. Debris avalanche scar on Black Mountain, West Vancouver, BC; right side of photo shows a colluvial/organic veneer; left side shows a glacially-eroded diorite surface (photo O. Hungr).

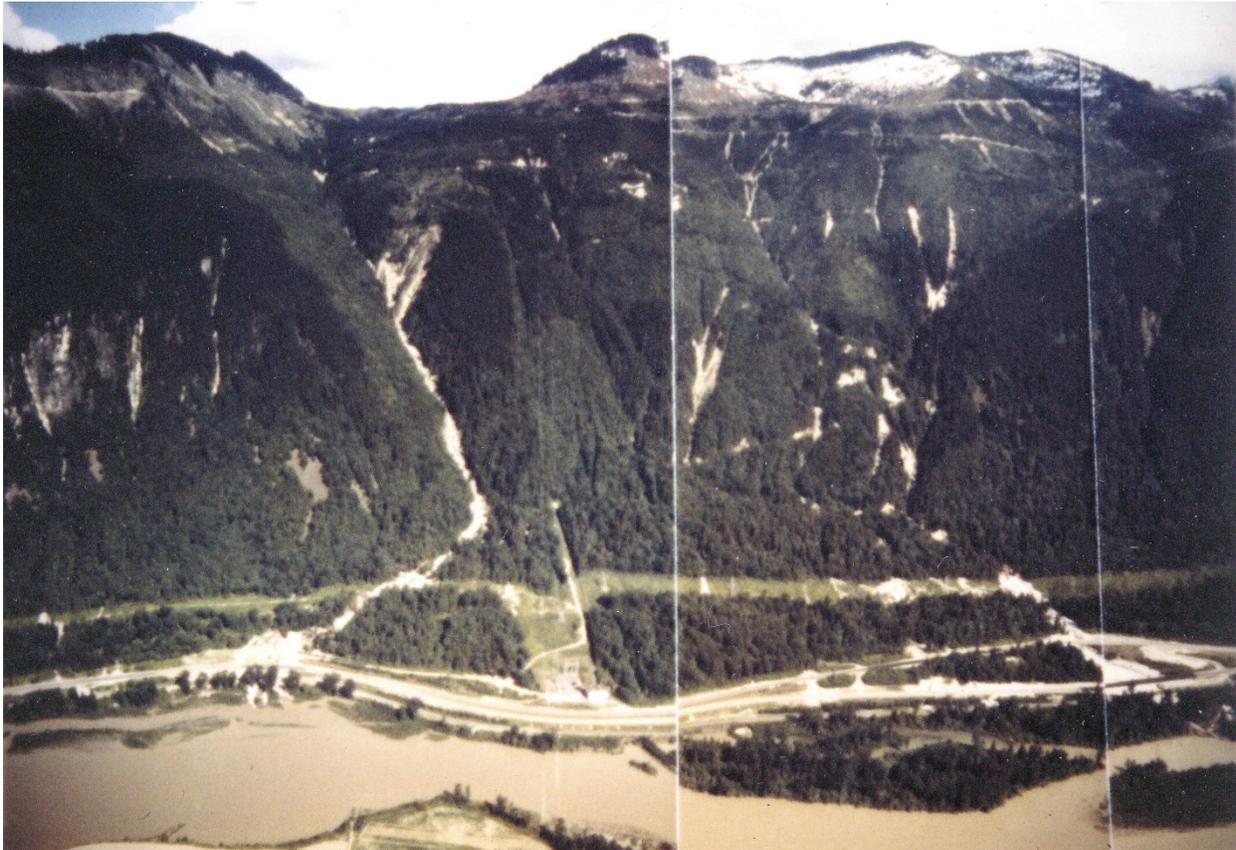
Figure 17. Cluster of debris avalanches and debris flows caused by a summer rainstorm east of Chilliwack, BC in 1983 (photo D.F. VanDine, used with permission).

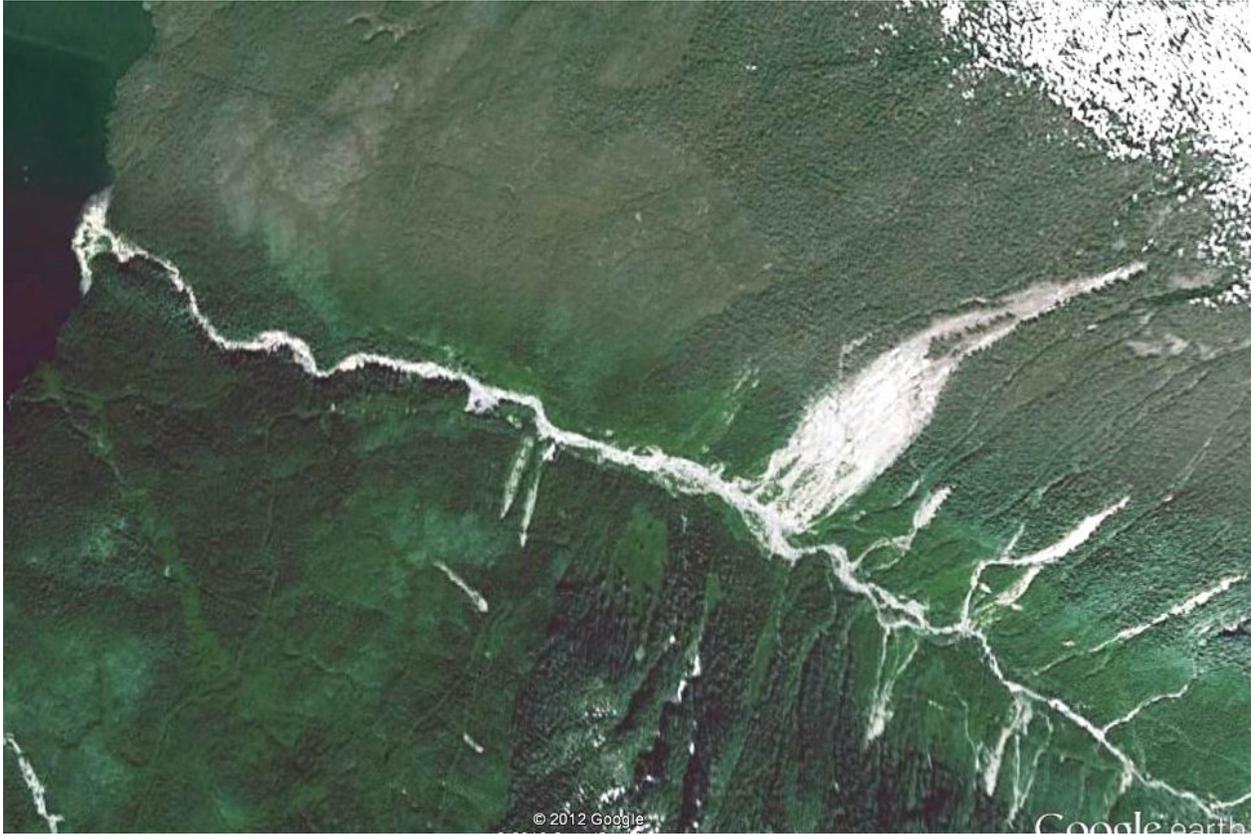
Figure 18. Largest debris avalanche adjacent to an unnamed tributary to Loughborough Inlet, BC; debris avalanche scar is 310 m wide at its widest point (Google Earth image).

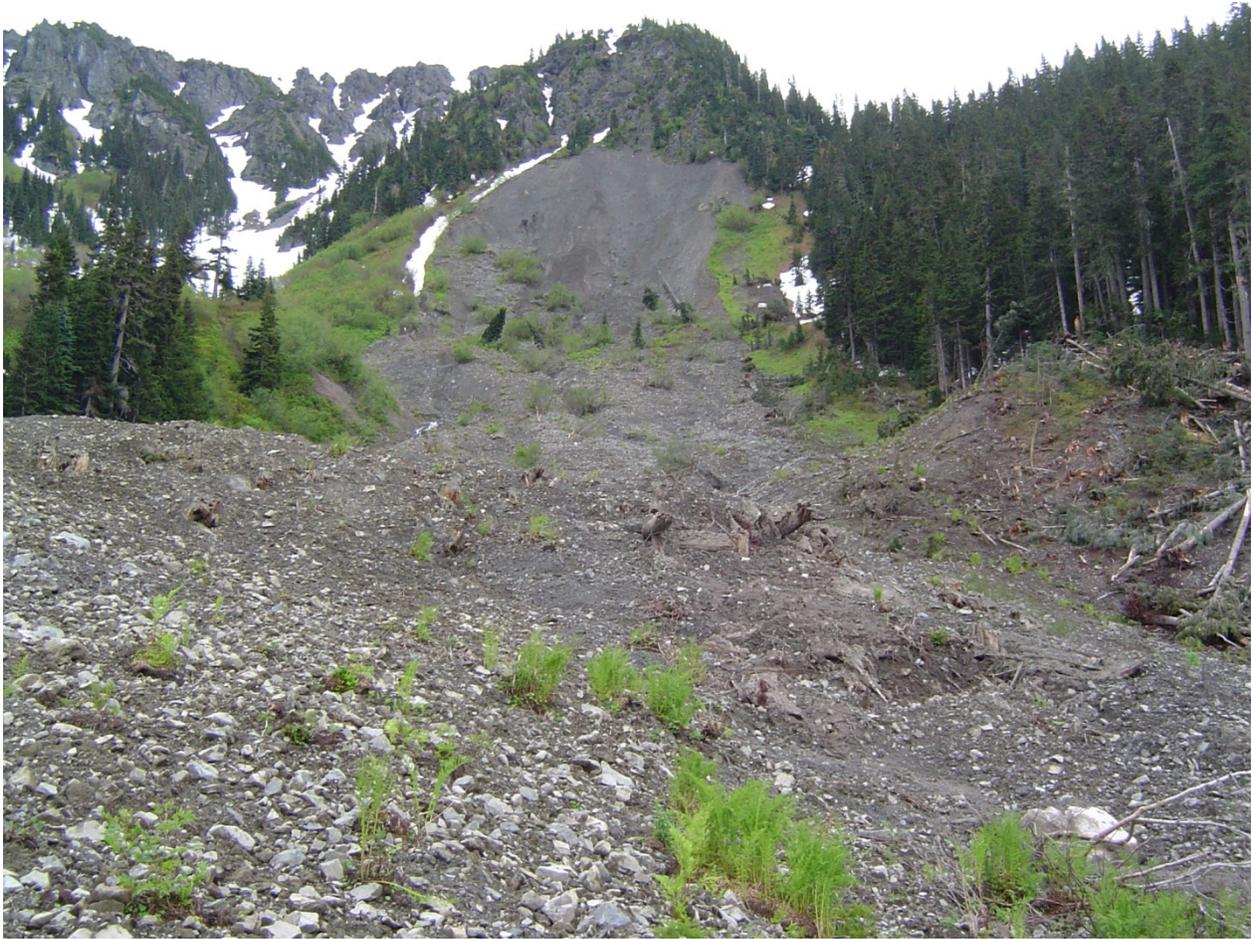
Figure 19. Initiation zone of the Legate Creek debris avalanche, Smithers, BC (photo M. Jakob, used with permission).

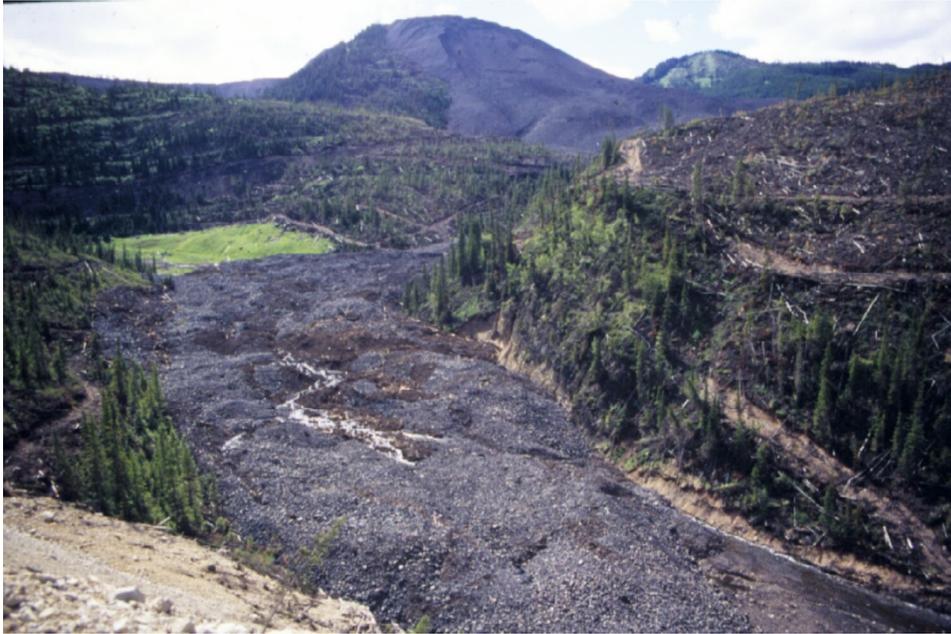
Figure 20. Debris avalanche caused by the failure of 60,000 m³ of coal mining waste from a spoil pile near Sparwood, BC; the source scar is visible in the background (photo O. Hungr).

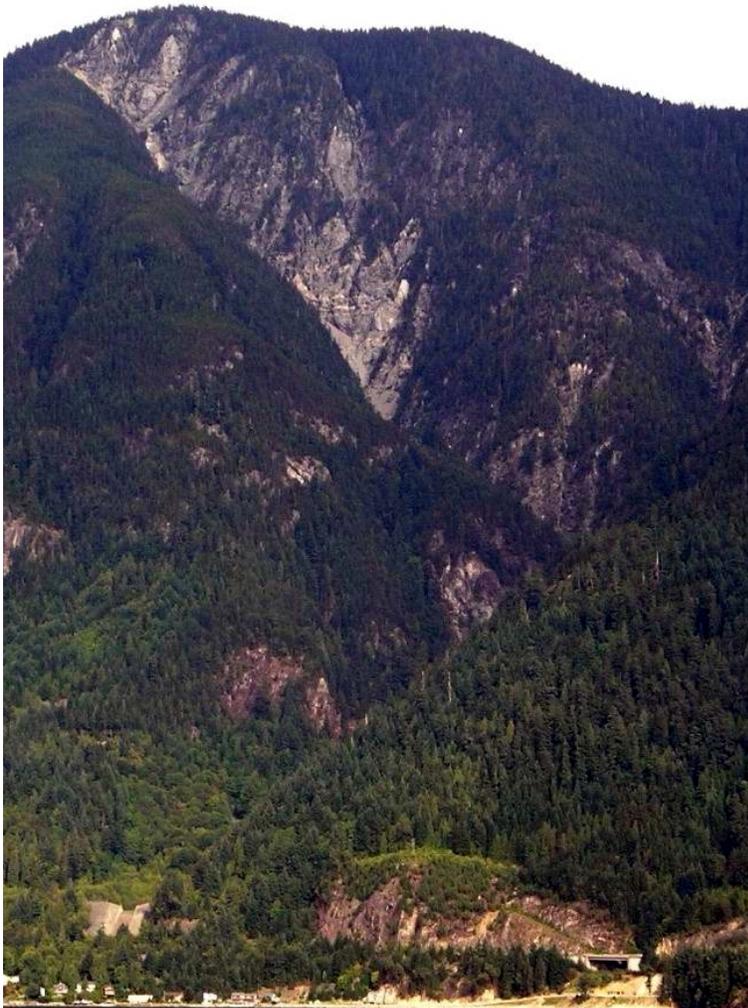
Figure 22. Overview of the Charles Creek drainage from Howe Sound, BC (photo O. Hungr).

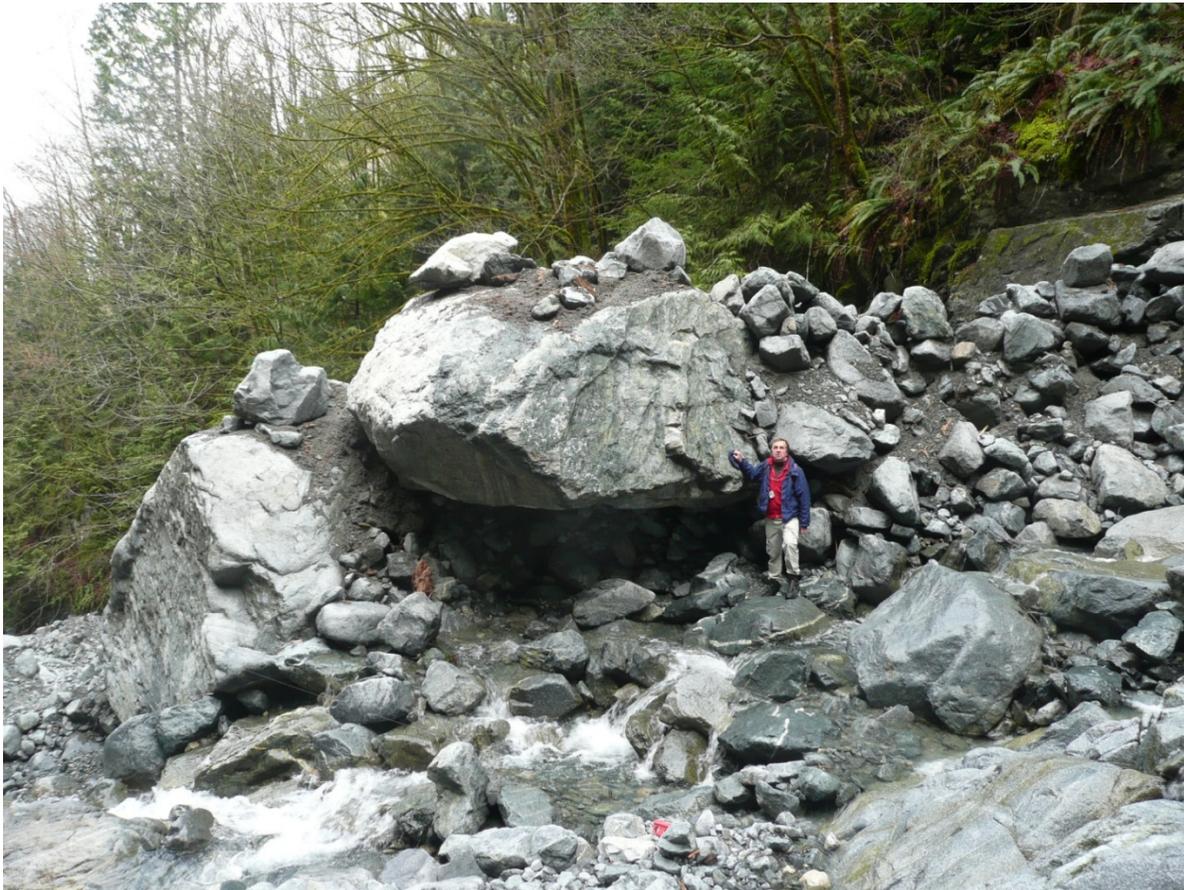
Figure 23. Coarse granular colluvial and stream deposits in Charles Creek, BC (photo P. Wilson, used with permission).

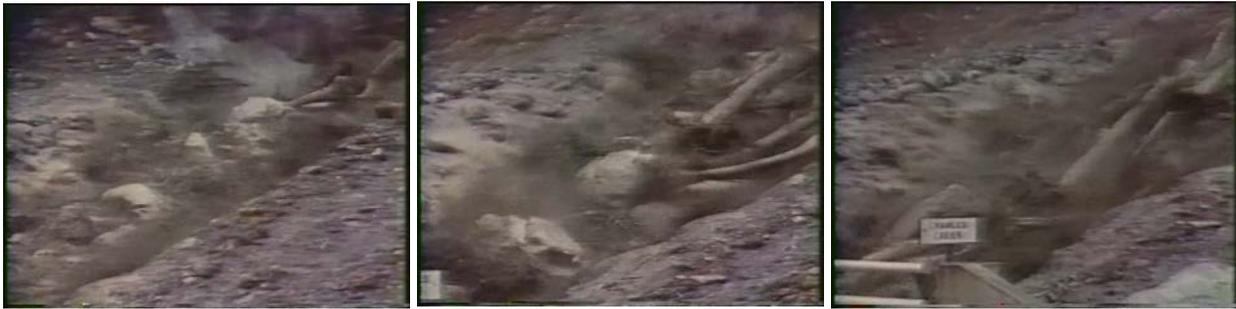
Figure 24. Three frames from a CBC video of the December 1983 Charles Creek debris flow.
