**GEOLOGICAL SURVEY OF CANADA
OPEN FILE 7897**

**EXAMPLES OF COMMON LANDSLIDE TYPES
IN CANADA**

**Canadian Technical Guidelines and Best Practices related
to Landslides: a national initiative for loss reduction**

O. Hungr and J. Locat

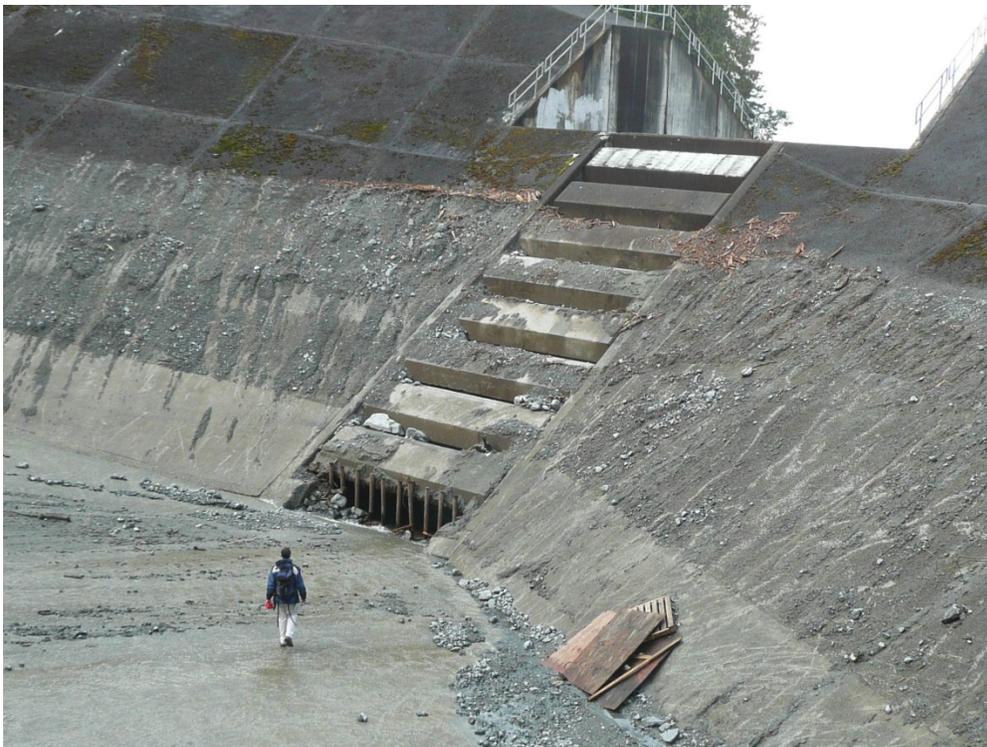
Figure 25. Charles Creek debris flow barrier, showing fill line from the approximately $20,000 \text{ m}^3$ 2010 debris flow (photo O. Hungr).

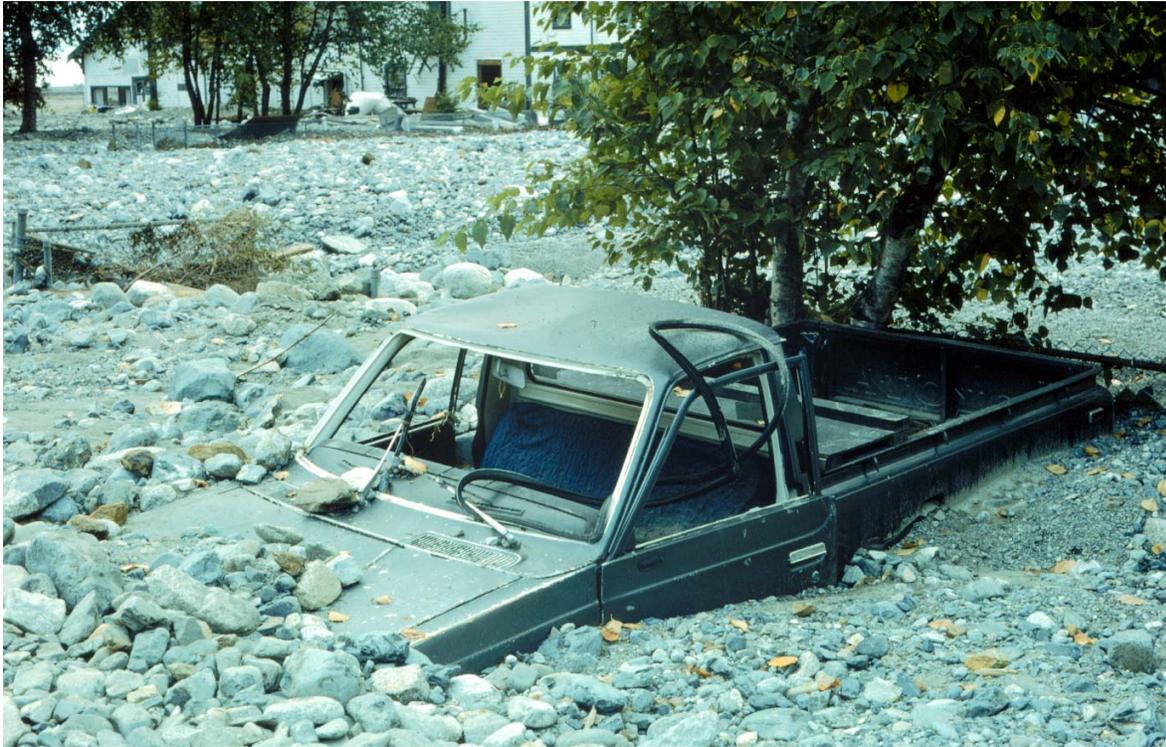
Figure 26. Deposit of the 1991 debris flood on the fan of Britannia Creek, BC (photo K. Fletcher, used with permission).

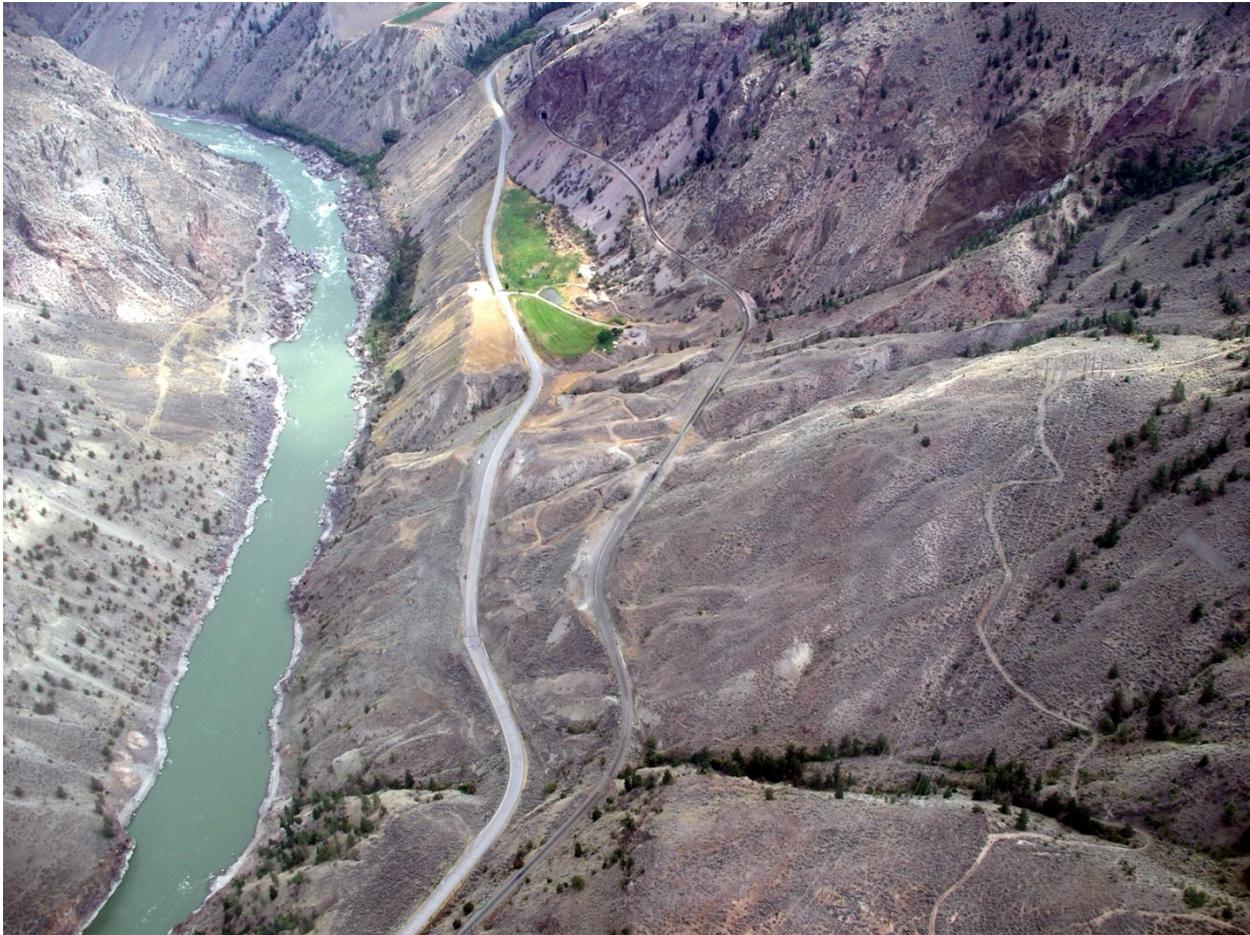
Figure 27. Tunnel earth flow above the Fraser River, upstream of Lytton, BC. The earth flow occupies most of the field of view on the right side of the photo. A local reactivation in recent years, near the centre of the photo, damaged both the highway and railway (photo O. Hungr).

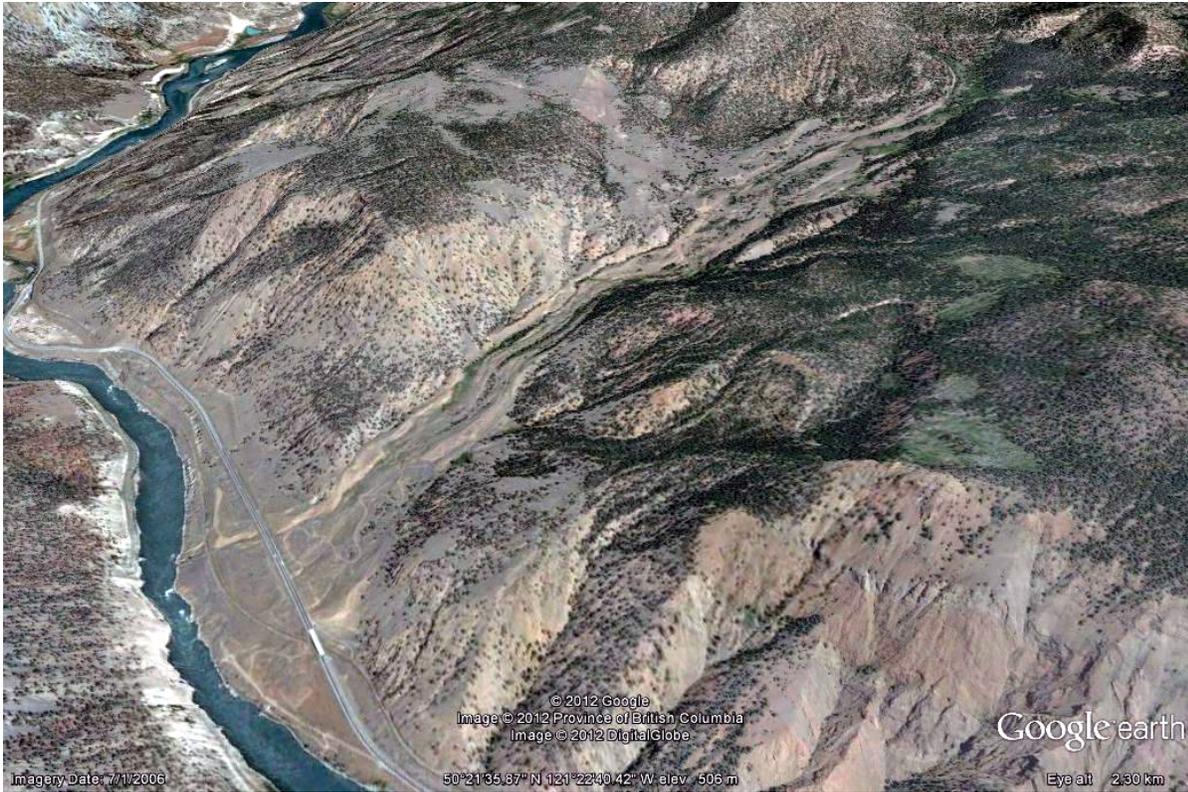
Figure 28. Drynoch earth flow, BC; width of the image depicts approximately 4 km (Google Earth image).

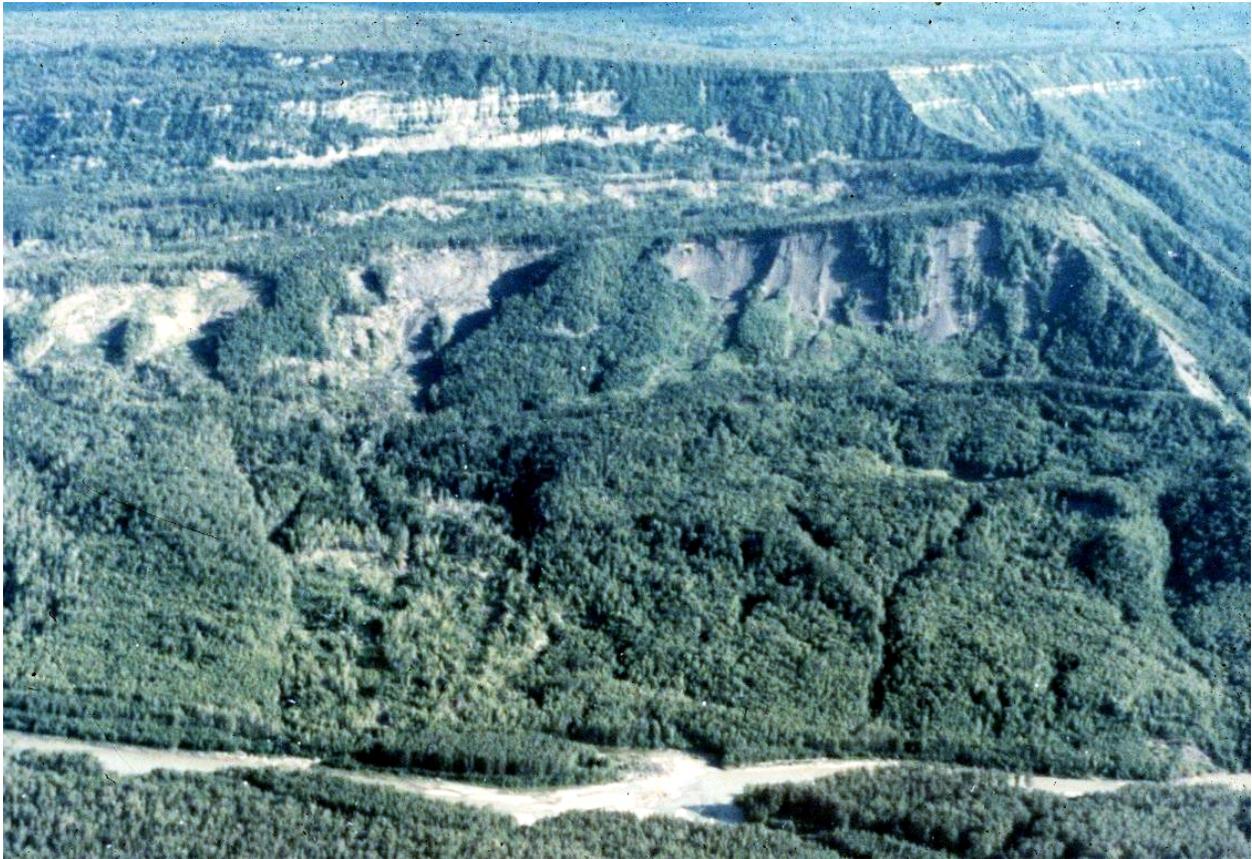
Figure 29. Earth flow complex in the Liard River valley, BC; a surging segment of the complex can be seen left of the photo centre (photo O. Hungr).

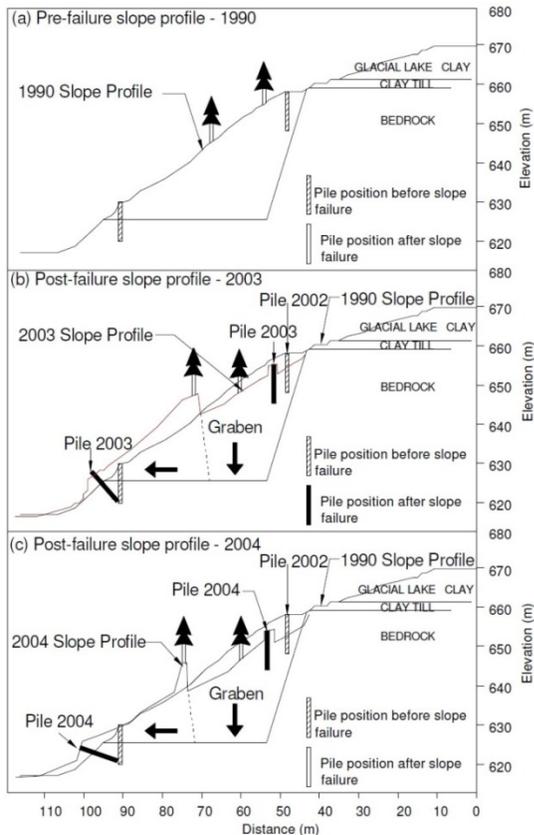
Figure 30. Schematic of the development of the Keillor Road compound slide in Edmonton, AB; the main scarp may not be as steep and linear as shown here, but may curve to a lower angle within the shale layer; such details are often difficult to document without extensive drilling investigation (Soe-Moe et al., 2009).

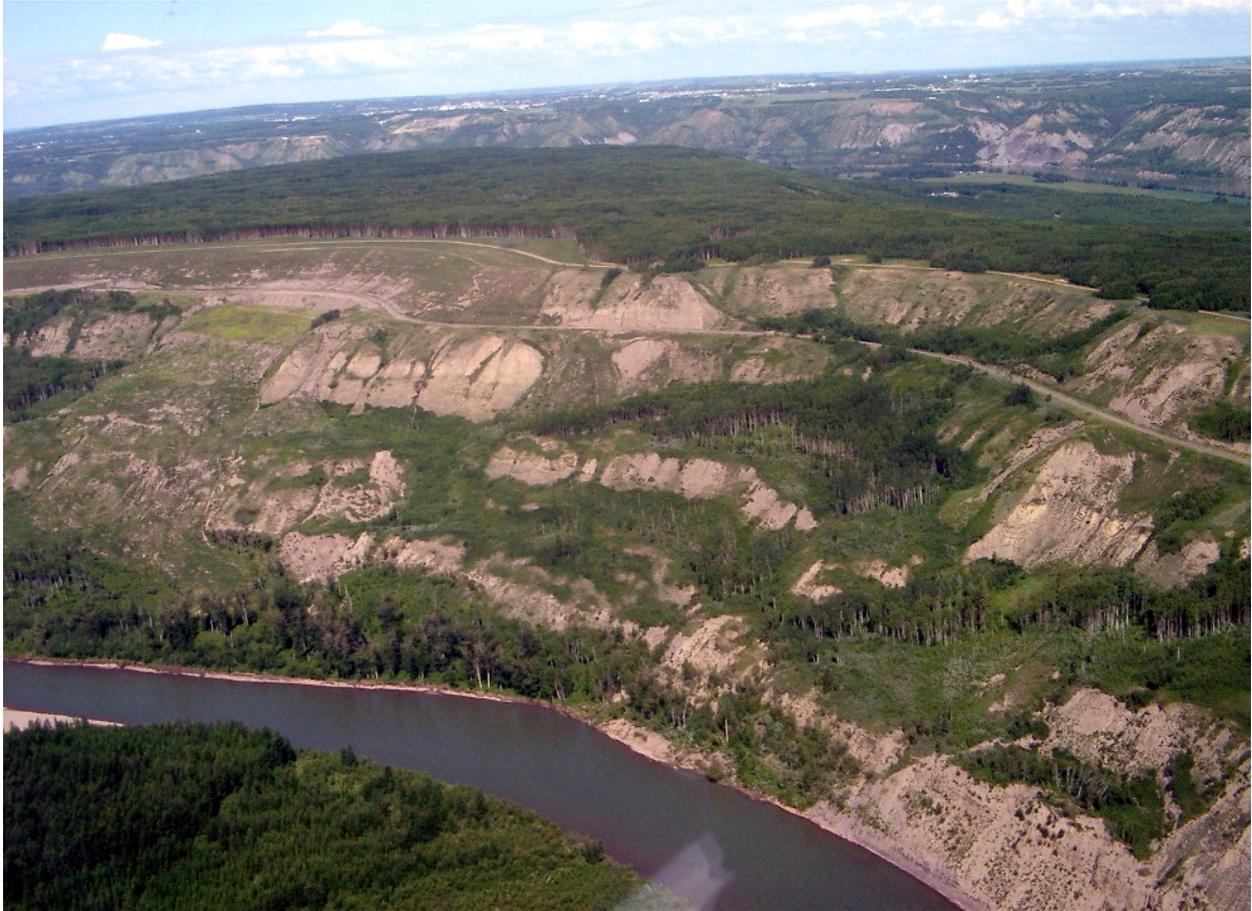
Figure 31. Multiple compound slides on the northern bank of the Pine River, BC; the bedrock-overburden interface is at mid-height of the slope (photo O. Hungr).

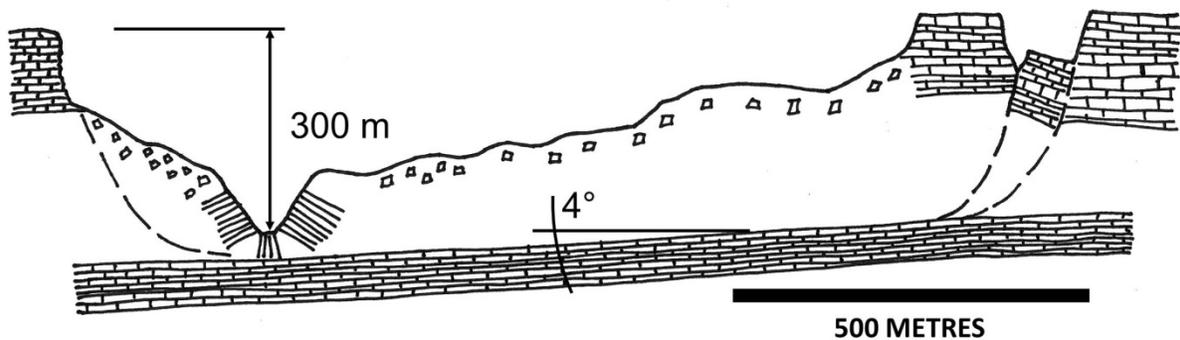
Figure 32. Schematic interpretation of the asymmetric landsliding on the two sides of Ship Creek, tributary to Scatter River, BC (Gerath and Hungr, 1983).

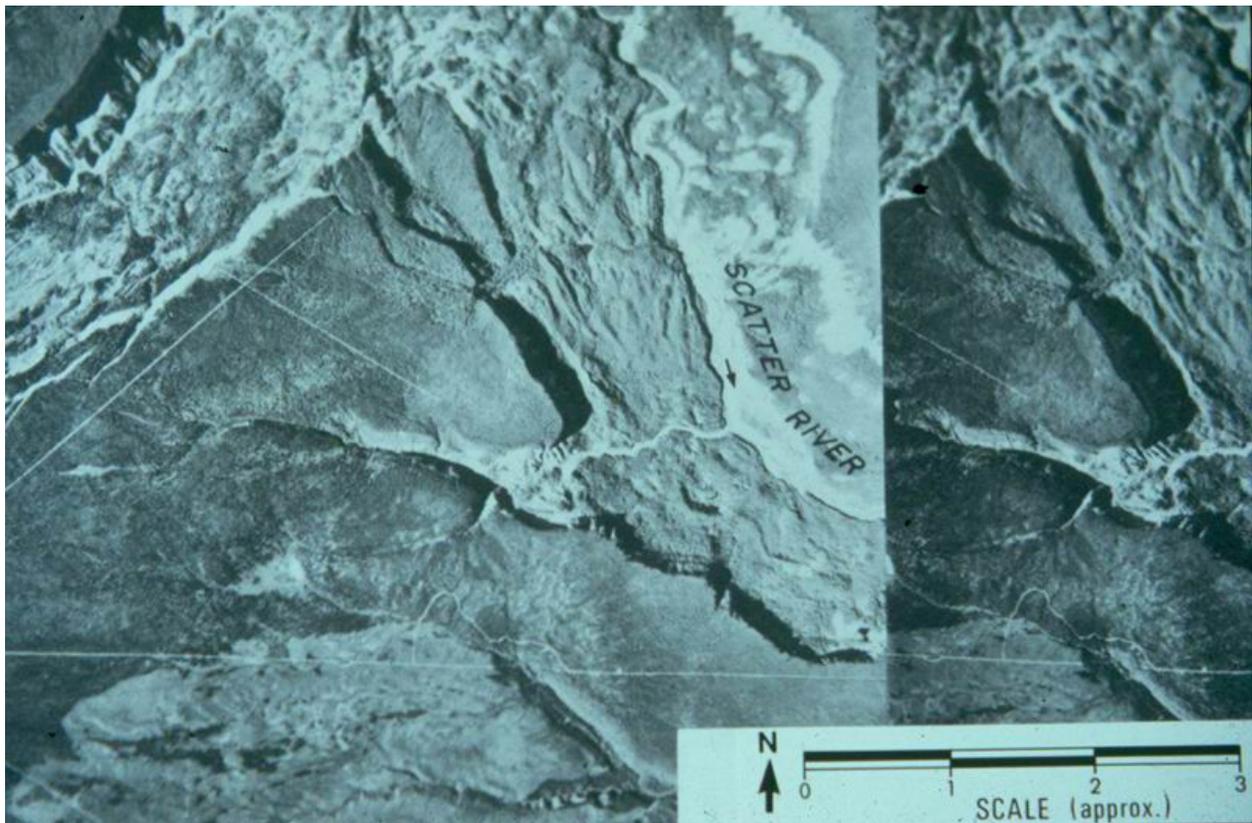
Figure 33. Stereo airphoto pair of landslides at the confluence of the Scatter River and Ship Creek (upper left corner of the image); the back-tilted landslide block above the centre of the image is 1.3 km long and 0.5 km wide (Gerath and Hungr, 1983).

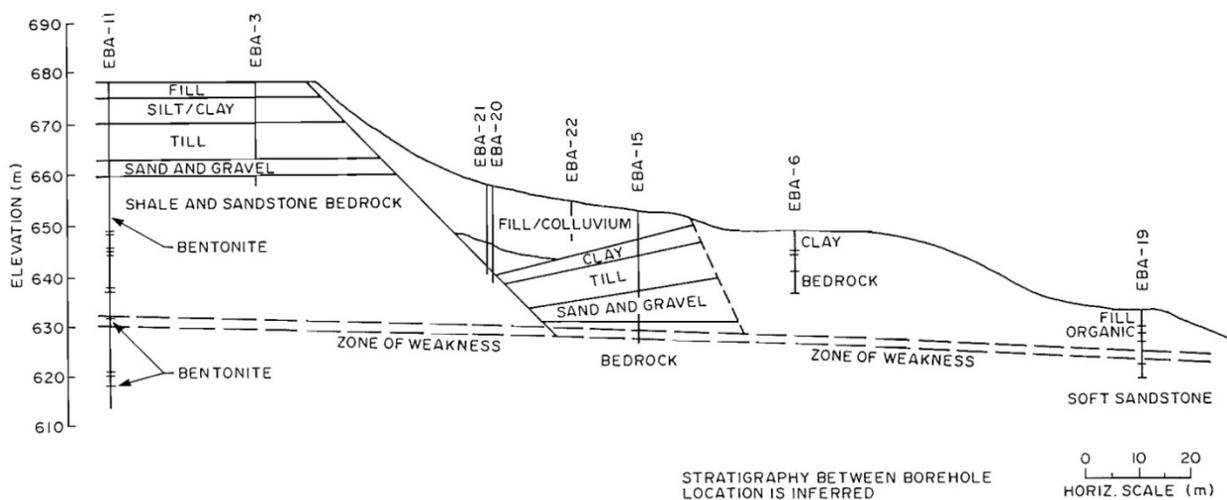
Figure 34. Cross-section of the Grierson Hill landslide (Chan and Morgenstern, 1987).

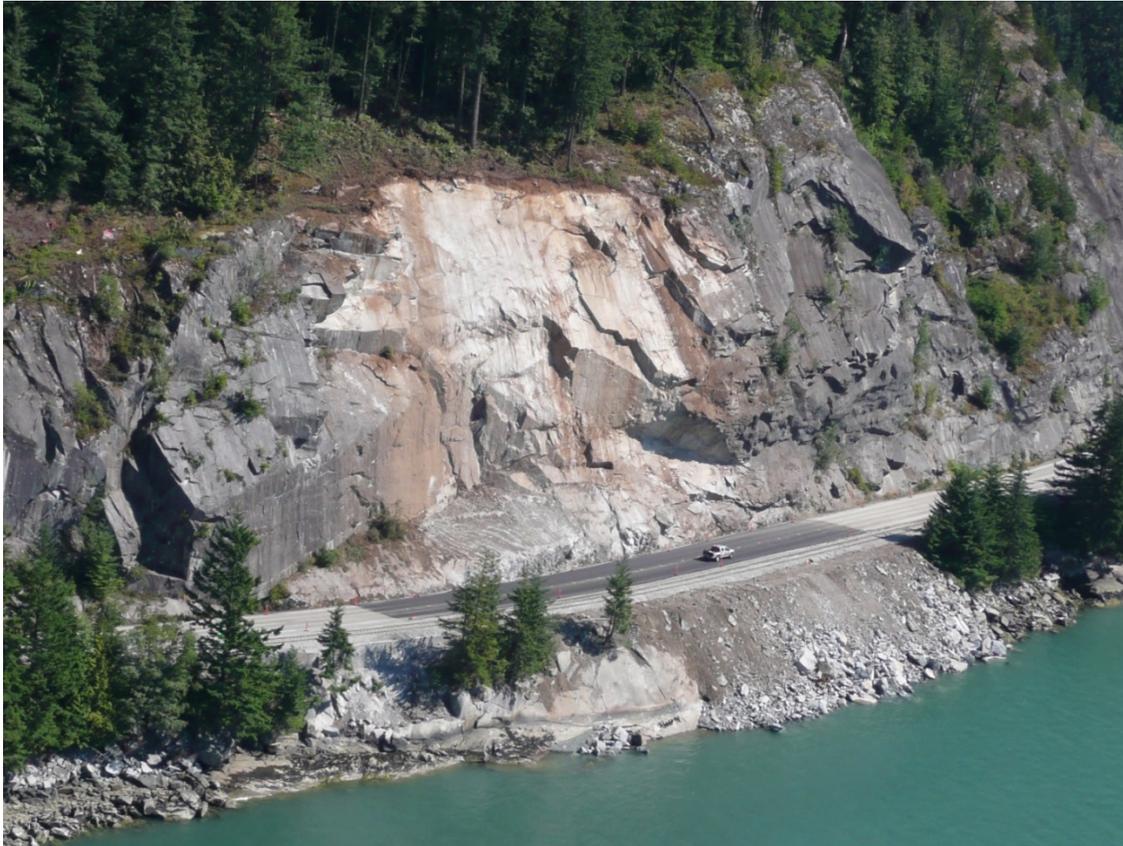
Figure 35. Rock slide at Porteau Bluffs, between Vancouver and Squamish, BC; photo, taken following the stabilization of the slope, shows the planar rupture surface, defined by a stress relief joint (photo O. Hungr).

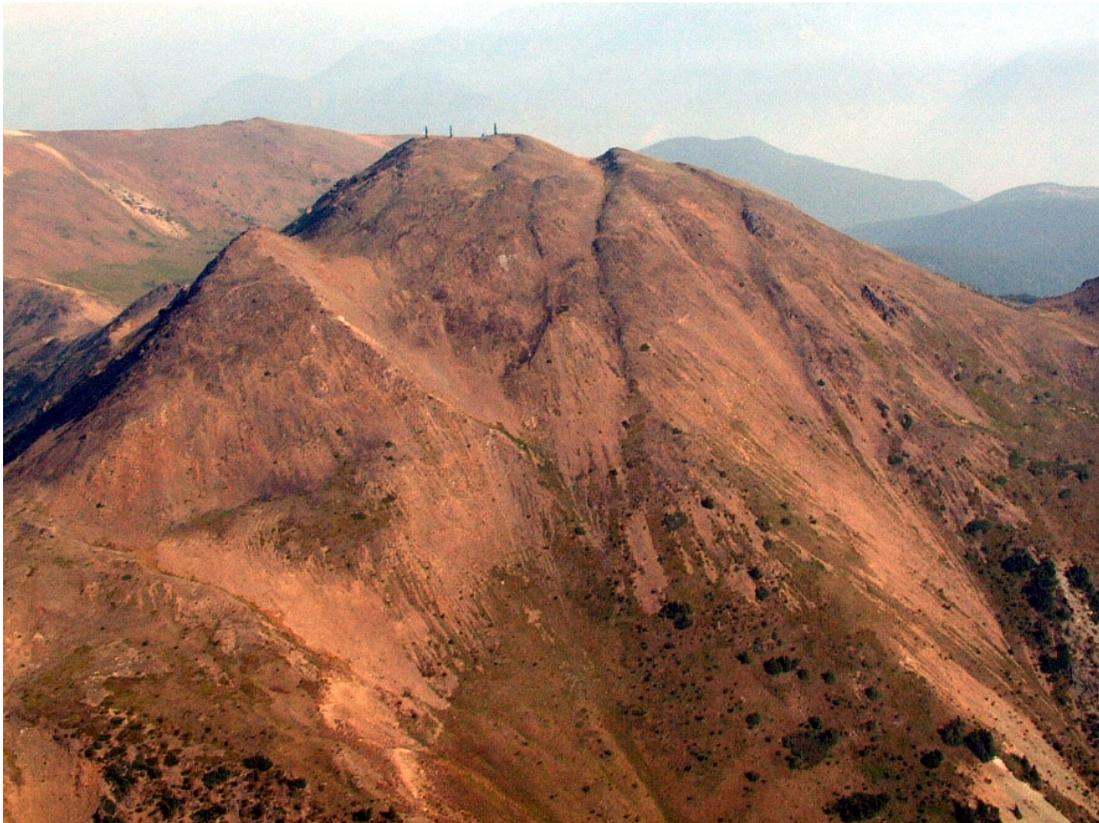
Figure 36. Example of mountain slope deformation ("sacking" directly right of the centre of the photo), on Mission Ridge, near Lillooet, BC (photo C. Esposito, used with permission).

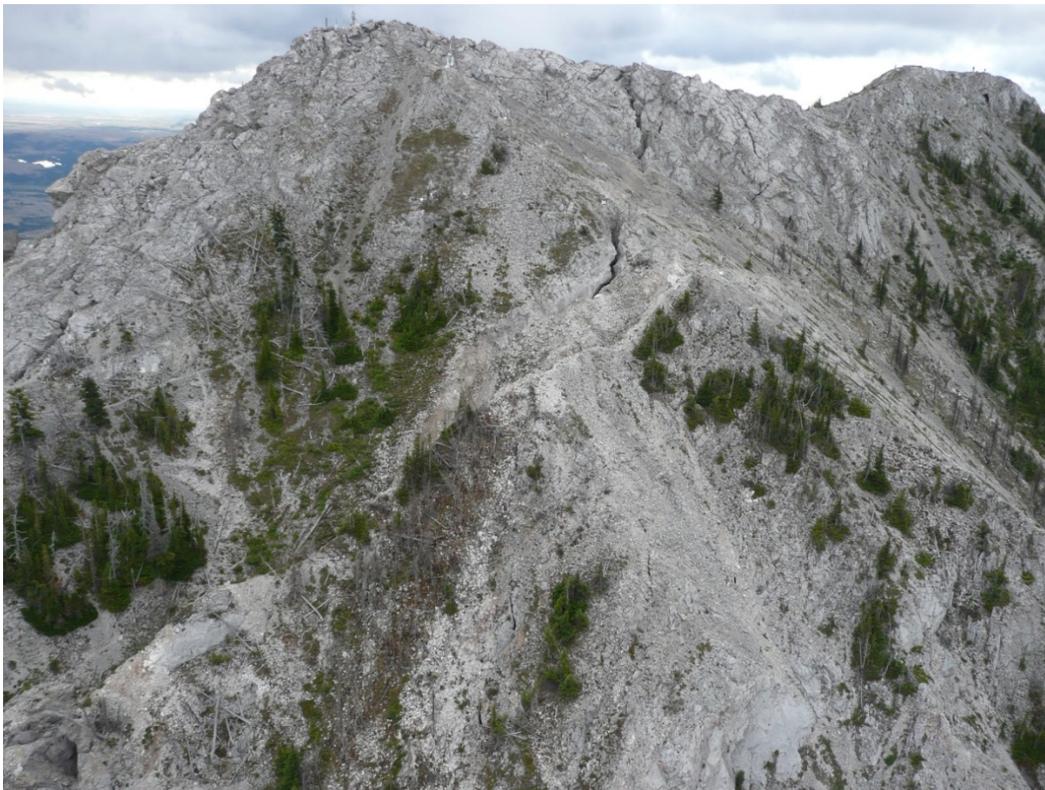
Figure 37. Tension crack systems behind the South Peak of Turtle Mountain, Frank, AB, that are being monitored by the Alberta Geological Survey (photo O. Hungr).

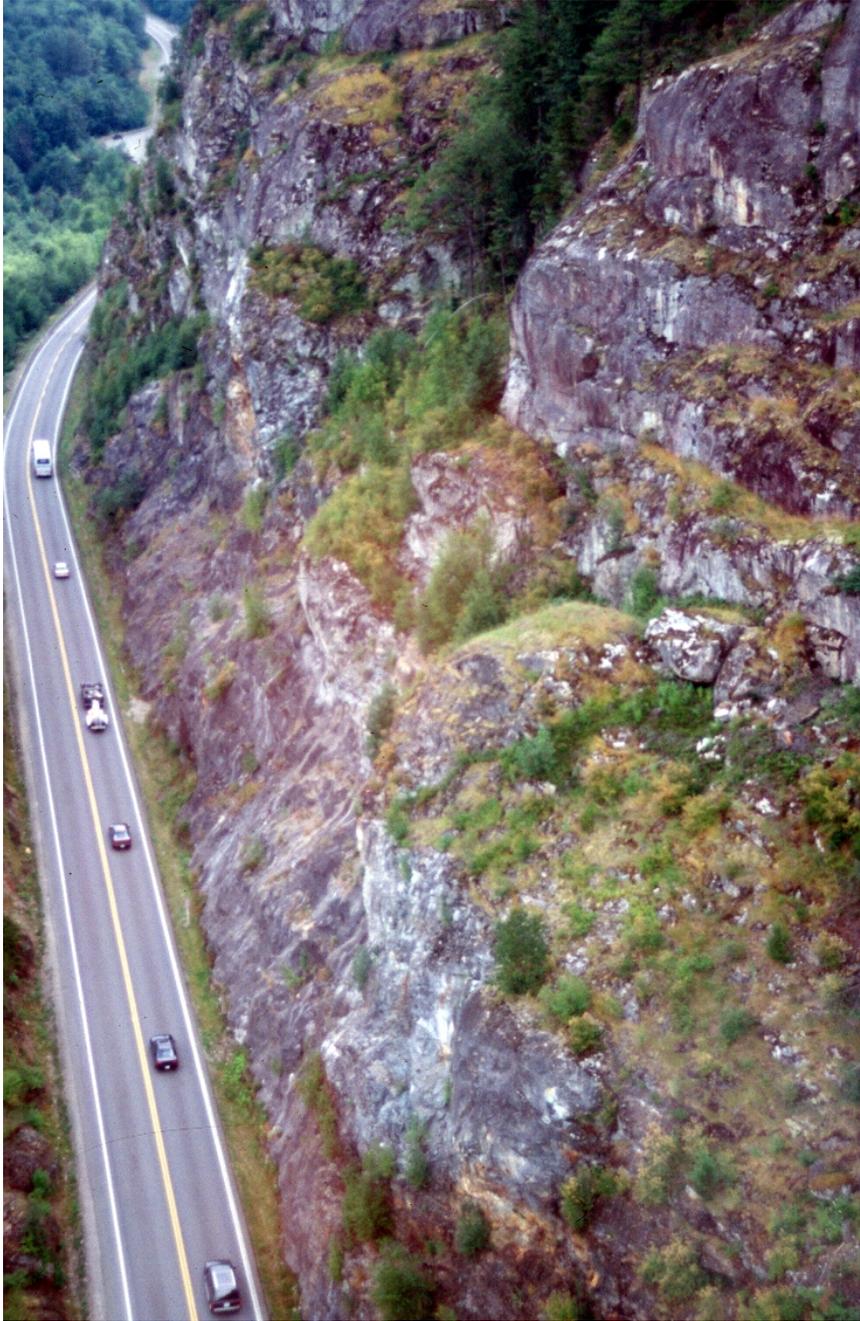
Figure 38. The site of a fatal rock fall on BC Highway 99, south of Squamish (Photo O.Hungr).

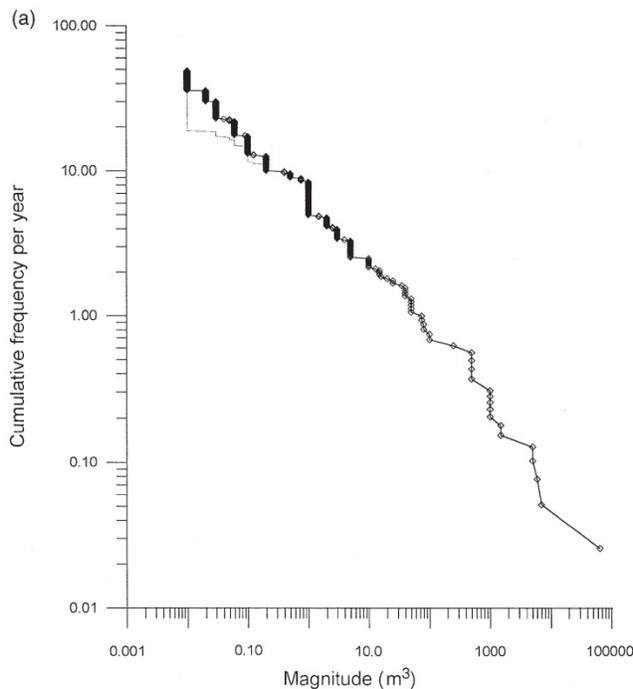
Figure 39. Magnitude-cumulative frequency curve for rock falls along a sector of BC Highway 99, between Vancouver and Whistler (Hungr et al., 1999).

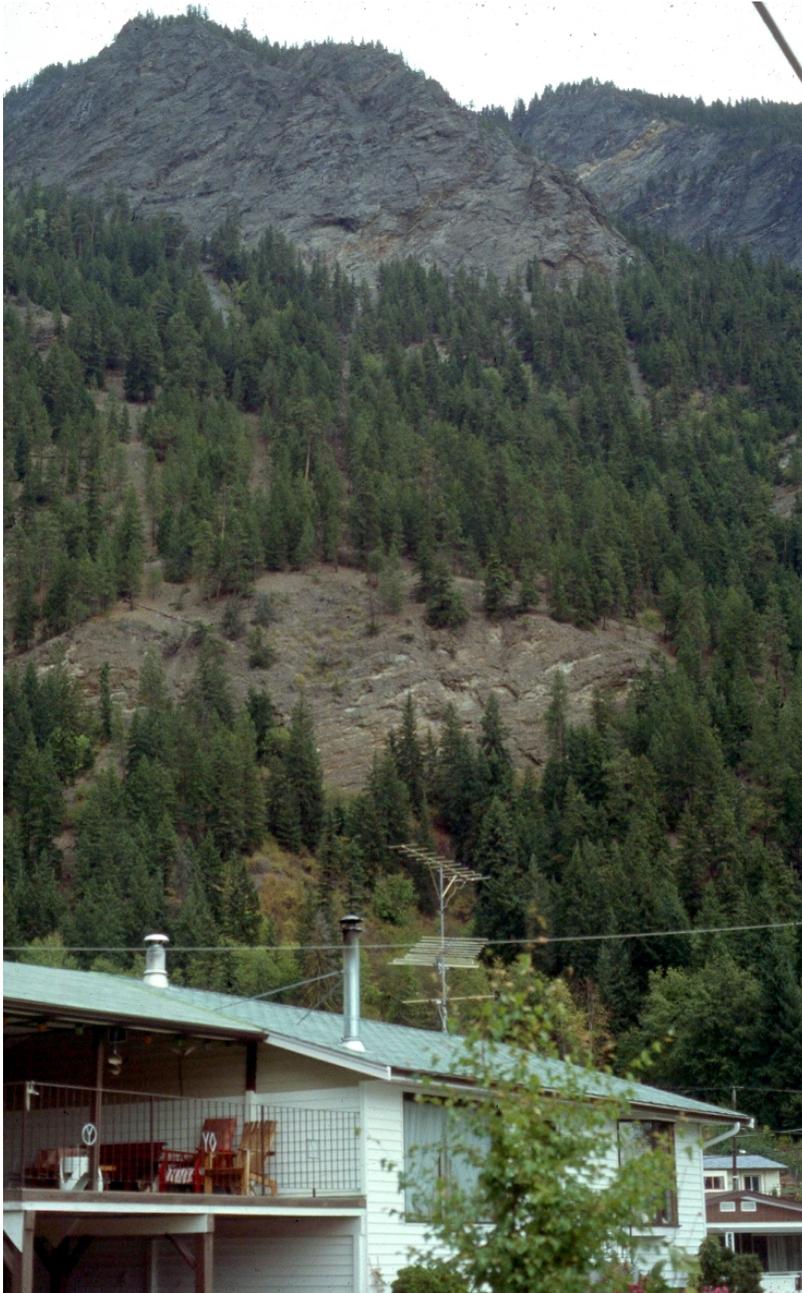
Figure 40. Source area and general path of the fatal rock fall of 2003 at Sunnybrae, near Salmon Arm, BC; the boulder path is the vertical cleared track through the trees, directly above the chimney; the boulder bounded over the cliff in the centre of the photo, changed direction and demolished a home to the right of the photo (photo O. Hungr).

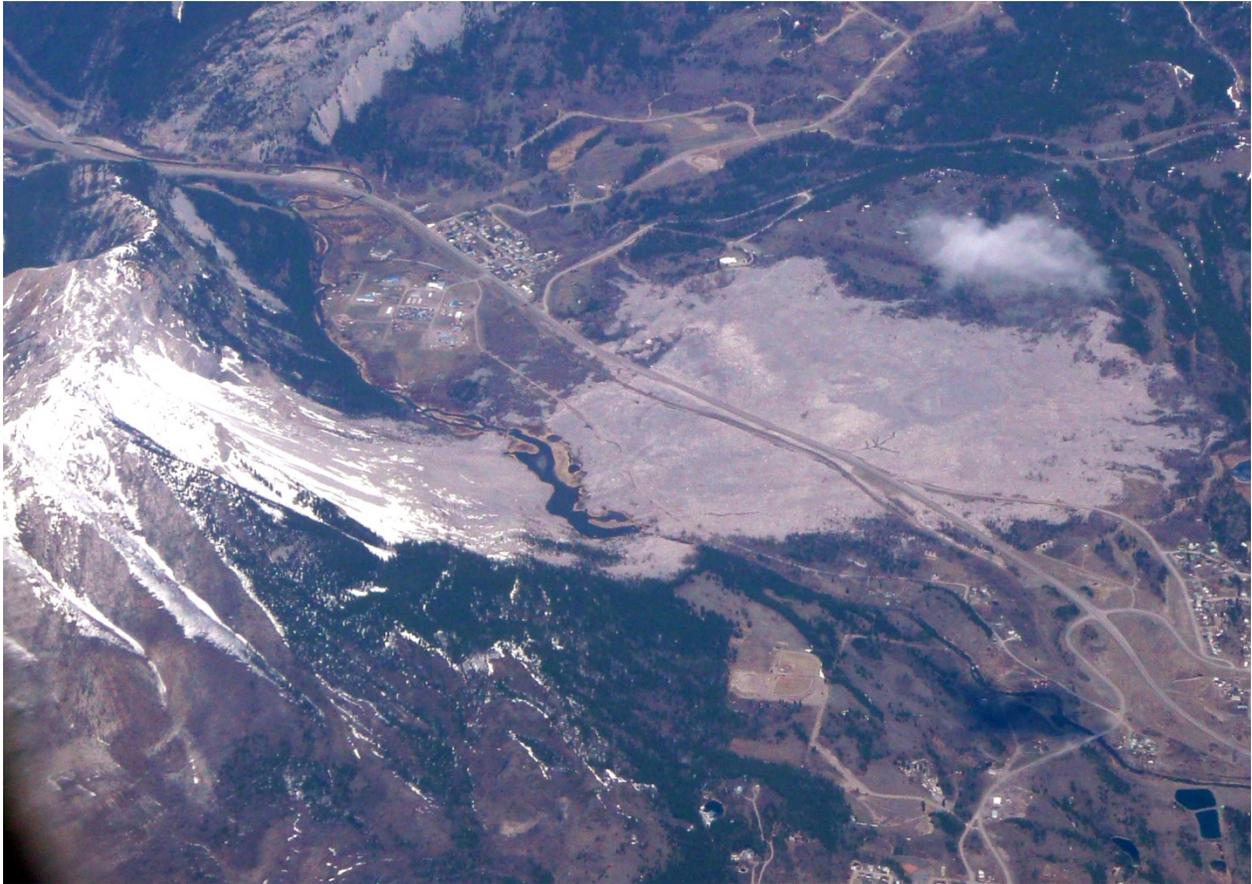
Figure 41. Panoramic view from the crown of the Frank landslide, AB; the toe is 3.3 km (horizontal) distance and 800 m below where the photo was taken; the remnant town of Frank, AB is to the left (photo O. Hungr).

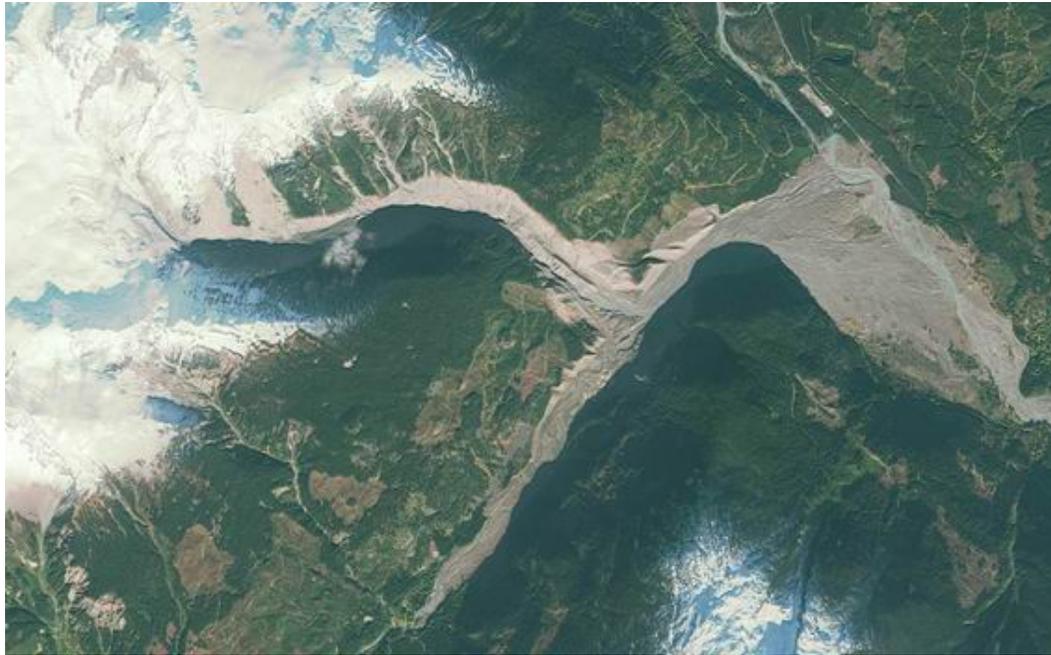
Figure 42. Orthophoto of the 2010 Capricorn Creek rock avalanche (image courtesy R. Guthrie, used with permission).

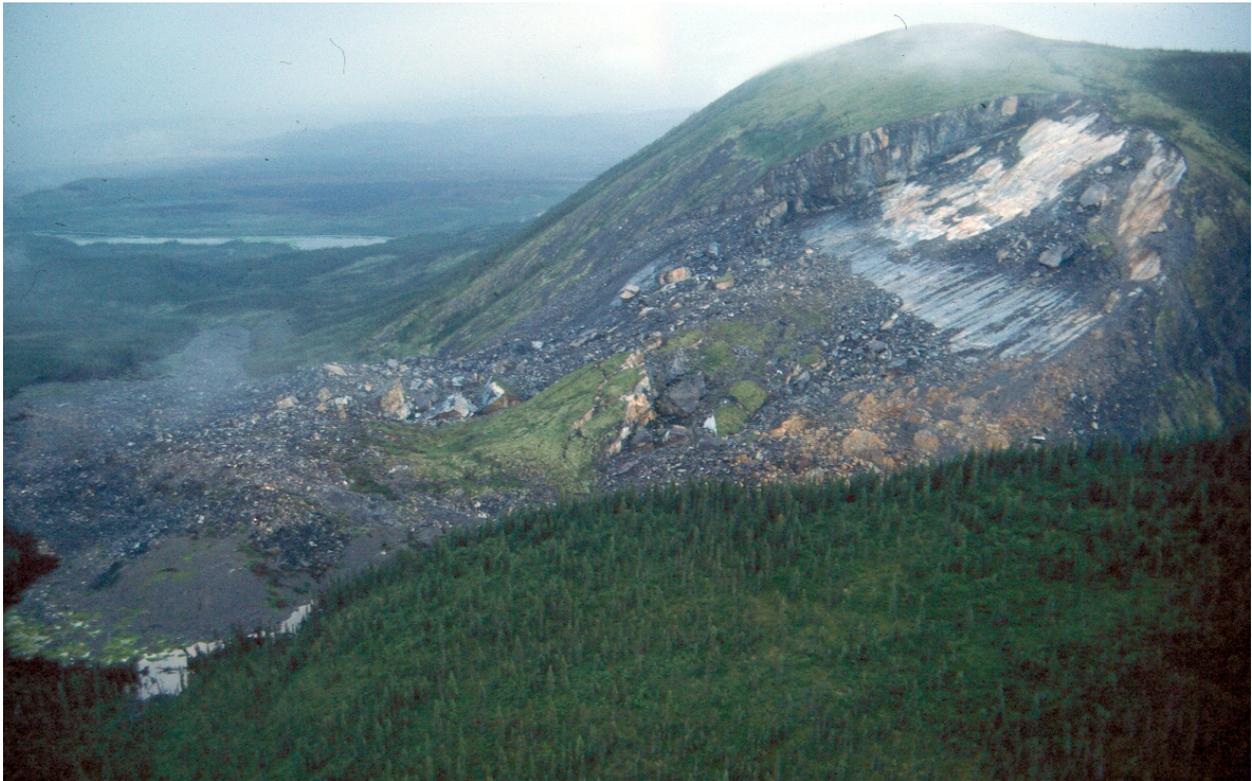
Figure 43. North Nahanni rock avalanche, Mackenzie Mountains, NWT; note the long travel distance of saturated soil that was liquefied by the impact of the rock avalanche (photo O. Hungr).

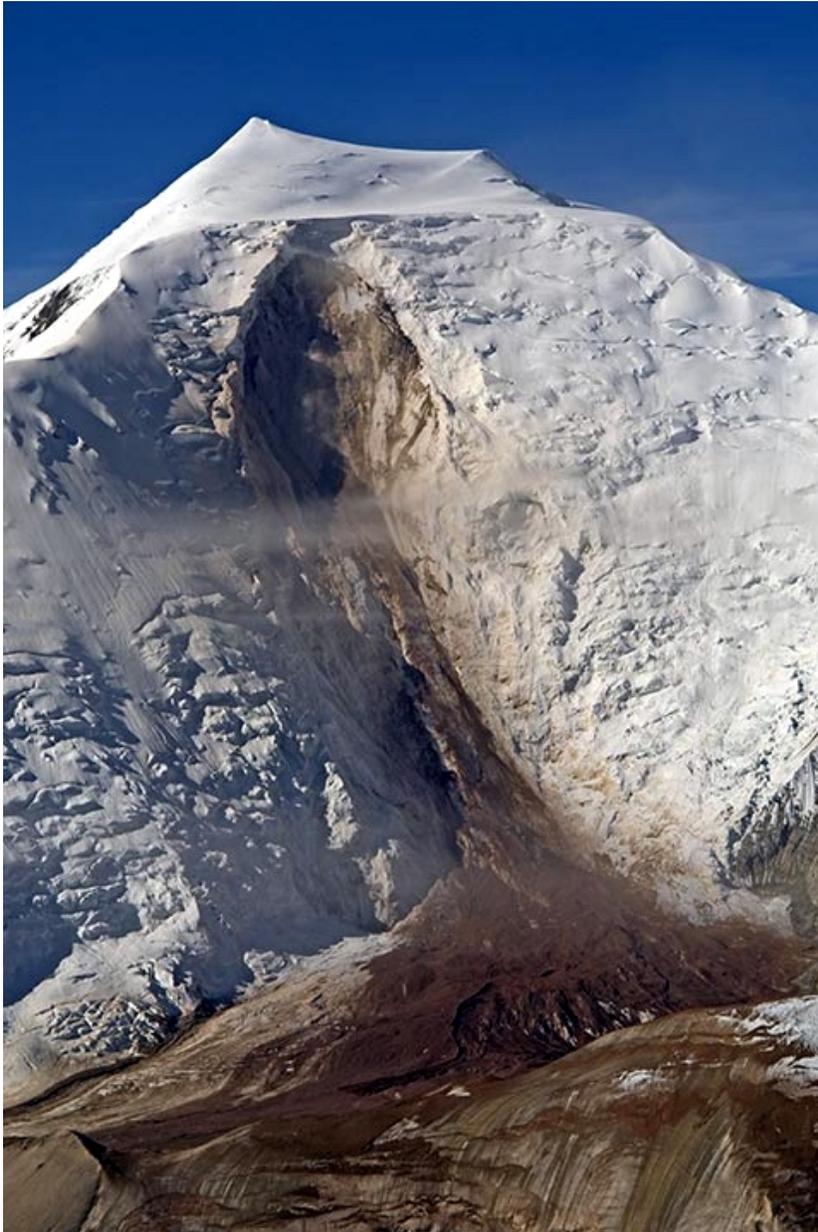
Figure 44. Mount Steele rock and ice avalanche, YT (photo P. Lipovsky, used with permission).

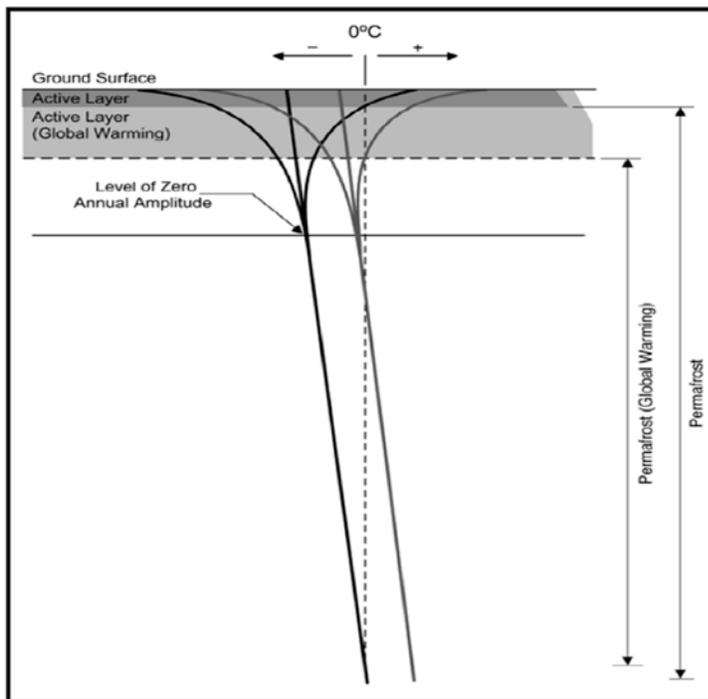
Figure 45. Example ‘trumpet curve’ of ground temperature profiles used to define the active layer; also shows an illustration of the effect of a global warming on the active layer (Weitzner et al. 2011).

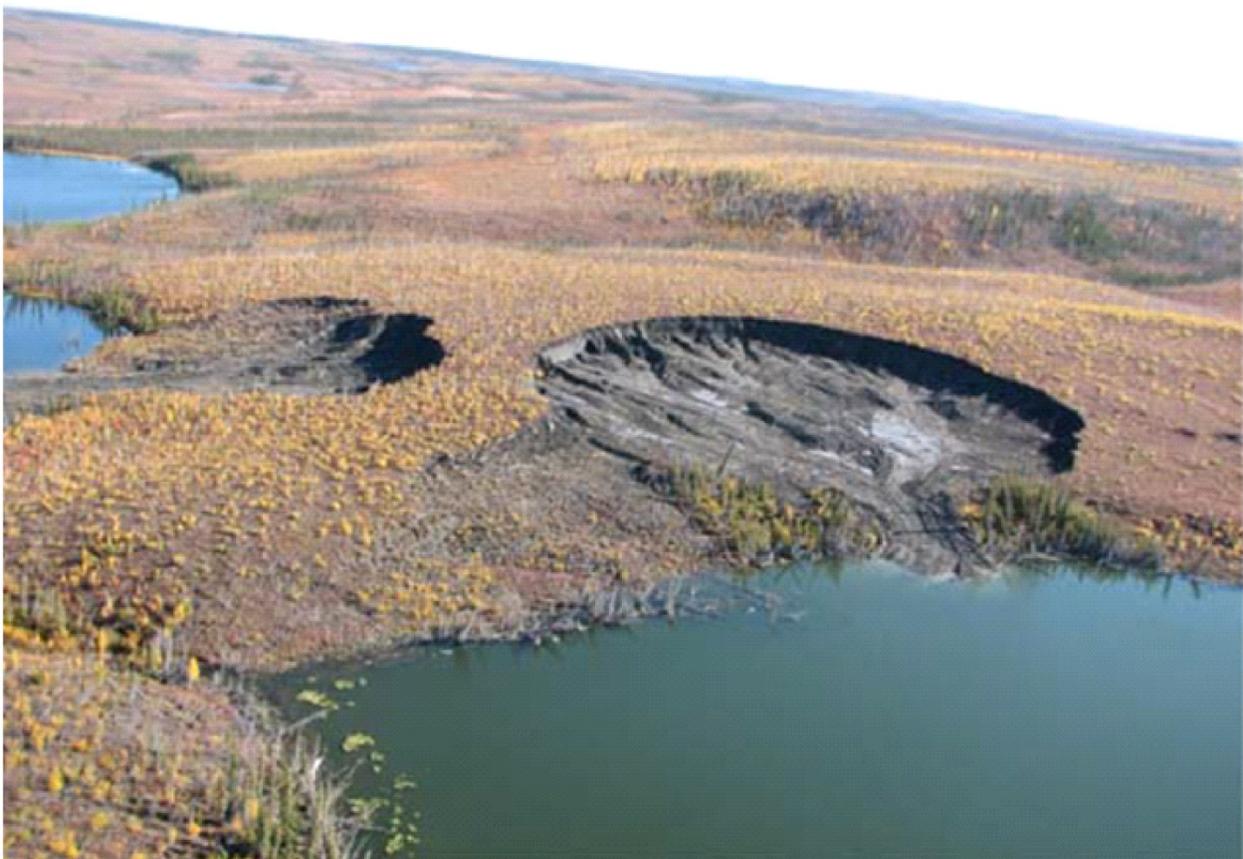
Figure 46. Retrogressive thaw flow, YT (Lipovsky and Huscroft, 2006).

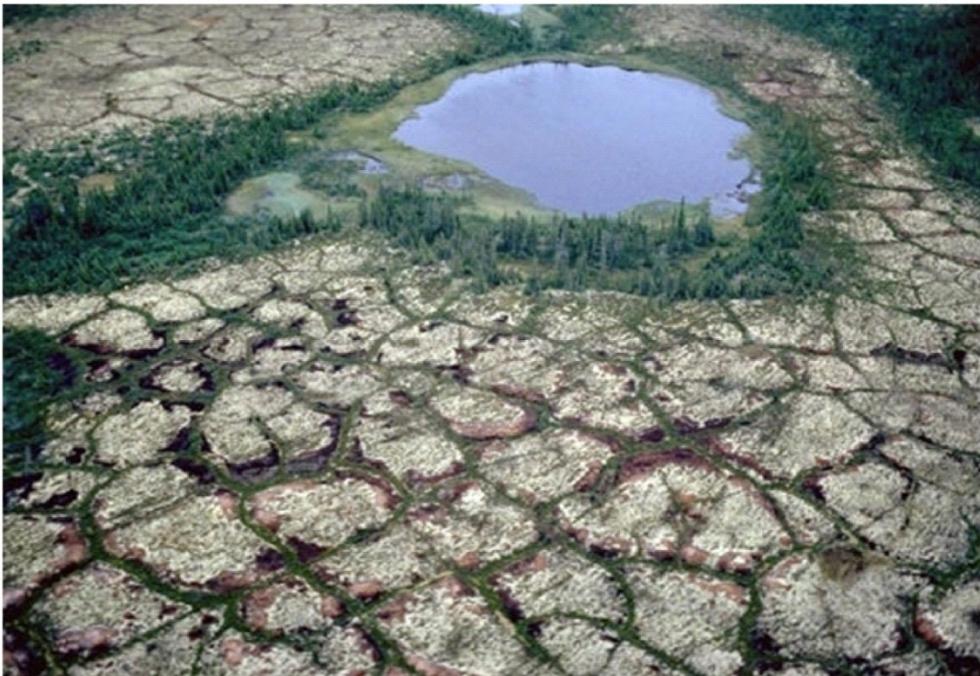
Figure 47. Pattern ground in dry sphagnum peat in the Hudson Bay lowlands, Brown polygons indicate massive ice wedges that extend down 2 or 3 m from the surface. (photo Natural Resources Canada).

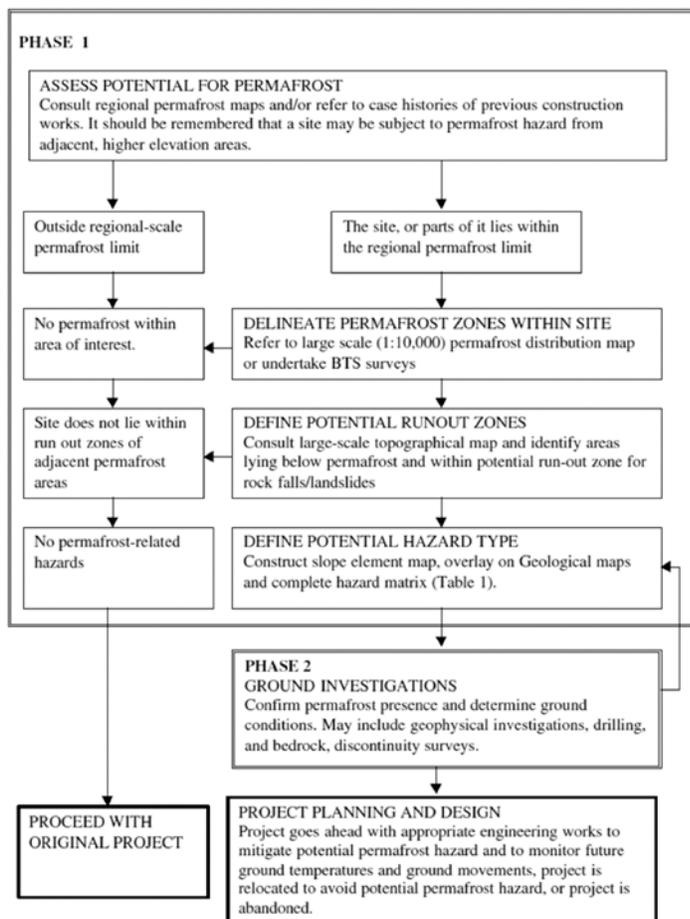
Figure 48. Flow chart illustrating integrated approach to assessing landslide hazards and risks in permafrost terrain (Harris et al., 2001).

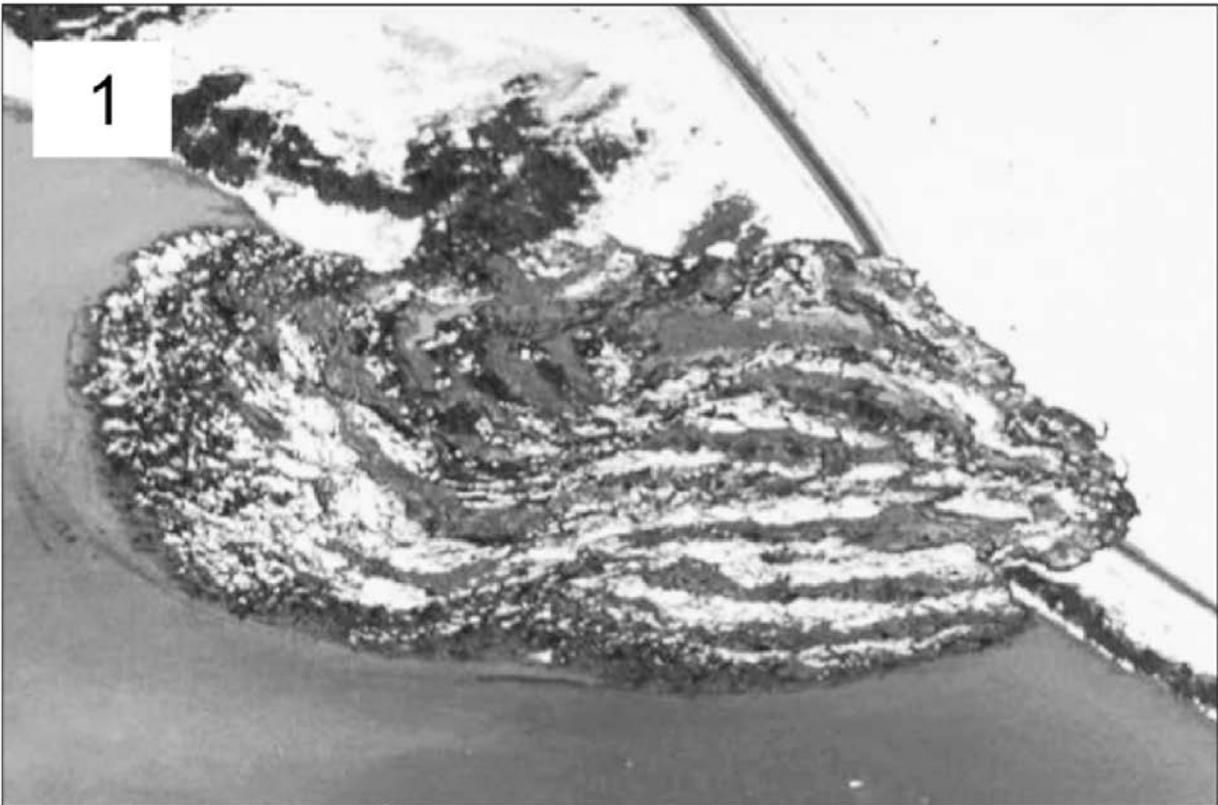
Figure 49. Havre St. Pierre landslide slide in sensitive clay along the north shore of the Gulf of St. Lawrence, QU (Bernarchez and Dubois, 2004).

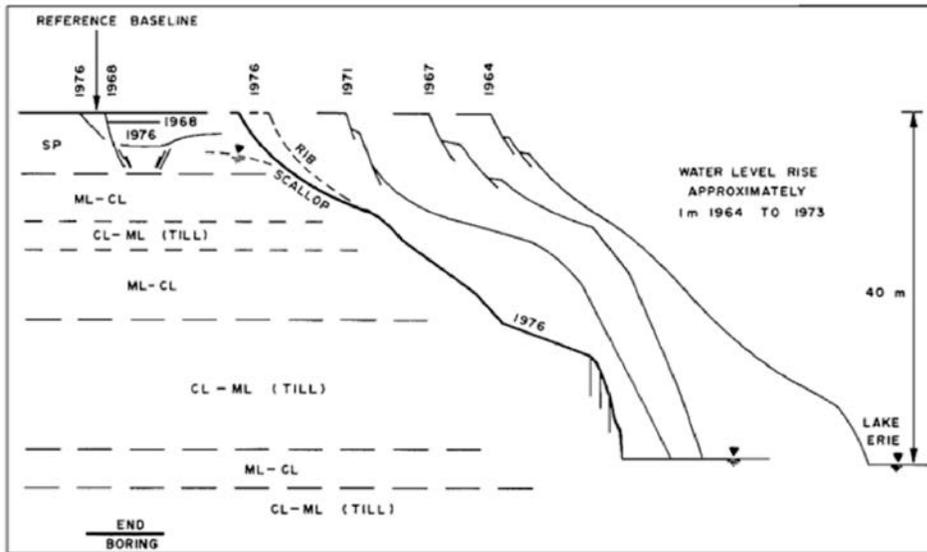
Figure 50. Shoreline retreat along the bluffs of Lake Erie, ON (Quigley et al., 1977).
