**GEOLOGICAL SURVEY OF CANADA
OPEN FILE 7897**

**EXAMPLES OF COMMON LANDSLIDE TYPES
IN CANADA**

**Canadian Technical Guidelines and Best Practices related
to Landslides: a national initiative for loss reduction**

O. Hungr and J. Locat

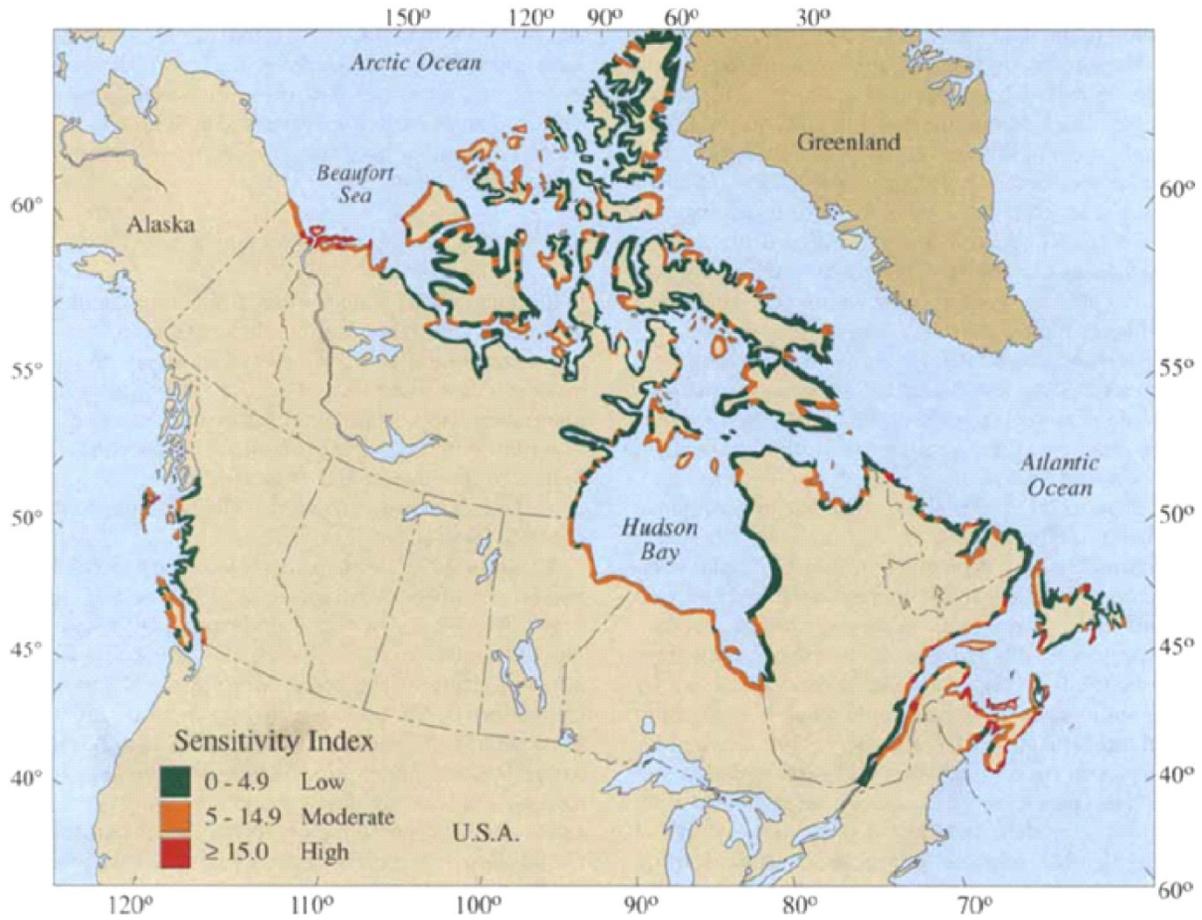
Figure 51. Sensitivity of Canadian coastlines to sea level rise (Natural Resources Canada).

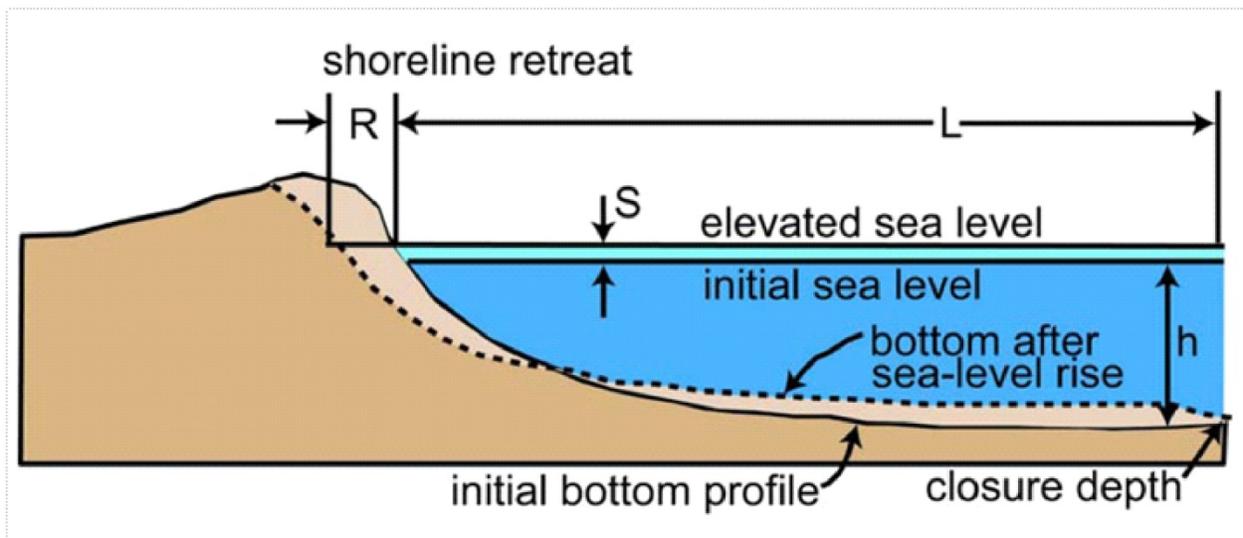
Figure 52. Schematic of the effect of sea level rise on shoreline erosion (Fitzgerald et al., 2008).

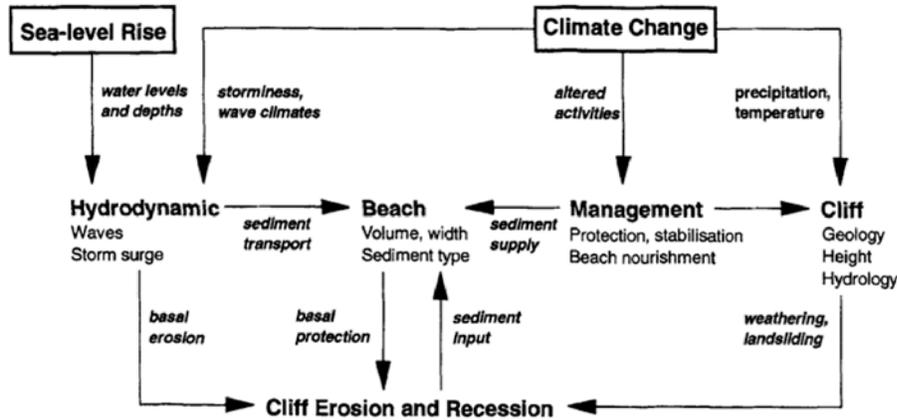
Figure 53. Summary of factors influencing cliff erosion (Bray and Hooke, 1997).

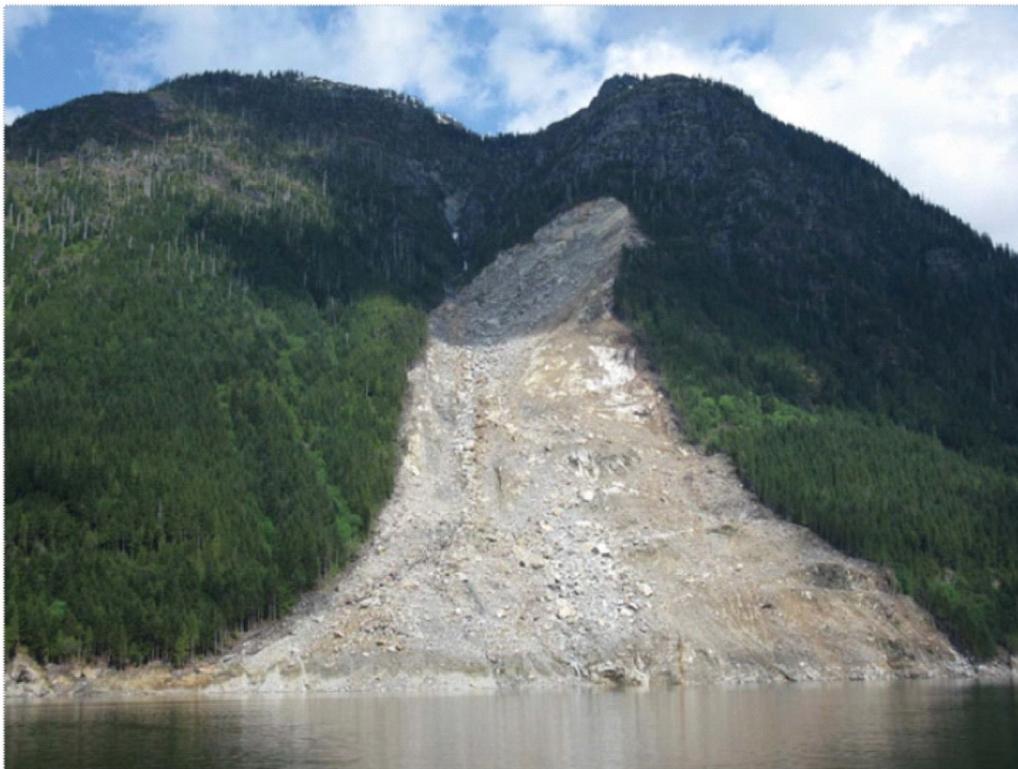
Figure 54. Chehalis Lake rock slide, BC (photo BC Ministry of Forests).

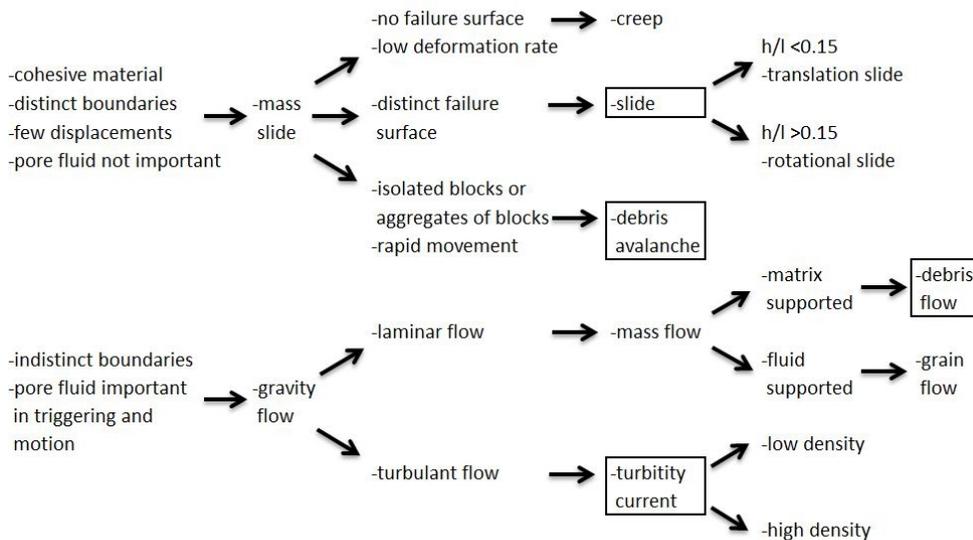
Figure 55. Classification of submarine landslides; main types are highlighted by a box (after Mulder and Cochonat, 1996).

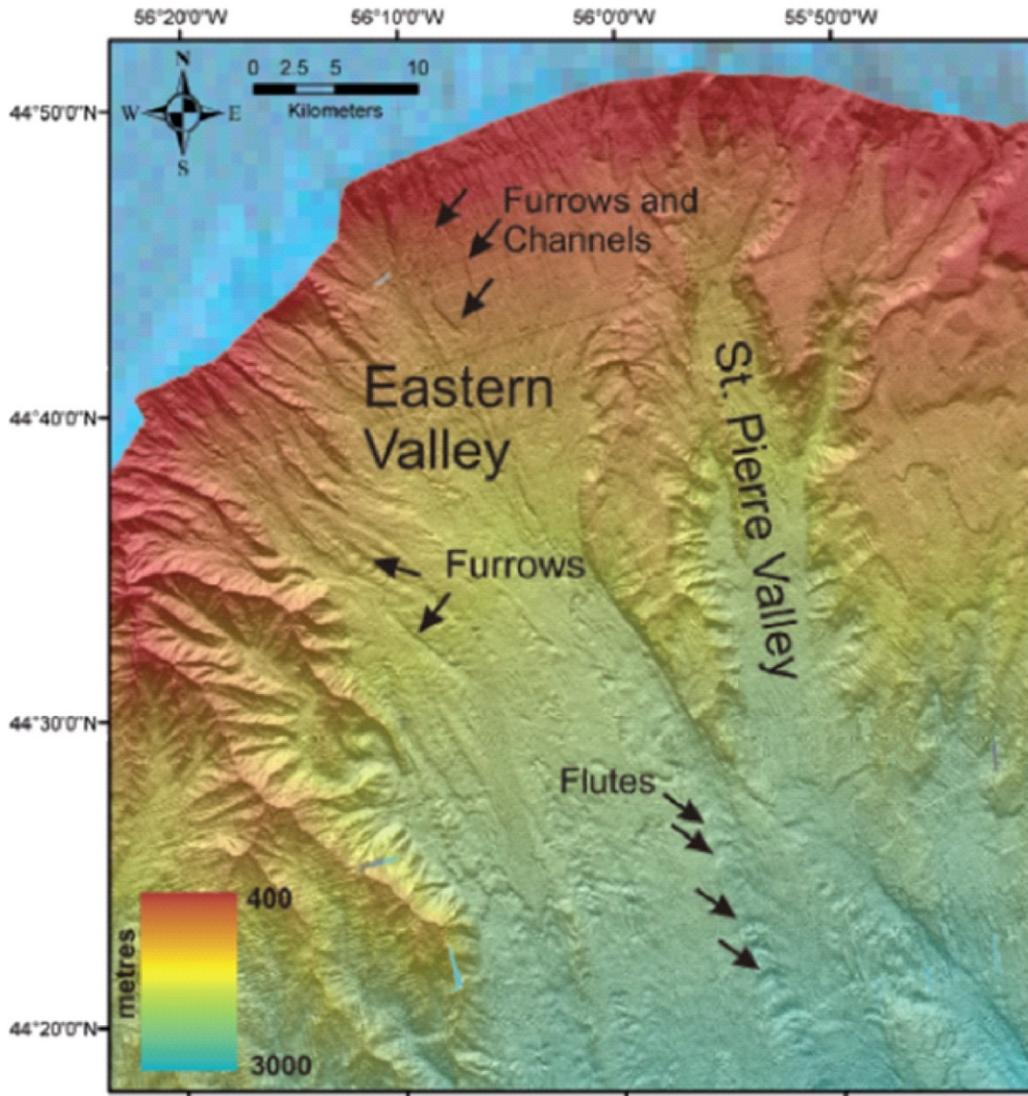
Figure 56. Grand Banks flow, NL, bathymetry showing the erosion characteristics of the valley; vertical exaggeration is 10 times.

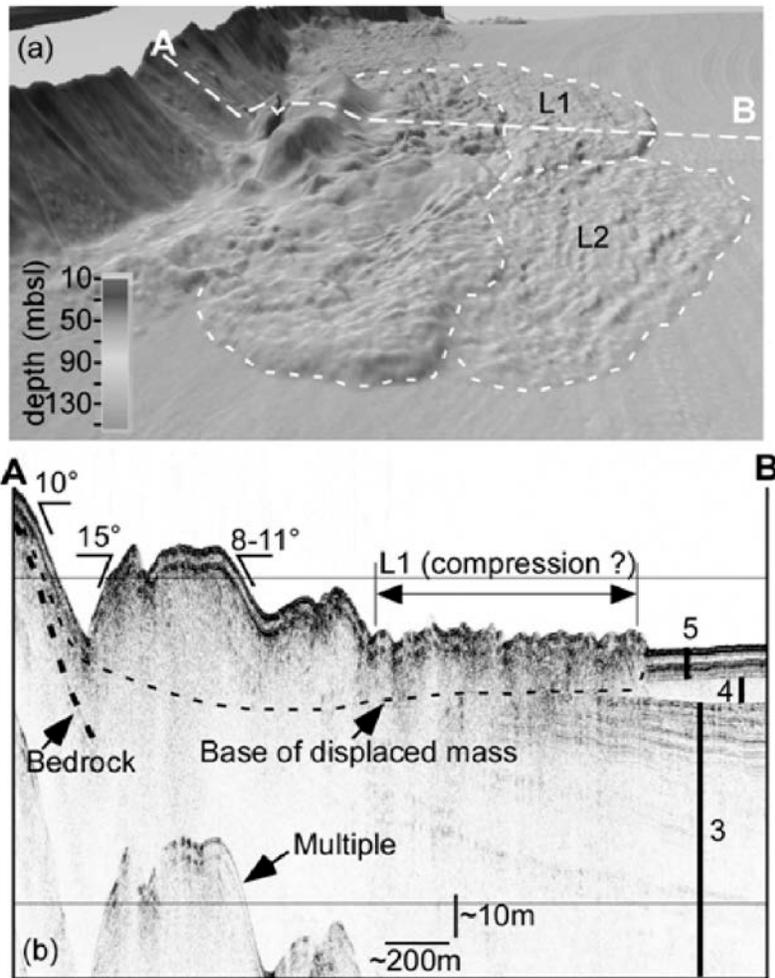
Figure 57. St. Siméon flow, QC (a) oblique view along the northern flank and (b) seismic cross section showing the thickness of the debris over the marine deposits (Locat et al., 2012a).

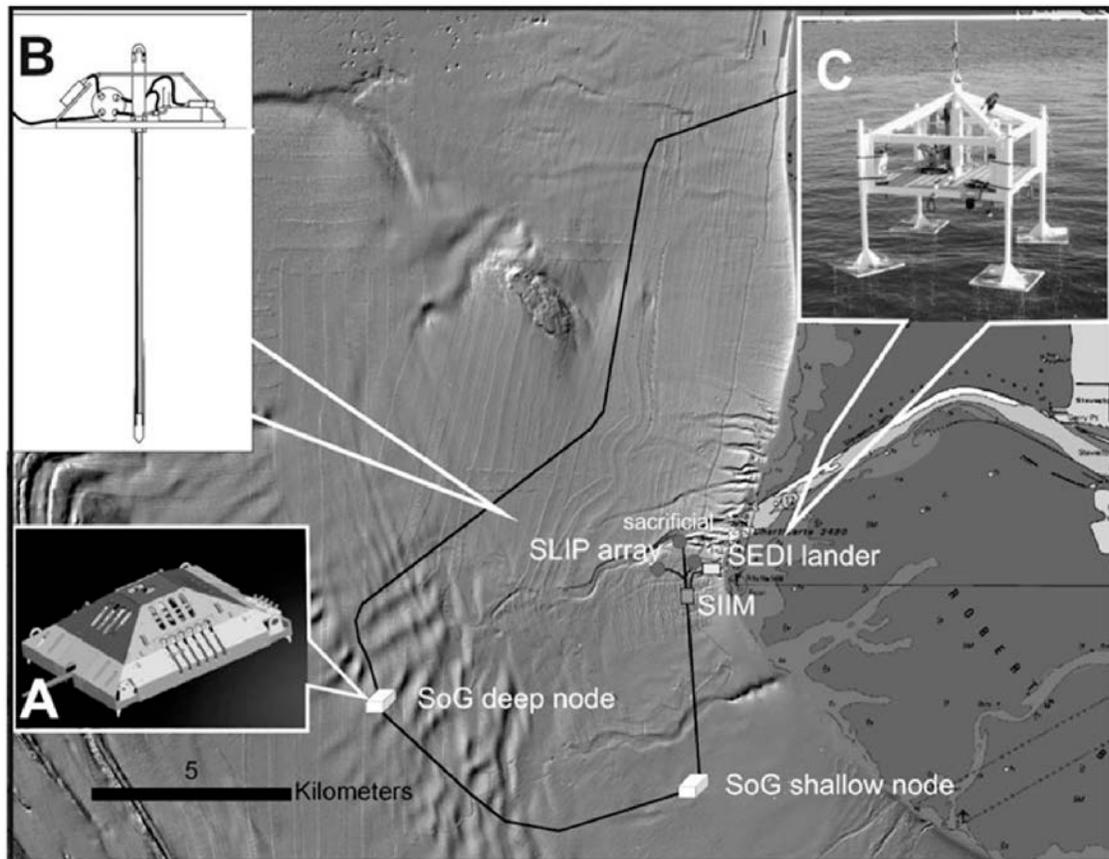
Figure 58. Schematic of VENUS (Victoria Experimental Network Under the Sea) installation in the Strait of Georgia, BC; the cable (black line) connects two nodes (A) to a shore station transmitting DC power and data; instruments can be plugged into the nodes; (SIIM) is a science instrument interface module; SLIP array (B) consists of four seismometers and piezometers; SEDI lander (C) is instrumented with devices to measure sediment fluxes and near-bed sediment transport (refer to Hill et al., 2008 for details).

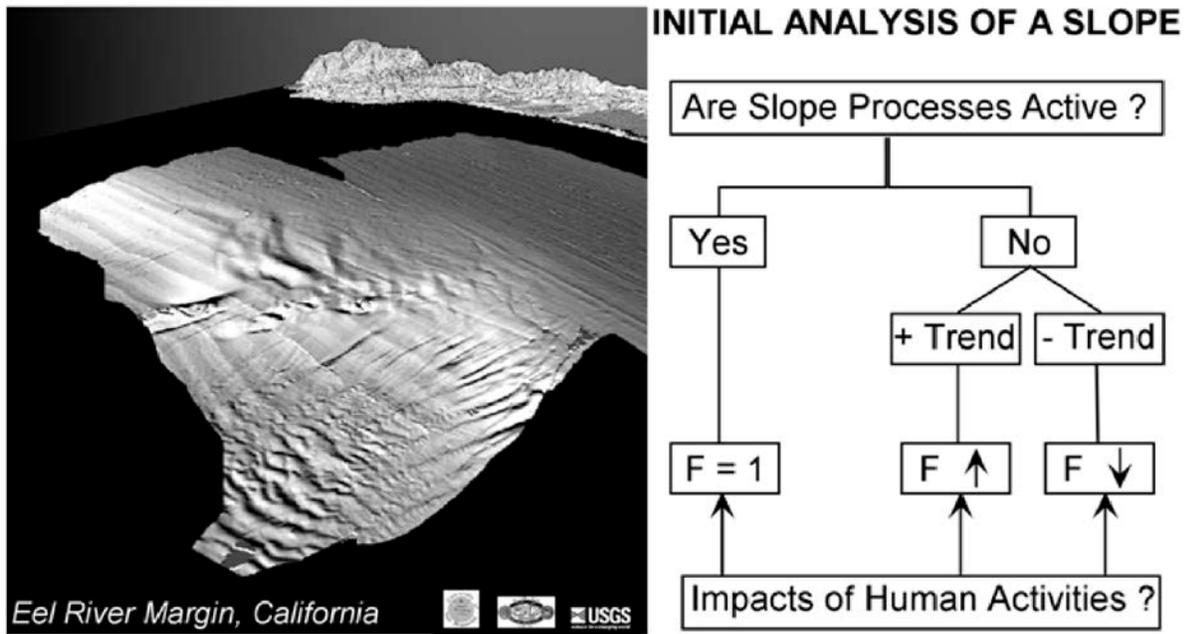
Figure 59. Initial analysis of the safety factor of a slope (F) illustrated with a multibeam 3D view of the Eel River Margin off Eureka, California (multibeam image is from USGS; refer to Locat, 2001 for details).

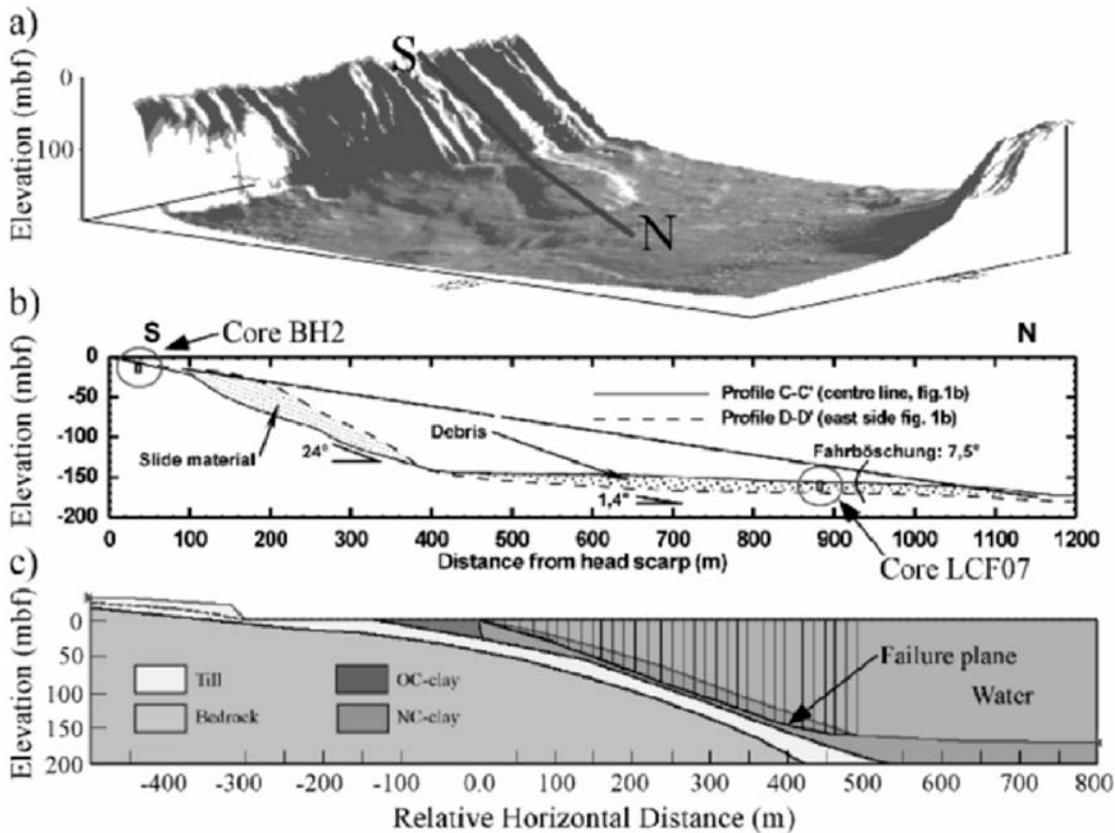
Figure 60. (a) 3D view of the Point-du-Forts landslide, QU; (b) geometric reconstruction of the pre-landslide slope, and (c) geological model used for slope stability analysis (refer to Locat et al., 2003 for details).

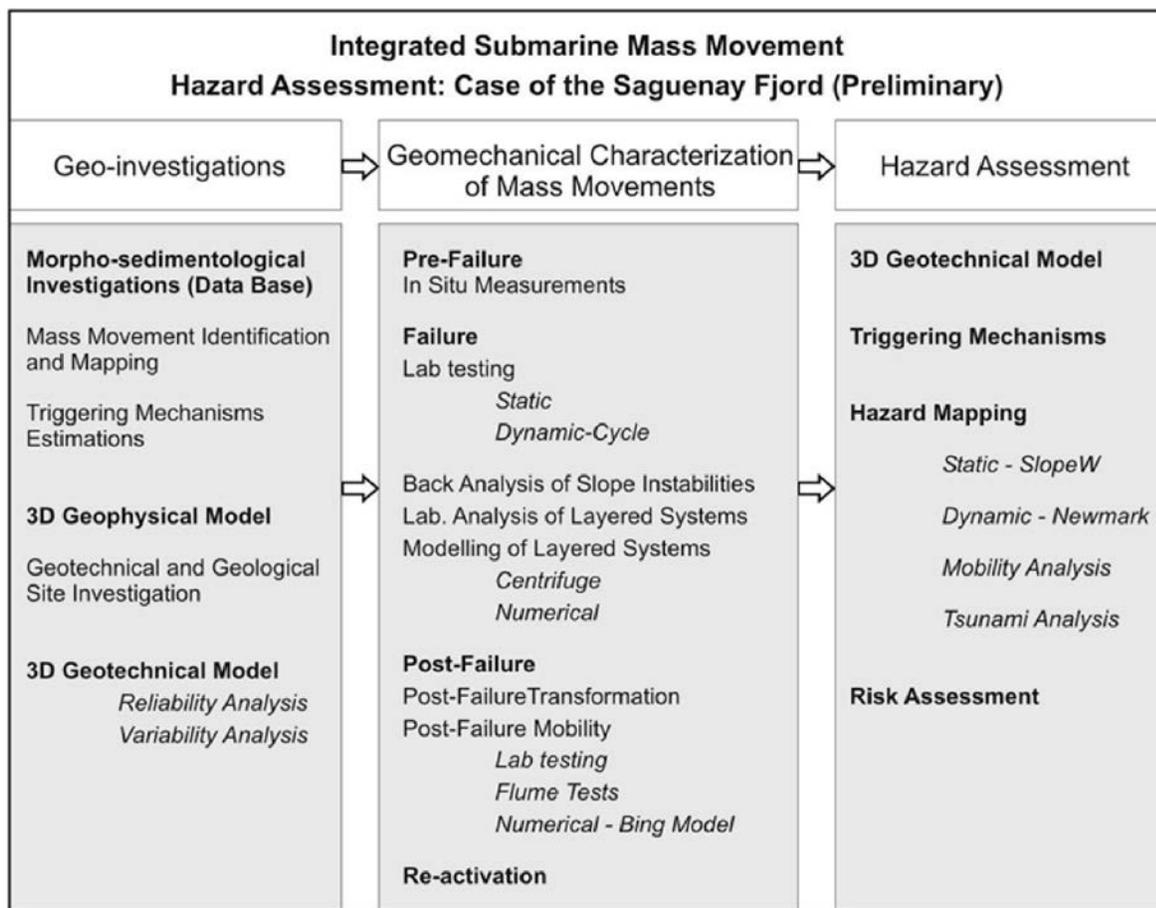
Figure 61. Approach for submarine landslide hazard assessment in the Saguenay Fjord region, QU (refer to Nadim and Locat, 2005 for details).

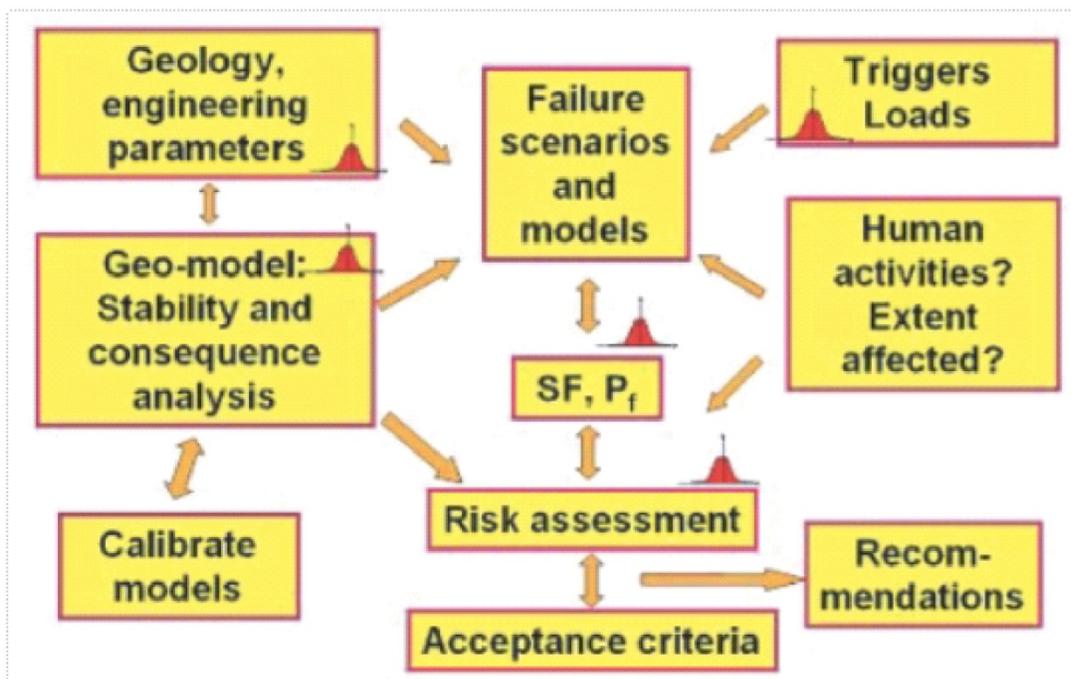
Figure 62: General framework for submarine landslide risk assessment; SF is factor of safety; P_f is probability of failure (refer to Nadim and Locat, 2005 for details).
