AVIATION INVESTIGATION REPORT
A10P0244

COLLISION WITH TERRAIN

CONAIR GROUP INC.
CONVAIR 580 C-FKFY
LYTTON, BRITISH COLUMBIA, 9 NM SE
JULY 31 2010

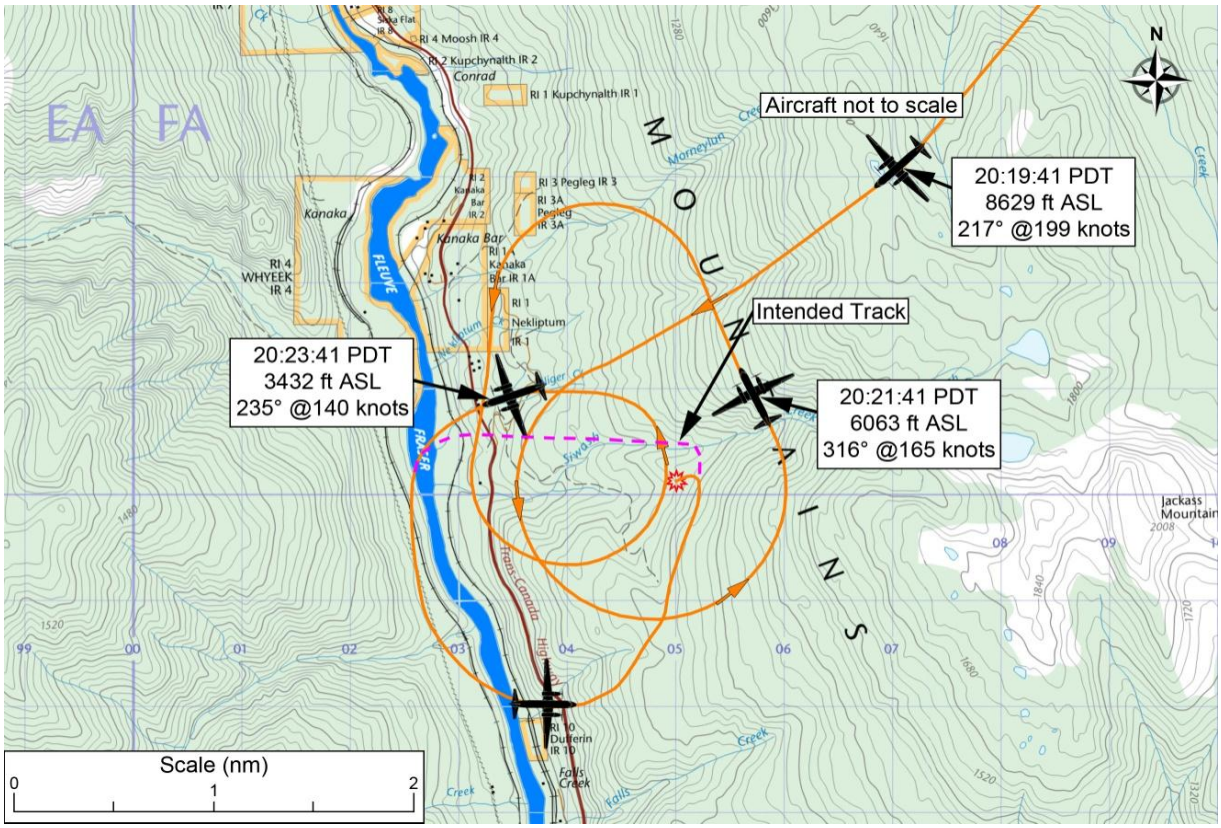
Figure 1. **Estimated flight path**

The plan was for Tanker 448 (T448) to make 8 left-hand circuits, dropping 1/8 of its retardant load each time. The terrain imposed a requirement to modify the standard rectangular circuit [1] to a triangular-shaped circuit (Figure 1). This consisted of flying a combined downwind/base leg from the Fraser River northbound over the rising east side of the canyon to a point at the edge of the ravine.

A single left turn to final required a change of direction greater than 90° at a bank angle of up to 40°. T448 then had to descend 900 feet into the ravine to make the drop. After each drop, T448 was to proceed straight ahead over descending terrain in the ravine back toward the Fraser River.

There were 2 sites associated with this accident: the site of the tree strikes at the edge of the ravine, and the main accident site at the bottom of the ravine. T448 struck 3 trees on a knoll at the edge of the ravine at approximately 3020 feet asl about 8 seconds before the crash.

It could not be determined if T448 approached the exact location where the bird dog had crossed the edge of the ravine. Since the edge of the ravine generally sloped down from right to left, a track further to the right would encounter higher terrain.
