Transport  
Canada

TP 185E  
Issue 4/2010

# AVIATION SAFETY LETTER

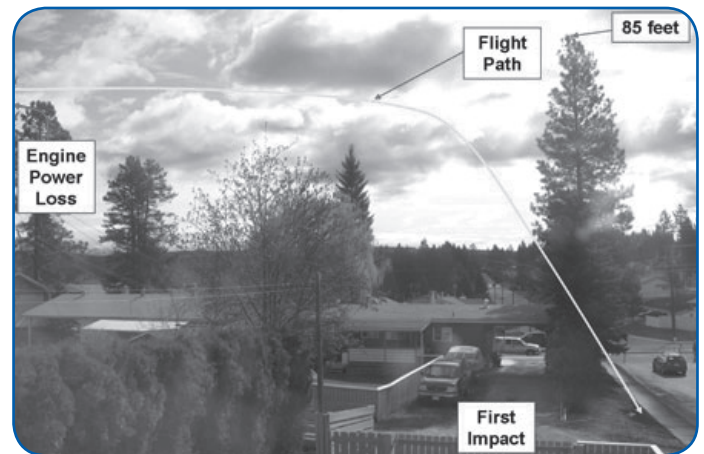
*Telemetry data from the helicopter allowed investigators to recreate the flight path, depicted above.*

The cause of the loss of engine power was not determined. No evidence was found to suggest that any of the engine modules had suffered any pre-impact mechanical event that would have contributed to a loss of engine power. The accident FCU and PTG were damaged, and while it is possible that either one malfunctioned, the TSB could not make a definitive conclusion on them.

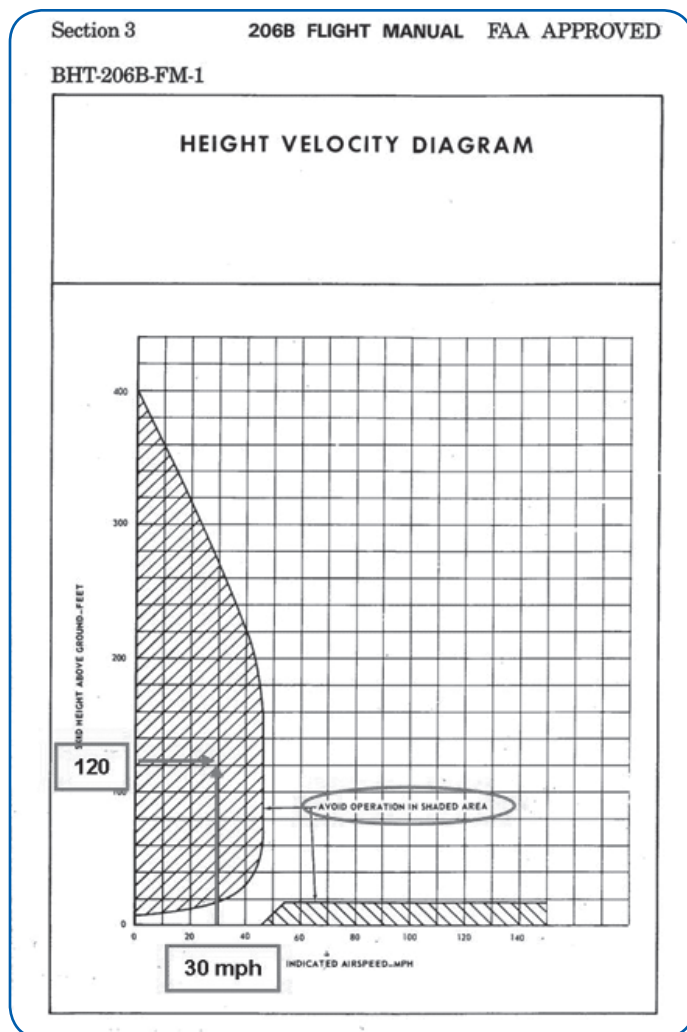
*Height velocity diagram*

The HVD shows that low altitude and low airspeed combinations present a significant challenge to pilots

in landing successfully from an event that requires an immediate landing. On the diagram, such higher-risk zones are labelled “avoid” areas and represent the worst circumstances for recovery. The accident helicopter was frequently exposed to the higher-risk avoid zones of the HVD during its passage over the built-up areas of Cranbrook.

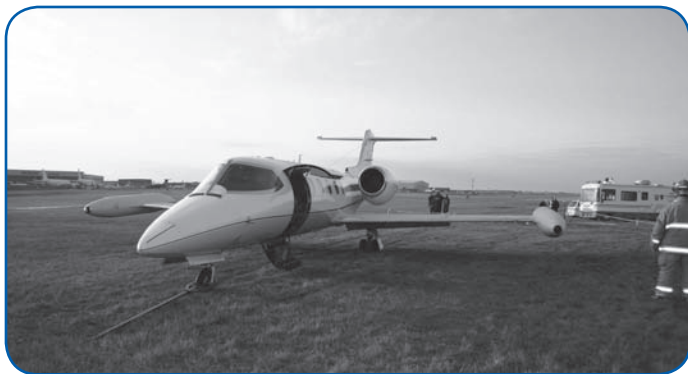
### TSB Final Report A06Q0190—Runway Overrun

1. A “B” nut loosened, resulting in a leak and depletion of the hydraulic fluid and preventing normal operation of the flaps, spoilers, thrust reversers, and wheel brakes.
2. The crew did not notice that there was a loss of hydraulic pressure and therefore did not plan for a landing without normal stopping systems or for the use of the emergency brake system.
3. When the aircraft landed, the flaps were extended to only 20°, the spoilers did not deploy because there was no hydraulic or backup air pressure, the thrust reversers did not deploy, normal braking did not work, and the emergency brake system was not used. Consequently, the aircraft overran the runway.

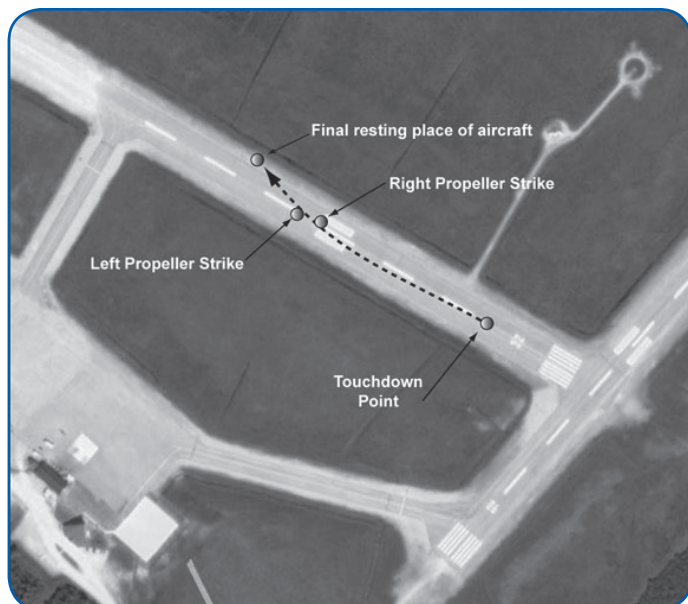
Site diagram

No faults were found with the aircraft that would indicate any mechanical failure or improper rigging of the landing gear. Retraction of the landing gear can only be accomplished if the down locks are removed during the retraction sequence. Therefore, due to the play in the landing gear handle, and the ease with which it could be bumped up, it is likely that the landing gear handle was inadvertently positioned above the locking solenoid before weight on wheels was achieved and that during the landing roll the handle was inadvertently bumped up far enough to begin the retraction sequence.

1. The spring in the landing gear handle was broken and allowed easy movement of the landing gear handle past the neutral stop.

2. During the approach, the landing gear handle was most likely placed in a position that bypassed the anti-retraction system.
3. The landing gear handle inadvertently moved to an “UP” selection during the landing roll, which activated the gear warning horn and retracted the landing gear.

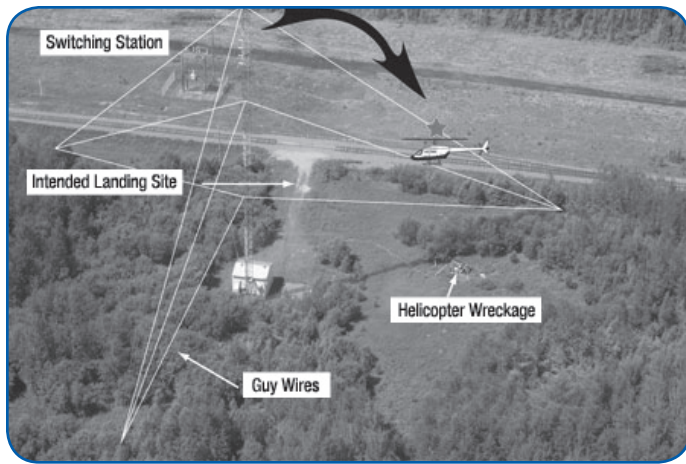
*Accident site*

The ELT did not activate even though impact forces exceeded the threshold of the G-switch. The type of G-switch used in this ELT was a single-axis, ball-and-spring-type switch. This type of switch will automatically activate the ELT only if a component of the impact force is in the same direction as the orientation of the switch.

During examination of the switch, black powder residue was found and the switch was seized within its casing; thus, electrical contact was never established and the ELT failed to activate. The ELT was properly attached and located in the cockpit of the helicopter as per current regulations, but the accident impact forces were in a direction that may not have activated the G-switch even if it had been serviceable. The failure of the ELT did not affect the rescue of the three injured persons because of the availability of phone service at the communications tower.

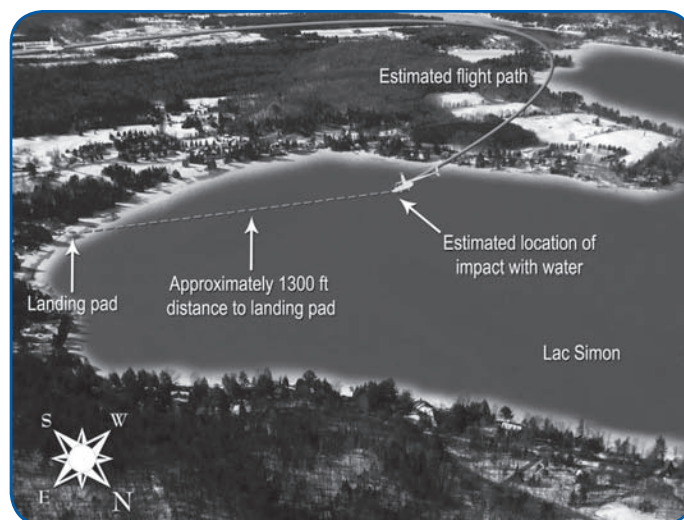
*Estimated Robinson R44 flight path before impact with water*

1. It is likely that the effect of the black hole illusion caused the pilot, in full control of the aircraft, to unknowingly fly the helicopter lower than the intended approach path, causing the helicopter to collide with the surface of the water well before reaching the desired landing area.
2. The helicopter approached the landing pad over water and, after colliding with the lake surface, the occupants had to evacuate in near-freezing water temperature, exposing them to hypothermia.
