**RAILWAY INVESTIGATION REPORT  
R10C0016**

**NON-MAIN-TRACK DERAILMENT**

**CANADIAN PACIFIC RAILWAY  
FREIGHT TRAIN 292-02  
MILE 0.0, BROOKS SUBDIVISION  
MEDICINE HAT, ALBERTA  
03 FEBRUARY 2010**

Report Number R10C0016

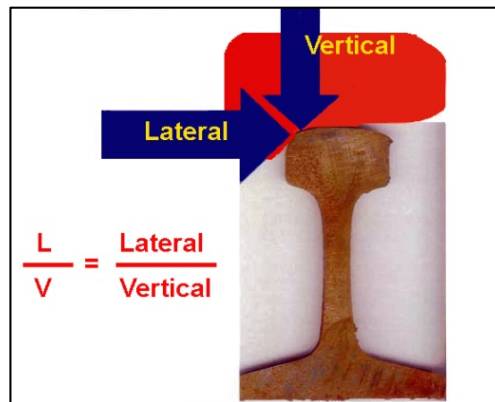
**Figure 4.** L/V Forces

All railcar draft gears have some longitudinal travel or “slack” designed into them which can be a significant factor in a long train with many cars. When head-end braking occurs, the train becomes bunched. The draft gear and cushioning devices become compressed and compression or “buff” forces result. The buff force generated can be high, especially during the transition from a stretched to a bunched state when the trailing cars impact against the cars ahead. When high buff forces act on cars on curved track, where the drawbars have taken an angle to each other, high lateral forces can be generated that come to bear through the wheel flange against the gauge side of the rail. The run-in of slack and the continued build-up of buff force during braking events must be properly managed to avoid elevated lateral versus vertical force (L/V) ratios (see figure 4).

L/V ratios quantify the relationship between the weight of the locomotive or railcar bearing down on the rail through the wheel interface (i.e., vertical force) and the force of the wheel flange pushing out on the rail (i.e., lateral force). The single wheel L/V ratio can be used to predict the risk of the wheel climbing the gauge face of the rail or lifting off the rail. Circumstances in which a car is operating with high lateral force and low vertical force can result in a wheel climb event and derailment. For normal flange/rail contact conditions, a wheel L/V ratio of 1.5 can cause wheel climb.

- The derailment was caused by the extremely high lateral force transformed from the high in-train buff force under the DB application which exceeded the GOI limits.
