RAILWAY INVESTIGATION REPORT
R10T0035

MAIN-TRACK TRAIN DERAILMENT

CANADIAN NATIONAL
FREIGHT TRAIN NUMBER M36921-02
MILE 92.10, KINGSTON SUBDIVISION
MORRISBURG, ONTARIO
02 MARCH 2010

Report Number R10T0035

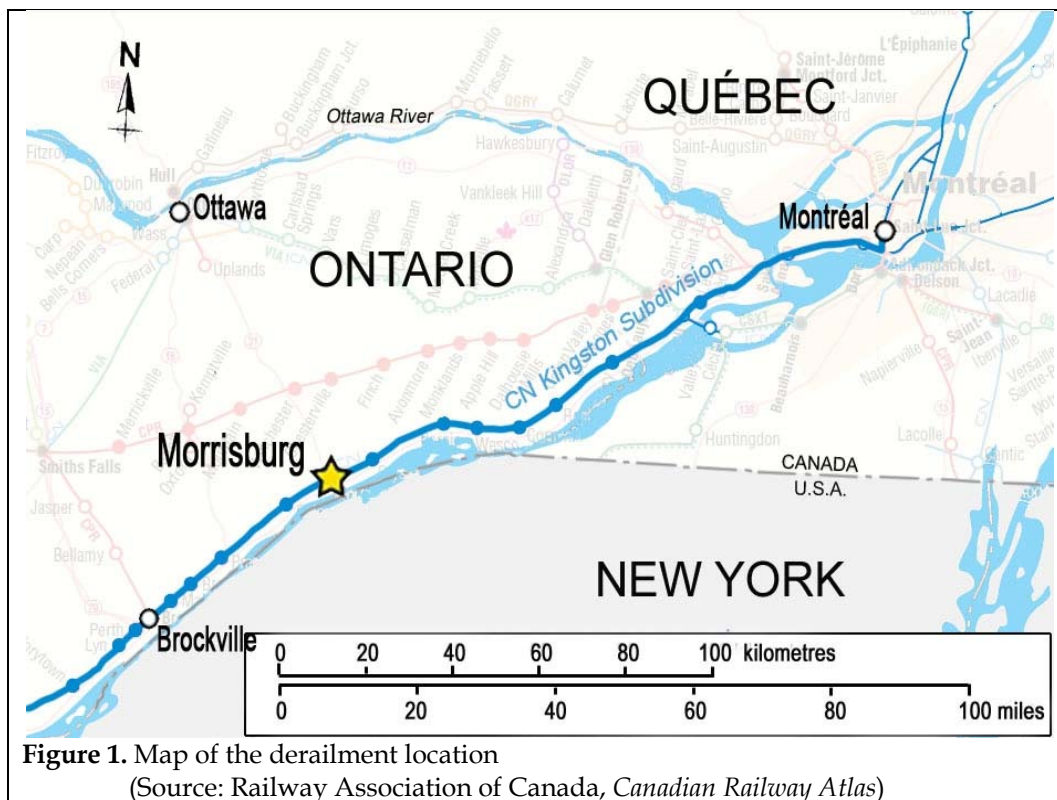
While en route after departing from Montreal, the train traversed several wayside inspection stations equipped with hot bearing and dragging equipment detectors. No alarms were noted. At 1418, while travelling in throttle 8 at a speed of 51 miles per hour (mph) on the north track, the train experienced an undesired emergency brake application at Mile 92.53, near Morrisburg, Ontario (see Figure 1). At 1419, the train came to rest with the lead locomotive at Mile 93.09. After stopping, the crew followed emergency procedures and determined that 26 cars (39th through 64th) had derailed.
