**MARINE INVESTIGATION REPORT  
M10F0003**

**KNOCKDOWN AND CAPSIZING**

**SAIL TRAINING YACHT *CONCORDIA*  
300 MILES SSE OFF RIO DE JANEIRO, BRAZIL  
17 FEBRUARY 2010**

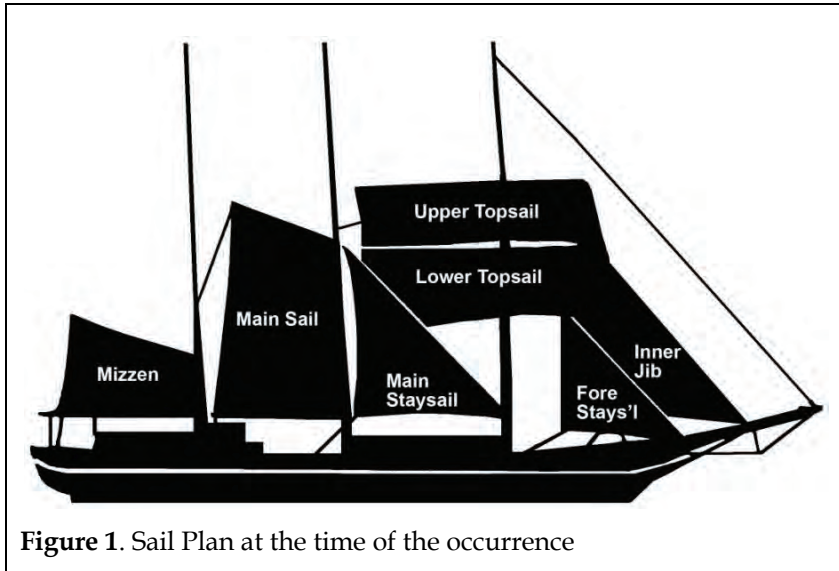
Figure 1. Sail Plan at the time of the occurrence

On the morning of 17 February 2010, in anticipation of the expected weather, the master shortened sail, culminating in the following sail plan at the end of his watch (1200): inner jib, fore staysail, upper and lower topsails, main staysail, main, and reefed mizzen sails (see Figure 1).<sup>12</sup> The 2/O, whose watch was from 12 to 4, arrived in the wheelhouse at 1150. During the handover of the watch, the master and the

2/O discussed the sail plan and the 2/O was advised that it was suitable for winds up to 40 knots. The master instructed the 2/O to maintain, if possible, the wind abaft the beam and to keep a comfortable heel angle for the classes. He also instructed the 2/O to brace the yards and to trim the sails as required as the wind backed, and to bear off to port and run before any squalls. The 2/O and master then discussed action to be taken in case it was necessary to reduce sail. The vessel was on a broad reach,<sup>13</sup> on a starboard tack, with a course between 200° and 220° (G). The apparent wind speeds were between 15 to 18 knots, with seas of 1.5 to 2 meters from the north and a long, low southerly swell. The air temperature was between 29°C and 31°C.

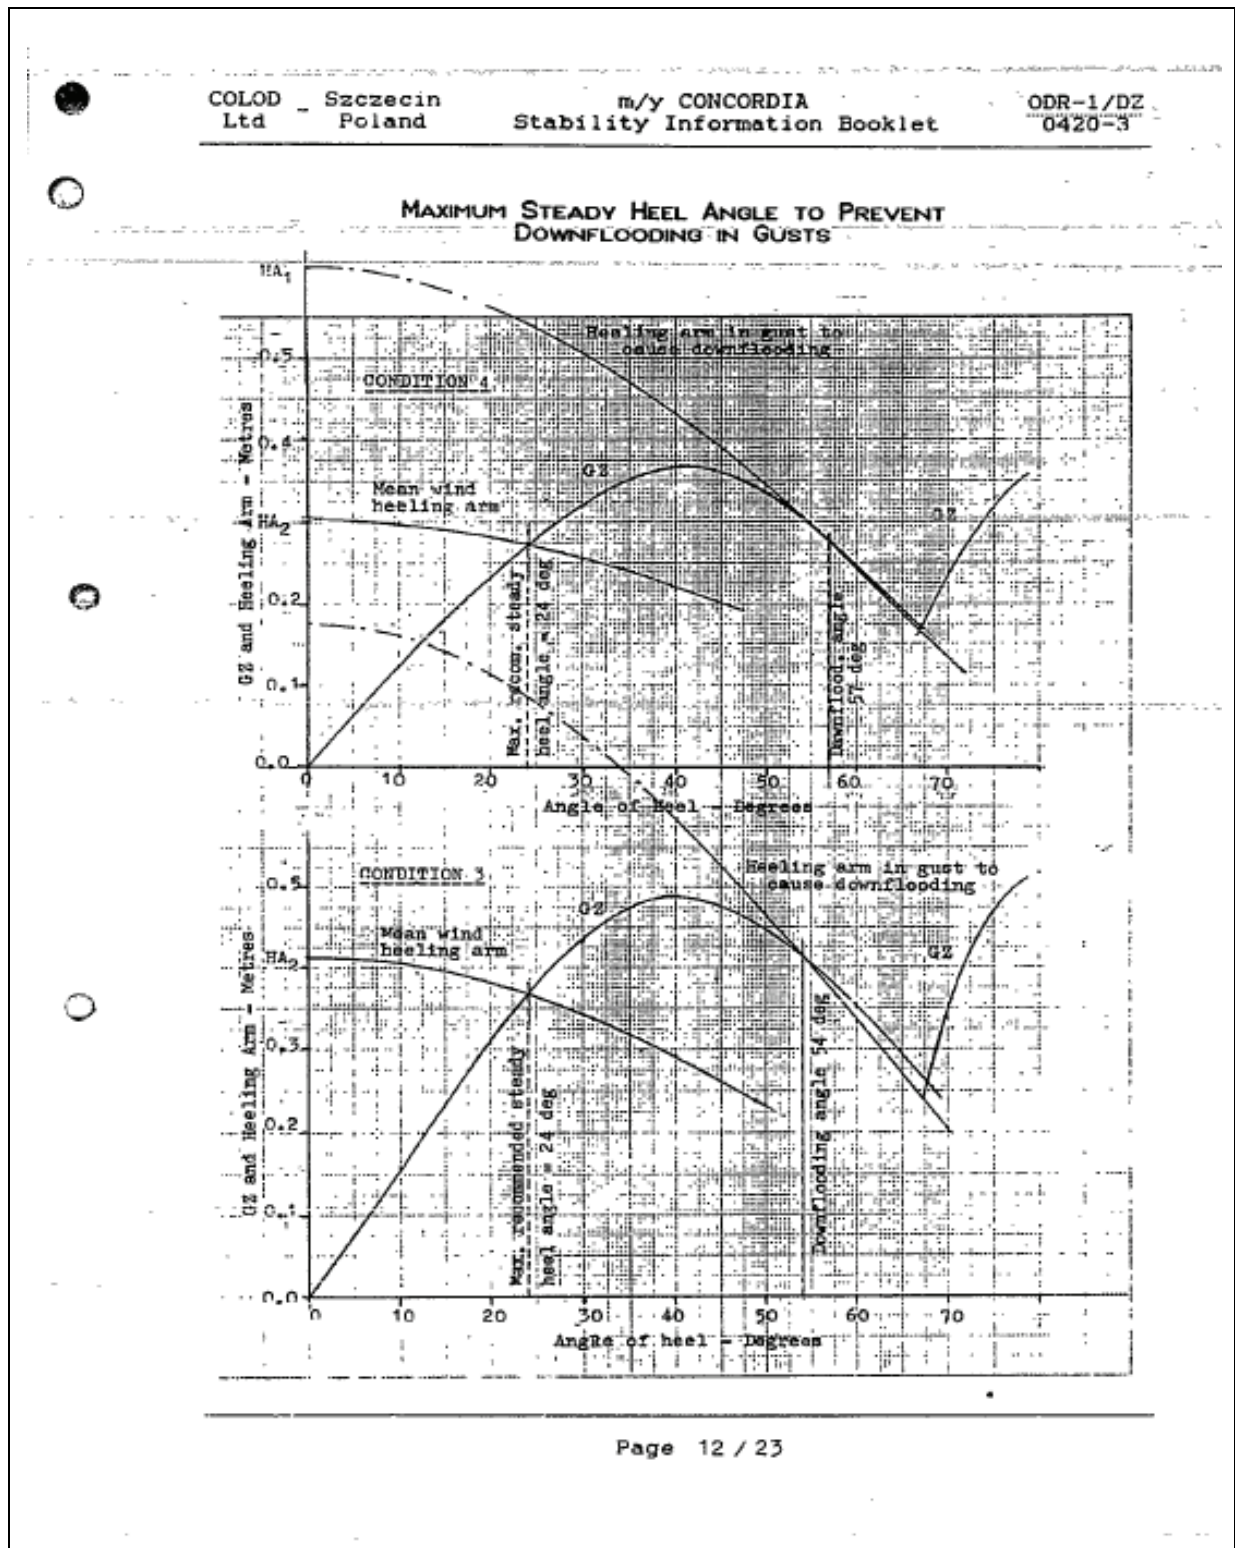
# Appendix F – Maximum Steady Heel Angle to Prevent Downflooding in Gusts and Squalls

Curves of maximum steady heel angle indicate the range of mean or steady heel angles beyond which the vessel will suffer downflooding in the event of a squall.

Operation of the vessel in cyclonic conditions particularly in the hours of darkness, where severe squalls are imminent requires the recommended maximum steady heel angle to be reduced depending on the mean apparent wind speed in accordance with the curves presented above.

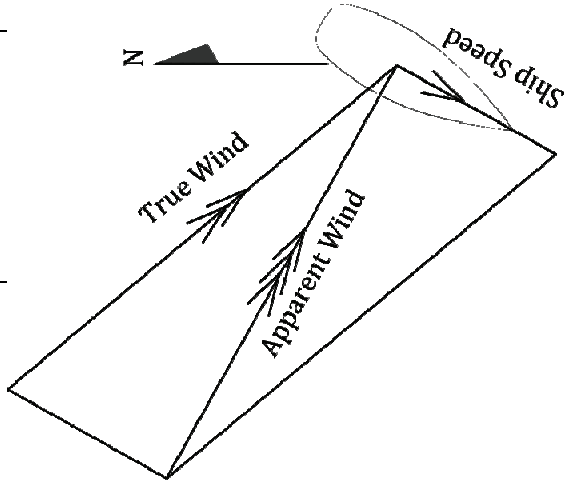
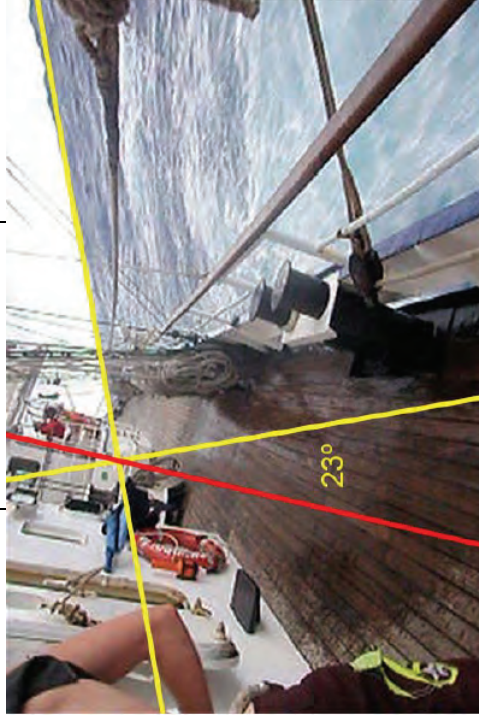
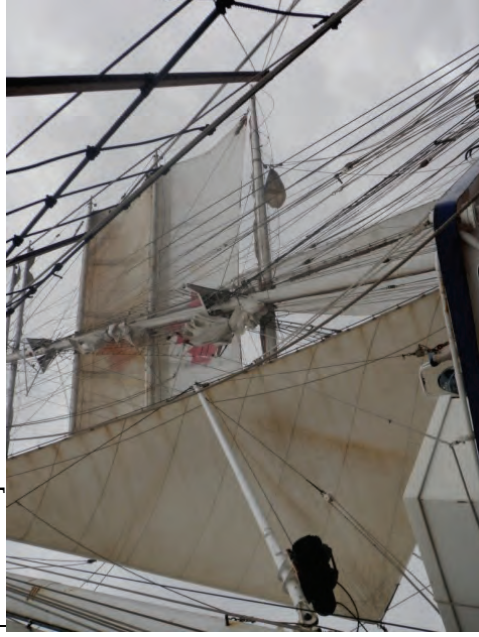
Time Period (Approx)	Ship Speed /Heading	True Wind	Apparent Wind	Heel	Notes
1420 2 to 3 minutes - Student takes video (57 sec) showing conditions on deck and some still photos	Approximation: 9 knots at 210°	Approximation: 25 knots at 320°	Investigation Info: 23 knots  Derived Using Approximations for Ship and True Wind Info: 23.5 knots at 88.9°  * See notes	Investigation Info: 23° min  Calculated range of apparent wind speed for this heel is 20 to 28 knots * See notes	<ul style="list-style-type: none"> <li>Analysis of video footage determined that the minimum angle of inclination of the vessel which could be discerned from the video was 23°. [See photo, below]</li> <li>Video shows inner jib with leading edge full but trailing edge flapping; likely due to blanketing effect of forestaysail. Main staysail and main also appear full, indicating a likely apparent wind angle at least at the beam or aft of that</li> <li>Square sails full, indicating likely apparent wind angle at least at the beam or aft of that [see photo below]</li> </ul>

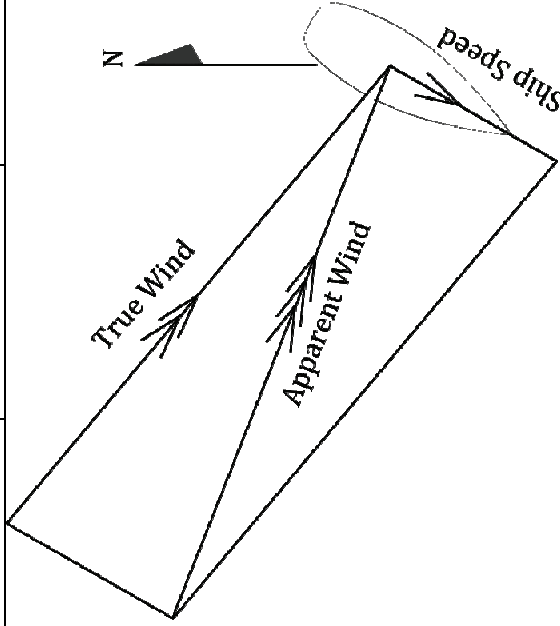
Time Period (Approx)	Ship Speed /Heading	True Wind	Apparent Wind	Heel	Notes
1423 Start of capsizing	Approximation: 9 knots at 210°	Approximation: 28 knots at 310°	<p>Investigation Info: Wind speed starts to increase (climbing to 27 knots) and apparent angle decreases</p> <p>Derived Using Approximations for Ship and True Wind Info: 27.9 knots at 81.5°</p> <p>* See notes.</p>	<p>Investigation Info: Vessel starts to heel; motion is essentially continuous</p> <p>Calculated range of apparent wind speed for heel from 38° to 68° is 27 to 37 knots</p>	<ul style="list-style-type: none"> <li>As vessel heels, port lookout moves to bridge door to express concern; at this point vessel would have been heeled to about 63.5° as bridge deck port side is just going underwater.</li> <li>Information obtained during the investigation indicated that winds did not reach a level that caused concern or made it impossible to remain standing upright on deck. Considering these factors and the calculations it is unlikely that the winds would have been much in excess of 40 knots.</li> <li>The 2/O observed the anemometer (30 knots from 120° to 150°) when the vessel was heeled by about 88°. It should be noted that the anemometer is not considered reliable at this angle and also that the vessel may have turned in response to the port helm.</li> </ul>
