Development and Assessment of Crawl Space Remediation Strategies

CMHC External Research Program (ERP) Project

Figley Consulting Associates Ltd.
Saskatoon, SK

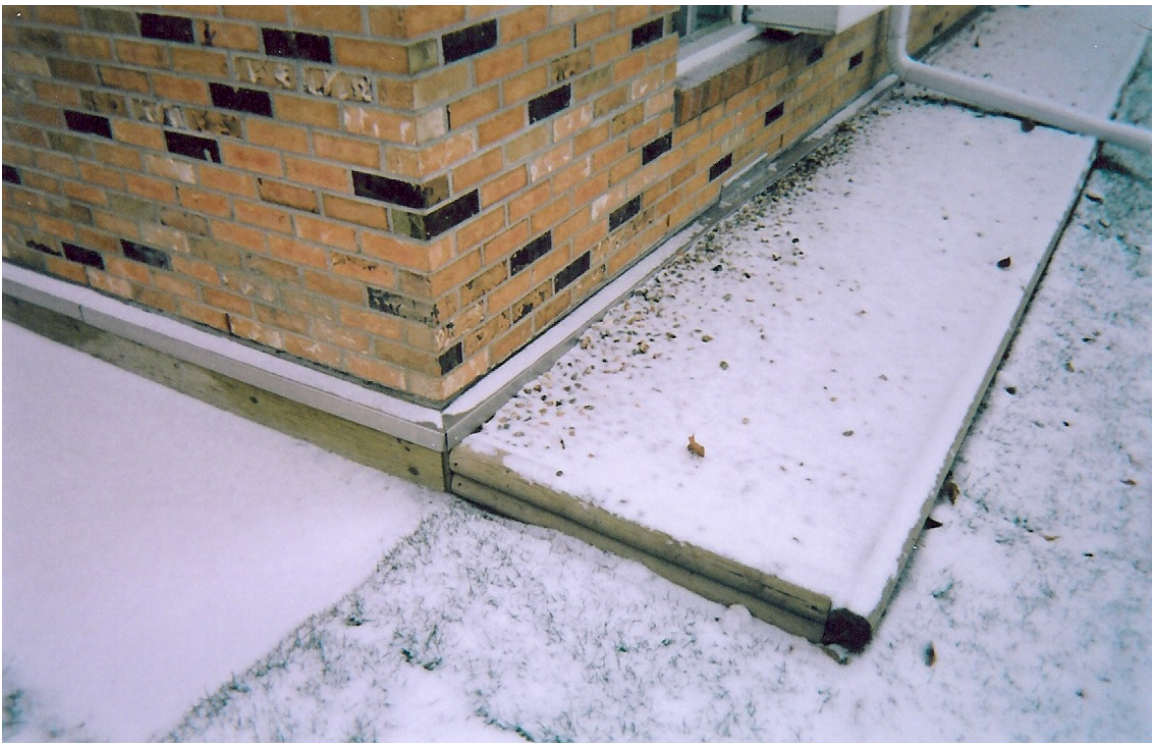
Photo 9: Perimeter of the building has a graded landscape. Exterior walls of the crawl space are insulated from the exterior, covered with pressure treated plywood and capped with metal flashing.

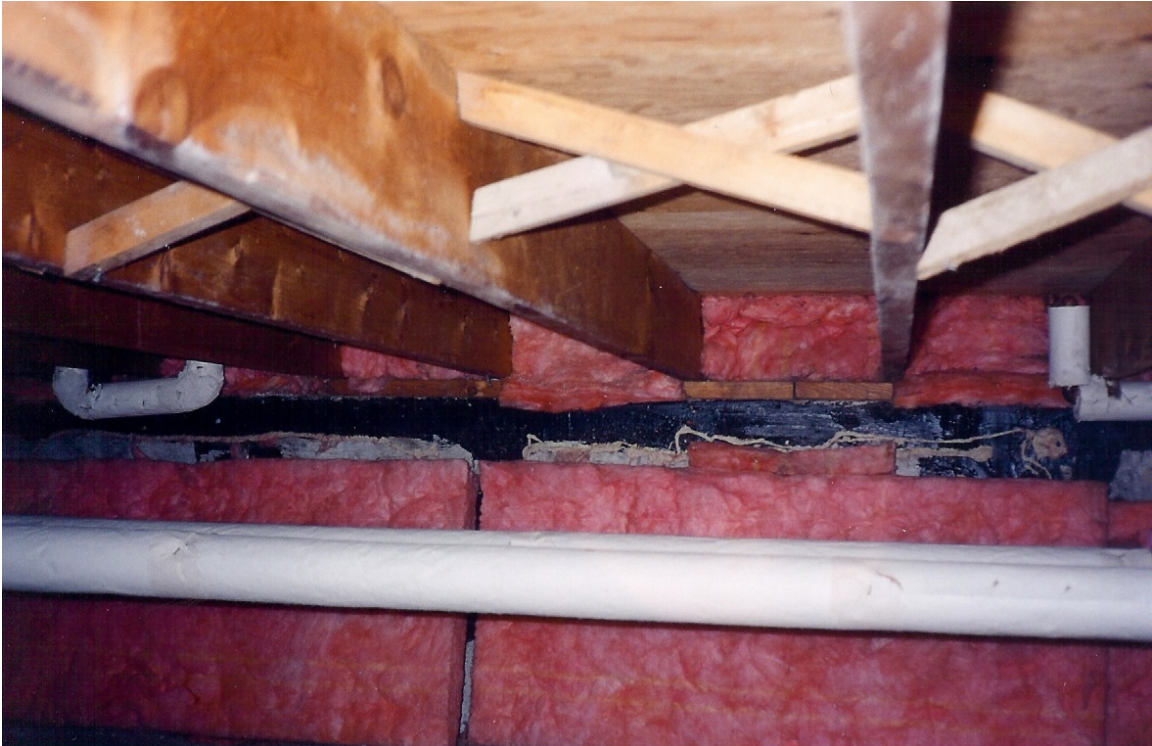
Photo 3: Interior batt insulation on the exterior walls of the crawl space was not sealed or covered. Floor joists are visibly moldy.
