LONG TERM PERFORMANCE
OF SLAB-ON-GRADE HOUSE
FOUNDATIONS IN REGINA,
SASKATCHEWAN

Final Report

J. J. Hamilton P.Eng.

October 20, 2004

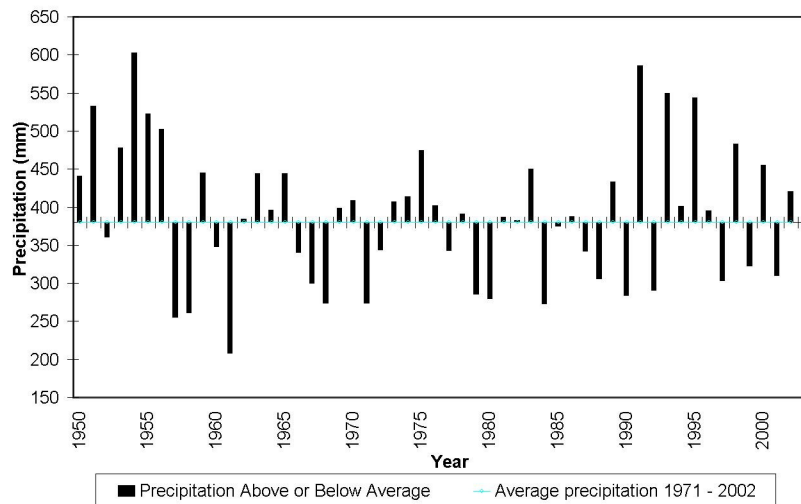
Figure 1 - Annual Precipitation for 1951 through 2003

Annual precipitation varies considerably and averages 380.55 mm (15 inches) over the 113 years of records. Figure 1 shows annual total precipitation above or below the average precipitation for the period 1951 to 2003. The range in annual precipitation for this period was 394.4 mm (15.5 inches) with a high of 602.7 mm (23.75 inches) in 1954 and a low of 208.3 mm (8.20 inches) in 1961.

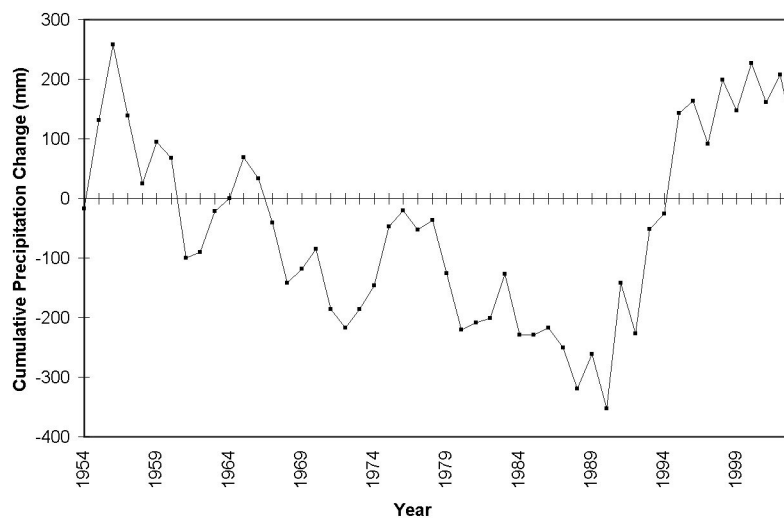
Figure 2 - Cumulative Departure from Long Term Average Precipitation

Figure 2 shows cumulative departure from average precipitation as calculated from 1890 using Environment Canada records for Station A, Regina with the plot showing the period of interest to this study. By summing the annual total differences (departures) from long term average annual precipitation the Cumulative Departure (CD) From Long-term Average Precipitation is calculated. In 1954 the annual precipitation was 227.6 mm (8.96 inches) more than the long term average. By adding 227.6 mm (8.96 inches) to the CD of -244.3mm (9.62 inches) for 1953 the CD of -16.7 mm (0.66 inches) is determined for 1954. In 1955 the annual precipitation was 147.5 mm (5.81 inches) above the long term average, resulting in calculated CD for 1955 of +130.8 mm (5.15 inches). This form of data presentation illustrates short and long term trends in drier and wetter than average precipitation. Correlations have been found between Cumulative Departure From Average Precipitation and the average moisture content of undisturbed soil profiles under flat topography and native grass vegetation. Correlations have also been found with vertical ground movements under conditions of zero runoff or run on and native grass vegetation. The subsoil moisture profiles prior to construction in an

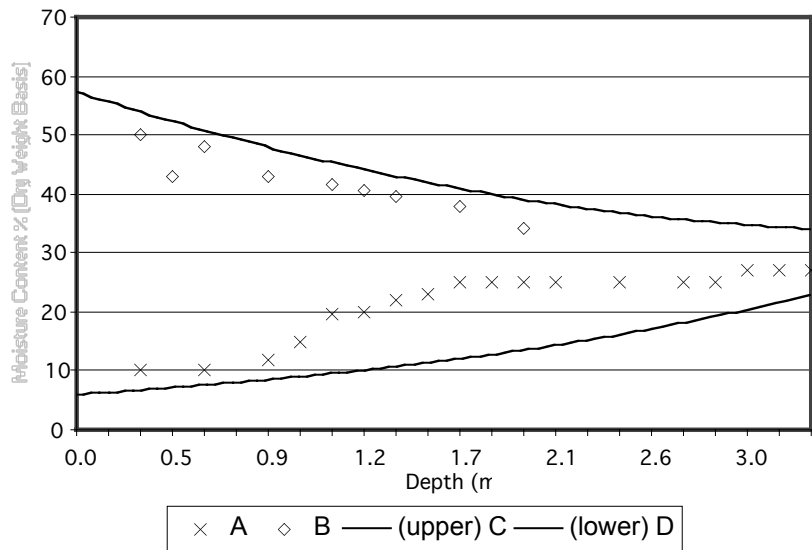
**Figure 3 - Probable Extreme Ranges of Water Content for Undisturbed Regina
Clays**

- A. Actual soil conditions after five years of heavy watering.
- B. Actual soil conditions after ten years in an uncovered crawl space
- C. Extremely moist conditions resulting from many years continuous surface flooding. (Hypothetical)
- D. Extremely dry conditions resulting from many years exposure to 75°F and 20% relative humidity. (Hypothetical)

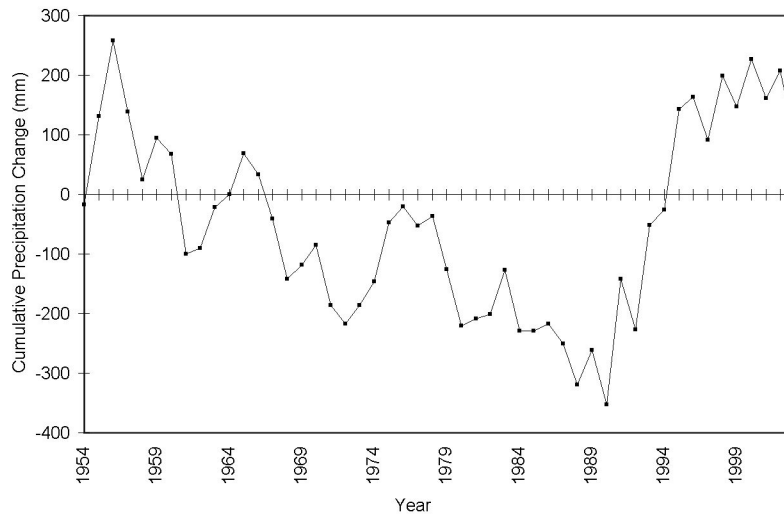
Figure 4b - Cumulative departure from Average Annual Precipitation

In Figure 4a the progressive heaving of the concrete back door stoop, the surface of the kitchen floor, the highest (NW corner), and the lowest (centre) points on the floor slab are shown above a plot of Cumulative Departure From Average Precipitation (Figure 4b).

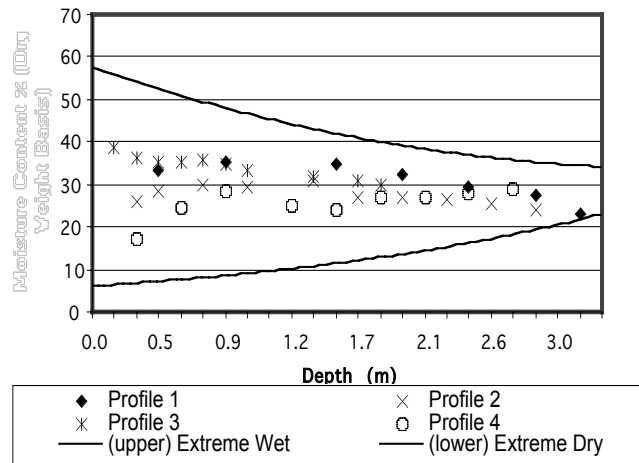
Figure 4c - Grass Covered Test Plot West Regina

By the summer of 1960 the soil moisture profile for a grass-covered backyard with no large trees or shrubs nearby is shown as profile #1 on Figure 4c, August 24, 1960. By Aug. 21, 1962 the soil moisture profile (#2) showed the effects of two drier than average years. The moisture profile (#3) for July 16, 1964 is wetter in the upper one m (3.3 feet) and drier in the next m (3.3 feet) than it was in 1960. The soil moisture profile (#4) for the same location on Aug. 21, 2003 shows the added influence of a line of lilac shrubs approximately 3 m (10 feet) away.

Water Content Profiles
 Profile 1 – August 24, 1960
 Profile 2 – August 21, 1962
 Profile 3 – July 16, 1964
 Profile 4 – August 22, 2003
