## Monitored Performance of an Innovative Multi-Unit Residential Building: Final Report

***MONITORED PERFORMANCE  
OF AN INNOVATIVE MULTI-  
UNIT RESIDENTIAL BUILDING***

**FINAL REPORT**

**Enermodal Engineering Limited  
650 Riverbend Drive  
Kitchener, ON N2K 3S2  
Tel: 519-743-8777  
Fax: 519-743-8778**

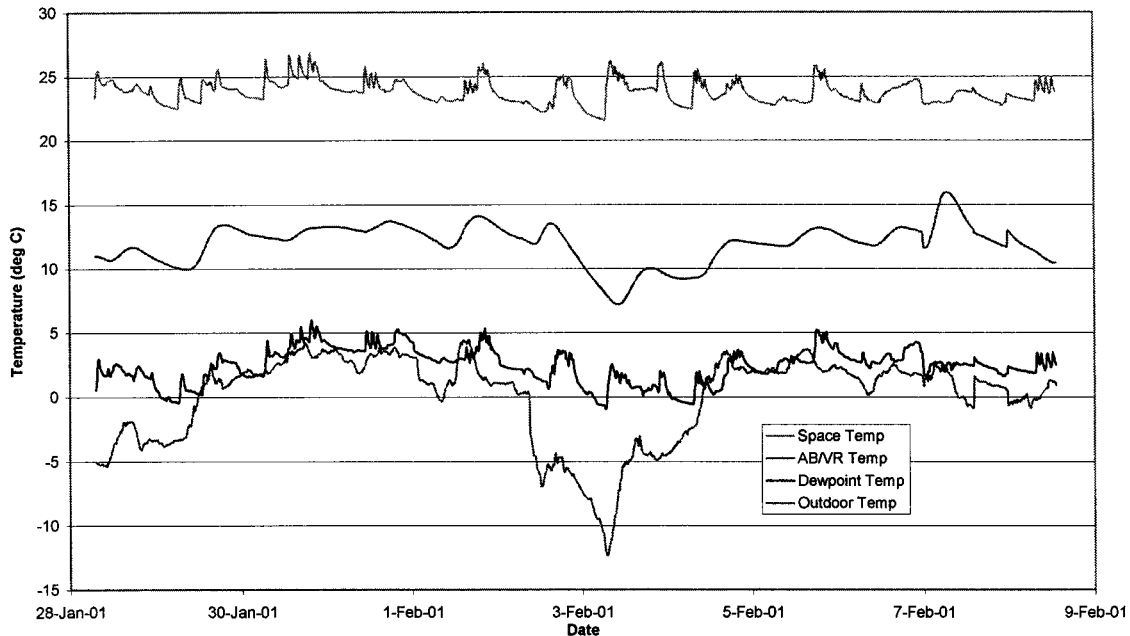
**Figure 3.4: Temperatures Across Brick Wall on a Cold Day**

Figures 3.4 and 3.5 show four representative temperatures over a typical three-day period in the winter for the brick wall and EIFS systems respectively. From top to bottom, the temperatures are indoor space temperature, surface temperature on the AB (exterior gypsum), dew point temperature of the indoor air, and outdoor temperature. All temperatures were measured, with the exception of the dew point temperature, which was calculated based on the measured temperature and humidity for the air in the space (typically around 25%). In the brick wall system (Figure 3.4), the surface temperature at

the plane of the AB is generally between 6 and 7°C warmer than the dew point temperature. Thus, there is little risk of condensation occurring on the plane of the AB.

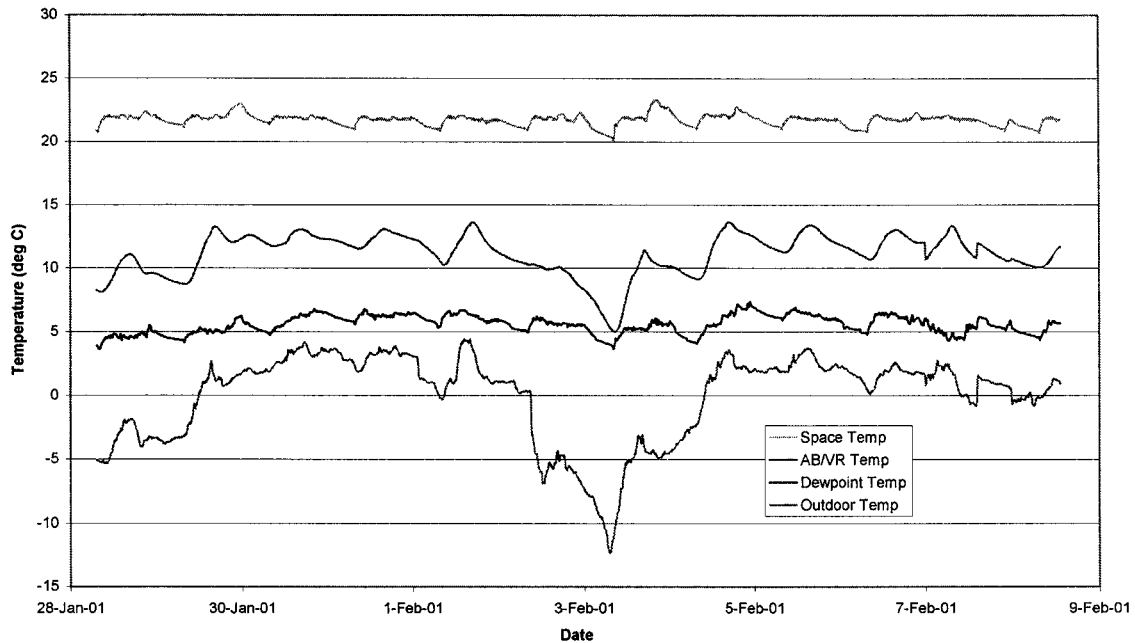
**Figure 3.5: Temperatures Across an EIFS Wall on a Cold Day**

Figure 3.5 shows the temperature measurements across the EIFS wall. Here the surface temperature at the plane of the AB is slightly closer to the dew point temperature than in the brick wall system. There are two reasons for this. First, the relative humidity in the suite is maintained significantly higher than in the suite with the brick wall section (35% vs. 25%). Second, the percentage of the total wall insulating value on the warm side of the exterior gypsum board is greater than for the brick wall. That is, the surface temperature at the AB is closer to the outside temperature because there is less insulation outboard with the EIFS system. Still, there is no real concern with condensation at the surface of the AB.

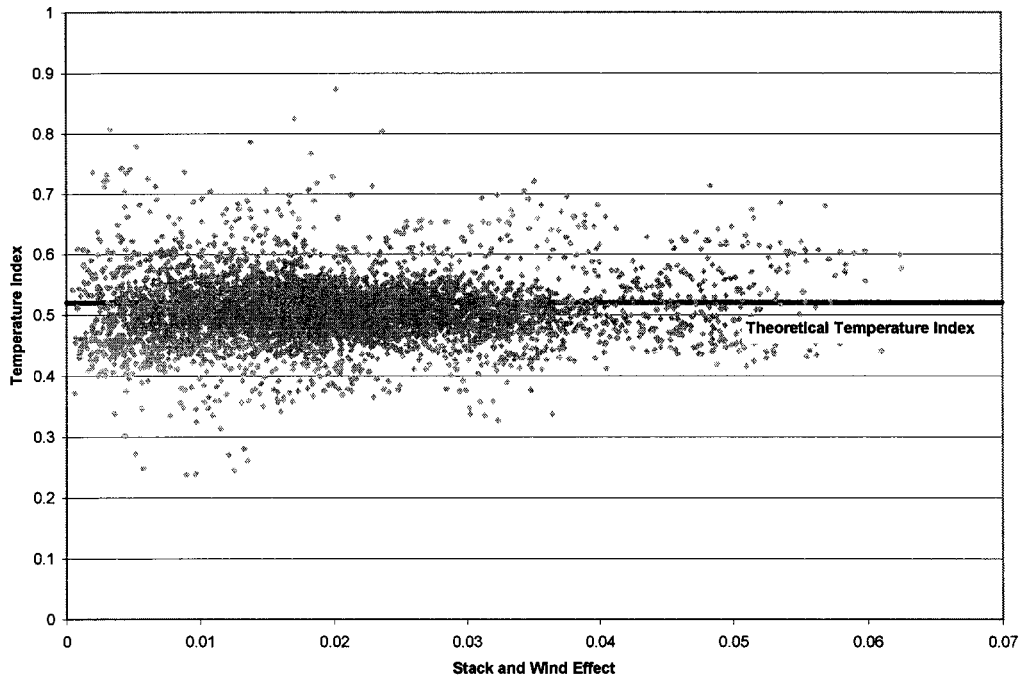
**Figure 3.7: Theoretical And Monitored Temperature Index for an EIFS Wall**

Figure 3.7 illustrates that the measured temperature index sometimes can exceed the theoretical index for the stucco wall. The variations do not follow any pattern with respect to pressure difference. This suggests that the air barrier is performing well and that there is practically no air movement through the air barrier. The scatter in the data is indicative of non steady-state conditions in the wall.

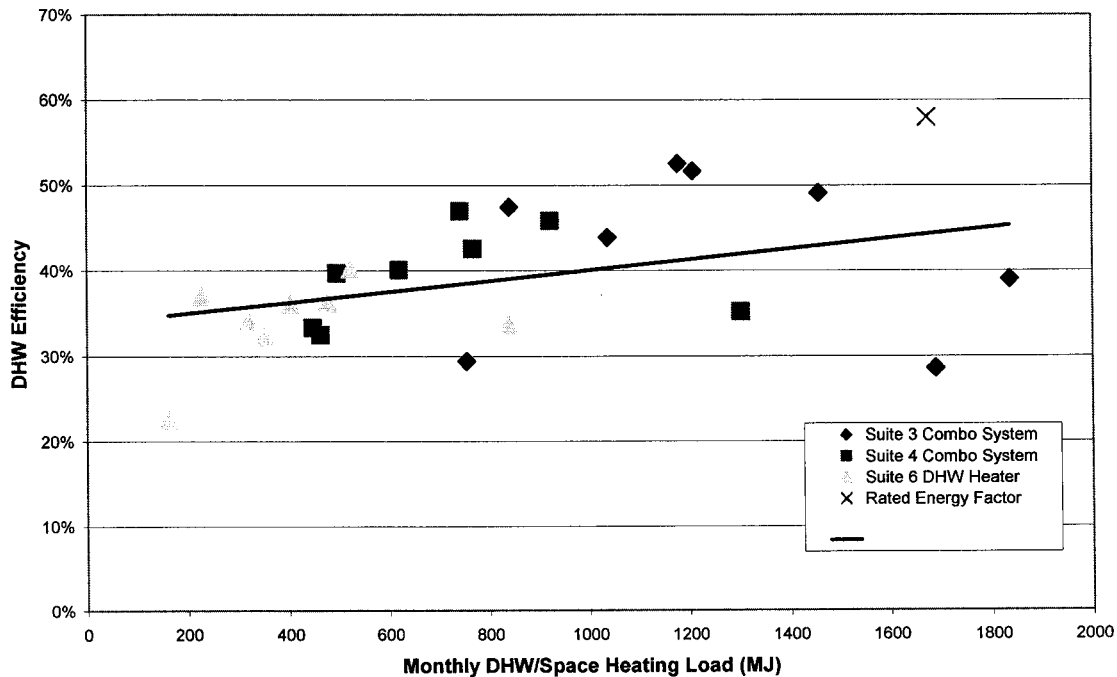
**Figure 4.2: Monitored Efficiency for Three Water Heaters**

As expected, Figure 4.2 shows that generally the seasonal efficiency fell as the water-heating load fell for the three water heaters monitored. As well, the monthly combustion efficiency is well below the measured combustion efficiency (Table 4.1) and the rated energy factor.

The monitored results show some correlation between DHW load and efficiency. Figure 4.2 below shows the correlation between monthly DHW and/or space heating load vs. calculated monthly efficiency. Each data point represents total load and efficiency for one month between February and August 2001. The rated energy factor of .58 (based on a load of 15 kWh/day or 1674 MJ/month) is also shown. A trend line drawn through the monitored points shows two effects, a linear relationship between load and efficiency, and the seasonal efficiency at the rating point below the energy factor. The limited number of data points (24) is insufficient for drawing definitive quantitative conclusions but the trends are valid.
