Deterioration of Parking Structures Research Project

**DETERIORATION OF PARKING
STRUCTURES RESEARCH PROJECT**

ABSTRACT

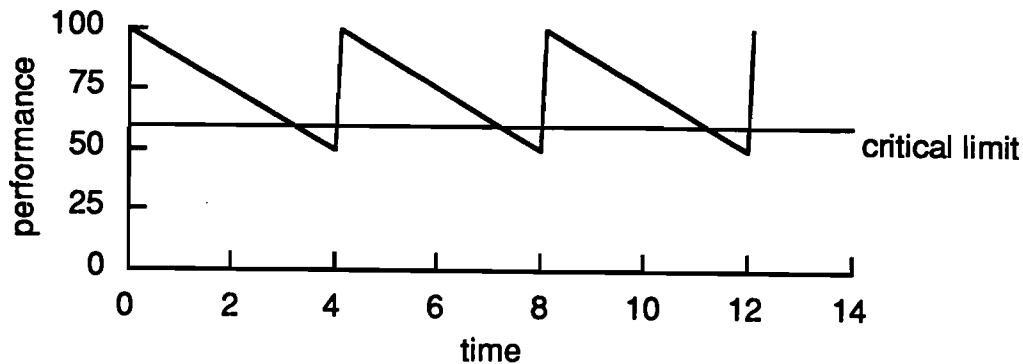
Fig. 3
Performance of a garage in time

Performance decreases rather rapidly below the critical limit at which time rehabilitation is needed to restore the level of performance, ideally to its design level. Because of the elevated chloride concentration of the concrete, deterioration reoccurs and eventually another repair will be necessary.

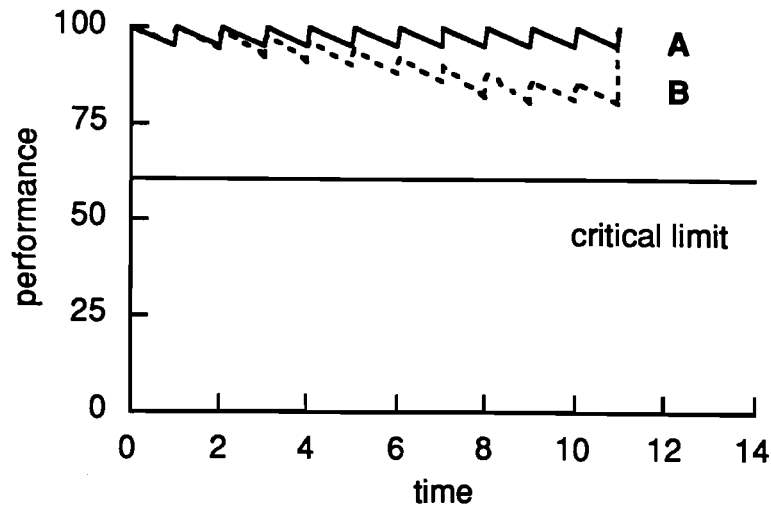
Fig. 4
Performance of a garage.
The effect of ongoing repairs

The performance in time if repairs are carried out at frequent intervals is represented by curve A of Fig. 4. Even if full restoration is eventually becoming difficult or impractical (Curve B), the great benefits of on-going rehabilitation is continuous excellent performance at a fraction of the cost of the major renovation approach.

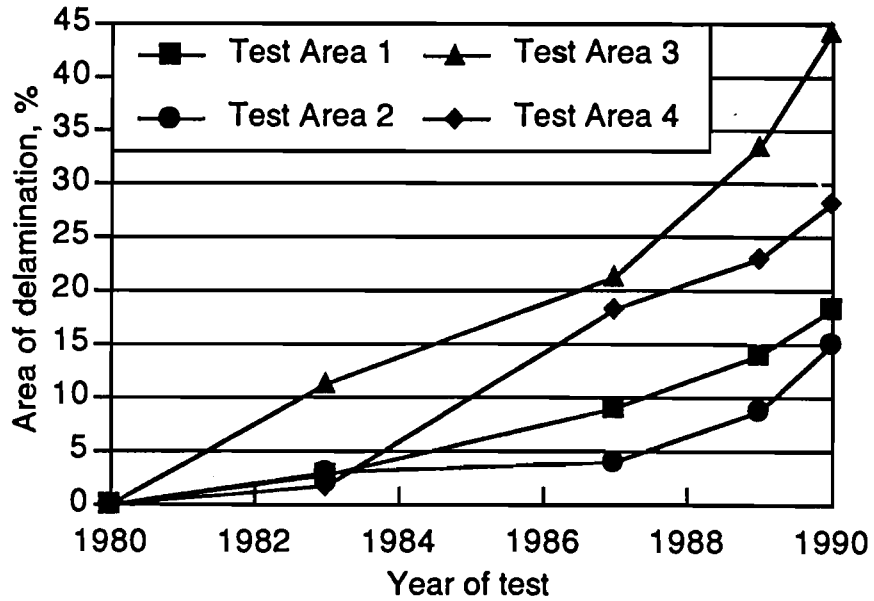
Fig.18.2
Garage No.18
Extent of delamination in test areas vs time

Delamination increases with time in an exponential fashion (e.g. Fig. 18.2, p.7, Appendix B) but over a period of 4-5 years the rate can usually be described by a linear equation (Fig. 18.3, p.7 Appendix B).

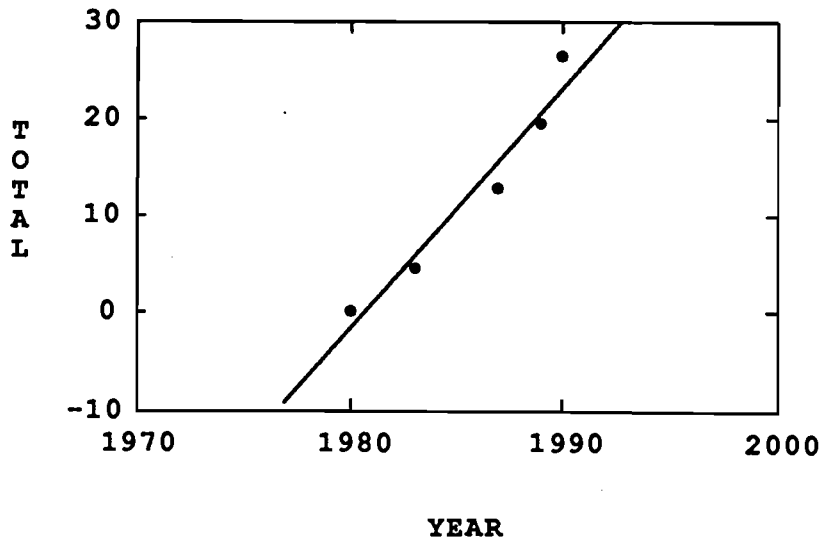
Figure 18.3
Garage No. 18
Regression line of extent of delaminations vs. time, all test areas

TOTAL=-4896.886+2.472*YEAR

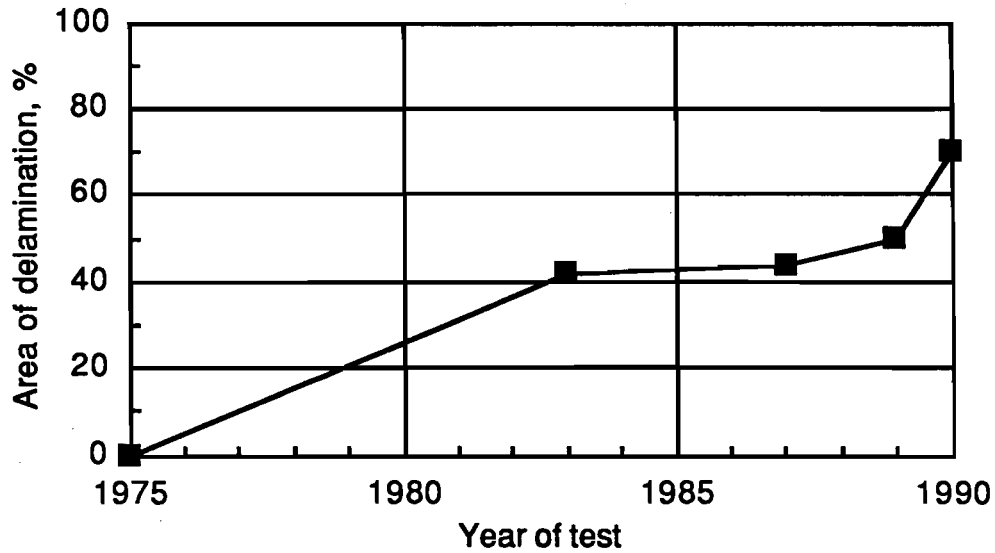
Figure 19.1
Garage No. 19
Total extent of delaminations in test areas vs. time

Almost certainly, the delamination indicated by the results in 1983 is to a large extent debonding. This is suggested by the pronounced plateau of the average (Fig. 19.1) and the results for several of the test areas. (Fig. 19.2 and Fig. 19.3).

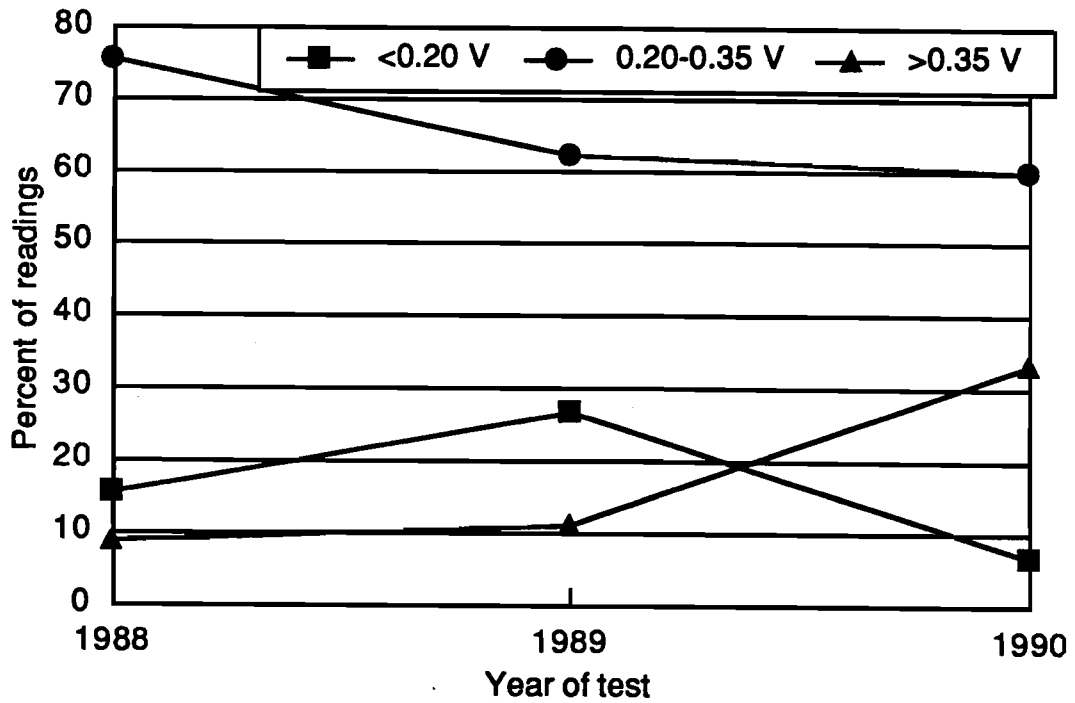
Fig. 53.7
Garage No. 53
Distribution of half-cell potential readings in Test Area B-3

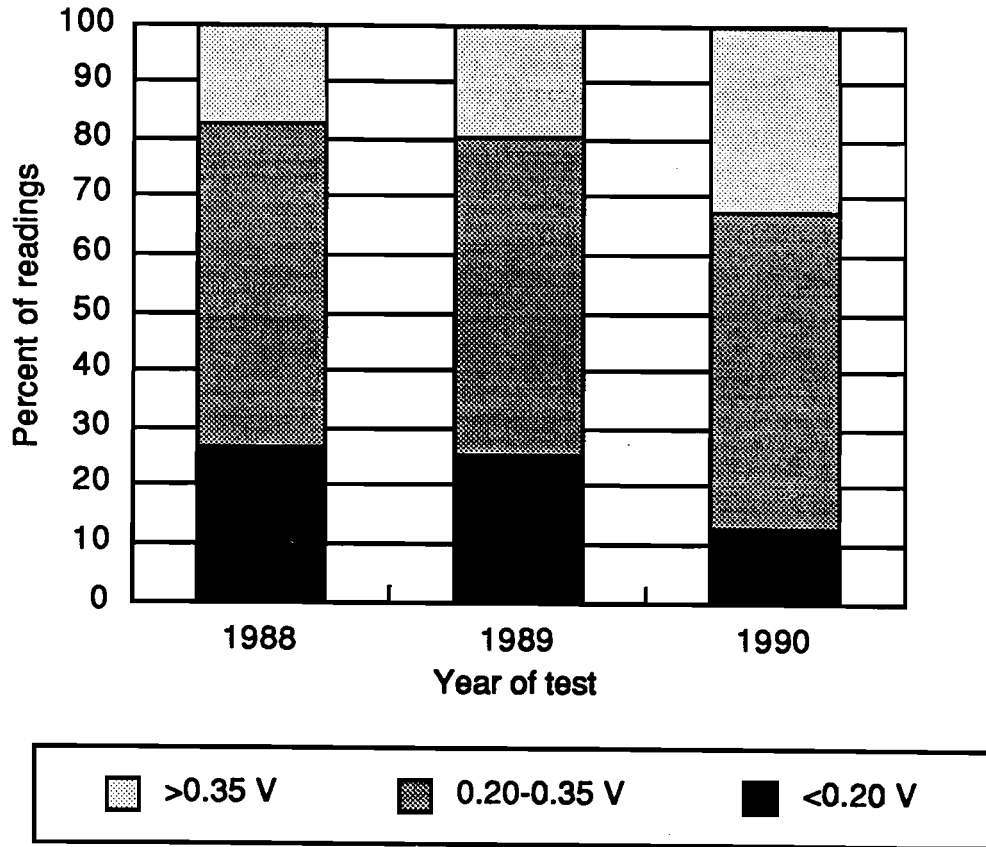
Fig. 53. 8
Garage No.53
Change of half-cell potential distribution
with time (all areas)

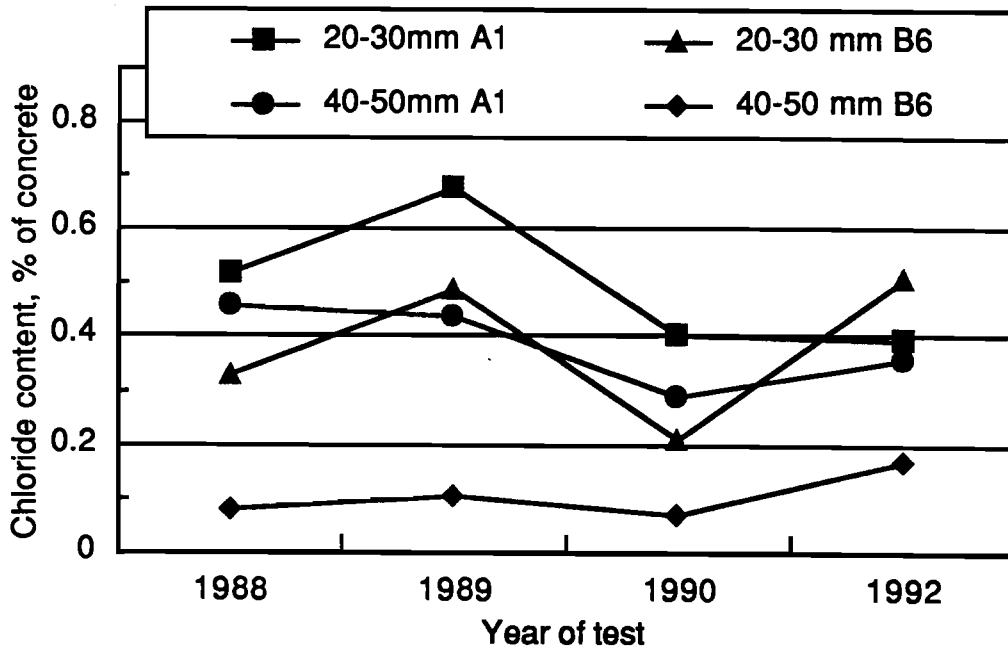
Fig. 53.9
Garage 53.
Chloride ion content (percent water soluble chloride ion by mass of concrete) of cored specimens

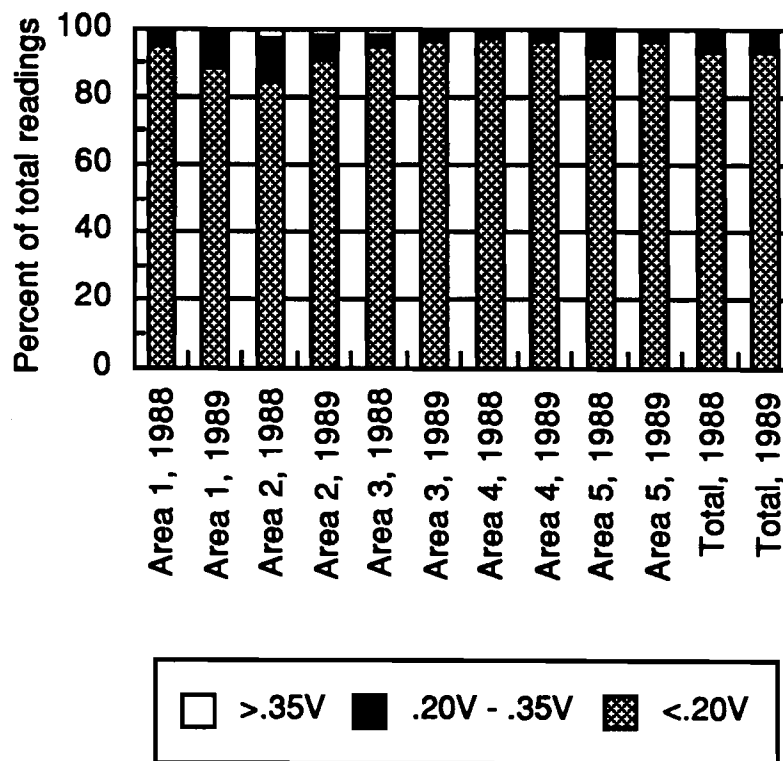
Half-cell Potential The distribution of the half-cell potential readings in the five test areas are presented in Fig. 54.1. Consistently with the delamination test results the overwhelming majority of the readings were less than -0.20 V (93.3%) and in the range of -0.20 V and -0.35 V (6.1%) indicating no, and little probability of corrosion, respectively. Only 0.6% of the readings had a value greater than -0.35 V, that signifies steel corrosion occurring at a greater than 90% probability. Considering the condition of this garage, the reliability of the finding that any corrosion is occurring must be questioned.

Fig. 54.1
Garage No. 54
Half-cell readings of stated ranges in test areas, percent

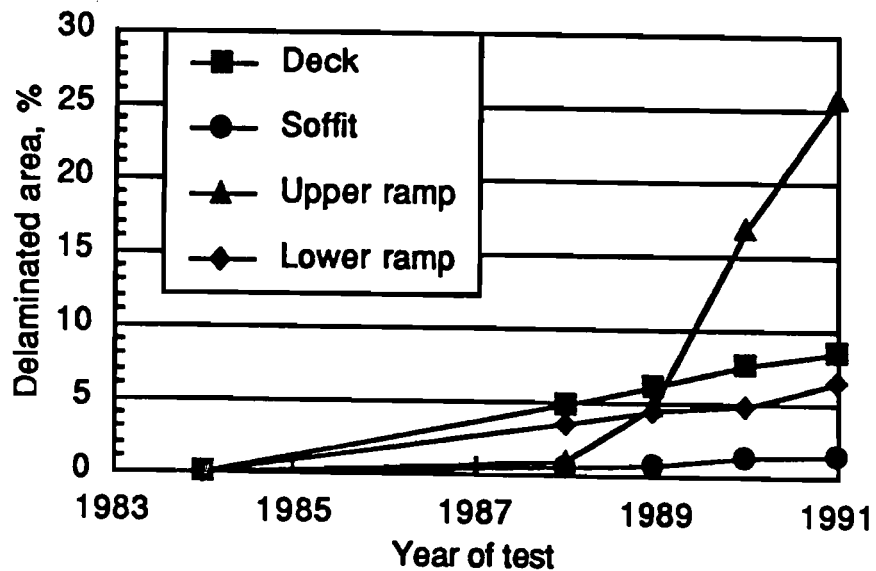
Delamination: The growth of the delaminated areas is shown in Figure 55.2, and the numerical values given in Table 55.2.

Fig. 55.2
Garage No. 55
Growth of the delaminated areas, expressed
percent of total

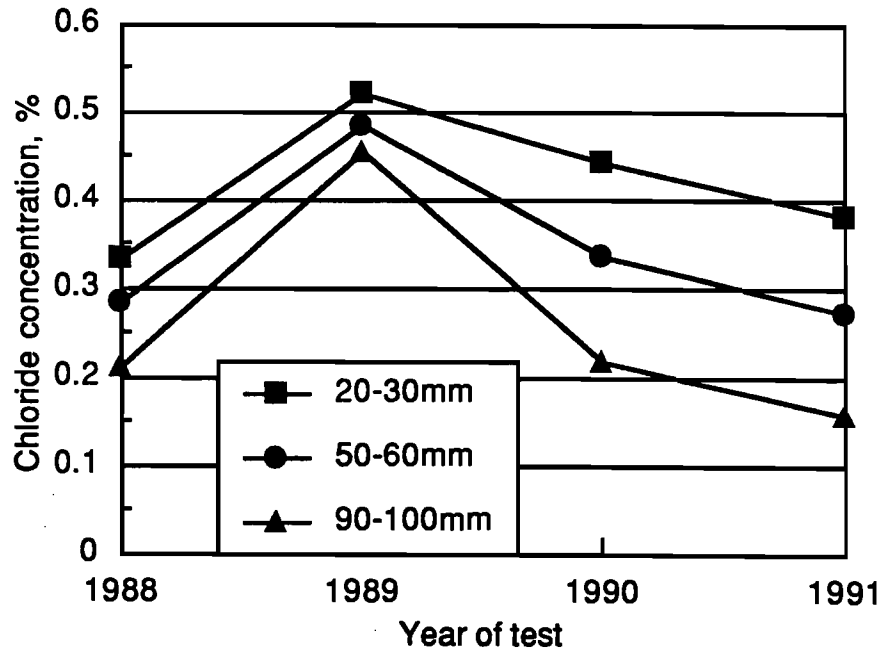
Fig. 55.3
Garage No. 55
Average chloride content, at horizons indicated,
of the three concrete cores extracted from the deck

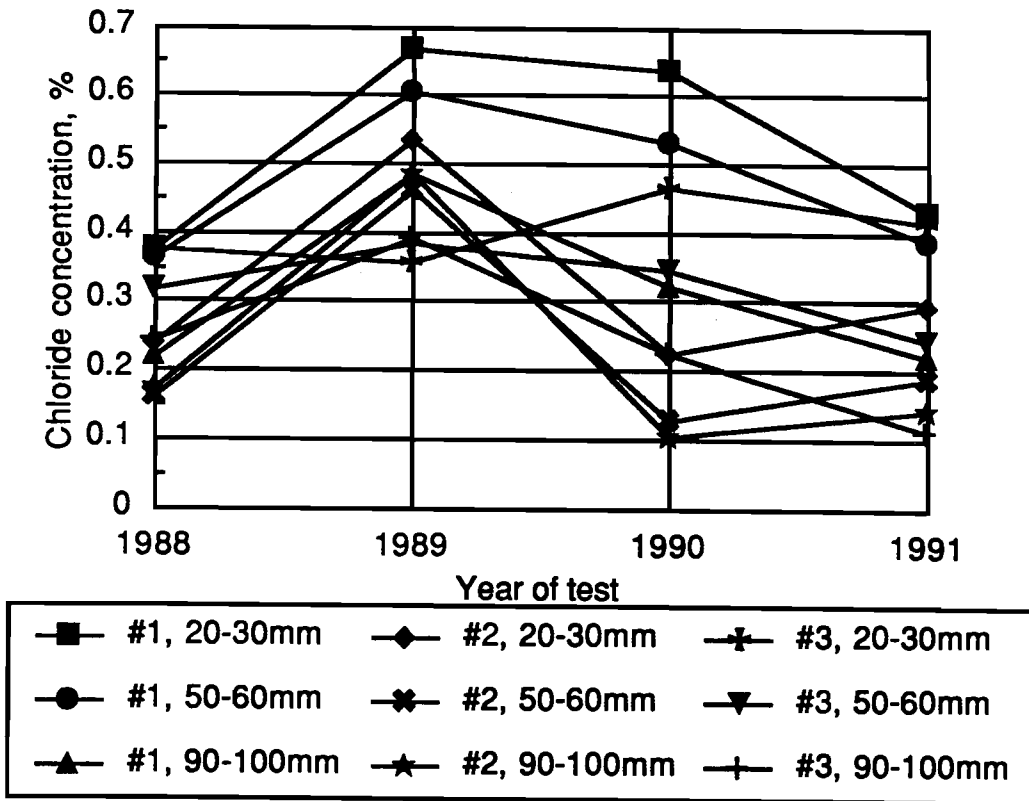
Fig. 55.4
Garage 55
Chloride content of concrete cores in
weight percent, at horizons indicated

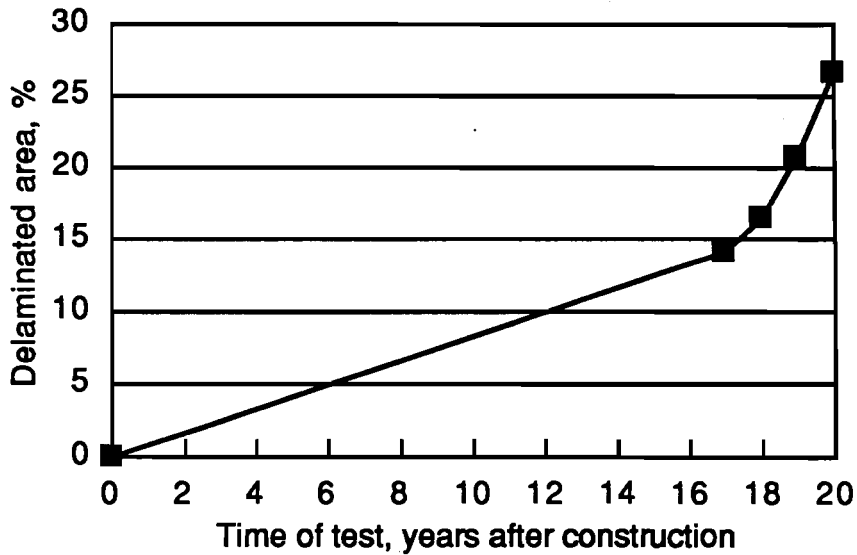
Fig. 56.1
Garage No. 56

Percent of delaminated area in suspended deck

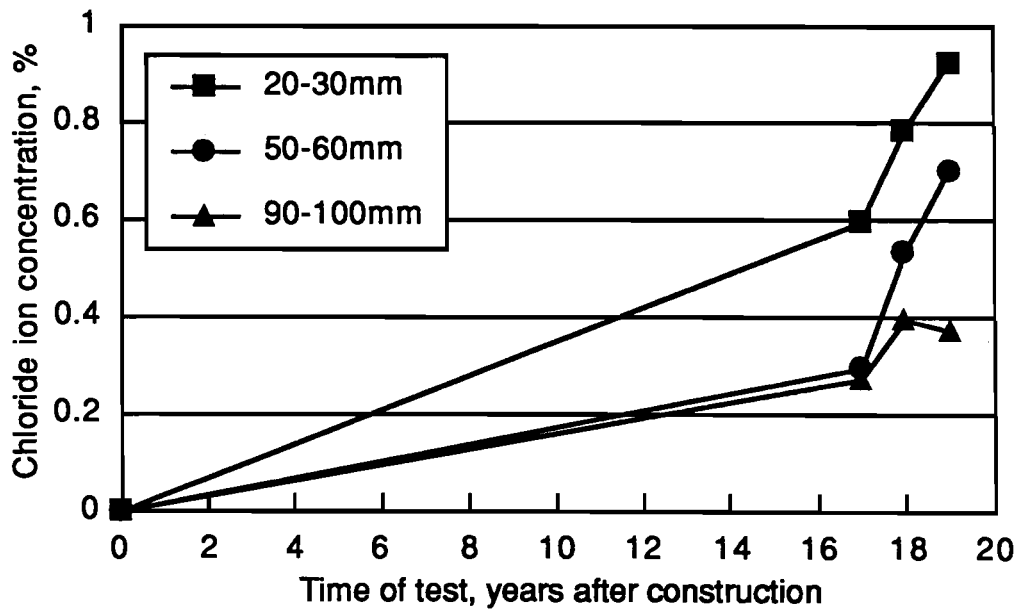
Fig. 56.2
Garage No. 56

Chloride ion concentration of concrete in the suspended deck at horizons stated, location No. 3

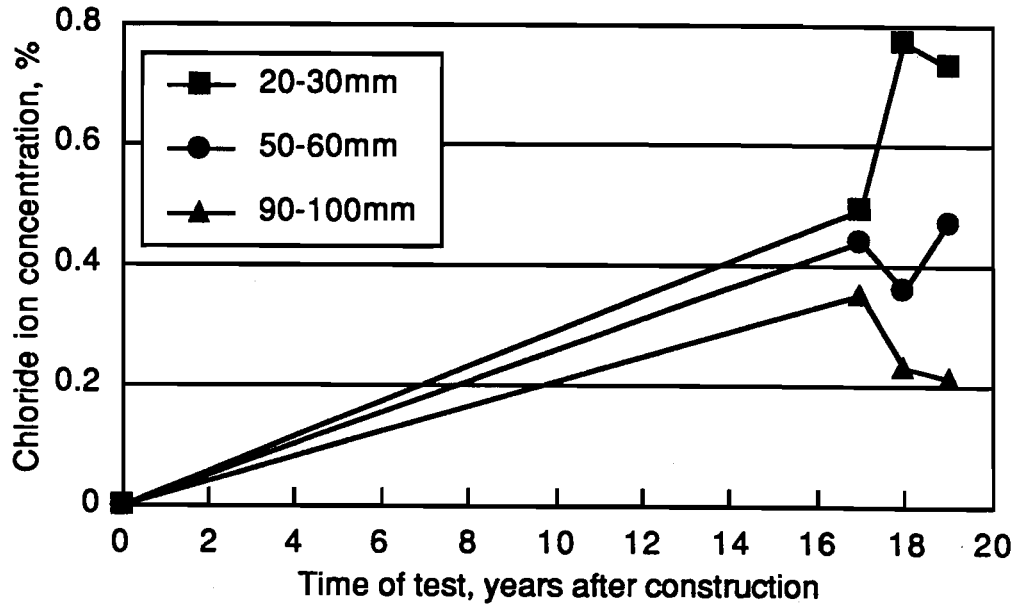
Fig. 56.3
Garage No. 56
Chloride ion concentration of concrete in the
suspended deck at horizons stated, location No. 10

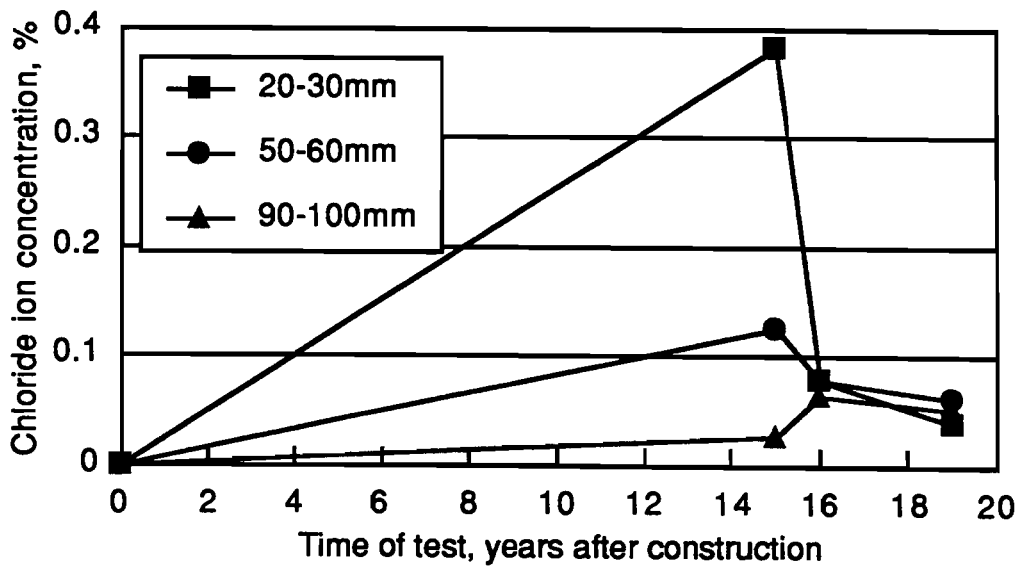
Fig. 56.4
Garage No. 56
Chloride ion concentration of concrete in roof slab,
at horizons indicated, location No. 4
(original concrete)

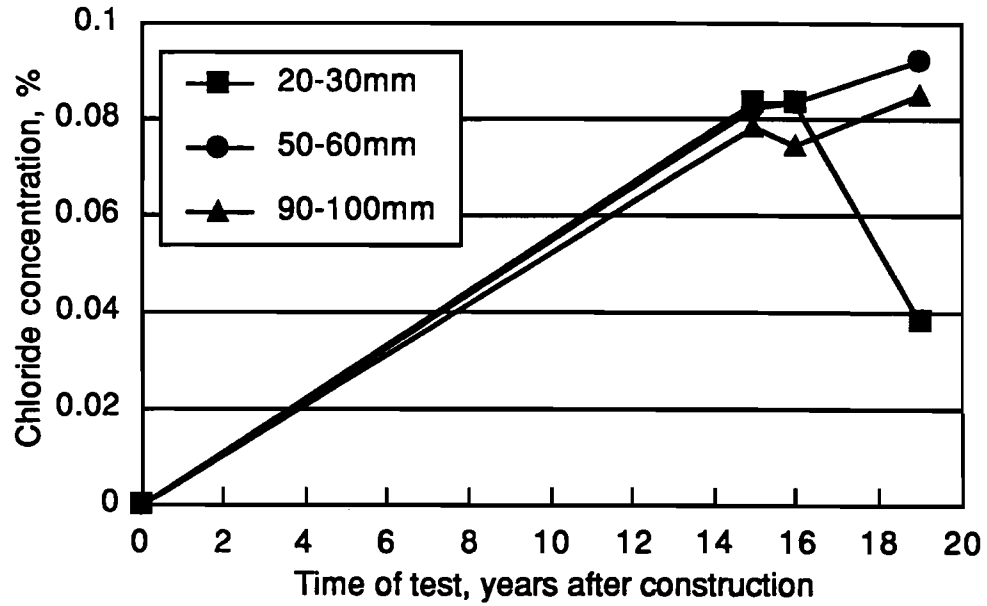
Fig. 56.5
Garage No. 56
Chloride ion concentration of concrete in roof slab,
at horizons indicated, location No. 6
(repair concrete)

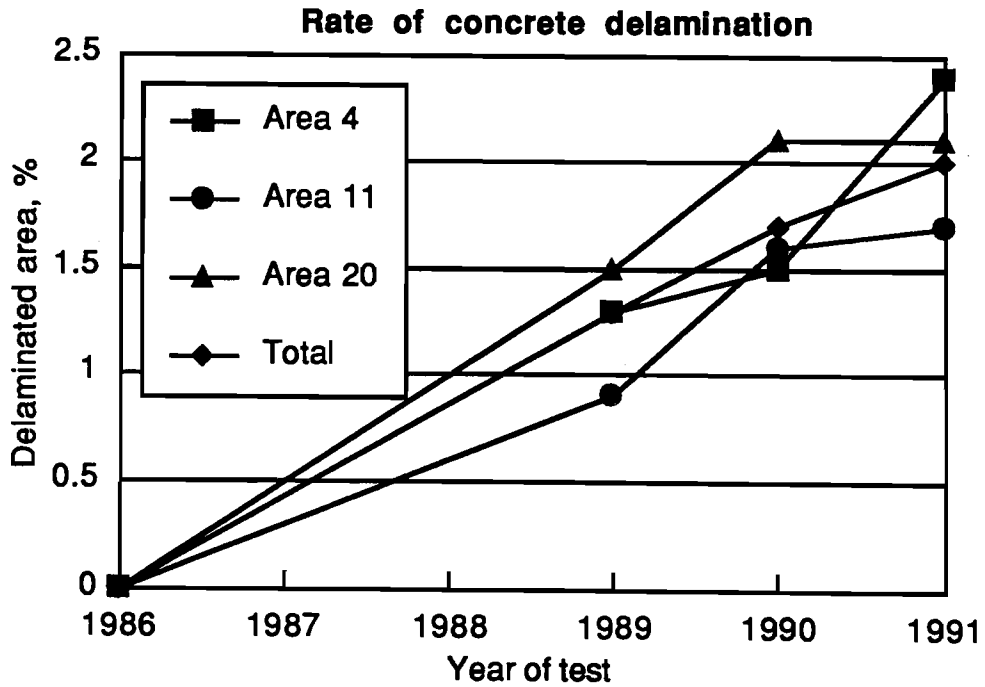
Fig. 57.1
Garage No. 57

In view of the constancy of the debonded values, it seems reasonable to ascribe only the "delaminated area" figures to be caused by corrosion activity. Assuming, as one has to, that no delamination existed after the repair in 1986 the incremental changes in the last three years appear to have taken place in a linear fashion. (Fig. 57.1).

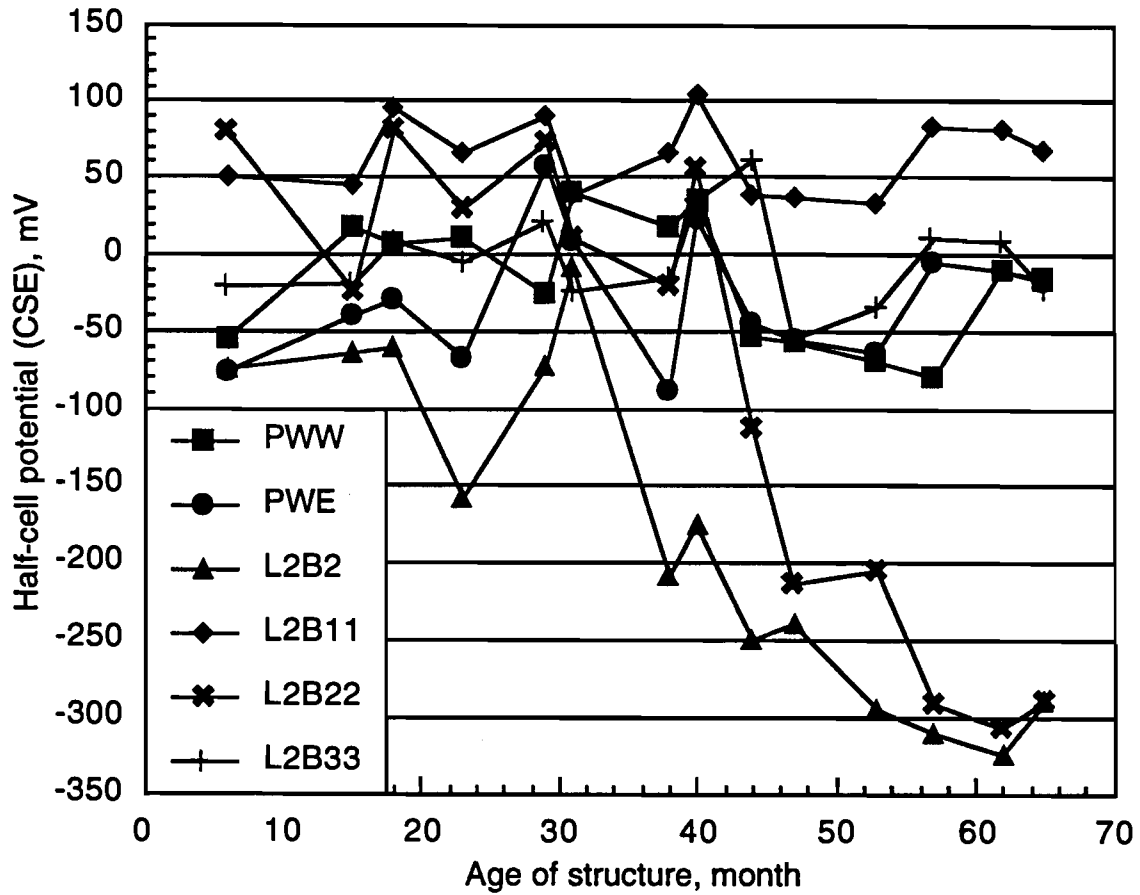
Suspended deck: The half-cell potentials with respect to a copper/copper electrode are listed in Table 59.1 and the corrosometer readings in Table 59.2. The half-cell potentials are also presented in graphical form in Figures 59.1 and 59.2.

For example, the results determined at location L2B2, L2B22 (Figure 59.1) and L3B22 shift to more negative values in time, indicating an increasing tendency for corrosion. However, in all three cases more positive values, of a magnitude that are generally considered to indicate the absence of corrosion, were measured occasionally. These results confirm our previous finding that a single set of measured potentials is an unreliable basis for reaching any conclusion.

Fig. 59.1
Garage No. 59
Half-cell potential of reinforcing steel in deck vs. time

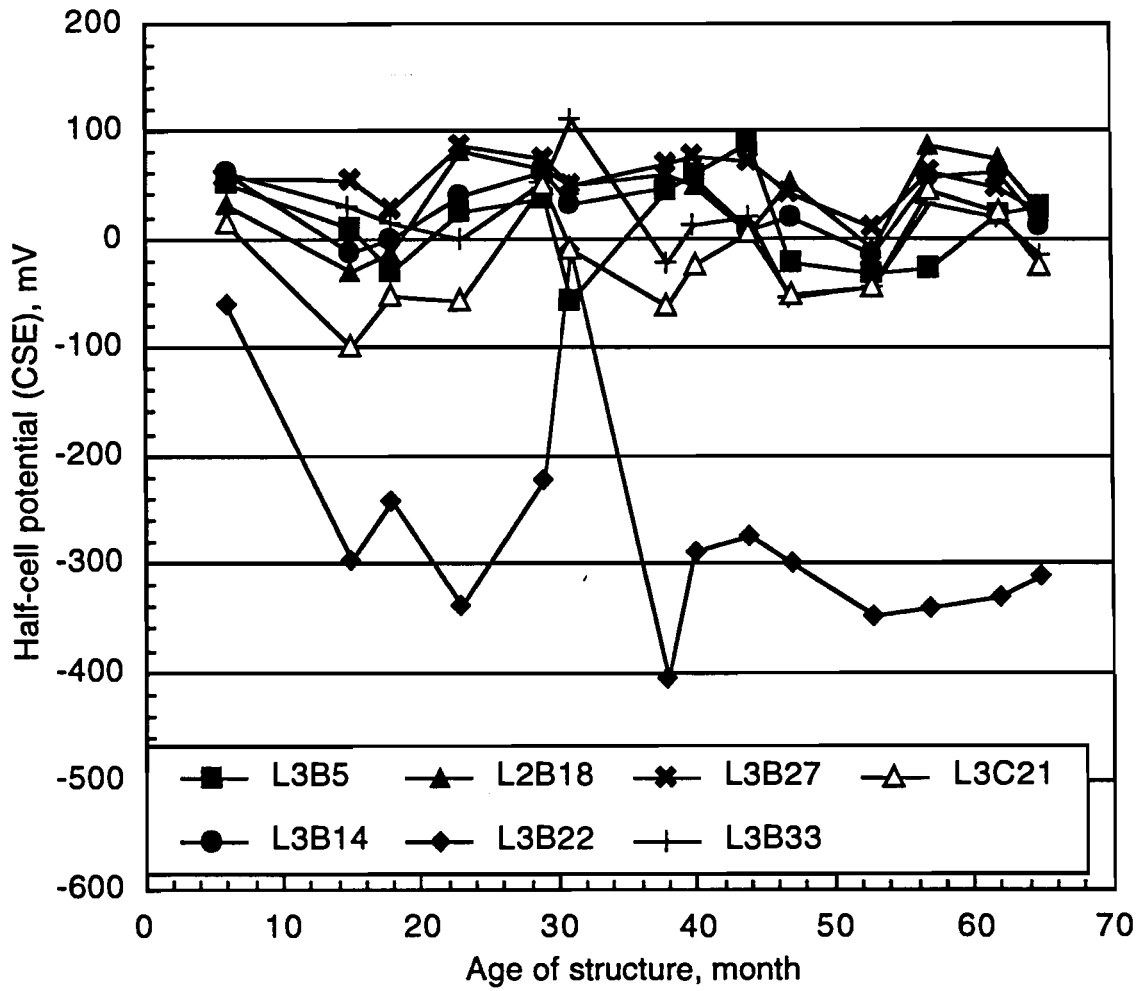
Fig. 59.2
Garage No. 59
Half-cell potential of reinforcing steel in deck vs. time

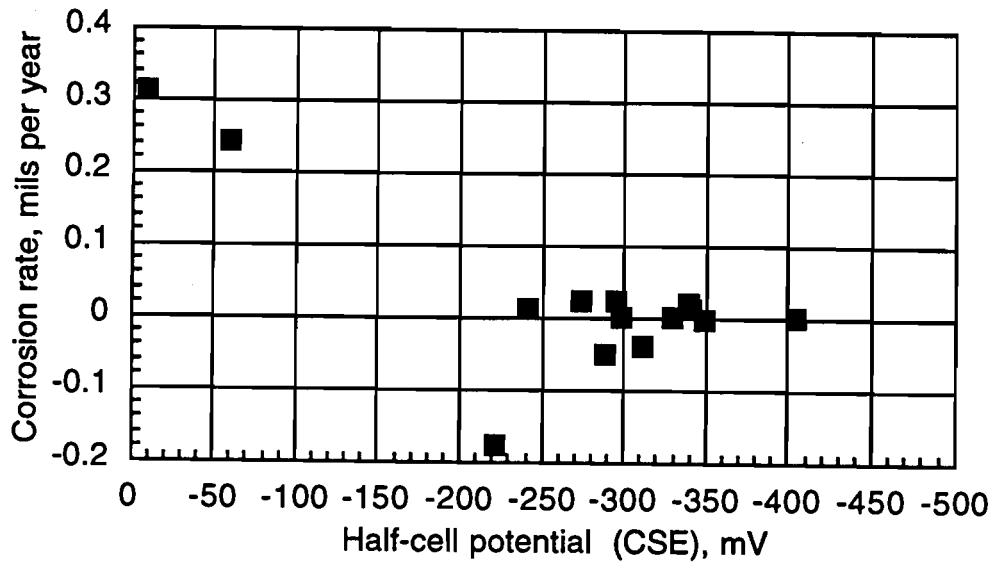
Plotting the half-cell potentials vs. the calculated corrosion rate at the same location reveals very little agreement (Figures 59.3 and 59.4);

Fig. 59.3
Garage No. 59
Half-cell potential vs corrosion rate
at L3B22 test point

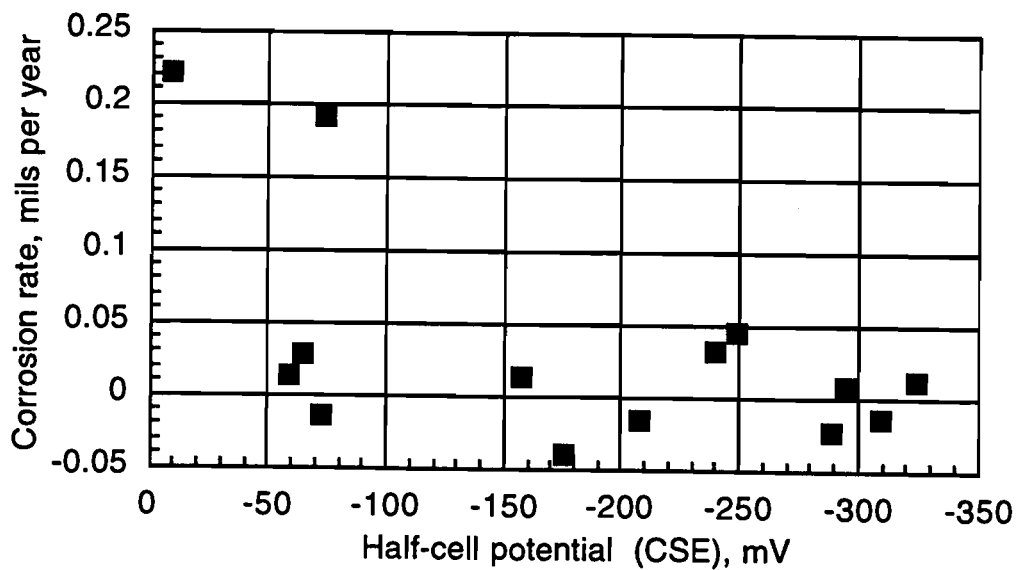
Fig. 59.4
Garage No. 59
Half-cell potential vs corrosion rate
at L2B2 test point

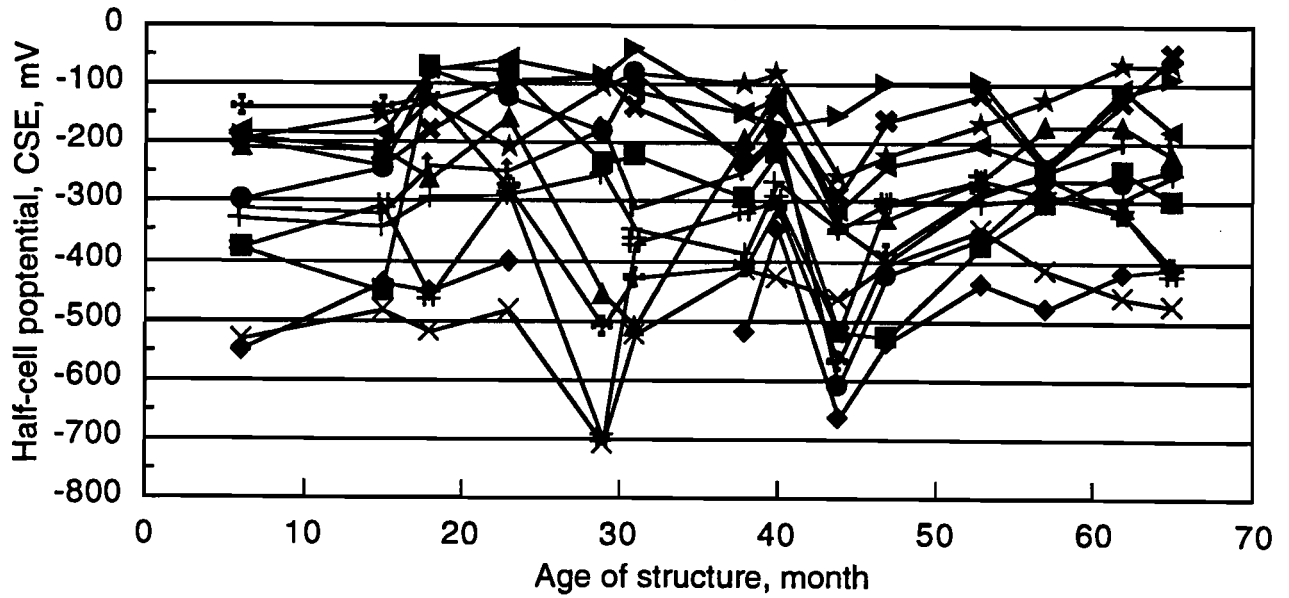
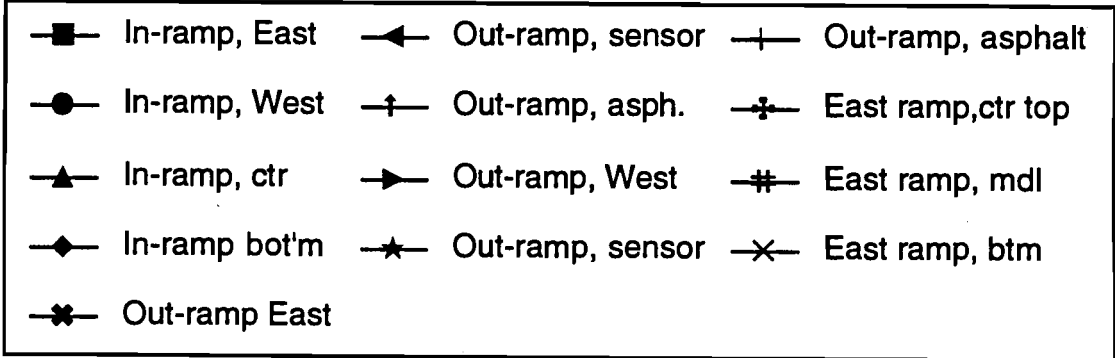
Immediately after construction, the potential values were negative and in the range that is considered indicative of corrosion. As it can be seen in Figures 59.5 to 59.8, no trend in time is apparent.

Fig. 59.5
Garage No. 59
Half-cell potential of steel in ramps vs. time

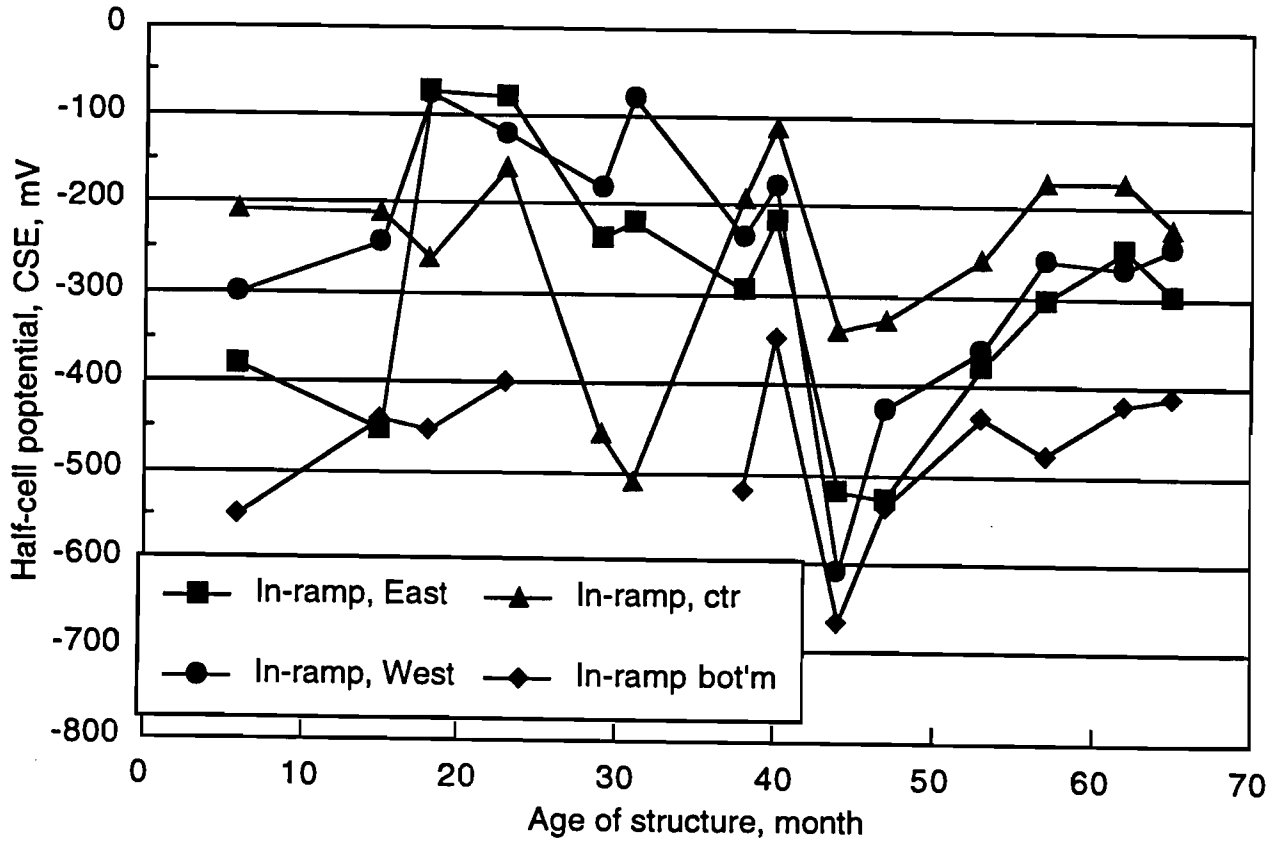
Fig. 59.6
Garage No. 59
Half-cell potential of steel in 'In-ramp' deck vs time

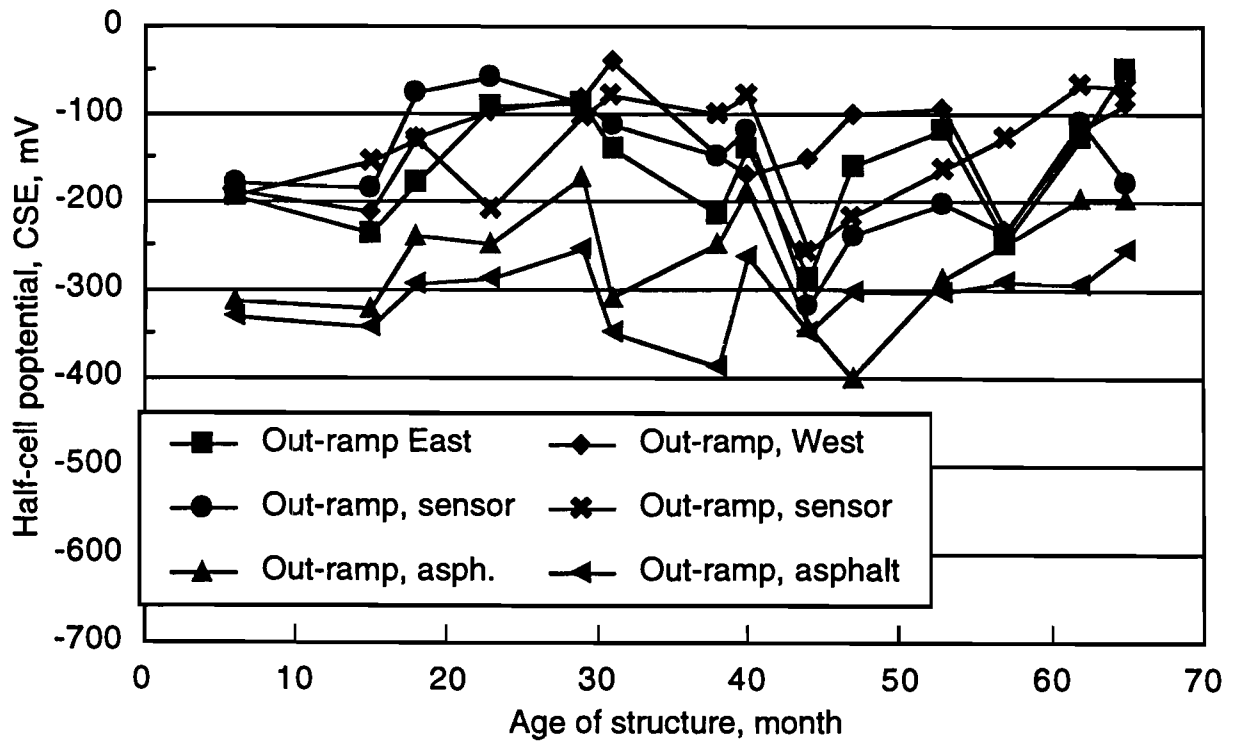
Fig. 59.7
 Garage No. 59
 Half-cell potential of steel in 'Out-ramp' vs time

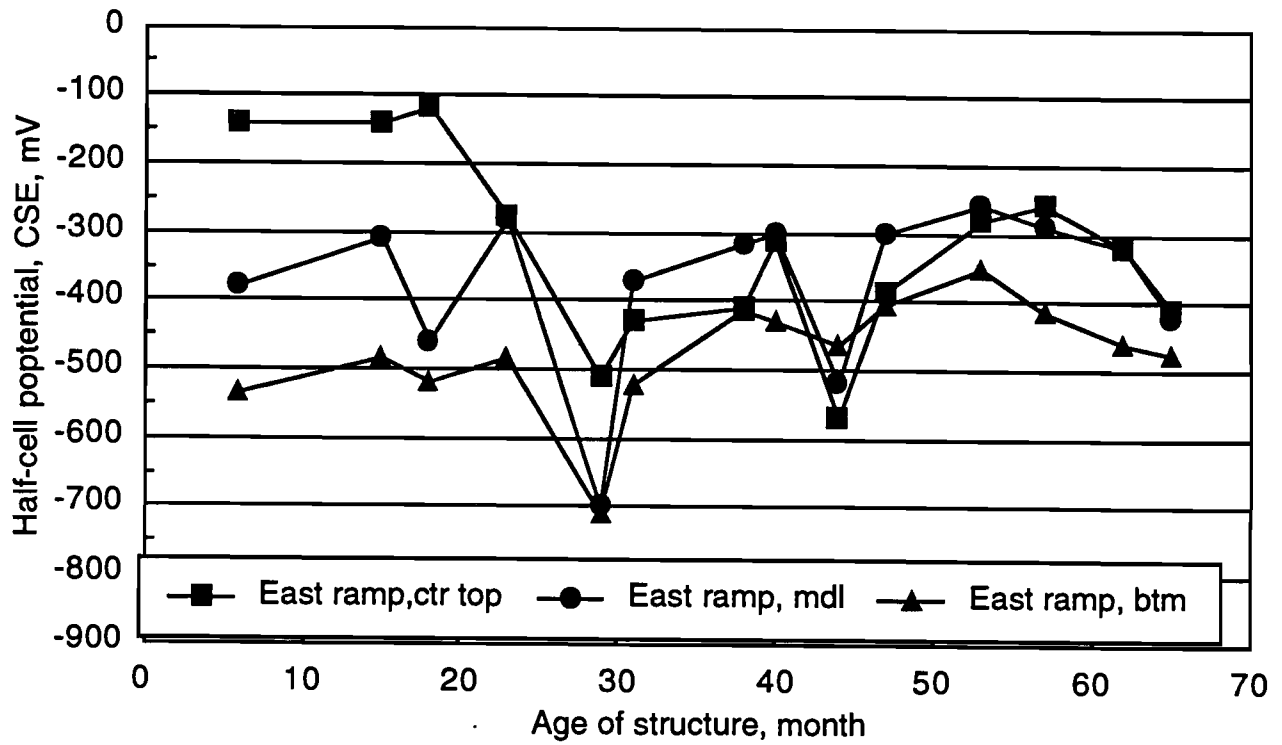
Fig. 59.8
Garage No. 59
Half-cell potential of steel in 'East-ramp' deck vs time

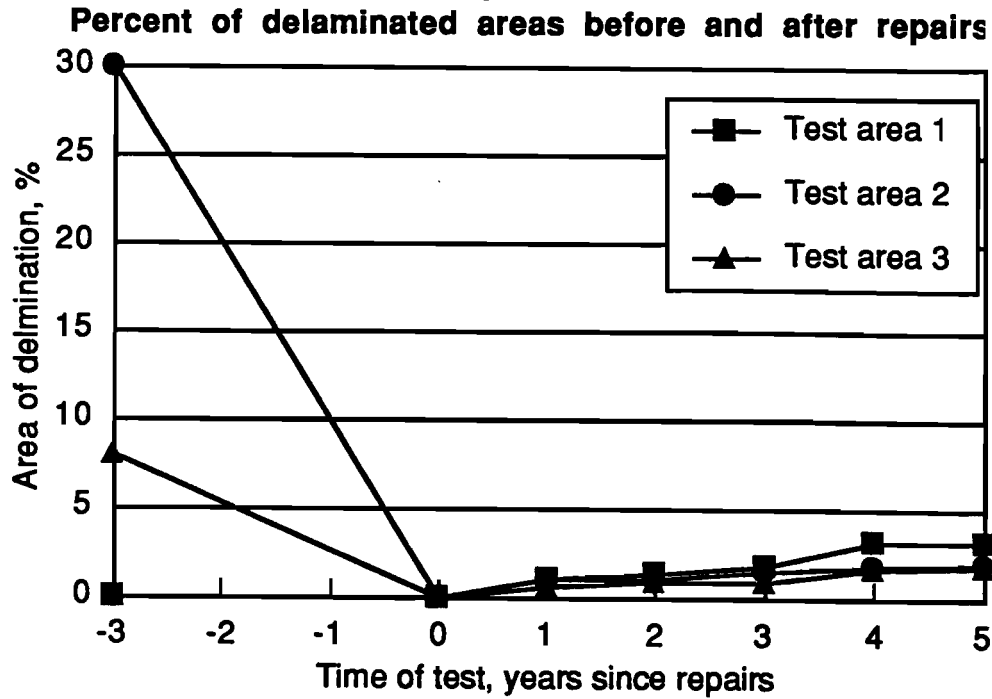
Fig. 62.1
Garage no. 62

Condition Survey - Delamination survey - The results of the yearly chain drag test are shown in Fig. 62.1. The results of the survey before the repairs are also indicated.

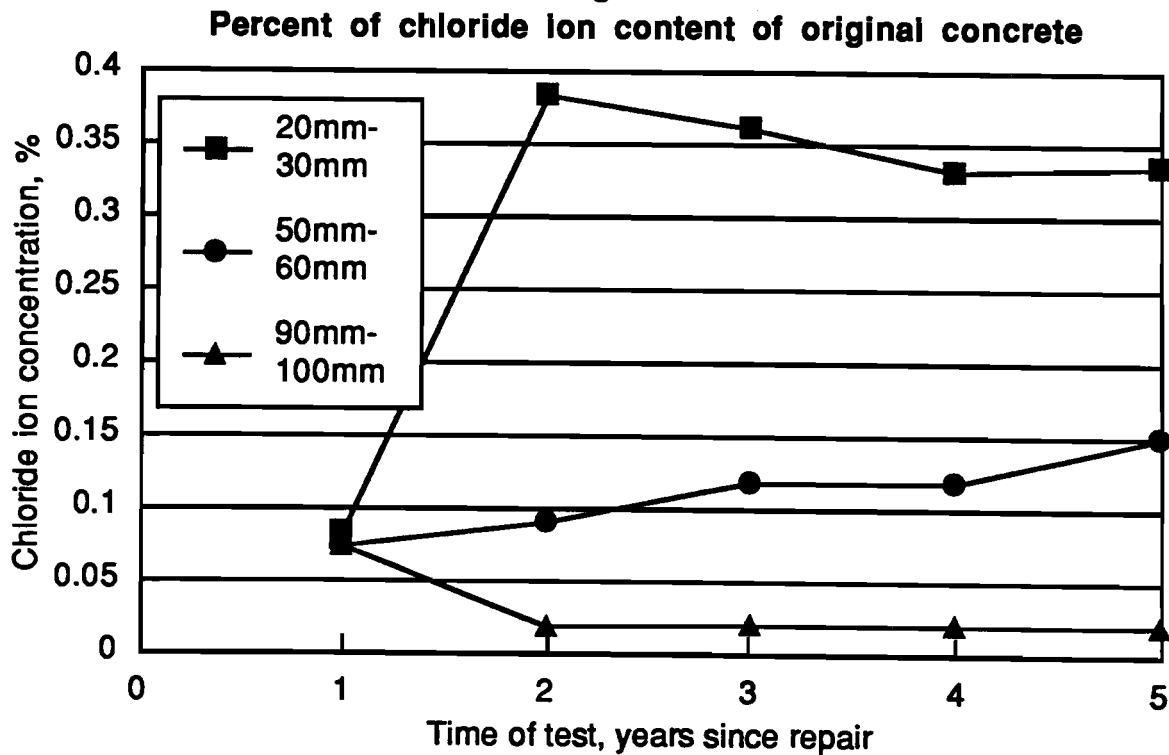
Fig. 62.2
Garage No. 62

Chloride ion concentration - The water soluble chloride ion concentration of the original and repair concrete at three horizons are given in Fig. 62.2 and Fig. 62.3.

The threshold chloride value, 0.035 percent by weight of concrete has been recently lowered by many consultants to 0.025 percent. The case of Garage 62 does not support this view.

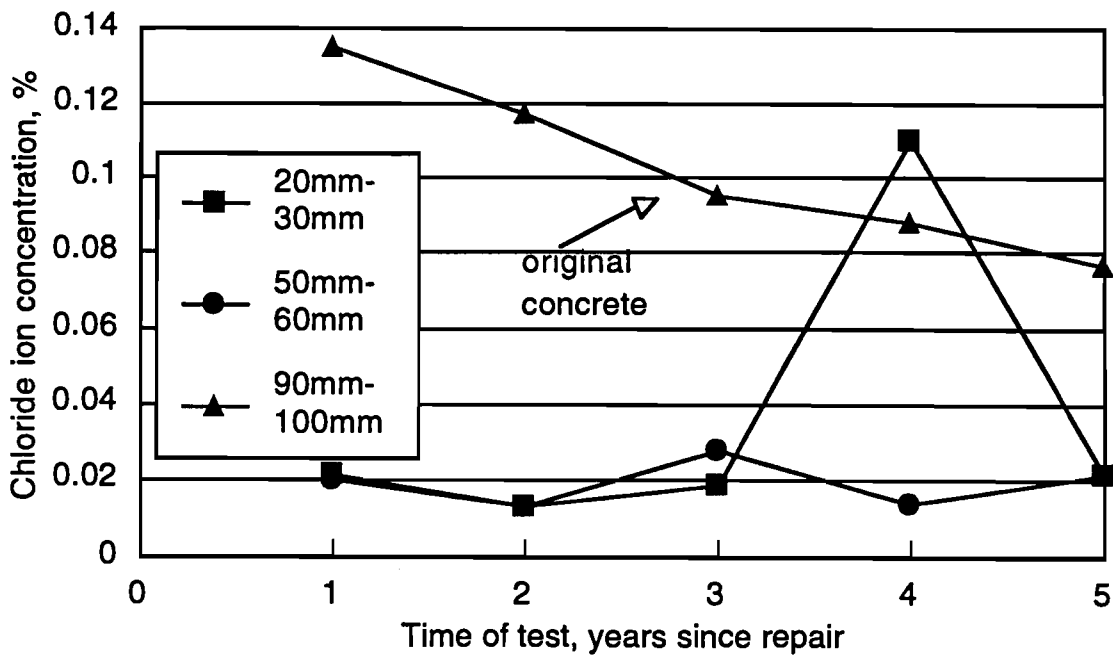
Fig. 62.3
Garage No. 62

Percent of chloride ion content of repair concrete

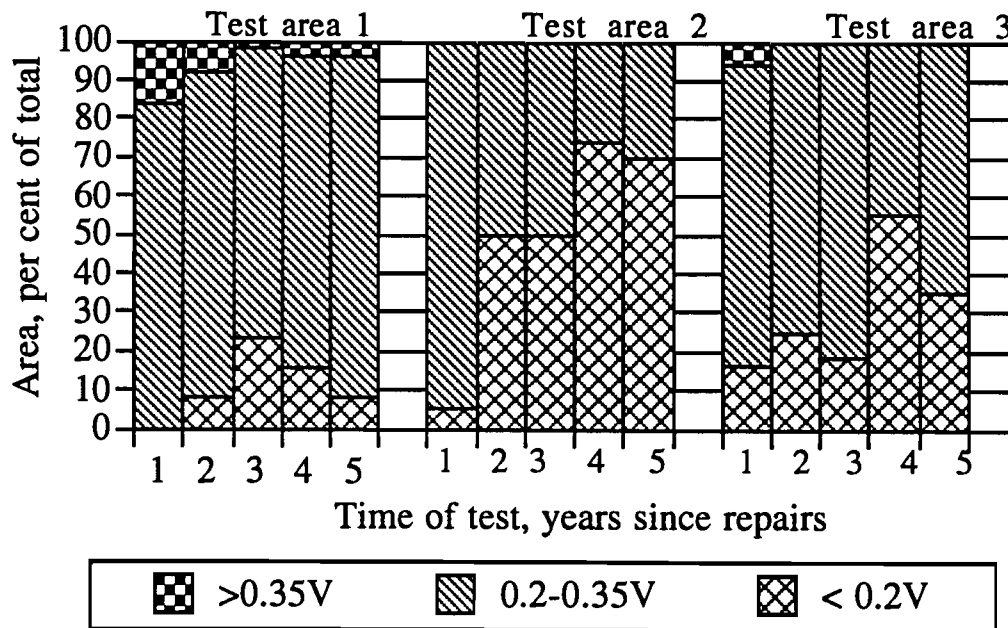
Fig.62.4
Garage No. 62

Half-cell potential - The percentages of the half-cell potentials indicating high, medium and low probability of corrosion of the reinforcing steel are shown in Fig. 62.4.

Percentage distribution of half cell potentials in test areas
