Deterioration of Parking Structures Research Project

**DETERIORATION OF PARKING
STRUCTURES RESEARCH PROJECT**

ABSTRACT

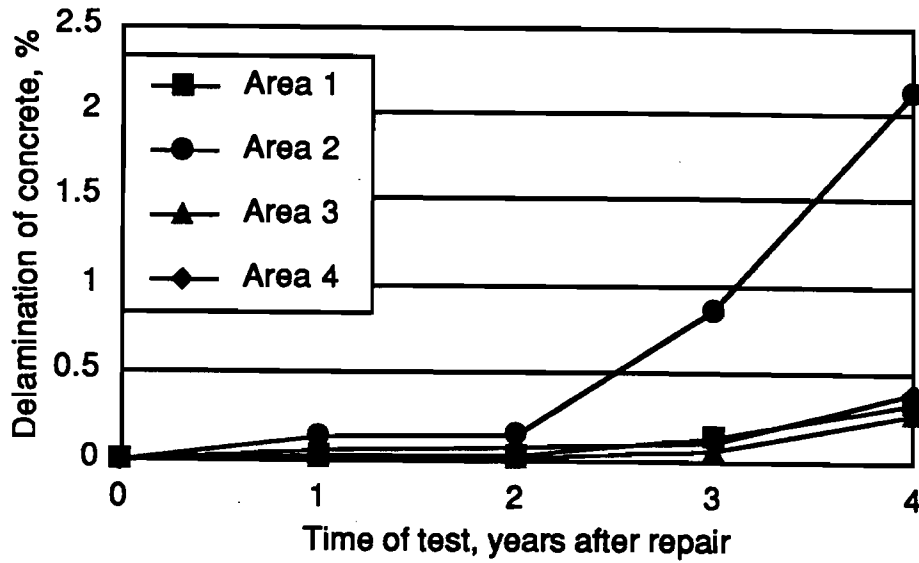
Delamination test - The size of the areas of the deck in which hollow soundings were found on performing the chain drag test, is shown in Fig. 63.1. The absolute level of the extent of delamination is very low, although the rate appears to be increasing, particularly in Area 2.

Fig. 63.1
Garage No. 63
Delamination of concrete deck,
percent of slab area

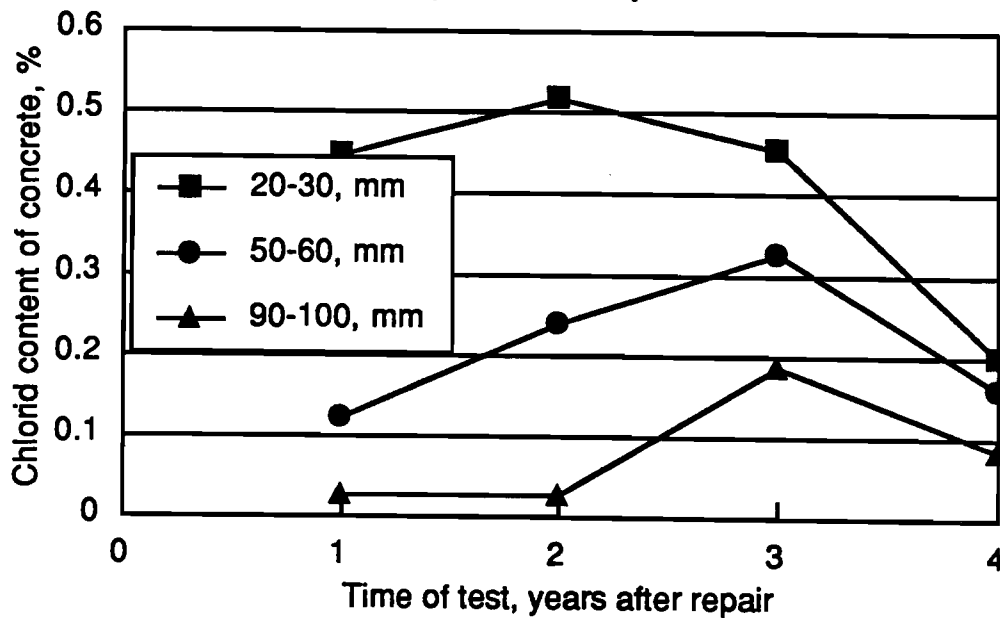
The concentration of chloride ions in the repair concrete is low, and no trend of increase is apparent. A single value, - one year after the repairs at the 50 mm to 60 mm horizon (Fig. 63.2), indicates increased concentration. This could be the result of either the migration of chloride ions from the original contaminated concrete or a decline effected by of CP which drives the negatively charged ions to the anode.

It is interesting to note that the chloride concentration at the 90-100 mm horizon is higher in the repaired than in the non-repaired original area (Fig. 63.3 and Fig. 63.2). Accumulation of chlorides in certain areas necessitated repairs and even the unrepaired surrounding areas, although not delaminated, have a higher than average chloride concentration.

Fig. 63.2
Garage No. 63
Water soluble chloride content of original concrete
at stated horizons, expressed as percent of mass

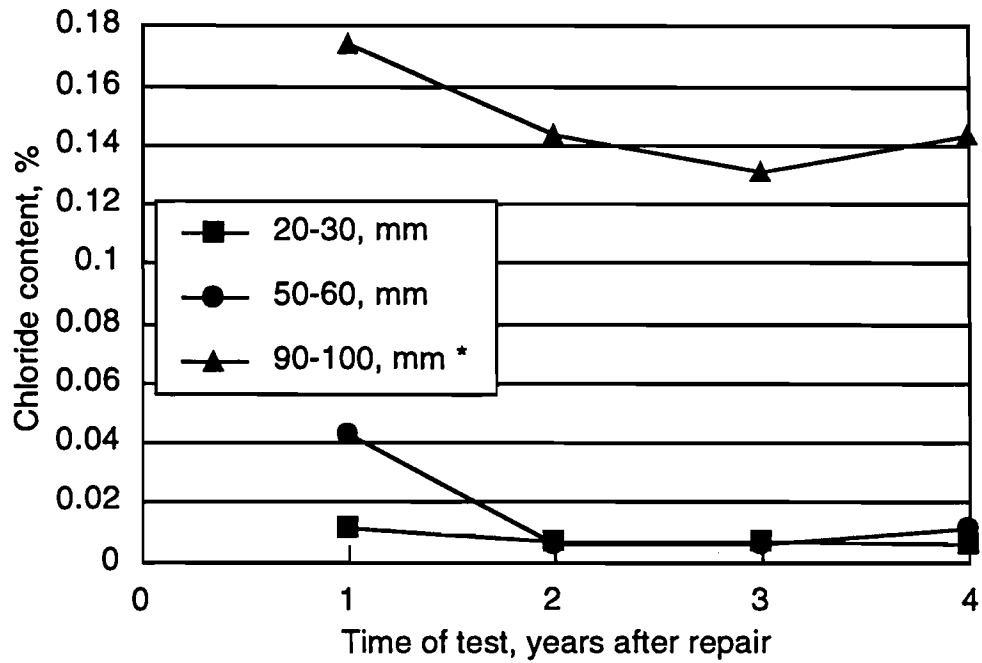
Fig. 63.3
Garage No. 63

Chloride content - the water soluble chloride content of the original and repaired concrete, at three horizons, are shown in Fig. 63.2 and Fig. 63.3, respectively.

Chloride content of repair concrete
expressed as percent of mass, at stated horizons

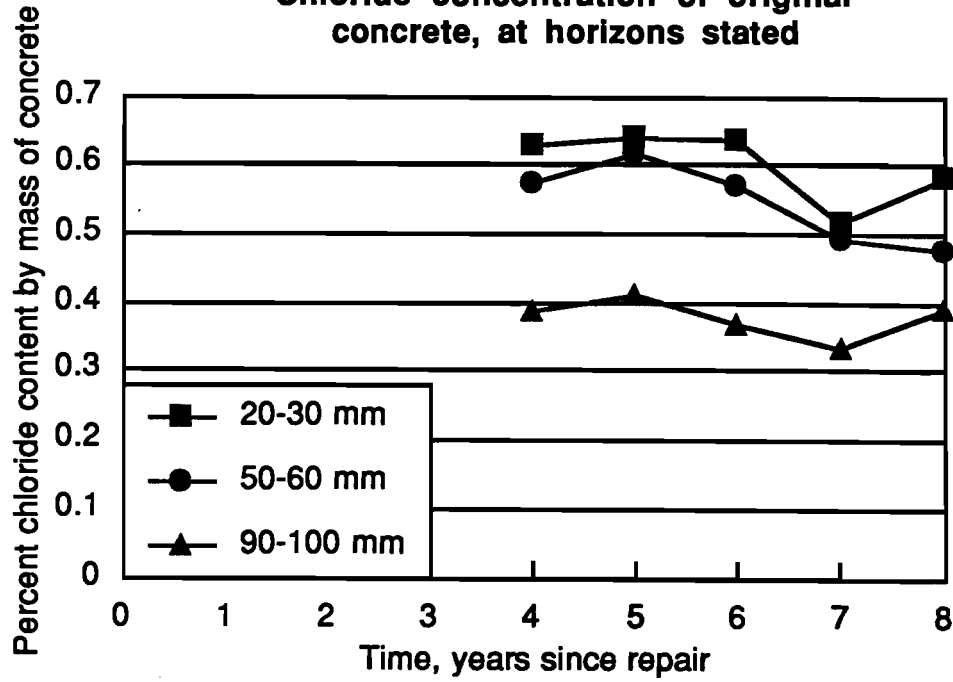
Chloride content - The chloride ion concentration was determined at three horizons and four locations. The results, shown in Figs. 64.3 through 64.6, indicate generally high values even at 90 mm depth; the threshold concentration of 0.035 percent is exceeded, in most cases, by a margin of ten. Significantly, the chloride content of the repair concrete four years after placement is well above the initial value by a wide margin. It cannot be ascertained whether this is the result of diffusion of chloride ions from the adjacent contaminated old concrete, or infiltration from the exterior, or both.

Fig.64.3
Garage 64
Chloride concentration of original
concrete, at horizons stated

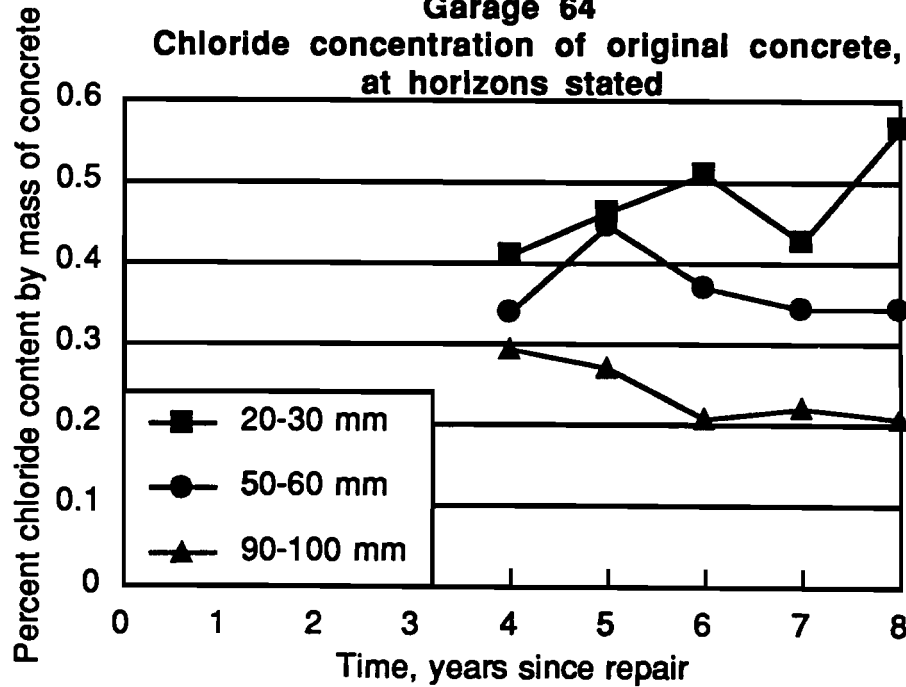
Fig.64.4
Garage 64
Chloride concentration of original concrete,
at horizons stated

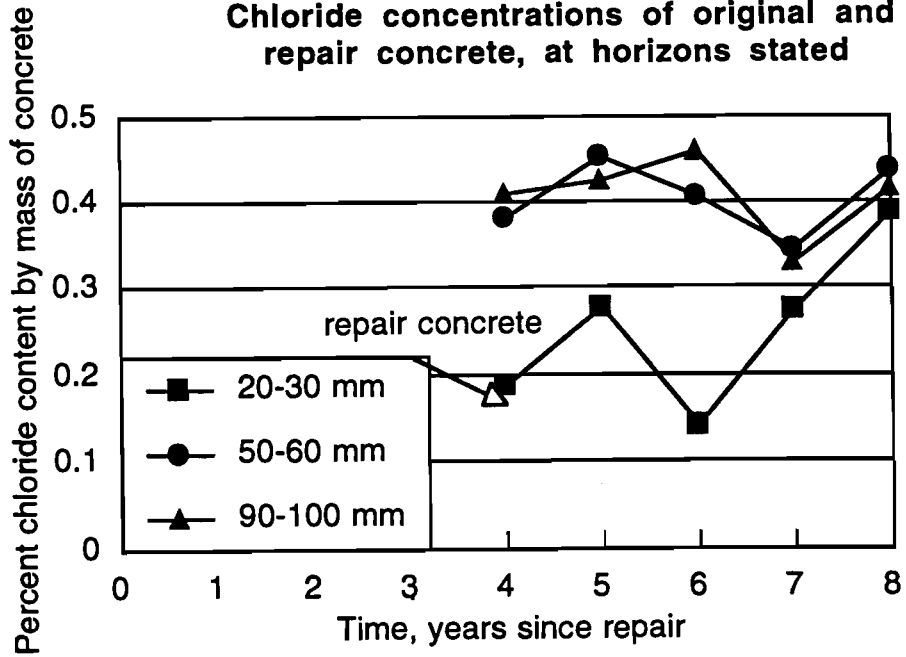
Fig.64.5
Garage 64
Chloride concentrations of original and repair concrete, at horizons stated

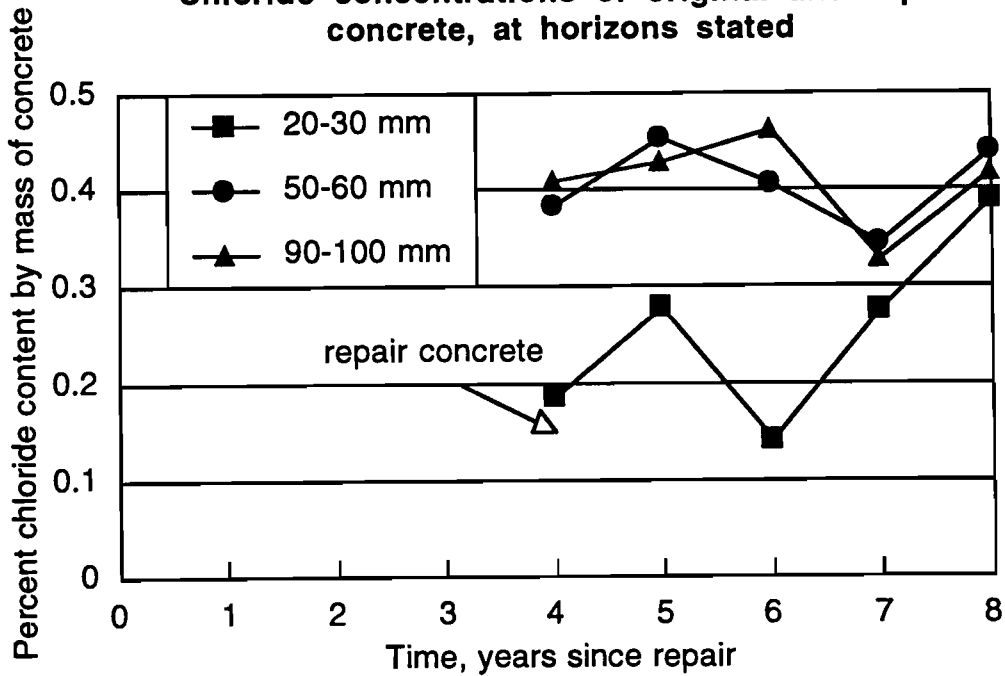
Fig.64.6
Garage No.64
Chloride concentrations of original and repair concrete, at horizons stated

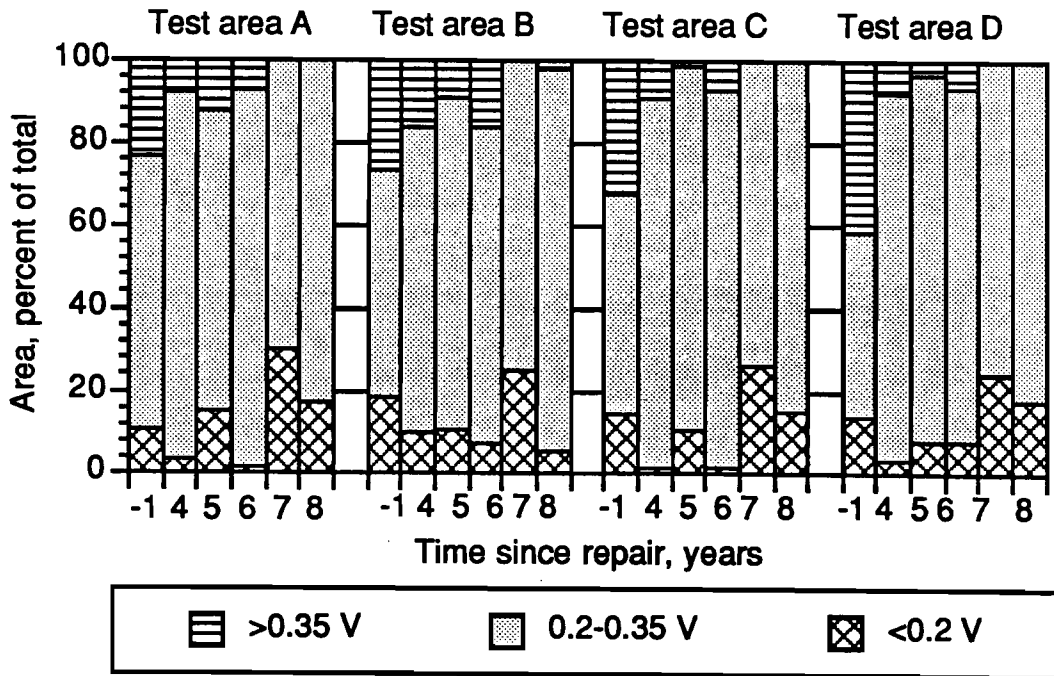
Half-cell potential - The half-cell potential values obtained in the four test areas are shown in Fig. 64.7.

Fig.64.7
Garage No.64
Half cell potential of test areas before and after repair

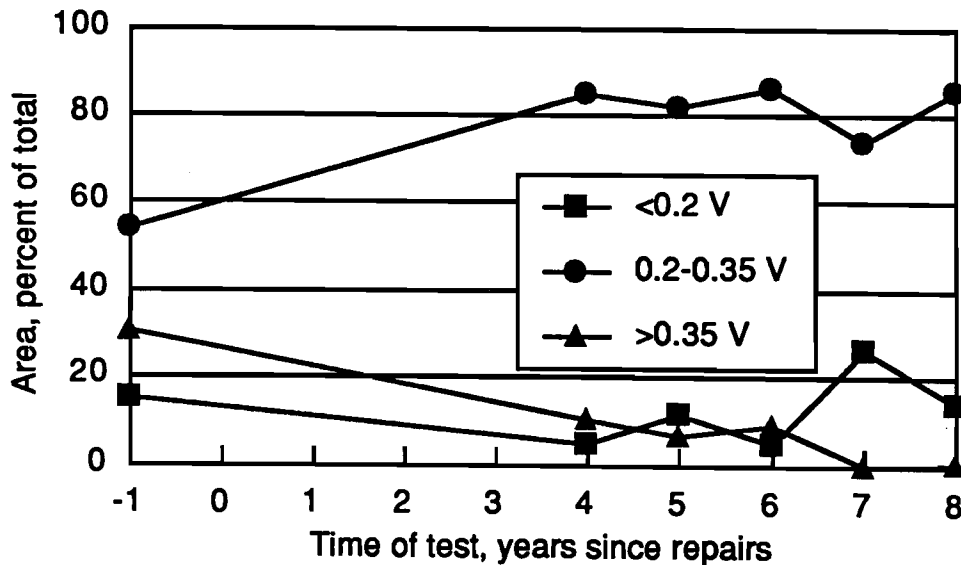
It is remarkable that while the extent of delamination/debonding has exceeded that found before the rehabilitation, the fraction of areas with greater than -0.35 V is far less than it had been in 1981, in fact, has been decreasing in the last 5 years (Fig. 64.8). The area in which the potential was greater than -0.35 V decreased from 10.5 percent to 0.4 percent in the last five years. Before restoration, the percentage of < -0.35 V was 30 percent.

Fig.64.8
Garage No. 64
Half cell test results.
Totals of values obtained in the test areas

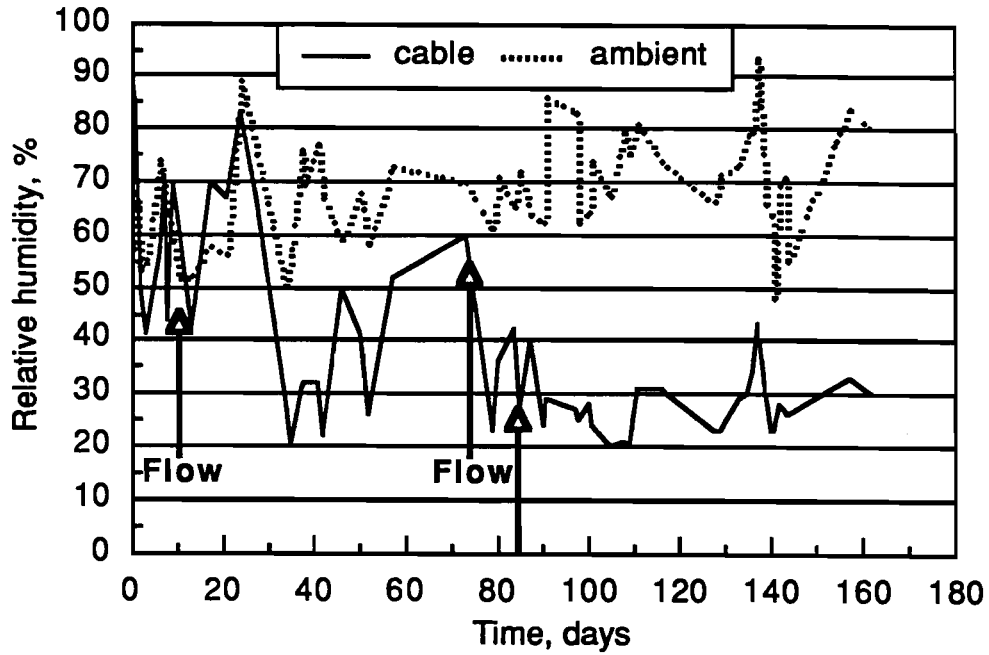
Fig. 21.1
Garage 21
Relative humidity in Cable 1W and
atmosphere during trial

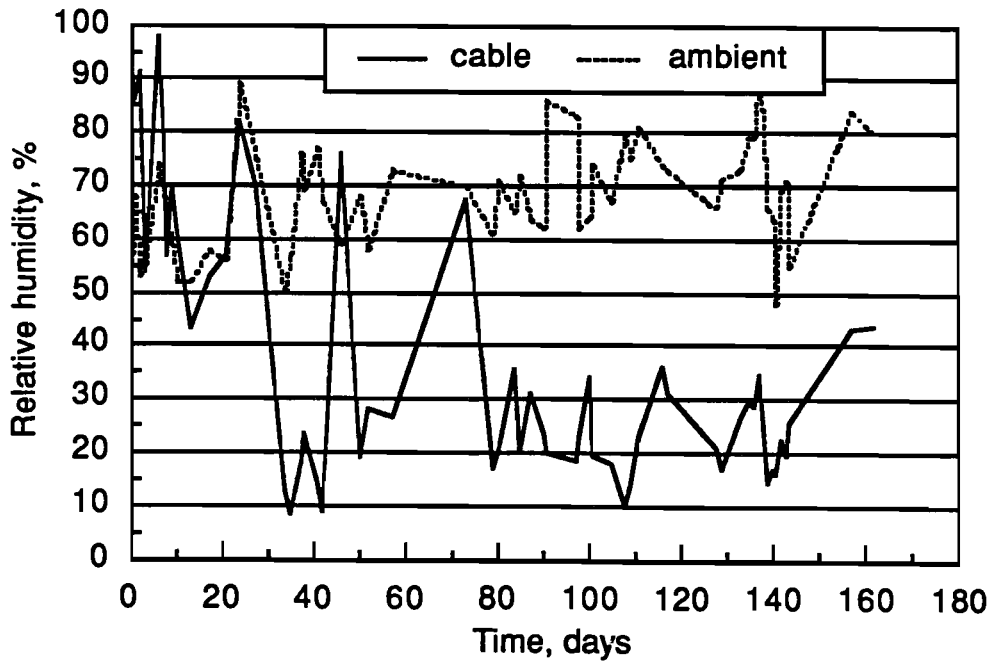
Fig. 21.2
Garage 21
Relative humidity in Cable 2W and
atmosphere during trial

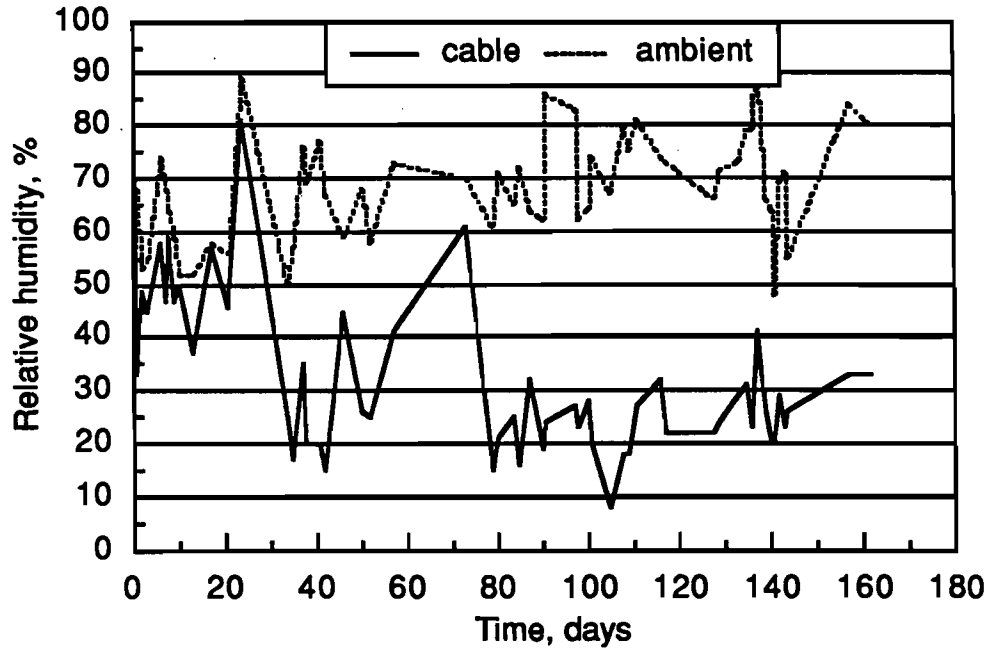
Fig. 21.3
Garage 21
Relative umidity In Cable 3W and
atmosphere during trial

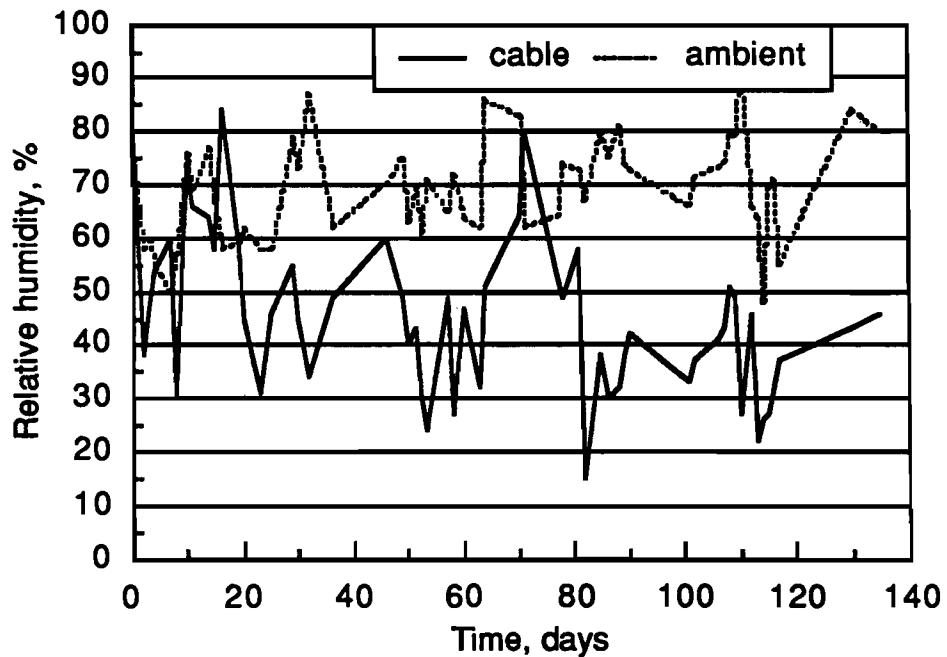
Fig. 21.4
Garage 21
Relative humidity in Cable 4W and
atmosphere during trial

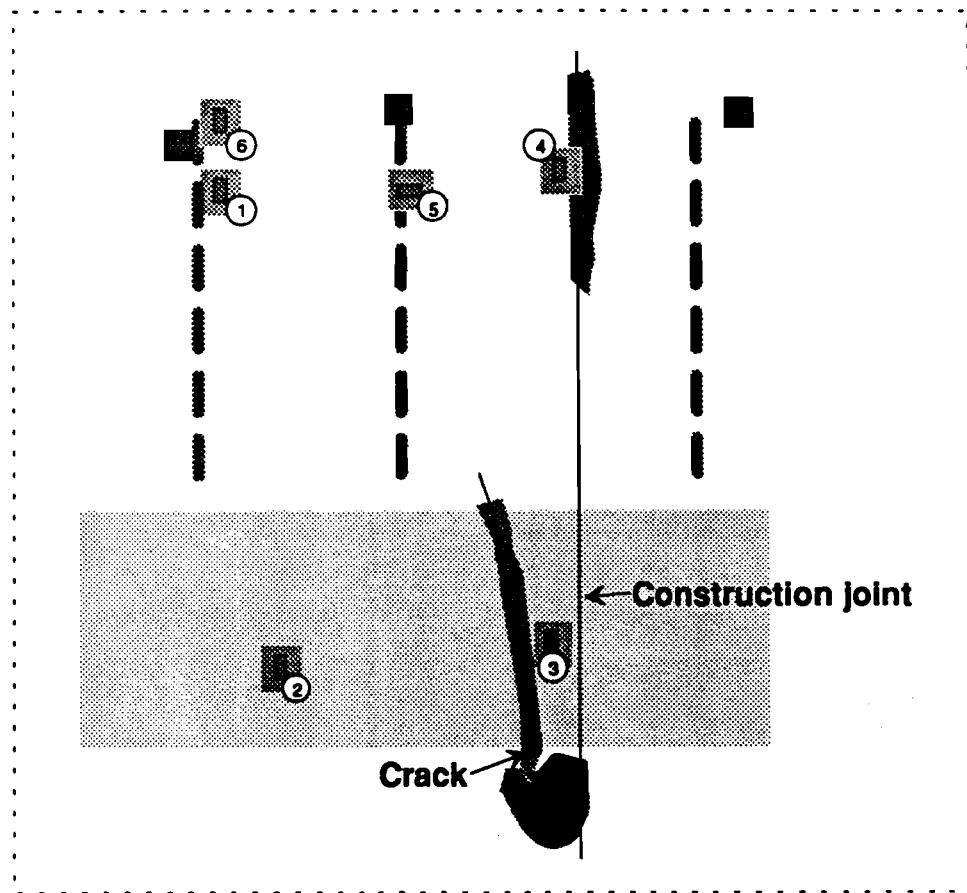
Fig 20.6
Garage No. 20
Schematic diagram of the monitored area

On 8th February 1990 four 3-inch deep wells of 31.75 mm diameter were drilled in the soffit of the slab to accommodate the sensors. Provisions were made to place one probe in the beam for reference purposes. A schematic diagram of the site with the location of the sensors is shown in Fig. 20.6.

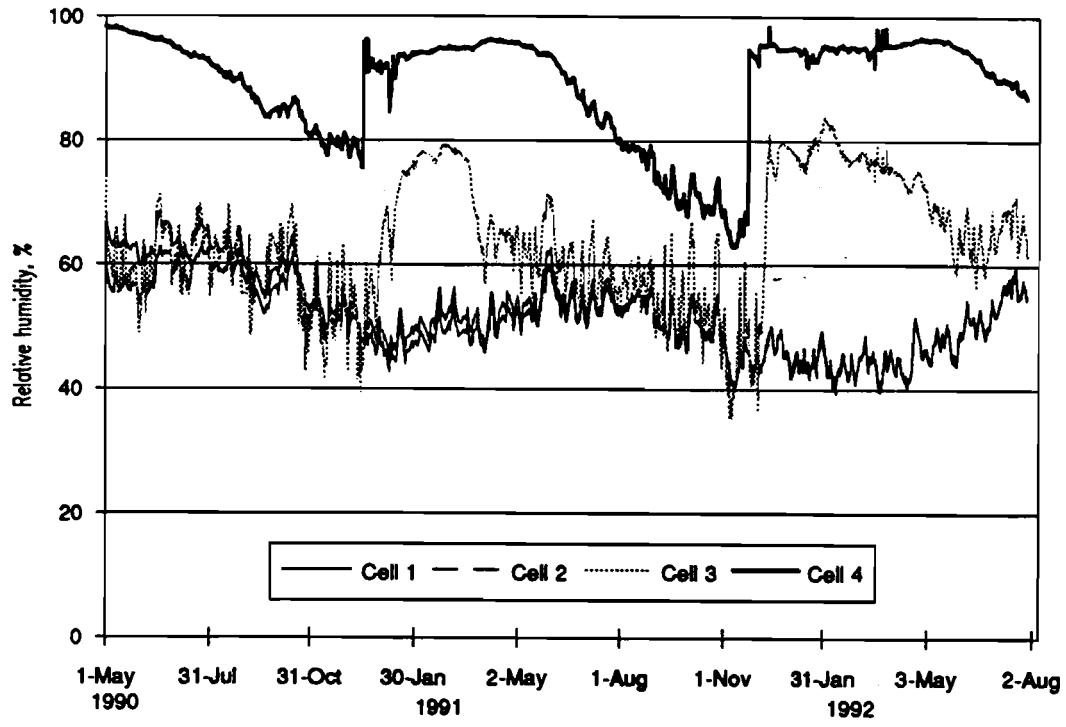
Fig. 20.7
Garage No. 20
Relative humidities indicated by sensors in floor slab

The changes of the relative humidity (RH), in the concrete slab as indicated by sensors Nos. 1 through 4 are shown in Figure 20.7.

3. The results obtained with sensor No. 4 are very different from those of cells No. 1 and 3, and are characterized by very high absolute values, often close to 100%, that slowly decrease in the summer months, but suddenly increase in November.
4. All curves indicate initially very high humidities, almost certainly due to wetting of the concrete in the coring operation. But while curves 1, 2 and 3 gradually decrease to 60% by July 1990, curve 4 remains above 95%.
5. Of great interest is the finding that, according to the readings by sensors Nos. 1 and 2, the RH at these locations was less than 50% in the winter months. In spring and summer the RH level increased, but only temporarily reached 60%.

Since the corrosion process stops when the RH falls below 50% (Fig. 20.10), it can be concluded that waterproofing membrane can significantly reduce the rate of corrosion. In fact, sensors Nos. 1 and 2 indicated low values from the early fall and, thus perhaps, it is more correct to say that corrosion in these zones takes place only for a few months of the year.

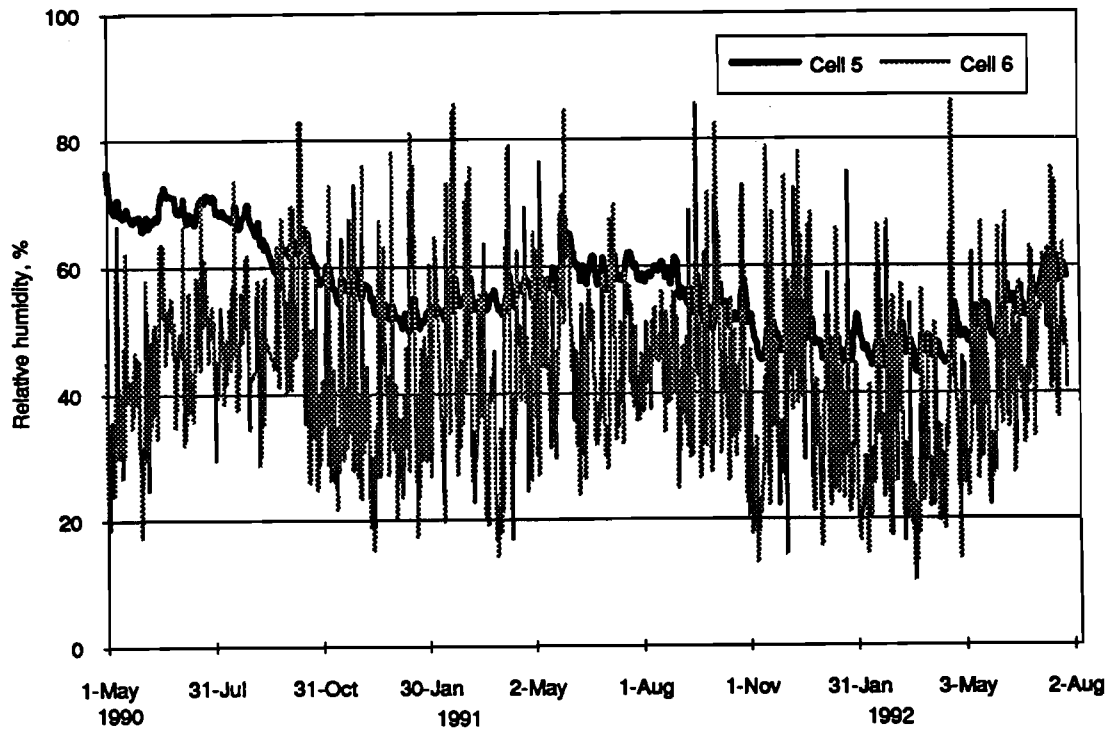
Fig. 20.8
Garage No. 20
Relative humidities indicated by sensors in beam and in air

Sensor 5 measures the RH in the beam. Curve 5 in Fig. 20.8 is a graphic representation of the obtained results.

Sensor No. 6 is exposed to the environment and the results, as shown in Fig. 20.8, represent the daily fluctuation.

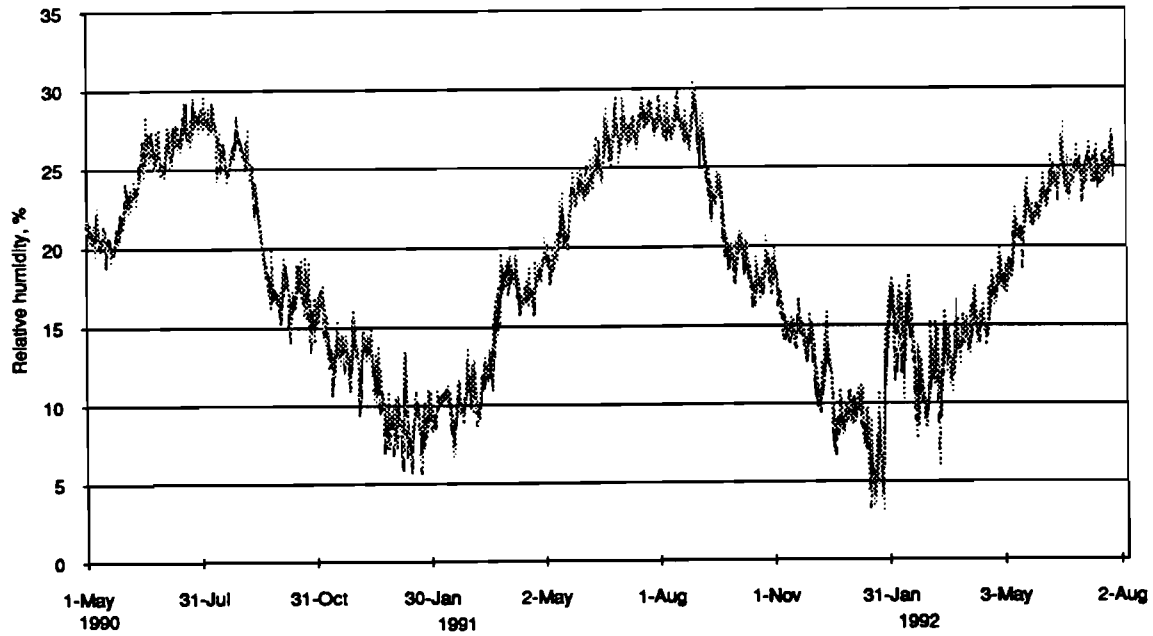
Fig. 20.9
Garage No. 20
Temperatures indicated by all six sensors

The temperature readings made with all the sensors are shown in Fig. 20.9. According to the composite curves the temperature varies between 30°C and 5°C.

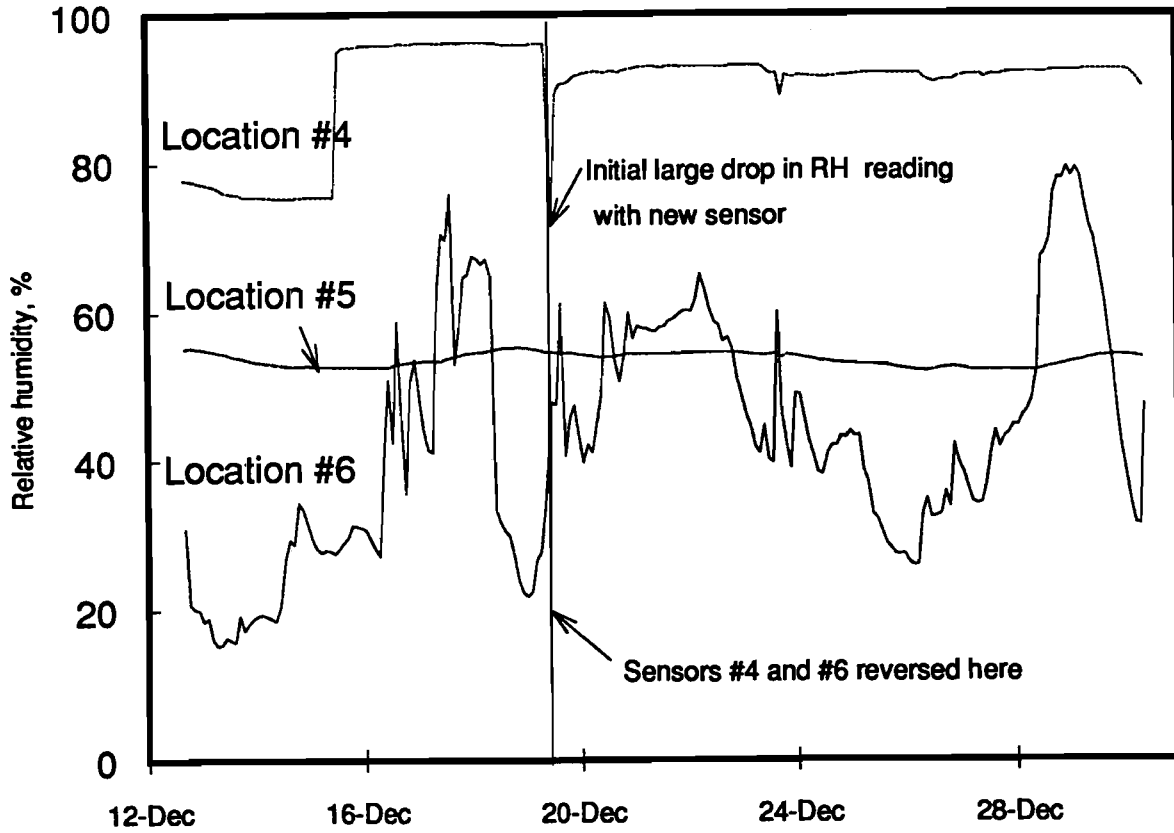
Fig. 20.11
Garage No. 20
Check of readings indicated by exchange of sensors

6. The unique results obtained with sensor No. 4 cannot be explained by assuming instrumental error, because on December 20th, 1990 the sensor was temporarily replaced with sensor No. 6, and the readings of the two transmitters were very similar (Fig. 20.11).

When well No. 4 was opened up for the installation of sensor No. 6, it was noted that the surface of the concrete in the well was wet and, at places, bulk water was present.

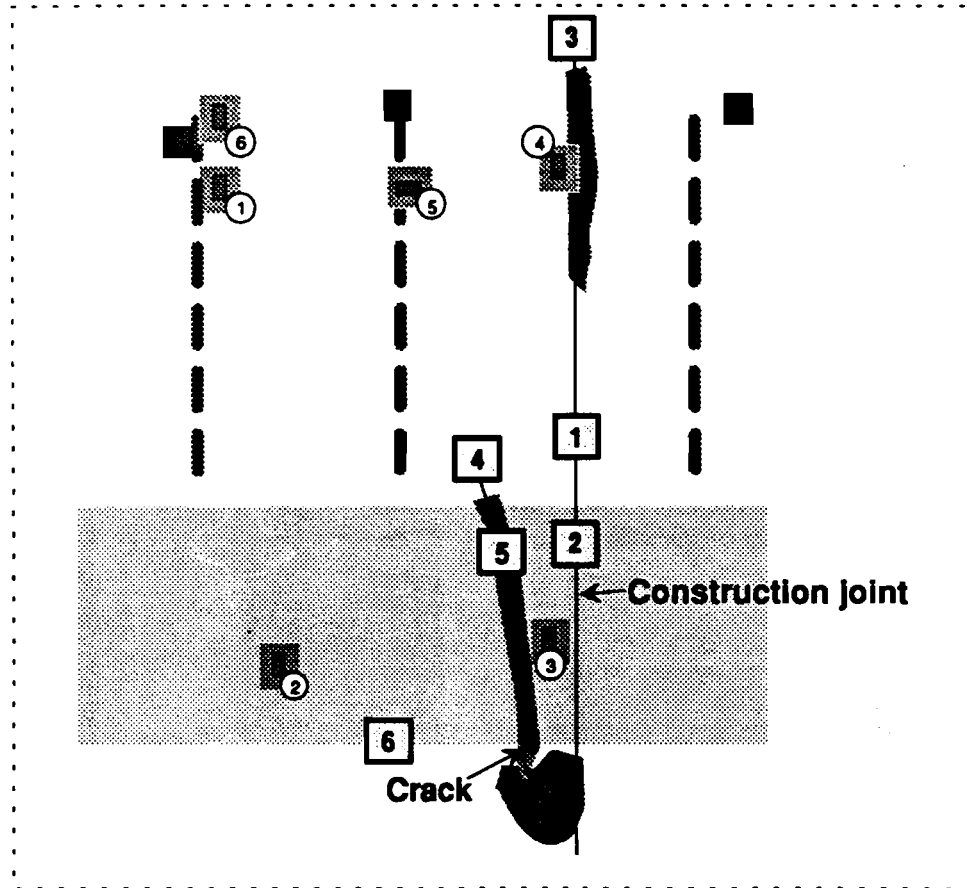
Fig 20.12
Garage No. 20
Schematic diagram of the monitored area

7. On examination of the concrete floor above the sensor No. 4 location, with the Schupack Concrete Tightness Tester, the following results were obtained (please refer to site plan in Fig. 20.12):

- i) Sensor No. 4 location is close to construction joint, with the membrane cracked along the joint;
 - ii) At test site approximately 4.5 m from sensor, marked No. 1 in Fig. 20.12, good vacuum was achieved;
