INVESTIGATING MOISTURE IN SEASONAL HOUSING

Abri Sustainable Design & Consulting

Final Report

15 November 2005

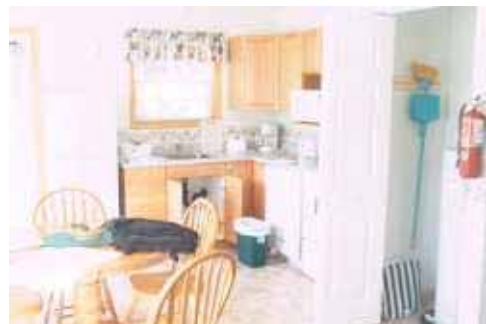
Interior: minimal permeable surfaces

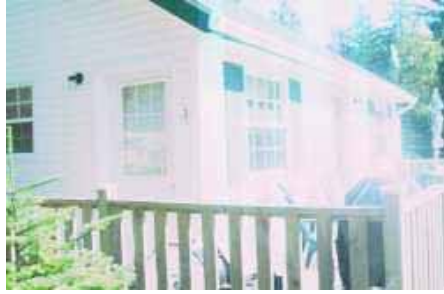
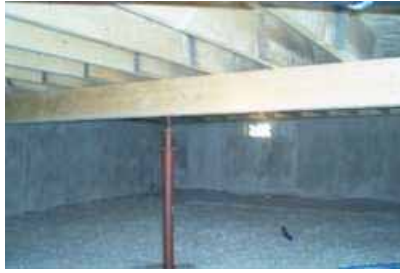
Exterior: B78A and B78B are identical rental units

Interior: dry crawlspace

B78A	Brief Description of House	Recommendations/Results
EGH and IAQ audit project team site visit Temp & RH monitored airtightness test results: 3.55 AC/H	Built in 2002 Rental bungalow on closed crawlspace, poured concrete walls and slab Insulated 2x6 construction (R20 walls/R32 clg) Double-paned single hung windows no shutters or awnings, 50% of windows face SW Electric baseboard, bath/kitchen exhaust 450m from ocean, in clearing in mature spruce forest Moisture problems: A, M1, W2, C One of two identical side-by-side rental units Condensation problems/mold growth at the rail of the single-hung windows Musty smell upon opening after winter	Close crawlspace vents Improve attic hatch seal Keep bath fans on as much as possible (these are toggled for guests to turn off) Install 'shrink wrap' on windows to reduce/eliminate condensation problems Changes were made at the beginning of the summer 2004, improvements were noted by the fall There was not much mold to begin with, but there was an improvement, particularly near the windows

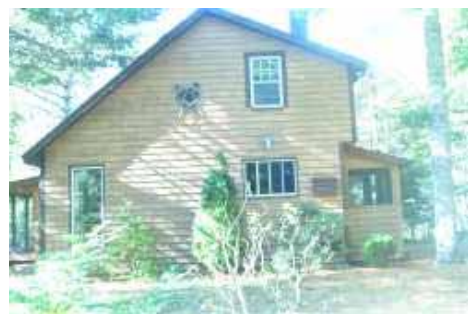
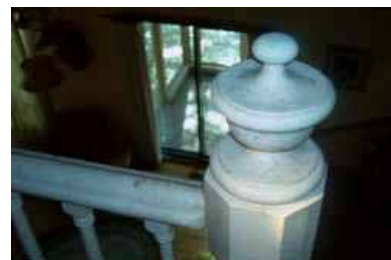
Exterior: much of house in constant shade

Interior: heavy mold growth in bathroom, on railing @ loft

B90	Brief Description of House	Recommendations/Results
EGH and IAQ audit project team site visit Temp & RH monitored airtightness test results: 8.93 AC/H	<p>Built in 1980s</p> <p>1-1/2 storey 2x6 construction (R20 walls and clg) 'dug out' basement w/open vents</p> <p>Mainly double-pane vinyl windows, no shutters or awnings, 40% of glazing oriented SE</p> <p>In a well-forested area, about 5m away from river</p> <p>Wood furnace, no ventilation</p> <p>Moisture problems: A, M1, W2 C</p>	<p>Extensive recommendations were made for this house, most were carried out:</p> <p>A complete clean up</p> <p>Basement vents closed off</p> <p>Isolation of basement/crawl-space area from house</p> <p>Thinning of trees around the homesite to allow for more air movement</p> <p>There was no evidence that mold was returning after these recommendations were carried out</p>

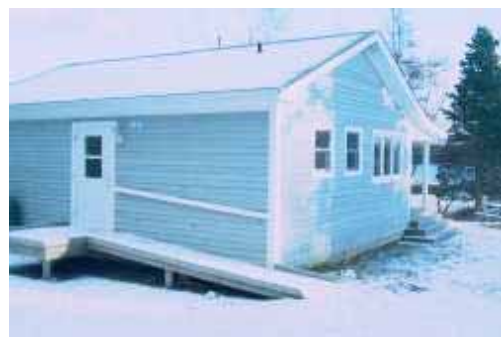
Exterior: wheelchair accessible rental unit

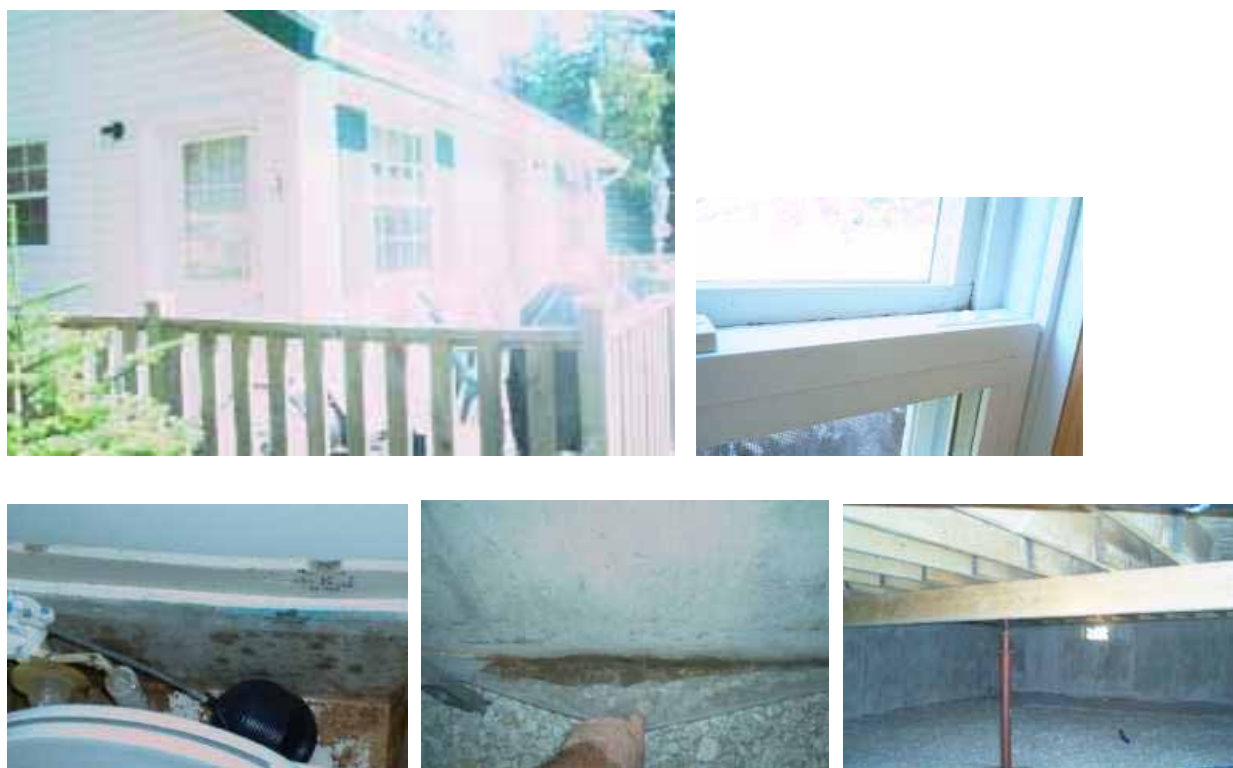
3.1 Weatherized Cottages B78A and B78B

These identical bungalows, built in 2002, are rental units within 20m of each other on a property located on Nova Scotia's South Shore. They are well-constructed on dry crawlspaces with 2x6 walls and truss roofs. The owners had noted that B78A showed more mold growth and/or the results of condensation (discolouration, staining etc. on woodwork) than B78B. B78A is in a more shaded location than 'B'. However, it is unclear whether the more shaded location is the cause of the higher RH levels. One datalogger was hung in each of the units, in the middle of the building.

These rental units were built to a higher standard than the other monitored houses, with air leakage rates of 3.55 and 3.86 air changes per hour (AC/H) respectively, the level of current residential construction. As well, as rental units, the level of expected cleanliness was much higher than in the other houses in the survey and in the field study sample. The owners were much more aware of the presence of mold and condensation stains than other owners, and the cottages were cleaned more thoroughly and more often than the other field study houses. Even so, there was evidence of mold growth in the bathrooms of both units, and mold on the

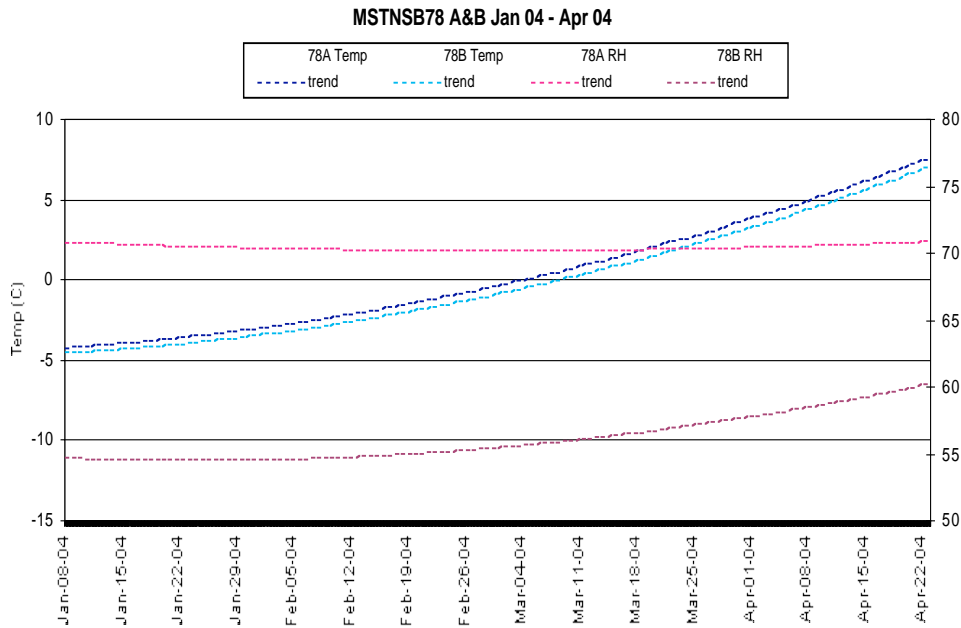
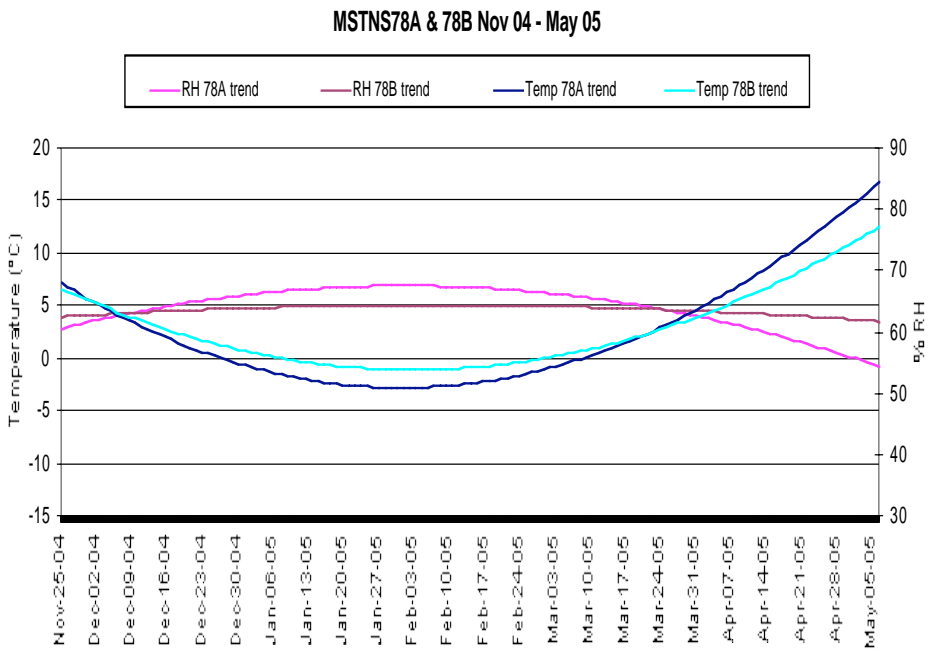
Temperature and RH trends were noted in these two cottages for both years, as shown in the following charts. 'A' shows a consistently higher temperature in 2003/2004. The same trends plotted for the second year show a different story, where 'A' has a slightly lower temperature curve than 'B' over the colder months of the year, but 'B' shows a higher temperature trend in the spring. The first year shows a concave trend for RH in both cottages, with a higher, slightly less concave line for the RH in B78A. The RH curve in B78A is fairly flat in the first year of the study, but much higher in general than that of 'B'. In the second year of the study, the RH curve in 'A' is much stronger than in 'B', and both are convex as opposed to concave. However, both are well under the 70% RH line of the graph, showing a significant reduction in overall RH levels in 'A'.

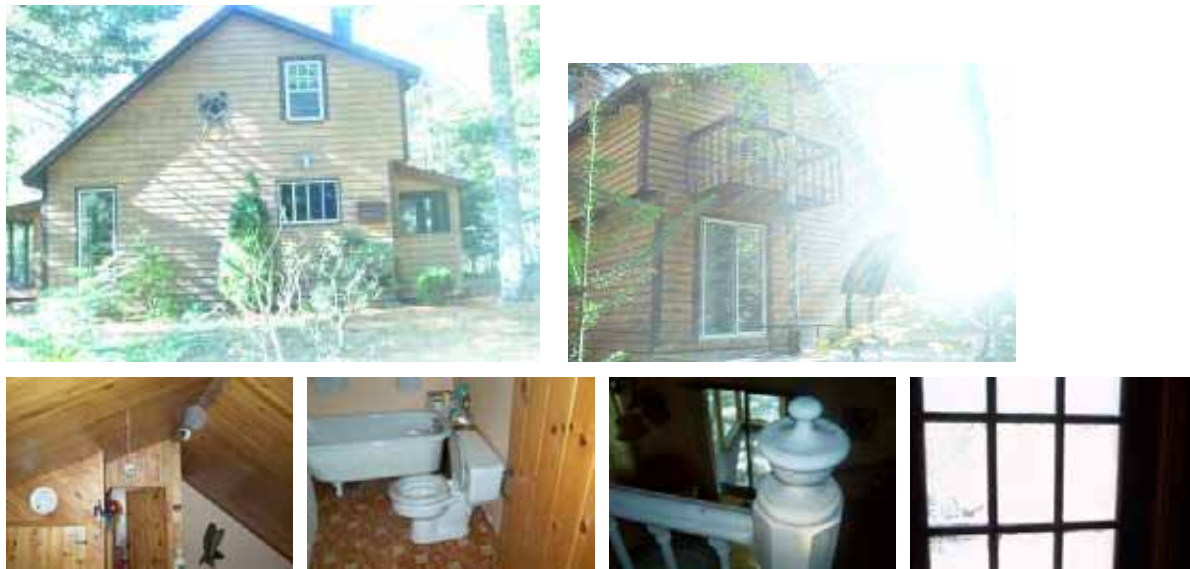
3.2 Weatherized Cottage B95

This weatherized cottage was built in the 1980s, with typical 2x6 stick frame details. A one-and-a-half storey building, it sits on a crawlspace that has a 'dugout' area that houses a wood furnace. This foundation has poured concrete walls and slabs throughout, with four vents – left open continuously – directly at grade level. The wood furnace was connected to the main floor via unsealed ductwork. The air tightness test result, 8.93 AC/H, indicates that this house has a high level of air leakage.

The house had been uninhabitable for two years prior to the study because of high levels of mold. The pattern of mold growth was difficult to discern, initially, it seemed that there was no pattern at all. Closer inspection showed a definite 'tide line' on the sloped ceiling, almost directly in line with the railing of the loft.

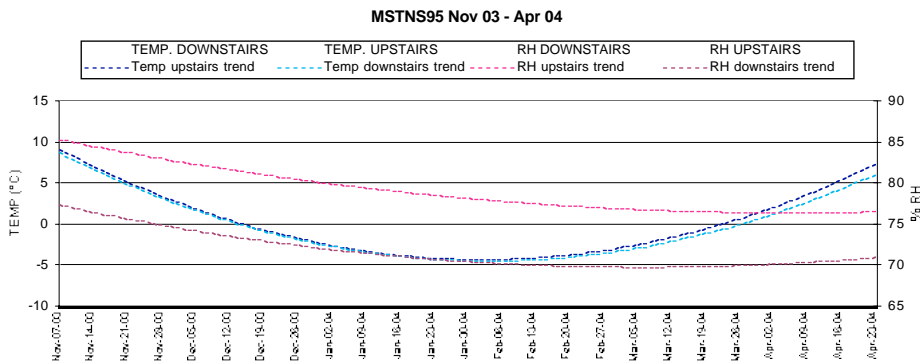
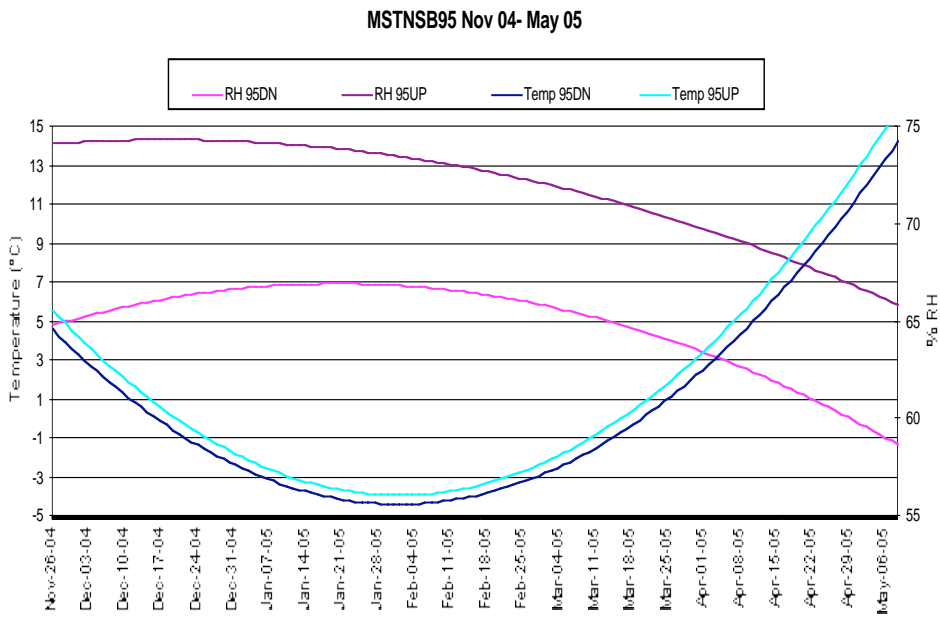
RH trends for this house are shown in the following two charts. The temperature curves over the two years follow similar concave patterns, as seen in all of the houses. The RH patterns, however, are opposite to each other over the two years of monitoring. A wider gap is seen between the main and upper floors in general after recommendations were carried out, however, the trendlines for both floors are below 75%RH in the second year, while they are above 70%RH in the first year.

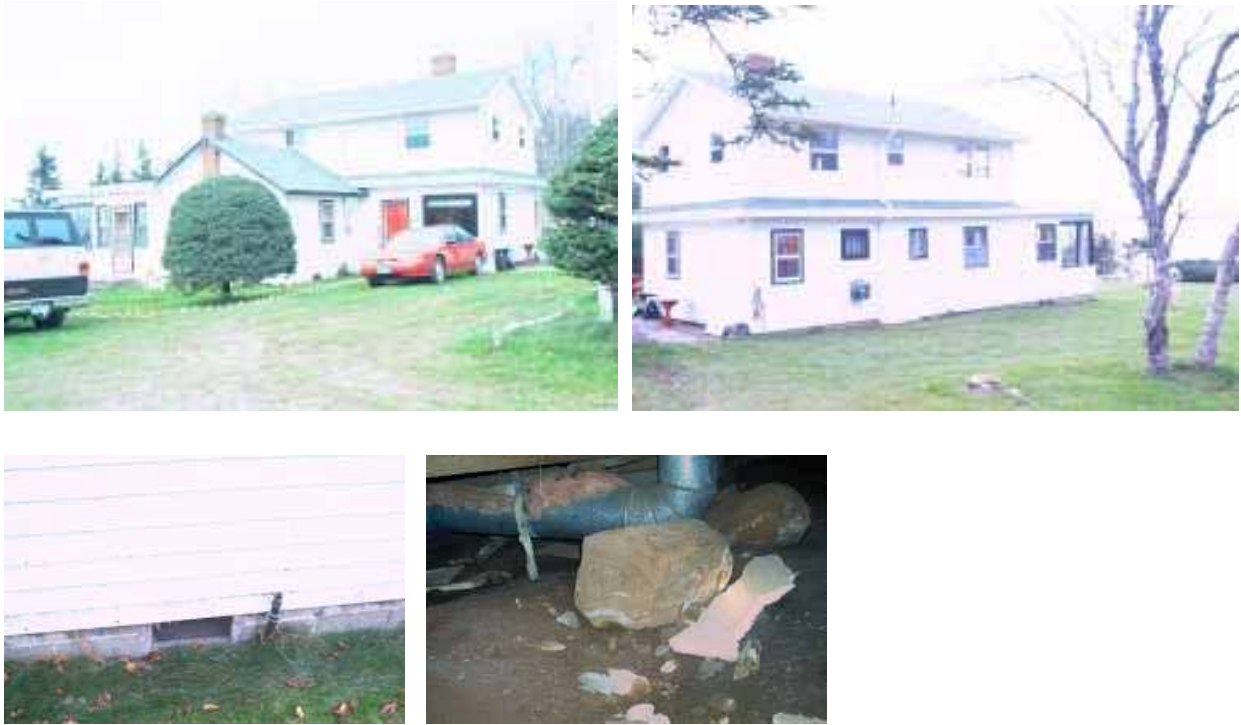
3.3 Uninsulated House C96

This house was originally built in the 1940s, with two early additions and a current upper floor addition. There are two distinct crawlspace areas and a slab-on-grade portion to the foundation. The crawlspaces, the areas of attachment/opening between the original house and the additions as well as the connection between the new upper floor and the existing main floor all showed large air leakage problems (the airtightness test showed an leakage rate of almost 17 AC/H). Addressing the issue of air leakage transference was nearly impossible, however, the owners complained of a consistent musty smell in the sitting room over the original crawlspace foundation. The main recommendation for this house was to install a vapour barrier on the dirt floors of the crawlspaces and also to install a small fan and duct system that could be used to depressurize the crawlspaces to reduce the amount of musty, damp air in the house when occupied. See following sketch for details of proposed crawlspace ventilation system.

Unfortunately, the datalogger malfunctioned during the first collection period (November and December 2003). What was thought to be a faulty battery was replaced for the second year of monitoring, but the sensor malfunctioned again, recording only the temperature levels in the house except for a few spotty RH values towards the very end of the data acquisition period.

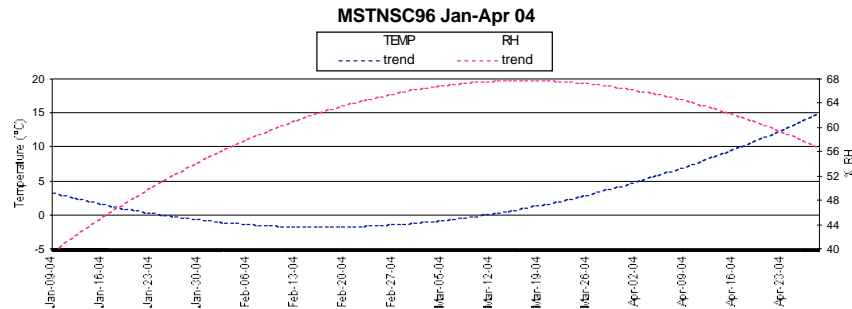
With averages well under 70% RH throughout the monitored time, and reasonably low RH ranges in each of the four months, this house has favourable drying conditions. The musty smell was most likely emanating from the crawlspace. There were vents on three sides of the foundation, and these were closed off so that the

fan system could effectively remove moist air from the crawlspace. The parameters for the design of the system came from the Minnesota building code, crawlspace ventilation requirements.

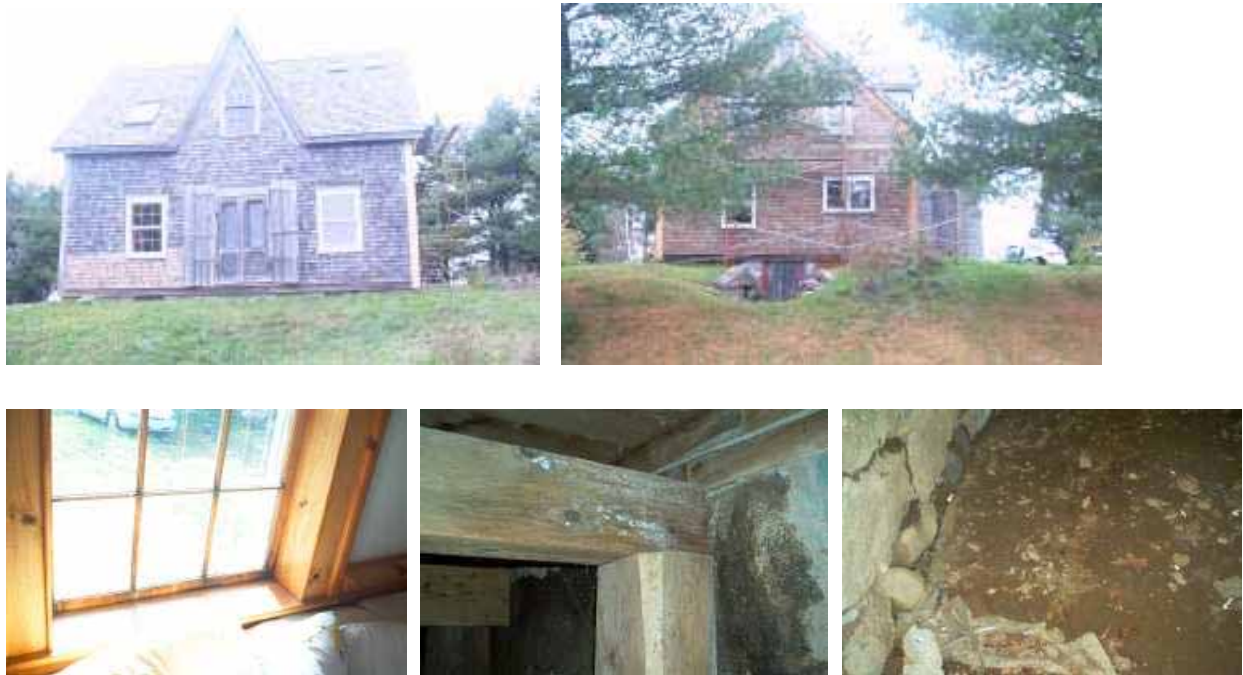
3.4 Weatherized House D68

This house was built in the 1860s, on a stone foundation with a dirt floor. The main issue with moisture and mold were based in the foundation area, and the recommendations reflect this, starting with clearing out the foundation and laying down a continuous sheet of polyethylene. The homeowner also resurrected a drainage pipe that the original builders had incorporated into the foundation floor to help keep it from flooding. Further recommendations included regrading the exterior to drop the grade line below the top course of stone and maintain a slope away from the exterior walls and installing eavestroughs with rainwater leaders and/or waterbarrels to eliminate as much surface water from reaching the foundation as possible.

The homeowner carried out the interior recommendations and was extremely pleased with the resulting decrease in musty odours in the living space, and the observably drier basement throughout the fall of 2004. She planned to carry out the exterior recommendations (regrading and eavestroughing) in the spring of 2005, however, a late spring rainstorm caused serious flooding before she could have this work done (but after the datalogger had been removed). Her observation was that the original drain worked extremely well to clear the standing water once the storm was over, but the basement was once again very wet this year.

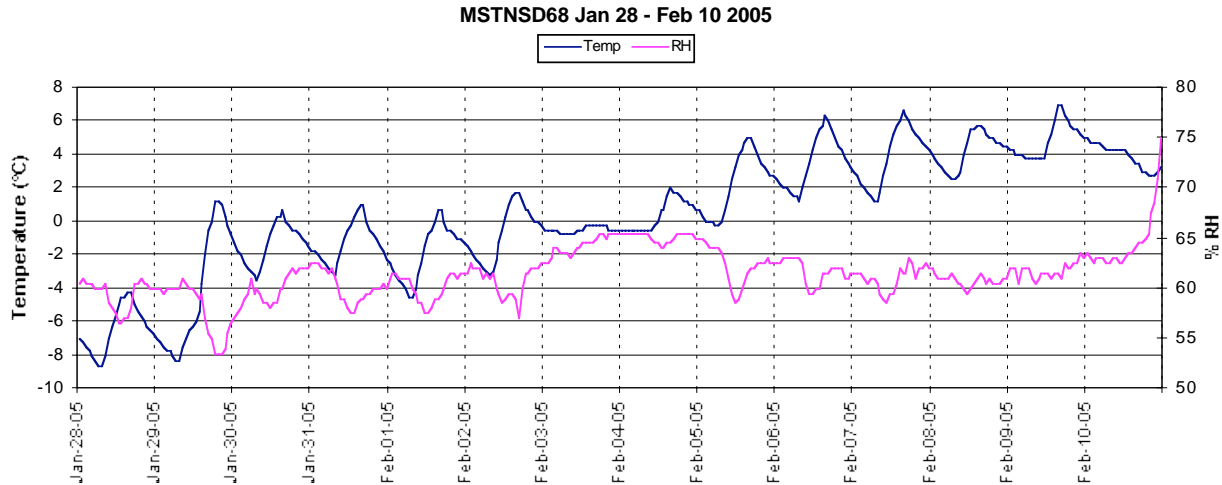
It is in this house that the anticipated pattern of temperature drop and RH rise on a daily basis is best represented graphically for most of the monitored period. In the following sample (January 28th through February 10th 2005), the dotted vertical lines indicate midnight for each date. The temperature peak is typically between 1pm and 5pm, while the temperature low is typically between 7am and 9am.

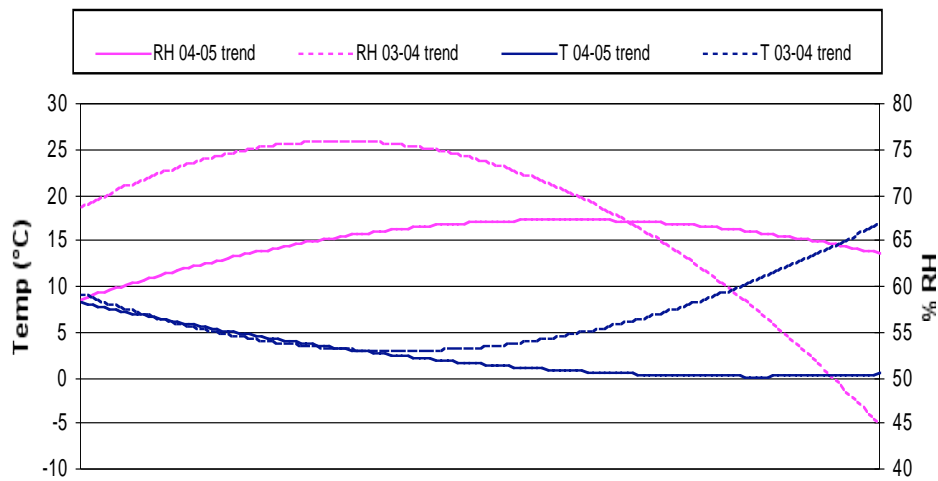
MSTNSD86 -- Comparison of Nov-Jan data, both years

The trendlines for D68 show similar forms to those of the preceding houses. The first chart below shows the comparison between the period November through January for both years of the field study. The RH trend for 2003/2004 is higher than that of 2004/2005 until January 2003, when the house was occupied for a period of time. The overall curve of the 2004/2005 trend is very similar in shape to the trendlines of the other houses in the study.

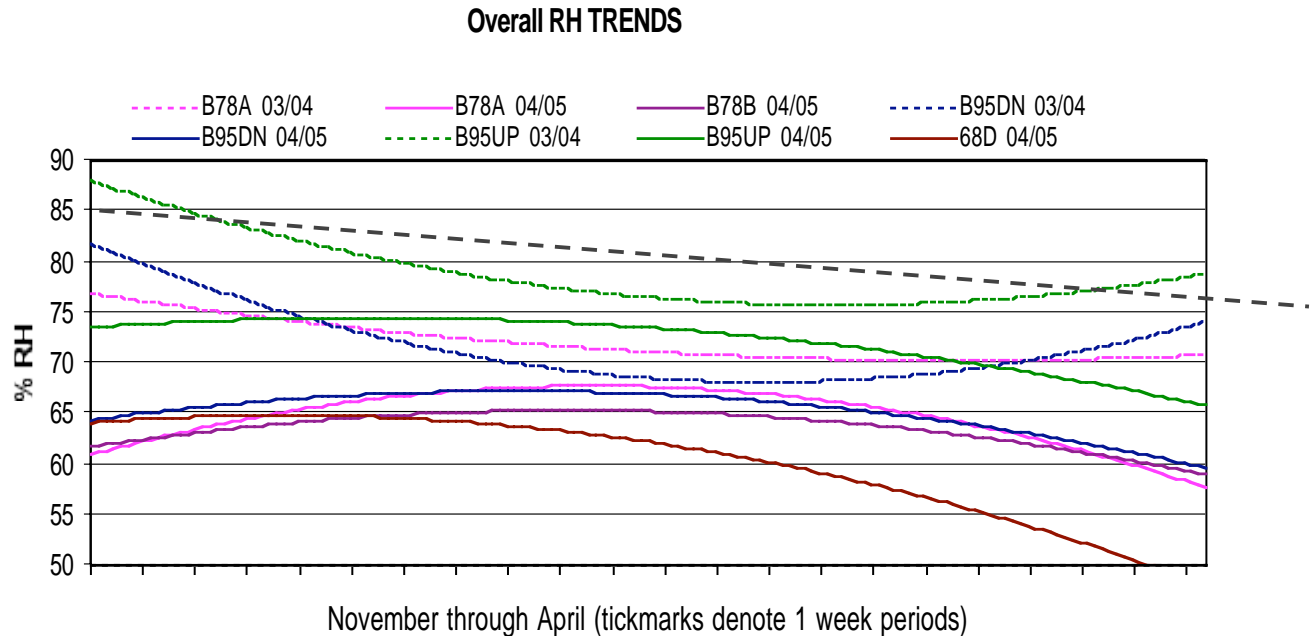
Comparison of Humidity Levels

The chart below shows humidity trends in all houses that had a full year data set. There are nine trendlines, with three full sets of data over two years for two houses (NS78A and NS95 UP and DOWN). The trendlines for 2003/2004 are shown as dotted lines, while 2004/2005 are solid. The heavy dashed line shows the average humidity for Halifax and region on a monthly basis¹¹. This chart shows the overall trend of higher humidity levels in the late fall than in the spring. It also shows the differences possible in yearly weather patterns, where the three trendlines for winter 2003 are convex, or nearly so, the five trendlines for four different houses are concave. This most likely indicates a wetter spring. In addition, the three trendlines for winter 2003 start off much higher than winter 2004, although they only refer to two houses. This could be attributed to the after effects of Hurricane Juan. Three of the five RH trend lines for 2004/2005 (B78A, B78B and B95DN) are very closely related throughout the monitoring period, and D68 varies from these three lines about 1/3 the way through the monitoring season (sometime in mid-January). The one trendline from 2004/2005 that is 'outstanding in it's field' is B95UP, and, just as it did in 2003/2004, this upper floor had consistently higher RH values than the main floor, however, it does mirror the curve of the main floor trendline (B95DN) quite handily.
