Radon Mitigation Planning Inspection
and Mitigation System Installation

On behalf of
Health Canada - Radiological Impact Section
And
Canada Mortgage and Housing Corporation

ARTHUR SCOTT AND ASSOCIATES

Fixing Houses with High Radon— A Canadian Demonstration

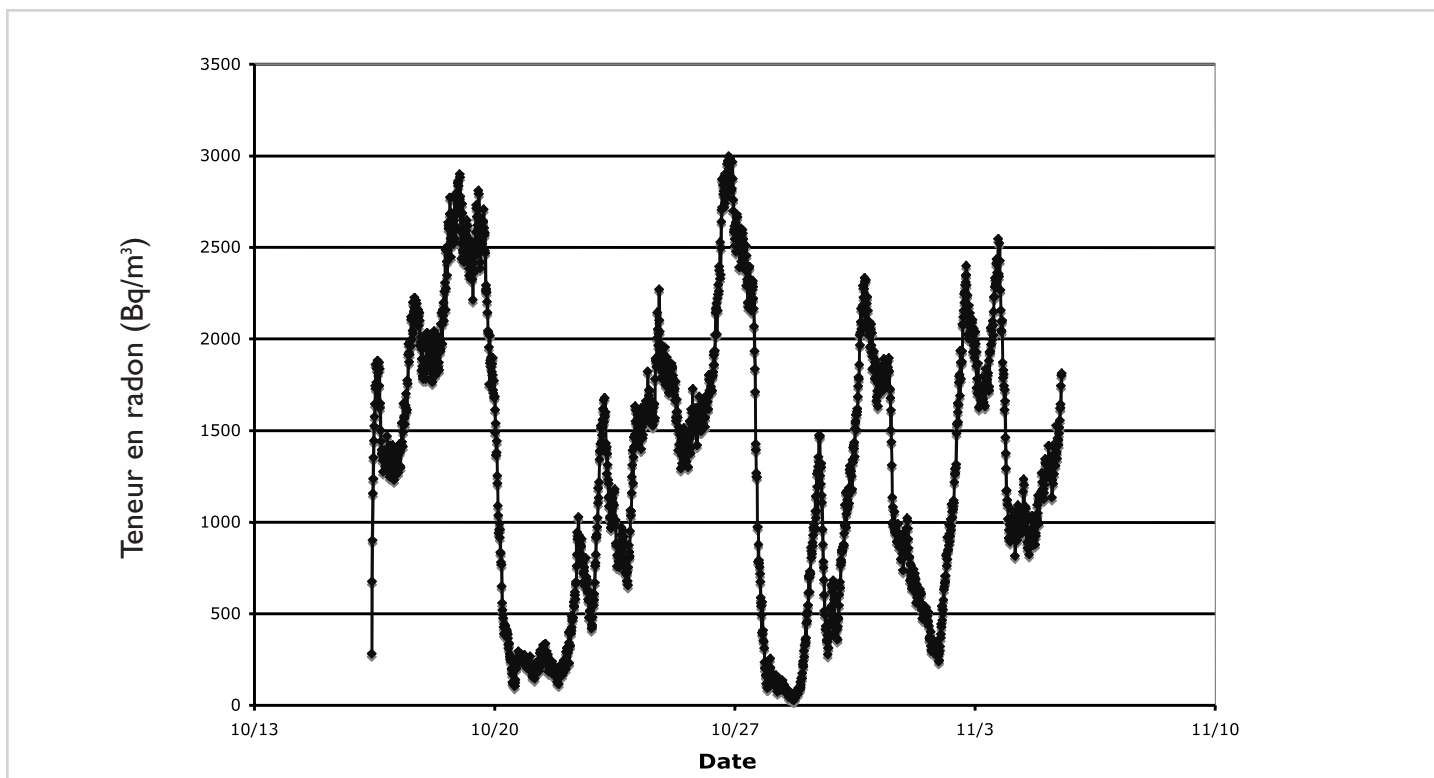
Figure 1 Suivi en continu de la teneur en radon, octobre et novembre 2007

La teneur moyenne mesurée au cours de la période d'examen a été de l'ordre de 1 400 Bq/m³, ce qui est considérablement plus élevée que la nouvelle ligne directrice et même l'ancienne. Le sous-sol était composé des murs de fondations et d'un plancher en béton, et n'était pas tellement différent des maisons avoisinantes. La dalle avait été mise en place sur une membrane de polyéthylène, ce qui aurait dû réduire le taux de pénétration du radon.

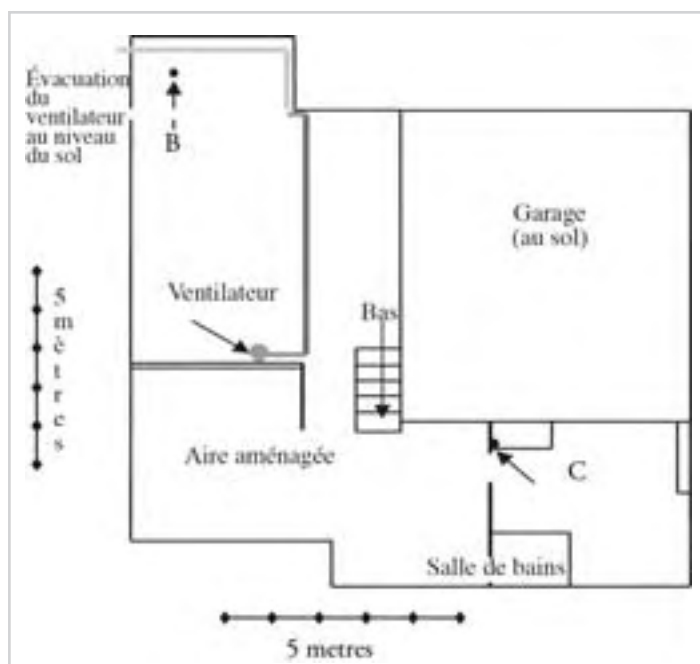
Figure 2 Schéma du système : ventilateur et conduits

Pendant la mise en service de l'installation, le débit du ventilateur n'était pas tout à fait assez puissant pour créer une dépressurisation à l'endroit des ouvertures B et C montrées dans la figure 2. Cette situation a été la cause d'inquiétudes, mais on a décidé de faire fonctionner le ventilateur durant un mois tandis que l'on suivait son efficacité, avant de se pencher sur des façons d'augmenter le débit du ventilateur.

Le ventilateur d'extraction évacuait l'air (sous la dalle) au niveau du sol et non au niveau du toit, comme le recommande l'agence de protection de l'environnement des États-Unis (EPA). Cette technique a été retenue en raison des préoccupations ayant trait à des problèmes de condensation possible et d'accumulation de glace dans les événements verticaux à l'extérieur de la maison dans les conditions climatiques qui ont cours au Canada. L'équipe de projet était d'avis que si le radon évacué revenait dans la maison par les portes, fenêtres ou autres points de fuite de l'enveloppe dans les environs du point d'évacuation du ventilateur d'extraction, les essais après la mise en place des mesures d'assainissement indiqueraient des teneurs élevées en radon dans la maison. Les teneurs en radon ont été mesurées pendant un mois au cours de l'hiver qui a suivi la mise en place du système. La figure 2 montre le sous-sol, l'emplacement des ouvertures pour le mesurage (B, C), et le ventilateur et le système de conduits.

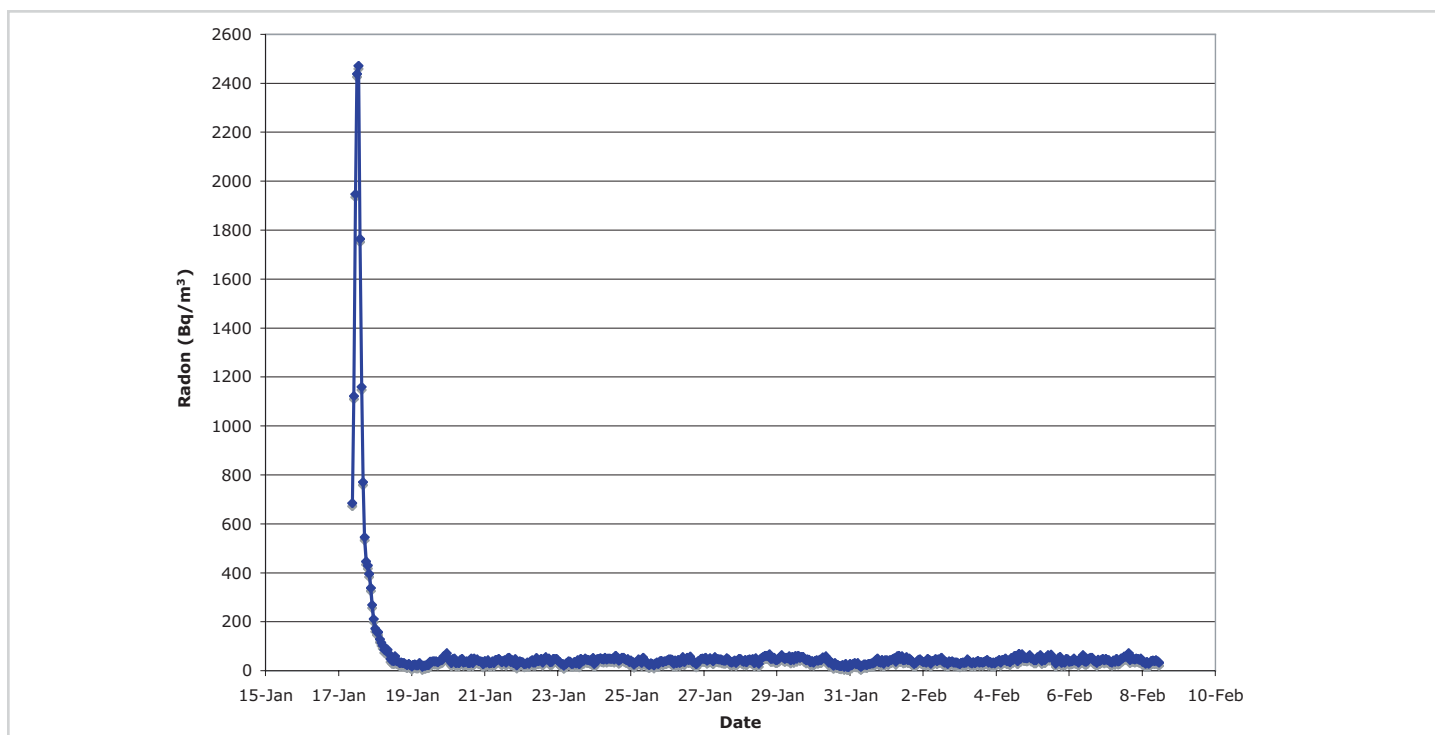
Figure 3 Suivi en continu du moniteur avant et après les améliorations

Le système s'est avéré d'une remarquable efficacité (voir la figure 3). Les teneurs en radon sont passées d'une moyenne de 1 400 Bq/m³ à environ 40 Bq/m³ pendant le mois qui a suivi les travaux, ce qui est considérablement plus faible que la ligne directrice de 200 Bq/m³ de Santé Canada. Le propriétaire-occupant était satisfait de l'installation et des résultats. La réintroduction du radon évacué n'a pas constitué un facteur à cet endroit durant la période.

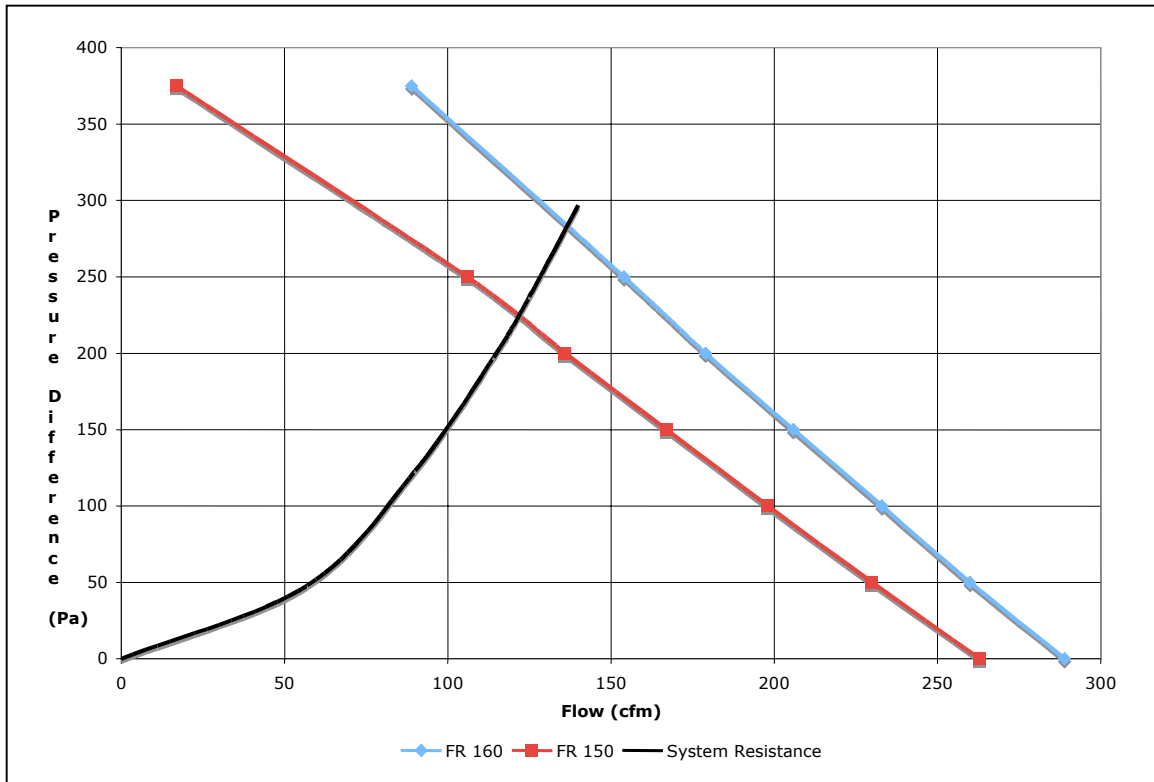
Figure 5 Fan and System Resistance Curves

Figure 5 plots the system resistance curve and the fan pressure/flow curves provided by the manufacturer for two Fantech fans sold for radon mitigation, FR-150 and FR-160. The predicted flow rate in the system with a given fan is where the fan curve intersects the resistance curve. The FR-150 curve intersects at ~120 cfm (57 l/s), which is close to the estimated flow rate required for effective performance in winter. The FR-160 curve intersects at ~130 cfm (61 l/s), which provides a margin over the design flow to compensate for underestimates in the required system performance.

Note that the design pressure drop across the entire system (fan inlet suction plus fan discharge pressure) as estimated in Table 2 was 205 Pa at 52 L/s. The measured system flow is 52 L/s (110 cfm), at which flow the FR-160 fan curve shown in Figure 5 indicates the fan produces a pressure differential of 340 Pa – 65% higher than estimated as necessary to produce the design flow. The choice of the larger fan (FR-160) to provide spare capacity is justified.

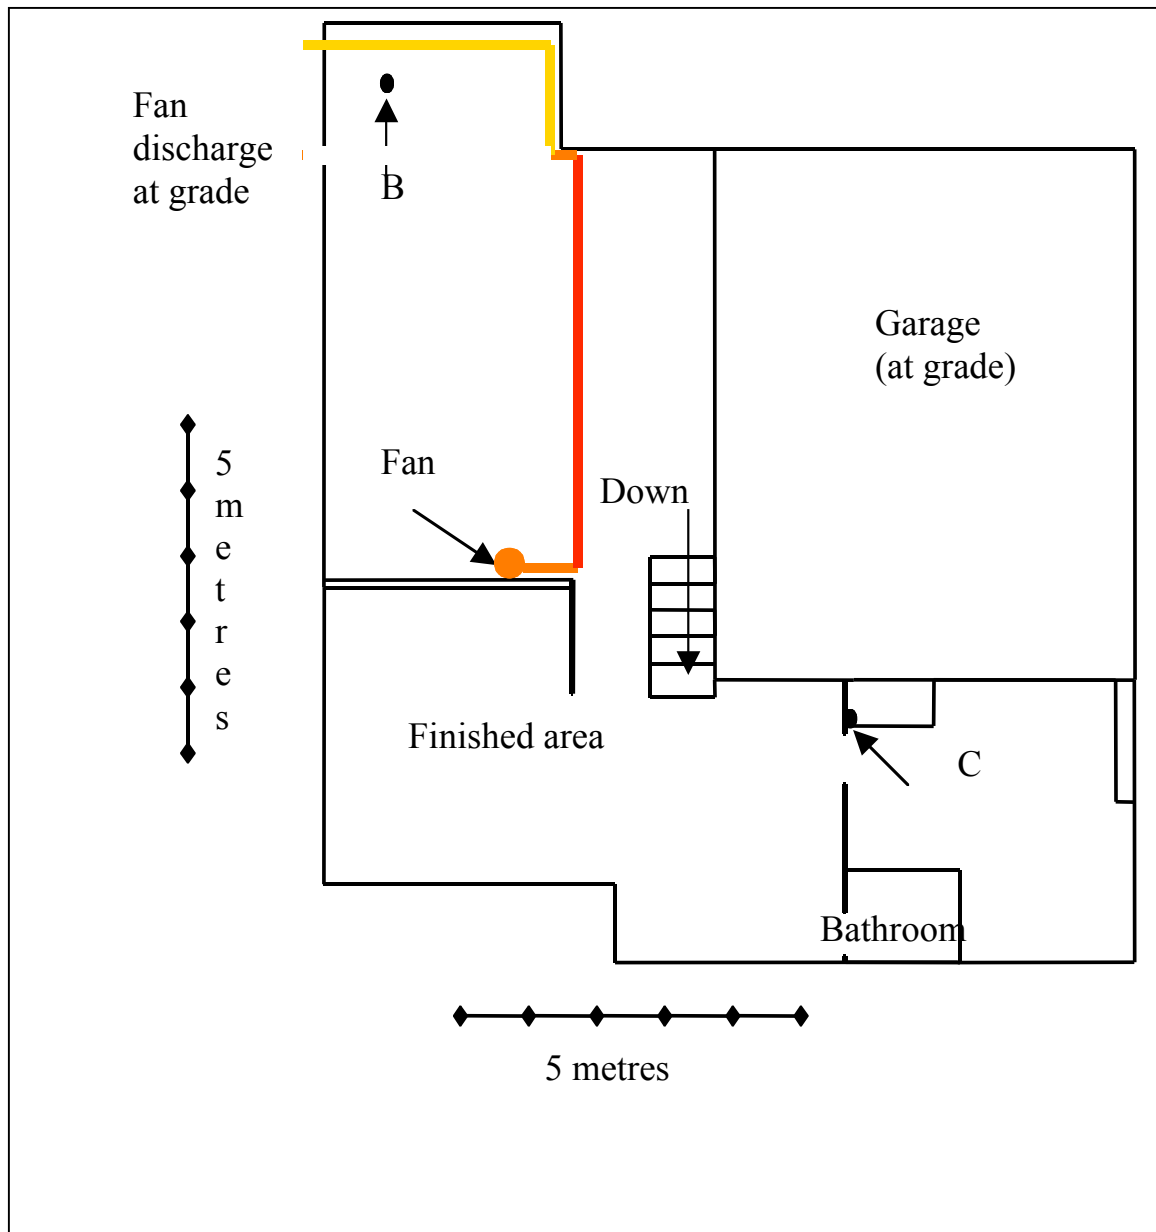
Figure 6 Installed Fan and Piping Layout

A local contractor was engaged, and after an inspection of the basement, suggested that the exhaust layout be modified to discharge closer to the front corner of the house to avoid interference with air ducting and electrical services. The modified design layout is shown in Figure 6.

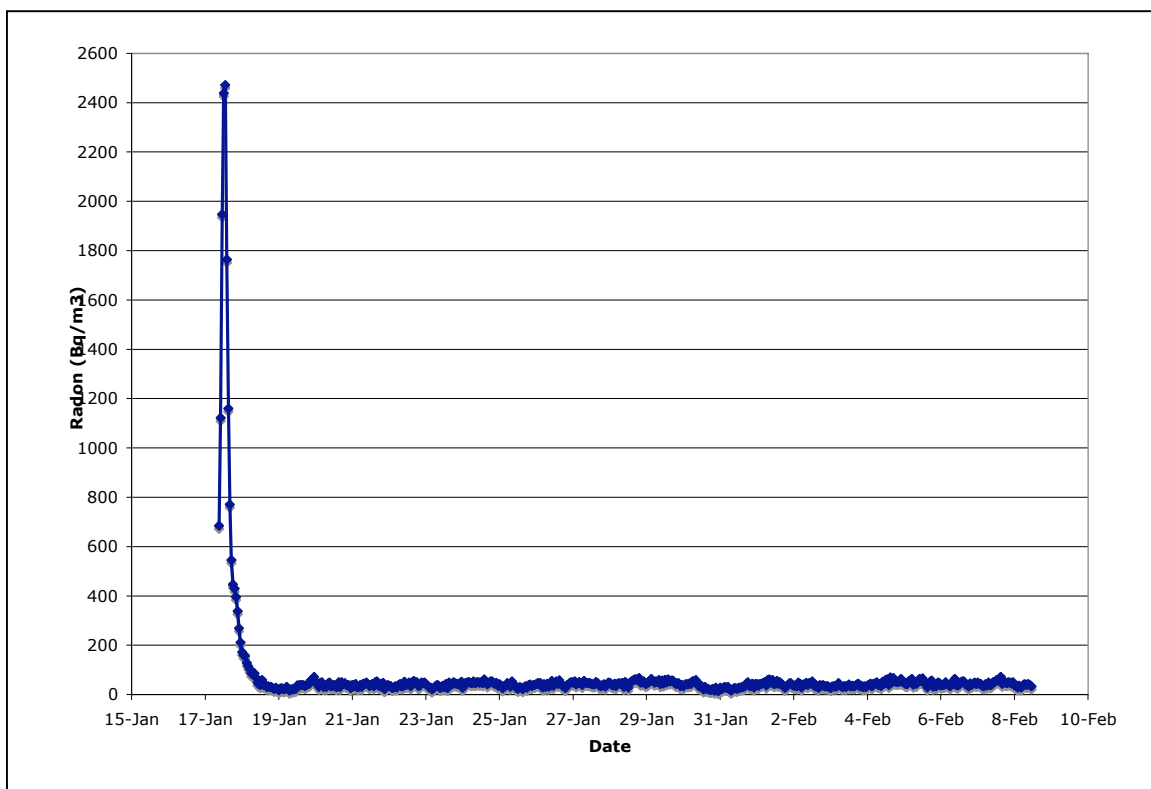
Figure 7 Continuous Monitor Trace During and Post Mitigation

The continuous radon monitor reading had been increasing every hour since it had been started at 8:00, and read 2470 Bq/m³ at 13:30. This reading represents the average radon concentration over the previous hour. This was the highest concentration measured in the basement, as readings fell steadily from that time on, reaching the average mitigated value of ~40 Bq/m³ by 9:00 am the next day. This is shown in Figure 7.

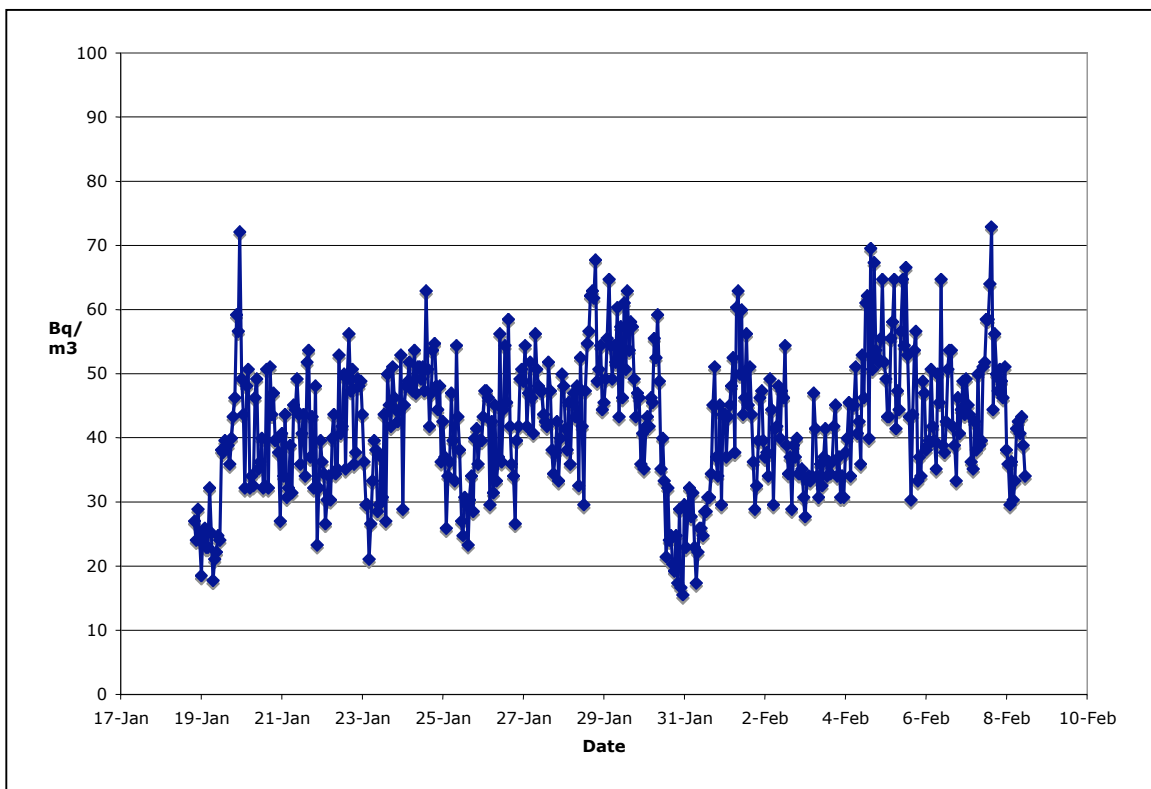
Figure 8 Continuous Radon Monitor Trace - Post Installation only

The performance during January-February 2008 was satisfactory, as shown in Figure 8. The average radon concentration is about 42 Bq/m³, well below the mitigation guideline value of 200 Bq/m³. The outside temperature during this period typically ranged from -10°C to -5°C, but fell to -20°C on 20 – 21 January. This would be expected to increase the slab pressure differential, and increase the radon inflow, but the continuous radon monitor trace shows that range of house radon concentrations over these days were not higher than the average over the period. There was little correlation between house radon concentration and exterior temperature, "high" measurements of 50 to 70 Bq/m³ on 5 - 6 February were associated with warmer temperatures of -5°C to 0°C.
