## Performance Monitoring of a Brick Veneer/Steel Stud Wall System

SUBMITTED BY: KELLER ENGINEERING ASSOCIATES INC.  
1390 PRINCE OF WALES DRIVE, SUITE 107  
OTTAWA, ONTARIO  
K2C 3N6

REPORT DATE: JUNE 4, 1993

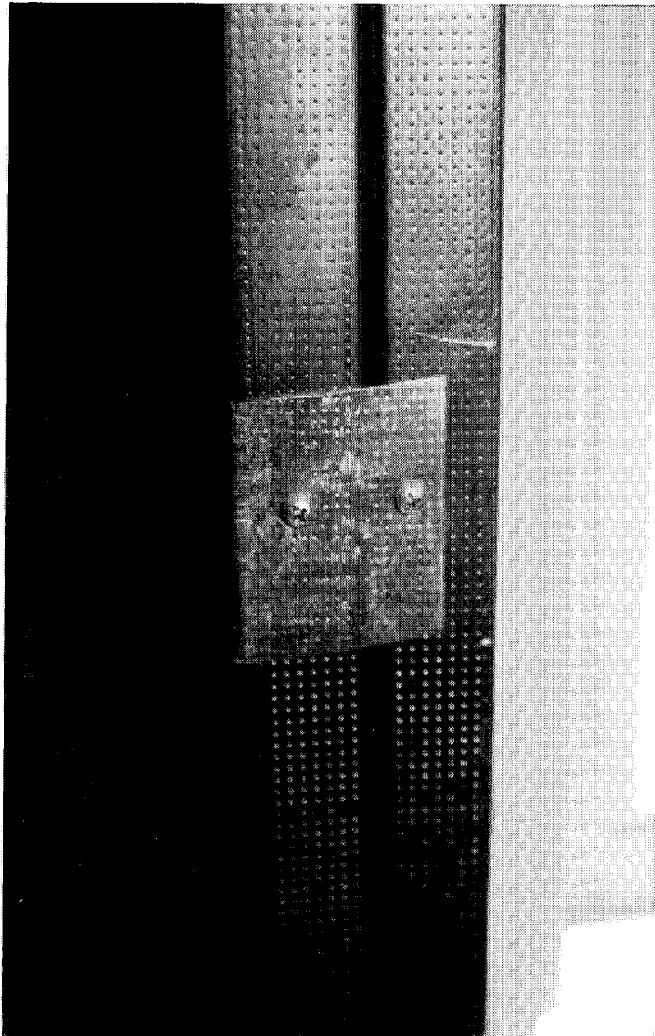
- 4 Showing the clip connection used to tie double studs

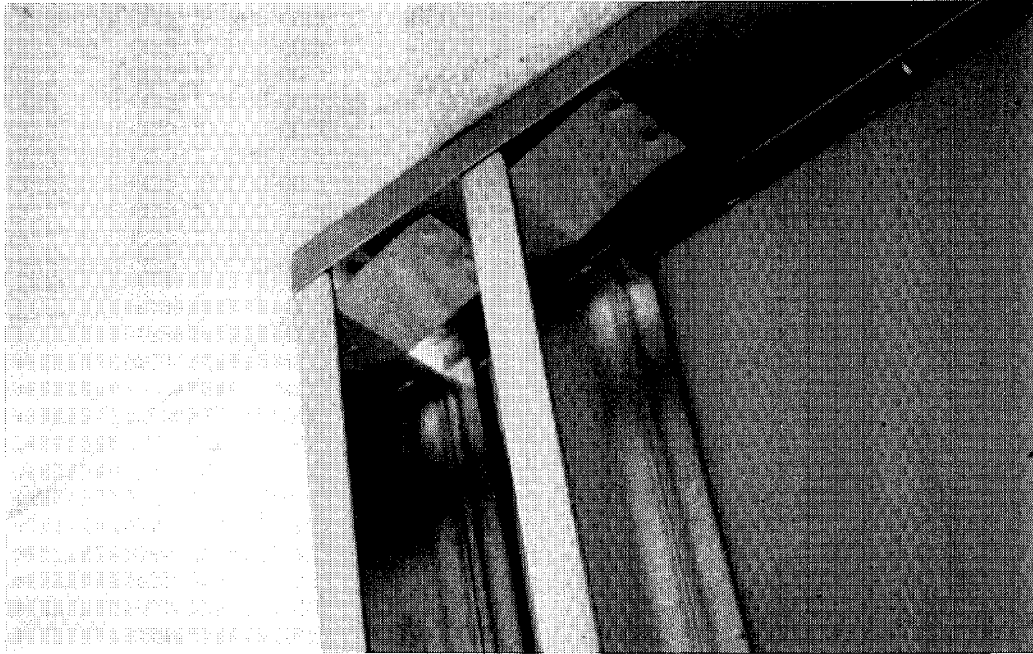
- 5 Showing the use of flexible ties between stud and top tracks. These types of ties have proven to be easy to install and hence economical but also very effective in transferring lateral load.

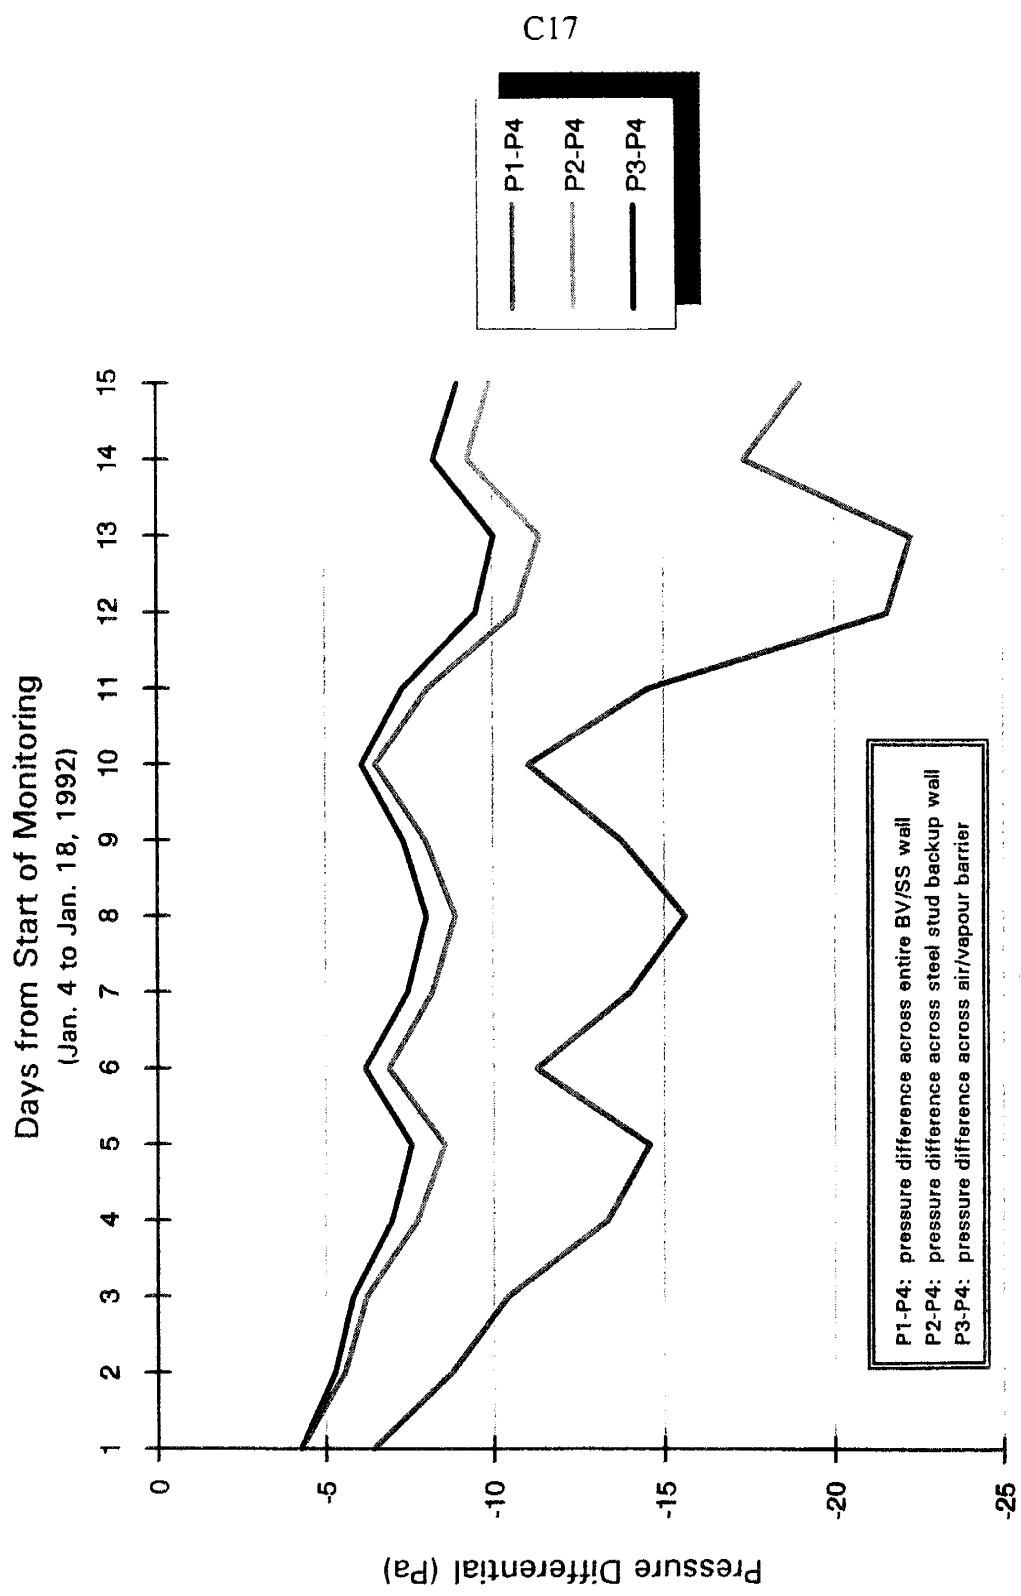
Fig. 15 Daily Average Pressure Differentials Across Test Wall

The graphs of P1-P4, P2-P4 and P3-P4 over the period of January 4 to 18, 1992, (Figs. 14 and 15) demonstrate that the test wall generally performs in a satisfactory manner since the wall meets most of the criteria outlined above. Note that, in both graphs, P1-P2 is represented by the distance between the curves of P1-P4 and P2-P4. Similarly P2-P3 is represented by the distance between the curves of P2-P4 and P3-P4. Fig. 14 illustrates the hourly average pressure differentials while Fig. 15 illustrates the daily average pressure differentials.

Fig. 14 illustrates that the pressure differential between the cavity air and the exterior air (P1-P2) varies significantly depending on wind conditions. During easterly winds, the magnitude of all pressure differential values are reduced as positive wind pressures partially counteract the negative pressure differentials caused by building pressurization. The simultaneous increase in pressure on the exterior and within the cavity illustrates that pressure equalization does occur to some degree and that both the brick veneer and the backup wall are affected by wind pressures, and thus resist, wind loads.

However, Figs. 14 and 15 also illustrate that when wind directions change, there is a greater change in P1-P4 than in P2-P4. In fact, the pressure difference across the brick veneer generally accounts for 50% of the pressure difference across the entire wall. Since the changes in the pressure differential between the exterior air and interior air tend to be greater than changes in the pressure differential between the cavity air and the interior air, pressure equalization is not fully effective. As such, wind loads are carried by the BV/SS test wall in a manner that is a combination of points (a) and (b) above. That is, pressure equalization causes a portion of the wind load to be immediately transferred to the backup wall but since pressure equalization is not fully effective, a portion of the wind load is still carried by the brick veneer.
