Monitoring the Performance
of an EIFS Retrofit on a 15 Storey
Apartment Building, Toronto, Ontario

FINAL REPORT

**Monitoring the Performance
of an EIFS Retrofit on a
15 Storey Apartment Building**

Toronto, Ontario

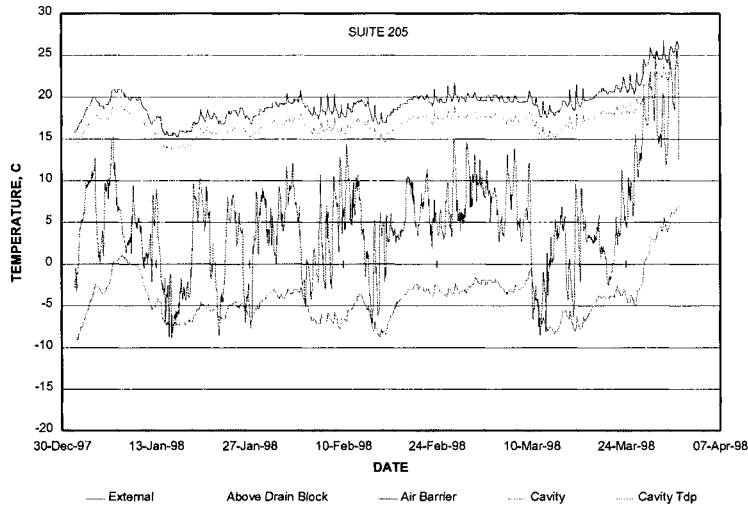
Figure D1. Measured surface temperatures and calculated cavity dew point temperature at Suite 205.

Temperature data from the five monitored locations are presented graphically in Appendix D. 'External' temperature is common to all three figures; 'Cavity Dew Point' temperature is calculated for each location. It is noteworthy that the air barrier and masonry cavity temperatures, which are nominally from the same plane of the wall, are similar but not exactly the same. There are two possible explanations for this. The first is the accuracy of the sensors and data loggers - the air barrier sensor is a thermocouple mounted on a surface; the masonry cavity sensor is a thermistor mounted in air. Both are estimated to have accuracy no better than $\pm 1^\circ\text{C}$. The second is the spatial separation of the sensors - they are physically located as much as a metre apart from each other (Figures 2.3 to 2.5). Hence, for a combination of both reasons, the measured air barrier and cavity temperatures are similar but not exactly the same.
