Investigation Of Crawl Space Ventilation
and Moisture Control Strategies for B.C.
Houses: Appendices

INVESTIGATION OF CRAWL SPACE VENTILATION
AND
MOISTURE CONTROL STRATEGIES
FOR B.C. HOUSES

Sheltair Scientific Ltd.
#2 - 3661 W. 4th Ave.
Vancouver, B.C. V6R 1P2

June, 1991

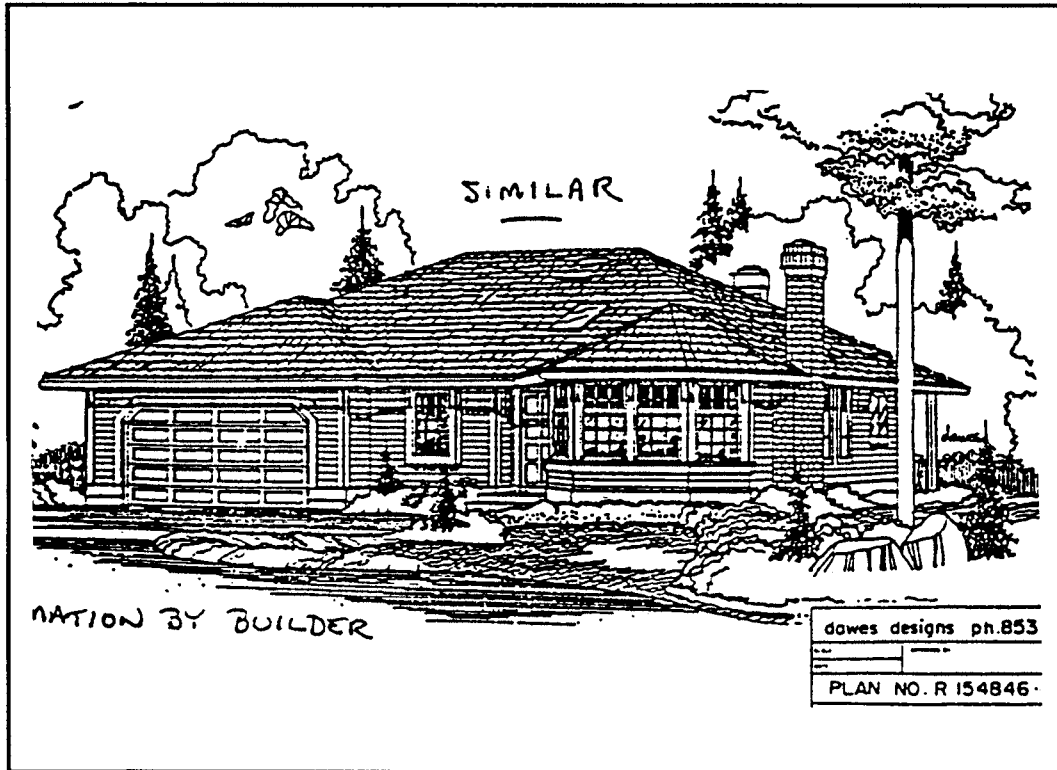
Figure 1: Front Elevation of House

The house was referred to Sheltair by NHWP who had received a complaint about surface water on the crawl space floor and high moisture and a musty smell in the living areas of the house.

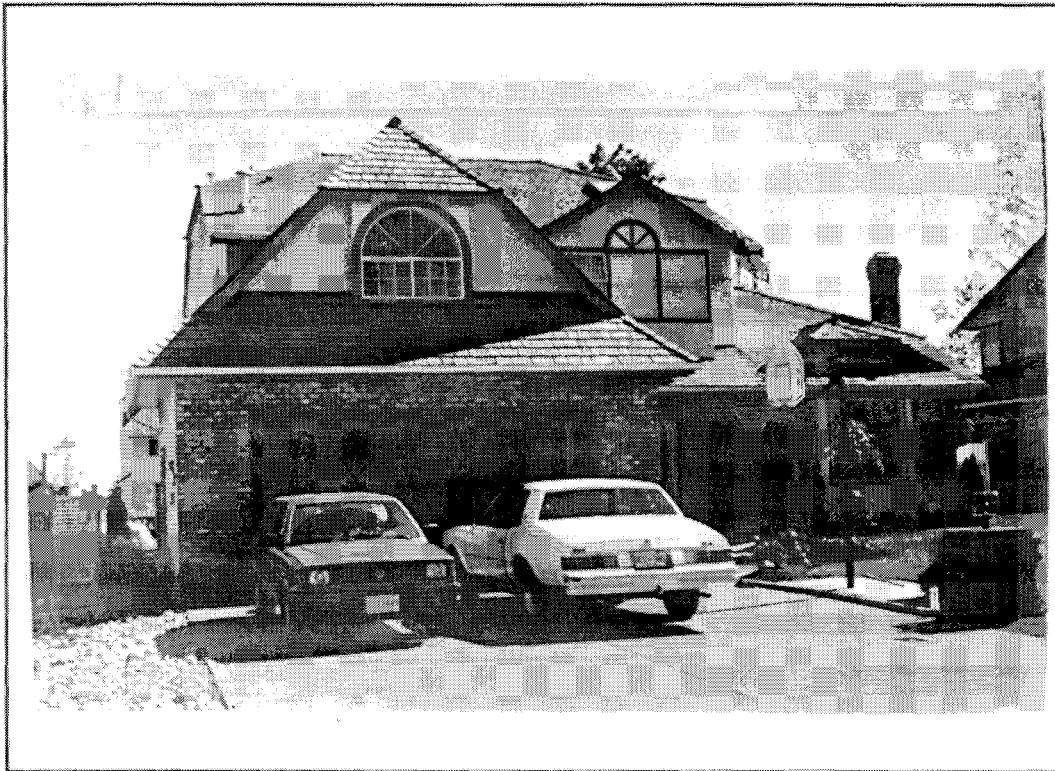
Figure 3: Front Elevation of House

- At House #2, a large municipal storm drain had been placed on the property line between House #2 and an adjacent lot. This is not a common phenomenon and homeowner believed that a failure in the piping system may be causing his ground water levels to be high. This would explain the absence of problems in the houses on neighbouring lots.

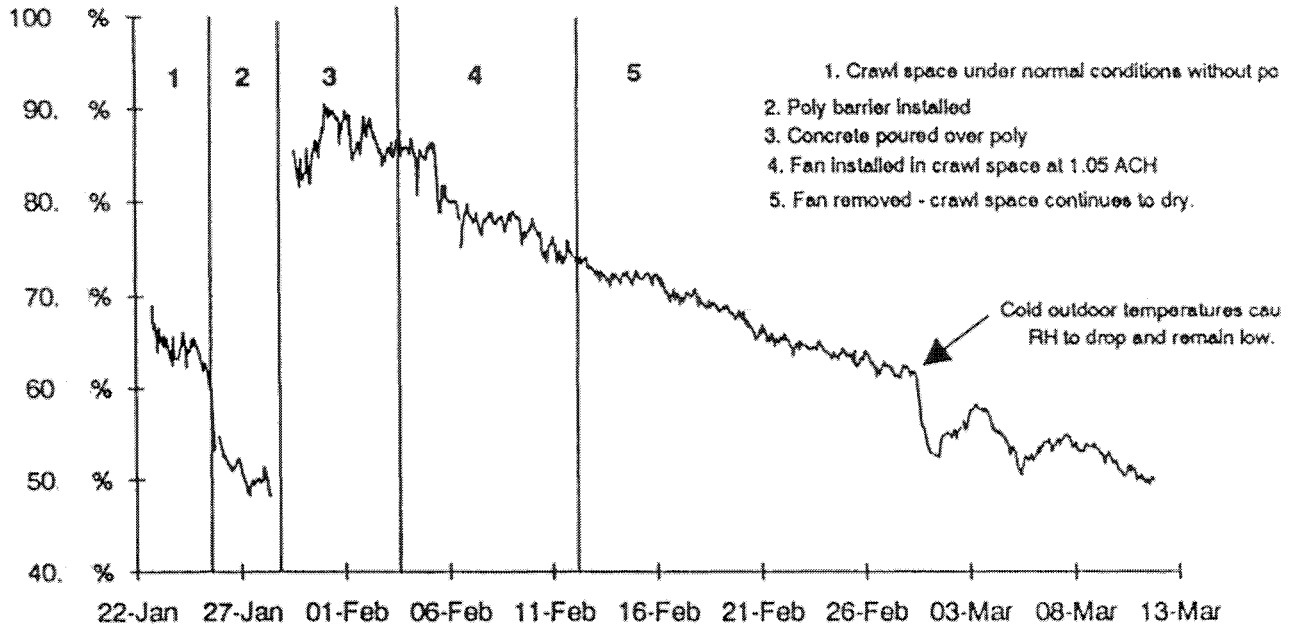
House #6 Post-retrofit Crawl Space Relative Humidity

After reviewing the data collected, it was seen that the moisture levels in the crawl space had stabilized at approximately 1.5 gm/kg higher than outdoors. This was a similar level that measured just prior to the placement of the new floor. This does not imply that the retrofit was not successful. The monitoring period was not long enough to give any satisfying conclusions about the long term effectiveness. At the time the data logger was removed, there was still considerable residual moisture in the structural members to hold the moisture at this steady level. During a cold period however, as can be seen in the graphs below, the crawl space dried out very quickly over 1 - 2 days and the levels did not rebound. Measurements of the slab MC show that the new concrete is already much drier than the original concrete MC. The following graphs & tables show the pattern of events and moisture levels over the entire monitoring period.

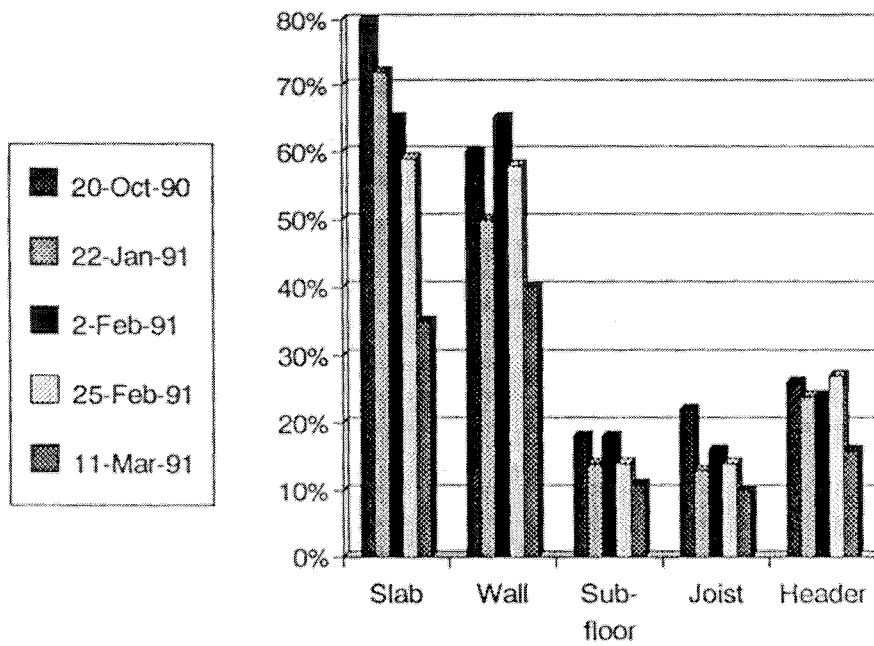
Moisture content measurements in House #6 crawl space over course of monitoring period.

Date	Location of measurement				
	Concrete M.C.		Wood M.C.		
	Slab	Wall	Sub-floor	Joist	Header
20-Oct-90	80%	60%	18%	22%	26%
22-Jan-91	72%	50%	14%	13%	24%
2-Feb-91	65%	65%	18%	16%	24%
25-Feb-91	59%	58%	14%	14%	27%
11-Mar-91	35%	40%	11%	10%	16%

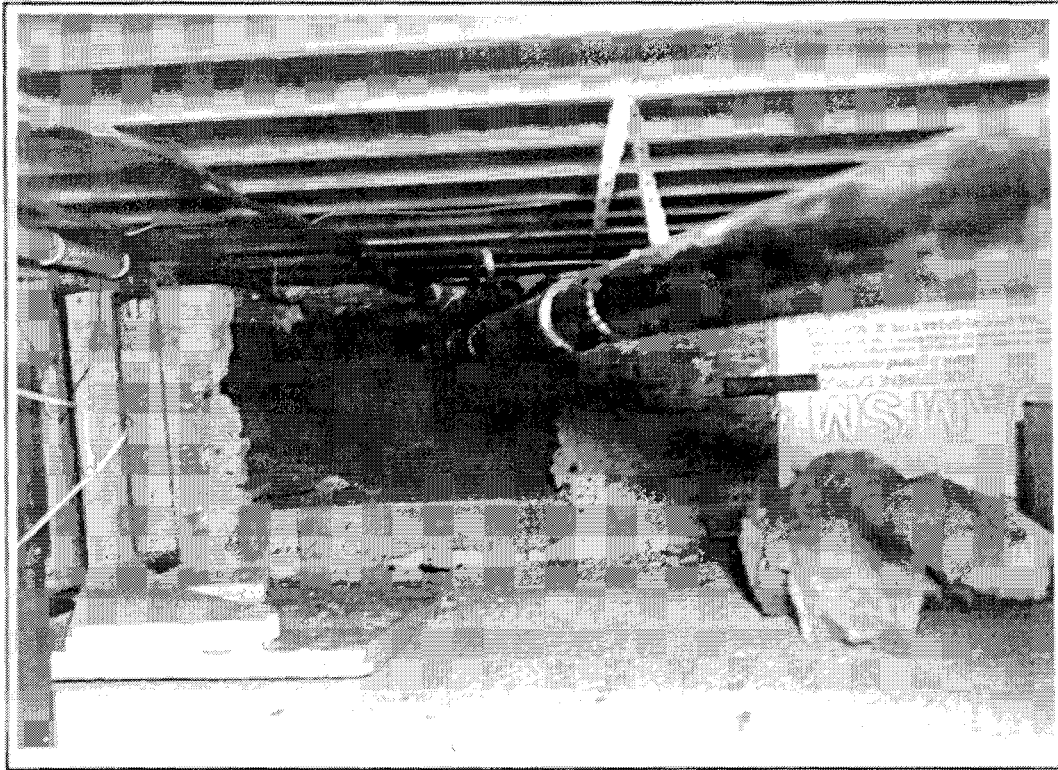
Figure 15: Access between heated and non-heated portion of crawl space.

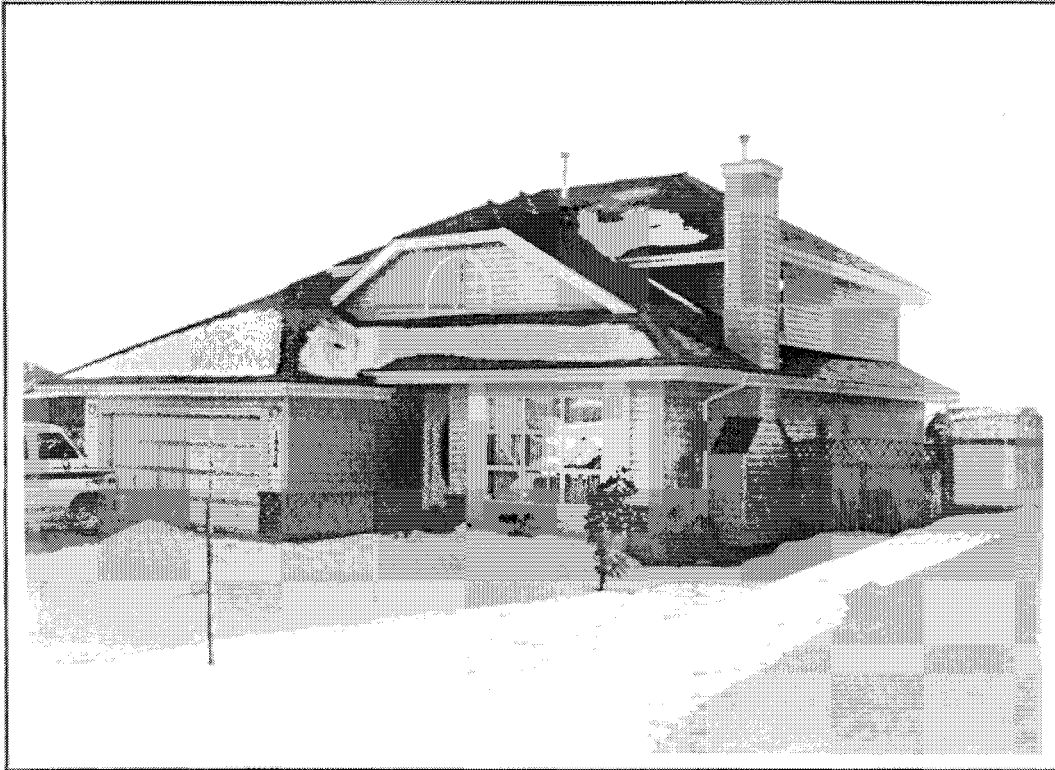
Figure 18: Front Elevation of House

- At House #9, ground water tables were well above the crawl space floor level. The site had been situated more than a metre lower than the adjacent lot. Run-off from the neighbouring lot is partly responsible, since conditions are worse on rainy days. It is also possible a spring is located under the slab since water levels are only kept under control by frequently pumping from sump pits that have been recently installed. While on site, Sheltair observed backfill which contained a large percent of organic matter which had been thrown in by the builder. A test of the foundation drain showed a blockage and almost no drainage from the highest point.

Moisture Content: Moisture content of wood varied considerably depending on location, with the wall sill joints ranging from 60 - 85%, and the sills themselves ranging from 15-24%.

It was difficult to understand the strategy that had been adapted by the contractor to resolve the moisture problem. The addition of crawl space vents would presumably assist in drying out the space. The addition of warm air supply to the crawl space may also be explained in terms of shortening the dry out period. However with open puddles around the crawl space, warmer temperatures could lead to additional humidity entering the living areas of the house. To evaluate this potential problem measurements were taken of pressure differential between the house and crawl space and outdoors. Figure 20 illustrates the pressure differentials in between these three zones, and reveals that under the normal operating condition, with the furnace blower running at low speed, the house is depressurized by over two Pascals relative to the crawl space. With the furnace blower operating at high the situation is even worse. The homeowners can expect more moisture problems indoors than before, given this situation. Advice was offered by researchers free of charge to assist in reversing the air and moisture flows. An offer was also made to develop a long term solution for their crawl space moisture problems. However the occupants decided to wait for further action from the site supervisor, or from the New Home Warranty Program if necessary. A short term solution was outlined for the residents, as follows:
