**RAILWAY INVESTIGATION REPORT  
R12E0008**

**MAIN-TRACK DERAILMENT**

**CANADIAN NATIONAL RAILWAY  
FREIGHT TRAIN M30141-20  
MILE 149.21, WAINWRIGHT SUBDIVISION  
FABYAN, ALBERTA  
21 JANUARY 2012**

Report Number R12E0008

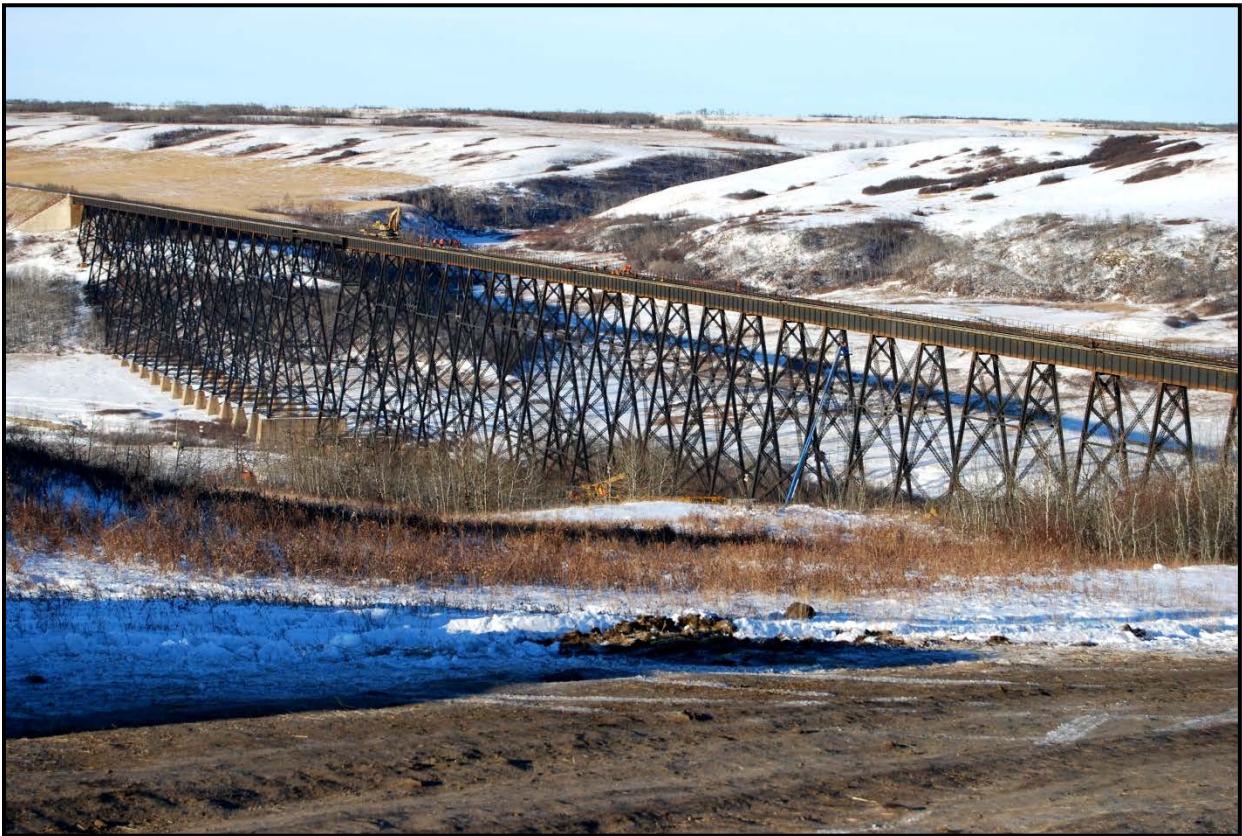
**Photo 5.** Fabyan Bridge (looking west)

Fabyan Bridge is a 2869-foot-long viaduct that spans the Battle River Valley and is a key structure in CN's mainline route (Photo 5). It has a maximum height of 190 feet. The bridge consists of:

- two 23-foot-long ballast deck prestressed concrete girder (PCG) spans;
- two 26-foot-long ballast deck PCG spans built in 1972;
- fifty-two 50-foot-long deck plate girder (DPG) spans; and
- one 152-foot-long deck truss (DT) span built in 1908.

In 1984, a concrete ballast deck replaced the open deck on the DPG and DT spans. The bridge spans are supported on steel lattice-braced towers.

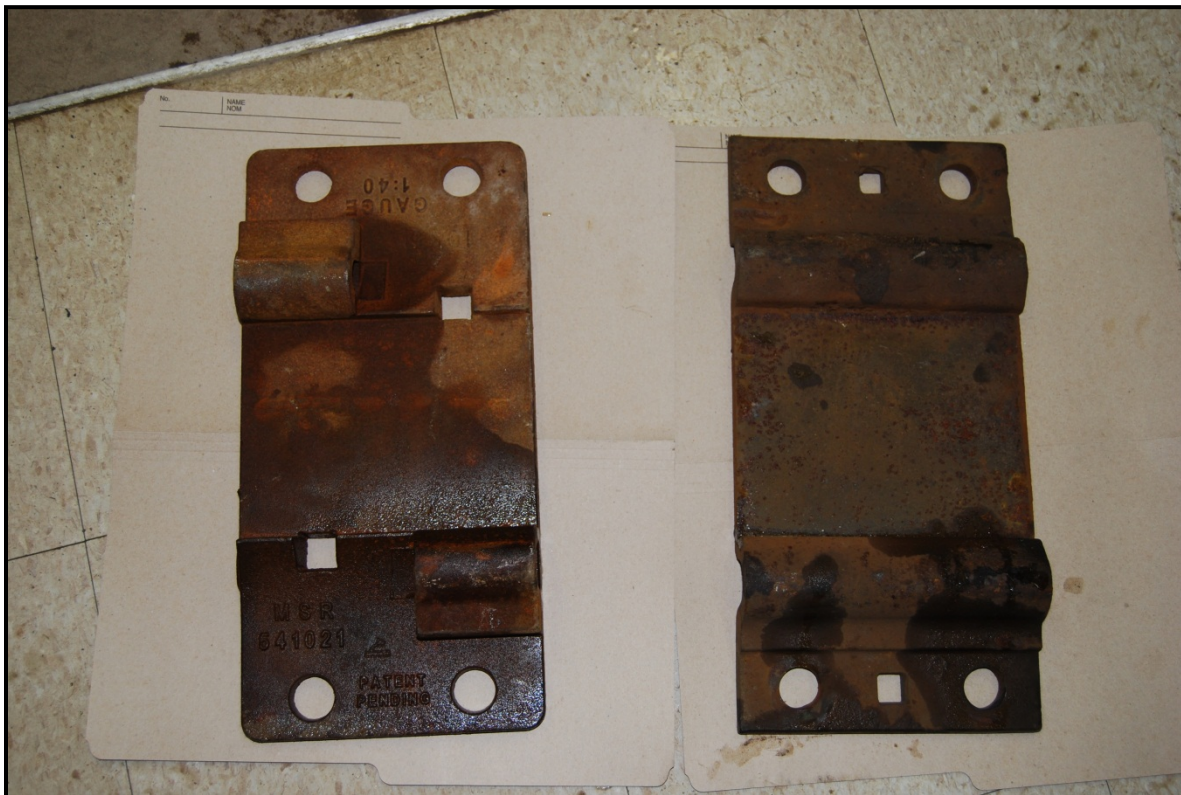
**Photo 6.** Cast plate (left) and rolled plate (right)

In contrast to the conventional fastening system, cast-plate and rolled-plate fastening systems (Photo 6) provide the 2 separate fastener functions. The rail is attached to the tie plate with an elastic fastener, normally an “e”-shaped round heat-treated steel bar (20 millimetres in diameter). The tie plate is then attached to the tie with lag screws or a combination of screws and spikes. The cast ductile iron tie plate has wedge-shaped lugs in the bottom that embed in the wood tie to add extra holding power. Rolled plates have smooth bottoms without lugs (Photo 7).
