**MARINE INVESTIGATION REPORT**  
**M09W0141**

**TUG GIRDING AND CAPSIZING**

**TUG *NORTH ARM VENTURE* WHILE TOWING THE BARGE  
*NORTH ARM EXPRESS*  
ENTRANCE TO SECHELT RAPIDS, BRITISH COLUMBIA  
19 JULY 2009**

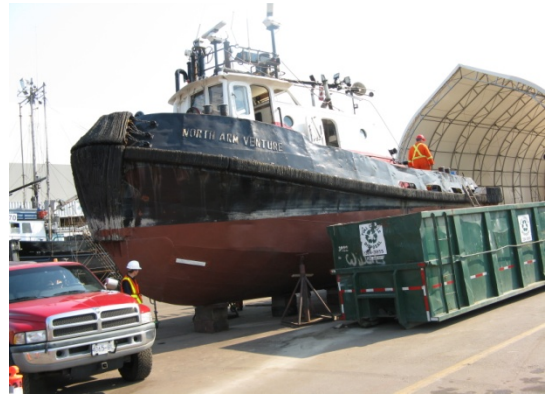
**Photo 1.** *North Arm Venture*

The *North Arm Venture* is a conventional coastal tug of steel construction (see Photo 1 and Appendix B). The navigation bridge is located on the fore part of the main deck. There is a conning position in the wheelhouse with steering and engine controls, another on the wheelhouse top with similar controls – allowing an unobstructed view in all directions – and a third steering position alongside the towing winch. All three positions are equipped with an abort switch for the tow line.
