**MARINE INVESTIGATION REPORT
M11L0050**

TAKING ON WATER AND ABANDONMENT

**SMALL FISHING VESSEL *LADY JACQUELINE*
OFF CAP DU PHARE, ÎLES-DE-LA-MADELEINE, QUEBEC
21 MAY 2011**

Report Number M11L0050

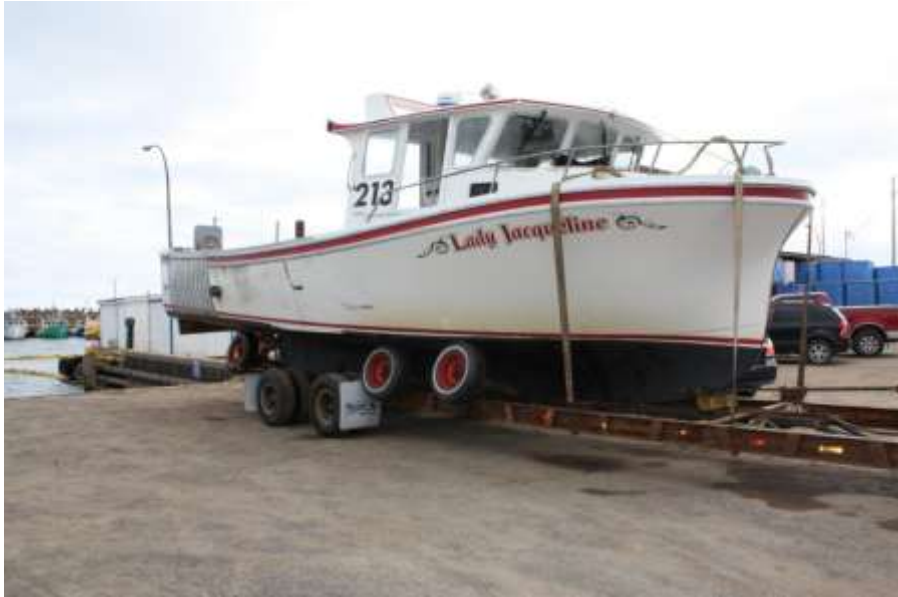
Photo 1. *Lady Jacqueline* at l'Anse-à-la-Cabane (Millerand) following salvage off Îles-de-la-Madeleine, Quebec

After recovery, the hull was examined and was found to be intact, but the machinery and equipment had extensive water damage. The lobster tanks were lost overboard. Only one of the 2 hatch covers to the engine compartment (the aftermost) was found to be secured to the deck opening. The remaining unsecured covers were found on deck, attached by their safety chain, but not in place (Photo 2). The vessel was subsequently repaired and put into operation.

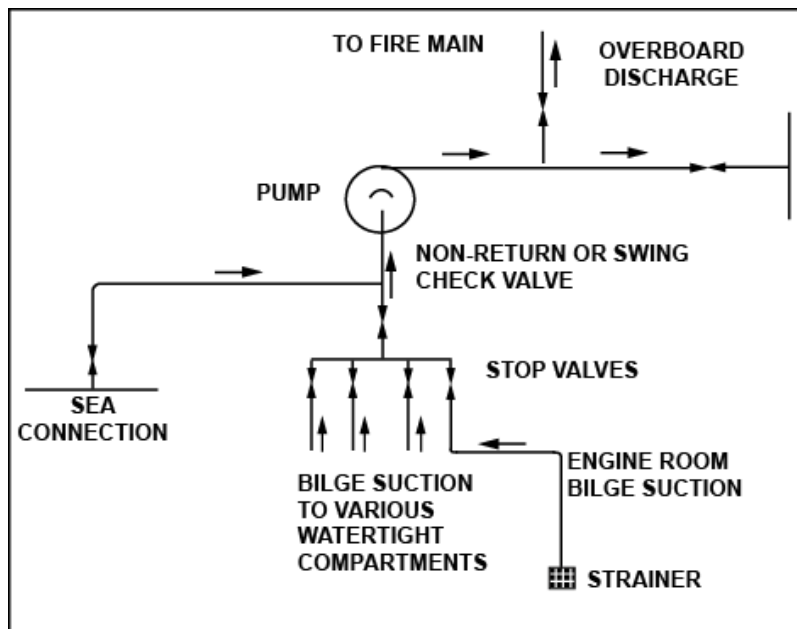
In 2003, TC issued its publication TP 10038, recommending the bilge pumping arrangement shown in Figure 4 below. Such an arrangement is normally comprised of at least one pump; a sea connection valve; a non-return valve installed on the bilge suction line to prevent back-flooding or ingress of water a strainer at each bilge suction line; and an overboard discharge valve.

Figure 4. Sketch showing recommended bilge pumping arrangement for small vessels. Reproduced from Transport Canada *Small Fishing Vessel Safety Manual*, publication TP 10038 E, (2003)

When comparing the bilge pumping arrangement of the *Lady Jacqueline* as shown in Figure 1 with the recommended bilge pumping arrangement in Figure 4, the following items were noted:

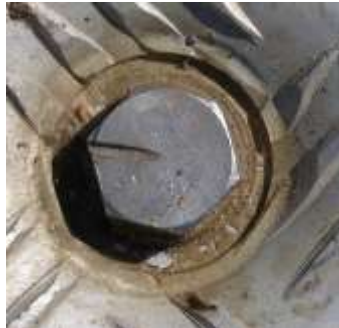
There were a total of 9 flush-deck openings (7 rectangular-shaped hatches and 2 round-shaped handholes) on the working deck of the *Lady Jacqueline* (Appendix A and Photo 8). Hexagonal bolts connected to dogs on the underside of the hatch covers were used to secure them (Photos 9 and 10). Most of the hatches had 6 hexagonal dog bolts with relatively large spacing between the bolts. The hexagonal bolts, approximately 15 mm in diameter, were recessed into the chequered plating.

Photo 9. Typical hexagonal bolt on hatch cover
