PIPELINE INVESTIGATION REPORT P09H0083

NATURAL GAS PIPELINE RUPTURE

**TRANSCANADA PIPELINE LIMITED
762-MILLIMETRE-DIAMETER PIPELINE
LINE 100-1 – MAIN LINE VALVE 111A-1
FROM KILOMETRES 11.12 TO 11.16
NEAR MARTEN RIVER, ONTARIO
26 SEPTEMBER 2009**

Report Number P09H0083

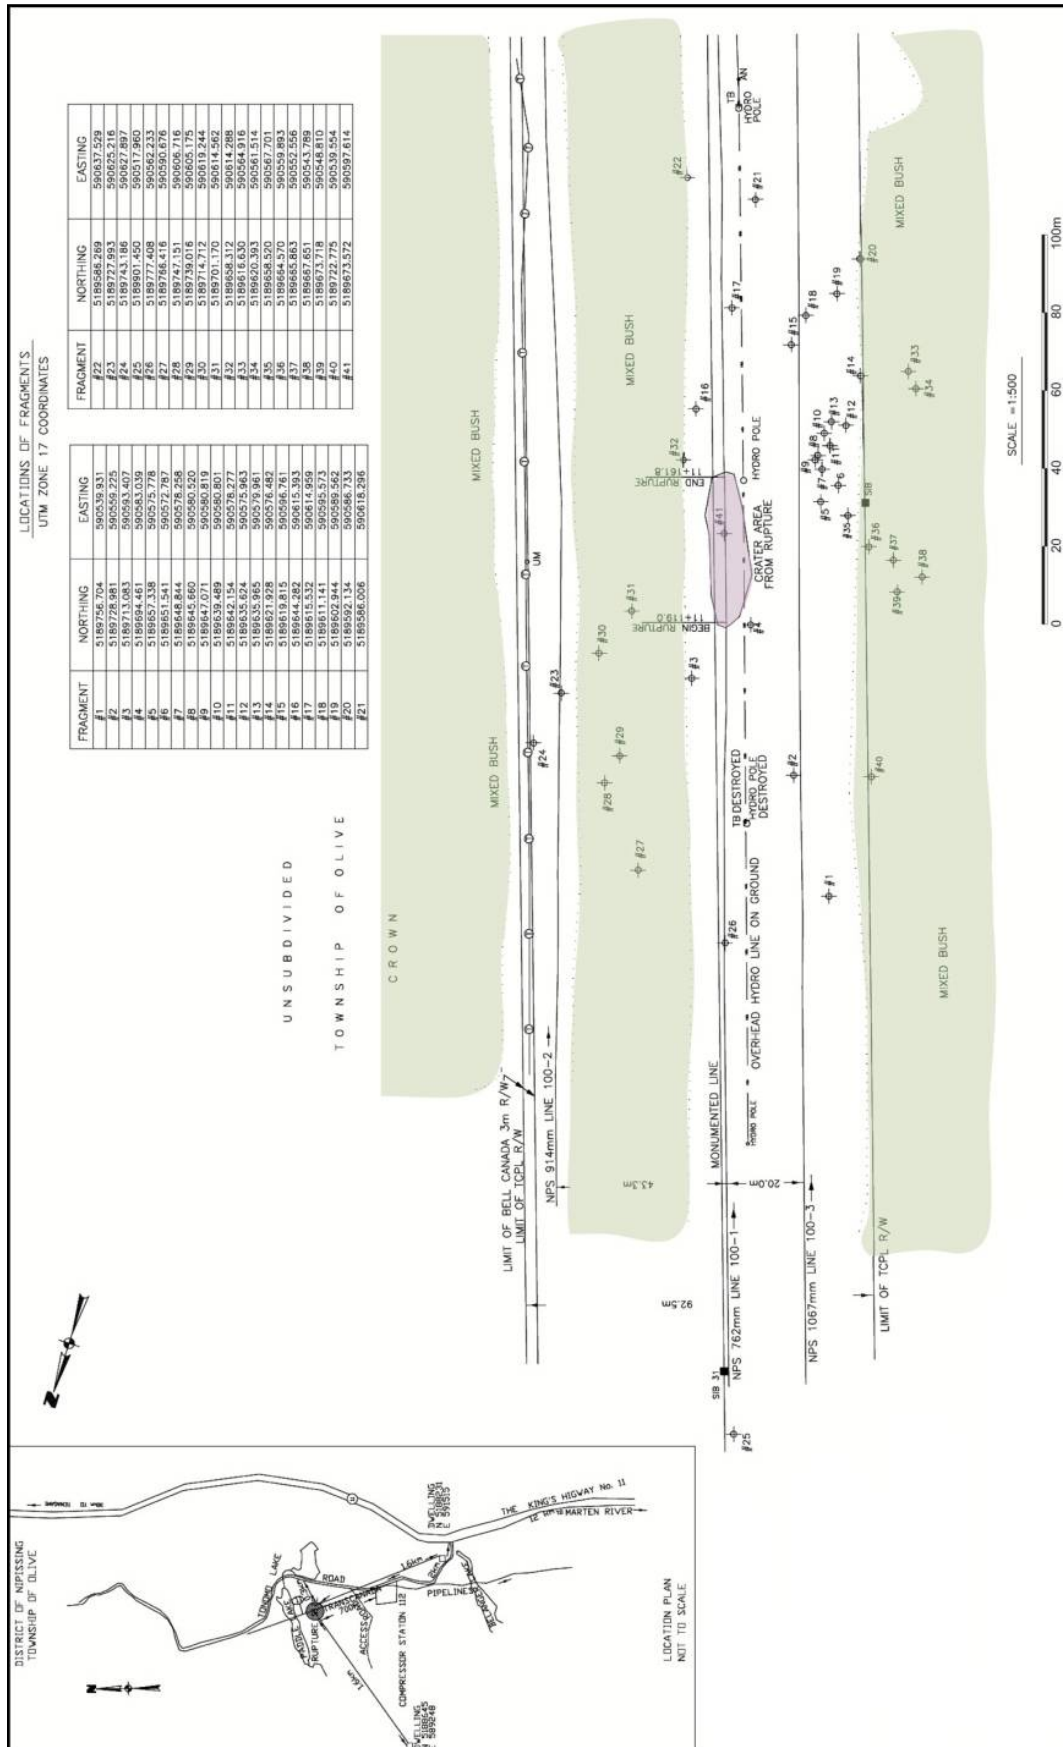
Numerous pieces of pipe were ejected onto the pipeline right of way and into the adjacent forested area. Figure 4 identifies the locations where pipe pieces were found.
