KENO VALLEY/DUBLIN GULCH ENVIRONMENTAL BASELINE ASSESSMENT

VOLUME II: Keno Valley Sites #1 to #20

Prepared for
Waste Management Program
Indian and Northern Affairs Canada

By
Environmental Services
Public Works and Government Services Canada

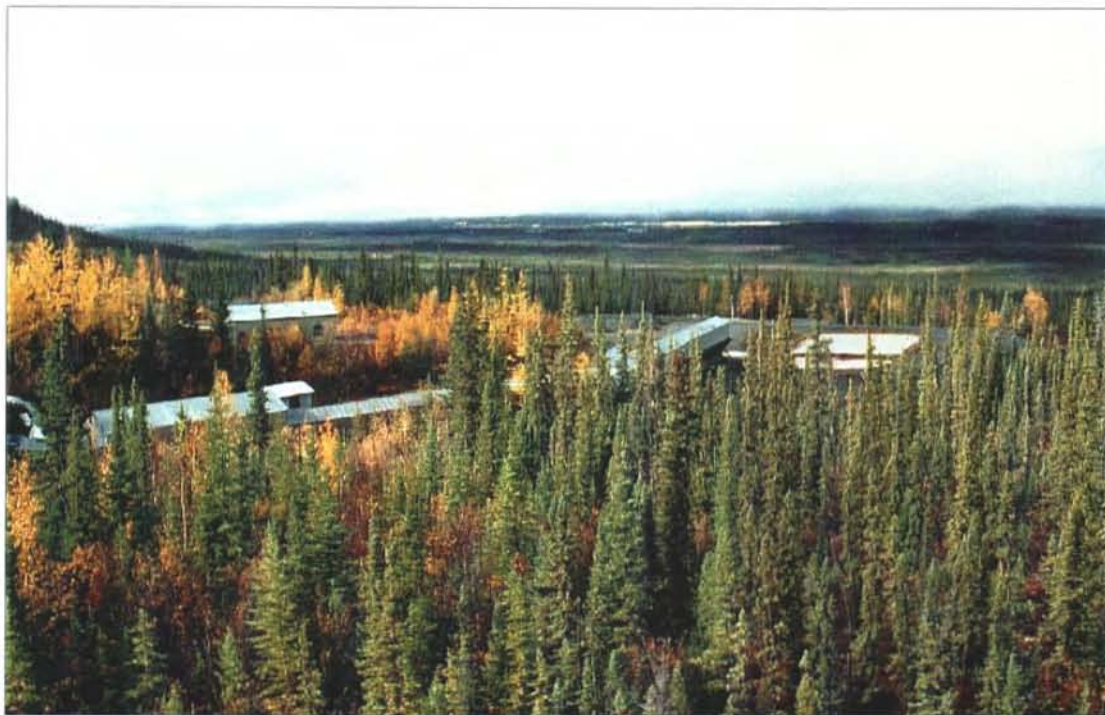
Photo 1-1 : Silver King. Silver King 100 Level Portal site, showing buildings (1A, 1B & 1C) and settling ponds. Looking northwest from the open pit waste dump across Galena Creek.

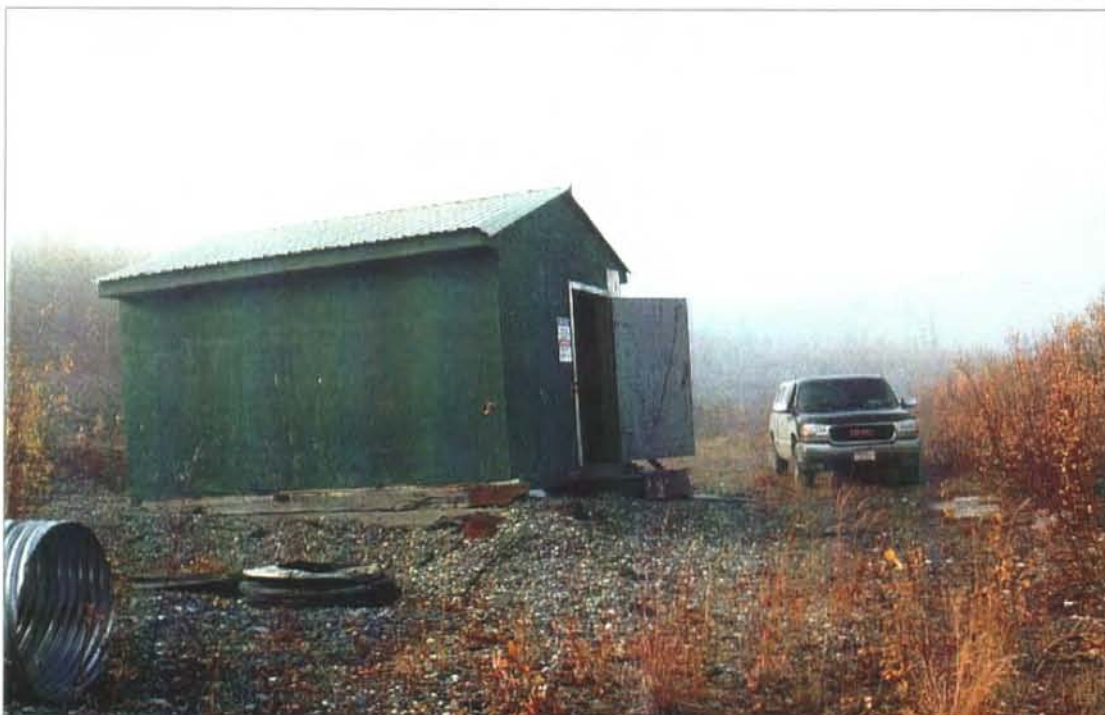
Photo 1-2 : Silver King. Ventilation Raise Building. Looking west, about 100m southeast of the open pit.

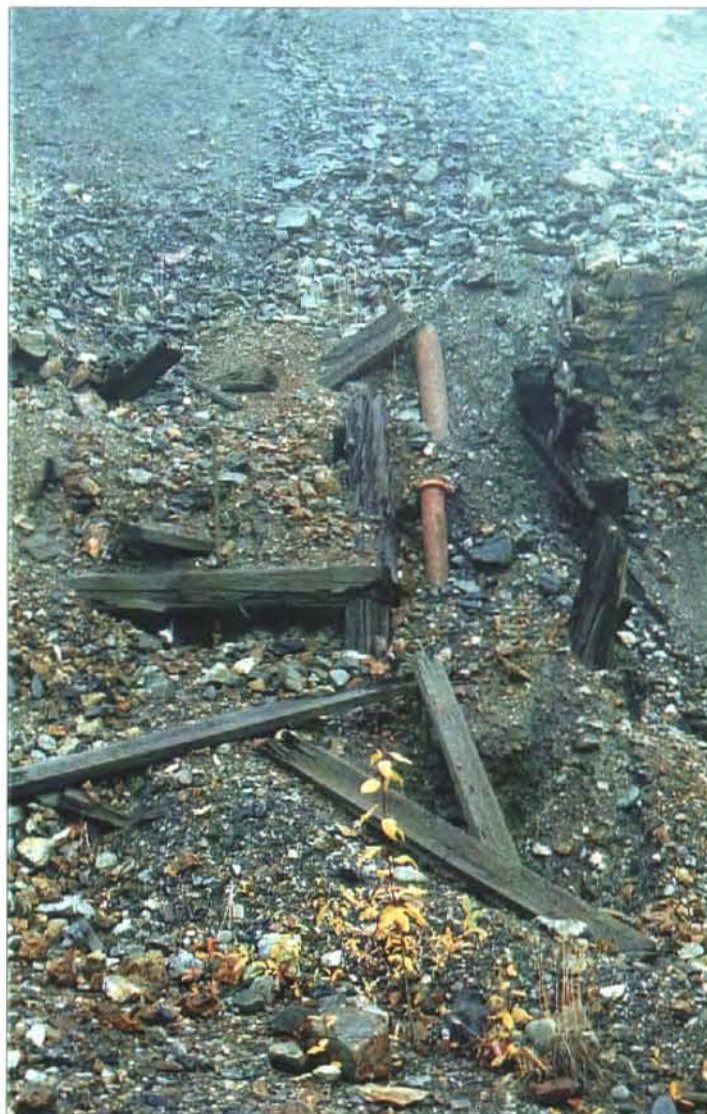
Photo 1-3 : Silver King. Timbers and pipe identify a filled-in raise or shaft (Shaft 1). Looking northwest at the bottom northwest corner of the Silver King pit.

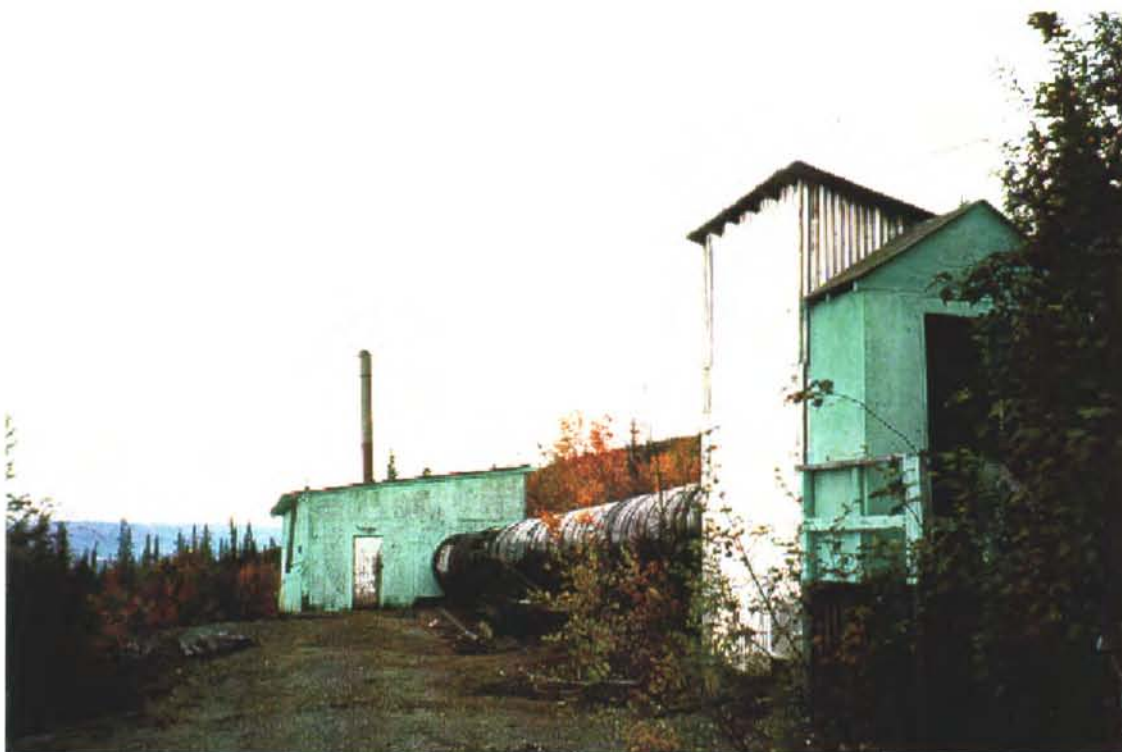
Husky mine is accessed via a shaft. The workings are flooded to surface. There are two raises to the surface. One of the raises was used for ventilation to the underground workings and has a heating furnace and downcast fans at the surface (photo 2-1).

Photo 2-1: Boiler house down draft raise & duct.

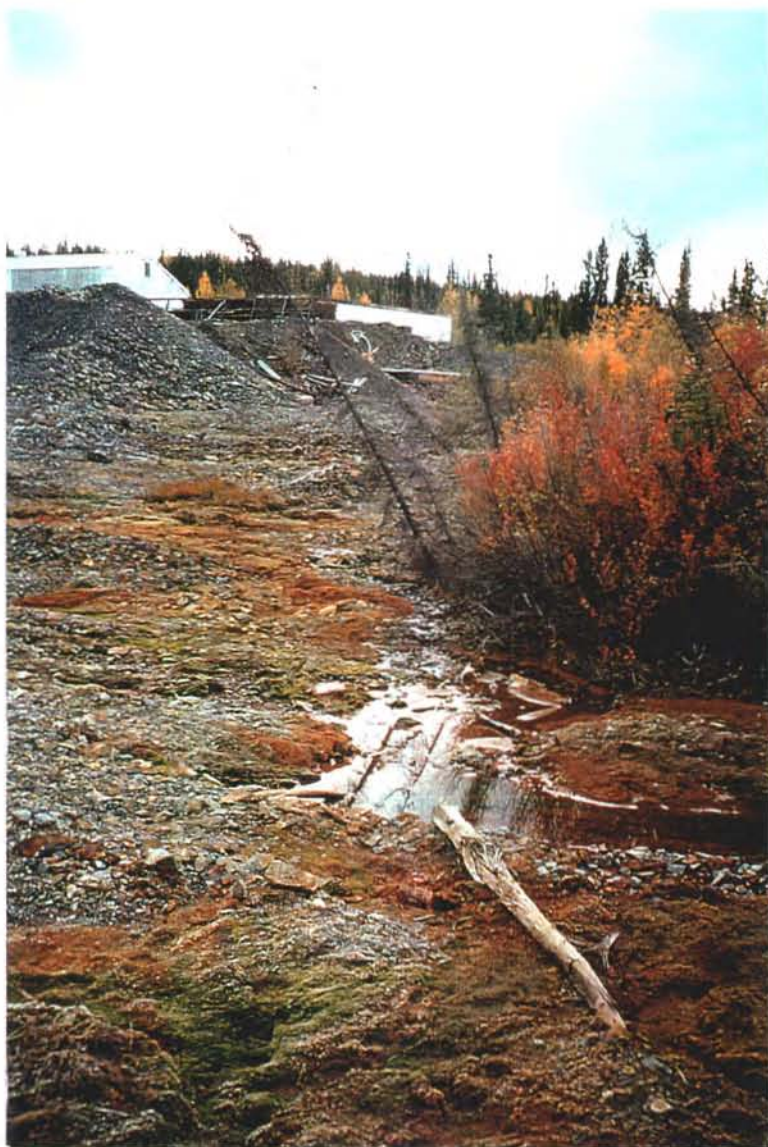
The dump is located on the north side of the shaft pad area. It consists mainly of quartzite with some quartz and minor amounts of schist. The quartzite has disseminated pyrite, arsenopyrite and quartz veinlets. The toe of the dump shows significant iron staining and precipitates. The vegetation near the flow is heavily stressed (photo 2-2).

Photo 2-2: Sample location 02-03, water taken 98 m from headframe.

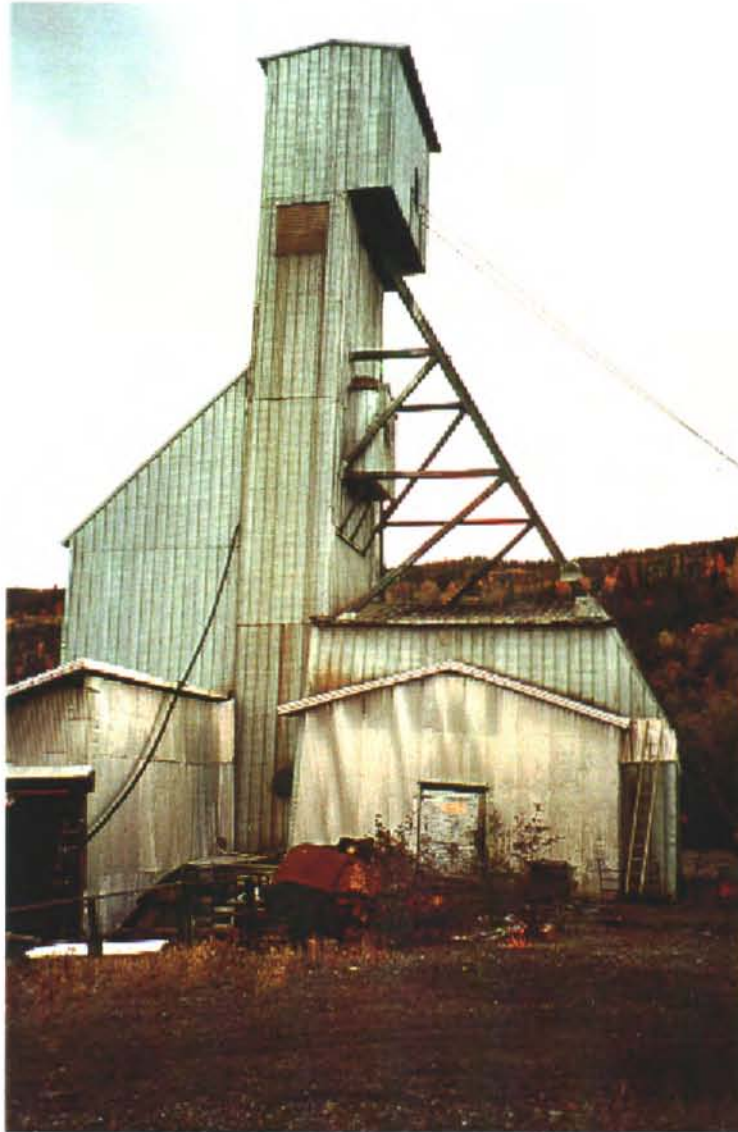
Building 2A – Shaft Headframe (photo 2-3)

Foundation: It appears from the exterior that the foundation is a floating concrete slab.

Hazardous Contents: There was one fuel drum that was not labeled sitting horizontally with a small amount of product having leaked from the bung. Soil staining was very minor.

Photo 2-3: Shaft & headframe.

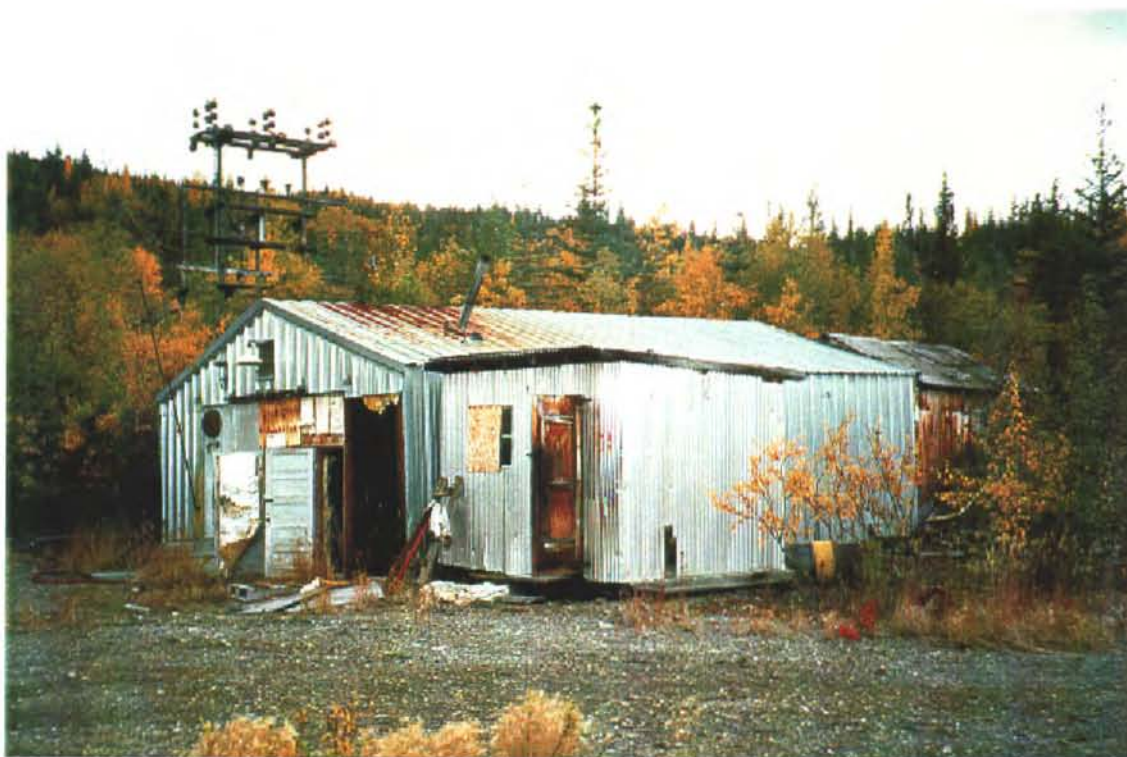
Building 2B – Hoist House (photo 2-4)

Construction: The structure was wood frame and encased in exterior steel sheathing including the roof. The building had fibreglass insulation. A small wooden porch was located off the west end. The doors were metal. The hoist cable openings were stained with lubricants and tar. There were some tar stains located directly under the cable openings, however, soil staining was minor in nature.

Photo 2-4: Hoist house.

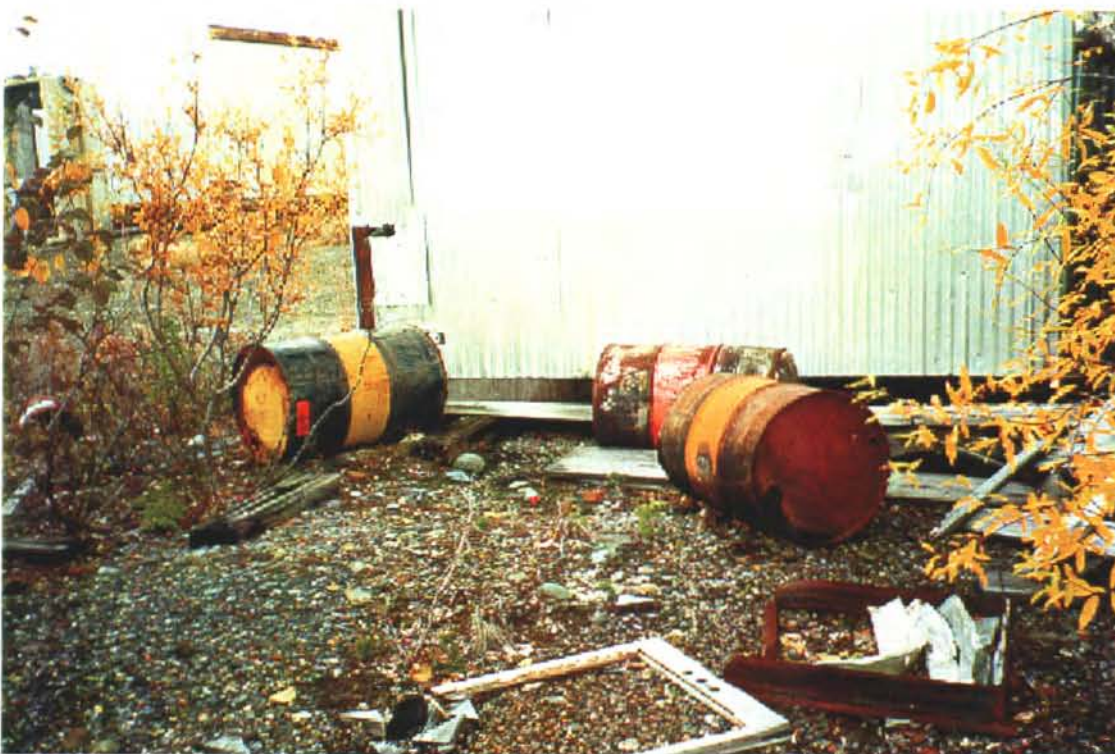
Note: There was some metal debris that was noted along the south side of the building that included empty and rusted out drums (photo 2-7). There was no sign of staining around the perimeter of building 2E.

Photo 2-7: 200L drums at rear of storage shed.

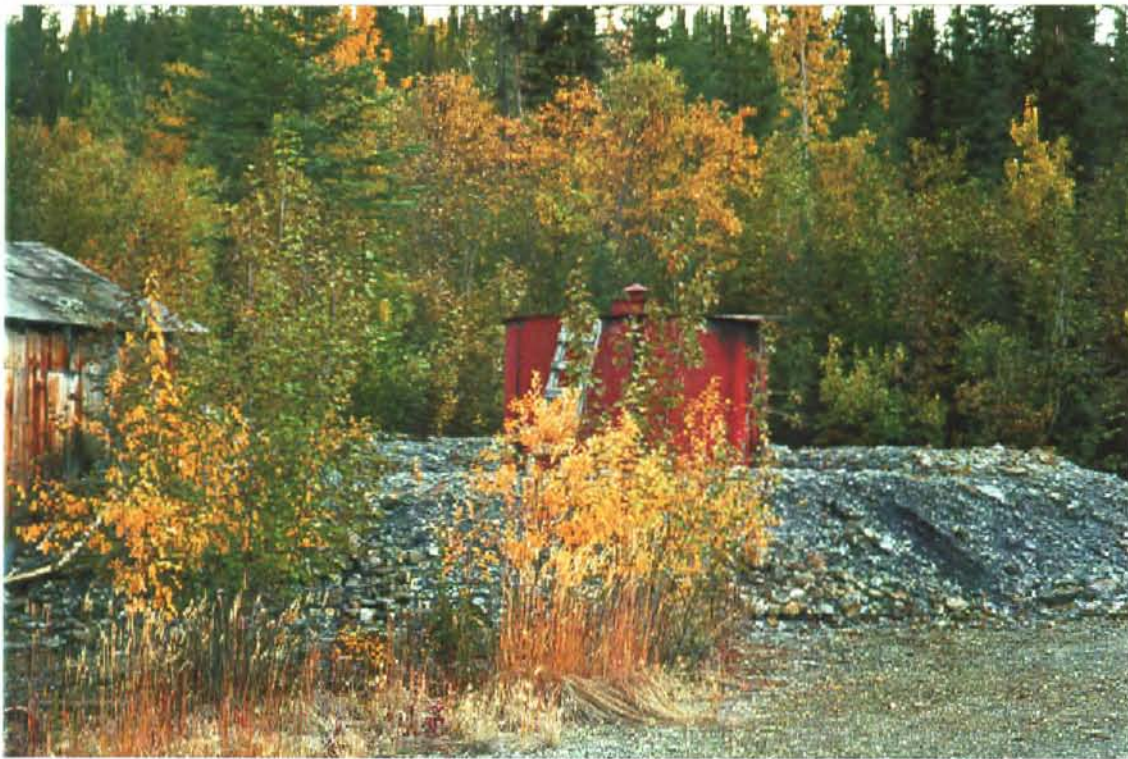
Location: An aboveground storage tank was located behind the boiler house (photo 2-8).

Photo 2-8: AST behind boiler.

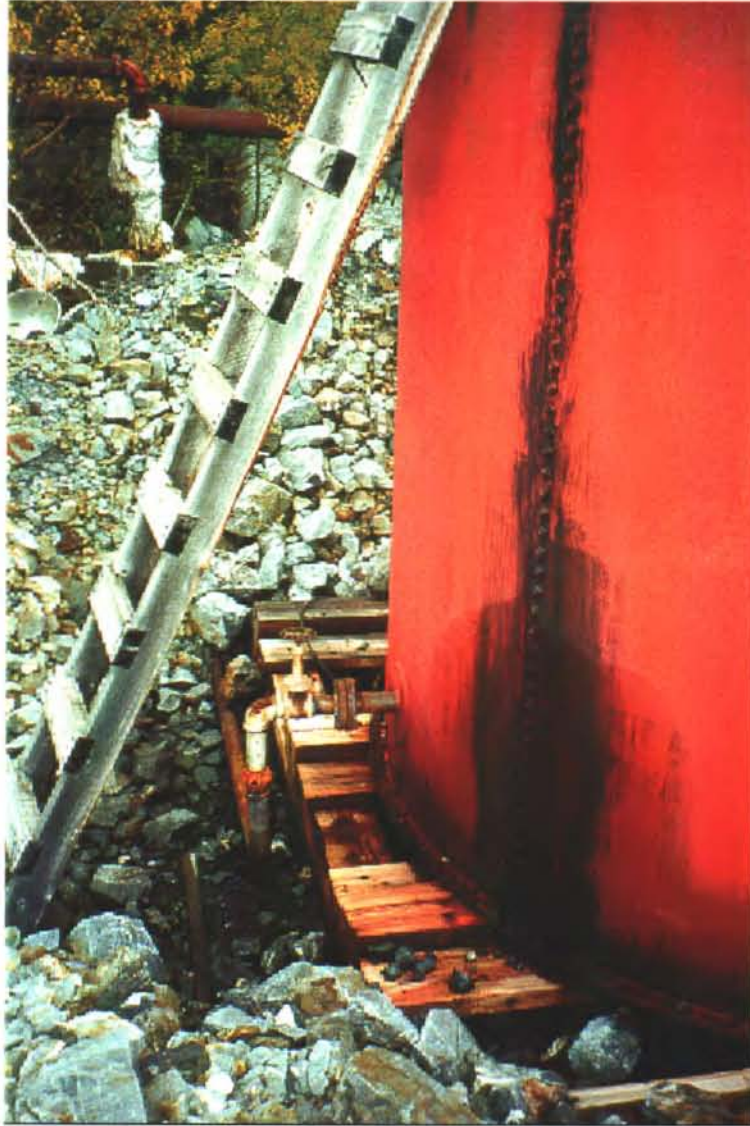
Above Ground Storage Tanks: The AST measured 3m in height and 2 m in diameter and consisted of steel bolted construction. There appeared to be staining along the bolted joints (photo 2-9). Soil staining was evident around the perimeter of the tank. There was heavy staining at the valves. A waste rock berm extends around the perimeter of the AST. Samples were not collected as the area surrounding the AST consisted exclusively of large waste rock.

Photo 2-9: AST & piping.

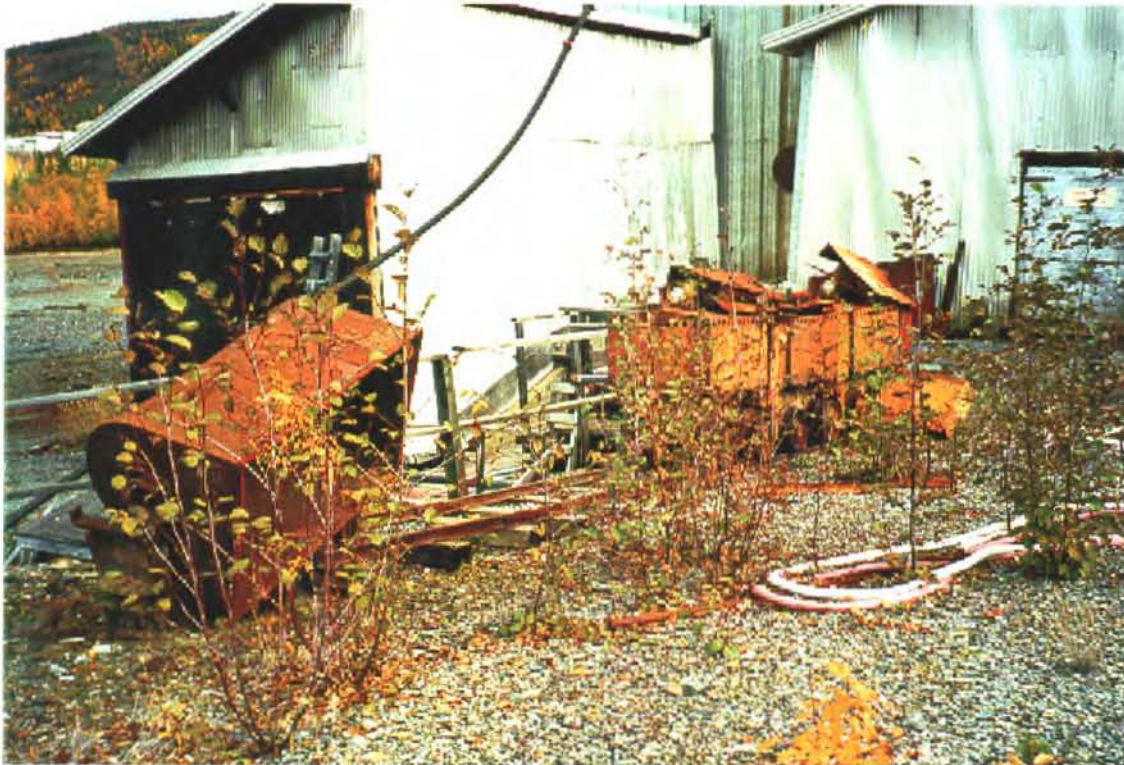
There were rails extending approximately 25m from the shaft house and stopped abruptly, rail debris and cars were abandoned in this area (photo 2-10). Approximately 28 rail cars were located behind building 2E (photo 2-11).

Photo 2-10: West side of headframe.

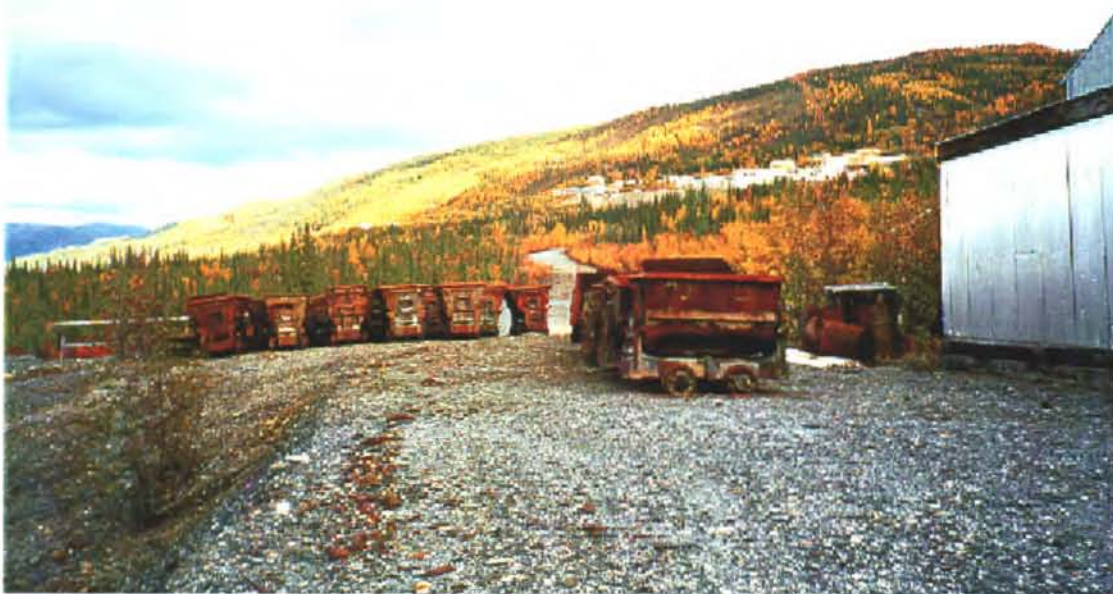
Photo 2-11: 28 Rail cars.

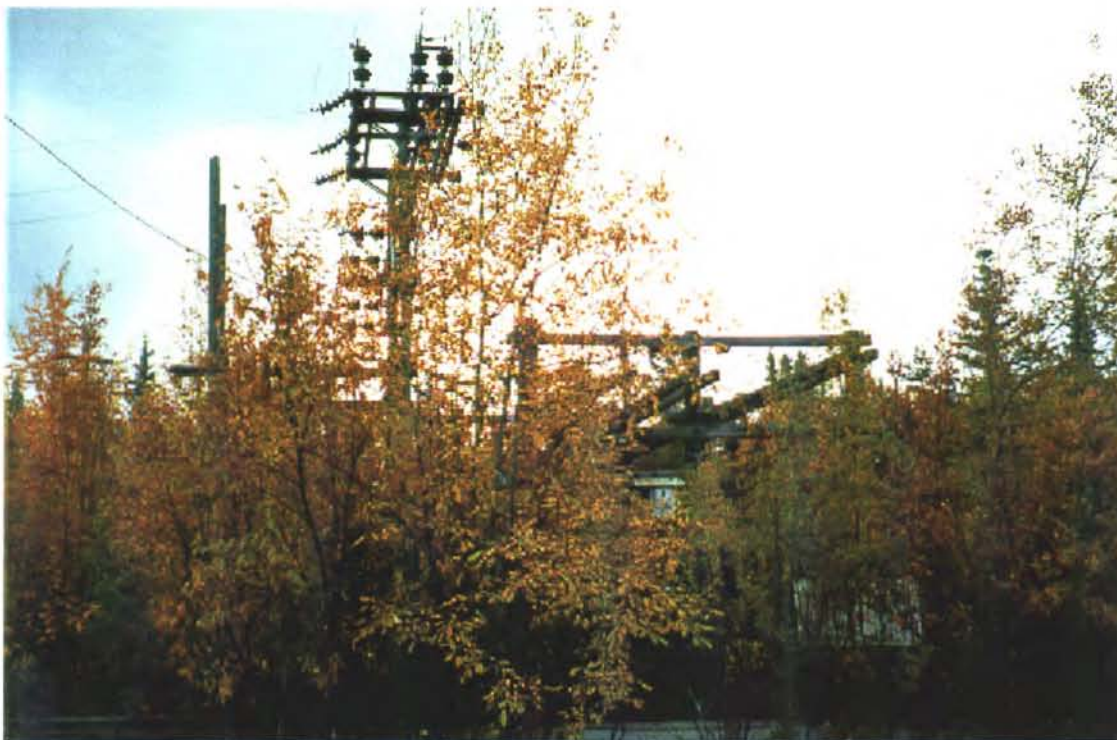
There was a transformer station at the site that was fenced and padlocked (photo 2-12). The transformers were situated on a concrete pad. They were still in service at the time of the site inspection, however, admittance to the transformers was restricted by padlock and no identification of the equipment was attempted. No samples were taken. These transformers were older and may contain PCB's.

Photo 2-12: Transformer compound.

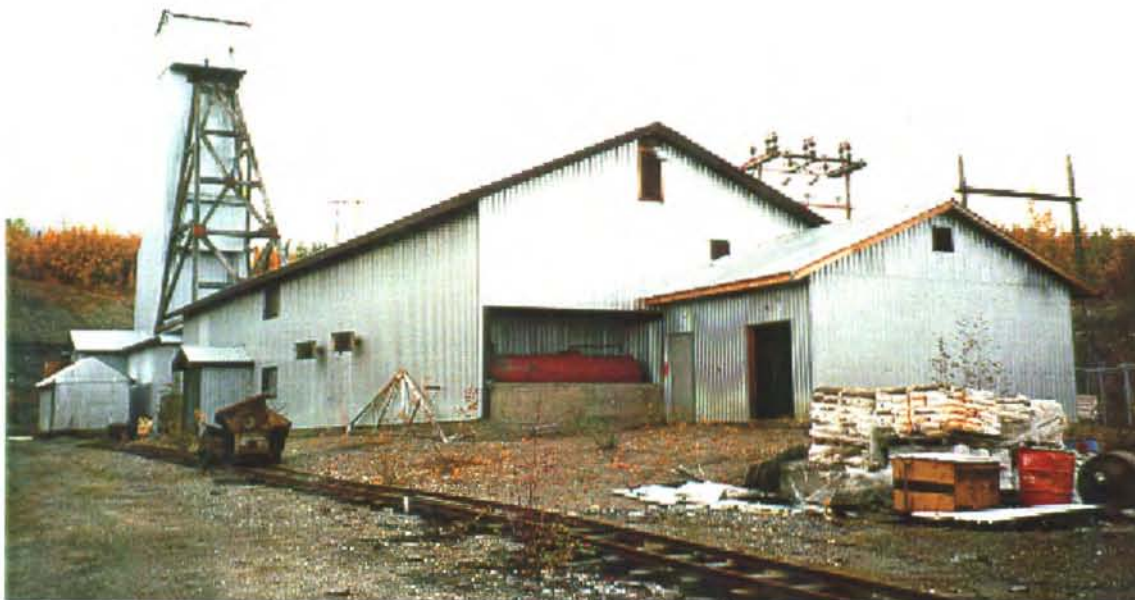
There was one aboveground storage tank (photo 2-15) that was located on the northwest corner of the hoist house. The tank was welded steel and no leaks were noted - no staining was noted in the concrete secondary containment.

Photo 2-15: Structures at site.

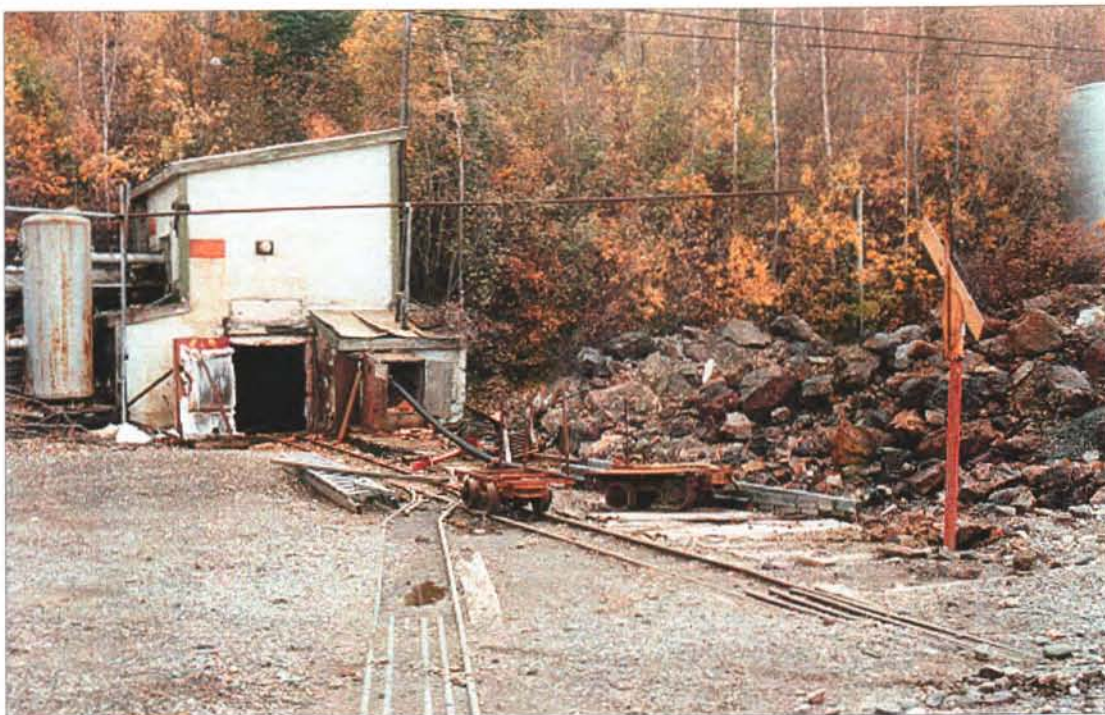
There are a few piles of low-grade open pit material (distinguished by larger rock size than from underground) near the 400 portal. This material is highly oxidized, and siderite-rich. The dark boulder pile in photo 3-1 is typical of this material.

The 400 level portal building is an insulated wood frame structure with asbestos siding (photo 3-1).

Photo 3-1 : Elsa Mine. Elsa 400 Level Portal. Looking southeast. Low grade open pit ore pile to the right of the tracks.

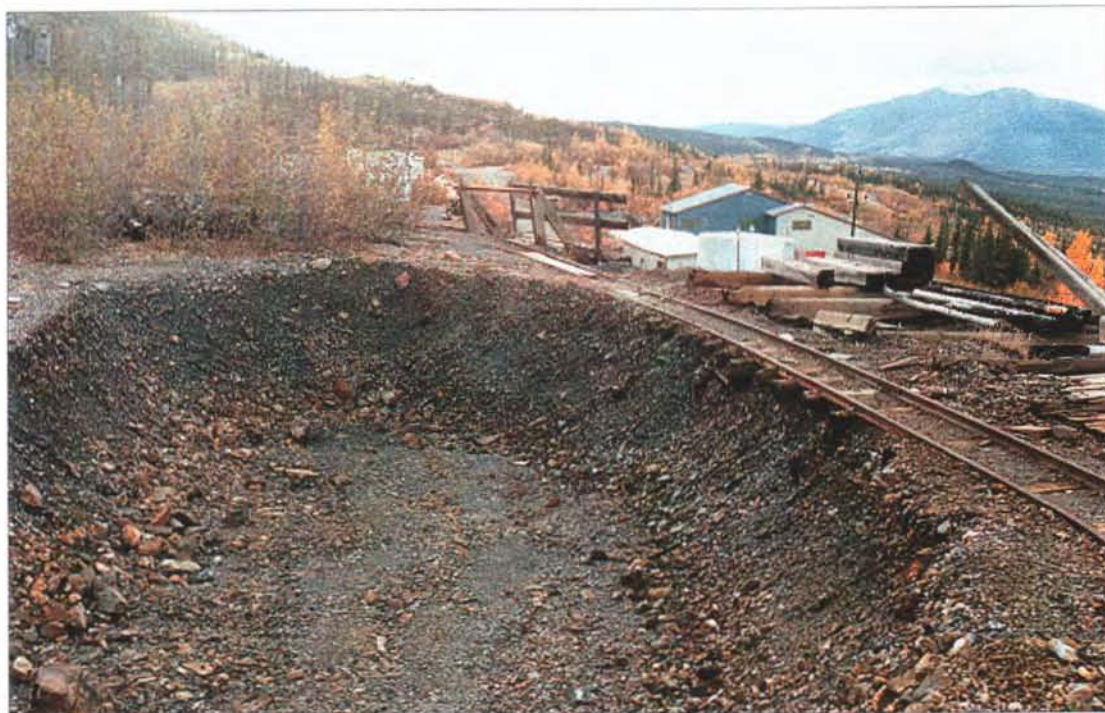
400 Portal Area Waste Rock Pile (Photo 3-2)

Photo 3-2 : Elsa Mine. Elsa 400 level tracks and grizzly. Looking southwest. Waste rock sample site 3_WR_TPBM_01.

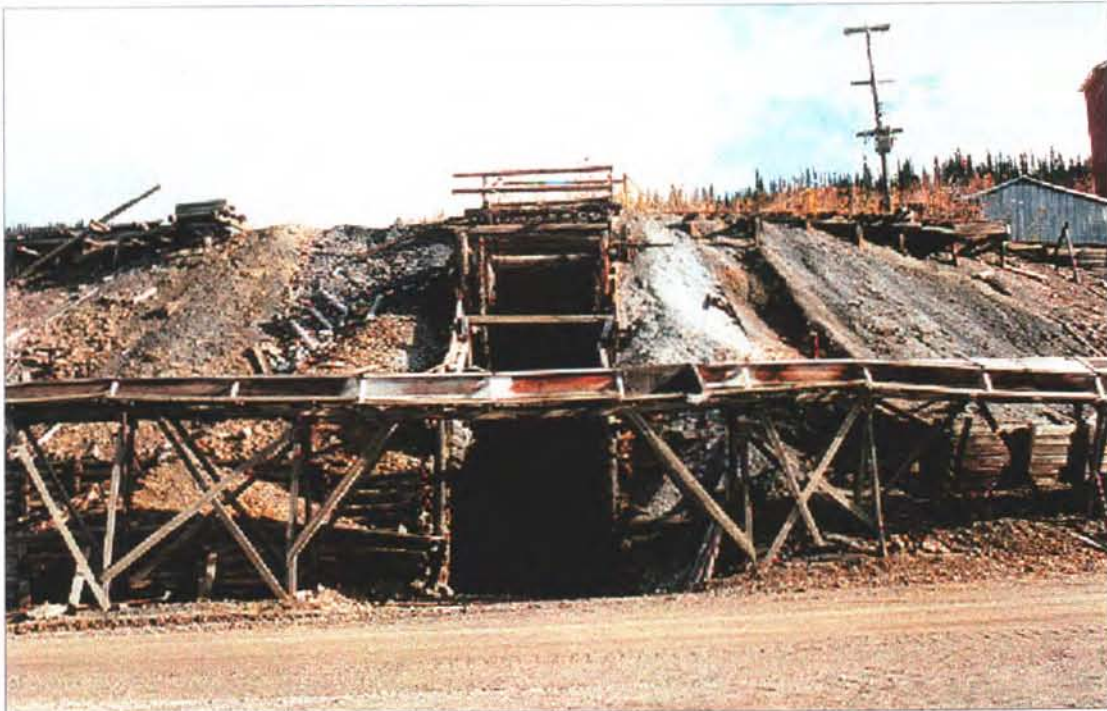
Photo 3-3 : Elsa Mine. Elsa 400 ore chute and grizzly from below. Looking southeast.
Note steep banks of waste rock.

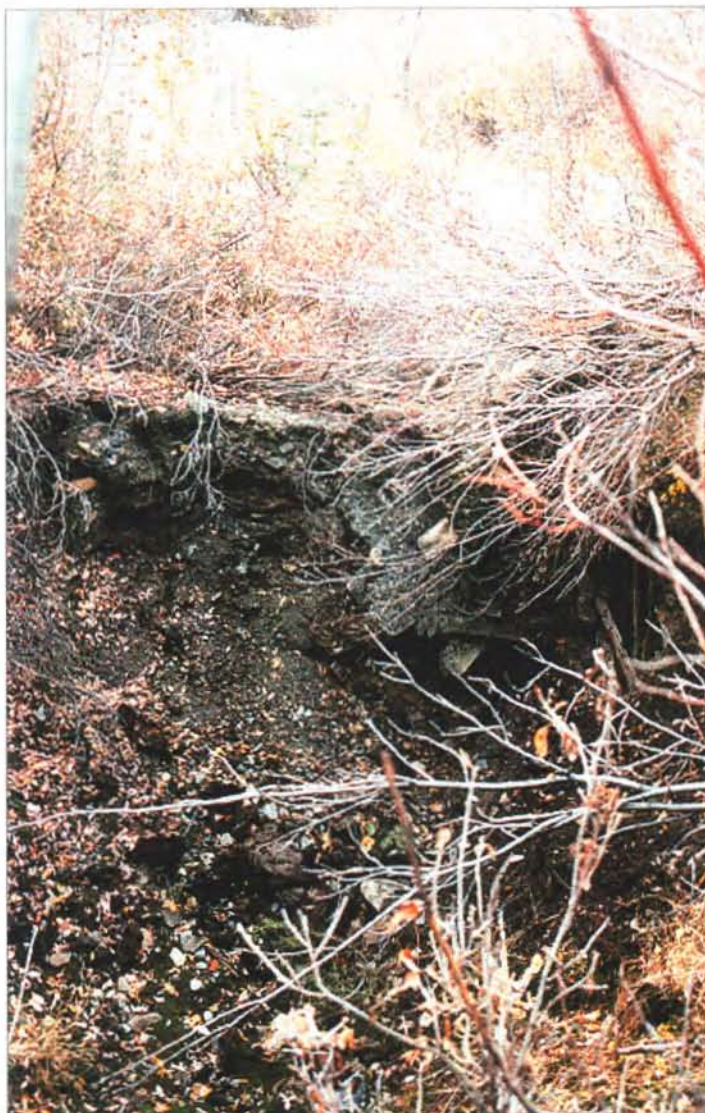
Powderhouse Corner Vent Raise (Photo 3-6)

Photo 3-6 : Elsa Mine. Collapsed ventilation raise,
Powderhouse Corner on Calumet Drive. Sink
hole is about 10m by 10m by 5m deep.
Looking north.

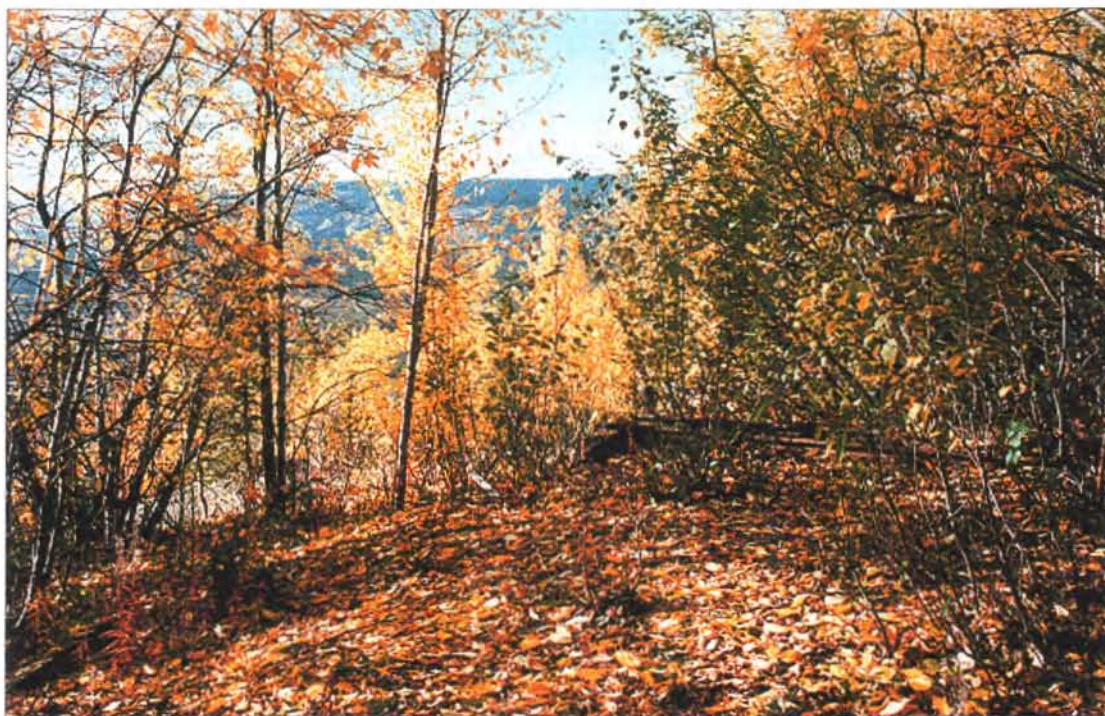
Photo 3-9 : Elsa Mine. Elsa +50 adit dump, showing dense natural revegetation and some slump features. Looking northwest.

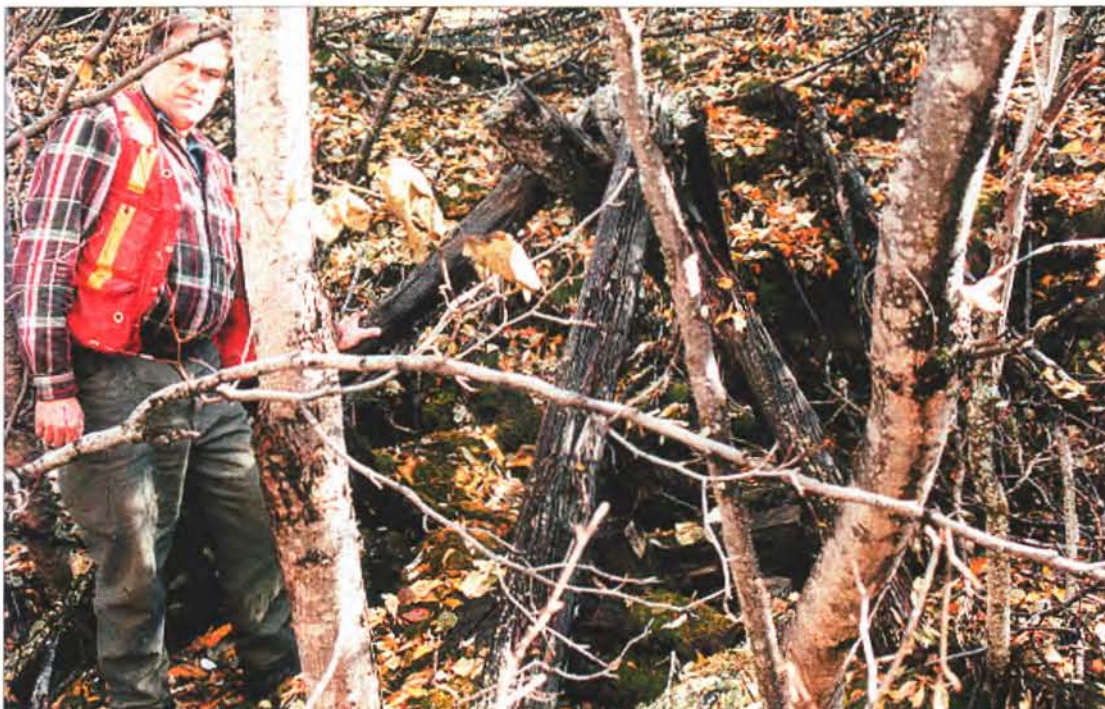
Tick Shaft (photo 3-10)

Photo 3-10 : Elsa Mine. Tick shaft. Rotting timberframe, collapsed adit. Looking south.

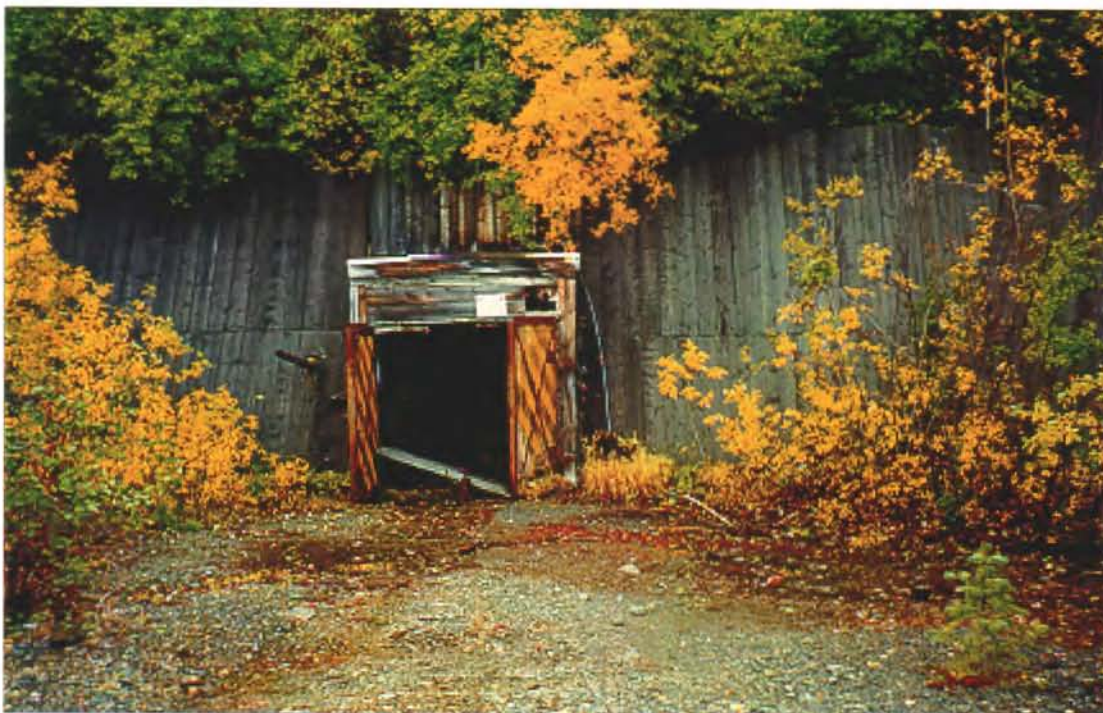
200 Level Adit (Photo 4-1)

Photo 4-1: Photograph of the adit at Dixie Mine, note the portal entrance has been blocked off with timber cribbing. (Azimuth 145°)

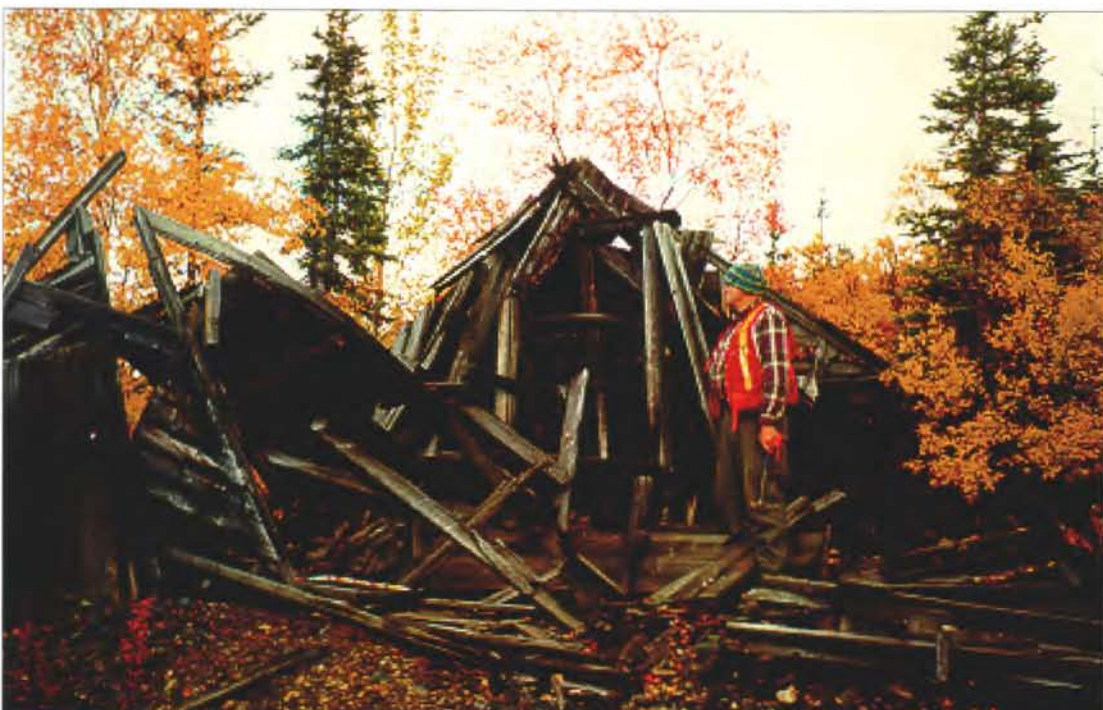
Dixie Shaft (Photo 4-2)

Photo 4-2: Collapsed structure above raise. The raise is located at the intersection of the powerline and roadway approximately 500m above the main Dixie site. (Azimuth 95°)

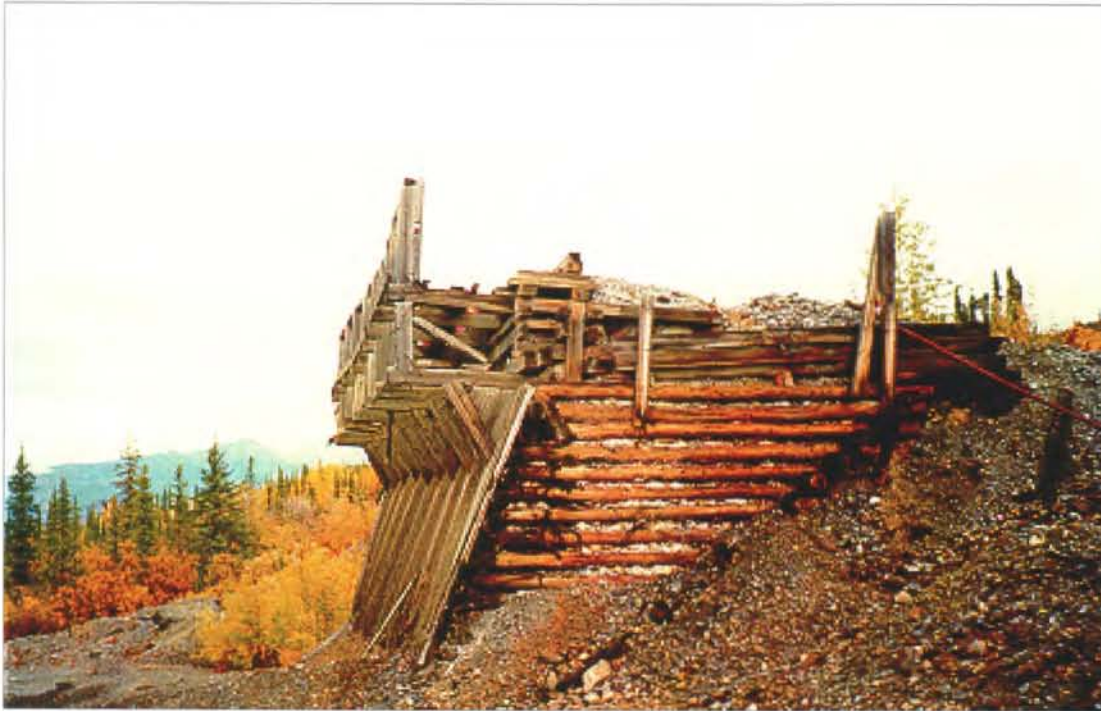
Photo 4-5: The loading area at the main Dixie mine site. (Azimuth 80°)

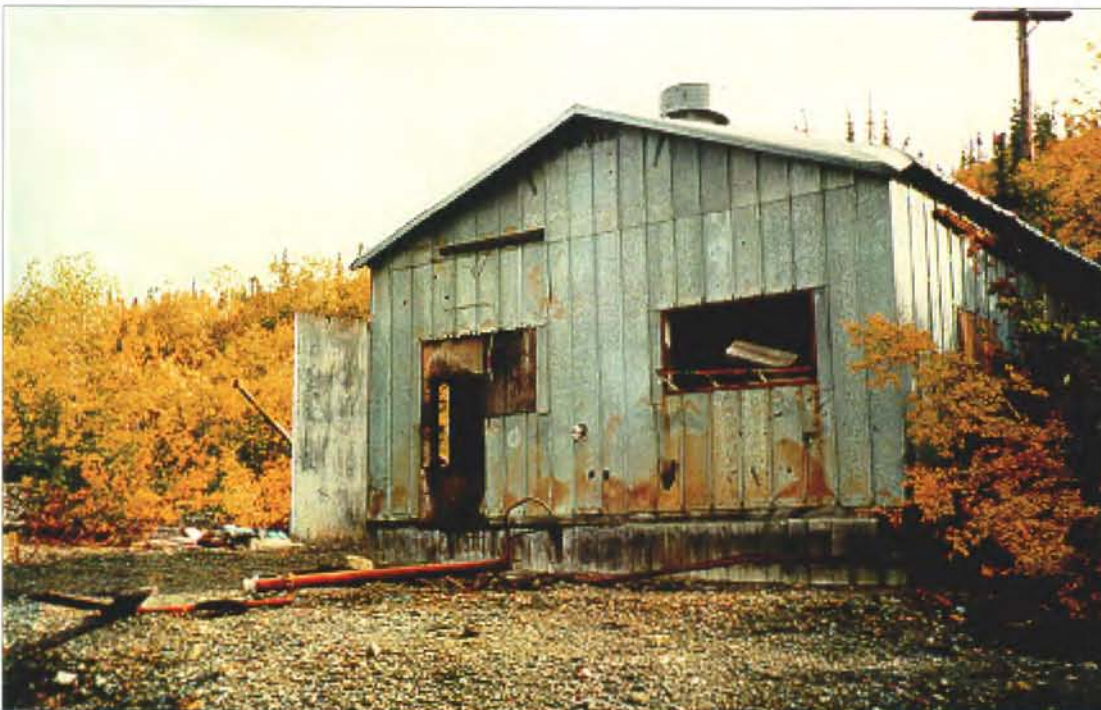
Photo 4-6: Building 4A (garage/office) facing NE. (Azimuth 75°)

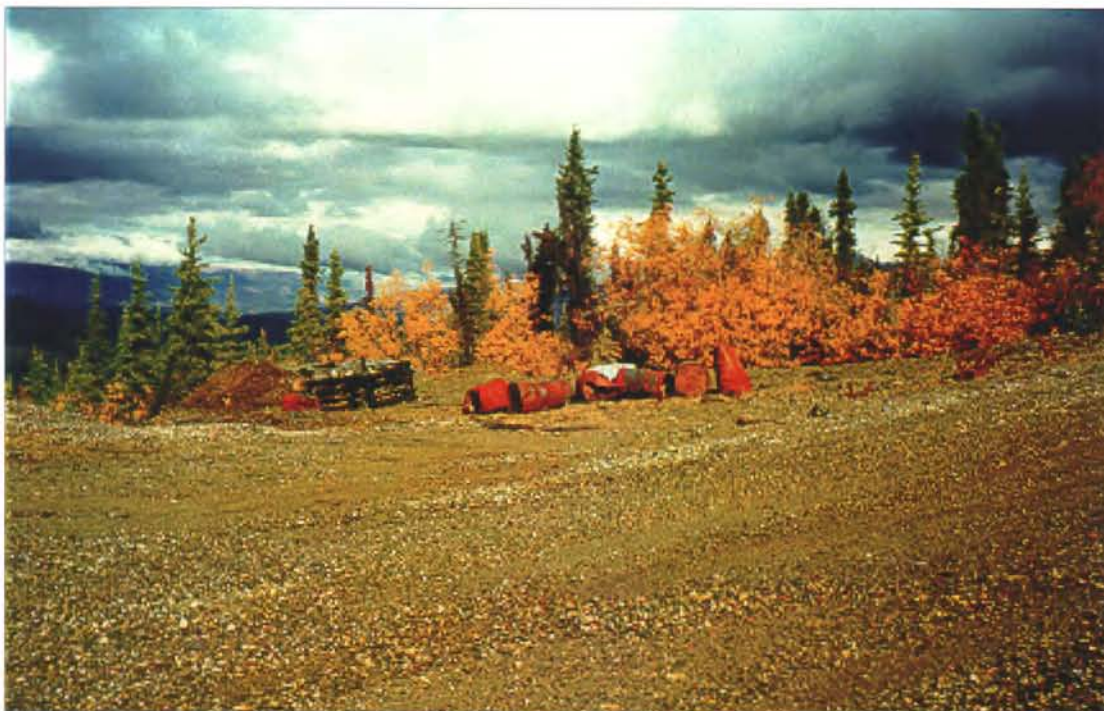
Photo 4-7: Empty barrels at the solid waste dump site. (Azimuth 25°)

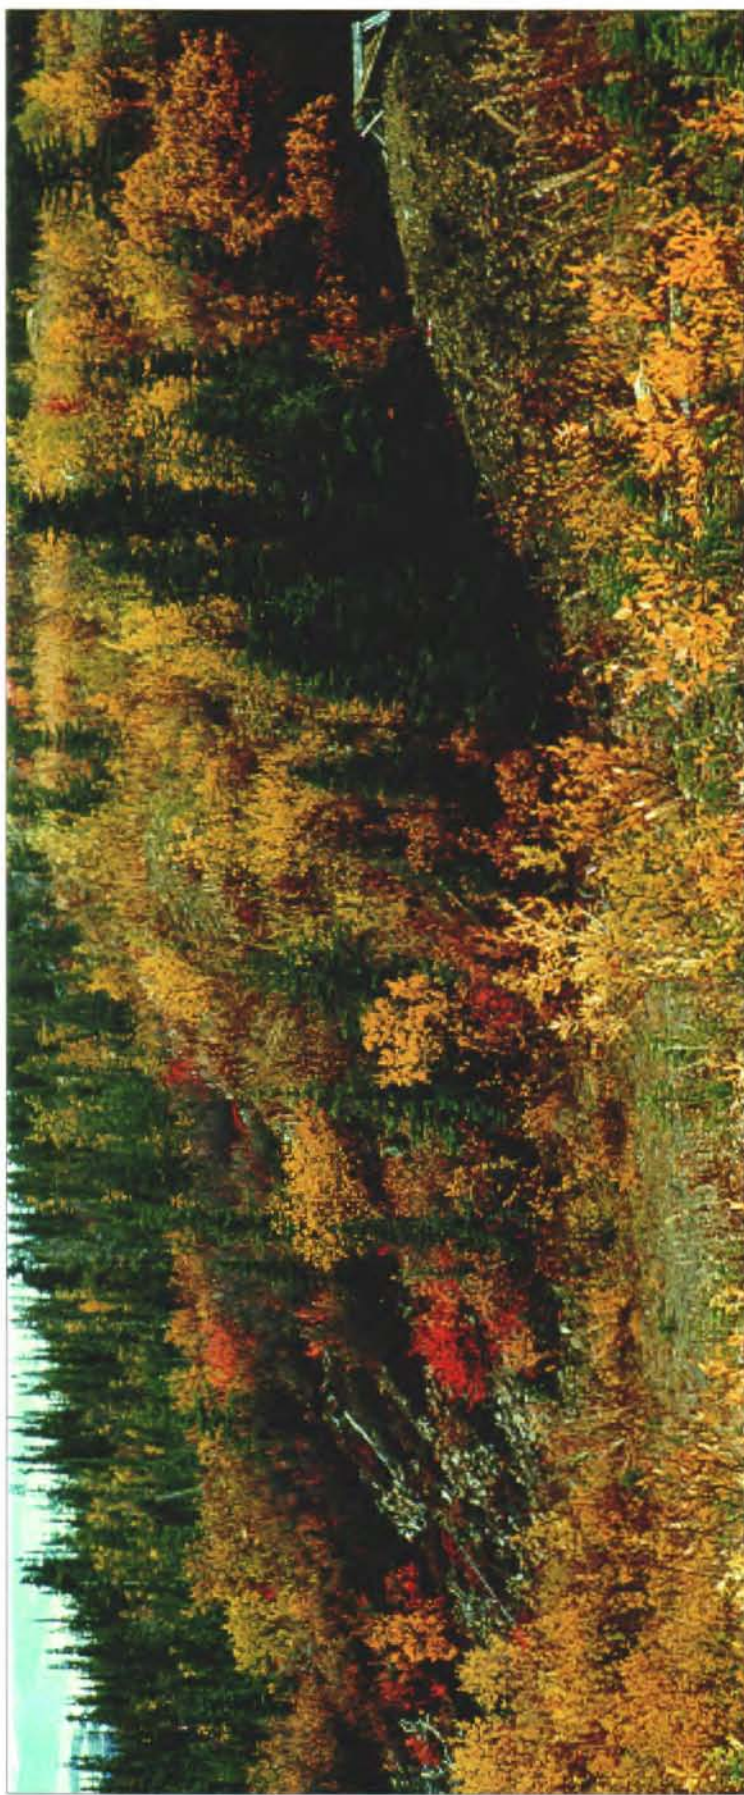
Photo 5-4: Trenched area below the collapsed shafthouse (shafthouse debris can be seen on the far right of photo).
