KENO VALLEY/DUBLIN GULCH ENVIRONMENTAL BASELINE ASSESSMENT

VOLUME II: Keno Valley Sites #1 to #20

Prepared for
Waste Management Program
Indian and Northern Affairs Canada

By
Environmental Services
Public Works and Government Services Canada

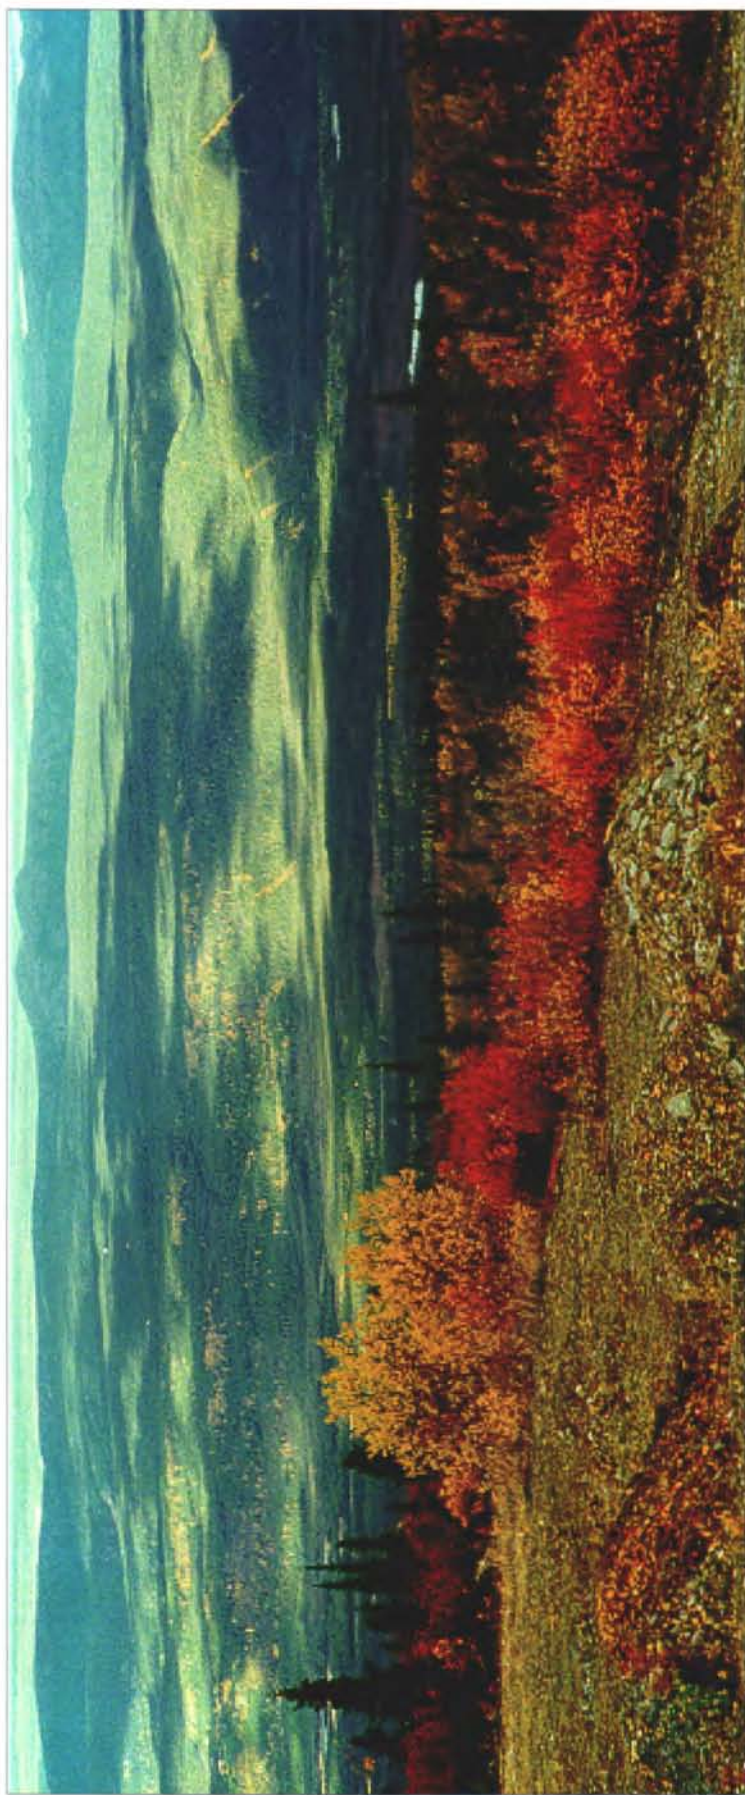
Photo 5-5: Small trenched areas can be noted in the foreground of the photo within the leveled area of the waste rock dump.

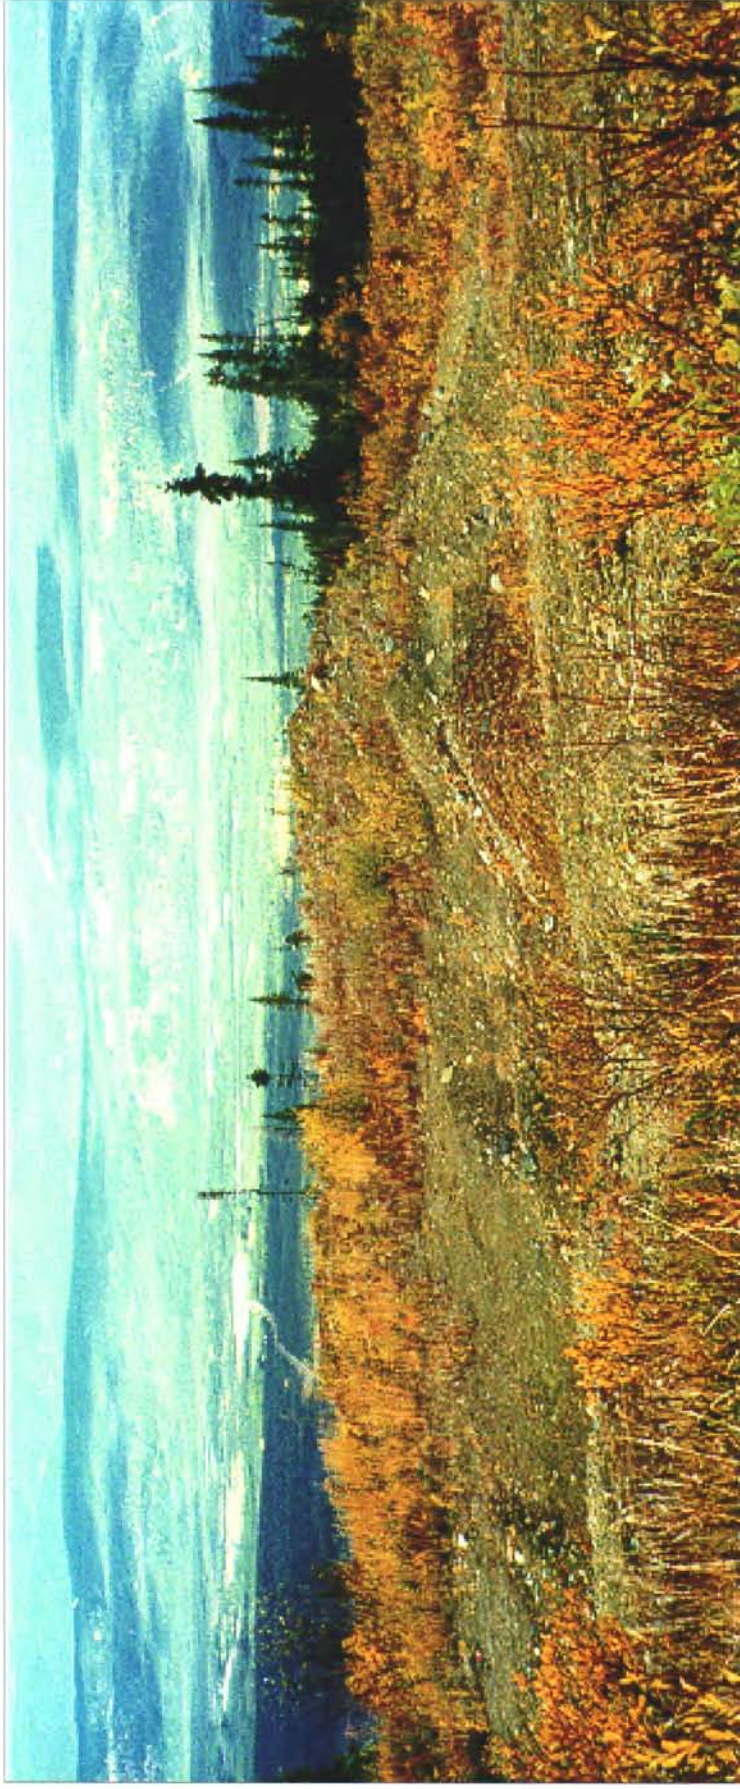
Photo 5-6: Trenched area is on the southwest portion of the Coral and Wigwam site.

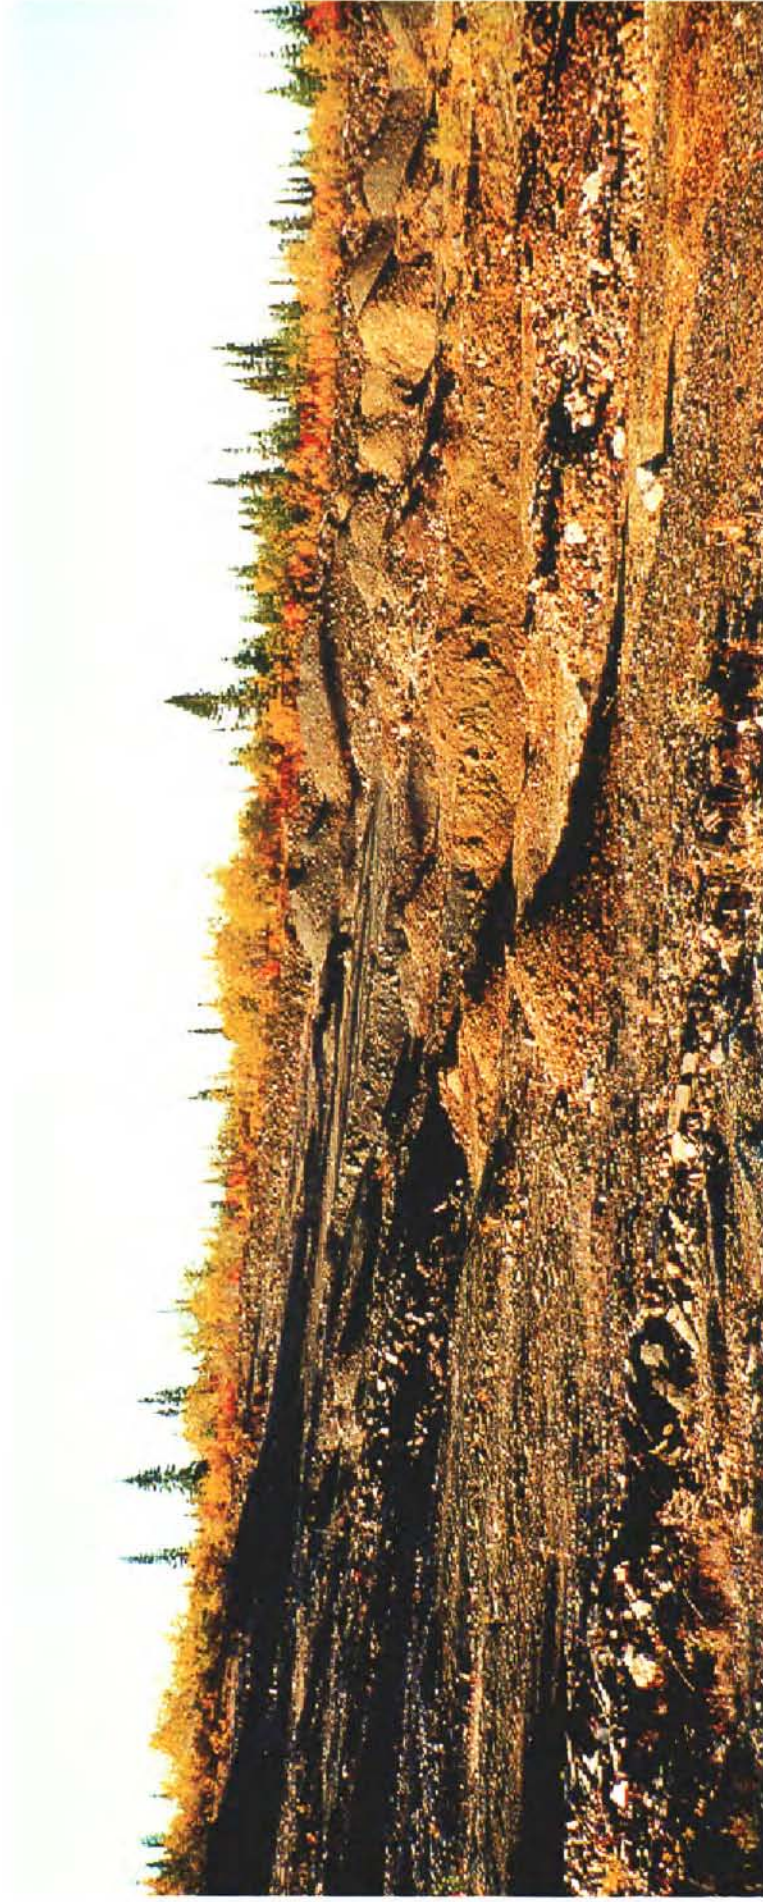
Photo 6-1 : Panoramic view of trenching at Birmingham Pit. (Azimuth 210°)

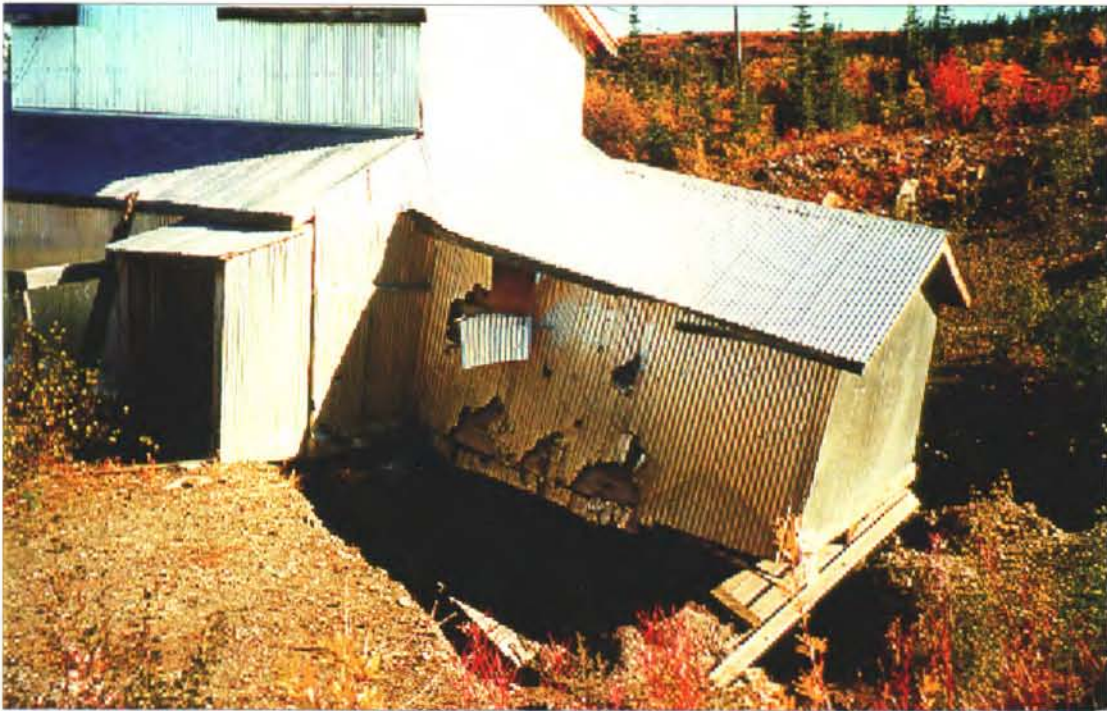
Photo 6-2 : Ruby Shaft. South portion of shaft house over opening has collapsed.

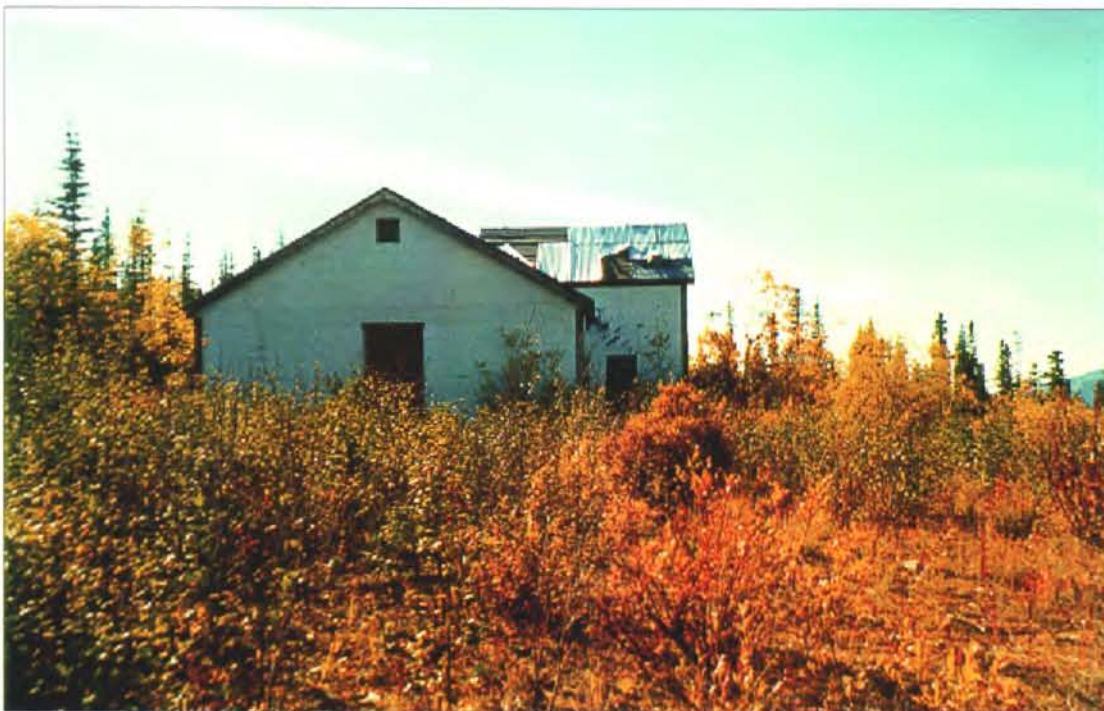
Photo 6-3 : Bermingham Pit. Building 1. Explosives magazine. (Azimuth 235°)

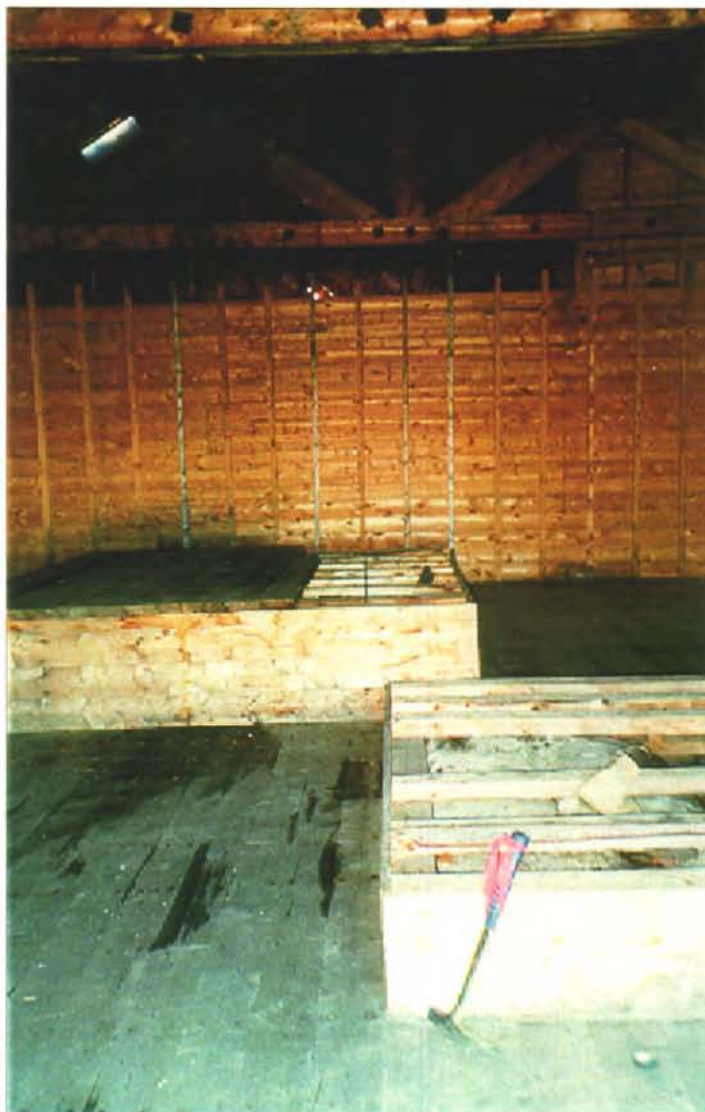
Photo 6-4 : Bermingham Pit. Building 1. Interior of explosives magazine. (Azimuth 225°)

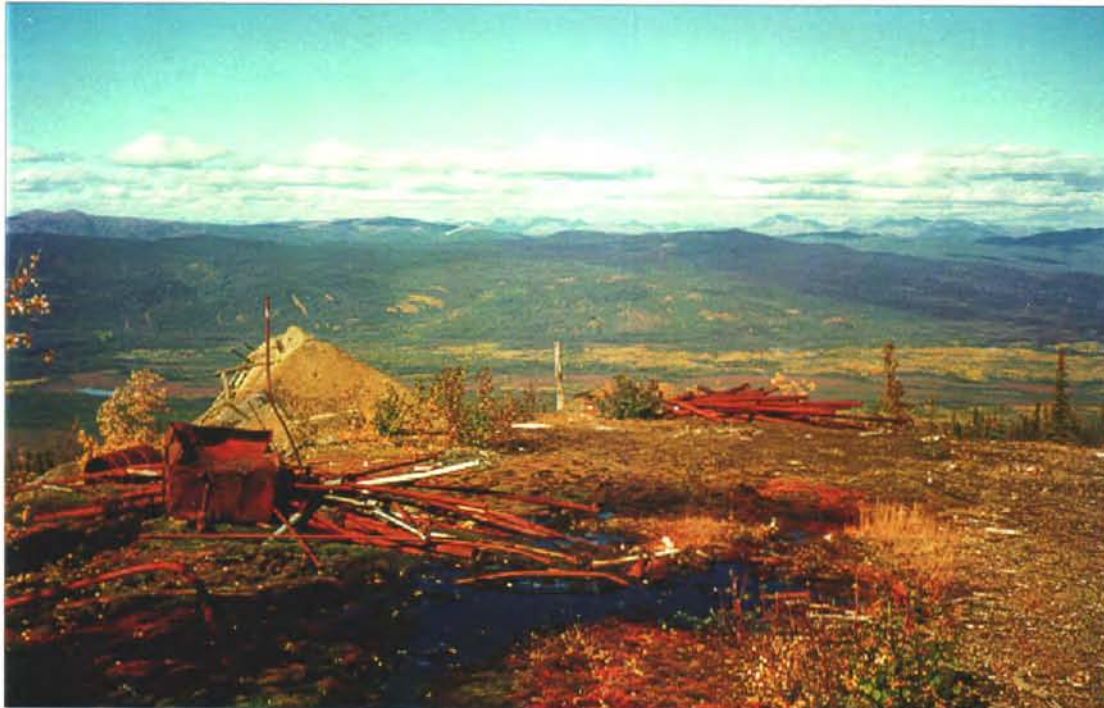
There were no rail or trestle structures at the site. There were metal tracks and associated debris piled at the site near building 6C (photo 6-10). The tramway structure is directly below the site, however, there is no indication that it was used by the Bermingham mine site.

Photo 6-10 : Bermingham Adit. Metal debris on dump. (Azimuth 325°)

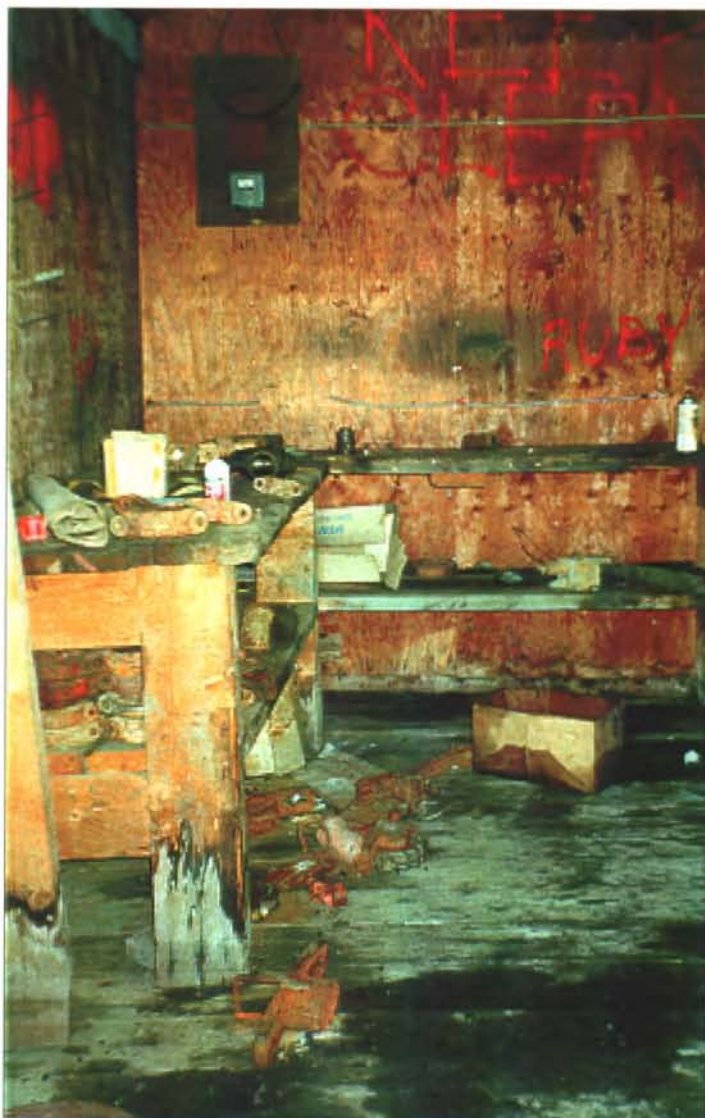
Non-Hazardous Contents: A furnace was located in the workshop with some staining evident around the base. Wood shelving with metal debris was located on two walls (photo 6-19).

Photo 6-19 : Ruby 400. Interior of the shop area of the garage.

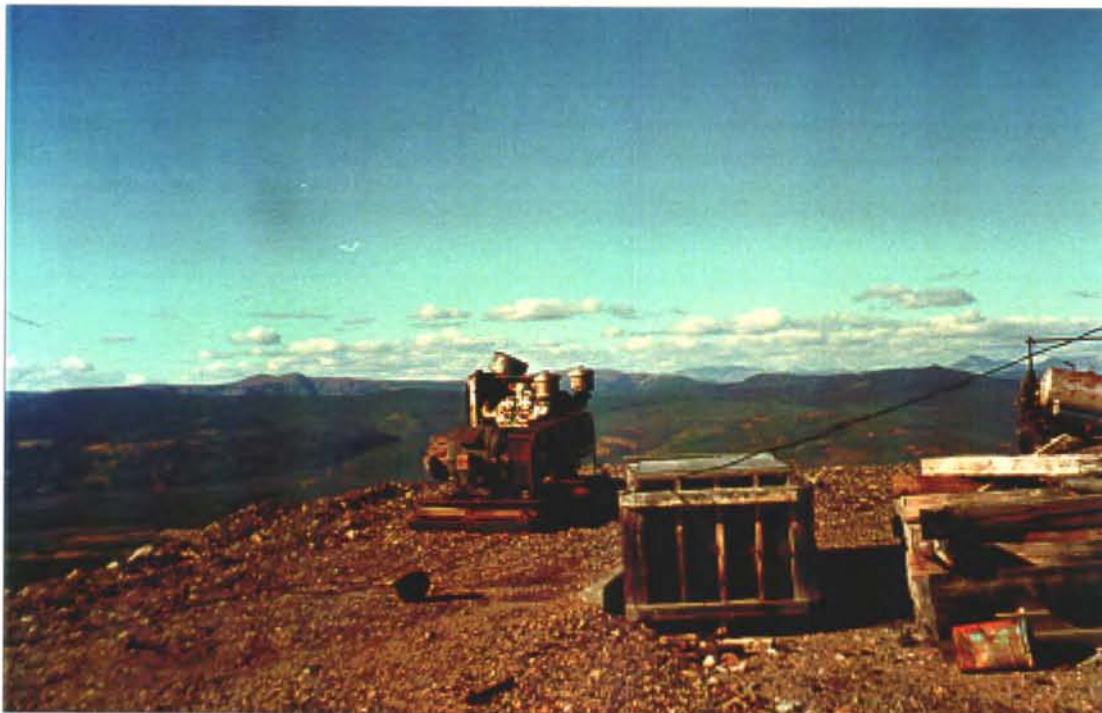
Photo 6-21 : Ruby 400. Abandoned compressor and some miscellaneous debris.

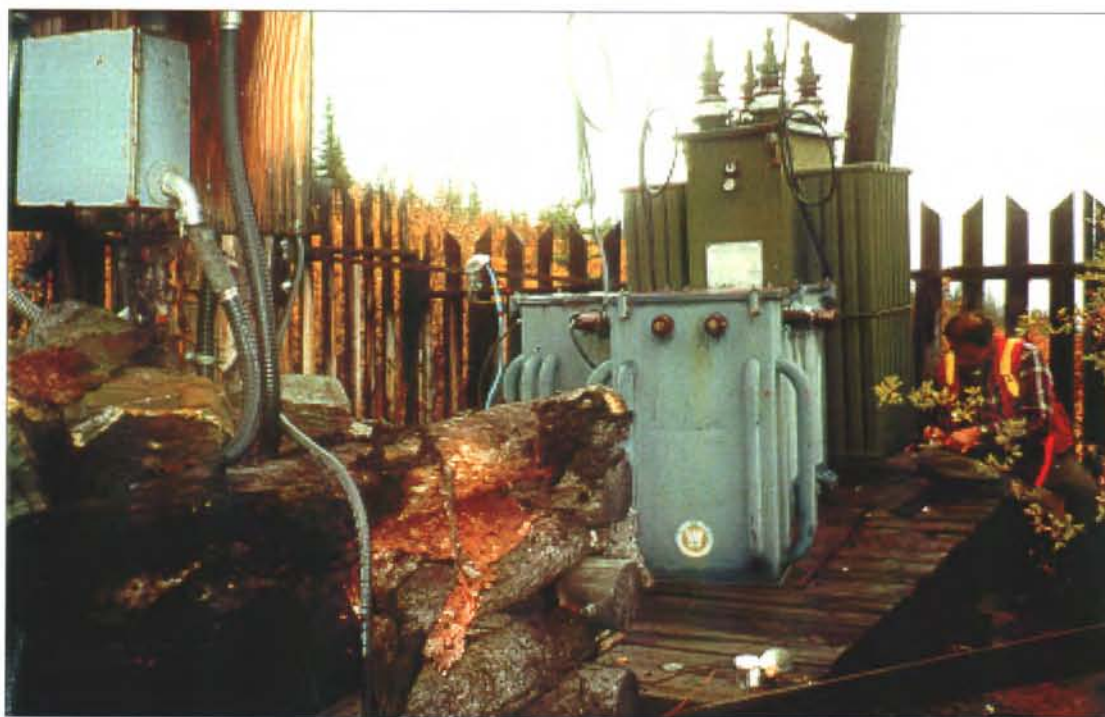
Photo 6-22 : Ruby 400. Transformer compound located at the mine site.

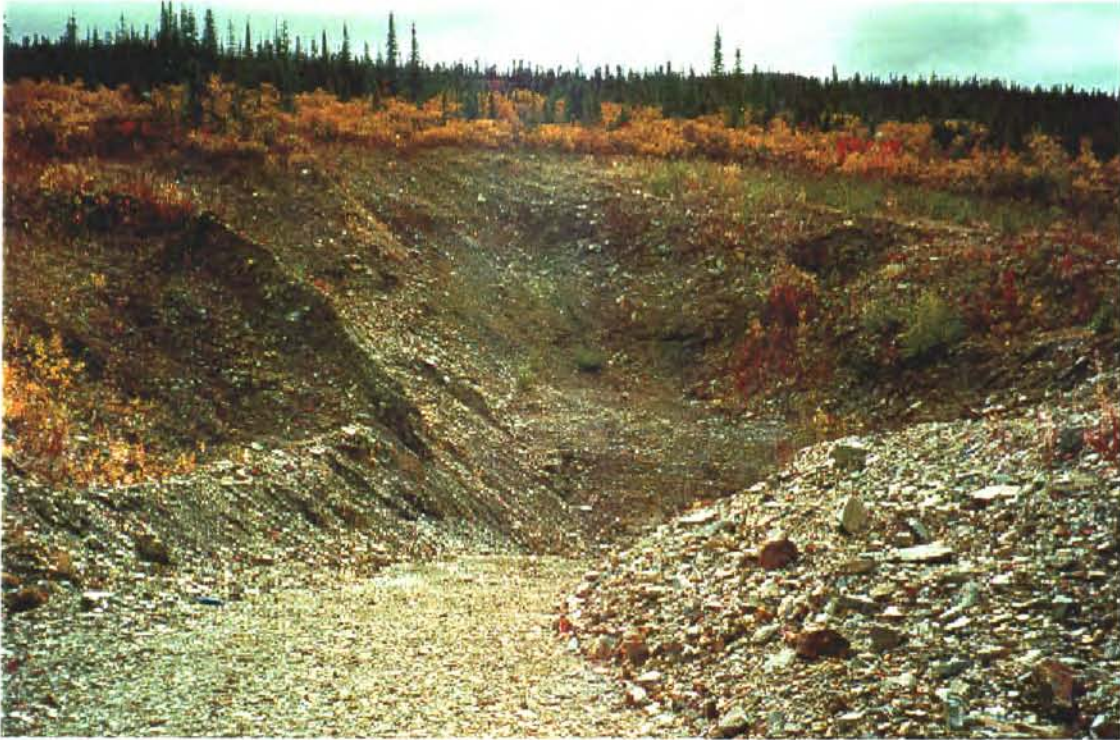
Photo 7-1: Eastern trench of the No Cash 100 mine site

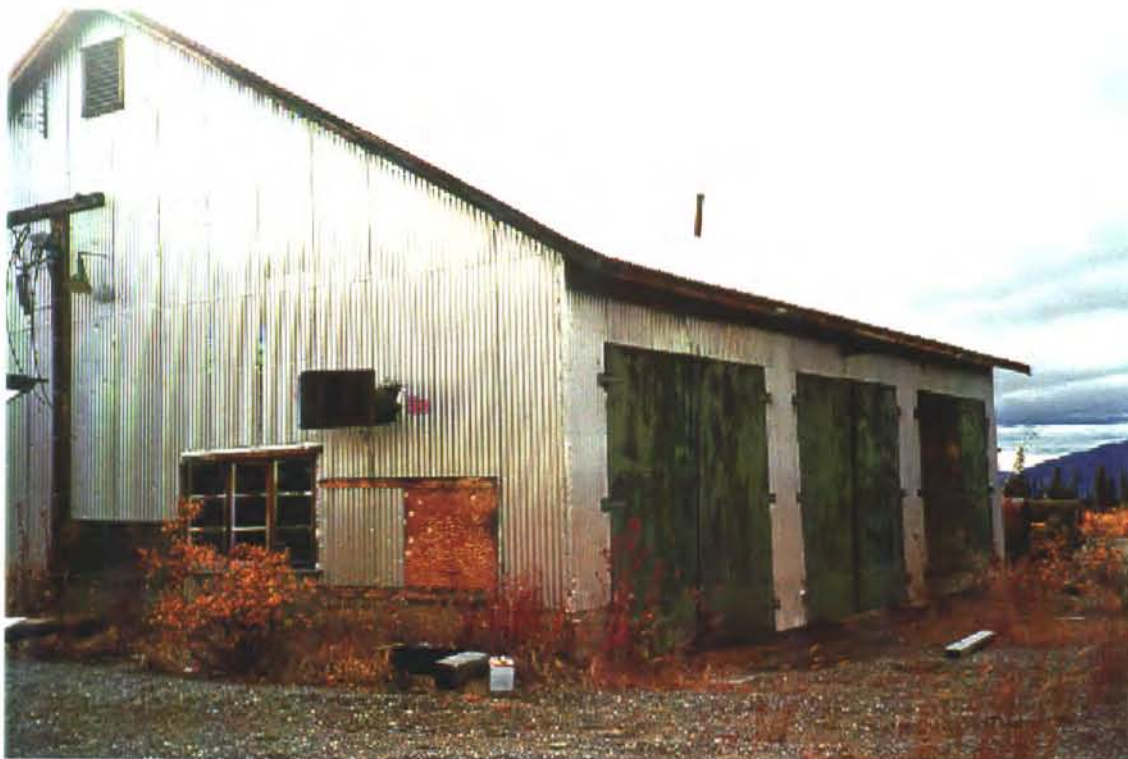
Photo 7-4: Garage structure located adjacent to the shafthouse. Note the batteries in the foreground.

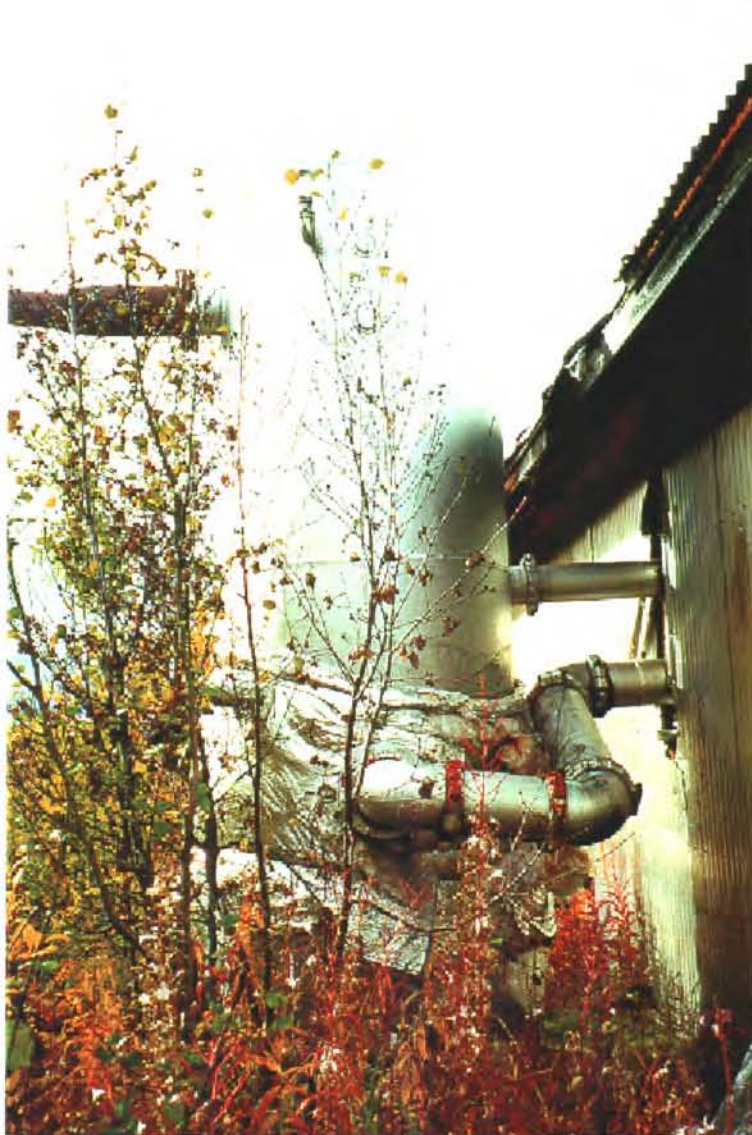
Photo 7-5: Receiving tank located on the outside of the garage structure. Tank was insulated with fibreglass.

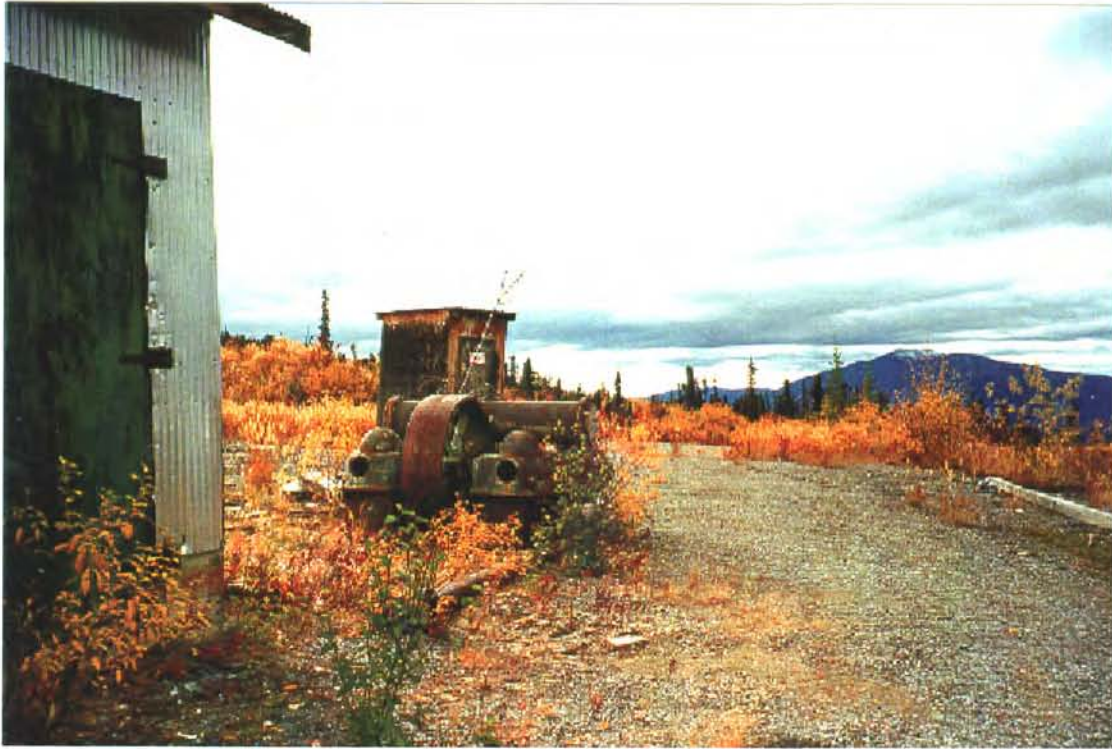
Photo 7-6: Abandoned compressor located on the northwest corner of the garage.

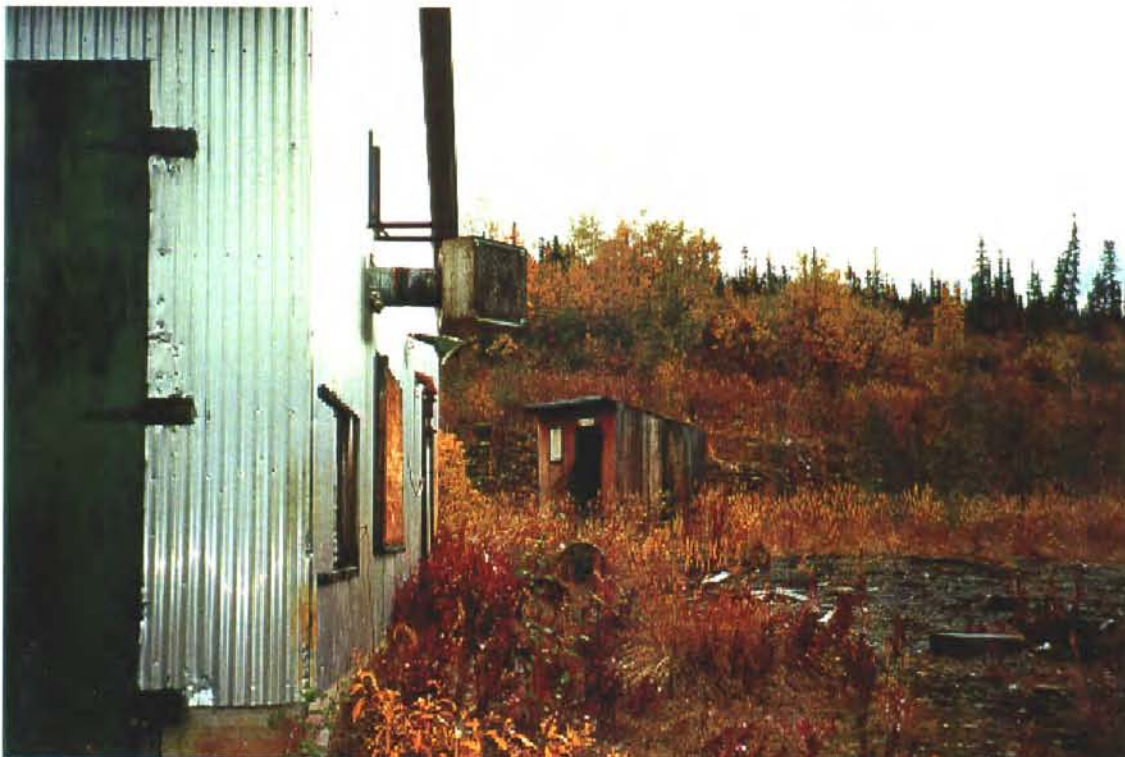
Photo 7-7: Shed on the southwest corner of garage that housed unknown product (samples taken).

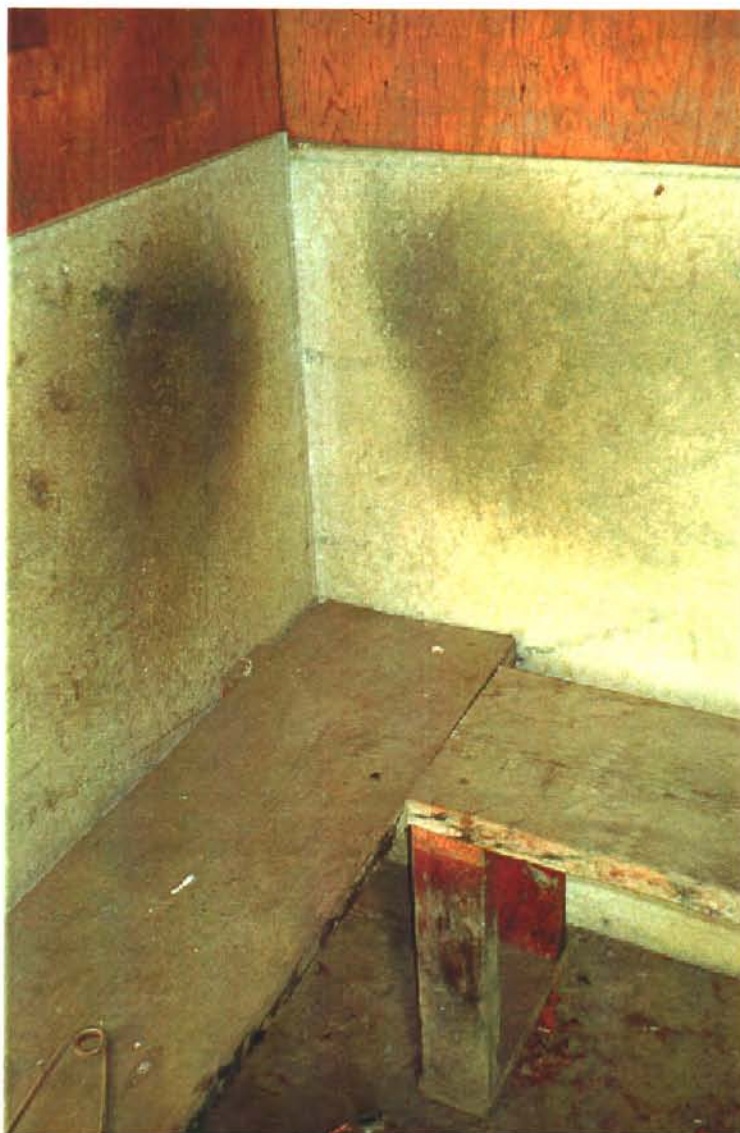
Photo 7-9: Interior of the lunchroom. Note the asbestos board on the walls.

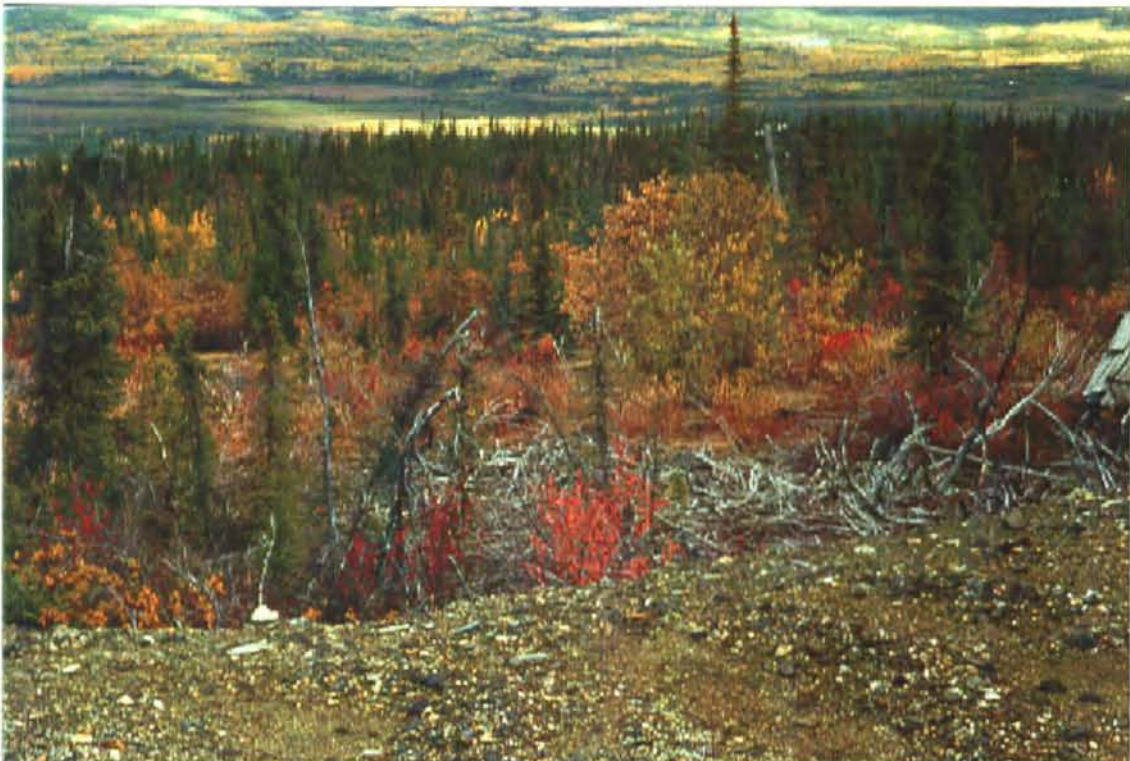
Photo 7-12: Kill zone below the waste rock dump.

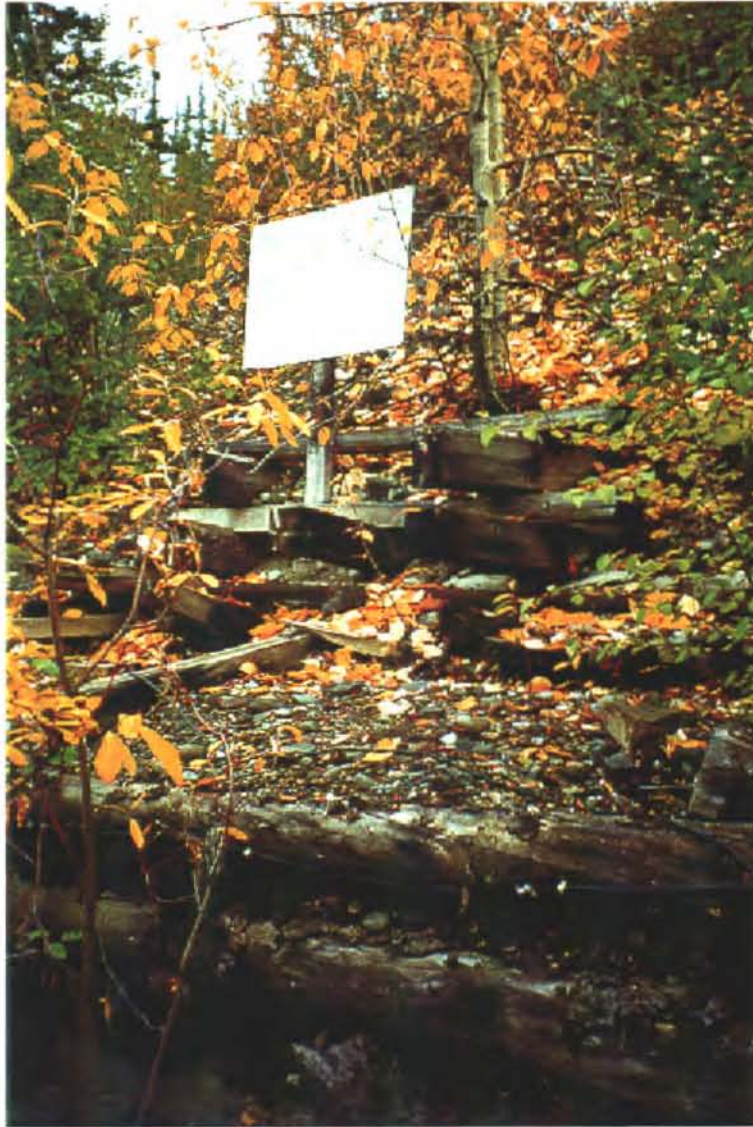
Photo 7-13: Old adit structure that has collapsed and caved in.

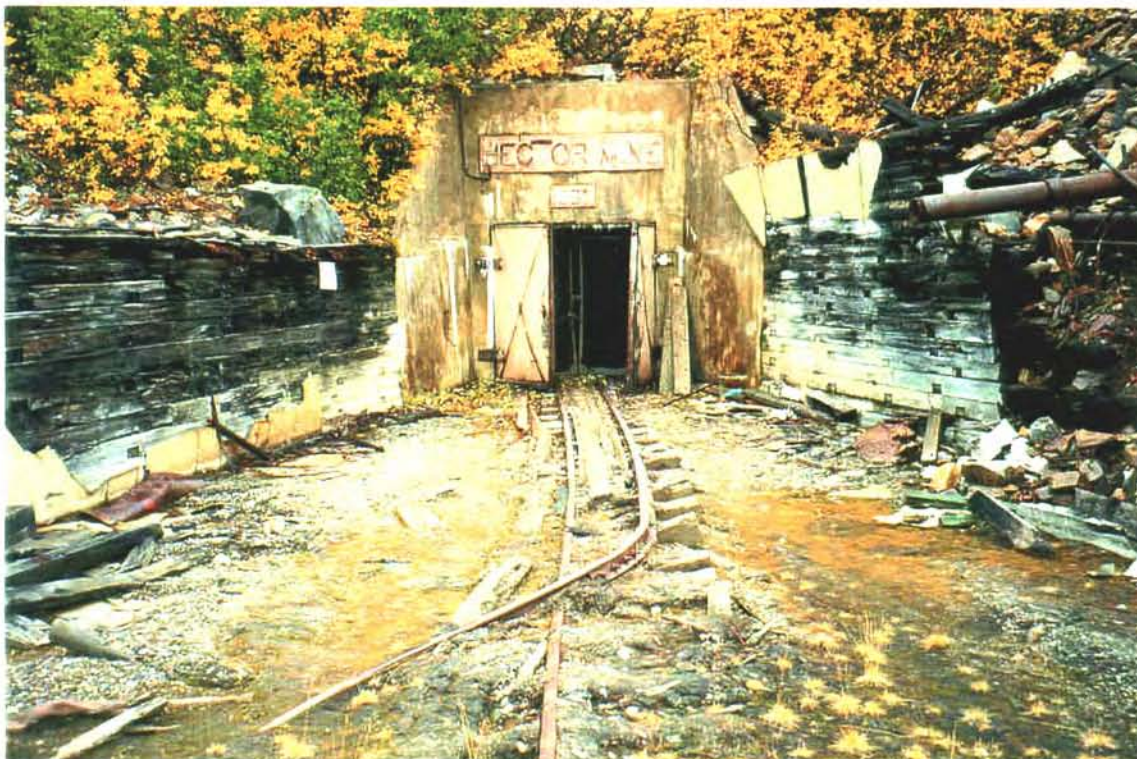
Condition: The adit appears to be stable but could only see to about 5 m.

Photo 9-1. Hector Adit, showing the buttressing, old rails and debris.

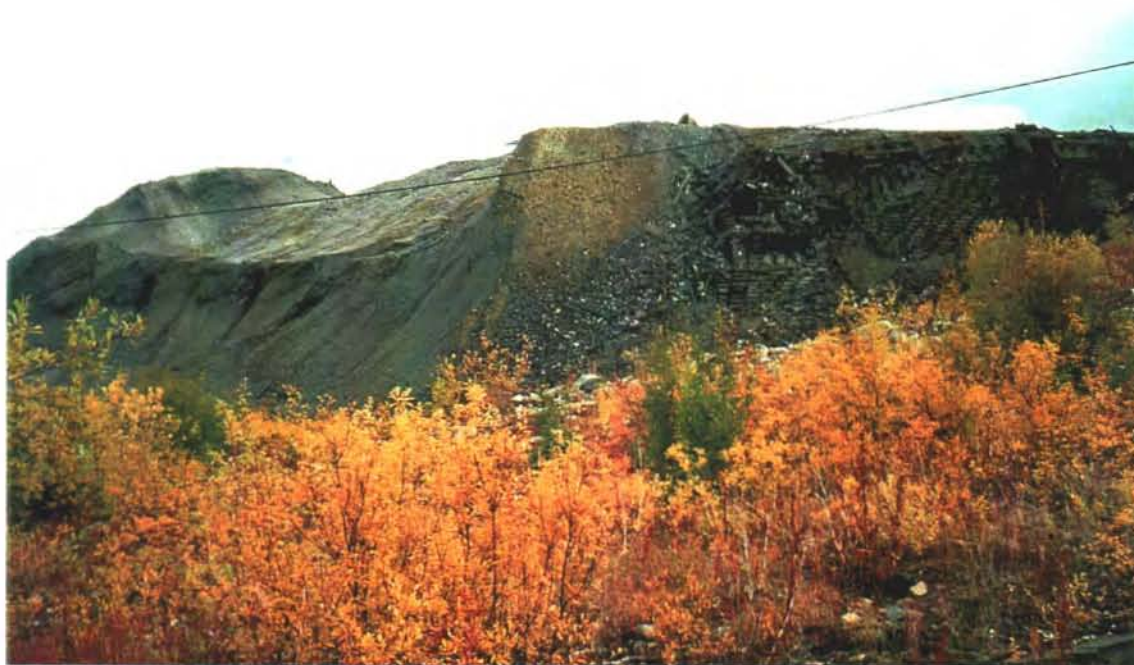
There are two loading facilities at the road outside the adit, to either side of the Hector dump. The west side of the dump has been buttressed to form a gully (Photo 9-4) where an old tram for transporting ore from the Hector mine to Elsa for processing. The tram towers are wooden and the cable is reportedly lying below the towers (Photo 9-15). The gully contains metal and wood debris (Photo 9-16).

Photo 9-4. Hector dump, looking northwest. Note old wooden buttresses and debris.

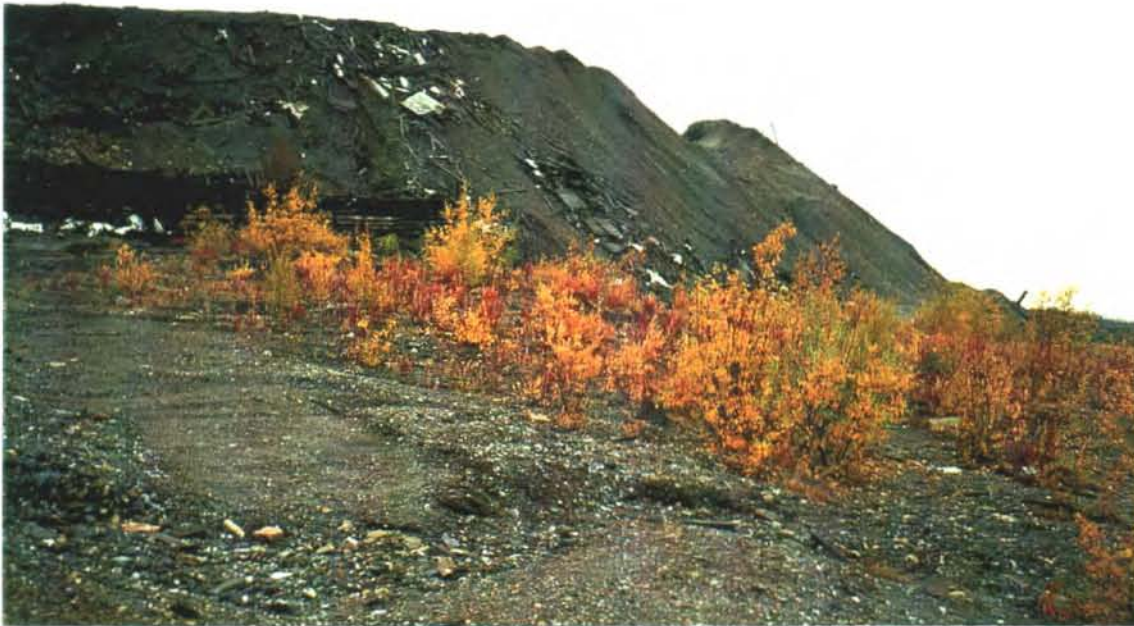
Photo 9-5. Hector dump, looking southwest. Note wooden buttressed and debris. Old steam plant was located at base of buttresses.

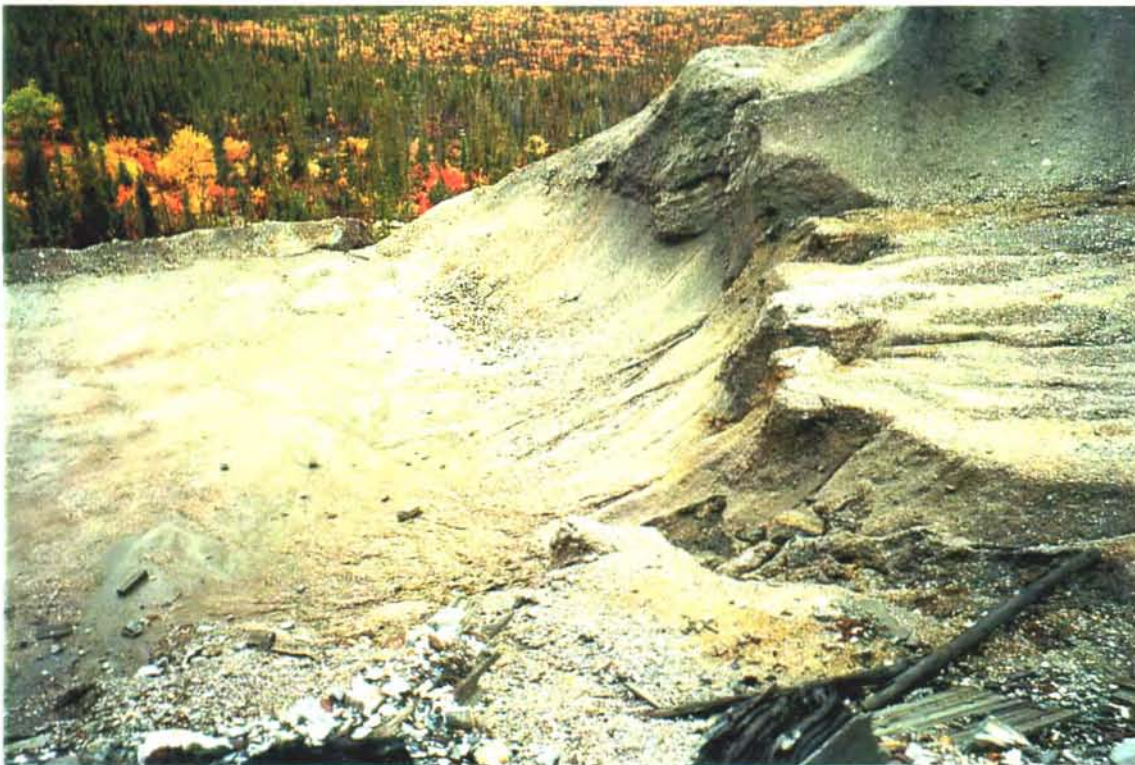
Photo 9-6. Portion of the Hector dump, looking north-northwest. This section of the dump appears to have been used as a loading point, or perhaps the waste was quarried at one time to be used as fill.

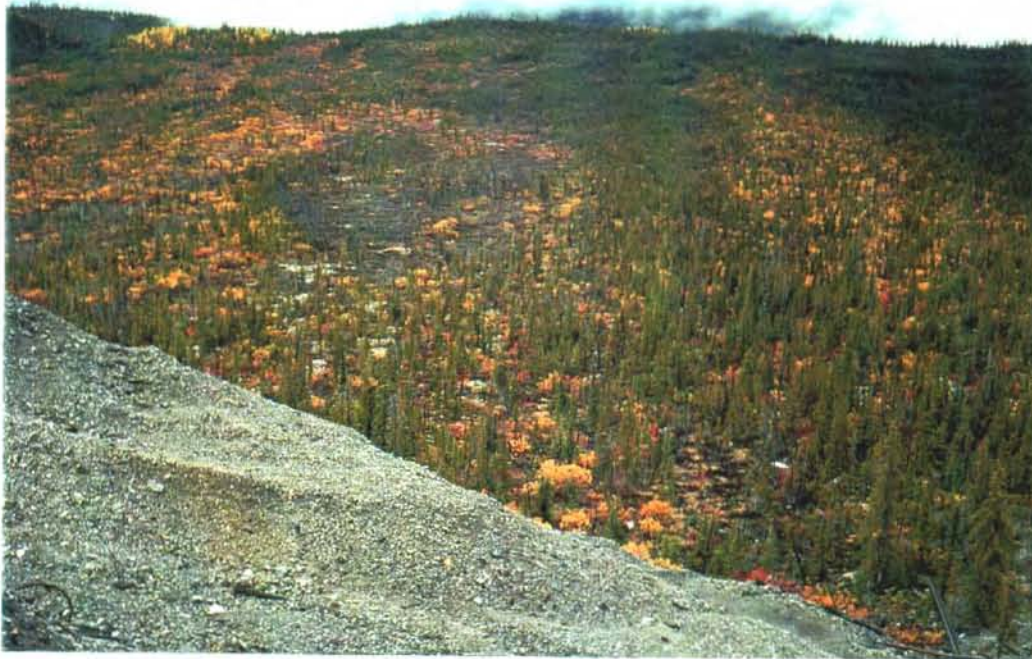
There is a zone of impacted vegetation beneath the dump (Photo 9-7) . According to UKHM (1996) this zone results from deposition of silt from mine water released during operation. The report states that there has been no drainage from the Hector 400 adit since mining ceased in October 1972.

Photo 9-7. Looking downhill (northwestward) at the vegetation below the Hector dump. Note the impacted vegetation (grey patch left of center in photograph). Whether this results from high sediment content in water discharged during mining, or from runoff and seepage from the waste rock dump, is unclear.

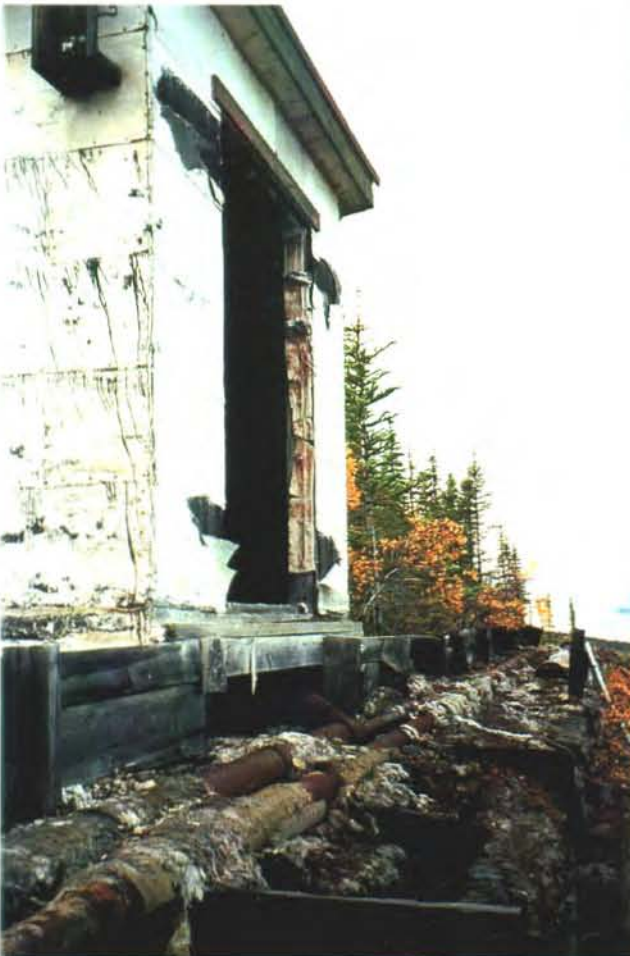
Location: Building 9A is approximately 100 m west of the Hector adit and above the Calumet Road. Building 9B is approximately 200 m west of the Hector adit and is below the Calumet Road. Both buildings are west of the hector dump. Building 9B is shown in Photo 9-8, along with the remnant utilidor that connects to the structure. Building 9A is identical.

Photo 9-8. Building 9B. Note wooden construction and tar paper siding. Also note metal piping and remnants of insulation that comprises the utilidors.

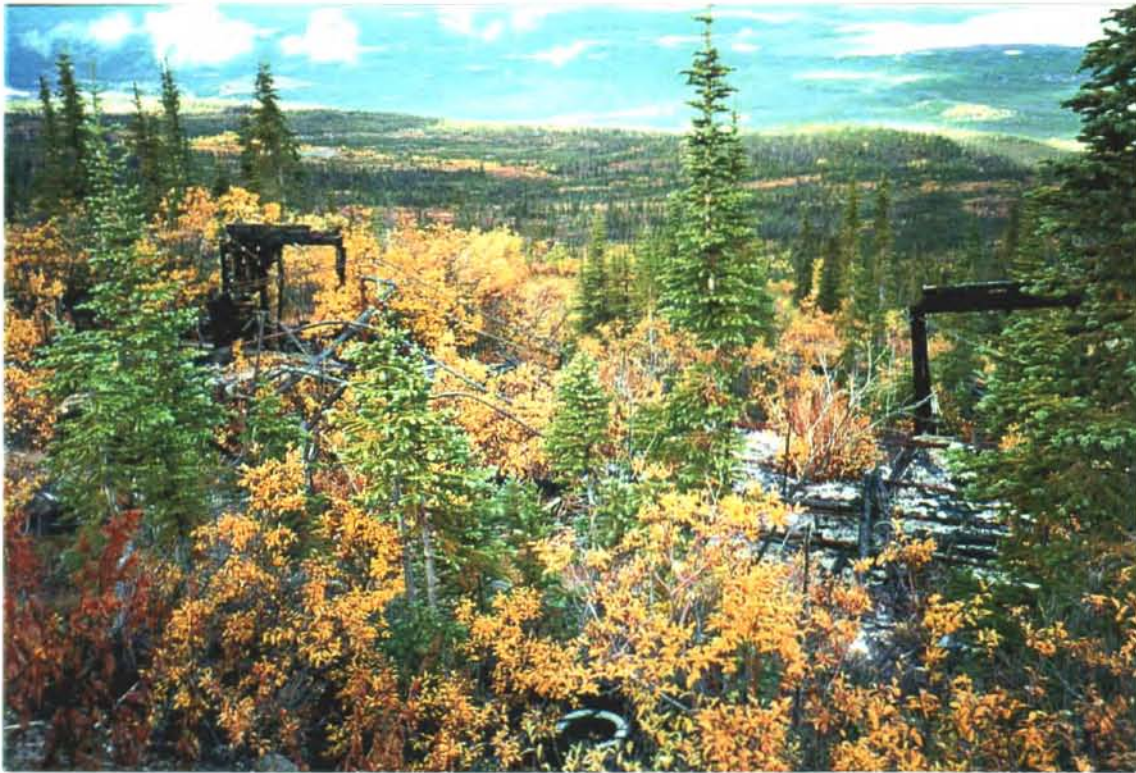
Photo 9-9. Burned out bunkhouse and wash house.
