KENO VALLEY/DUBLIN GULCH ENVIRONMENTAL BASELINE ASSESSMENT

VOLUME II: Keno Valley Sites #1 to #20

Prepared for
Waste Management Program
Indian and Northern Affairs Canada

By
Environmental Services
Public Works and Government Services Canada

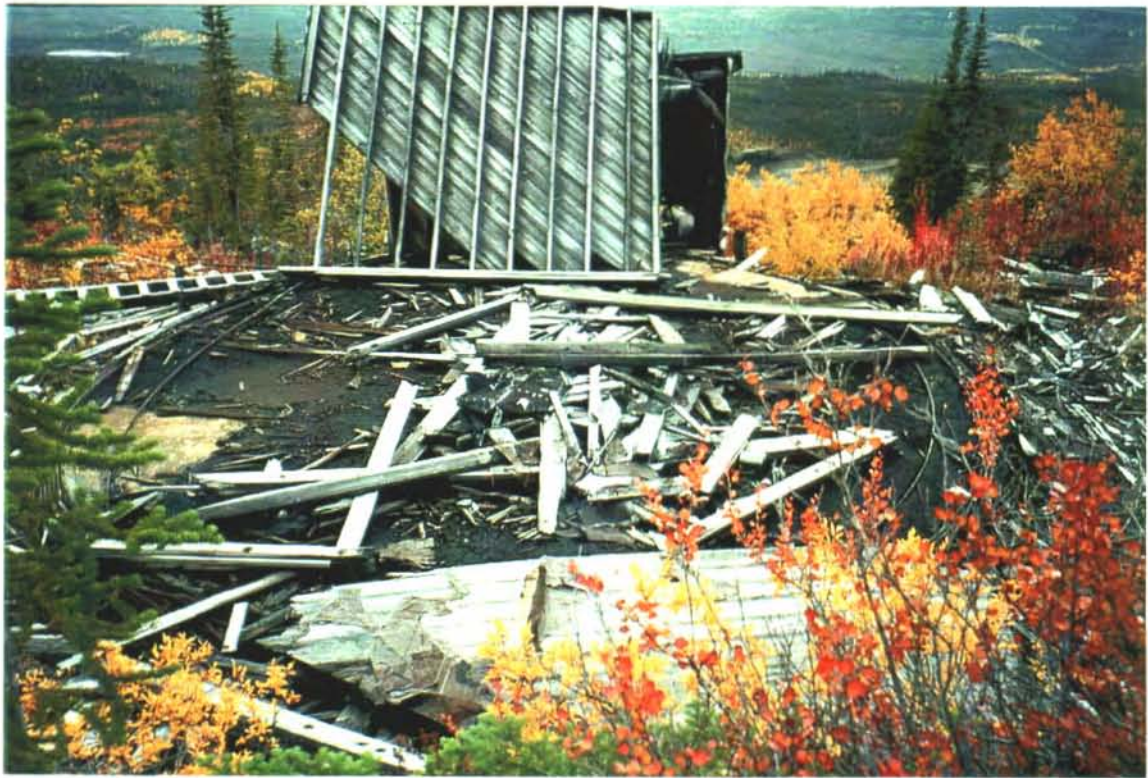
Non-Hazardous Contents: Associated with the building are the remnants of a large water storage tank. Behind and uphill from the building is a large (5 m diameter) round concrete foundation (Photo 9-11). Upon the concrete and to adjacent to it are approximately 400 m of 3 cm thick steel cable, in segments of about 10 m lengths. These are the stays that held the wooden storage tank together. There is also some wood debris from the collapsed tank and part of the building.

Photo 9-11. Concrete foundation of storage tank with debris from storage tank. Building in the background.

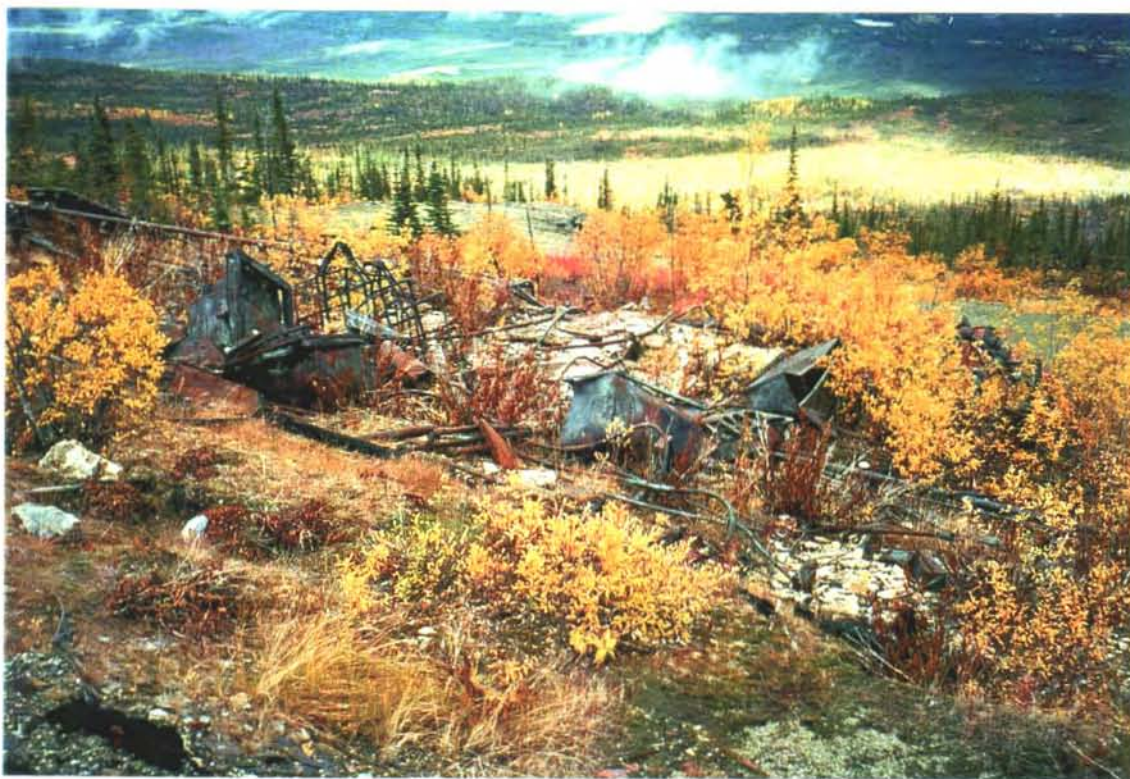
Assay lab: Located to the east of Building 9B. Dimensions (L x W x H): 2 m x 3 m (collapsed). Brick construction. Metal pipes and rusted ovens remaining (Photo 9-13). No hazardous contents observed.

Photo 9-13. Remnants of assay laboratory. Note metal debris and concrete foundation.

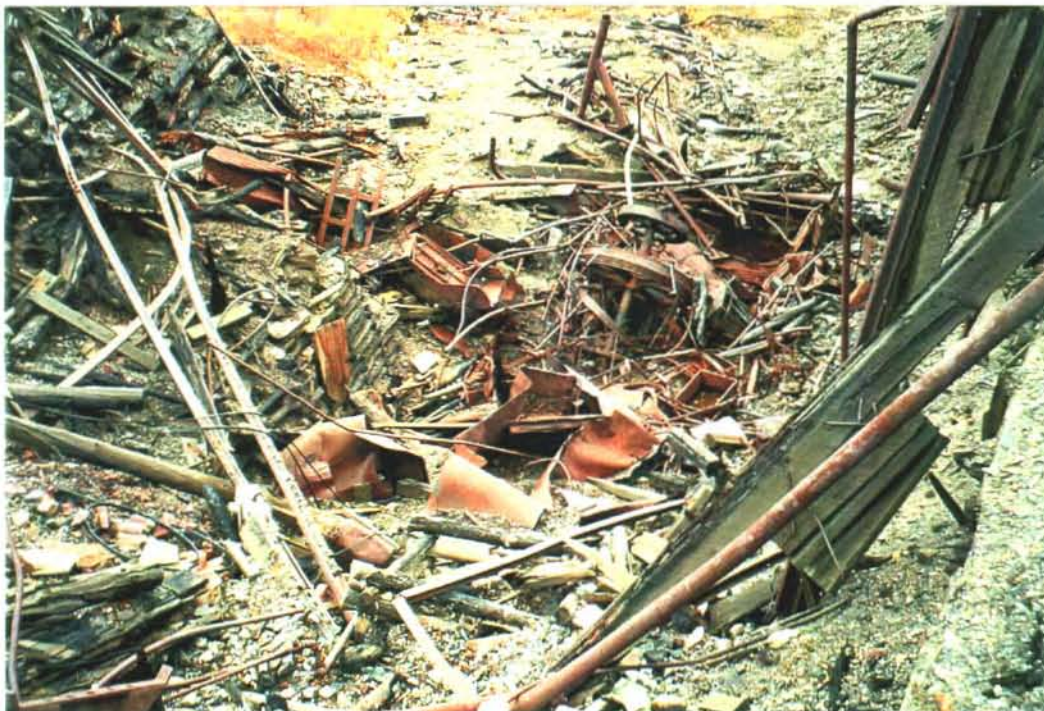
There are two loading facilities at the road outside the adit, to either side of the Hector dump. The west side of the dump has been buttressed to form a gully (Photo 9-4) where an old tram for transporting ore from the Hector mine to Elsa for processing. The tram towers are wooden and the cable is reportedly lying below the towers (Photo 9-15). The gully contains metal and wood debris (Photo 9-16).

Photo 9-16. Debris in gully adjacent to the Hector dump.

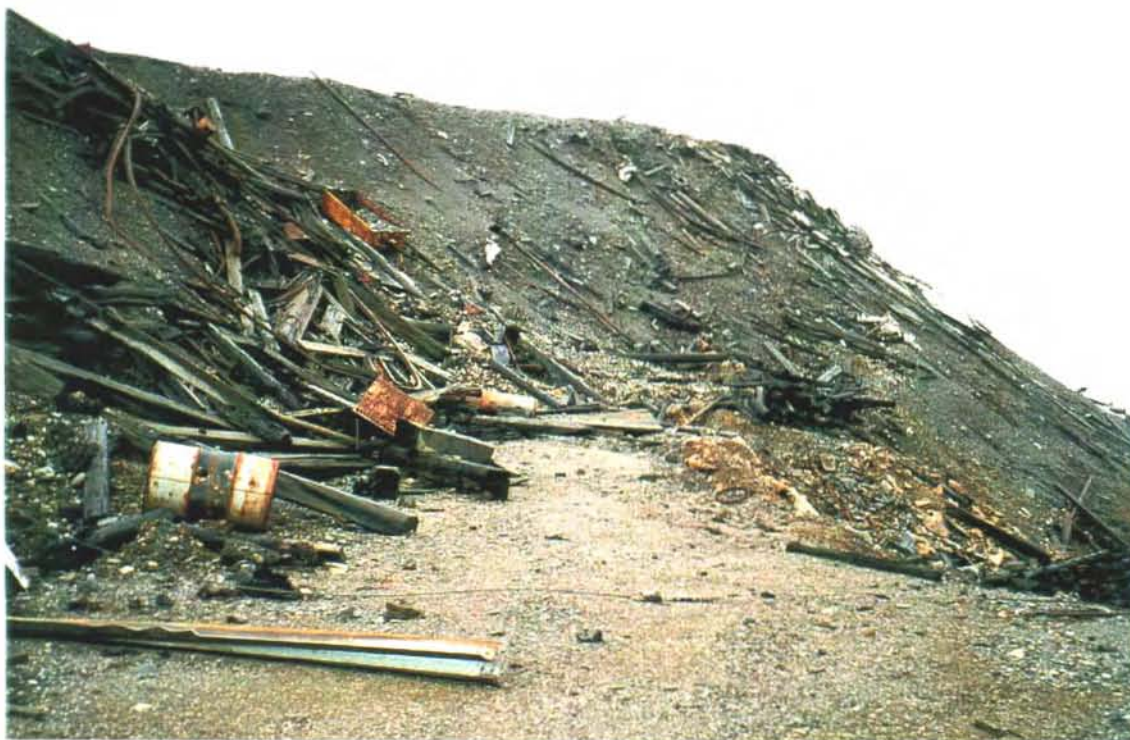
There is abundant metal and wood debris on and adjacent to the dump (Photo 9-19). This material is described in Section 6.6 Loading Facilities.

On the east side of the dump, are larger loading structures with more buttressing (Photo 9-17). A coal-fired steam plant built at the loading facility at the Hector adit was used to heat the mine buildings. The concrete foundation for the plant and small pile are still on site, but the building has been removed (Photo 9-18). There is abundant metal and wood debris in this area (Photo 9-19).

Photo 9-19. Metal and wood debris on the side of the Hector dump.

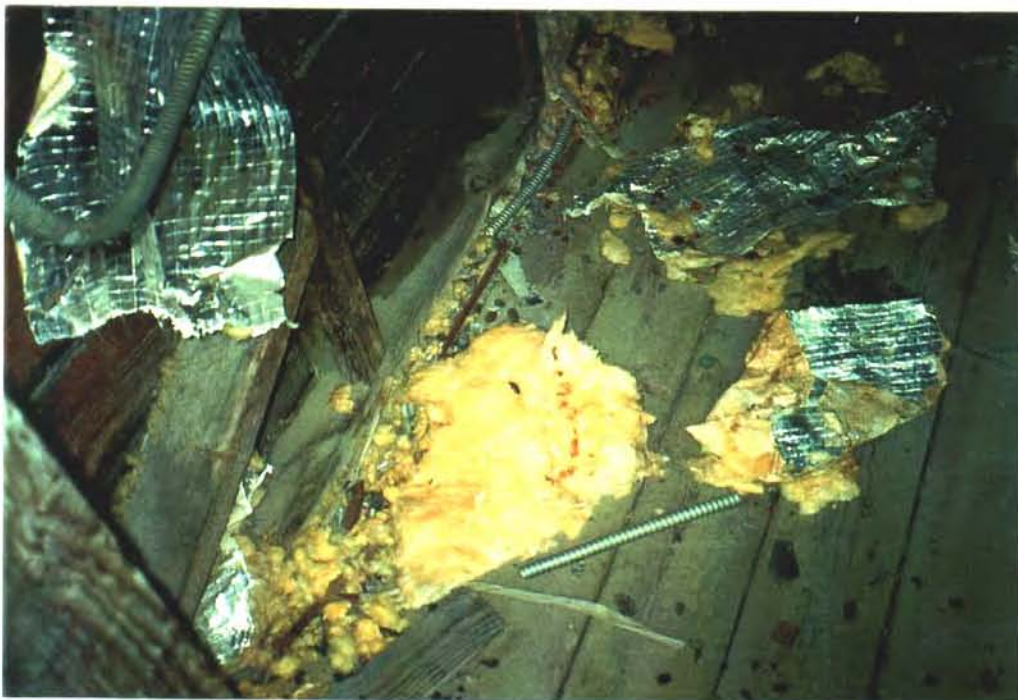
Photo 9-21. Insulation in the electricity shed, adjacent to the conveyor structure at the Loading Facility at the Calumet 1-15 dump.

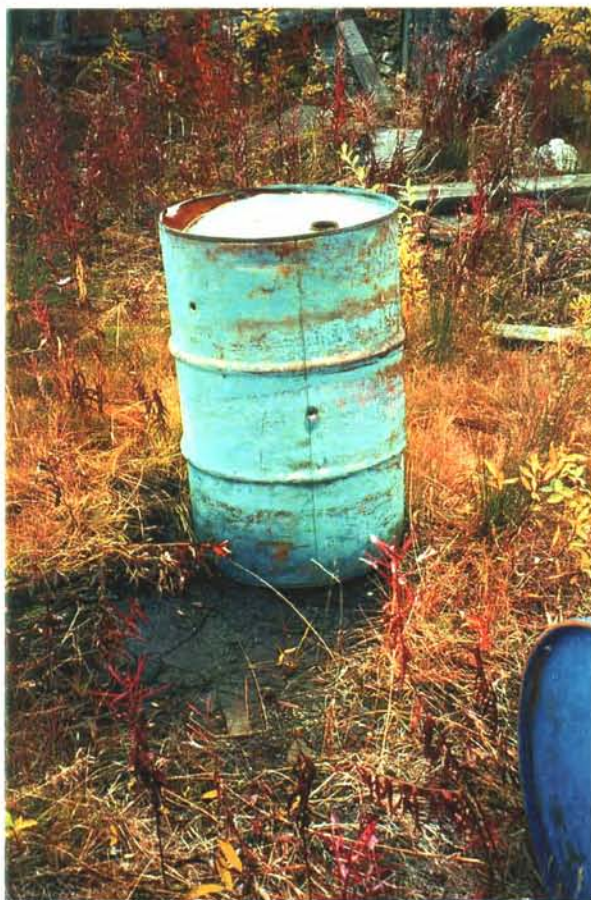
Photo 9-22. Oil spillage from barrel that is half full of oils and water. The other tow barrels are empty.

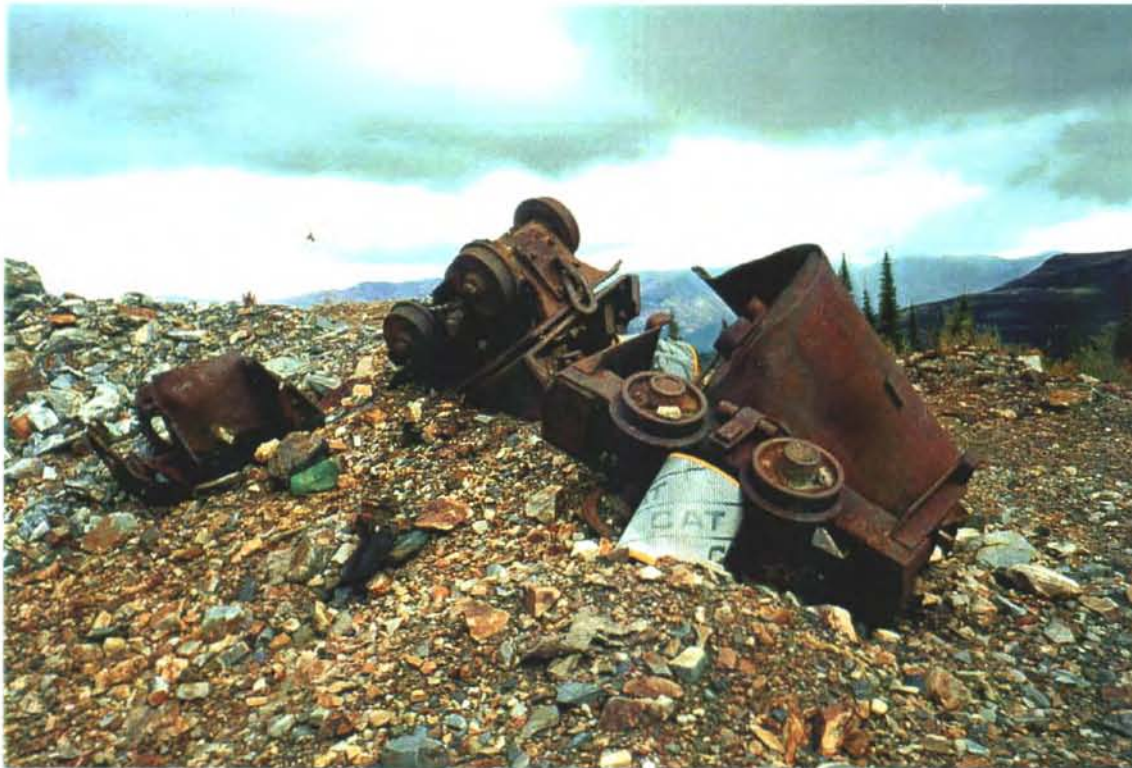
Photo 9-23. Old ore carts and debris at the upper loading facility on Calumet 1-15 dump.

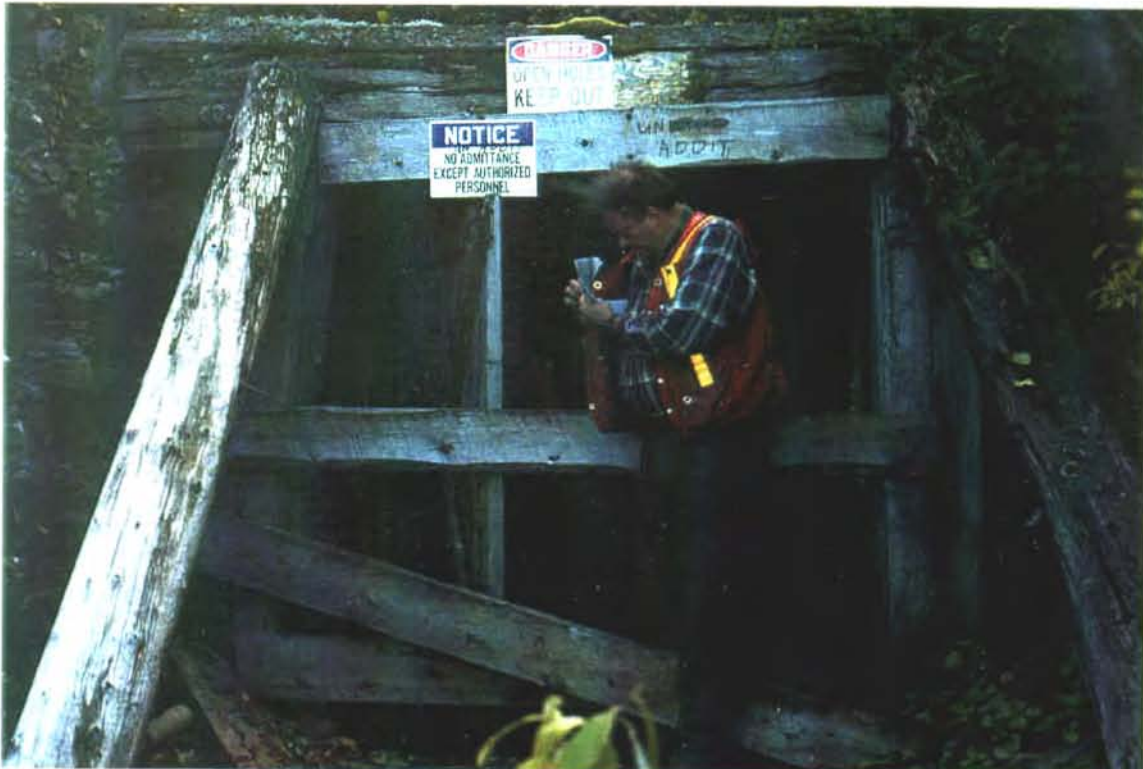
The UN portal is 2 m high and constructed with wood beams (Photo 10-2). The adit has a wooden door to the adit was open at the time of the site visit. The adit is blocked by ice that extends to the sides of the adit, and comes to within 20 cm of the roof. The ice block is reportedly present year round, but has never fully blocked the water flow (B.Dunn, pers. comm).

Photo 10-2. UN portal showing wooden debris and open door.

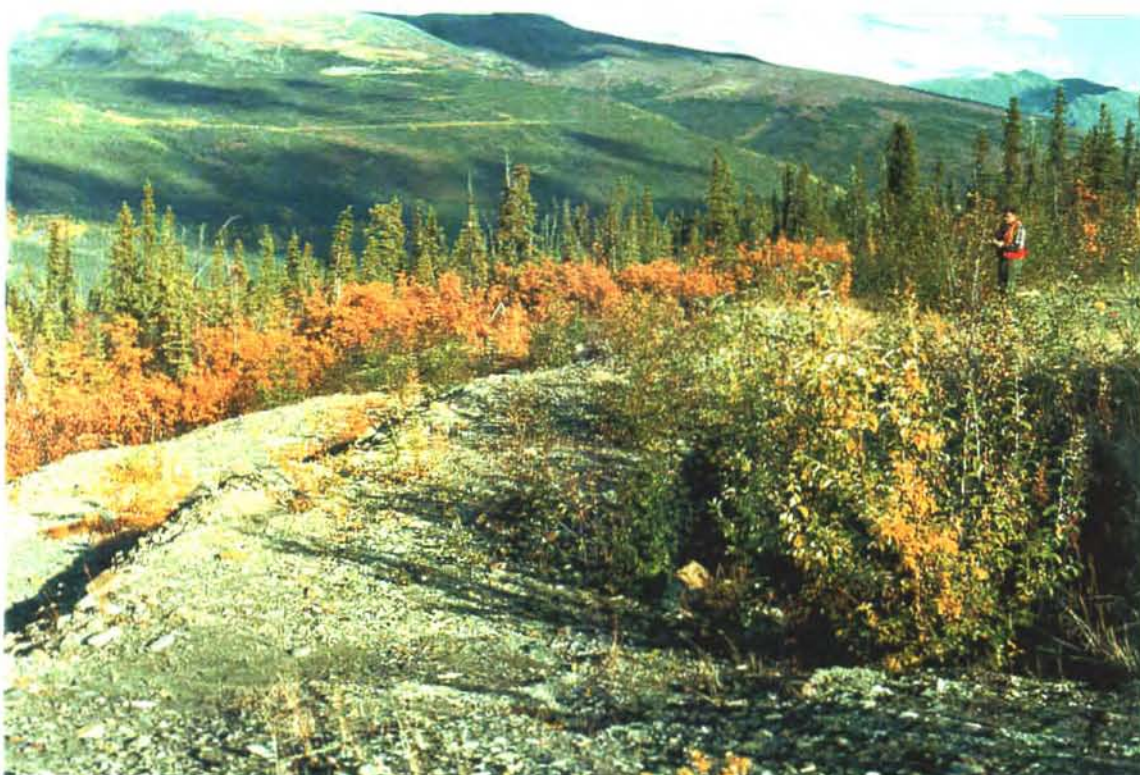
Photo 10-3. Waste rock pile outside the UN adit, showing natural revegetation.

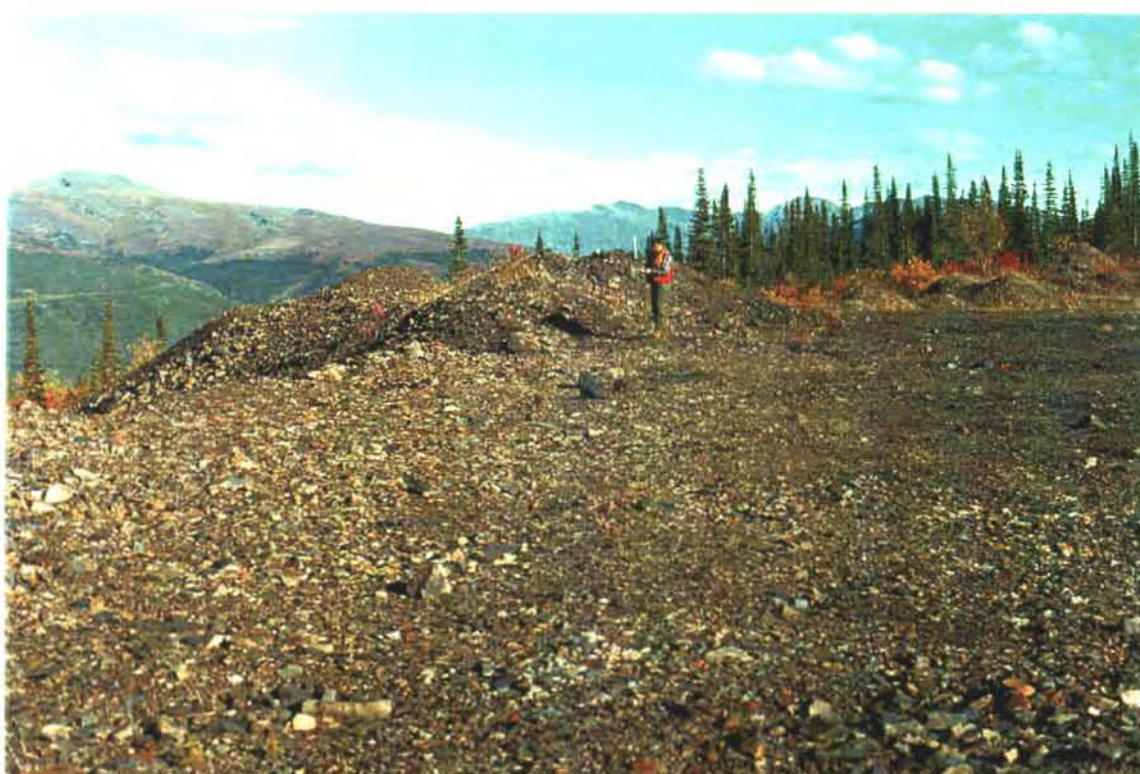
Photo 10-4. Miller waste rock pile.

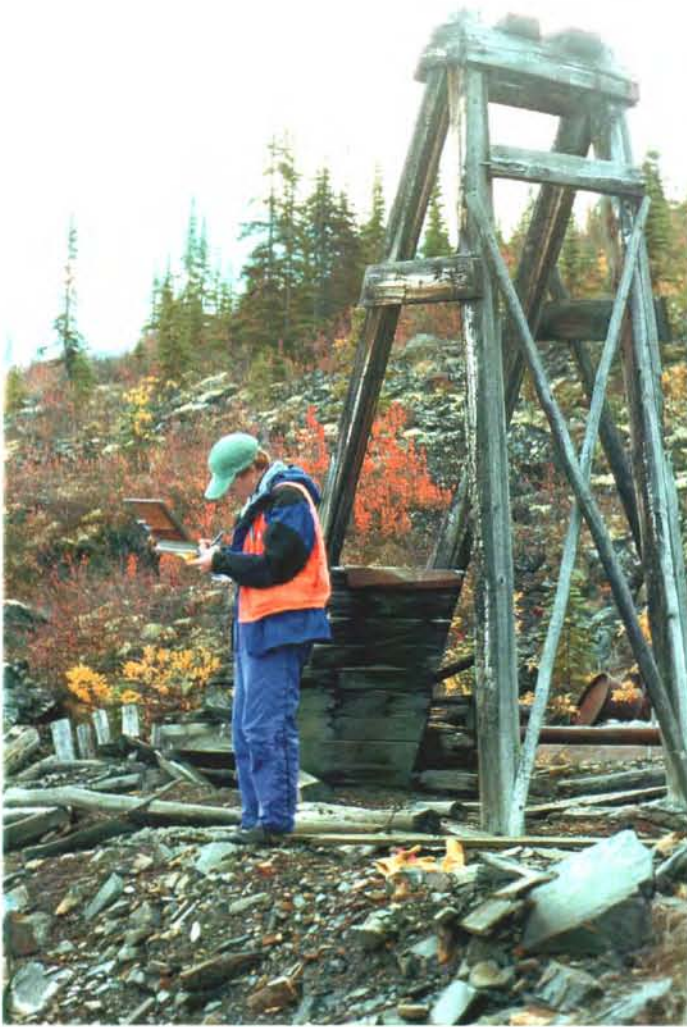
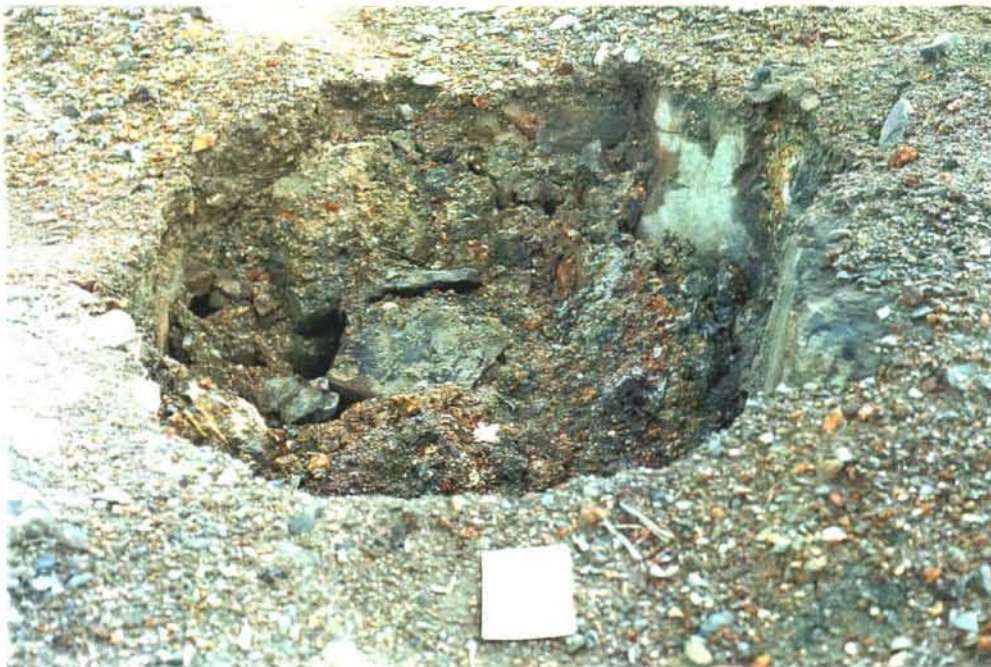
Supports: There is a wooden A-frame above the shaft that likely once held a pulley. The wooden supports around the shaft are in poor condition, and the ground to the NNE of the shaft is subsiding due to collapsing workings below (Photo 11-2).

Photo 11-2. Subsidence over adit workings, near the McLeod Shaft. The collapsed area measures approximately one meter across.

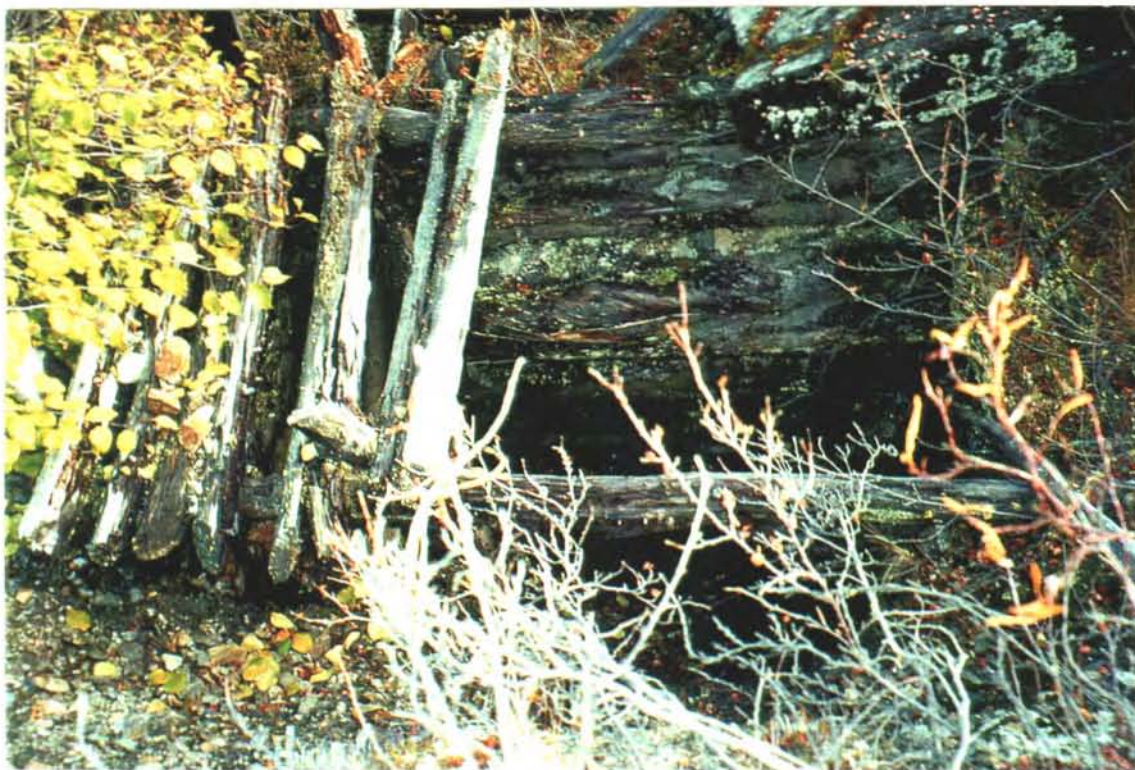
Condition: The bush has grown up around the shaft that is well hidden. The wooden supports for the shaft entrance has collapsed on one side and there are wooden timbers blocking the entrance.

Supports: The wooden supports around the shaft are in poor condition.

Photo 11-3. Unnamed Shaft. The wood constructing the shaft is rotted and unstable, and the area around the shaft is overgrown.

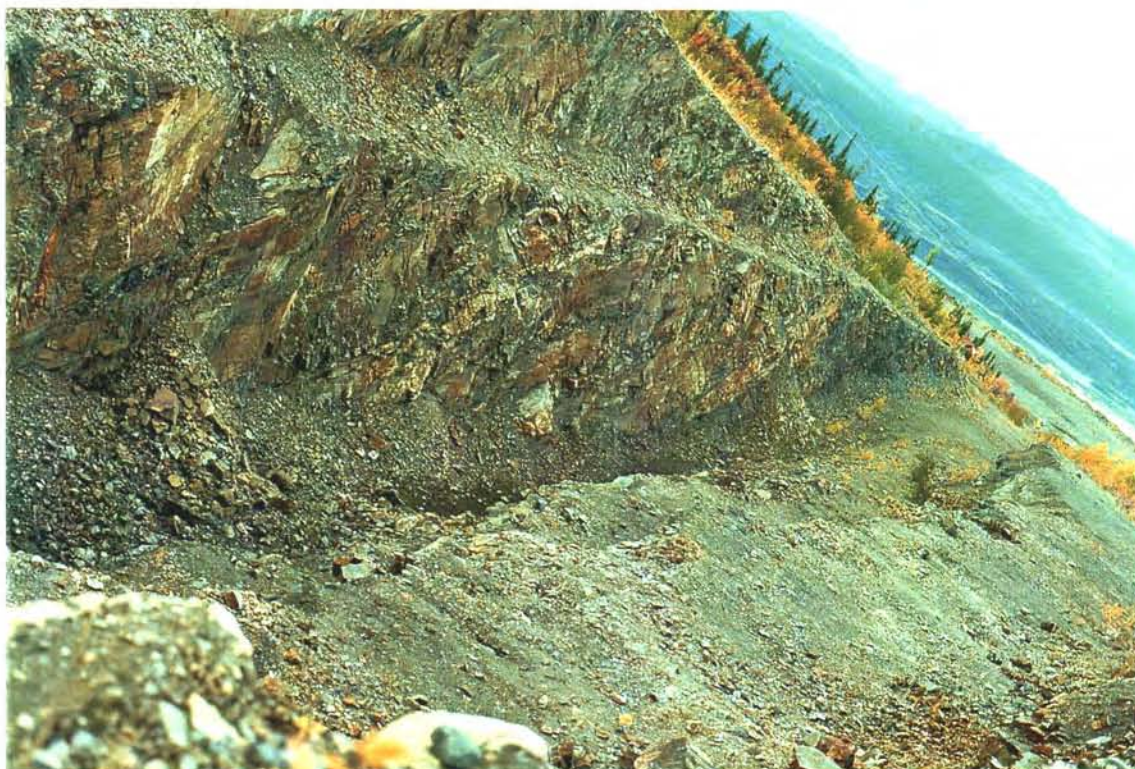
There are three open pits in the Sime area of the Galkeno property. The pits were excavated in thickly bedded, resistant quartzite much of which is moderately iron stained. All of the pits were dry when they were visited in September, and there was no evidence water ponding at any time of the year. The pits are very steep-sided, and walls reach from between 0 and approximately 100 m high. Therefore, they pose a substantial hazard from both the steep drop-offs and rock fall. Each pit is accessible by car and can be entered on foot.

Photo 11-7. #35 Vein Pit. Note steep pit walls.

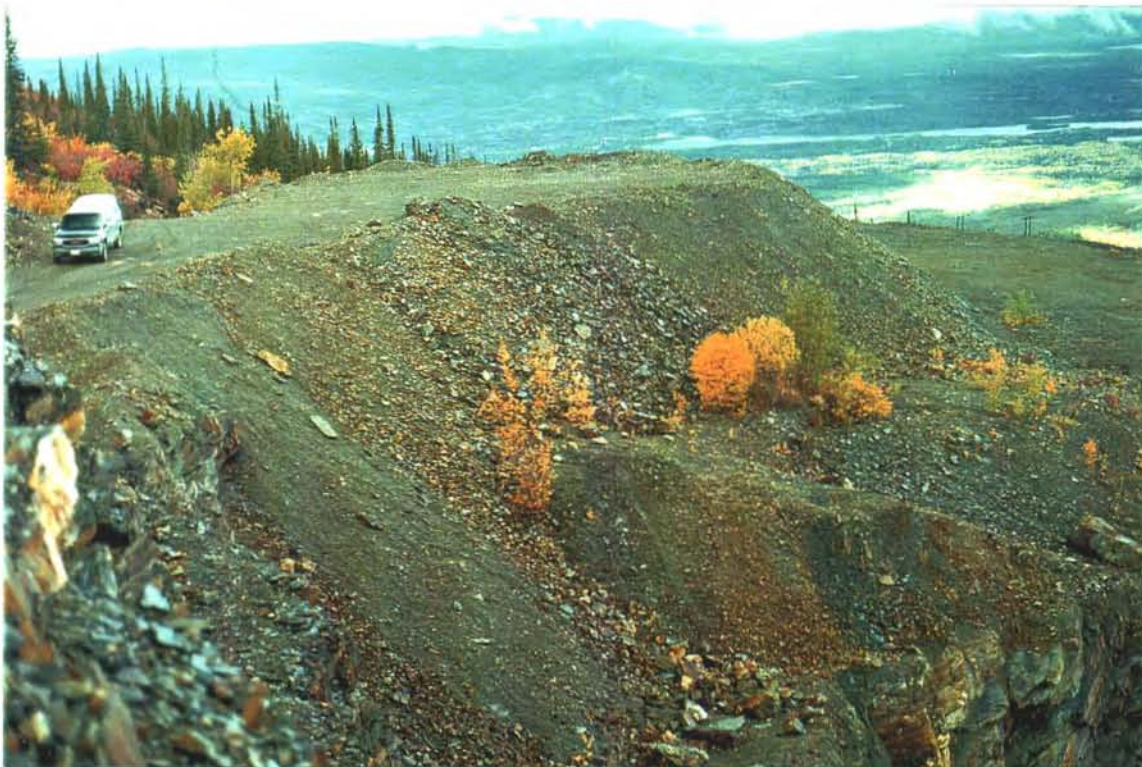
Waste rock was deposited outside the 100, 200, and 300 level adits, and adjacent to the open pits. Waste rock associated with the open pits is generally composed of quartzite and schist showing little mineralization (Photo 11-10). Waste from the underground mine is generally composed of similar material, but has more alteration and mineralization. The amount of waste at each adit and pit are provided below (UKHM, 1996).

Photo 11-10. Waste rock dump located adjacent to the Sime #4 open pit (lower right-hand corner of photograph).

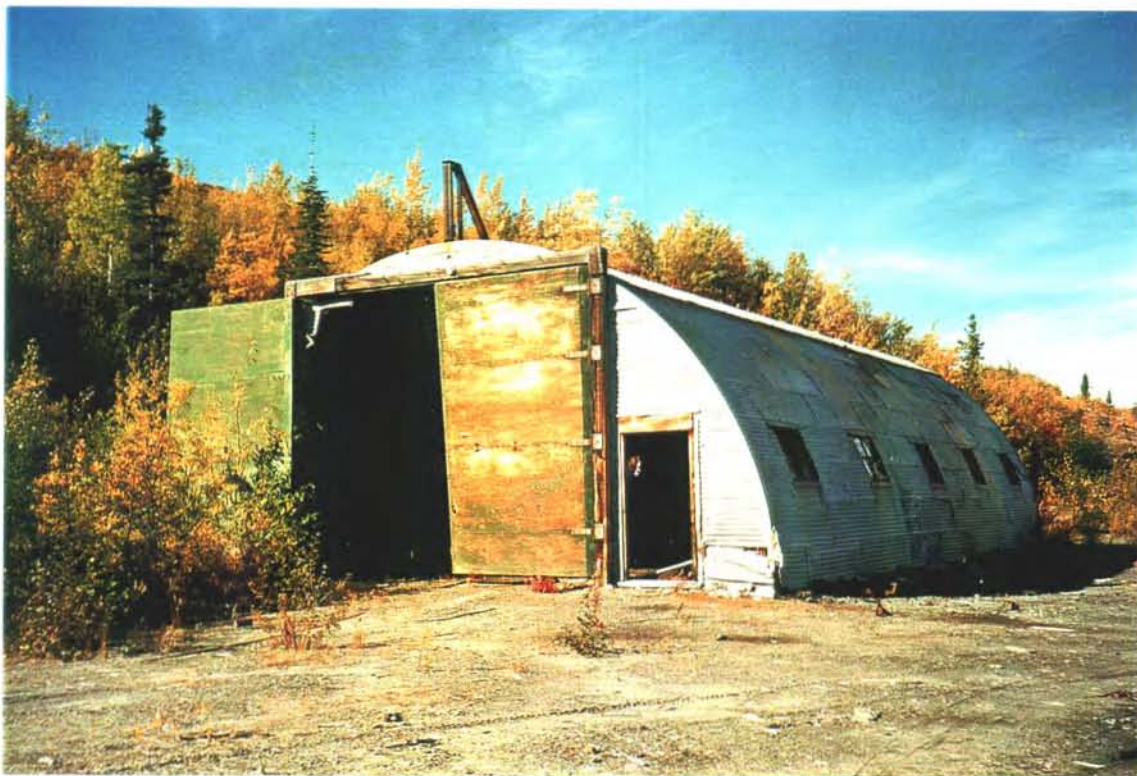
Foundation: concrete; heavily stained (hydrocarbon odour)

Surrounding area: Hydrocarbon staining was found adjacent to the north and west walls of the building. The northern stain measures 8.5 m x 2 m x 3 cm deep, and the contaminant appears to have leaked from inside between concrete and building frame. The west stain measures 6 m x 3.5 m x 3 cm deep and appears to have leaked from an above ground storage tank.

Photo 11-11. Building 11A - Quonset Warehouse, looking northwest. Located near the 300 level adit.

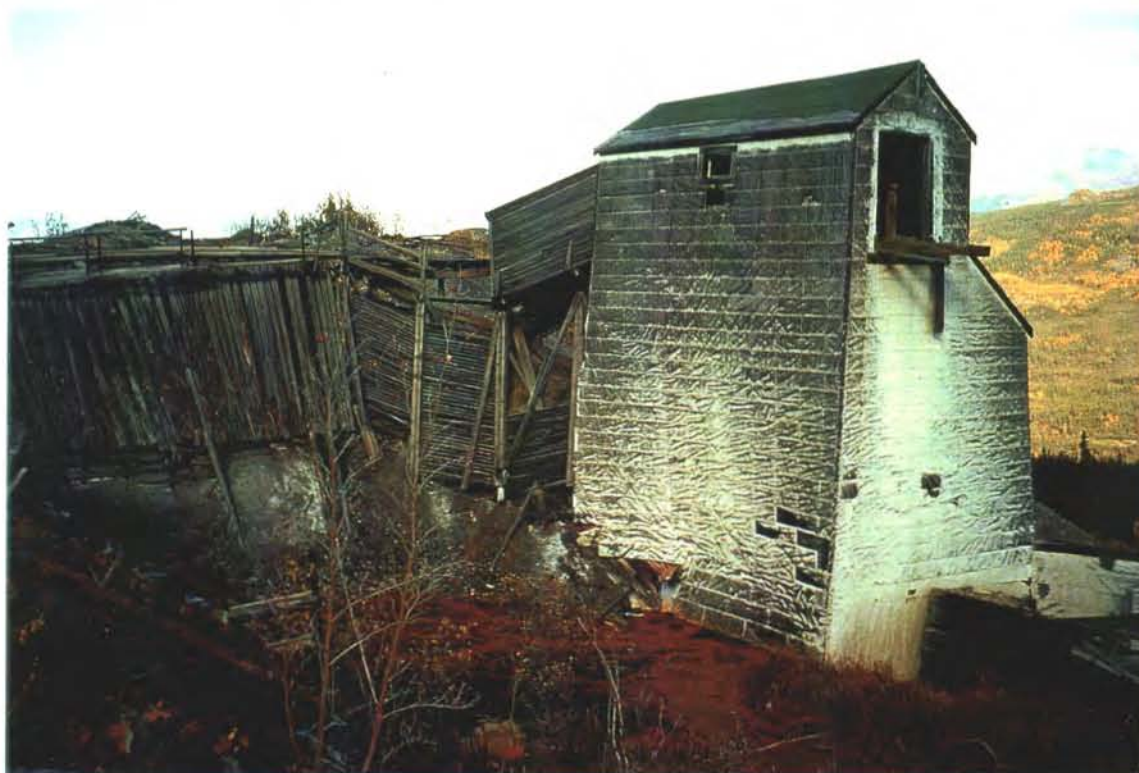
This building is very unstable and poses a hazard, particularly since there is good access to the site.

Condition: Poor. Very unstable as building is leaning downhill.

Photo 11-12. Building 11B - Loading Elevator, looking northwest. The building is located on the waste rock dump outside the 300 level adit. Note how the building is leaning away from the waste dump (also see Photo 11-14).

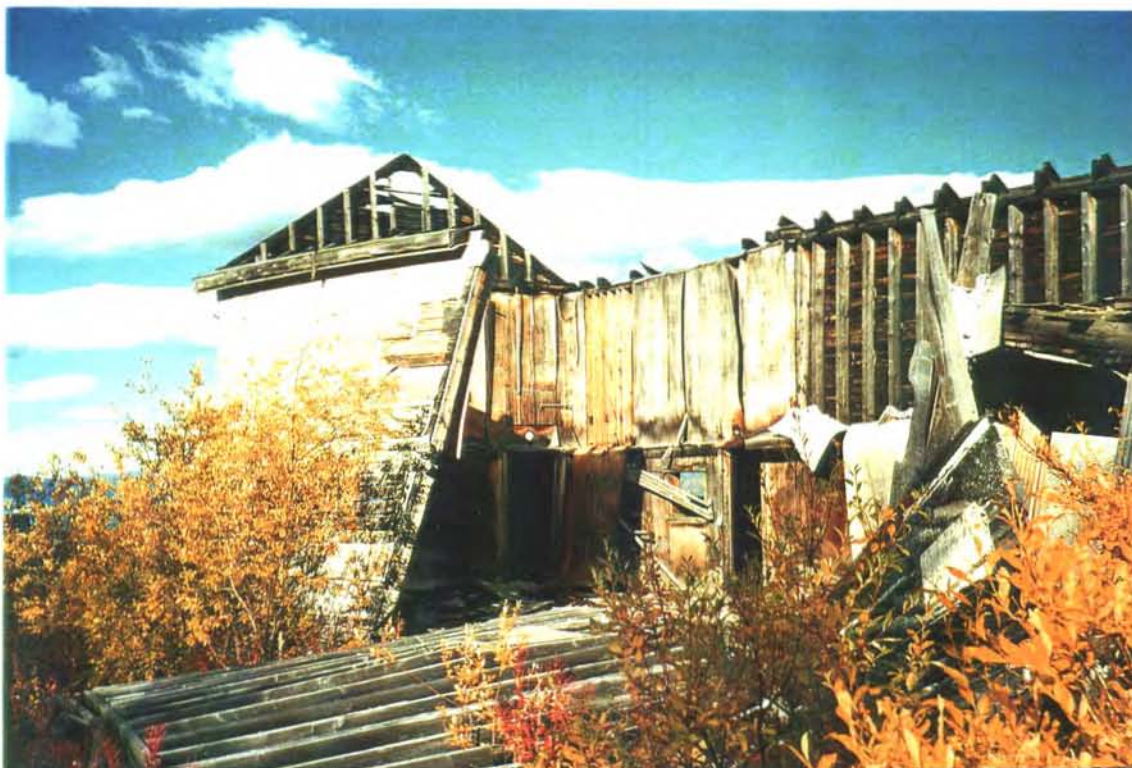
Condition: Poor. Roof has collapsed.

Photo 11-13. Building 11G, showing the remaining walls.

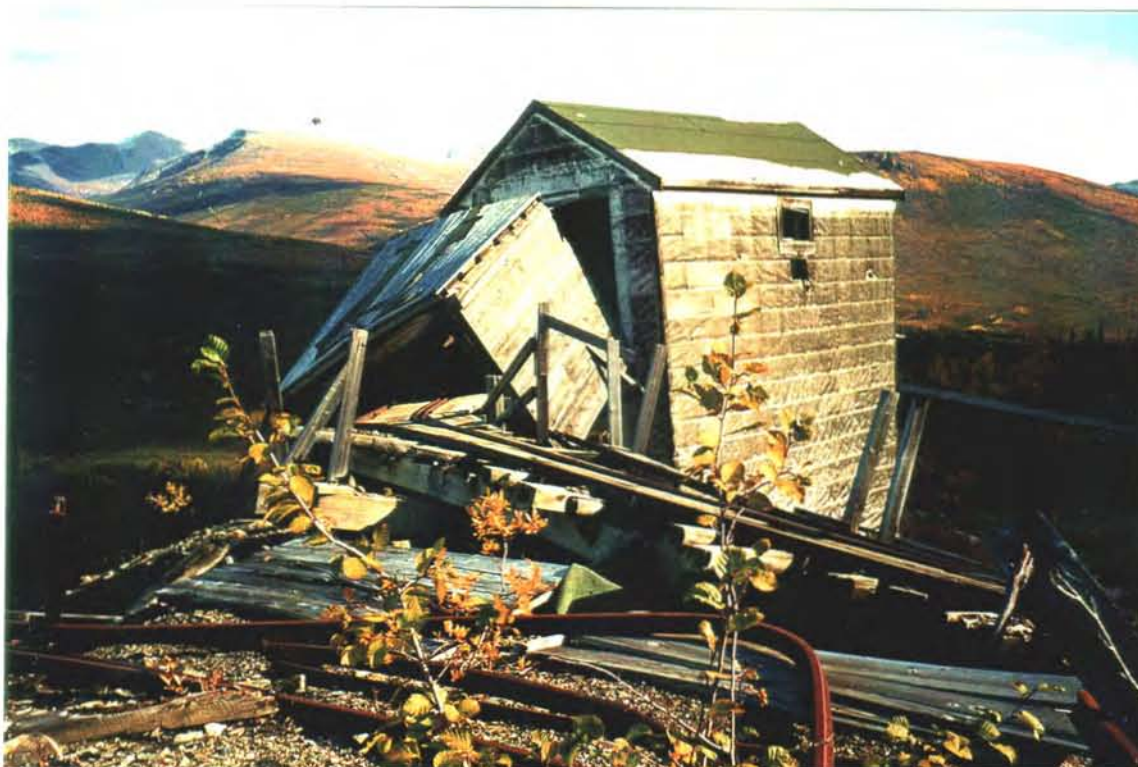
There are tracks running out of adit (Photo 11-4) and along side the loading elevator (Photo 11-14).

Photo 11-14. The top of the Loading Elevator, looking northeast. There is wooden boards and discarded rails out side this building.

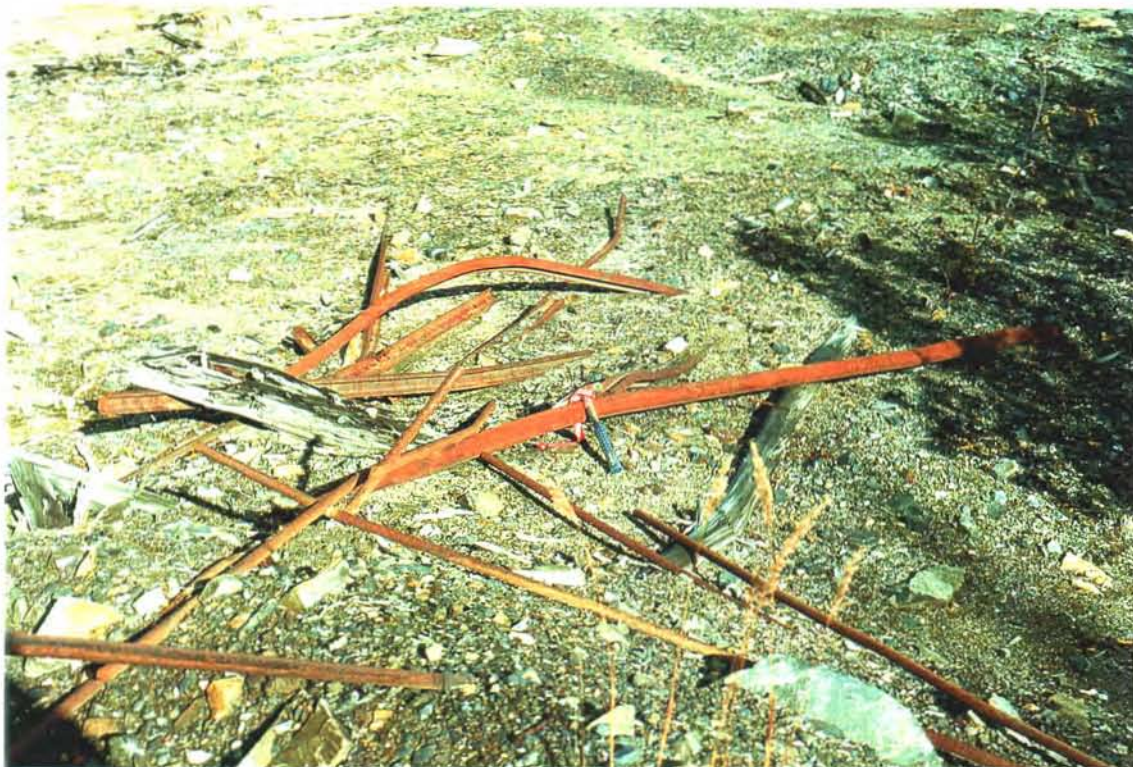
Fabrication: Approximately 30 m of steel rail attached to the wooden ties runs out of adit (Photo 11-6). More rail and other metal and wood debris are deposited on platform outside adit (Photo 11-15).

Some rail and metal piping, and abundant wood debris has been deposited outside this adit (Photos 11-6 & 11-15).

Photo 11-15. Debris outside the 100 Level adit.

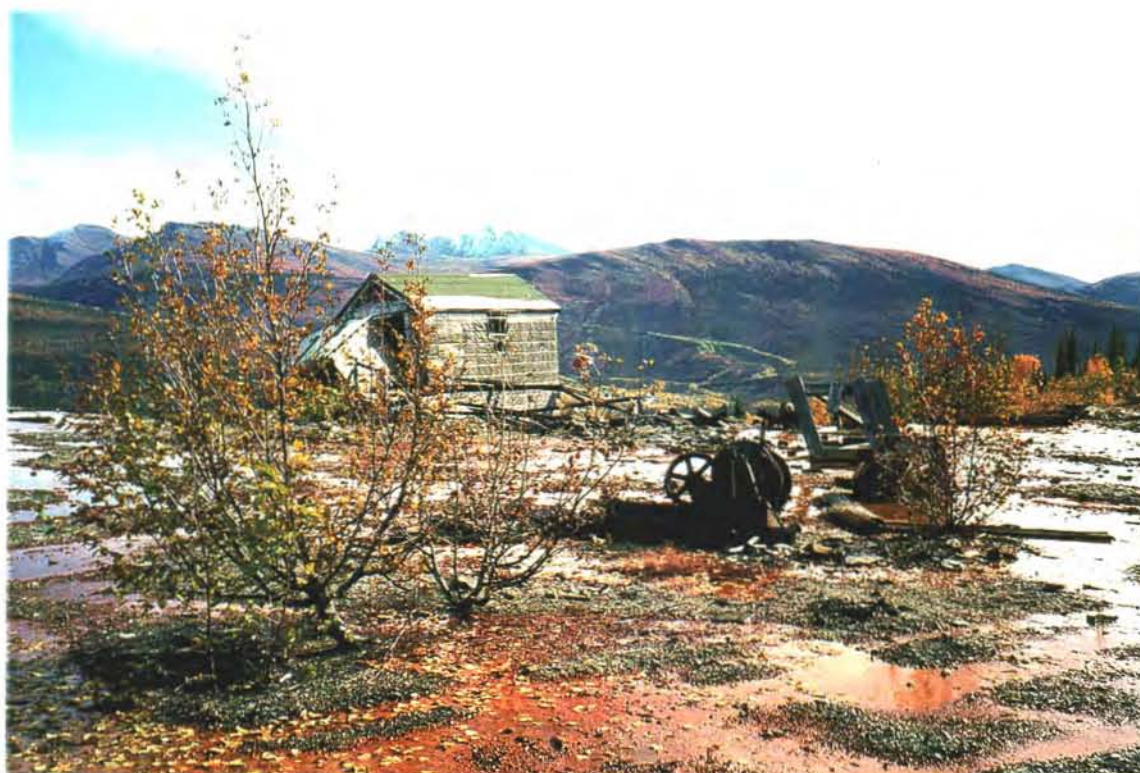
Most debris is at the 300 level adit. There is wood debris as well as rail and track immediately outside the adit (Photo 11-4) and on the top of the waste dump (Photo 11-16).

Photo 11-16. Debris outside the 300 Level adit, on the dump surface.

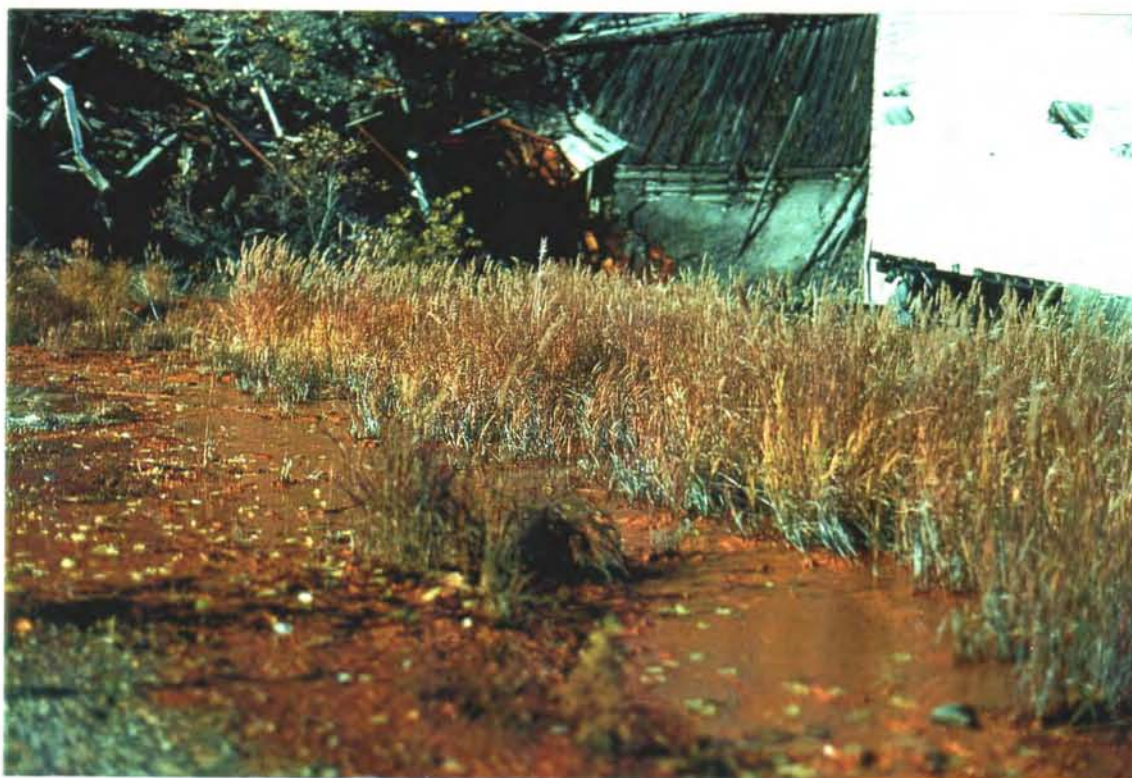
A large pile of mainly metal debris is located adjacent to the loading elevator (Photo 11-17). Additional debris is located below the waste dump at the 300 level adit, consisting of several empty, rusted barrels, miscellaneous metal debris and tar paper from buildings and large wooden cable spools (Photo 11-18).

Photo 11-17. Debris outside the 300 Level adit, adjacent to the Loading Elevator.

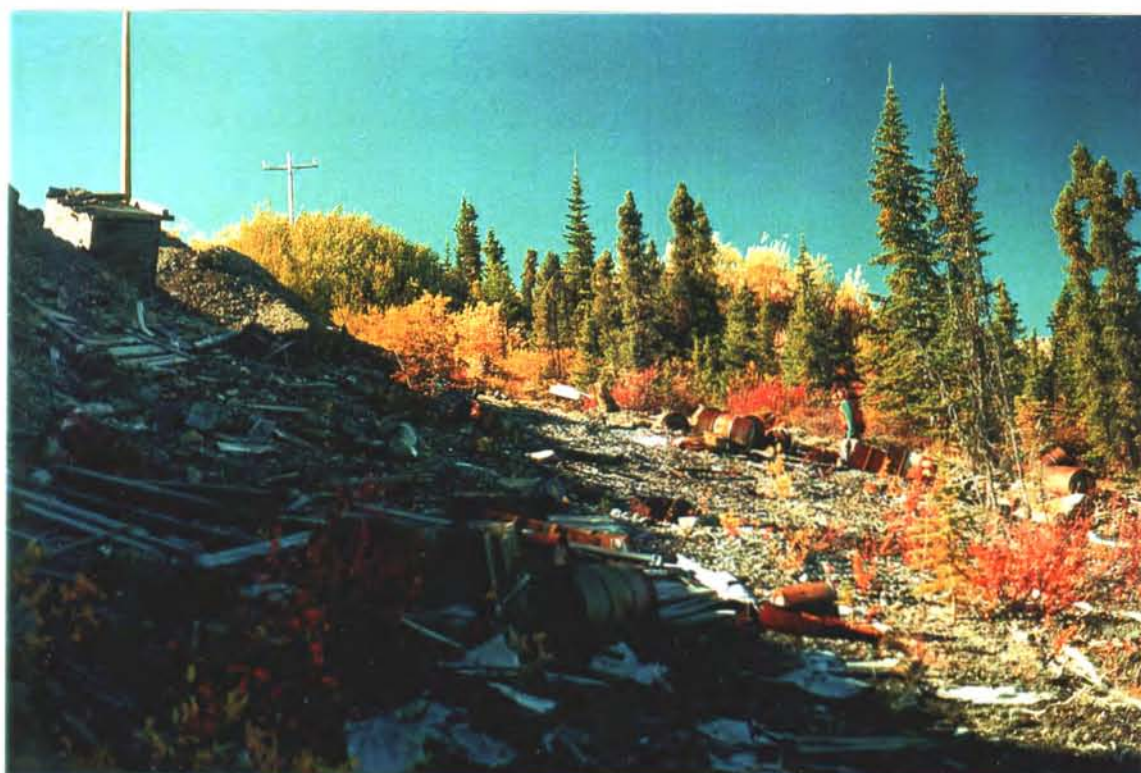
Photo 11-18. Debris at the bottom of the 300 level waste rock

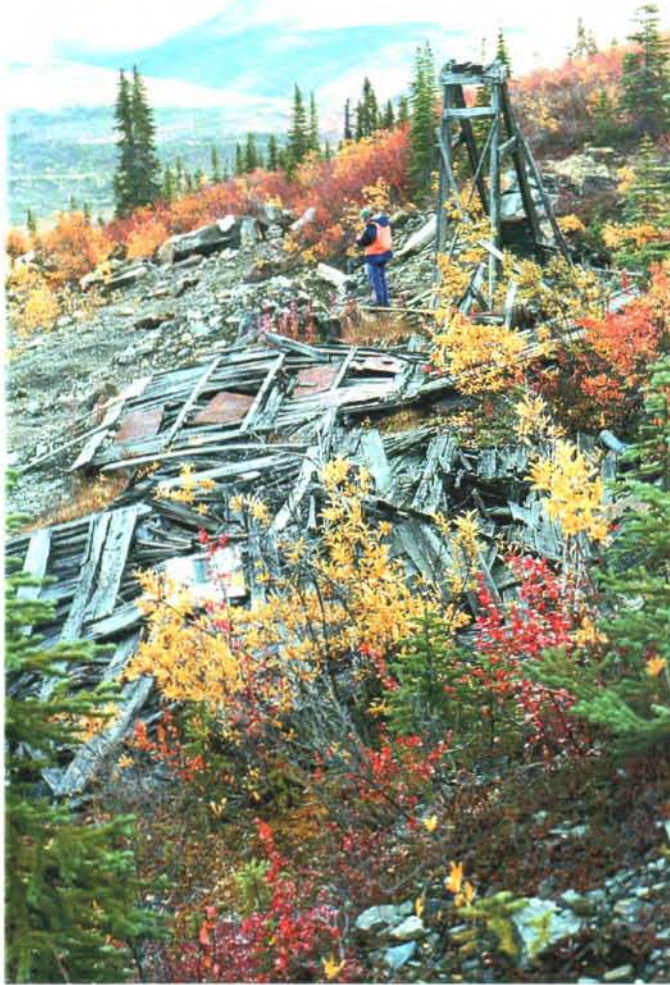
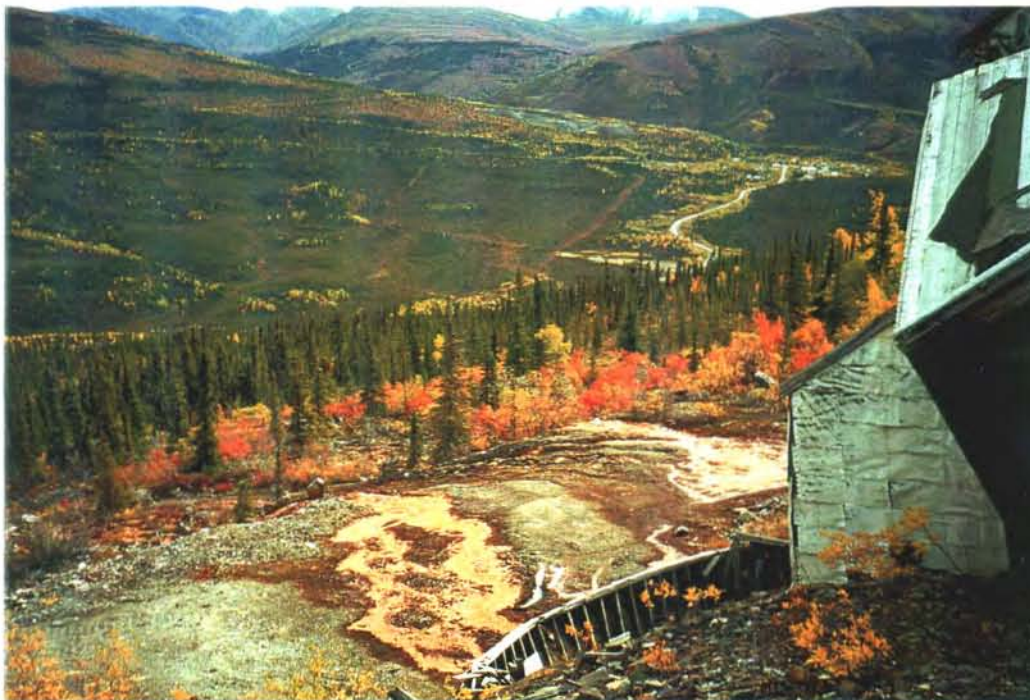
Photo 11-20. Drainage from the 300 level adit as it flows past the Loading Elevator and down below the mine site.
