KENO VALLEY/DUBLIN GULCH ENVIRONMENTAL BASELINE ASSESSMENT

VOLUME II: Keno Valley Sites #1 to #20

Prepared for
Waste Management Program
Indian and Northern Affairs Canada

By
Environmental Services
Public Works and Government Services Canada

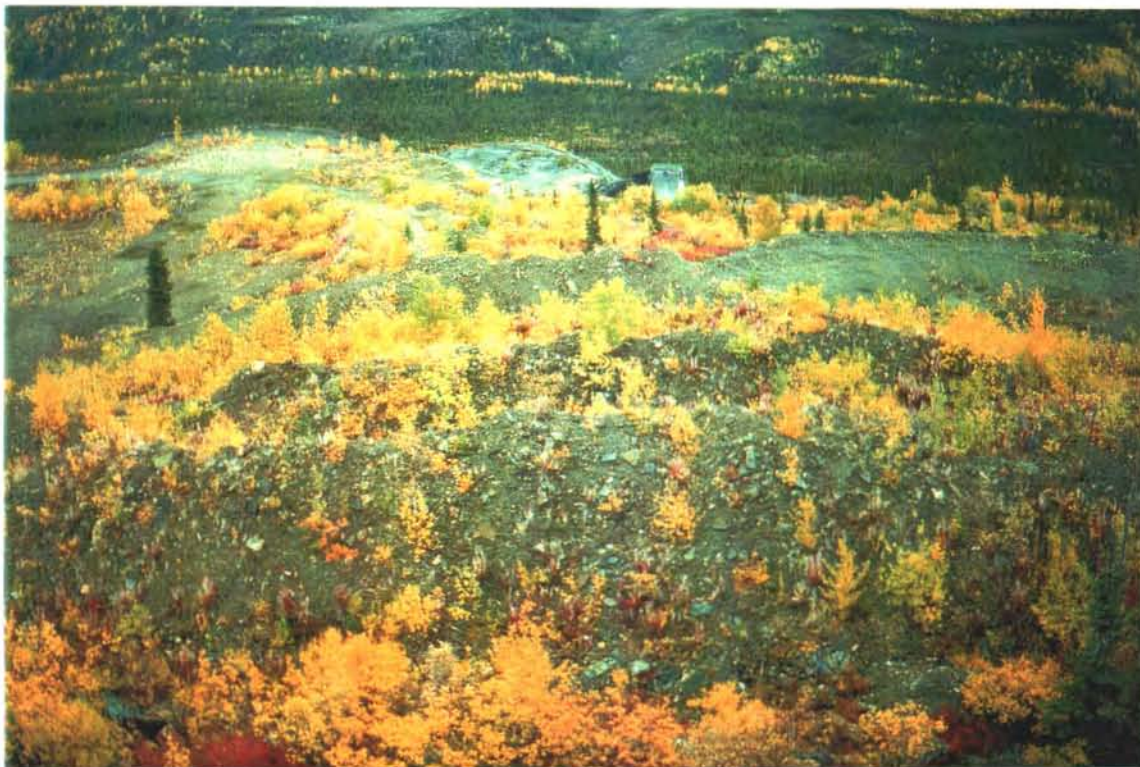
Many of the waste rock piles are beginning to revegetate naturally with small bushes and some grasses. This is particularly true of the waste piles surrounding the open pits (Photo 11-21). Grasses are also growing in the drainage from the 300 level adit.

Photo 11-21. Natural revegetation of the some of the waste rock piles. Revegetation is more extensive in areas such as this where the material has a range of grain sizes. Contrast this with Photo 11-10 where there has been less revegetation.

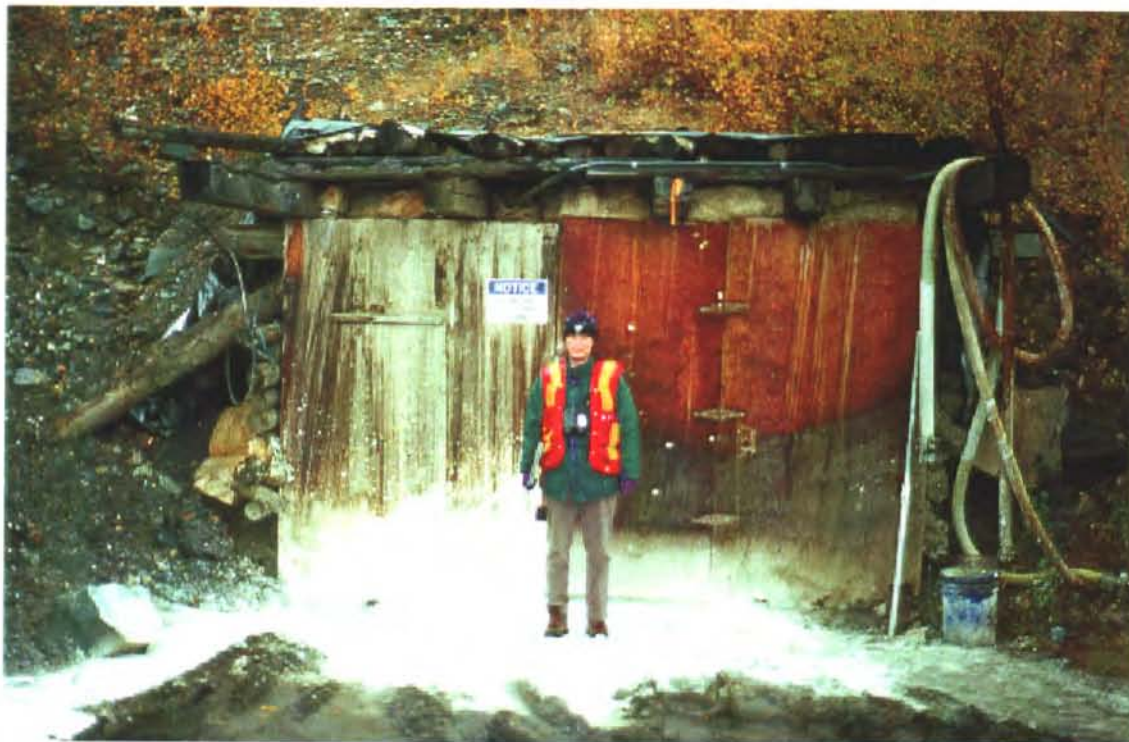
Photo 12-1: Galkeno 900 portal with spilt lime out front, the water treatment facility is located within the adit. (Azimuth 270°)

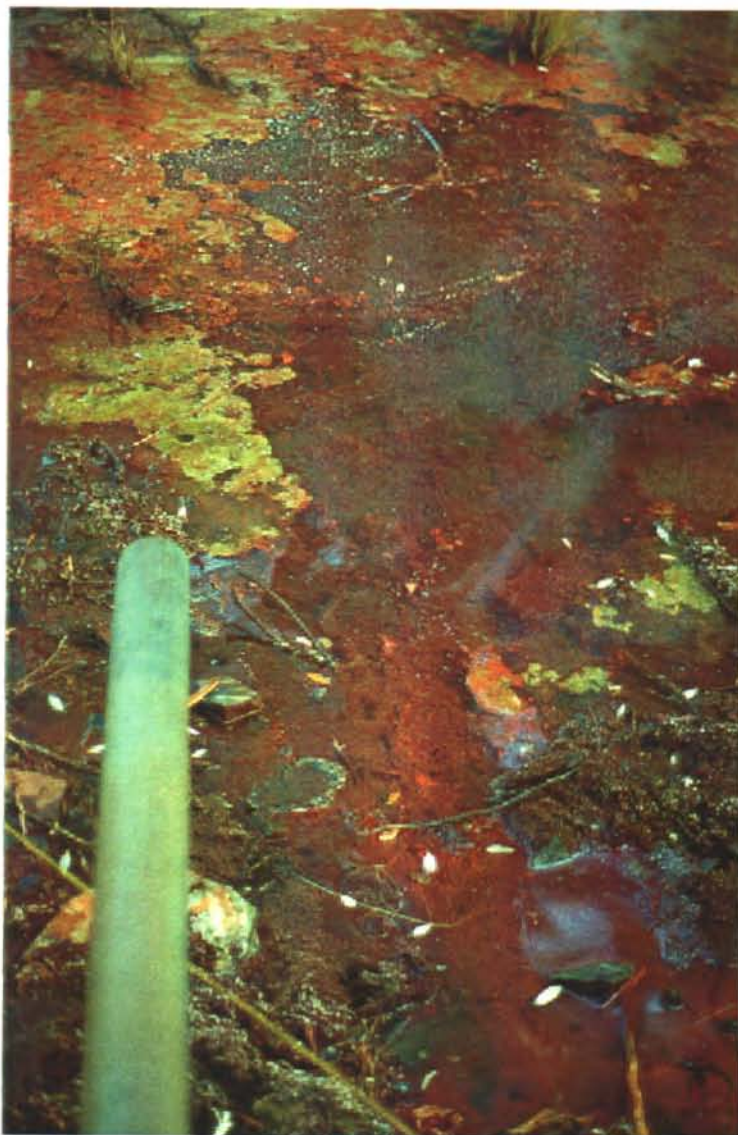
Photo 12-12: Pipe leading to the westernmost old settling pond.
Note the iron precipitate in the water. (Azimuth 090°)

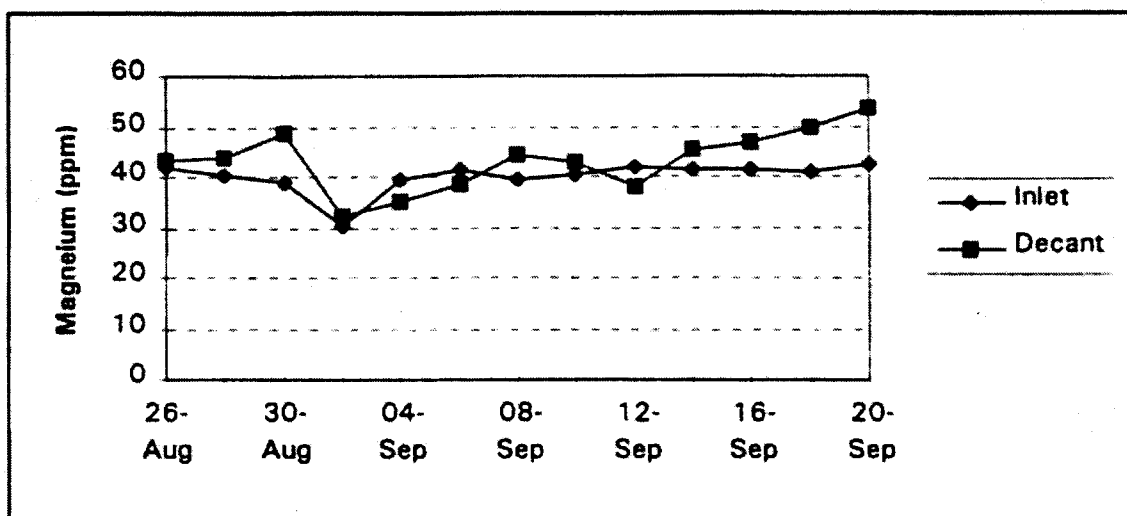
A noticeable decrease in inflow concentrations of zinc occurred on September 2. This can be explained by noting a similar decrease in magnesium concentrations in the wetland inflow and decant (Figure 8)⁵. All other element concentrations decreased similarly in the inflow and decant

(e.g., Figure 9 to Figure 12). Assuming that magnesium behaves as a conservative tracer, these data suggest that heavy rainfall diluted the mine water. A dilution factor was calculated and applied to the inflow and decant zinc concentrations on September 2 (Figure 7). This correction shows somewhat more readily that zinc concentrations were leveling off at approximately 4 ppm before September 8.

Figure 6. Magnesium concentrations in the inflow and decant of the Galkeno constructed wetland.

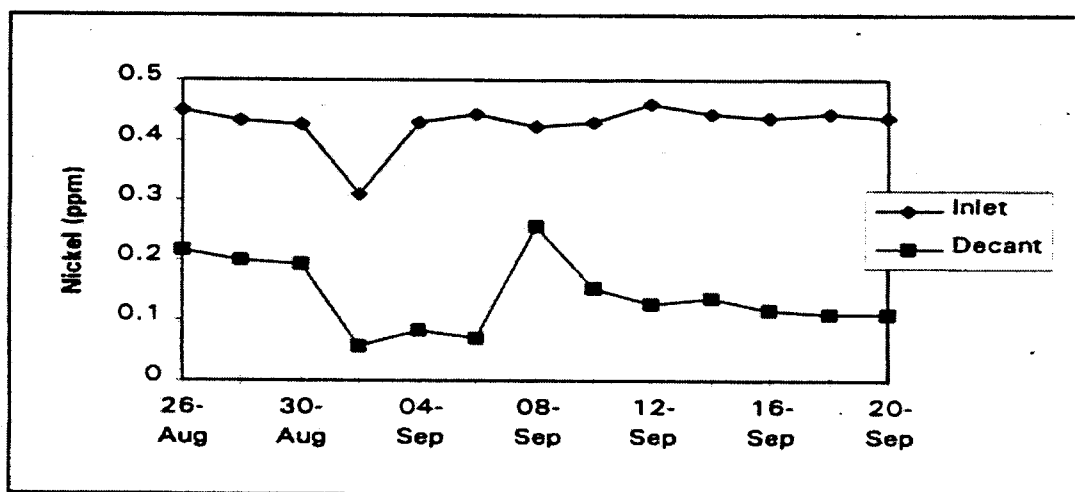
Nickel was also removed in the wetland (Figure 9). Inflow concentrations remained nearly constant at approximately 0.44 ppm, whereas decant concentrations appeared to stabilize at approximately 0.1 mg/L. Interestingly, the same pattern as for zinc was observed for nickel concentration in the decant: they leveled off to below 0.1 ppm until September 8, whereupon they suddenly increased. Subsequently, decant concentrations leveled off at slightly more than 0.1 ppm.

Figure 7. Nickel concentrations in inflow and decant of the Galkeno constructed wetland.

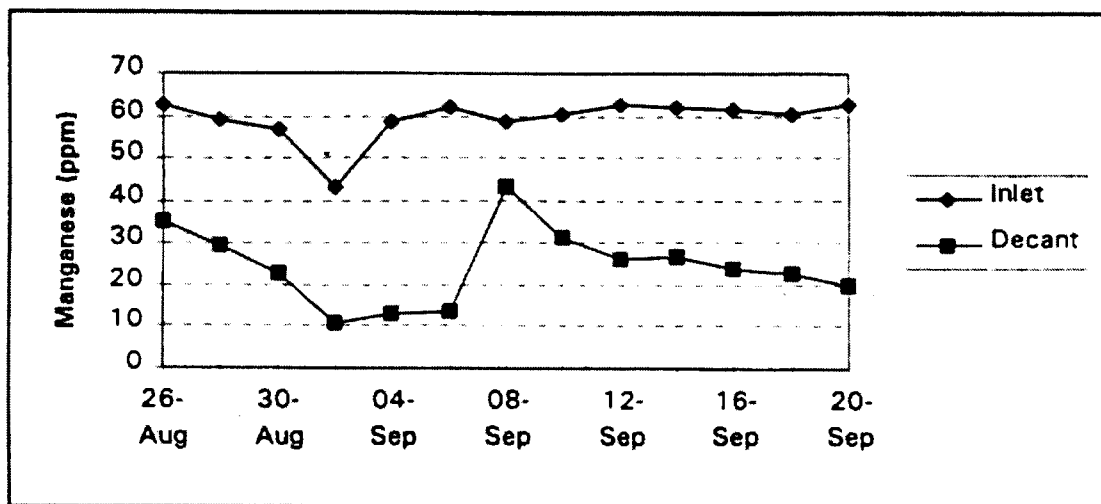
Manganese concentrations (total metal) also decreased in the wetland (Figure 10). Manganese concentrations in the decant also showed the same pattern as zinc concentrations. That is, they initially decreased to about 13 ppm until early September, whereupon they increased to a peak on September 8, leveling to about 20 ppm by the end of the sampling period.

Figure 8. Manganese concentrations in inflow and decant of the Galkeno constructed

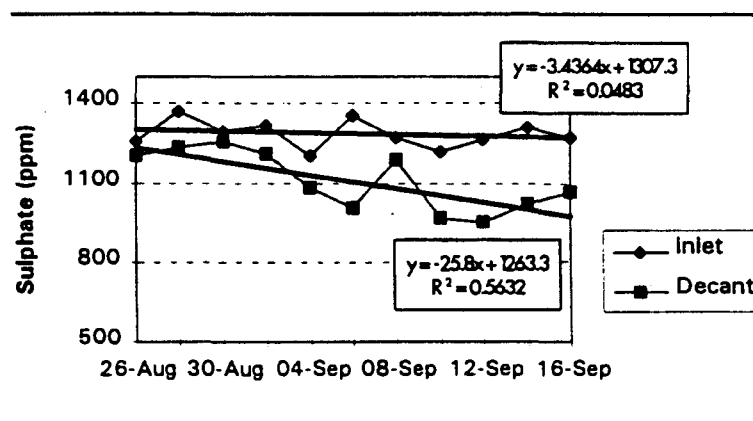
Figure 9. Sulphate concentrations in inflow and decant of the Galkeno constructed wetland.

1. Sulphate concentrations in the decant were gradually decreasing during the test period, indicating that insoluble sulphides (or, less likely, sulphur) were increasingly being retained in the wetland. This indicates that steady state conditions had *not* yet been attained, otherwise, lower, but *constant* sulphate concentrations would be expected in the decant.
2. A sudden jump of the decant sulphate concentrations observed on September 8. Such an

The latter observation provides a reasonable explanation for the jump in zinc and manganese concentrations in the decant observed on September 8. These metals were probably retained as sulphides in sediments and they became reoxidized — and redissolved — when the sediments were stirred up.

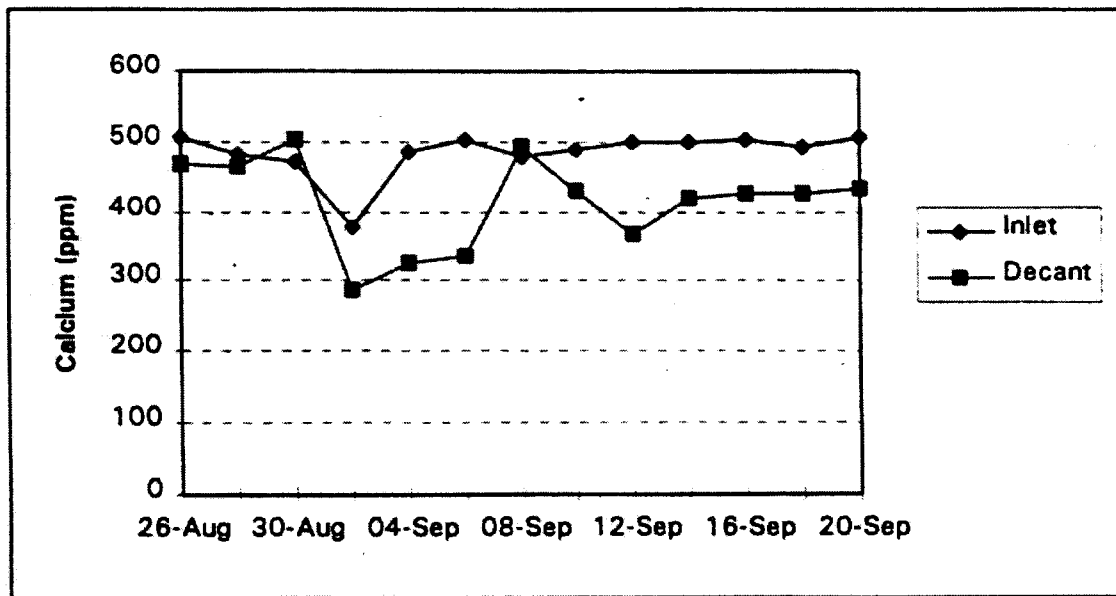
Figure 10. Calcium concentrations in inflow and decant the Galkeno constructed wetland.

These data not only confirm that the Galkeno constructed wetland functioned similarly to the natural wetlands, they indicate that a full-scale wetland treatment system is likely to store a tremendous buffering capacity in sediments. Such a buffering capacity may be important in mitigating potential increases in the acidity of the mine drainage being treated.

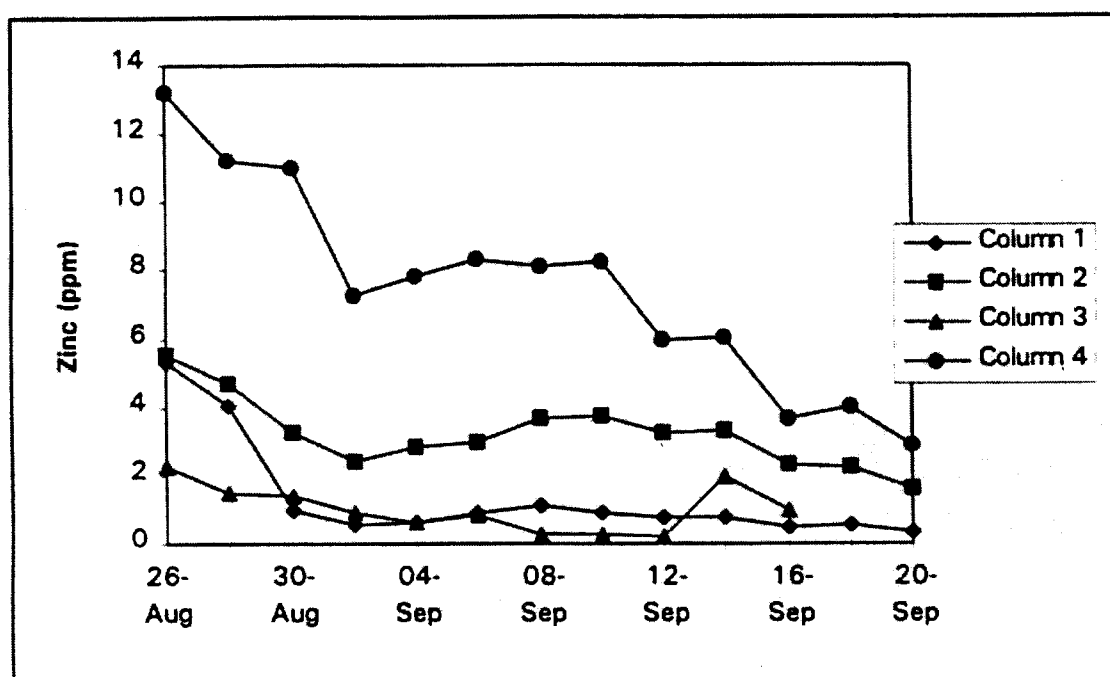
Figure 11. Zinc removal in the Galkeno constructed wetland *in situ* microcosms.

Data from columns 5 and 6 were lost because they were damaged midway through the study. In addition, the data from Column 2 are suspect, because of the increase in zinc concentrations in early September, which persisted until the end of the study. Results from these columns were removed from the data set, and only the data from Columns 1, 3, and 4 were considered further.

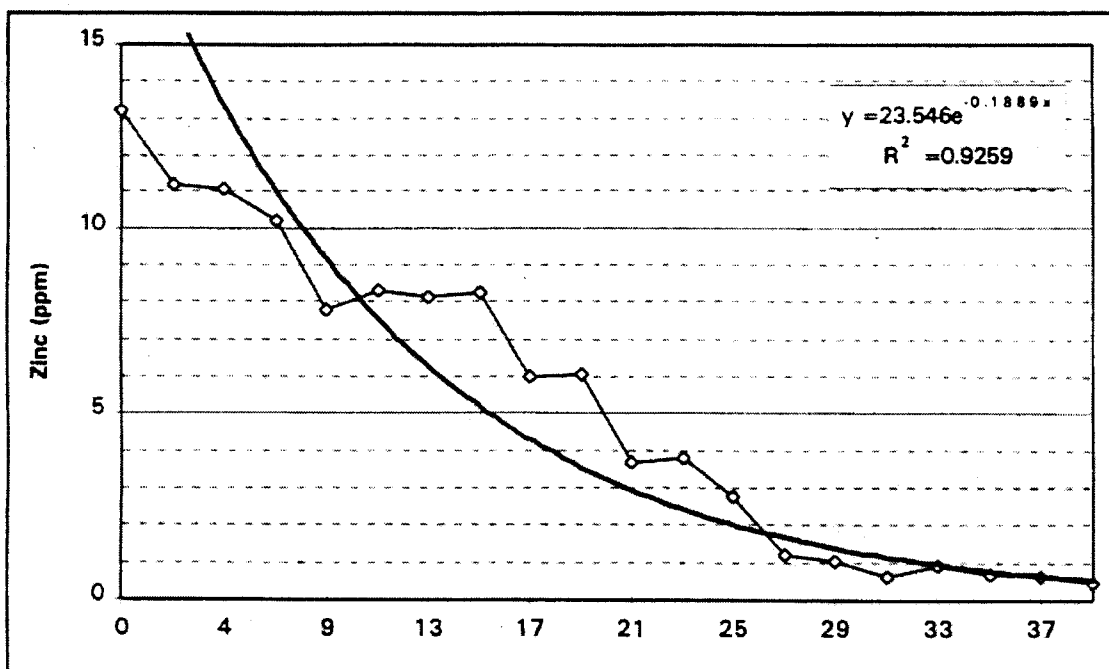
Figure 12. Combined data from Columns 1, 3, and 4 for zinc removal.

Despite the different waters used in the columns, the data obtained from combining the available data set produced a curve which fitted very well with an exponentially-decaying trendline ($R^2 = 0.93$). Applying the same removal rate to the zinc -concentration data from the Galkeno natural wetland (Section 3.1.3), the predicted retention time should be approximately 14 days vs an retention time of 11.4 days estimated from field data. This close agreement suggests that the above rate of zinc removal is reasonable. Applying this removal rate to the data from the Galkeno constructed wetland⁹ indicated that it had a retention time of approximately 14.7 days vs a nominal retention time of 19.3 days. This is again in reasonably

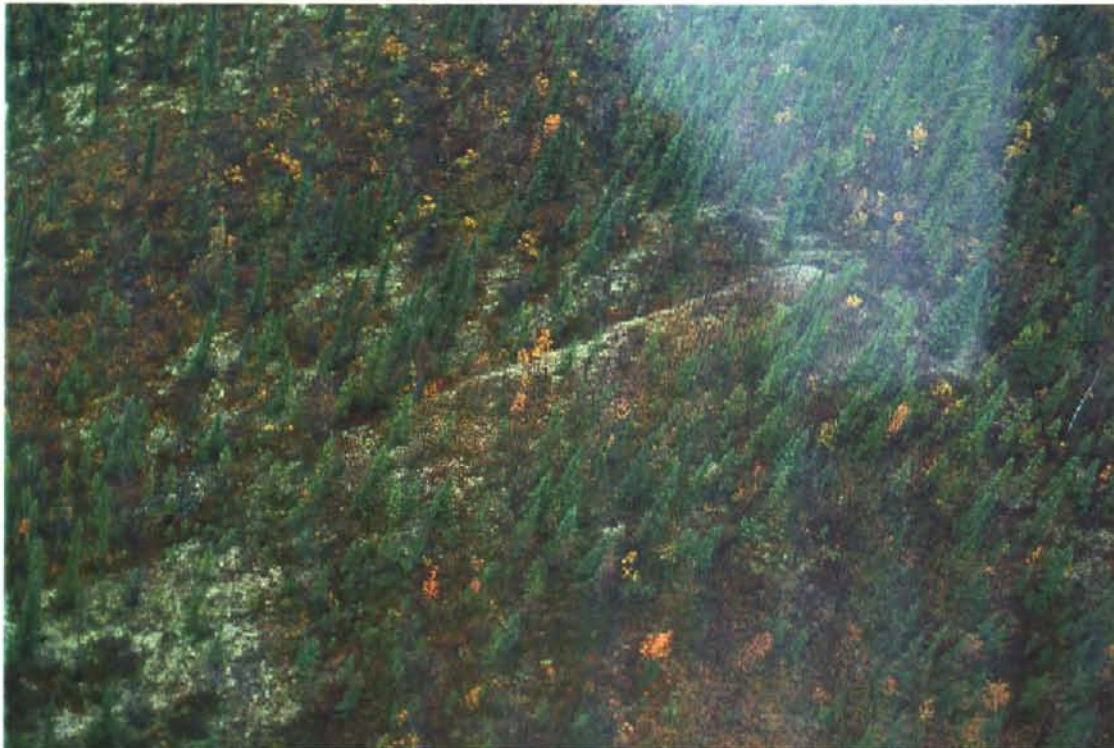
Condition: There is no evidence of slumping of the trench walls, which were stable at the time of the site visit.

Photo 13-1: Aerial shot of trench #1. (Azimuth 180°)

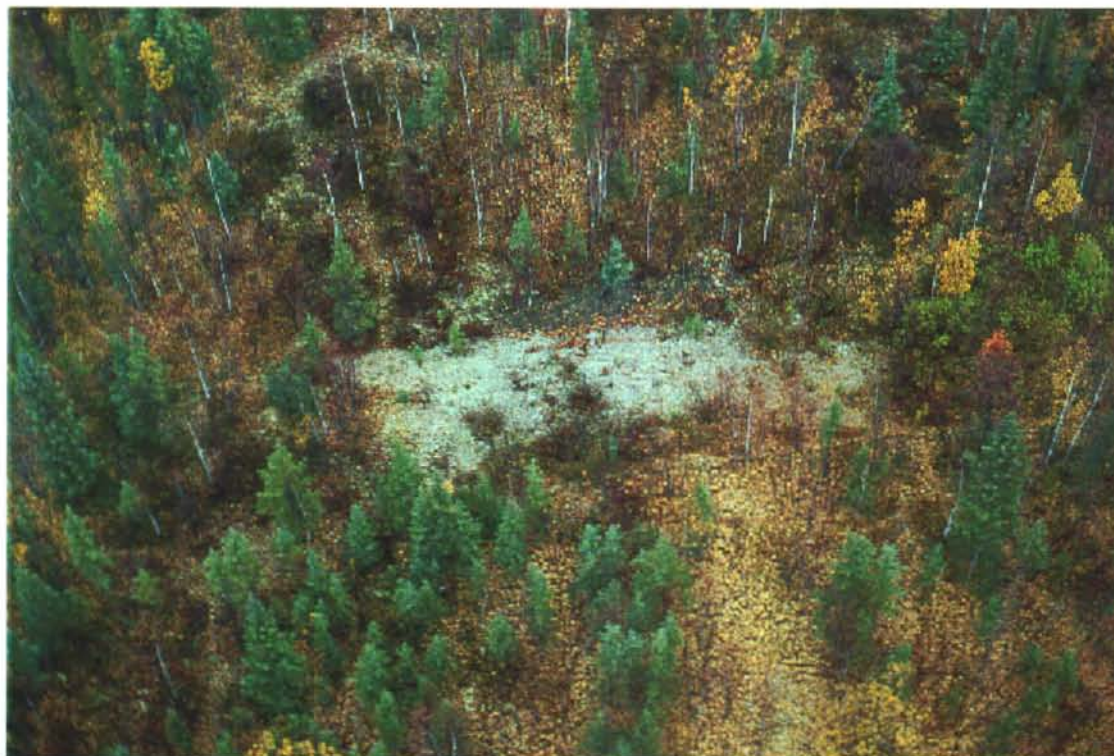
Condition: There is no evidence of slumping of the trench walls.

Photo 13-2: Aerial shot of trench #2. (Azimuth 280°)

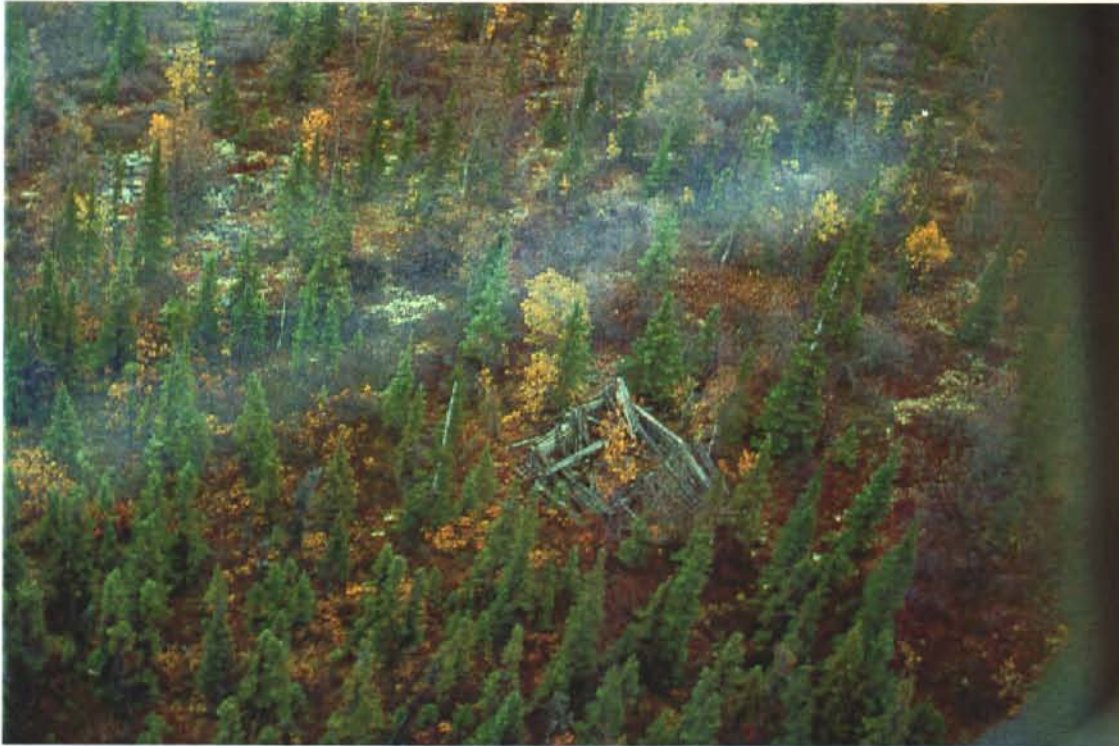
Photo 13-3: Aerial shot of the collapsed log cabin. (Azimuth 260°)

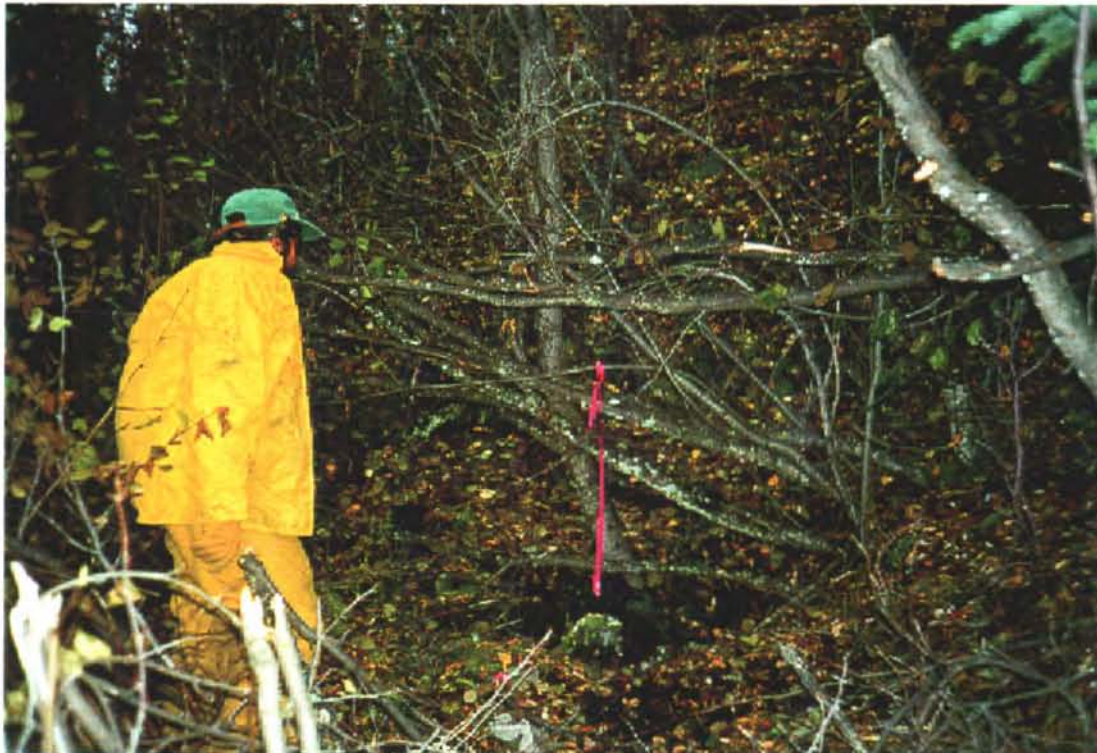
Condition: All of the shafts are partially to completely collapsed, and the northernmost shaft has 40 cm of standing water covering the fill material.

Accessibility: The shafts are only about 70m up a gentle slope from the Silver Trail Highway, but access is impeded by very dense bush. The shafts are not likely to be a hazard due to small size, collapse of material into the shafts, shallow water in the shafts, trees growing around the shafts, and old timbers and ladders projecting out of the shafts.

Photo 14-1: Lower shaft; opening located below flagging. (Azimuth 180°)

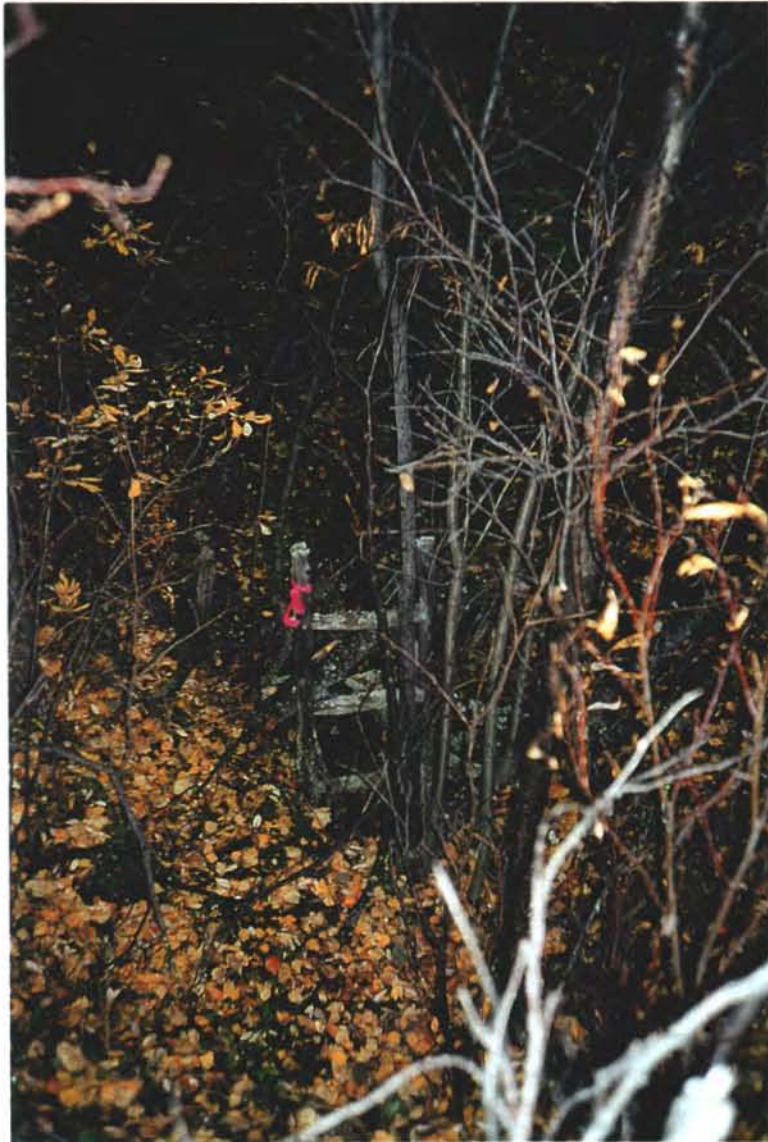
Photo 14-2: Lower-middle shaft; note ladder extending out of shaft opening. (Azimuth 040°)

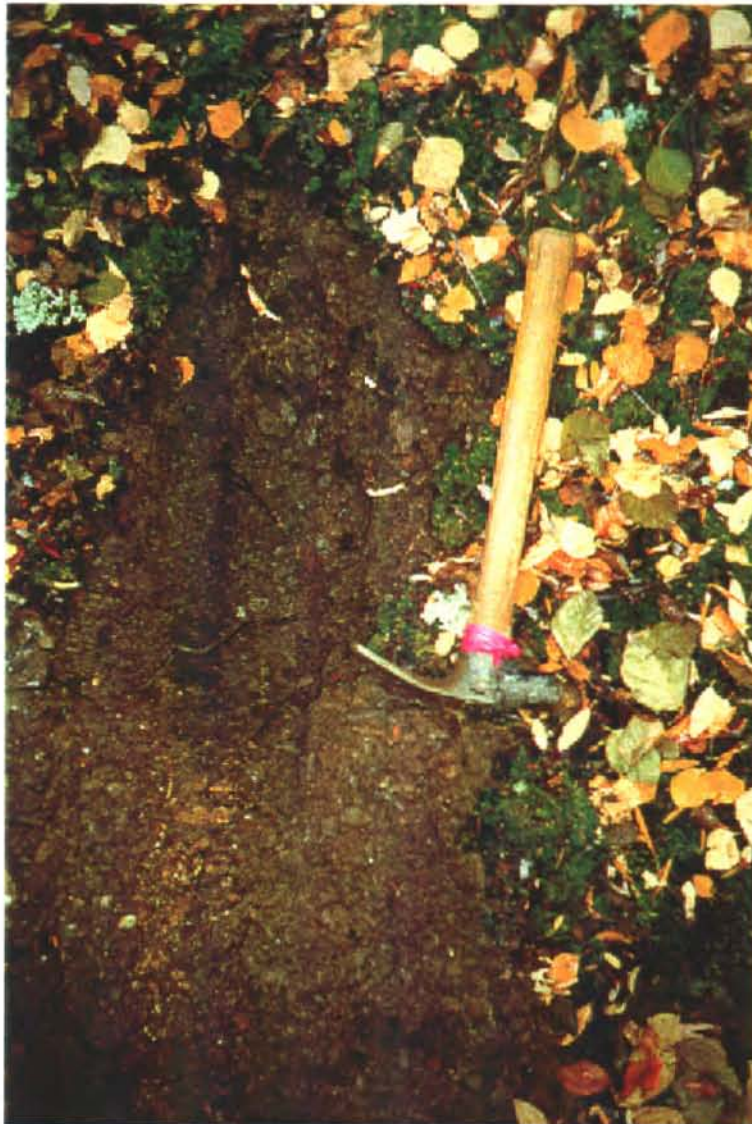
Photo 14-3: Test pit in rock dump for lower-middle shaft.

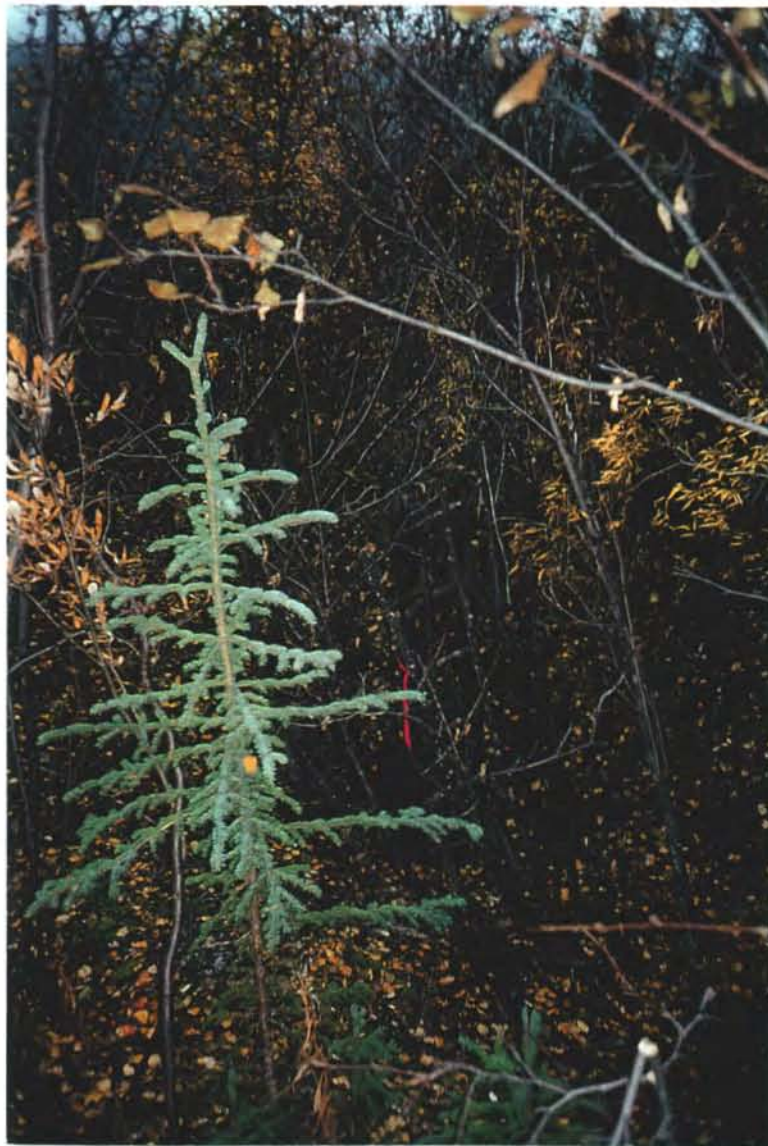
Photo 14-4: Upper-middle shaft and rock dump area; note flagging on ladder extending from shaft opening and mapper standing at end of rock dump. (Azimuth 120°)

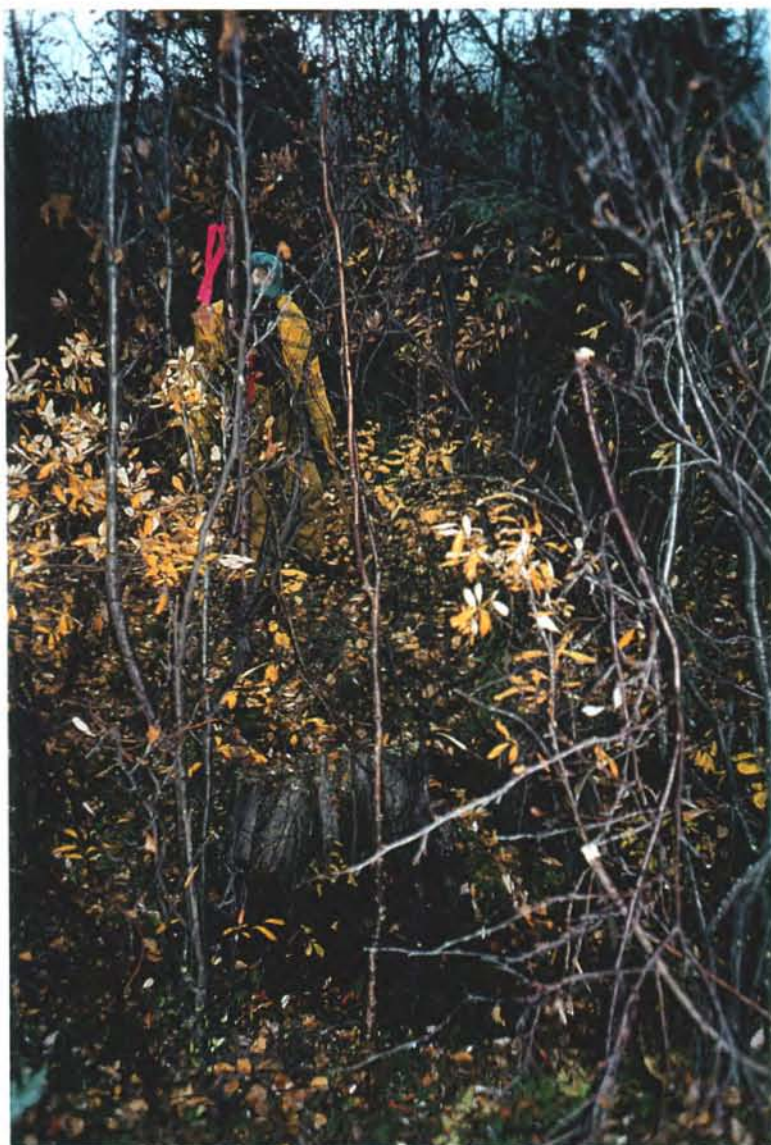
Photo 14-5: Upper shaft site. (Azimuth 050°)

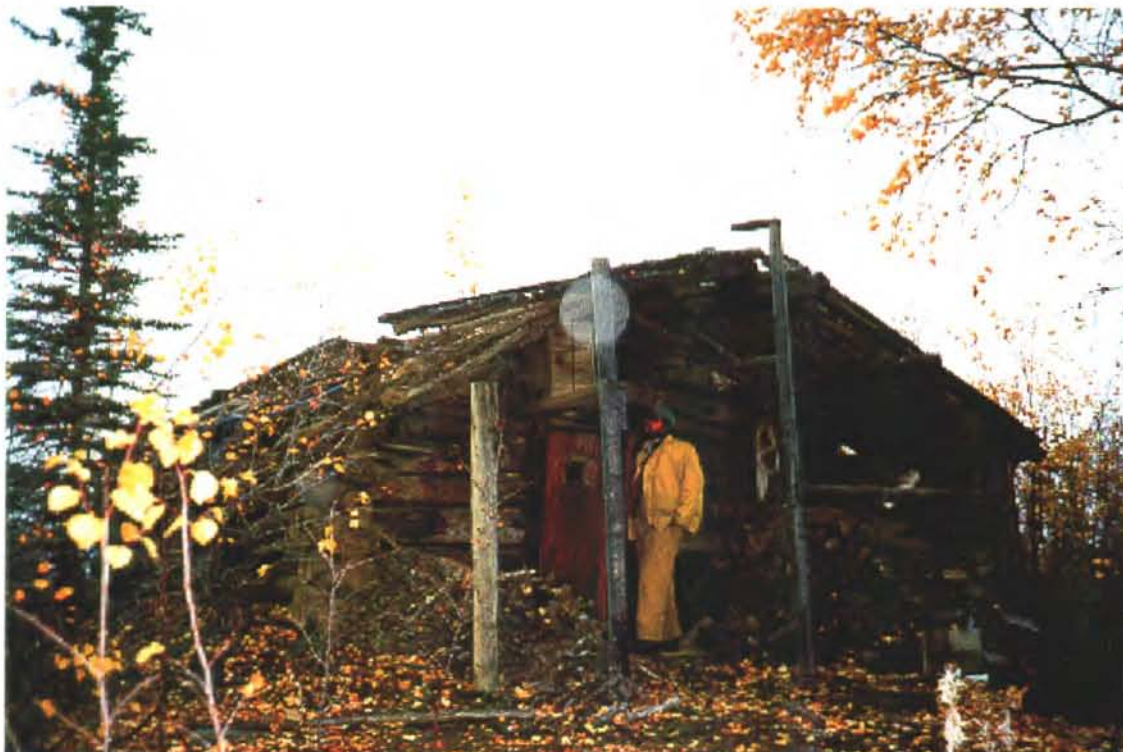
Photo 14-6: Recent cabin (early 1980's); note collapsed sod roof structure. (Azimuth 340°)

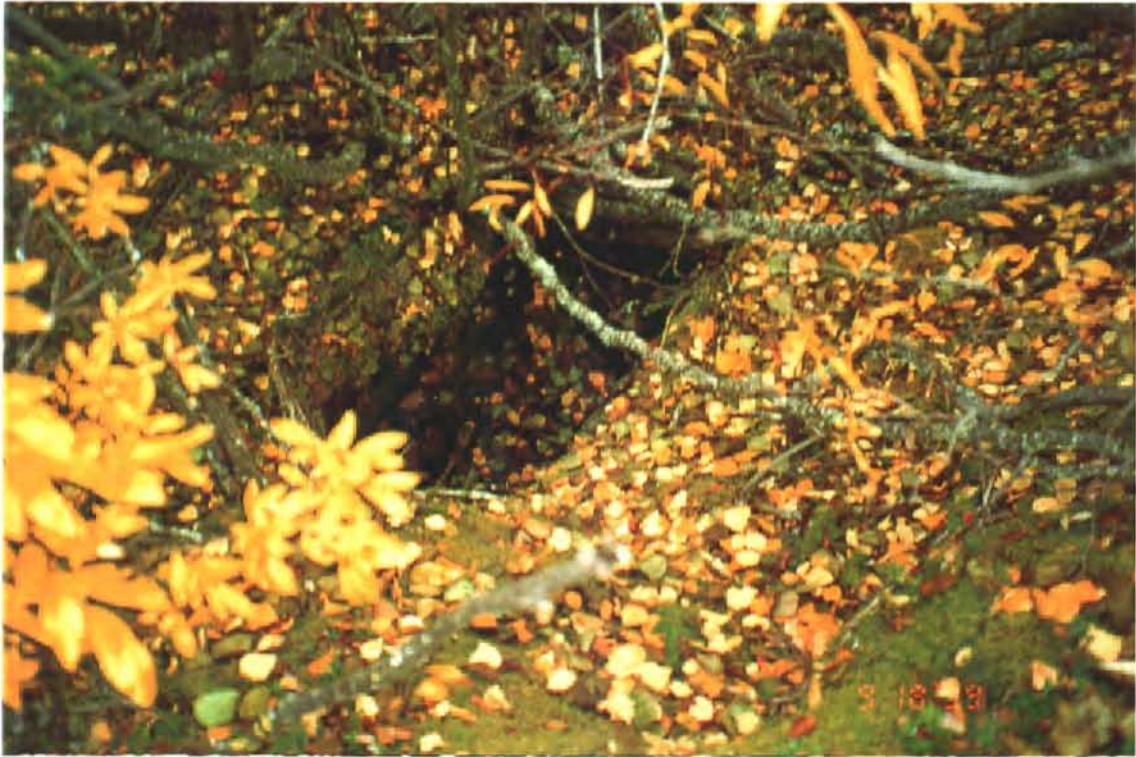
Condition: Organic material has slumped into hole. Quite stable due to water filling hole.

Photo 15-1: Remains of shaft #1. Note water level just below grade.

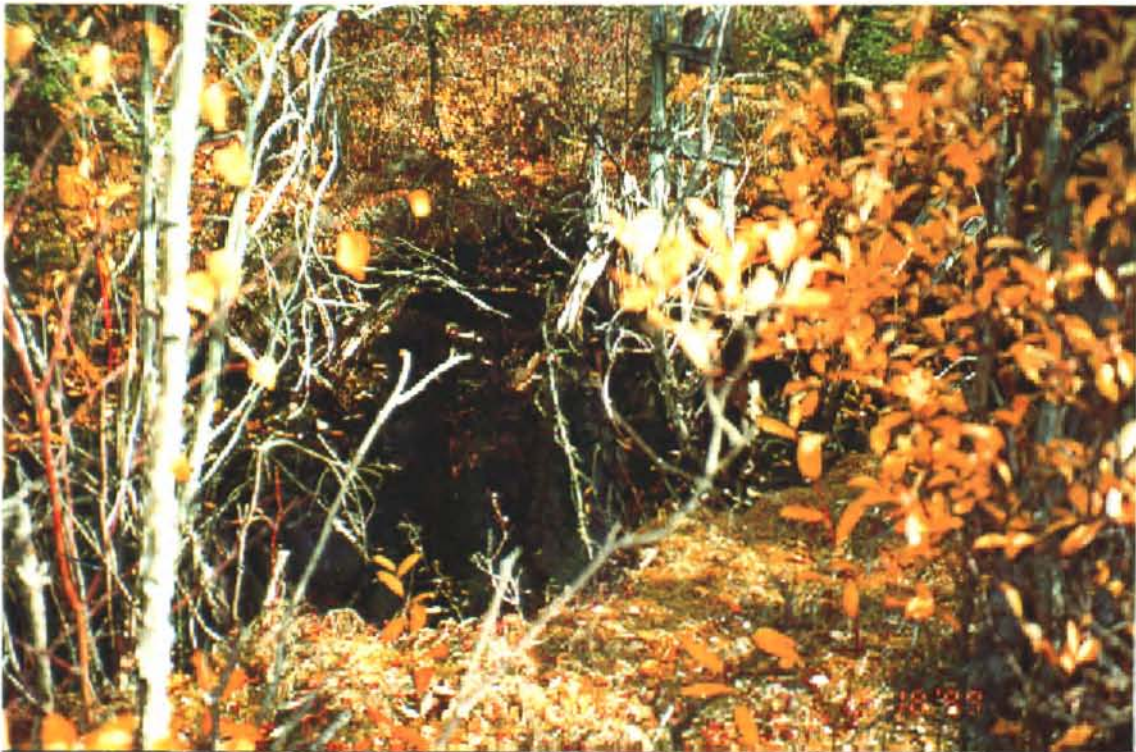
Collapsing timbered shaft, dense revegetation. Digging into waste pile located rusty greenstone with about 1% pyrite.

Condition: Partially collapsed, filled with debris.

Photo 15-2: Timber-lined remains of shaft#2.

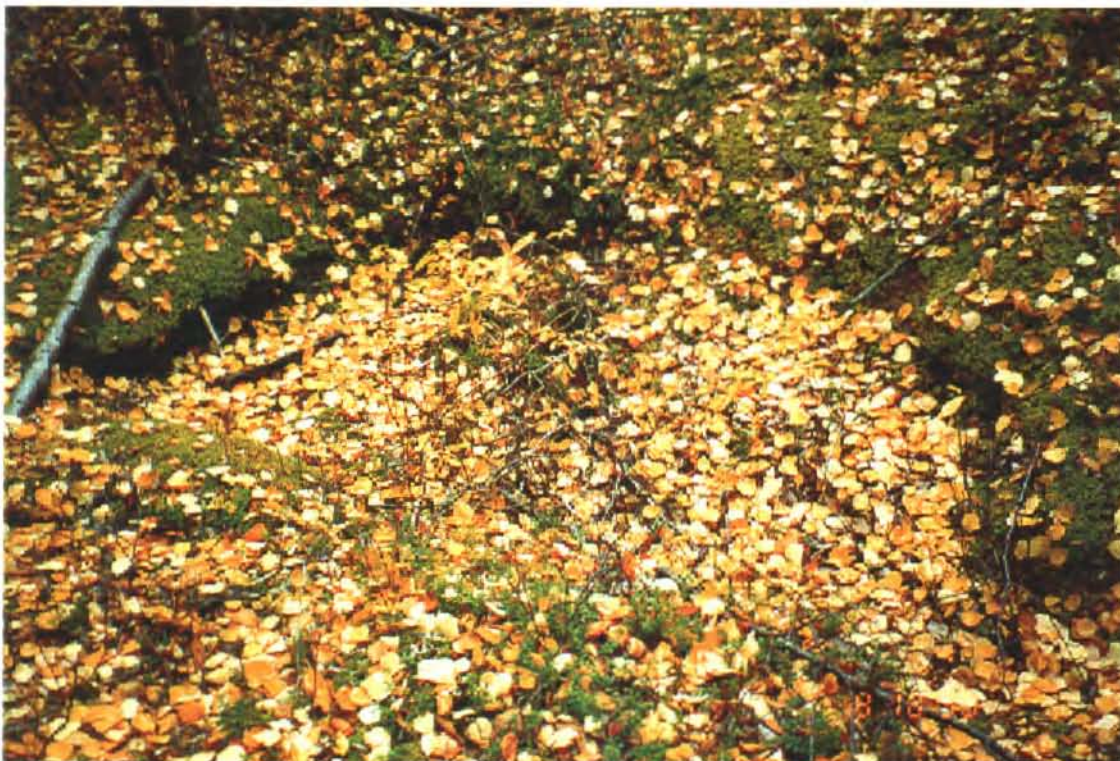
Condition: The pits are extensively overgrown and there is little evidence of their former usage.

Photo 15-3: Reclaimed small test pit above shaft site.

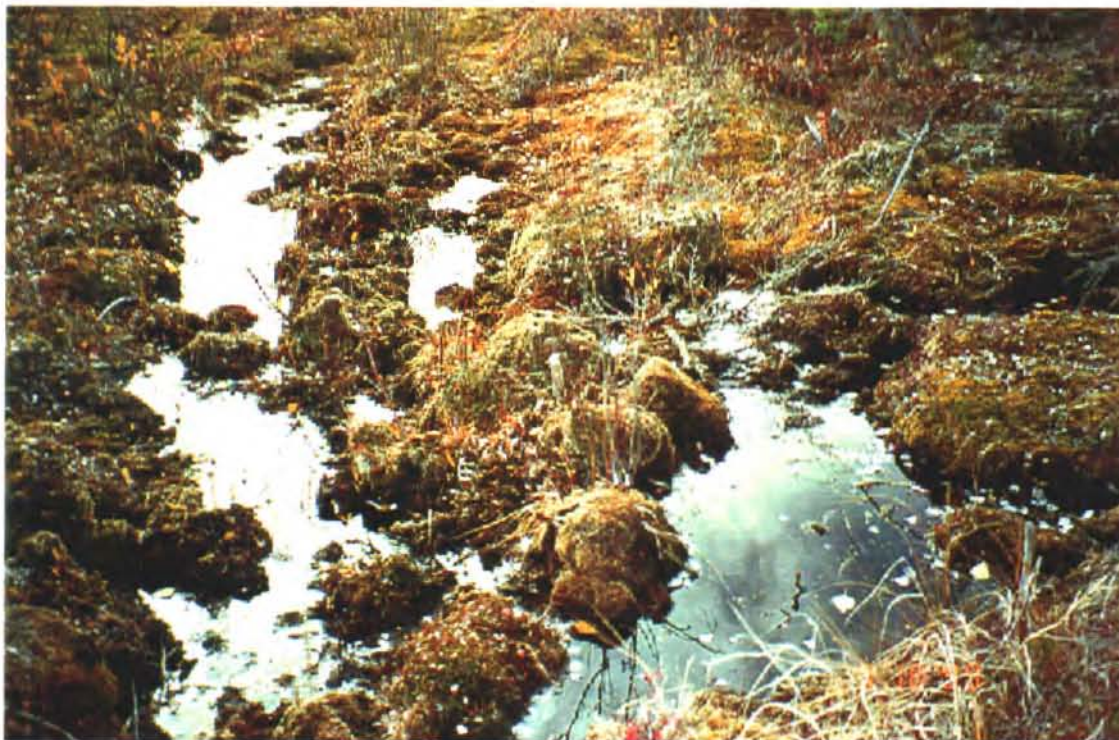
There is no surface water upstream of the site on this slope. A seasonal stream (photo 15-4), paralleling the site, surfaces downgradient from the test pits but upstream of the two shafts. A surface water sample (15-WQ-StrCD-03) and duplicate (15-WQ-StrCD-04) were collected from this stream immediately downstream of the test pit area. Stream flow was less than 1 L/s at the time of the site visit.

Photo 15-4: Small creek above shaft site.

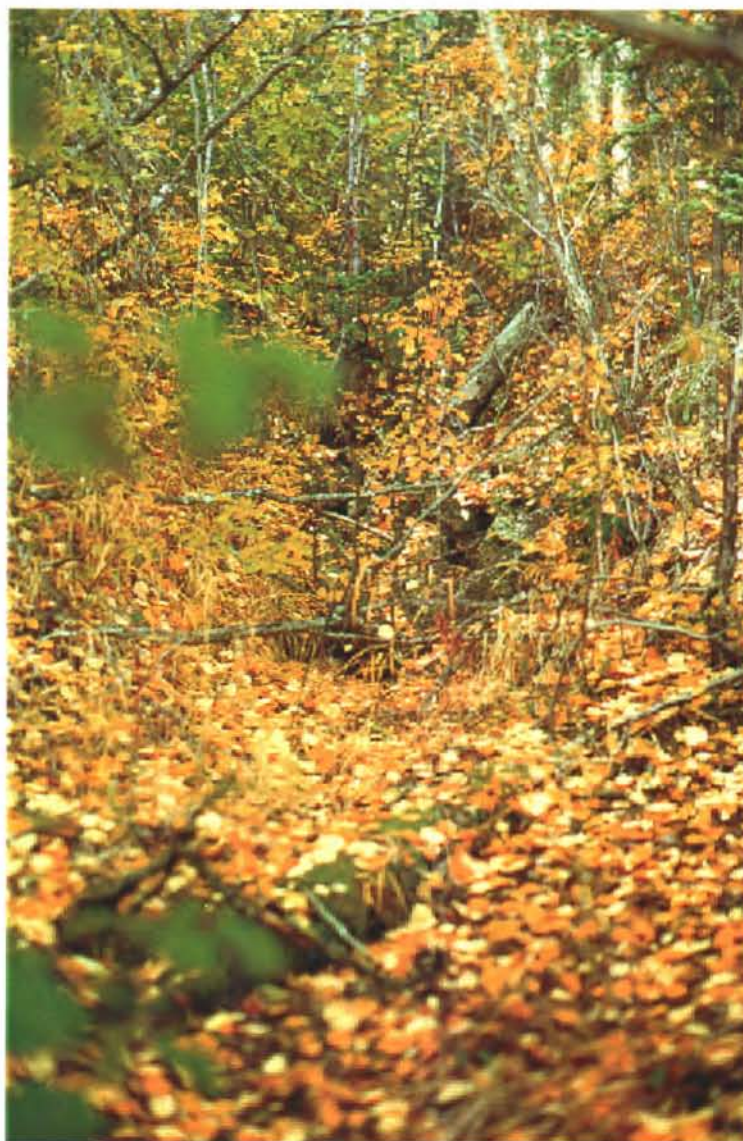
Photo 16-1: Collapsed and overgrown portal and adit are barely visible from under the leaf cover.
(Azimuth 270°)

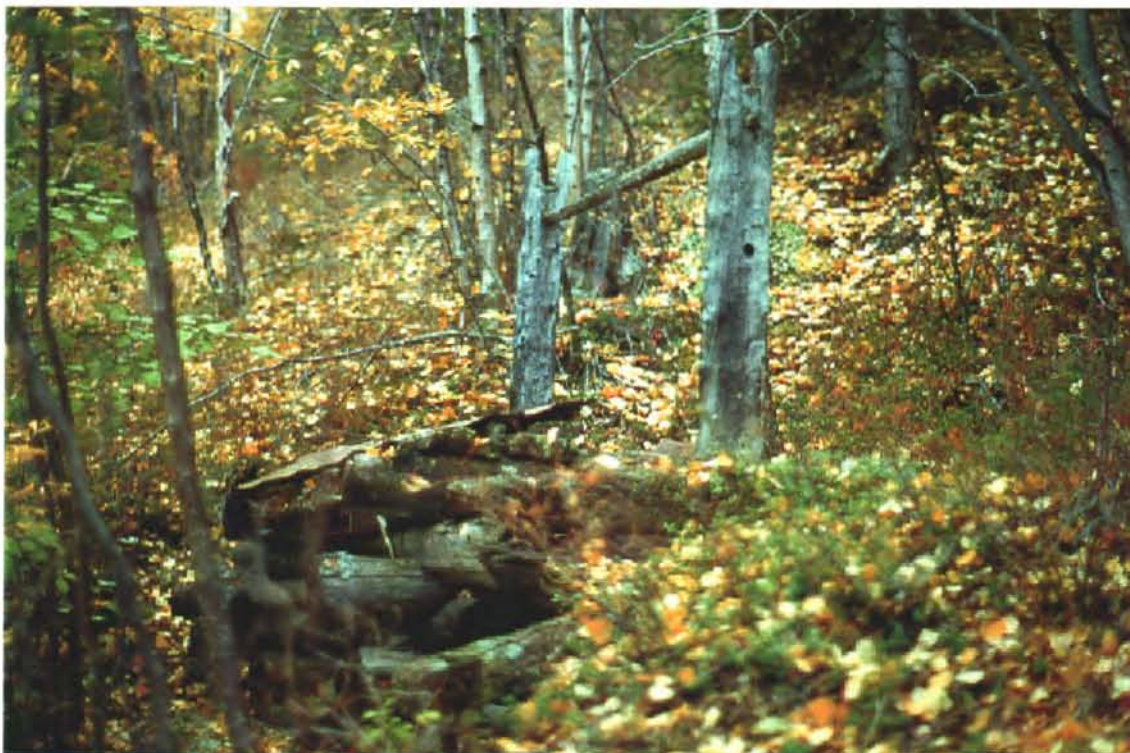
Photo 16-2: Rico shaft with windless on top. (Azimuth 210°)

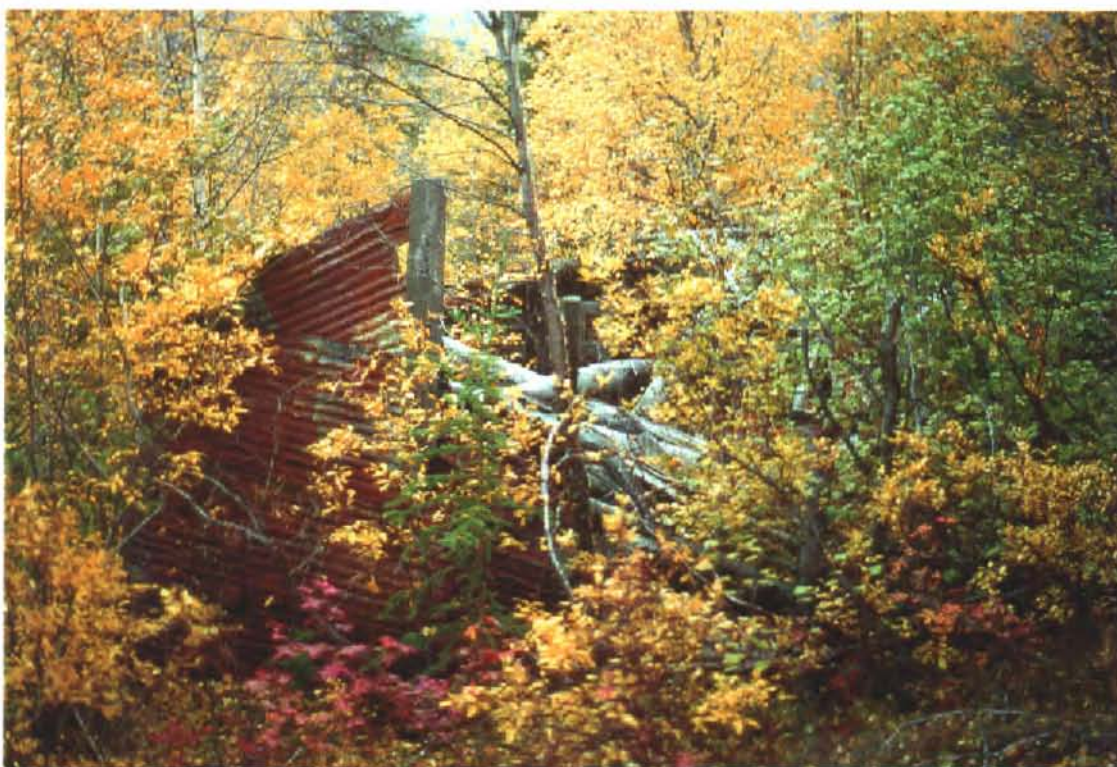
Photo 16-3: Collapsed log cabin with metal sheeting which covers the north side of the cabin. (Azimuth 150°)
