KENO VALLEY/DUBLIN GULCH ENVIRONMENTAL BASELINE ASSESSMENT

VOLUME II: Keno Valley Sites #1 to #20

Prepared for
Waste Management Program
Indian and Northern Affairs Canada

By
Environmental Services
Public Works and Government Services Canada

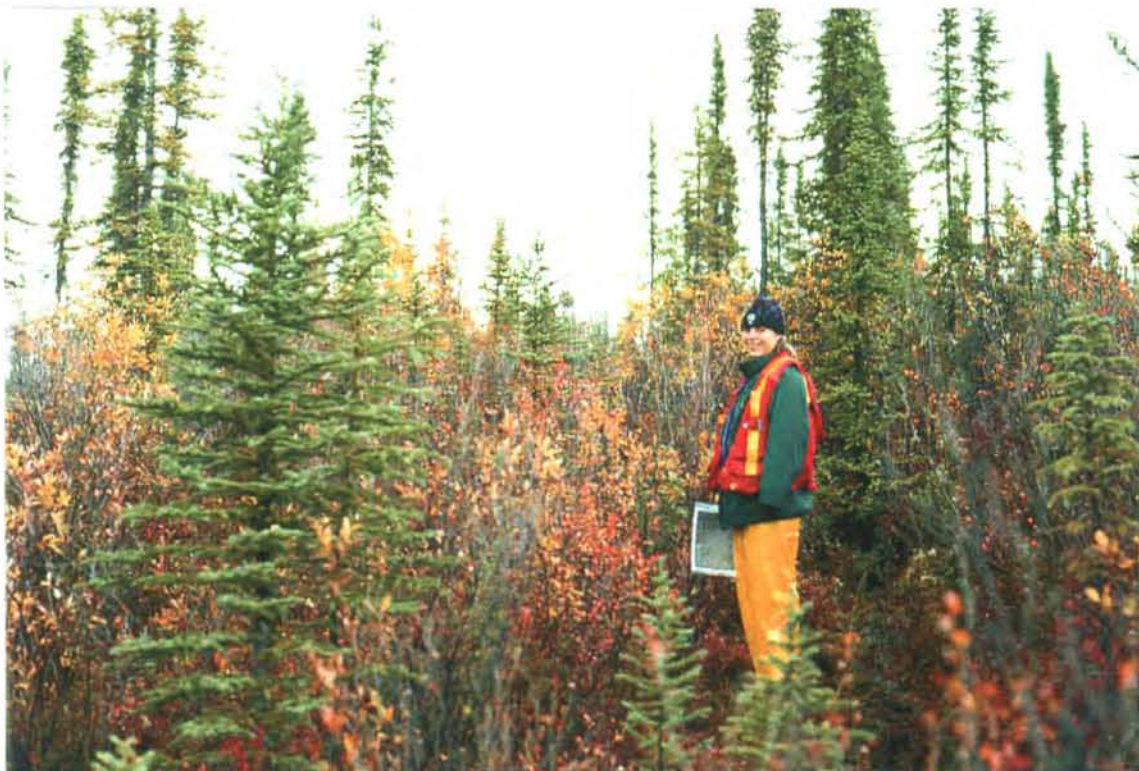
The site has almost fully revegetated naturally. All trenches are well overgrown with a thick carpet of moss, and willows (1-2m high), and small evergreens up to 2 meters tall (Photos 17-1).

Photo 17-1: View of overgrown trench at the Duncan Creek site, looking northward.

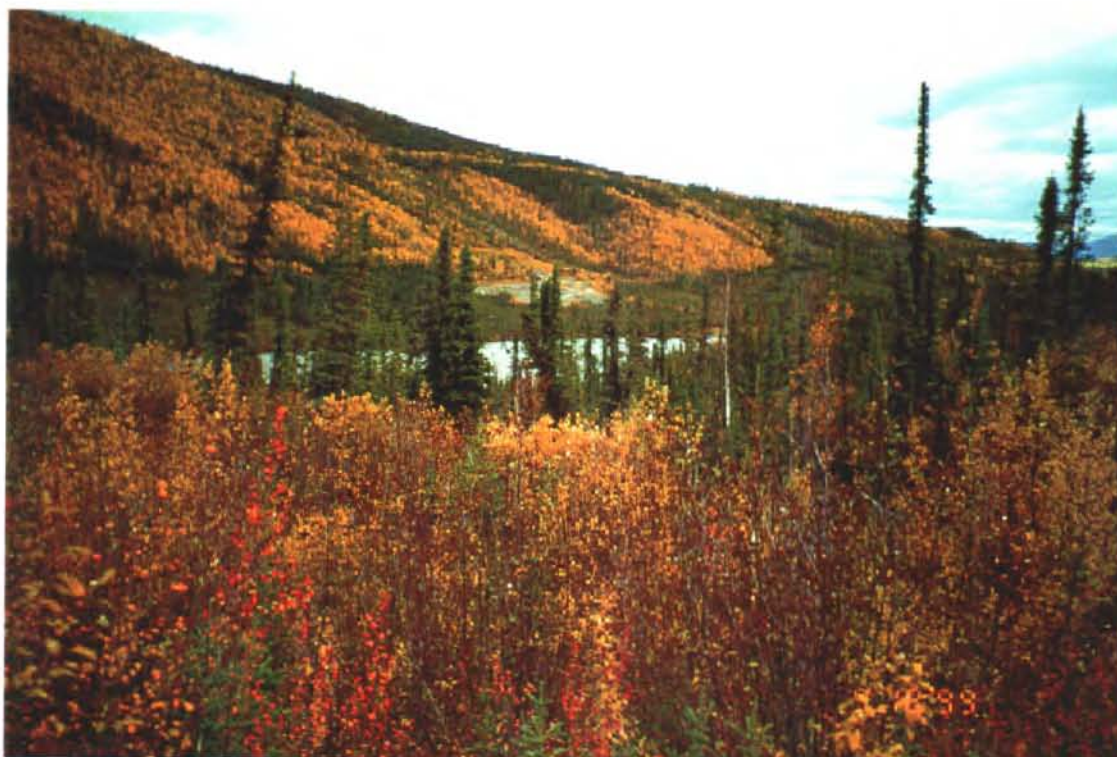
Photo 18-1: Forested area and Christal Lake in background north west of site.

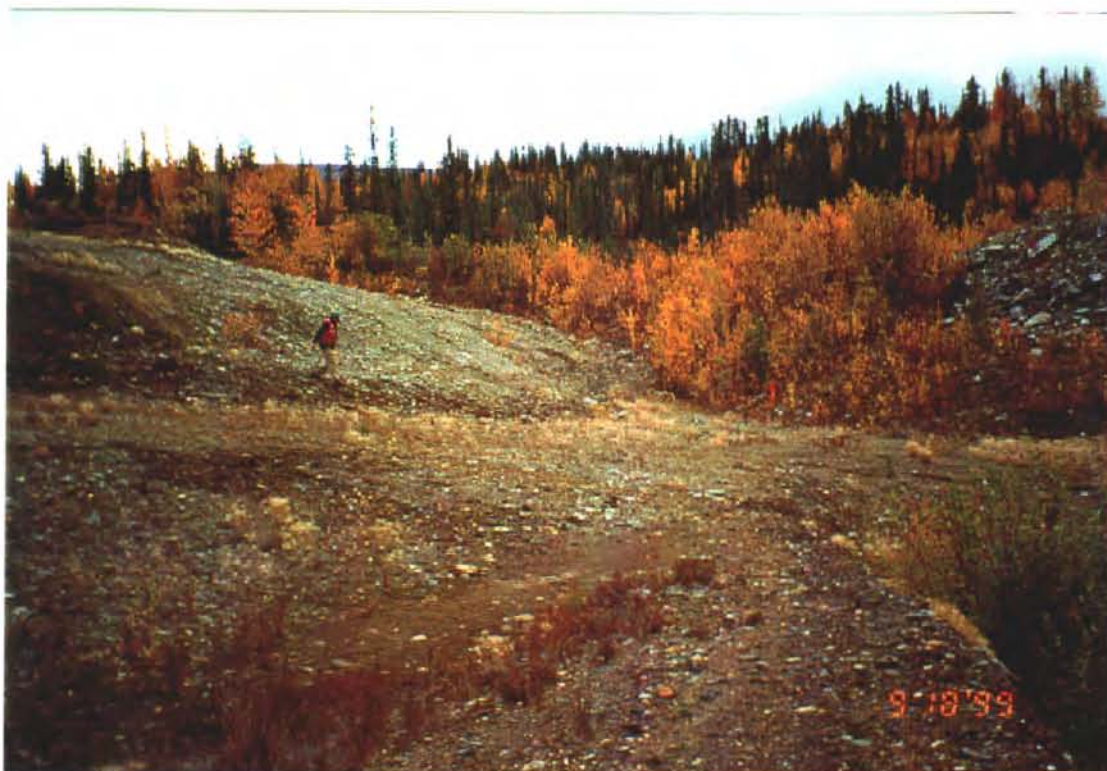
Photo 18-2: Waste rock area near north end of main site.

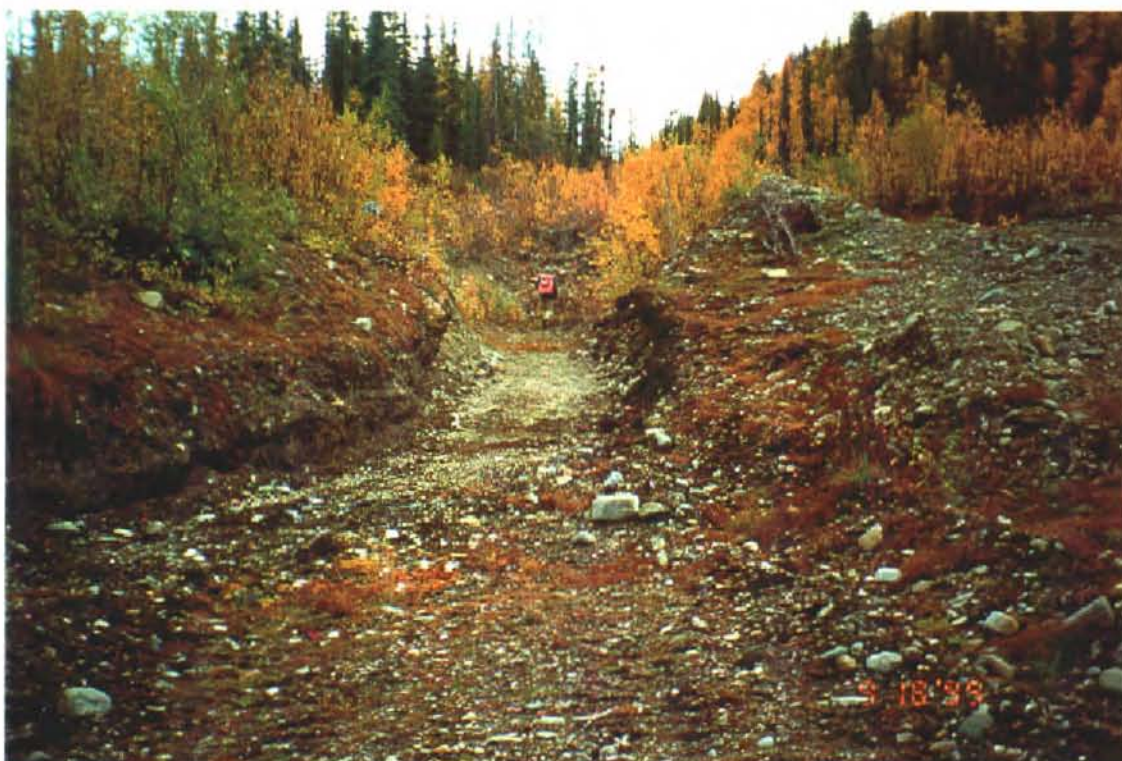
Photo 18-3: Bulldozed trench at second site.

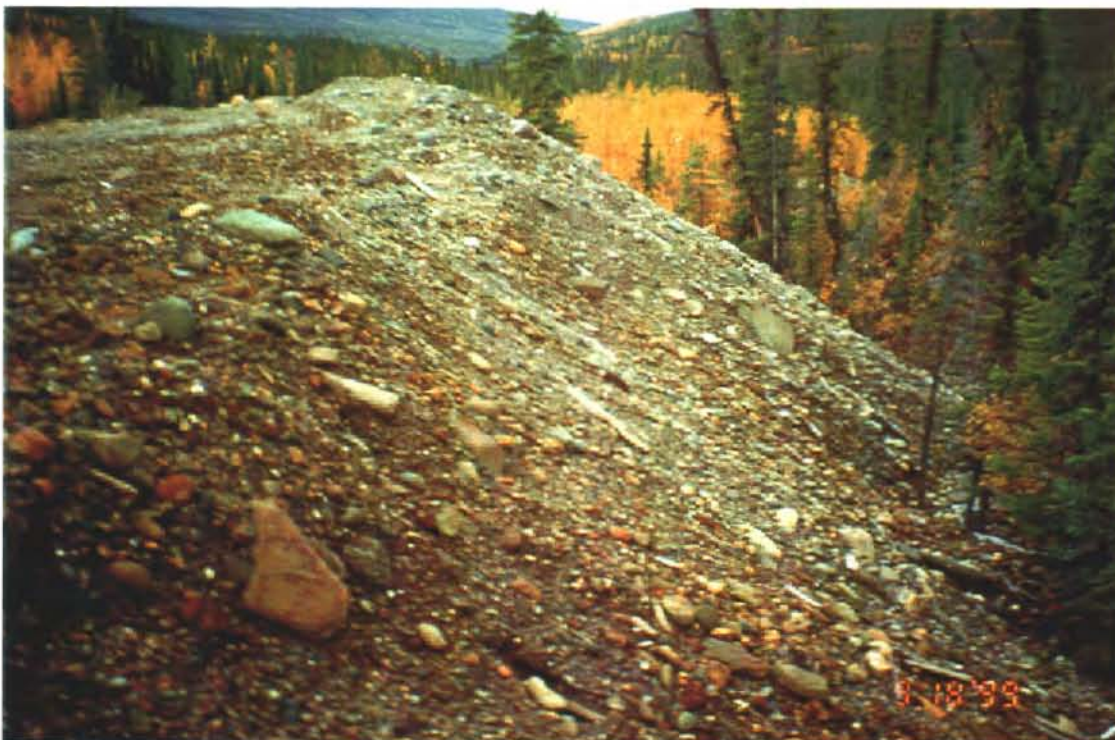
General Description: Open pit development has produced four lobes of waste rock. The two northwestern lobes are dominantly barren overburden (photo 18-4). The northeastern lobe, site of sample 02, is composed of mixed mineralized material and overburden (photo 18-5). The southern lobe, site of sample 03, is dominated by barren quartzite. The waste rock dumps are partially revegetated, except near well-mineralized areas. Vegetation is well established where there is fine-grained material or moisture traps. There is no apparent drainage at the site, as it is dominated by well-drained gravel. Oxidation related staining of the waste rock is apparent at the northeastern lobe of waste.

Photo 18-4: Large waste rock pile slope at north end of main site.

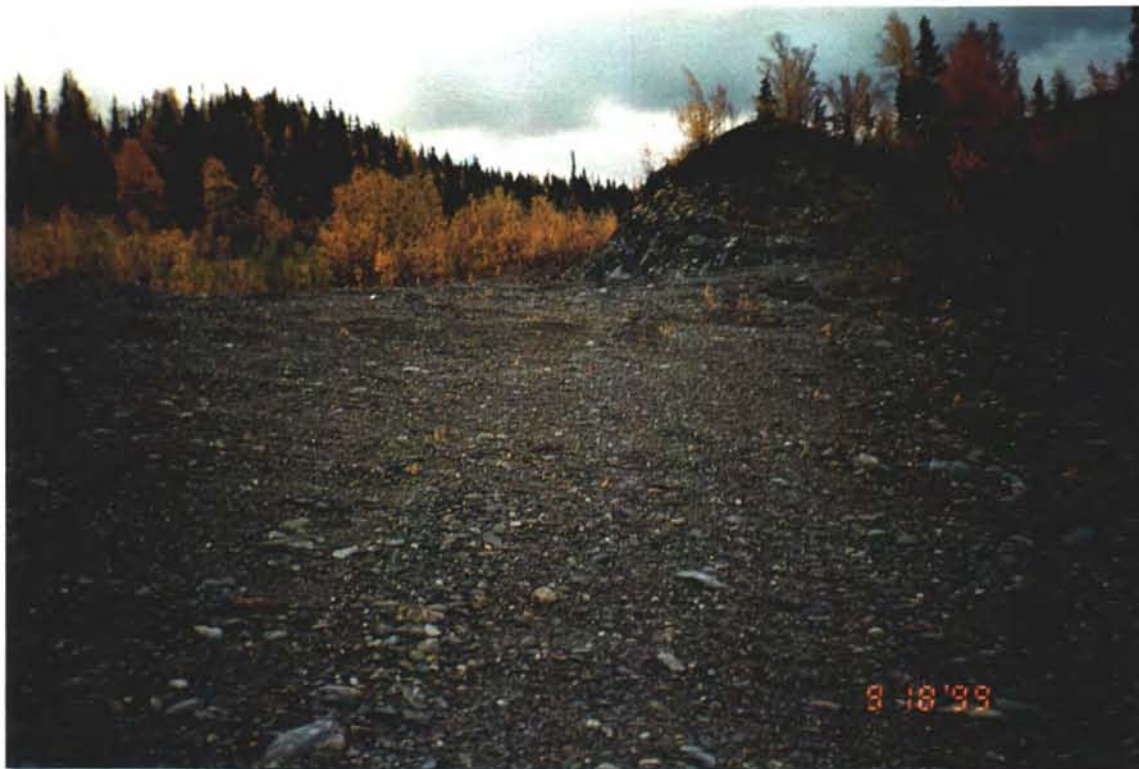
Photo 18-5: Leveled area at main site. Note rock outcrop on right side of photo.

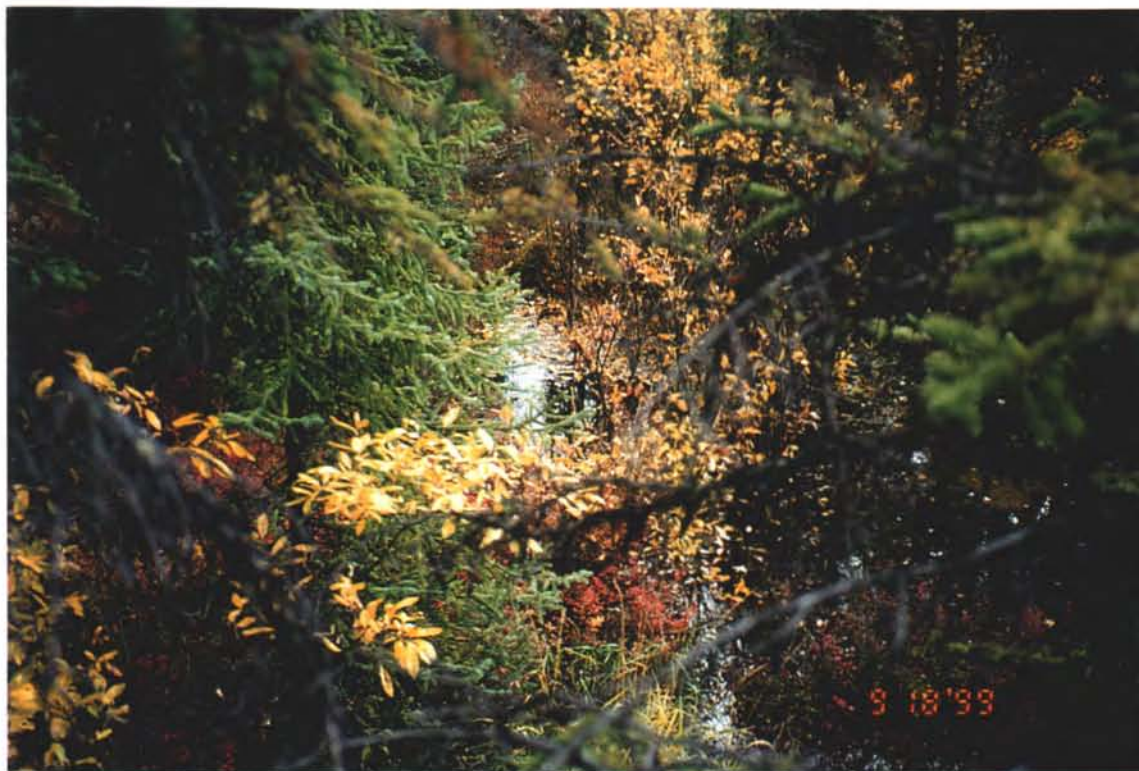
There was evidence that water had ponded in the north trench in the recent past, however, it was dry during the site visit. The north trench area drains northwest towards Christal Lake, a distance of approximately 750 m (photo 18-1). Surface runoff from the site enters a pond immediately north west of the site (photo 18-6), which discharges into a small creek flowing into Christal Lake. A water sample (18-WQ-Str-CD-01) and duplicate (18-WQ-Str-CD-02) were collected from the pond. Laboratory and field analyses are provided in Attachment B.

Photo 18-6: Creek runoff to north west of trench site.

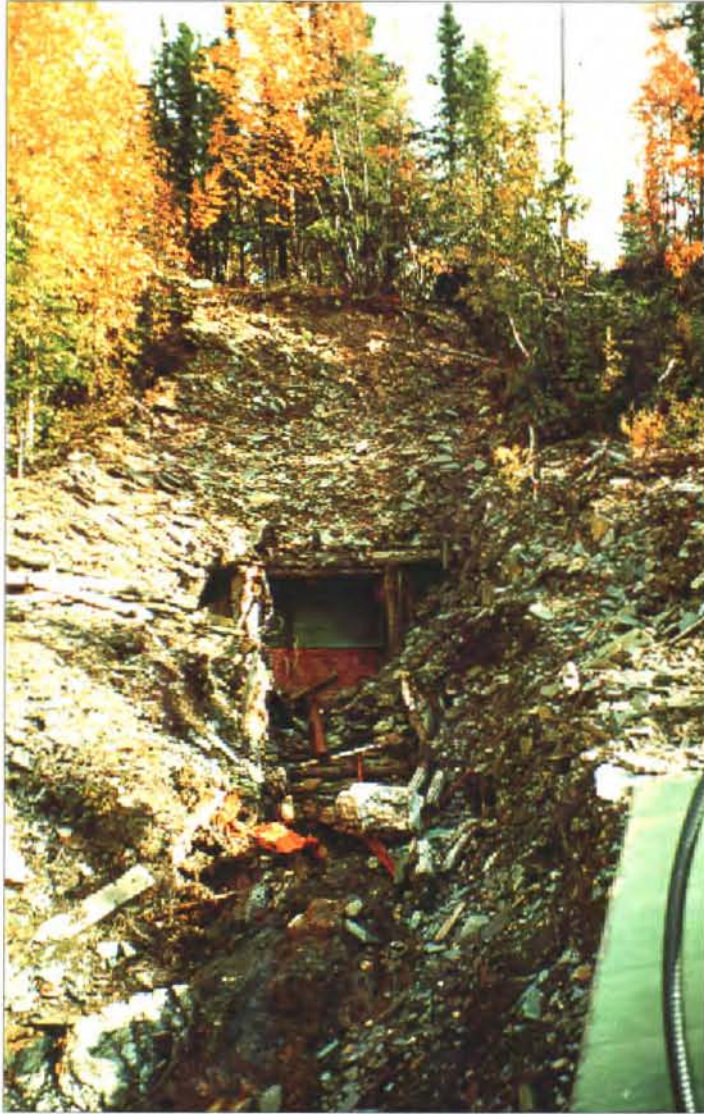
400 Level Portal (photo 19-2)

Photo 19-2: 400 level portal and runoff channel. Note debris at entrance.

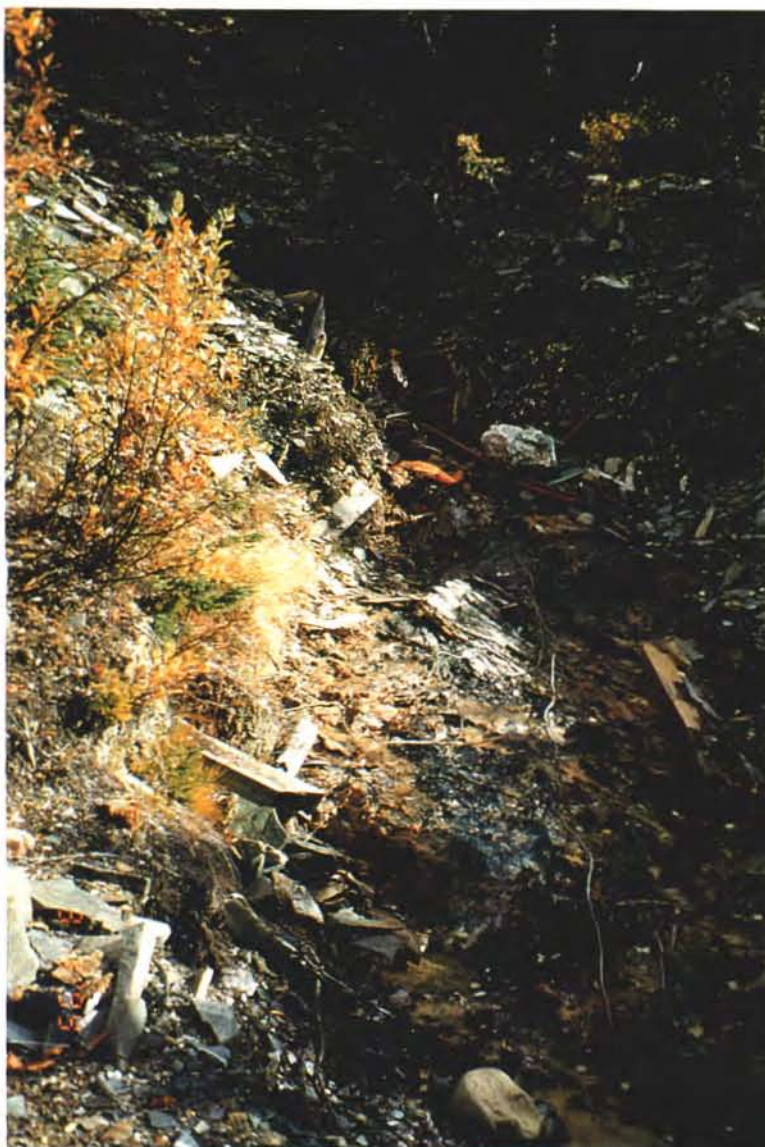
Waste rock pile – 400 Level Portal (photo 19-3)

Photo 19-3: Runoff channel below 200 level portal. Note adjacent waste rock.

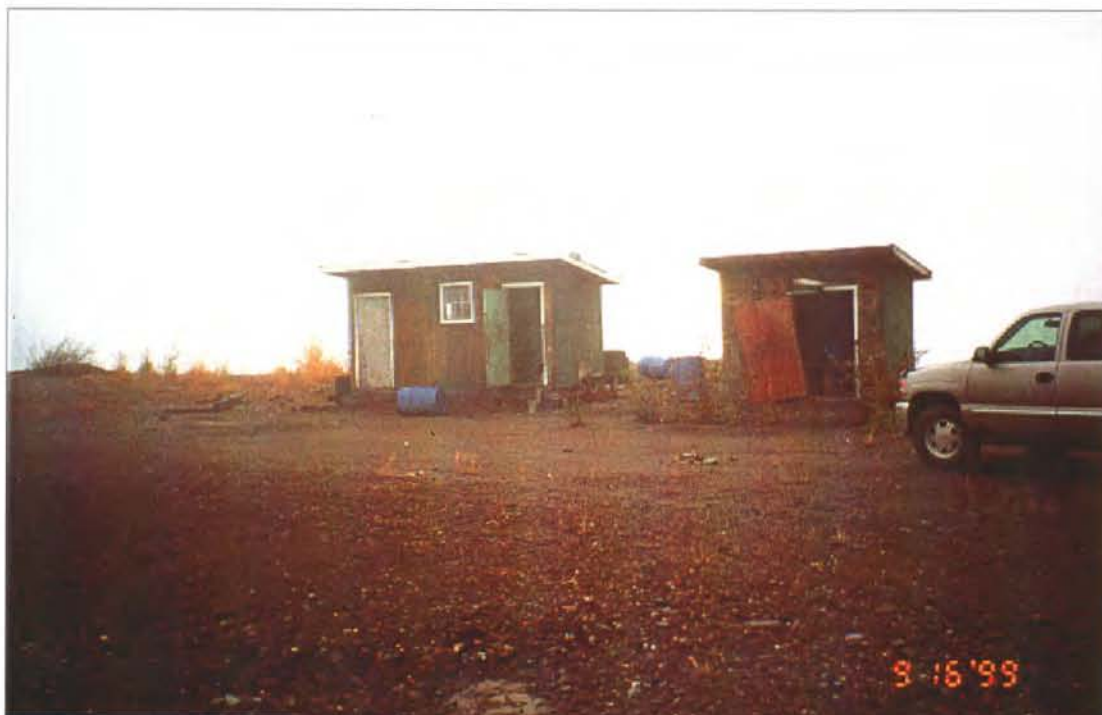
Photo 19-5: Buildings 19A & 19B at upper camp.

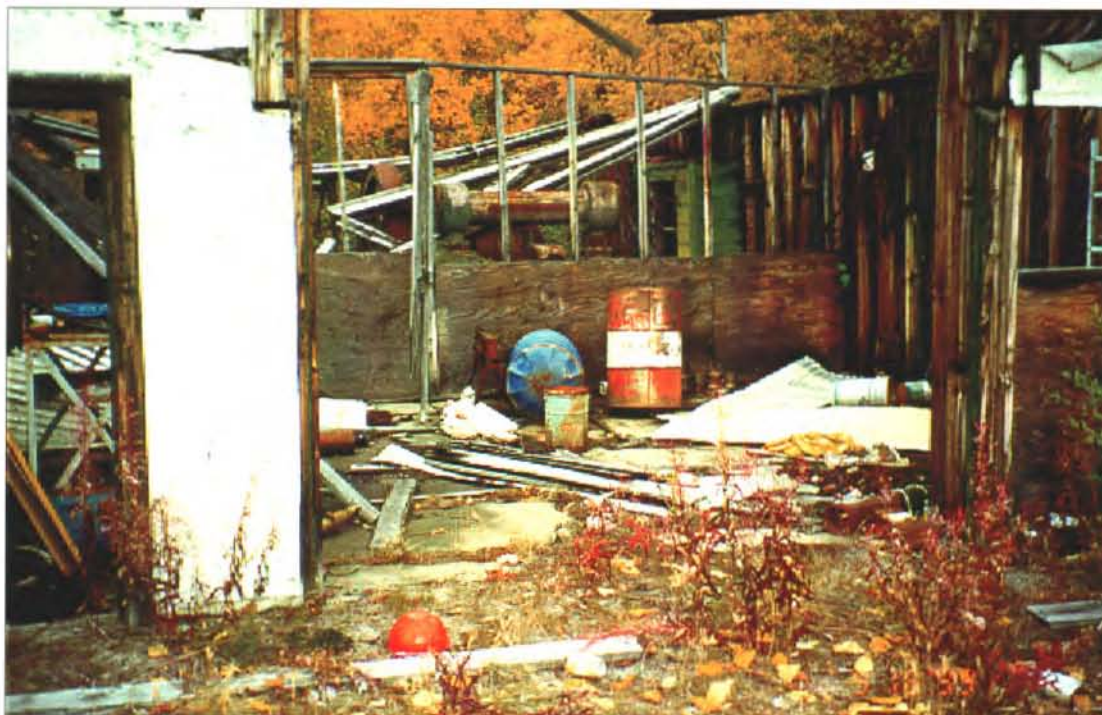
Hazardous products: Used six-volt battery. Partially full barrels and pails (photo 19-9). Note: all partially full pails and barrels at the lower site were placed in this building prior to sampling.

Photo 19-9: Former storage area in building 19E where hazardous liquids stored.

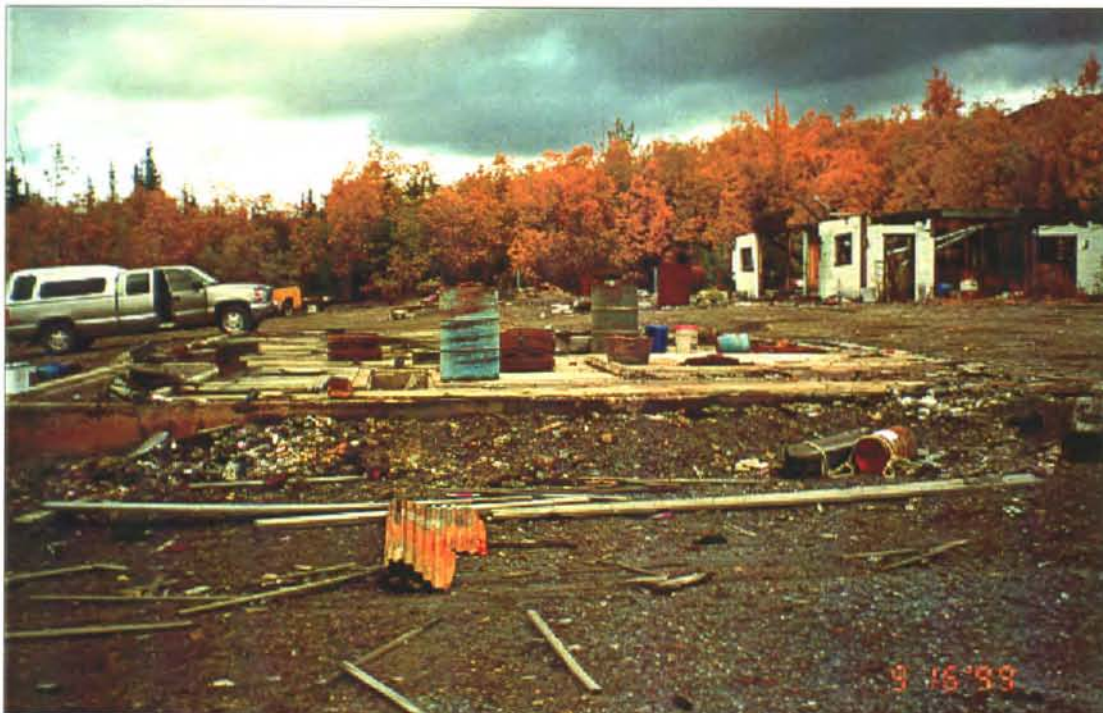
Building 19G (photo 19-11)

Photo 19-11: Concrete foundation (building 19G) and much debris.

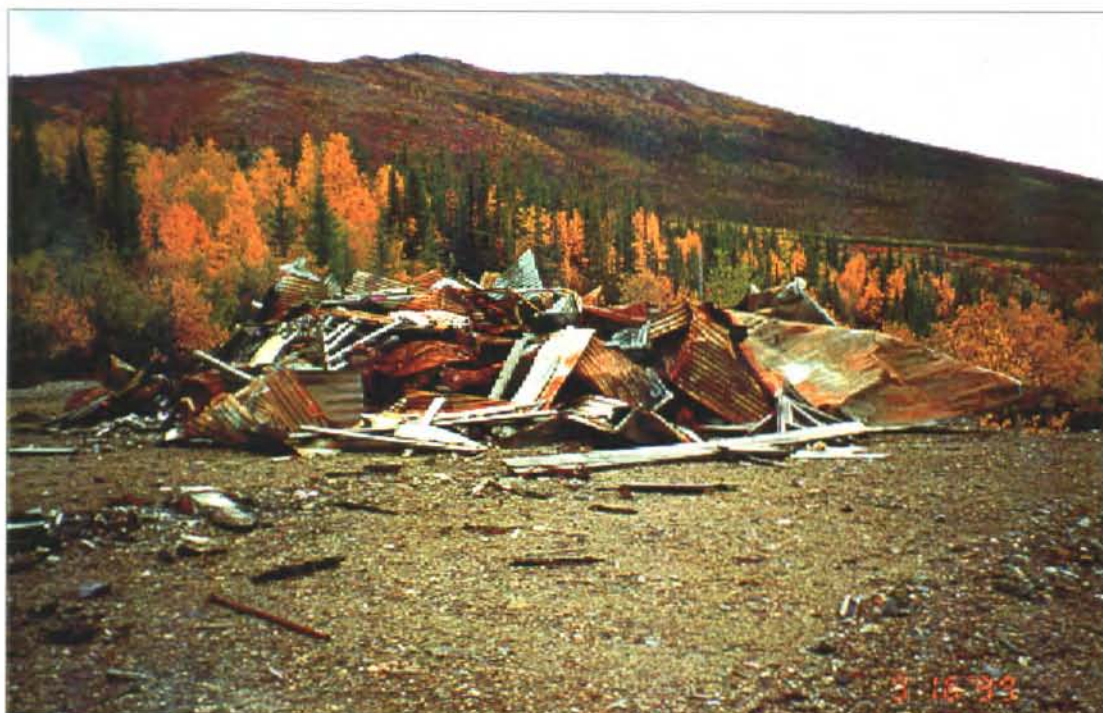
Surrounding area: Large amount of demolition debris in a single pile (metal cladding, small equipment, wood) (photo 19-12) that has been extensively burned; metal and wood debris; vehicle hulk; barrels and pails (empty and partially full).

Photo 19-12: Construction waste debris remaining from demolition of building 19G.

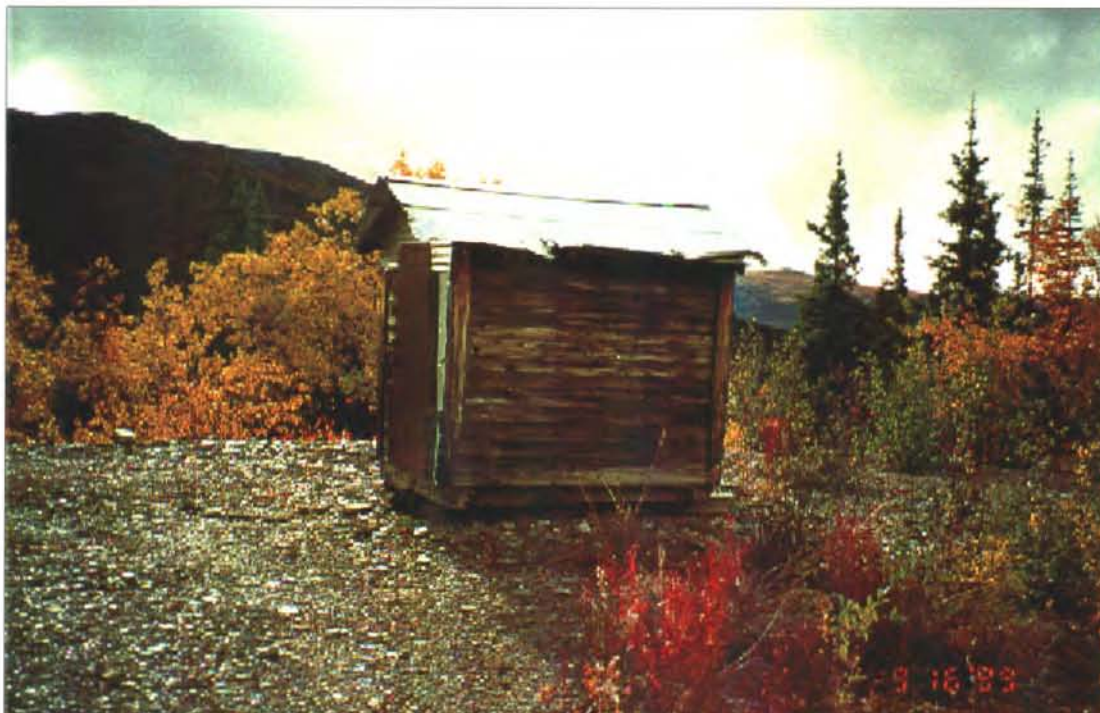
Building 19I (photo 19-13)

Photo 19-13: Explosives shed above pit site.

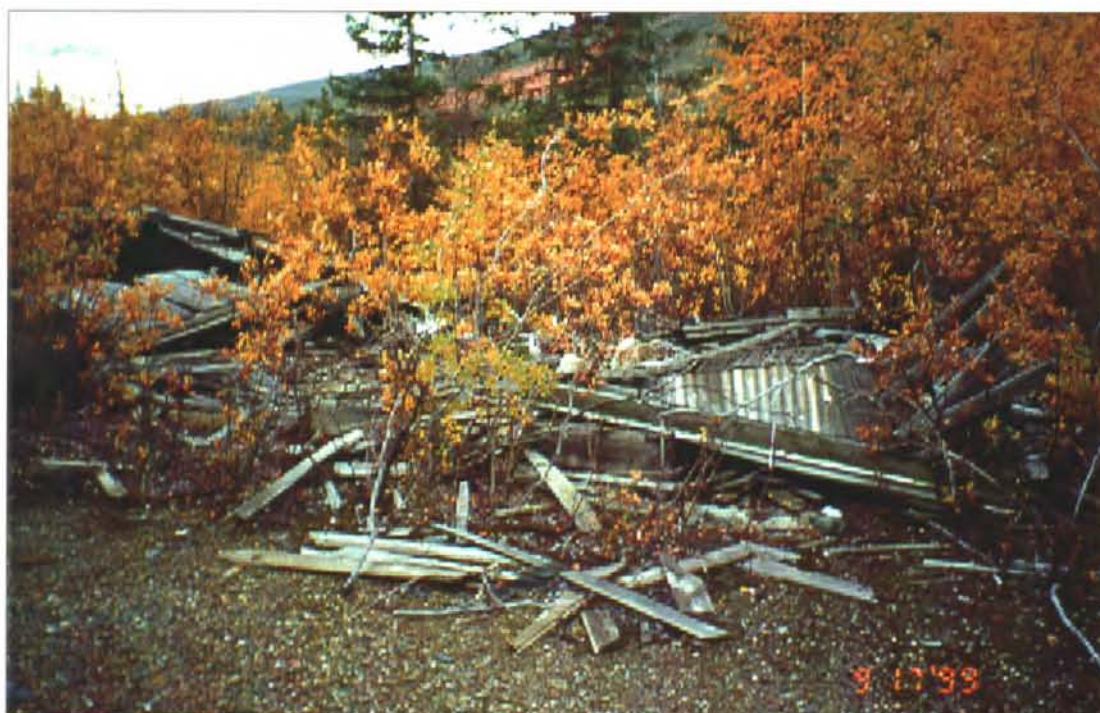
Building 19N (photo 19-14)

Photo 19-14: Remains of building 19N at loading site below lower road.

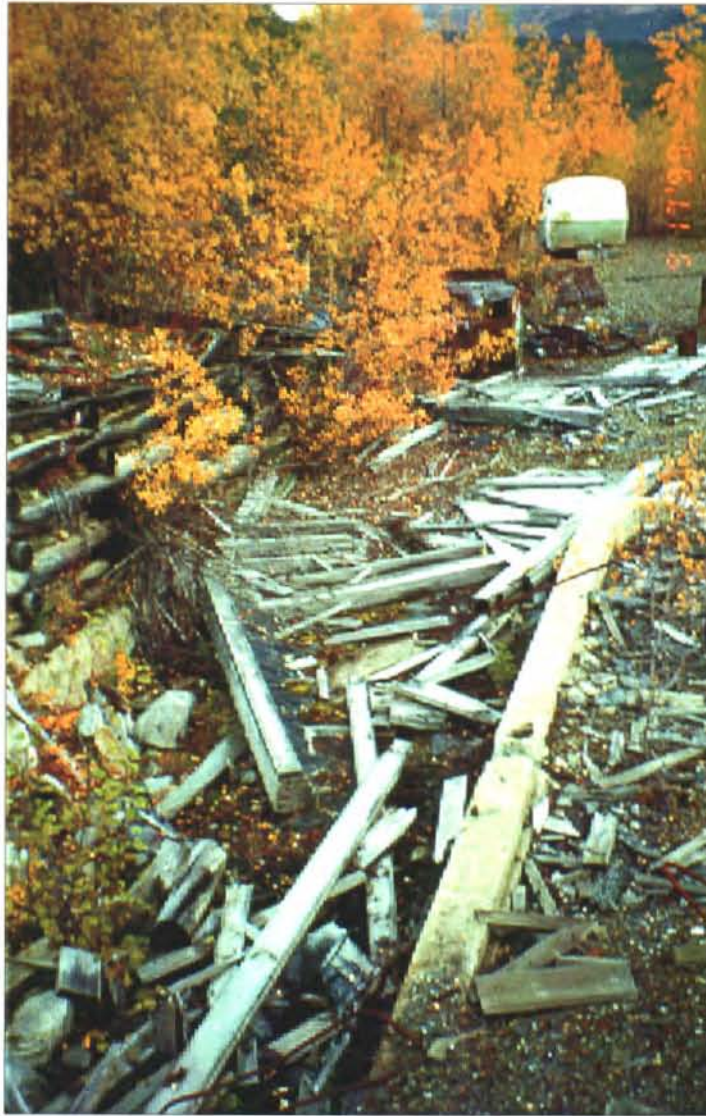
Non-Hazardous contents: Building debris strewn throughout area including construction waste from the former loadout ramp (photo 19-15).

Photo 19-15: Wood debris at loadout site.

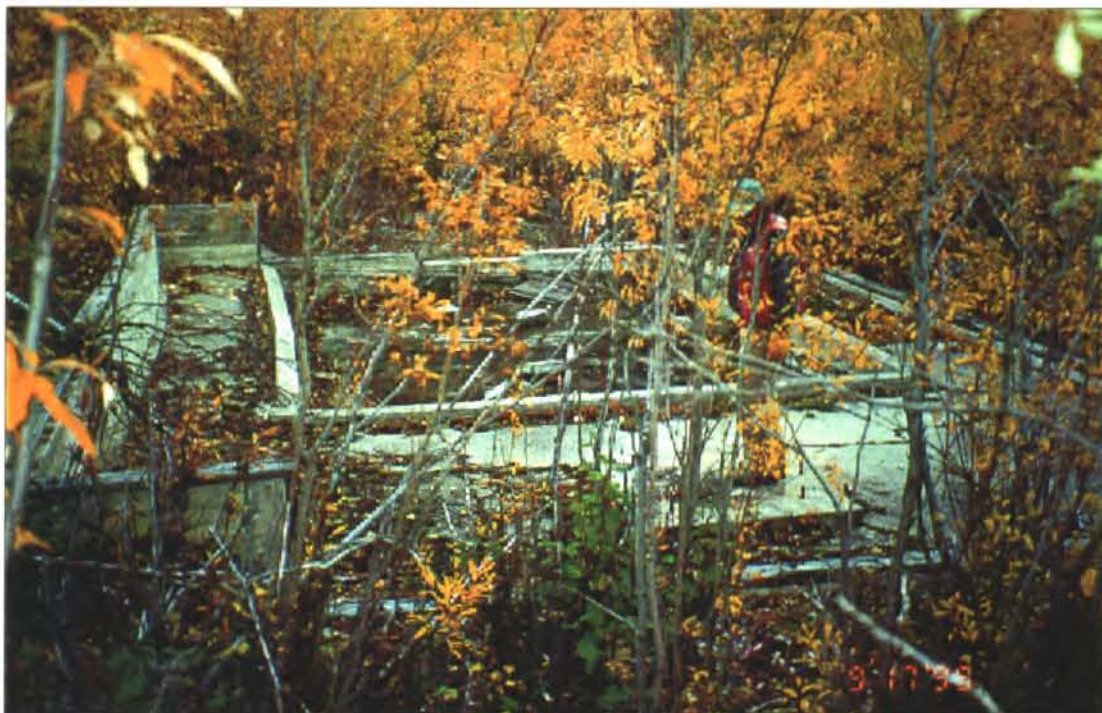
Building 19O (photo 19-16)

Photo 19-16: Concrete foundation (building 190) at loadout site.

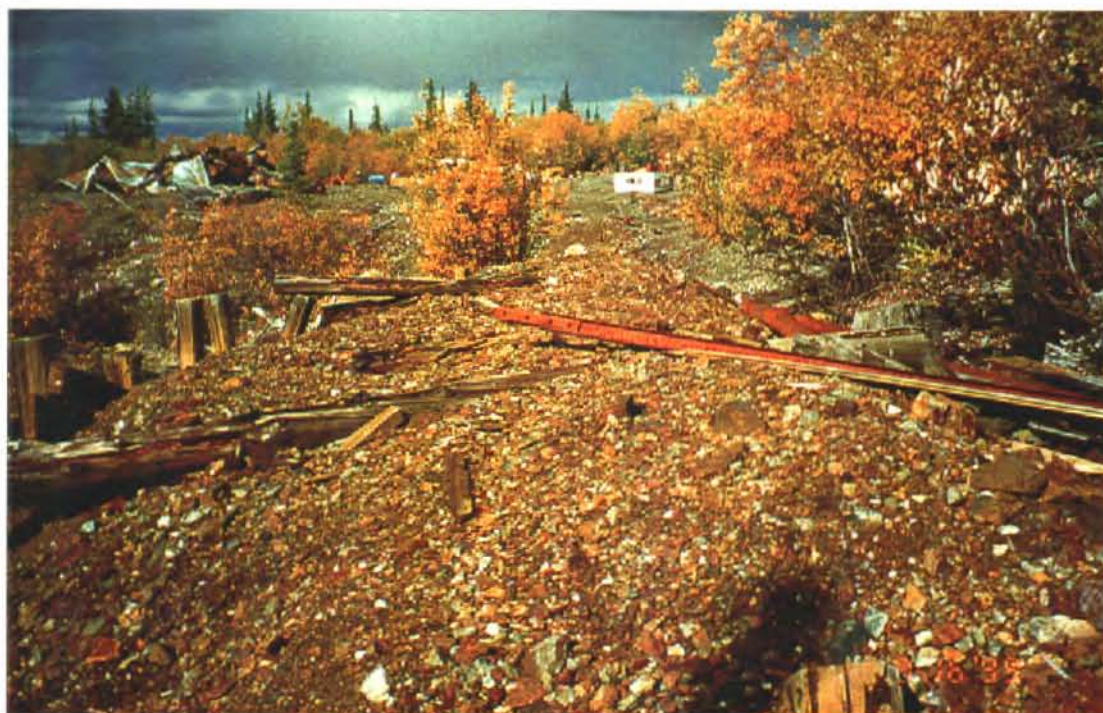
6.3 Rail and Trestle (photo 19-17)

Photo 19-17: Former trestle area at 400 level portal.

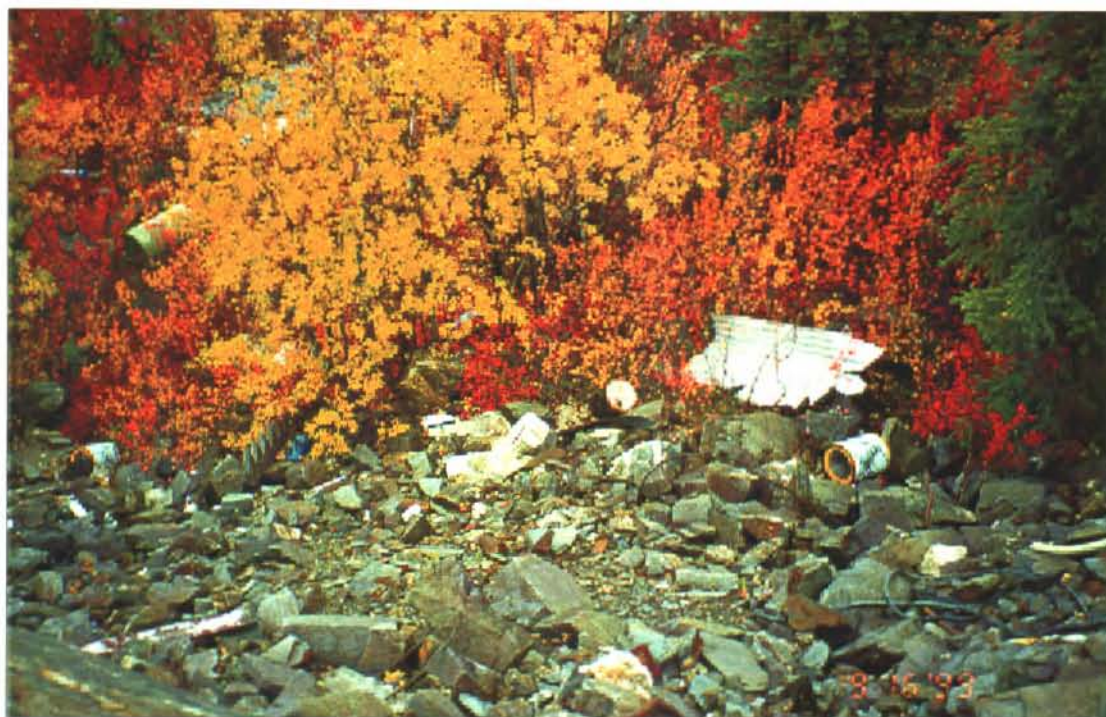
Location & access: Immediately west (below) waste rock pile comprising upper camp site (photo 19-18).

Photo 19-18: Solid waste dump at bottom of waste rock dump at upper camp.
