# KENO VALLEY/DUBLIN GULCH ENVIRONMENTAL BASELINE ASSESSMENT

VOLUME III: Keno Valley Sites #21 to #40

Prepared for  
Waste Management Program  
Indian and Northern Affairs Canada

March, 2000

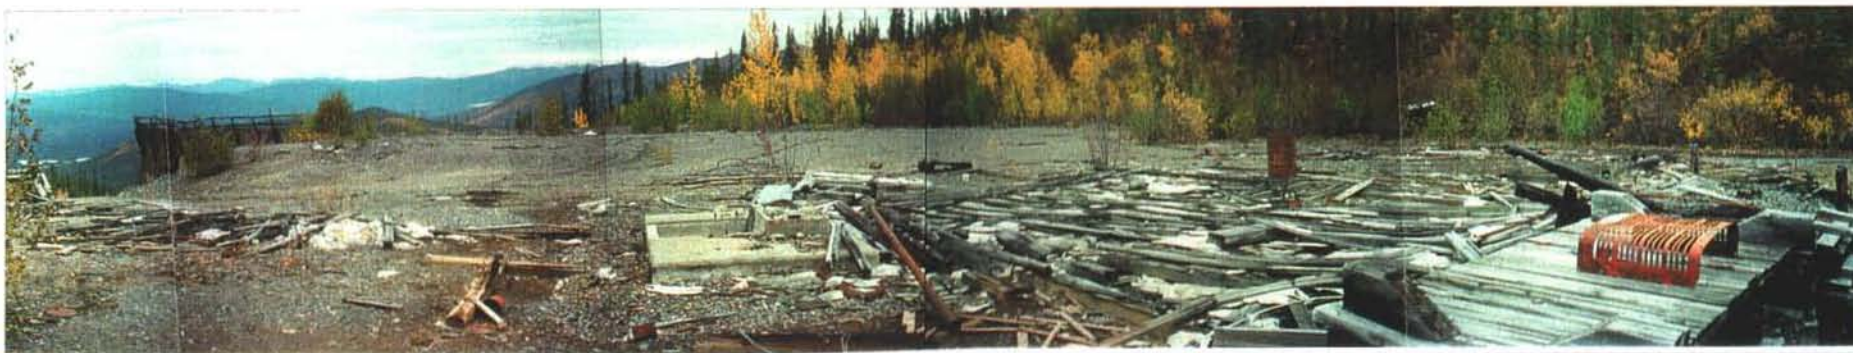
Photo 21-1: Panorama of main Werecke Camp and Sadie Ladue Mine area showing end dumped waste rock and overburden piles, Pitt#1 and decline hole to left, and partially collapsed shaft structures to far right.

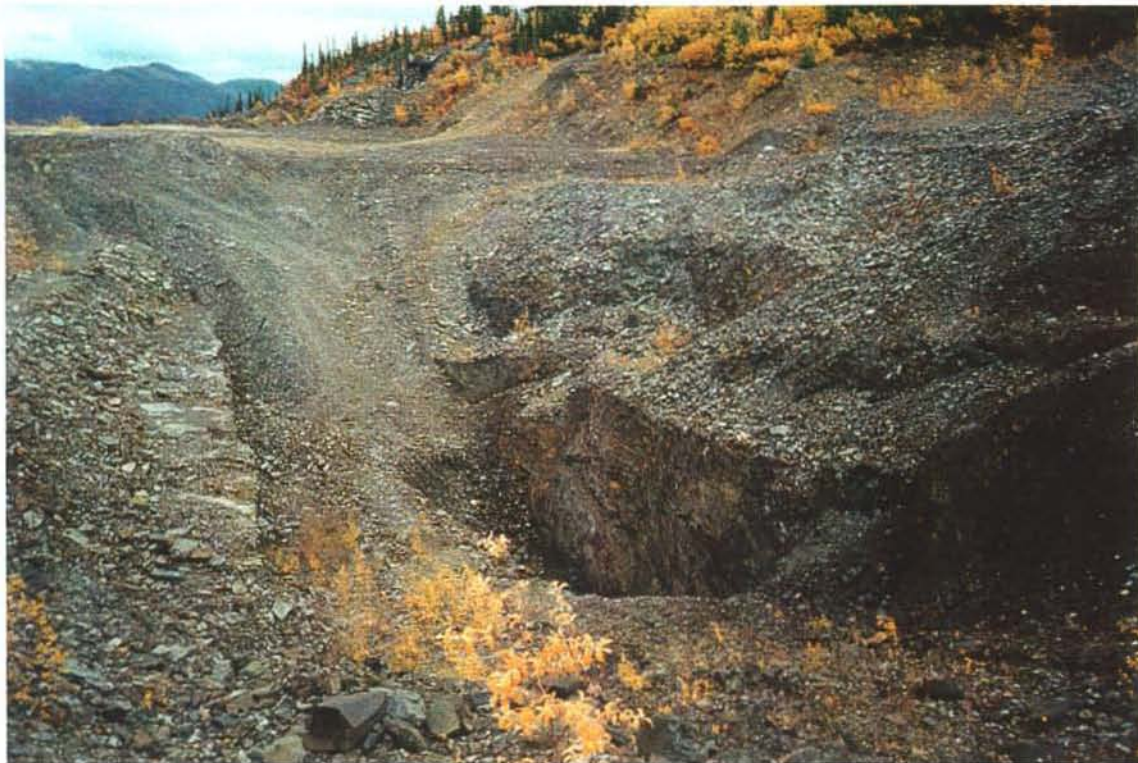
Photo 21-2: Overview of Pit#1 developed in the late 1980's. (Azimuth 060°)

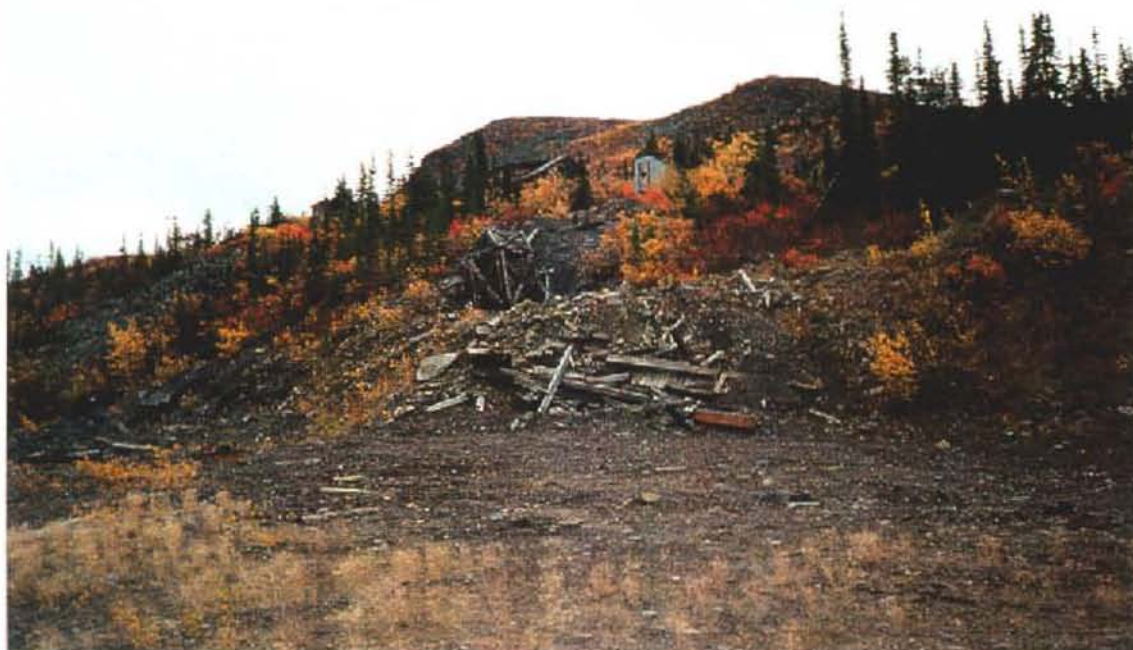
Photo 21-4: Sadie Ladue shaft area. Note dilapidated tressel, outhouse over callapsed manway and managers house in background. (Azimuth 080°)

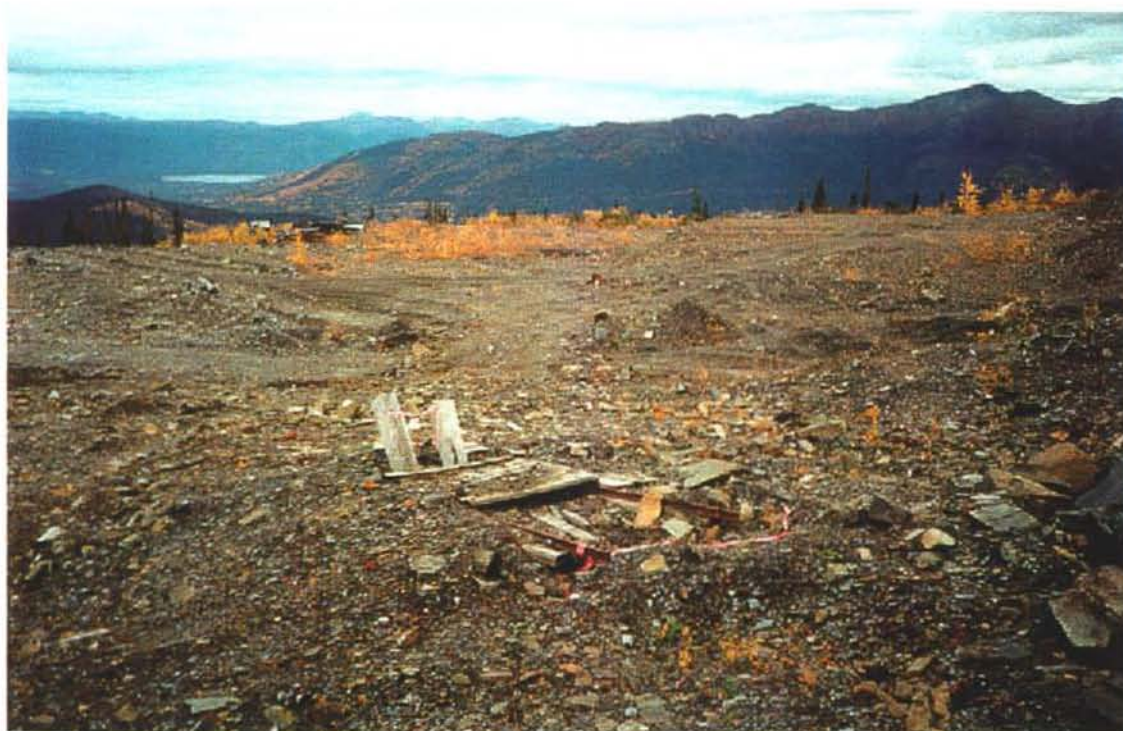
Photo 21-5: Sealed haulage shaft. (Azimuth 000°)

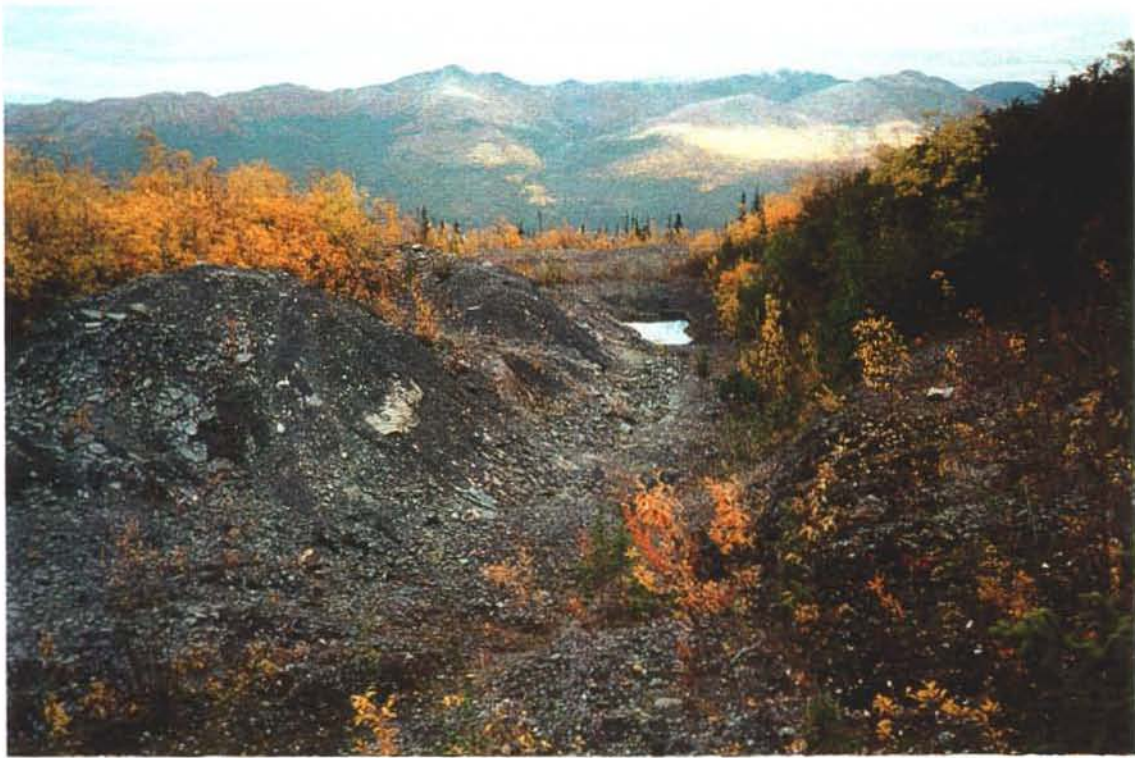
Photo 21-6: Pit #4 with ponded water from groundwater seeps. (Azimuth 030°)

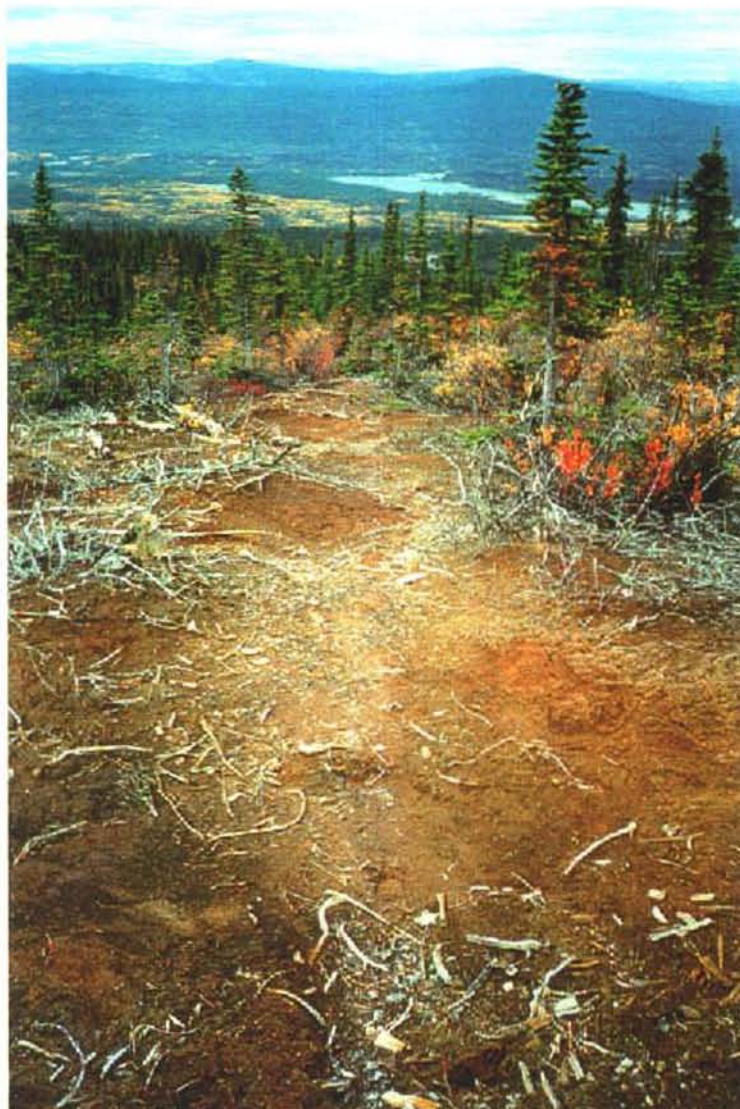
Photo 21-8: Tailings material 250m down slope of Wernecke Camp area (el. 1220m).

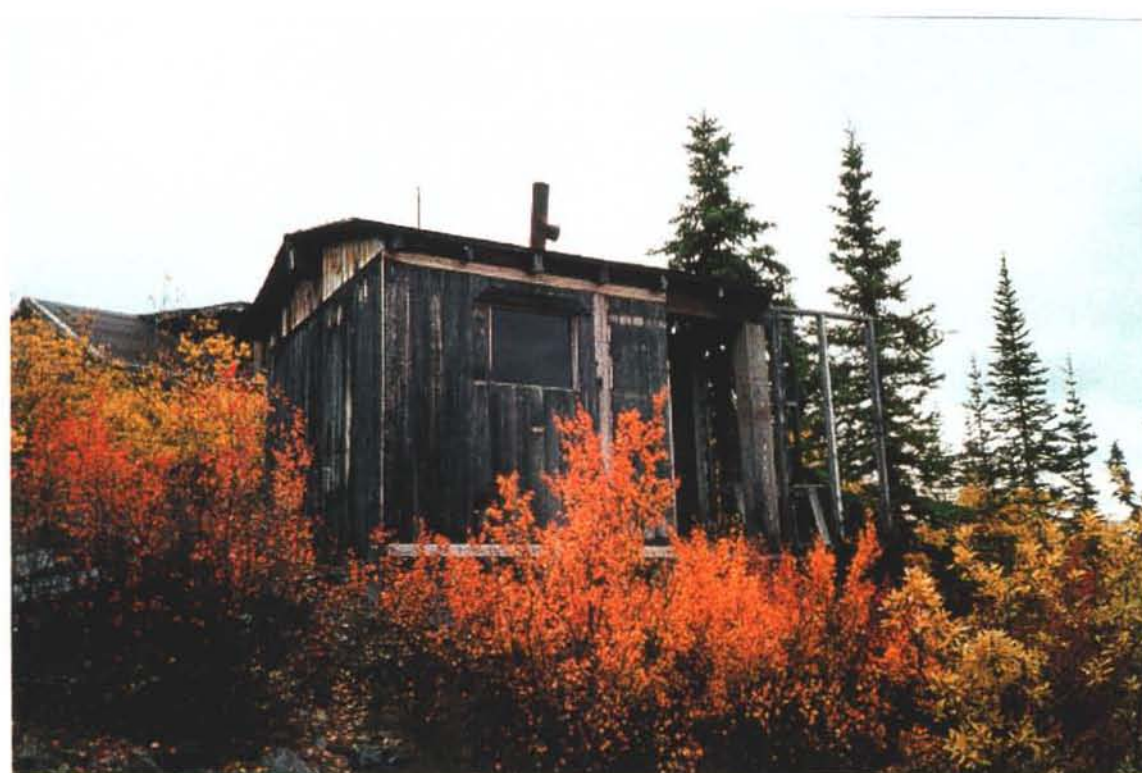
Photo 21-10: Sauna built in 1986 (Bldg. 21-B). Note sound condition. (Azimuth 180°)

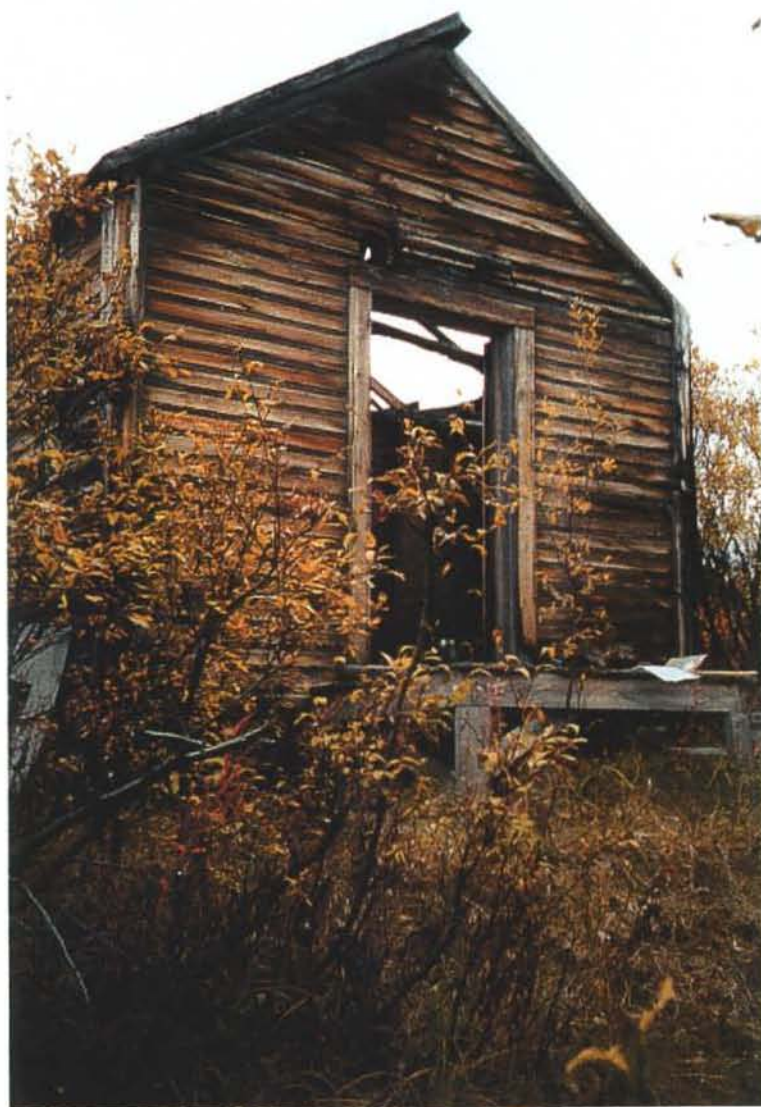
Photo 21-11: Partially collapsed building (Bldg. 21-C). (Azimuth 160°)

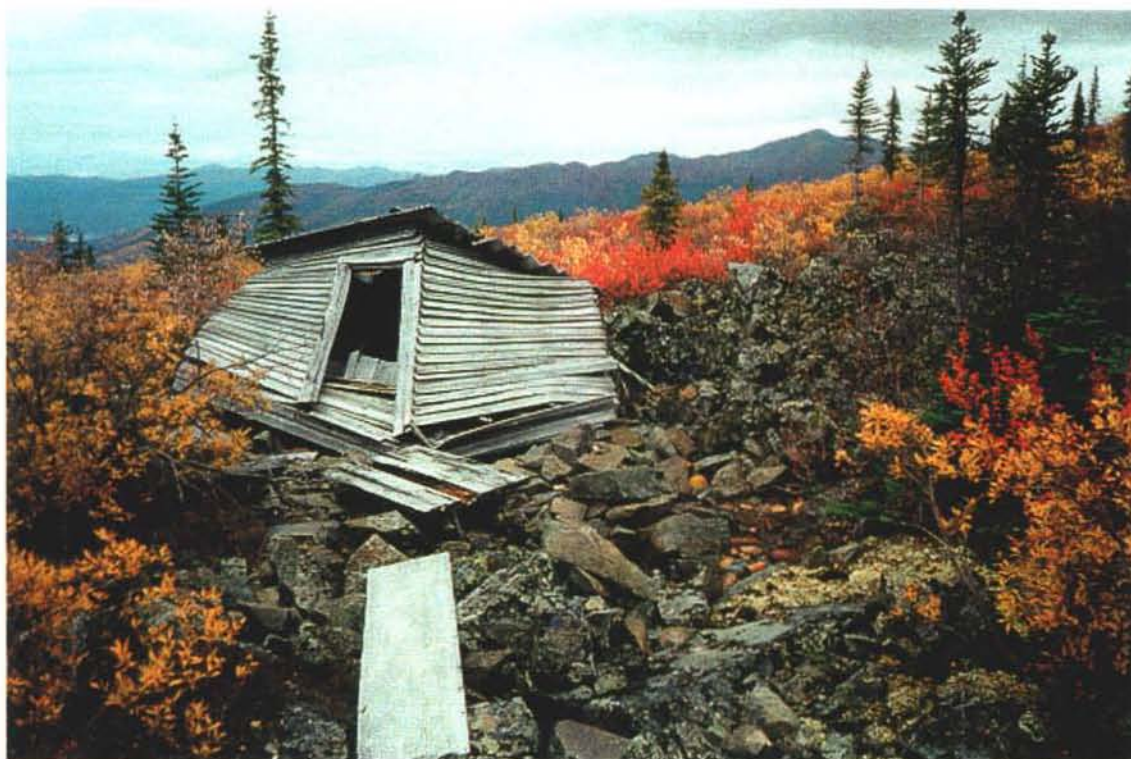
Photo 21-13: Collapsed shed (Bldg. 21-E) (Azimuth 000°)

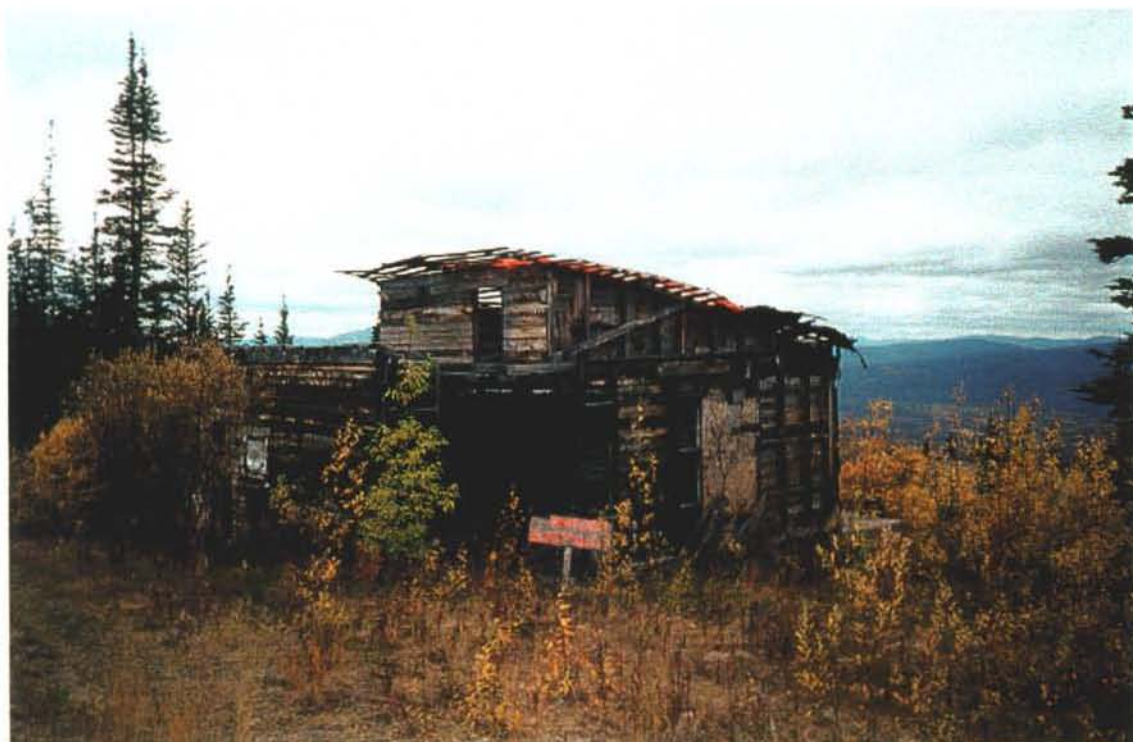
Photo 21-14: Dilapidated mine building (Bldg. 21-F). (Azimuth 260°)

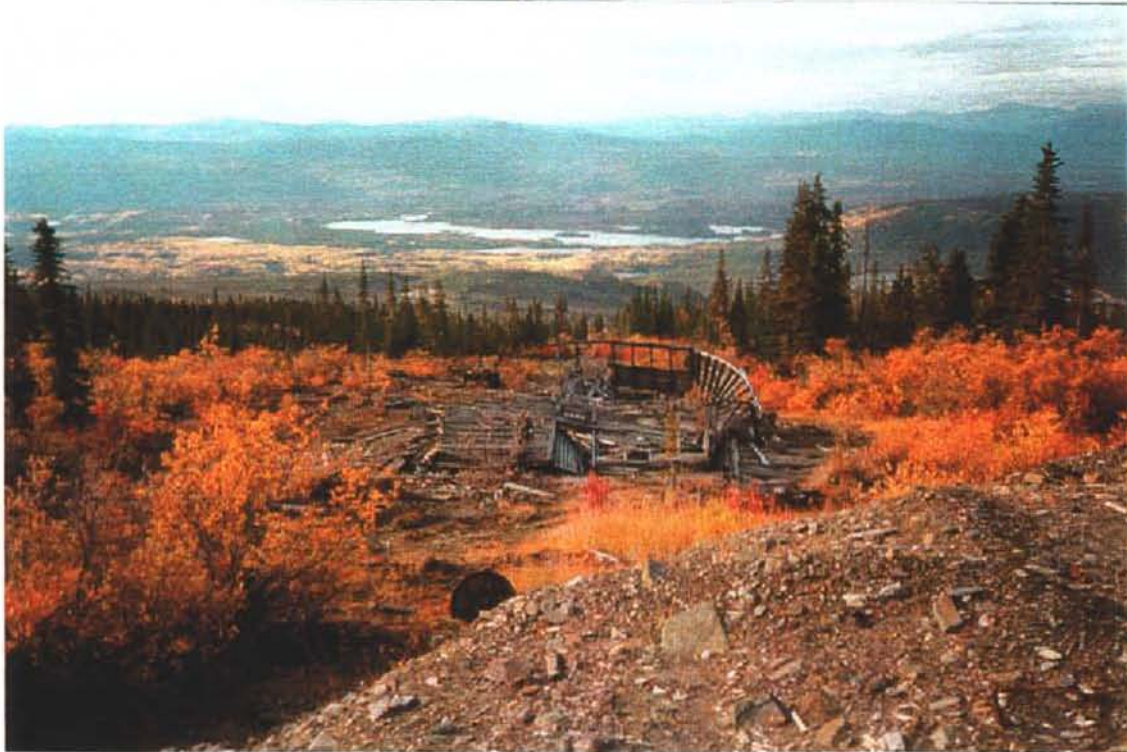
Photo 21-17: Collapsed building (Bldg. 21-J). (Azimuth 320°)

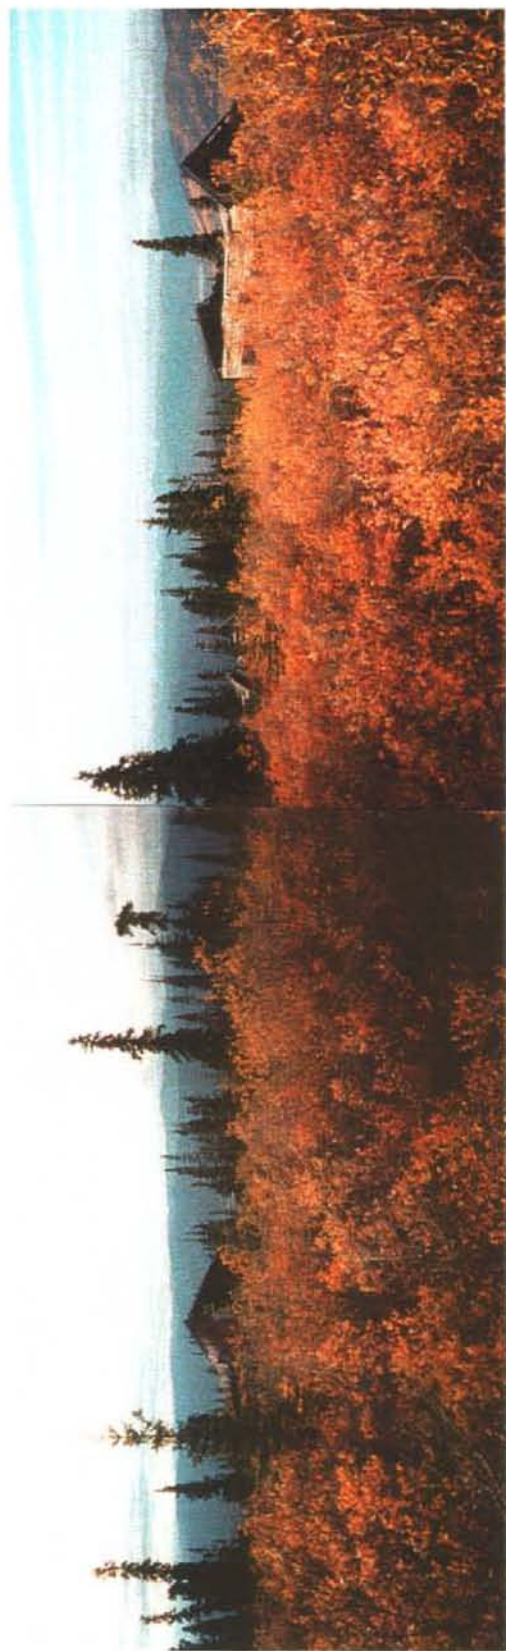
Photo 21-19: Partially collapsed buildings (Bldgs. 21-L). (Azimuth 280-340°)

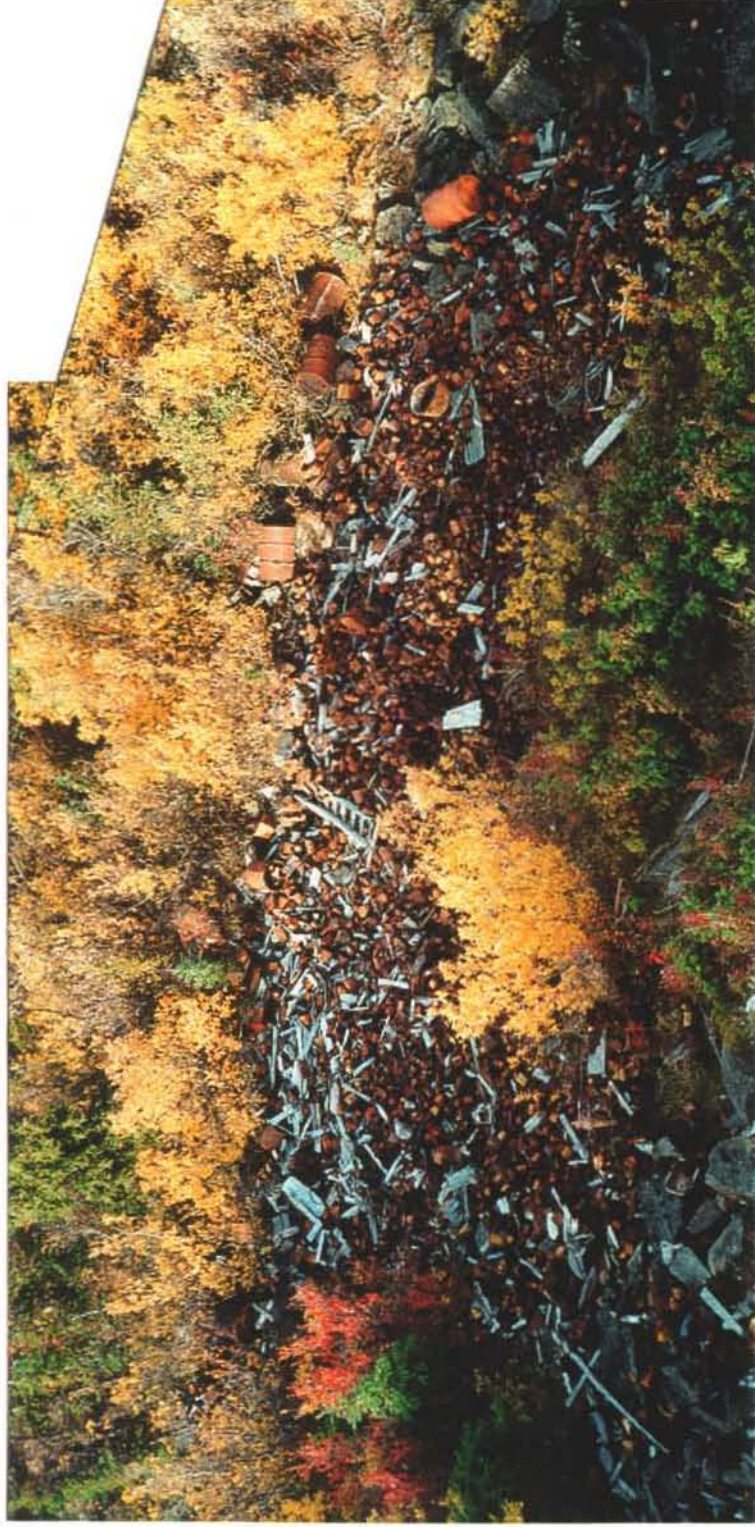
Photo 21-20: Dump site consisting primarily of cans and glass below cookhouse. (Azimuth 000°)

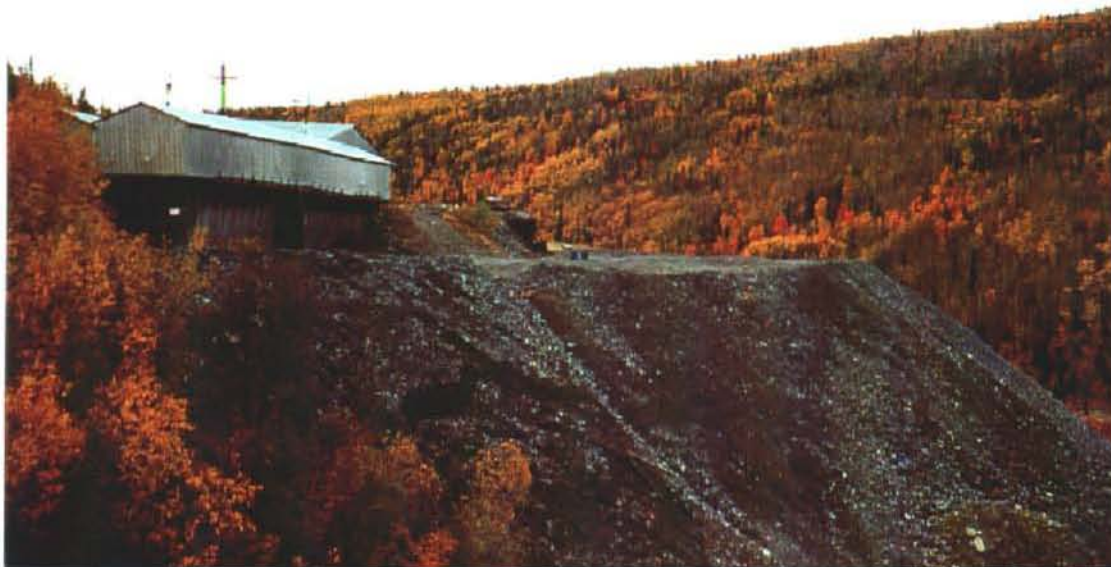
Condition: The portal and underground workings are in good condition and continue to be maintained by United Keno Hill Mines.

Photo 22-1: View of Bellekeno 625 level adit site from opposite side of Thunder Gulch

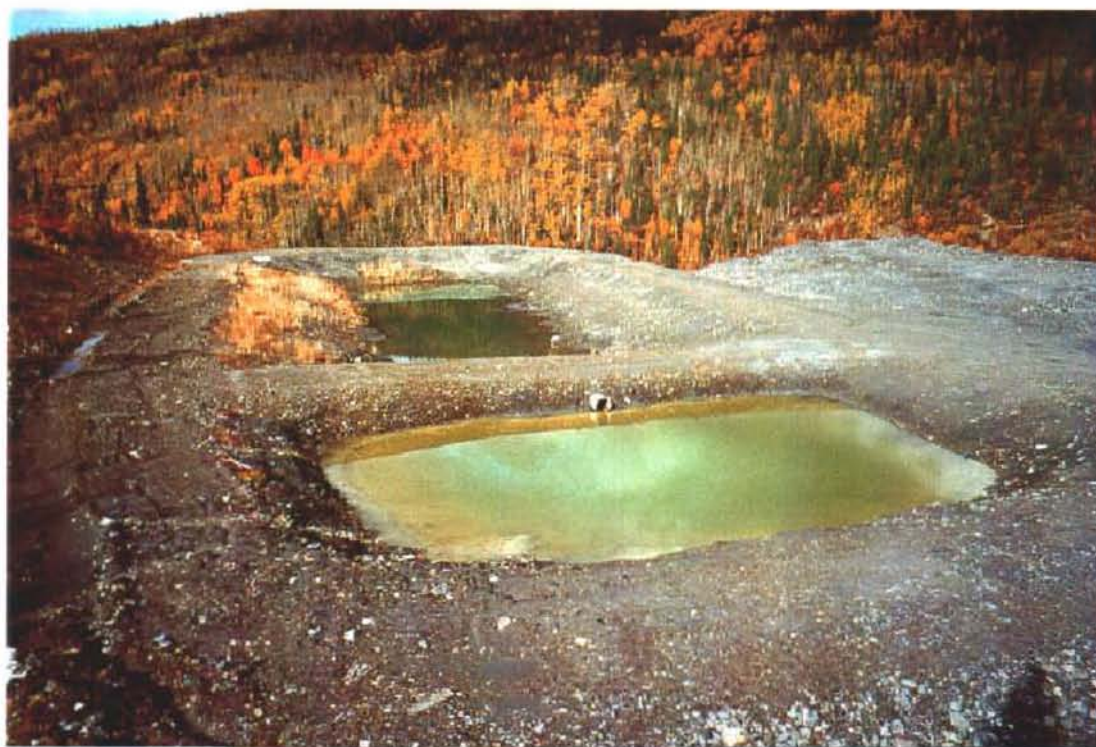
Water collected in the Bellekeno mine system is pumped out at the 625 level and treated with lime to neutralize acid in the effluent. The treated water is collected in two ponds at the Bellekeno 625 level site where lime and precipitates are allowed to settle (photo 22-2).

Piping: PVC tubing is used to carry the effluent from the mine to the treatment plant and from the treatment plant to the settling ponds. There were no breaks or leaks observed in the piping.

Photo 22-2: Settling ponds for treatment of water removed from Bellekeno mine at 625 level adit.

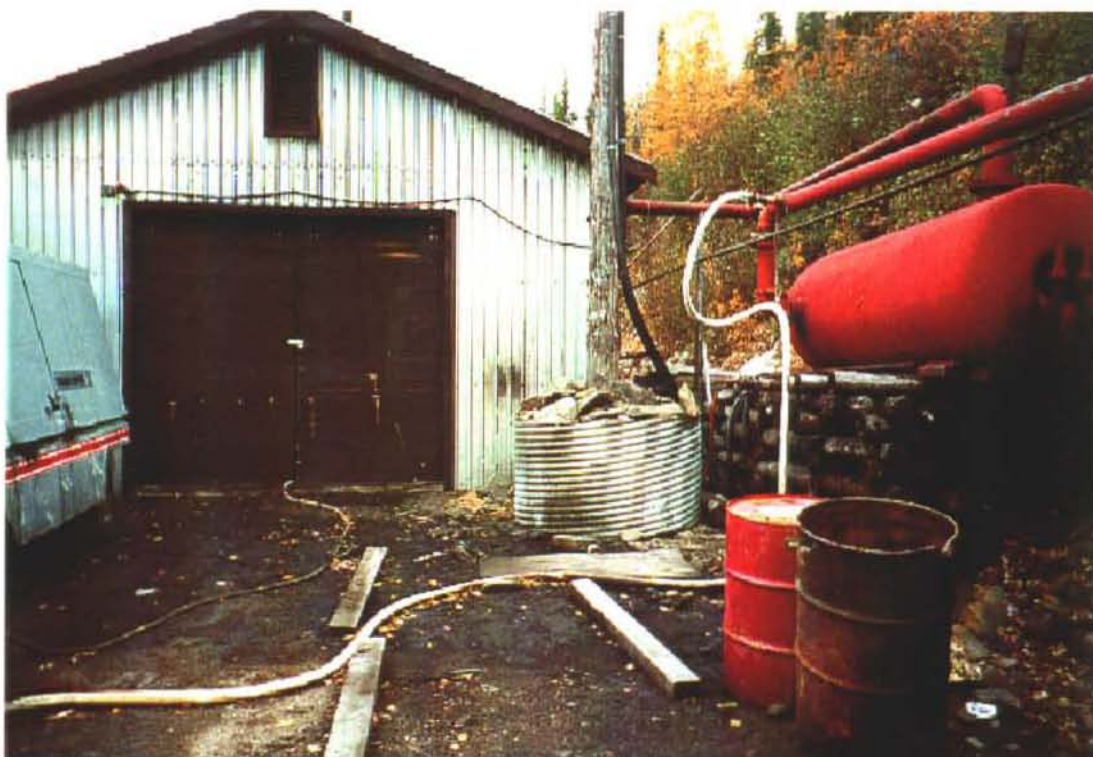
Building 22C is the Bellekeno 625 level adit compressor house. 3 compressors are housed inside the building and another mobile compressor is situated outside. A 2000 L gasoline storage tank is located in this building and appears to have been leaking at some time. The AST is currently empty. The building is also being used to store a variety of fuels, solvents and lubricants. The floor of this building is heavily stained with hydrocarbons.

Photo 22-4: Compressor house at Bellekeno 625 level adit (Building 22C). Hydrocarbon staining is evident at entrance.

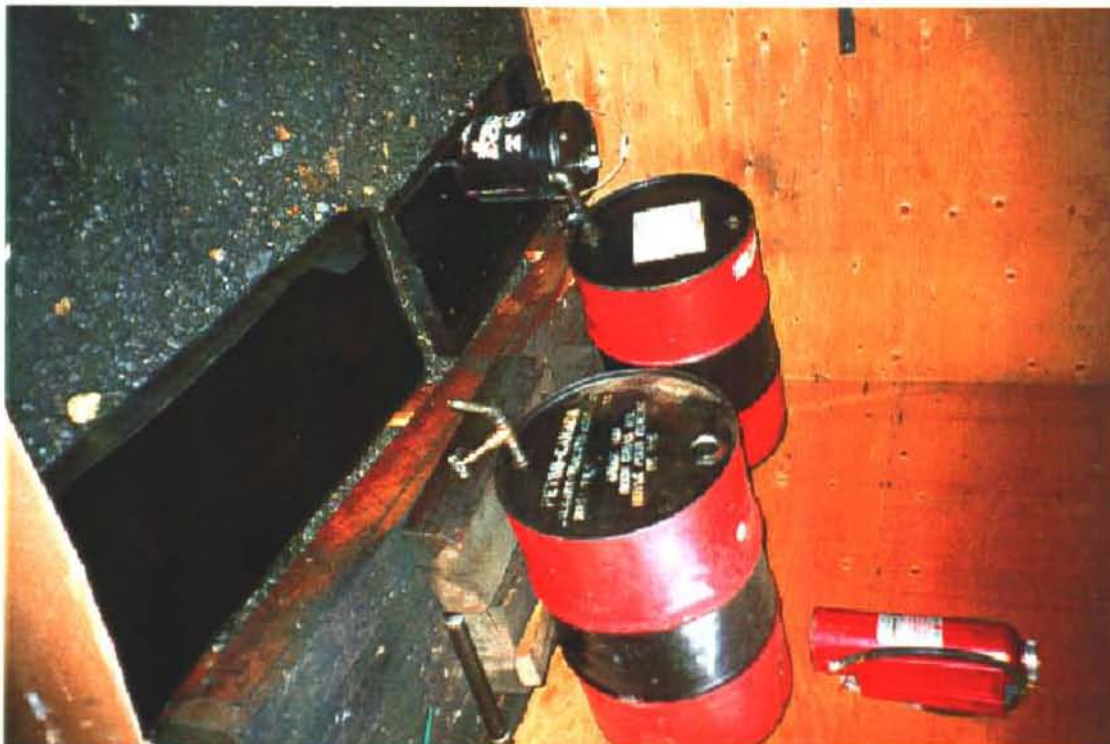
Several containers of liquid hazardous materials were observed in the compressor house at the Bellekeno 625 level adit site (photo 22-6).

Photo 22-6: Oil barrels fitted with dispensing valves located inside compressor house. Spill trays are filled with oil and hydrocarbon staining is evident on floor.

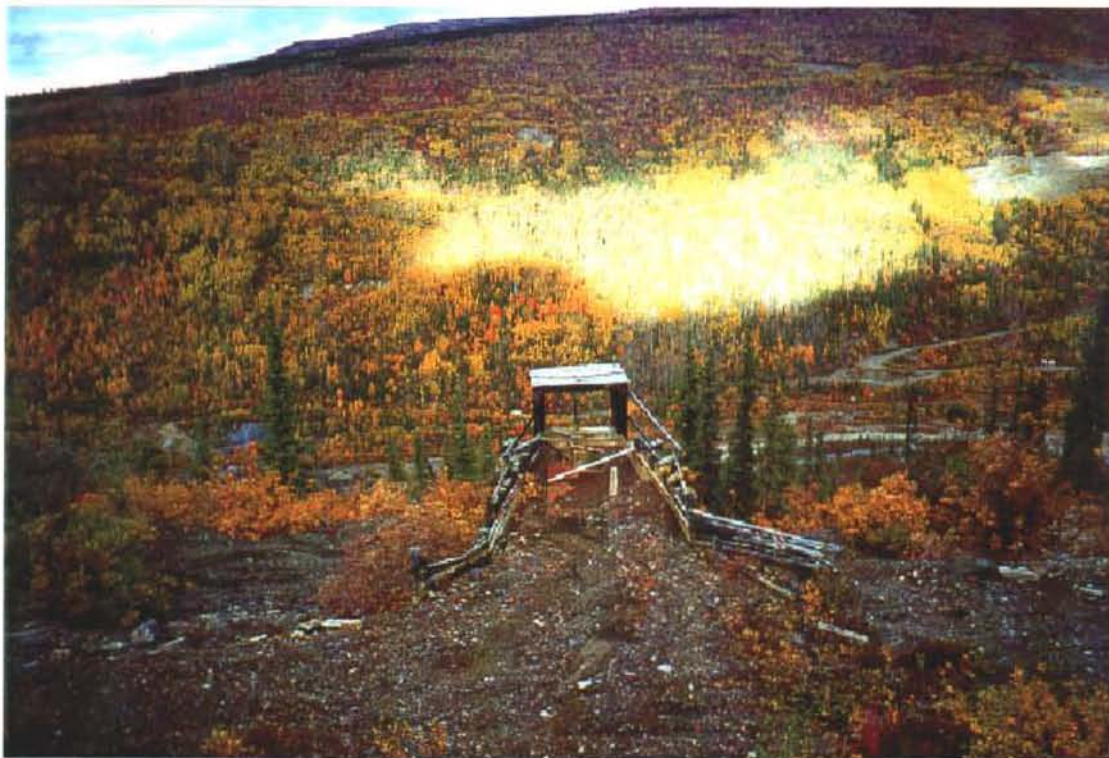
There is a dump point with a grizzly located at the Bellekeno 200 level adit site (photo 22-8). It is located at the top of the lower waste rock pile (WR200b). The structure is made of logs and planks. It is in poor condition and in danger of collapsing. There was no other milling or processing infrastructure discovered at the Bellekeno site.

Photo 22-8: View of wooden load out from the edge of waste rock dump at Bellekeno 200 level adit (Azimuth 020°)

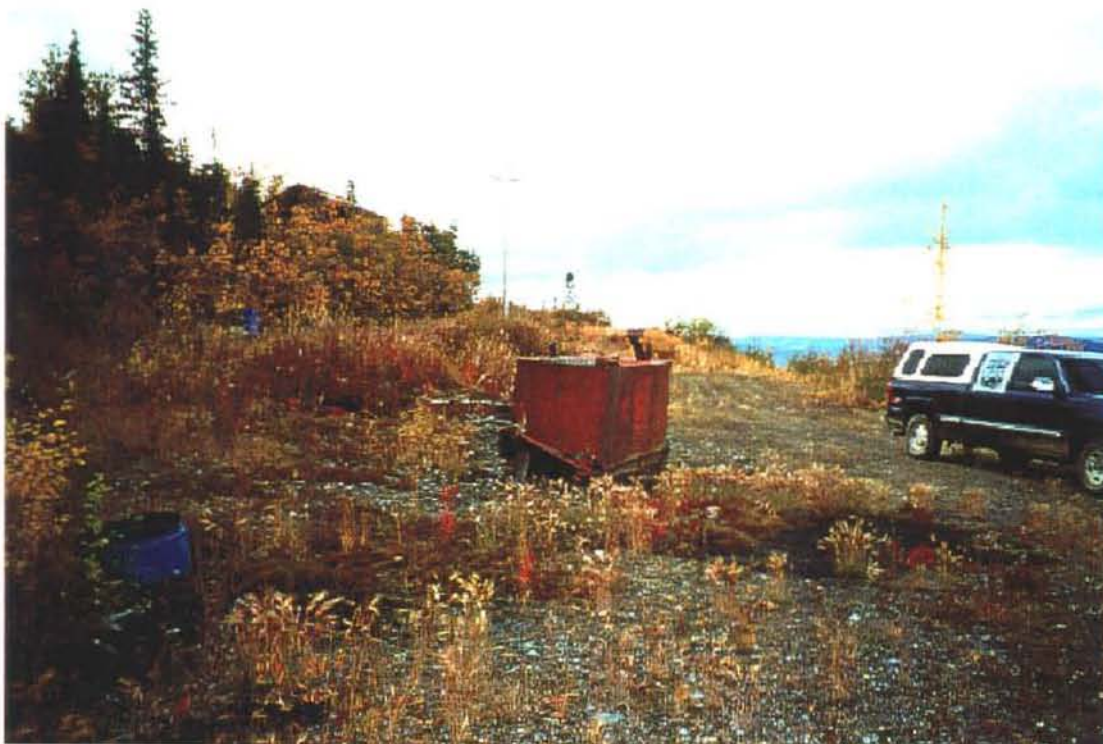
Photo 22-9: View of mobile fuel storage tank containing diesel and gasoline located adjacent to Bellekeno 20d0 level adit (Azimuth 304°)

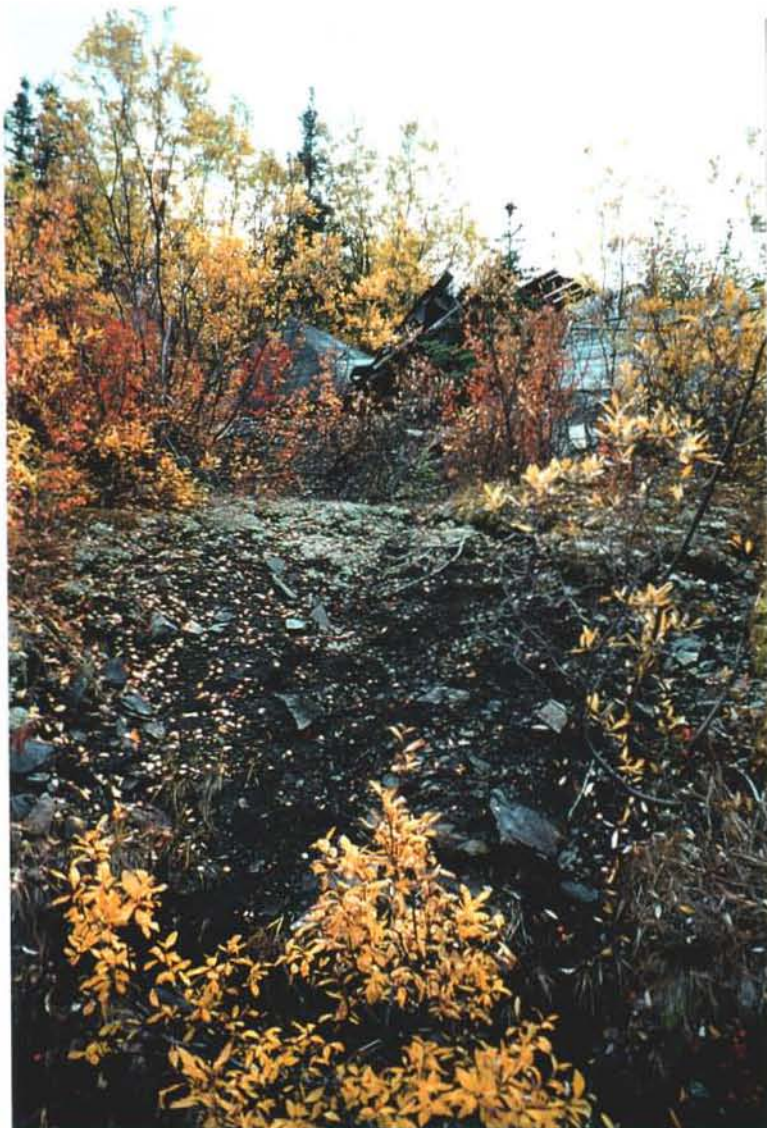
Condition: Both the adit portal and the shaft house have collapsed.

A waste rock pile is located just below the Bellekeno 100 level adit. The pile is 8 m long, 3 m wide and 3 m high. The waste rock in this pile consists of grey quartzite with siderite, quartz, pyrite, galena, and limonite mineralization. The waste rock is minorly rusted. The paste pH of an undocumented rock sample taken of the waste rock pile was 7.1. Parts of the waste rock pile were displaced during the construction of an adjacent power line. There is some natural reclamation of the site by moss and shrubs along the sides and top of the waste rock pile.

Photo 22-10: Collapsed entrance to Bellekeno 100 level adit with waste rock dump in foreground.

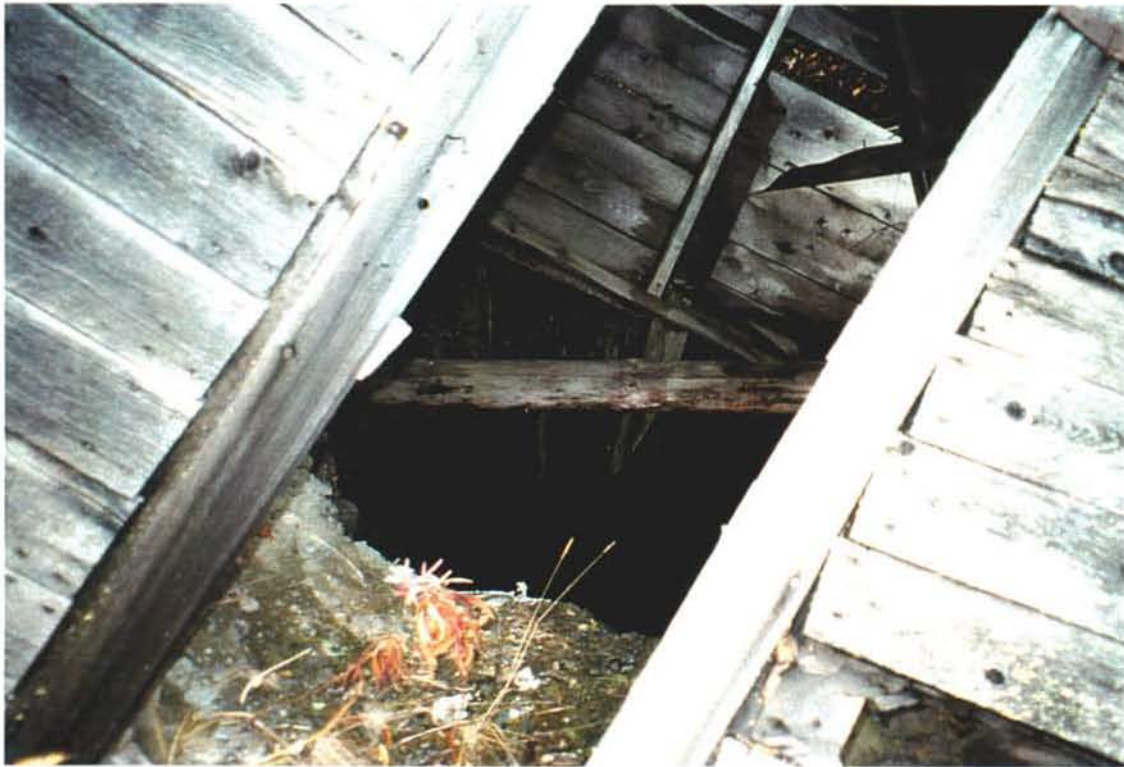
Photo 22-11: Collapsed structure enclosing shaft across Sourdough Hill Road from Bellekeno 100 level adit

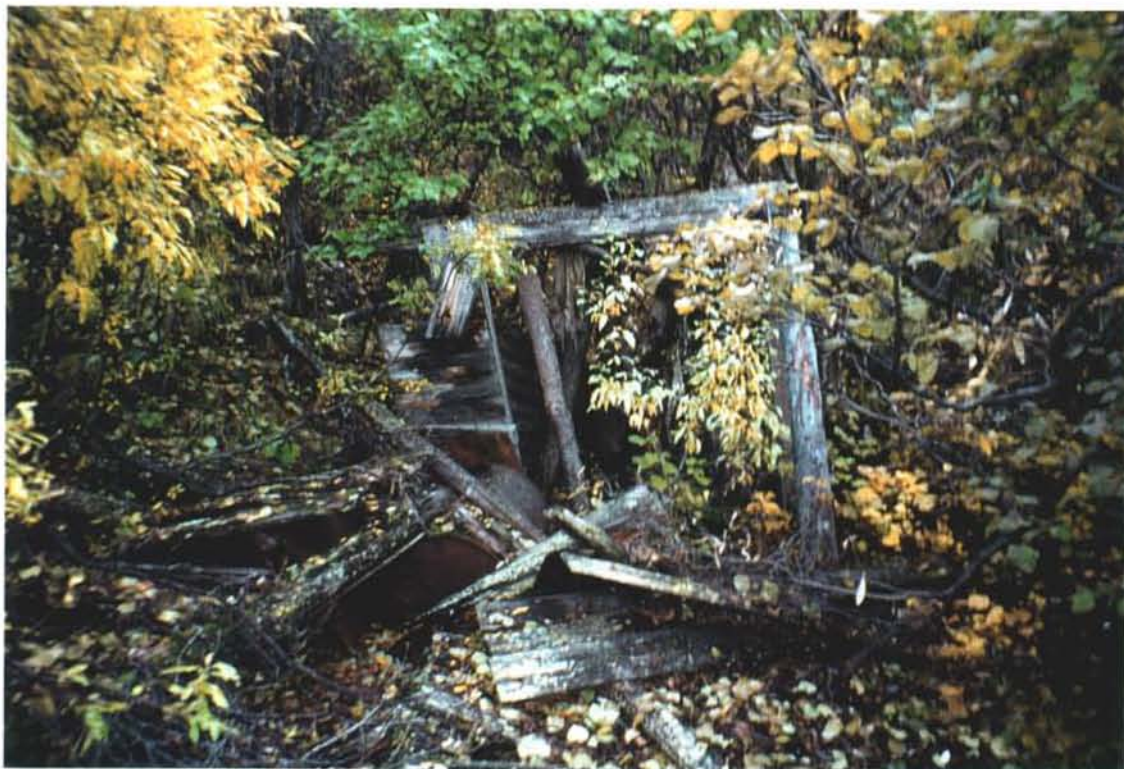
Condition: The adit portal has collapsed.

A waste rock pile is located at the Mayo Mines adit. The pile is 12 m long, 10 m wide, and 5 m high. The waste rock in this pile consists of grey quartzite with minor amounts of greenstone. Mineralization consists of sphalerite. The waste rock is minorly rusted. Waste rock sample 99-22-4-1 was taken from this pile. The field paste pH of this sample was 7.6. There is some natural reclamation of the site by moss and shrubs along the sides and top of the waste rock pile. Laboratory analysis data are contained in Attachment B.

Photo 22-12: View of collapsed entrance to Mayo Mines adit (Azimuth206°)

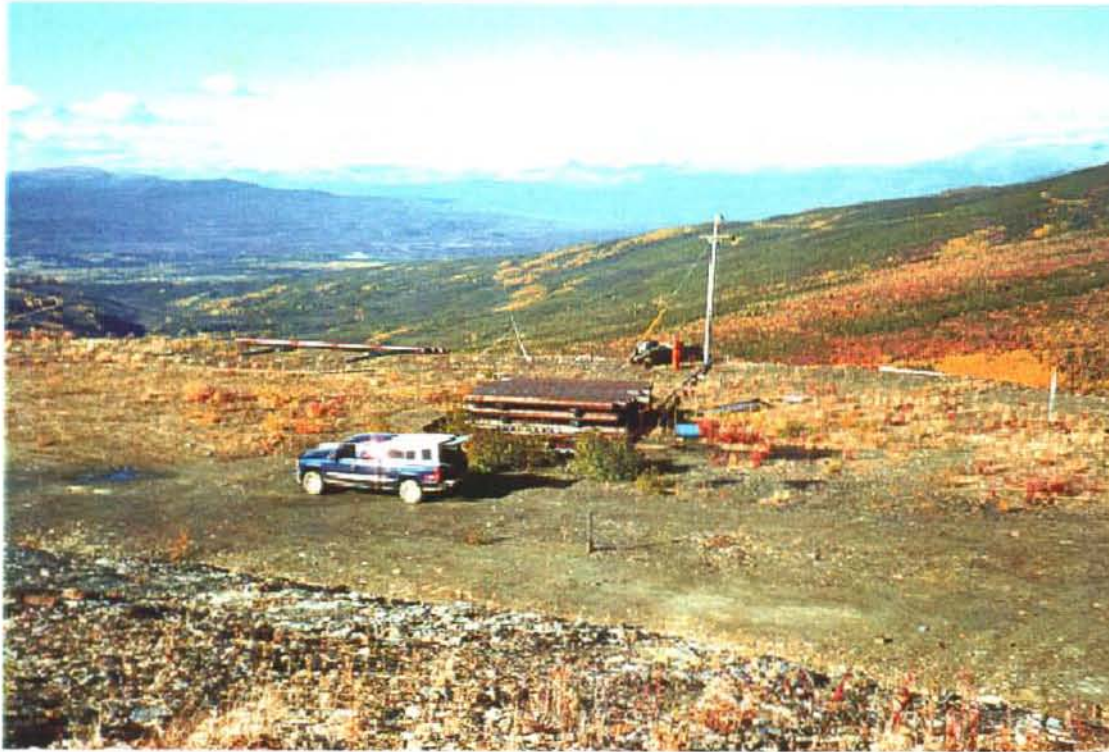
The Bellekeno backfill pad was the site of an attempt to drill a hole from the surface into the Bellekeno mine workings. The hole was to be used to backfill the underground tunnels. The operation was abandoned before the drilling was completed. An area of soil contamination was observed at this site adjacent to the drilling site (see Figure 4; photo 22-14). The source of contamination appears to have been the oily metallic sludge produced during the drilling operation. The estimated depth of the contaminated soil is 0.15 m. The estimated dimensions of the area of contamination are 12 m x 4 m. Two more small areas of surface staining were observed adjacent to the larger area. Soil sample 99-22-1-1-.01 was taken from the contaminated area at a depth of 10 cm. A background sample was taken of the soil at the Bellekeno Backfill site at a depth of 10 cm (sample 99-22-1-2-.01). Laboratory analysis data are contained in Attachment B.

Photo 22-13: Bellekeno Backfill site. Drilling site is at centre of photograph next to laydown of pipes.

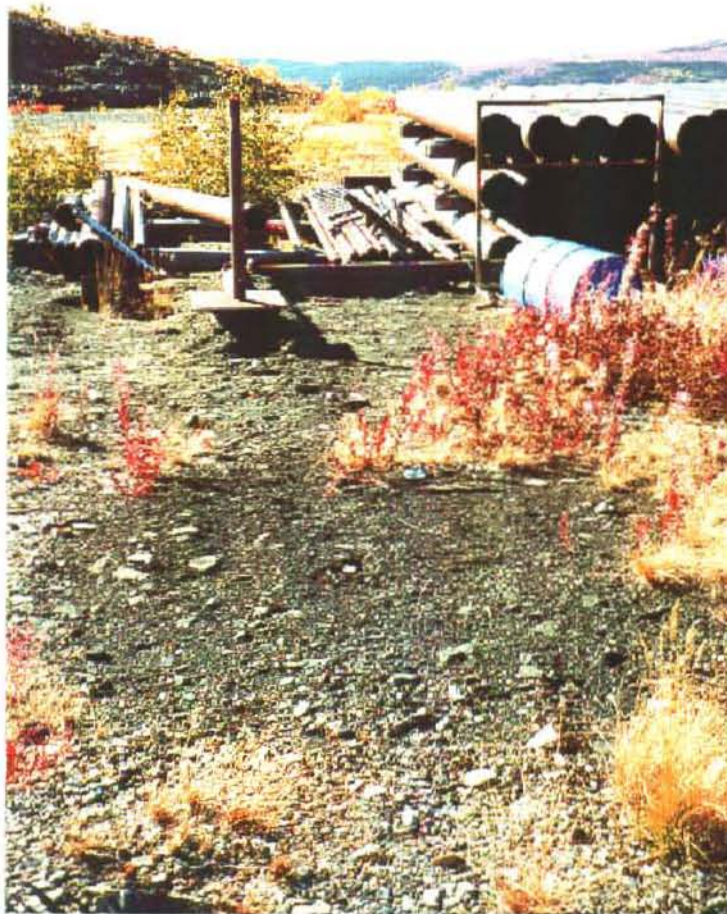
Photo 22-14: Drilling site with soil staining in foreground. Laydown of piping and empty hydraulic fluid barrel are in background.

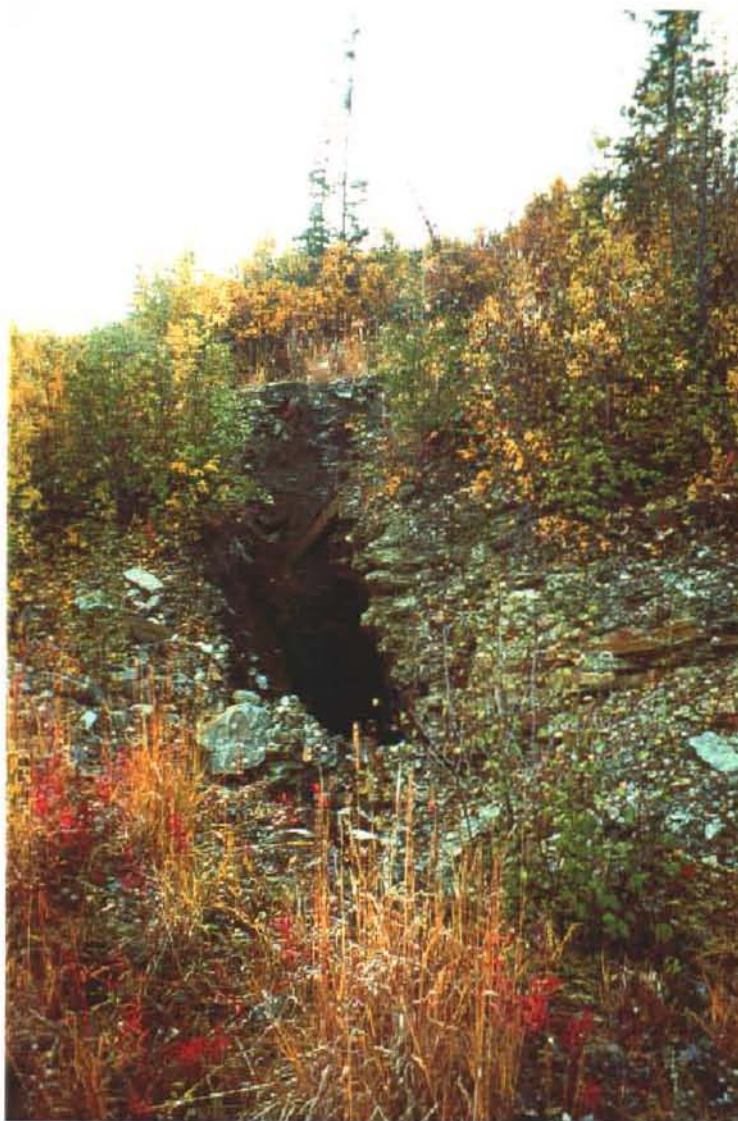
Shaft 1 is the most obvious because it lies in the middle of a trail leading off of Sourdough Hill Road. It is connected to an adjacent open stope that has broken through to the surface (see Figure 5).

Condition: The shaft and stope remain unstable and could be prone to continued collapse.

Photo 22-16: Stope broken through to surface just below Eureka Shaft 1.
