# KENO VALLEY/DUBLIN GULCH ENVIRONMENTAL BASELINE ASSESSMENT

VOLUME III: Keno Valley Sites #21 to #40

Prepared for  
Waste Management Program  
Indian and Northern Affairs Canada

March, 2000

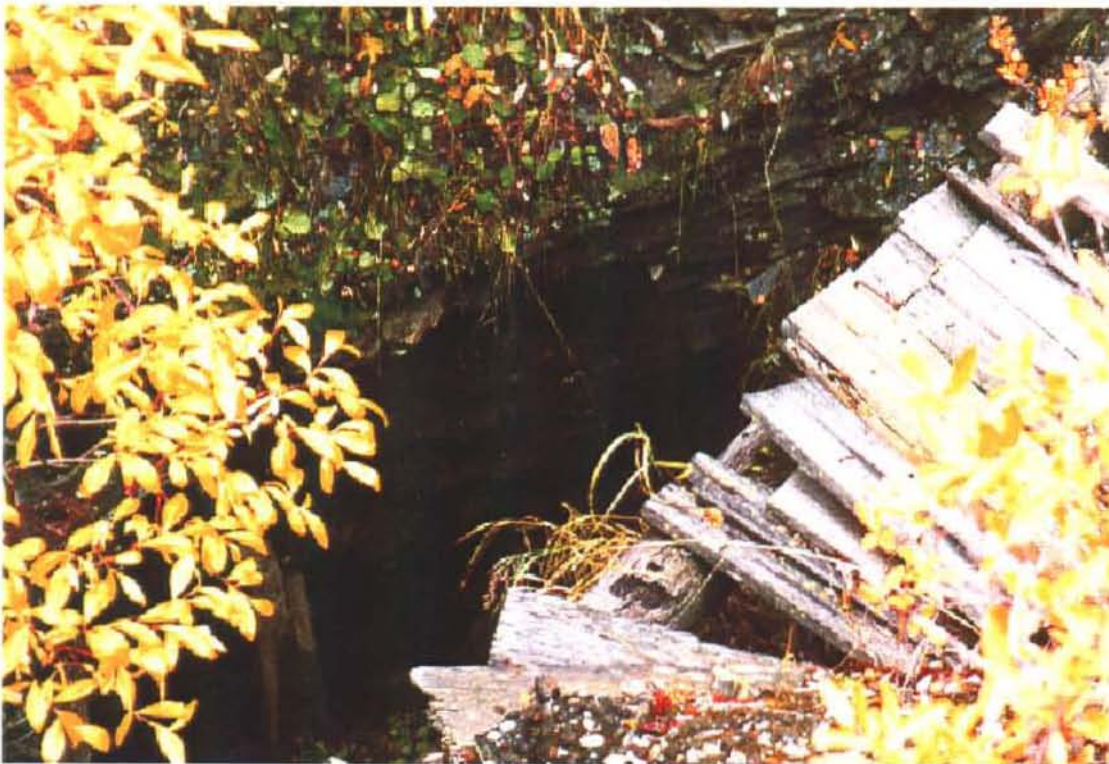
Condition: This shaft remains unstable and could be prone to continued collapse.

A waste rock pile is located at the Eureka workings near Eureka Shaft 3 (see Figure 5). The pile is 3 m long, 2 m wide, and 2 m high. The waste rock in this pile consists of steely grey and rusty oxidized ore. The rock is mainly grey quartzite with minor amounts of greenstone. Mineralization includes siderite, sphalerite, limonite, pyrite, and trace galena. Waste rock sample 99-22-06-01 was taken from this pile. The field paste pH of this sample was 6.4. Laboratory analysis data are contained in Attachment B.

Photo 22-18: Partially collapsed shaft (Eureka Shaft 3) located about 37 m south of Eureka Shaft 1.

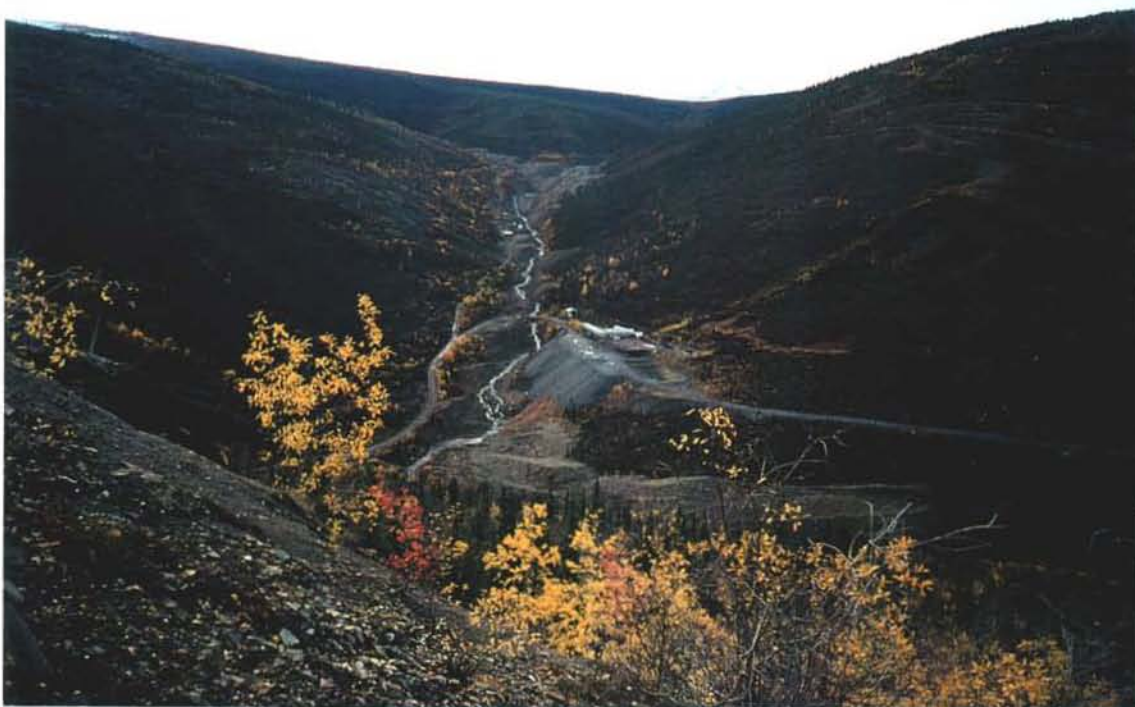
Photo 22-20 : Overview of Bellekeno site. Note use of mine waste rock for road ballast and its proximity to creek in Thunder Gulch.(Azimuth 170°)

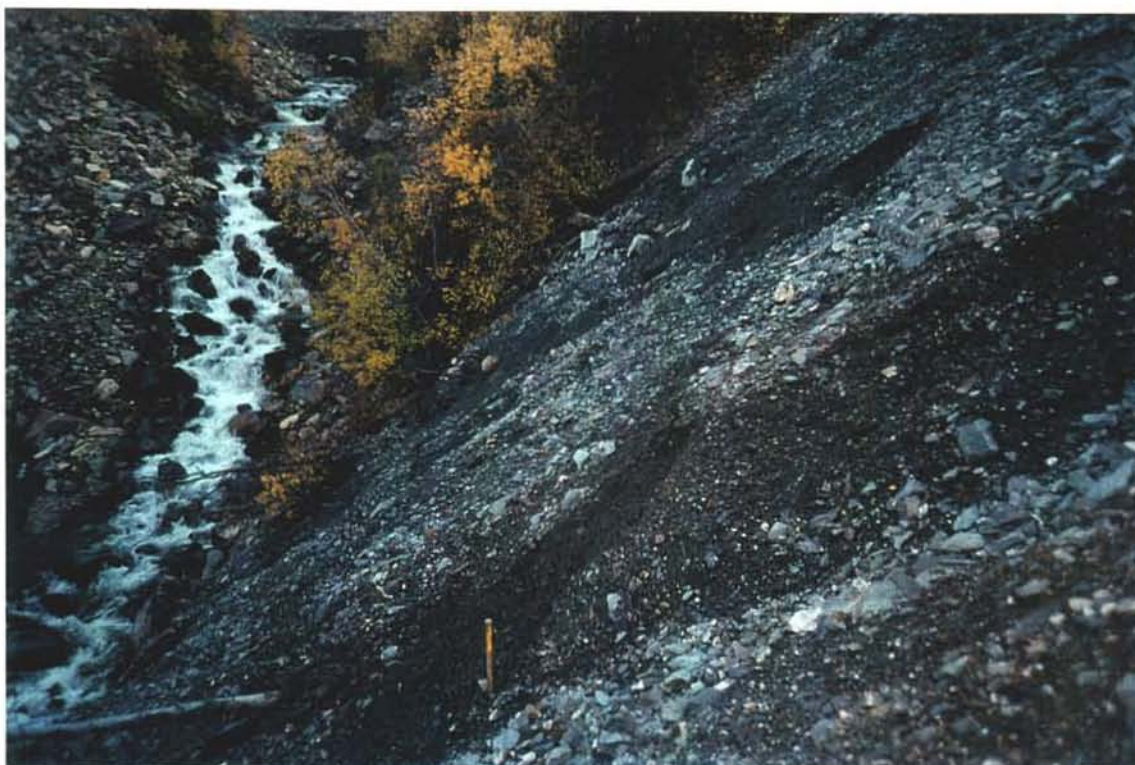
Photo 22-21 : Slumping evident in Bellekeno mine waste rock above Thunder Gulch creek. (Azimuth 160°)

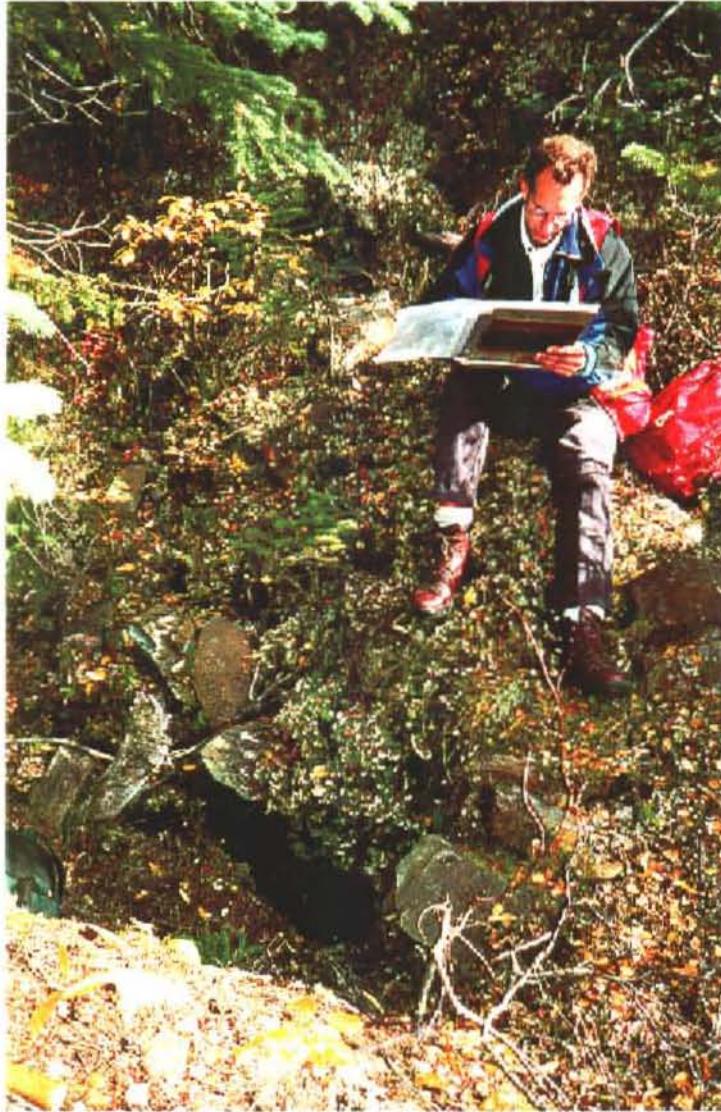
Photo 23-1: Caved lower portal area; note small opening below mapper's feet and natural revegetation of the site. Photo Direction (Azimuth 040°)

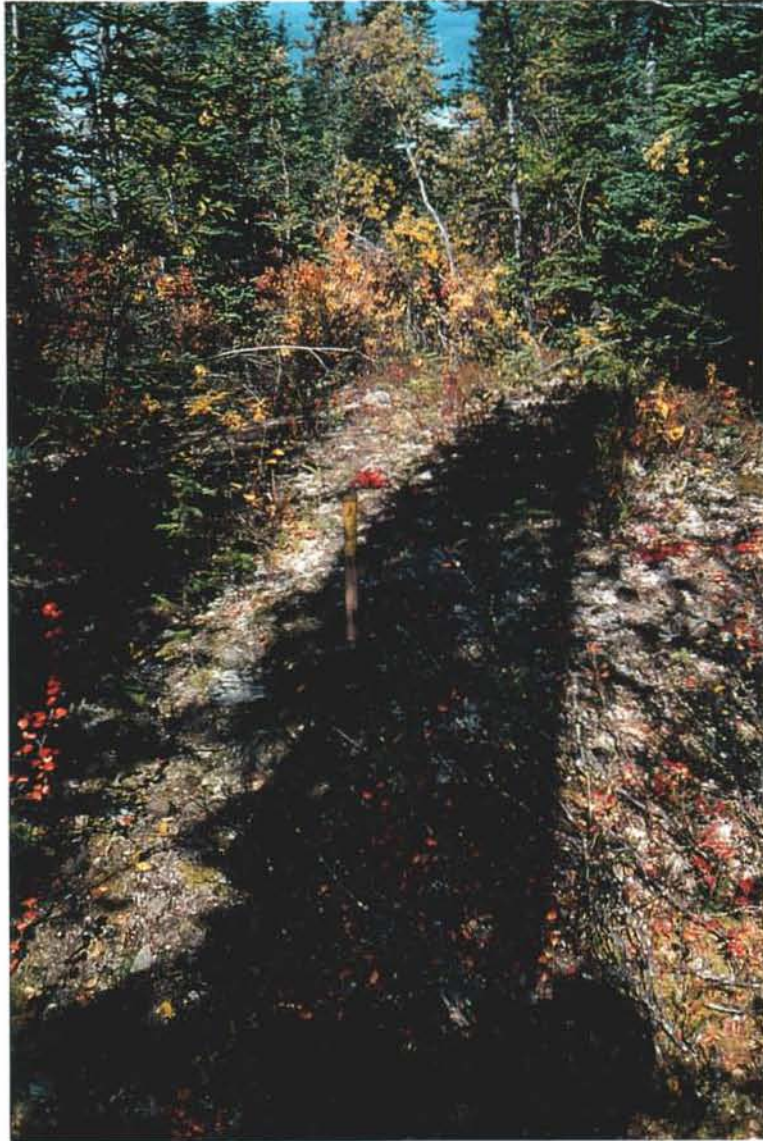
Photo 23-2: Rock dump from lower trench and adit. Note heavy natural revegetation. Photo Direction(Azimuth 340°)

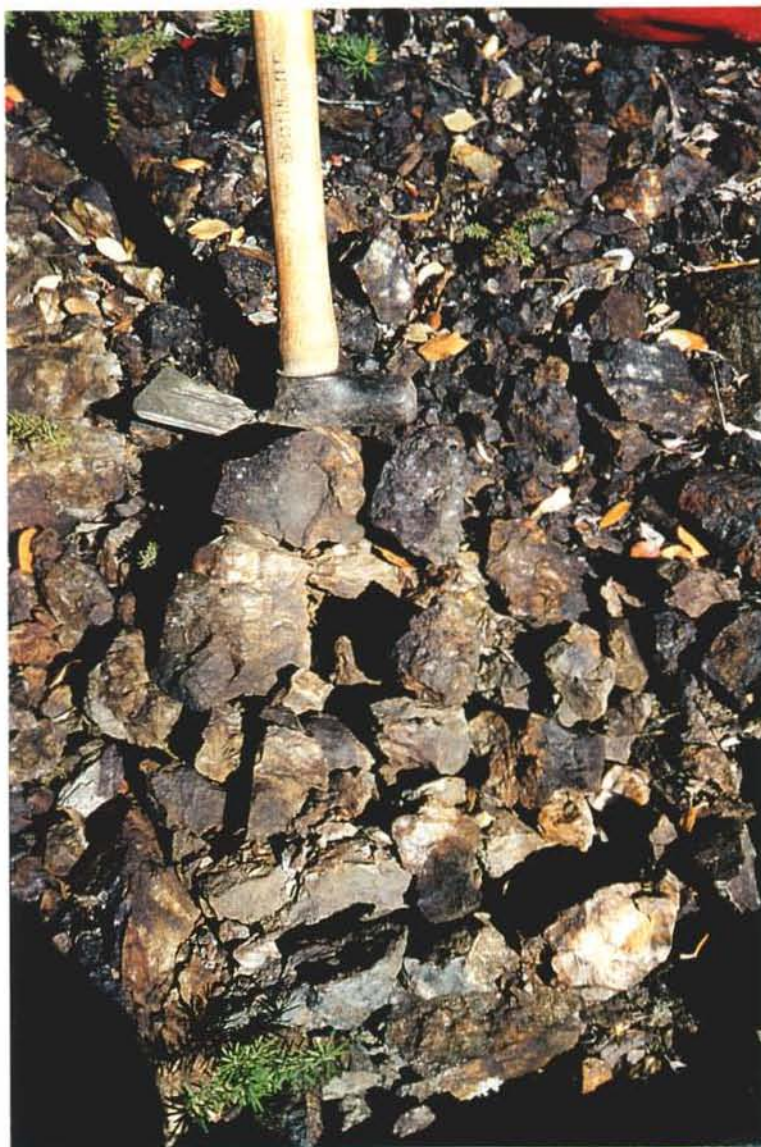
Photo 23-3: Close-up of strongly weathered, semi-massive galena-tetrahedrite siderite-quartz vein ore stockpile material (5m x 3m x 0.5m).

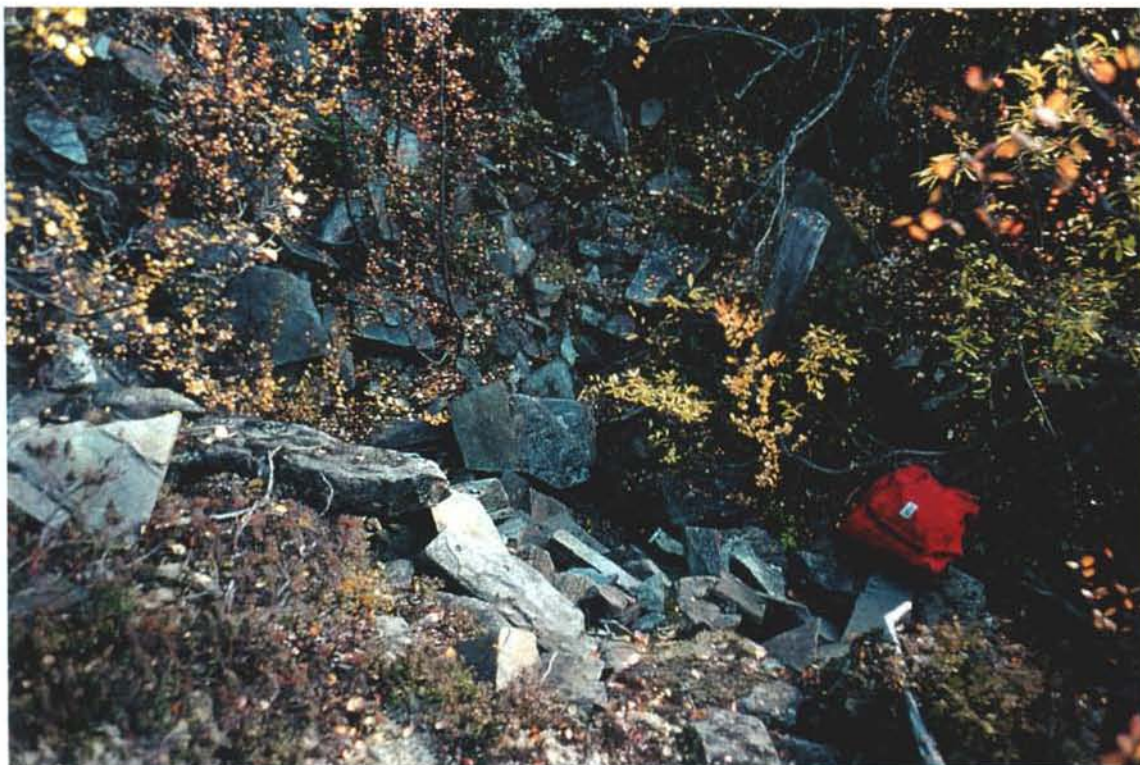
### **Middle Adit/Trench (photo 23-4)**

Photo 23-4: Collapsed middle trench and adit area. Note portal timber above pack protruding from angular colluvial greenstone boulders.  
Photo Direction (Azimuth 150°)

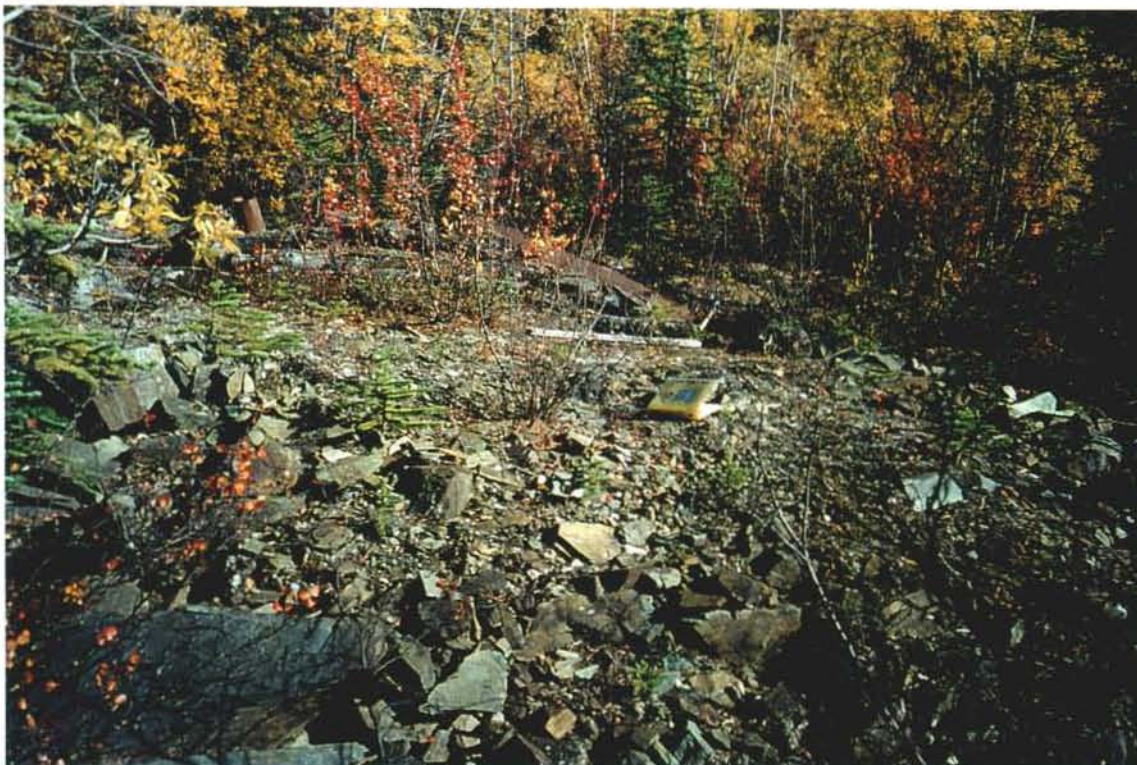
### **Waste rock pile #1 (photo 23-6)**

Photo 23-6: Rock dump from upper trench and adit (18m x 4m x 2m). Material comprised of approximately 80% colluvial soil and angular greenstone boulders.  
Photo Direction (Azimuth 120°)

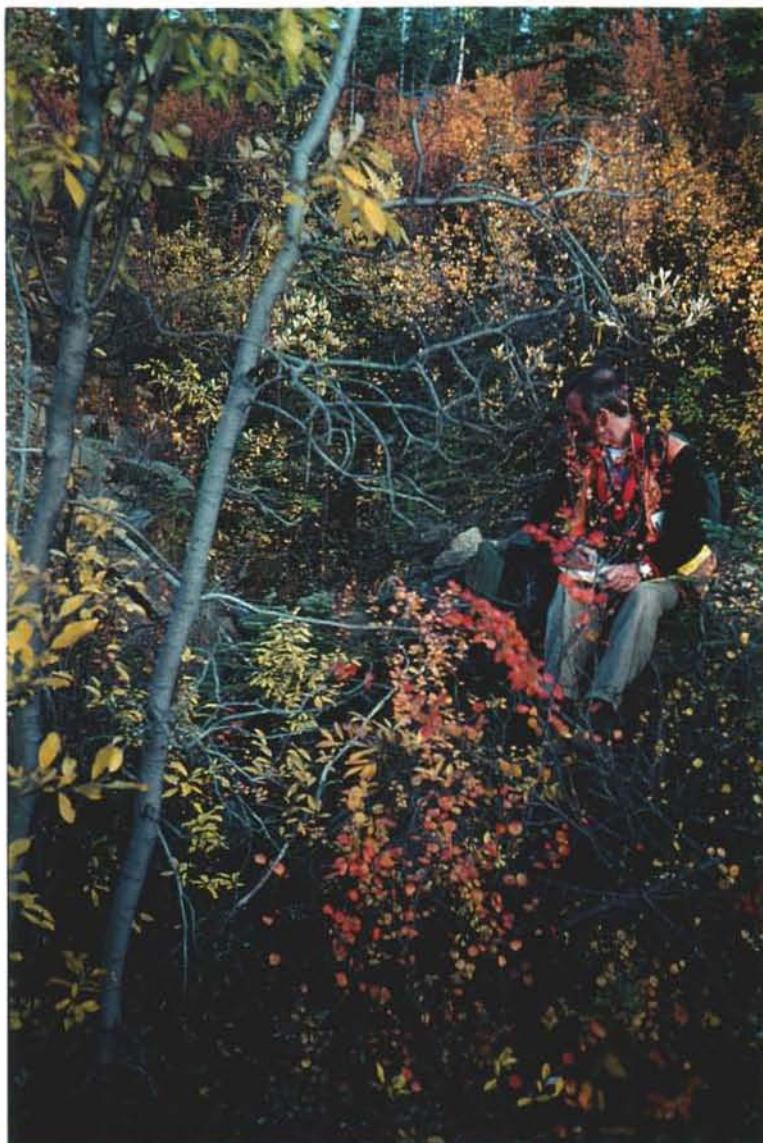
### **Upper Adit/Trench (photo 23-5)**

Photo 23-5: Collapsed upper trench and adit area.  
Photo Direction (Azimuth 120°)

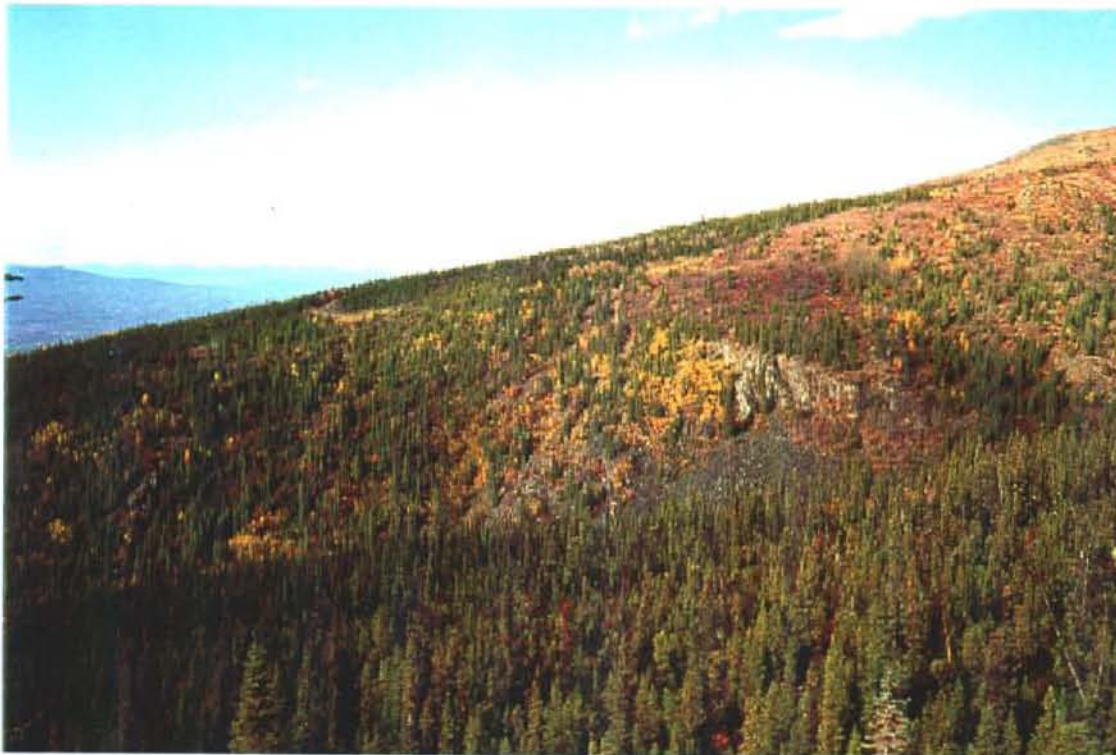
Croesus No. 1 is located on a moderately steep, 26° slope within Erickson Gulch on the west side of Keno Hill. The site has a southern aspect and is thickly vegetated with spruce, fir, alder and willow. Below 1230m, the site occurs within the talus debris fan of a prominent outcrop of greenstone that extends up the slope of the hill. Soils are poorly developed, derived from colluvial materials and ranging in thickness up to 1.5m. Above 1230m, bedrock is covered with a blanket of glacial gravels. Permafrost is likely, especially in the shadow of the gulch on the lower portions of the slope. Minor earth flows are evident on the slope immediately west of the site.

Photo 24-1: Overview of Croesus site. Note waste rock dump WR-02 from Adit #2 at phot centre; also Blackcap (Site #25) waste rock dumps at top right corner. (Azimuth 350°)

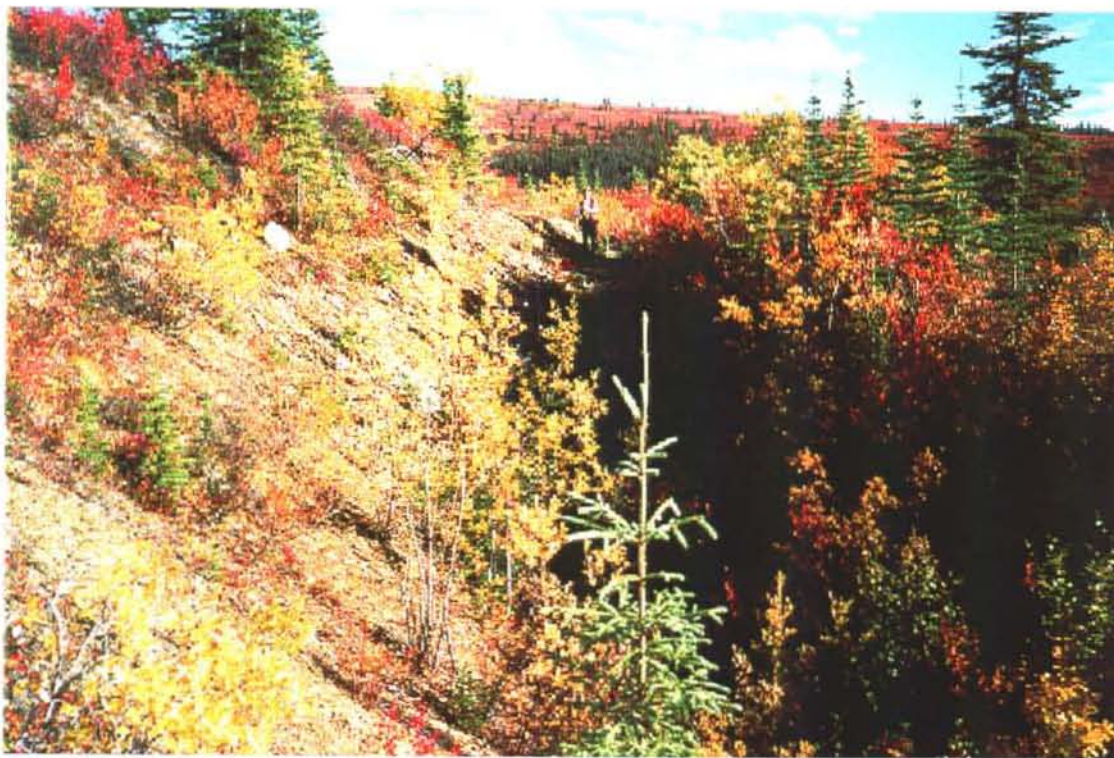
### **Trench #1 (Photo 24-2)**

Trench #1 occurs at roughly 150m northeast of the Blackcap Road switchback. The trench was cut by bulldozer into glacial gravel and broken phyllite bedrock to a depth of 5m. The trench arcs in a 30m long semi-circle with steep sides that slope up to 40° into a narrow v-shape. The slopes are loose, but not a hazard. The site is partially revegetated with willows.

Photo 24-2: Upper Trench #1 into thick colluvial soils.(Azimuth 130°)

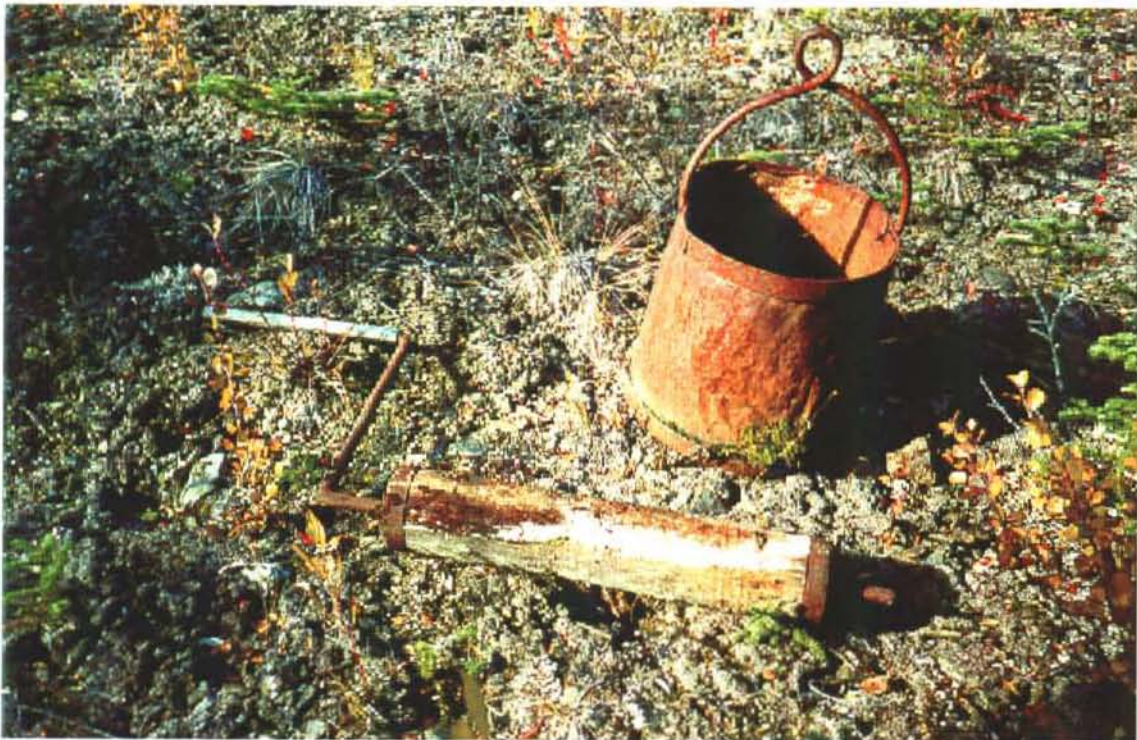
There are three shafts indicated on a map prepared in the 1960's by Boyle. A windless and a shaft bucket found in the base of the Trench #1 likely indicate the location of Shaft #1 (Photo 24-3). The shaft appears to have been filled by later trenching. A shallow boxhole dug into the overburden just above Adit #1 correlates to the site of Shaft #2 as indicated on Boyle's map. It is located at an elevation of roughly 1250m. The sides of the shaft have collapsed in and it is now less than a metre deep. There are no structures or equipment associated with it and it poses no risks. Shaft #3 is indicated by Boyle to be on the eastern side of Erickson Gulch just above the creek. This shaft was not investigated.

Photo 24-3: Windless and shaft bucket from backfilled shaft in area of upper trench (Shaft#1).

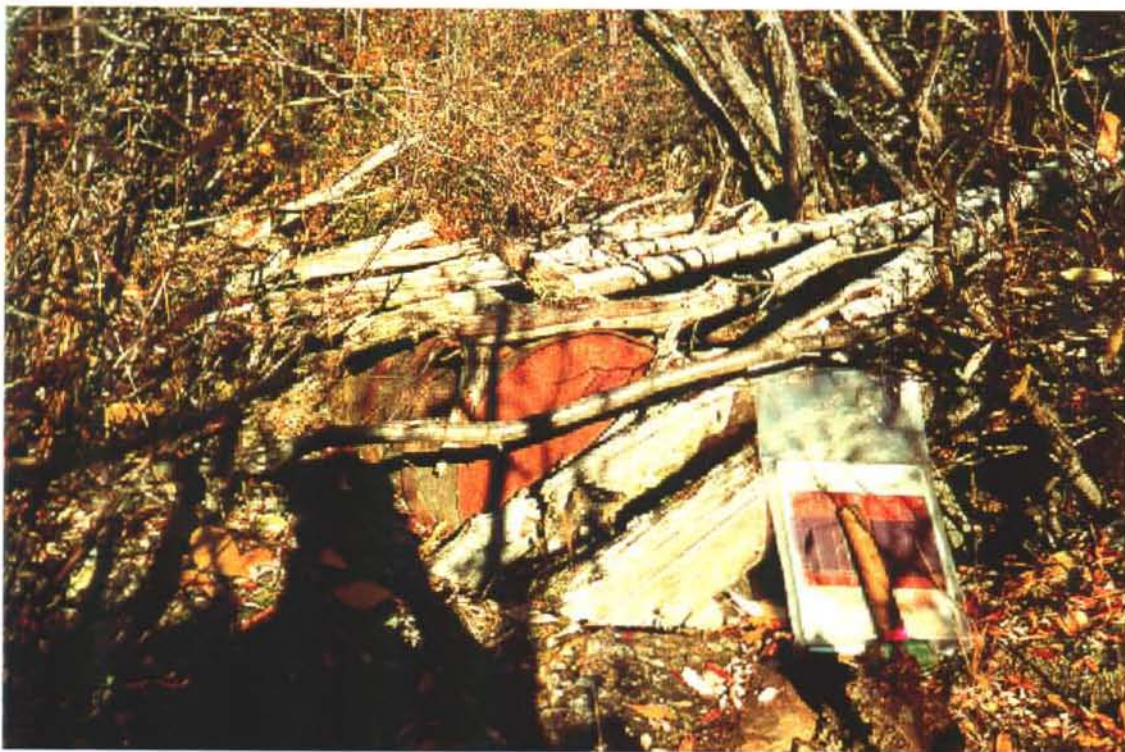
Photo 24-4: Adit #1 portal area. (Azimuth 030°)

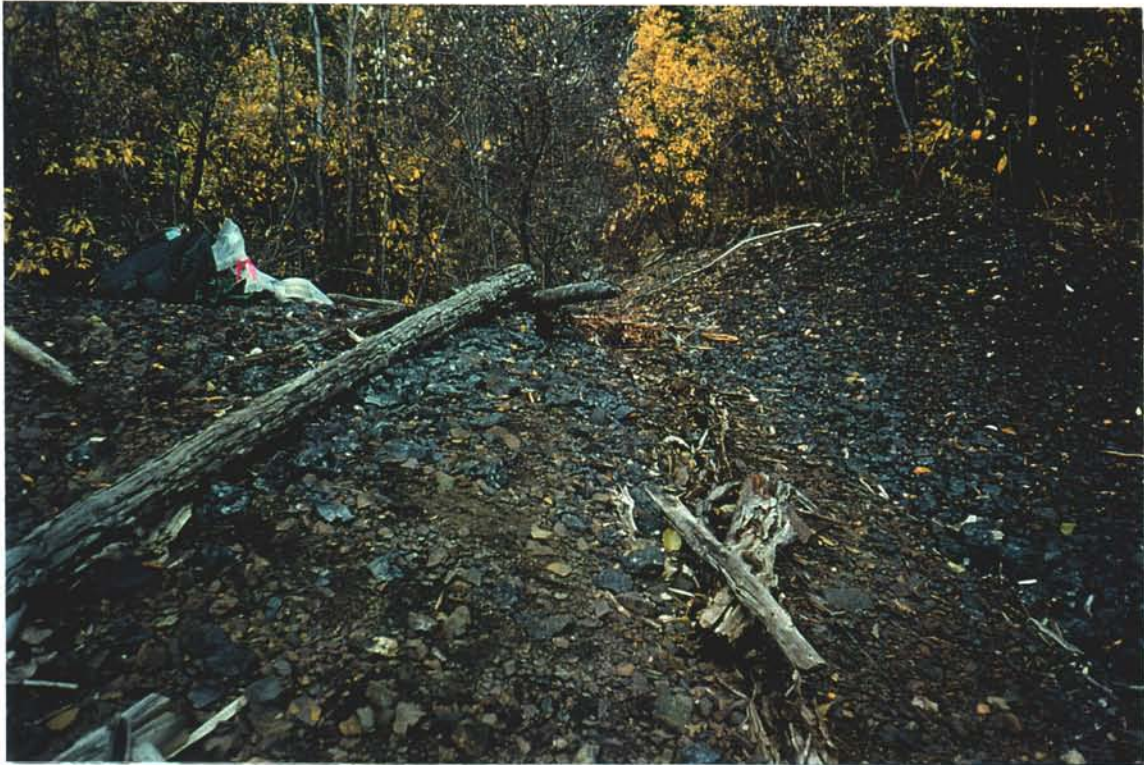
### **Waste Rock Pile WR-02 (photo 24-5, 24-624-7)**

This waste rock pile was formed by end dumping from Adit #2. The majority (~67%) of the surface rock is coarse crystalline siderite, roughly 30% is blocky greenstone, 3% is quartz and there is trace calcite. The slope of the pile is about 30°. There is abundant manganese staining in the siderite vein material. Strong oxidation occurs to a depth of at least 50cm.

Photo 24-5: Top of waste rock dump WR-02. Note abundant manganese stained siderite vein material. (Azimuth 010°)

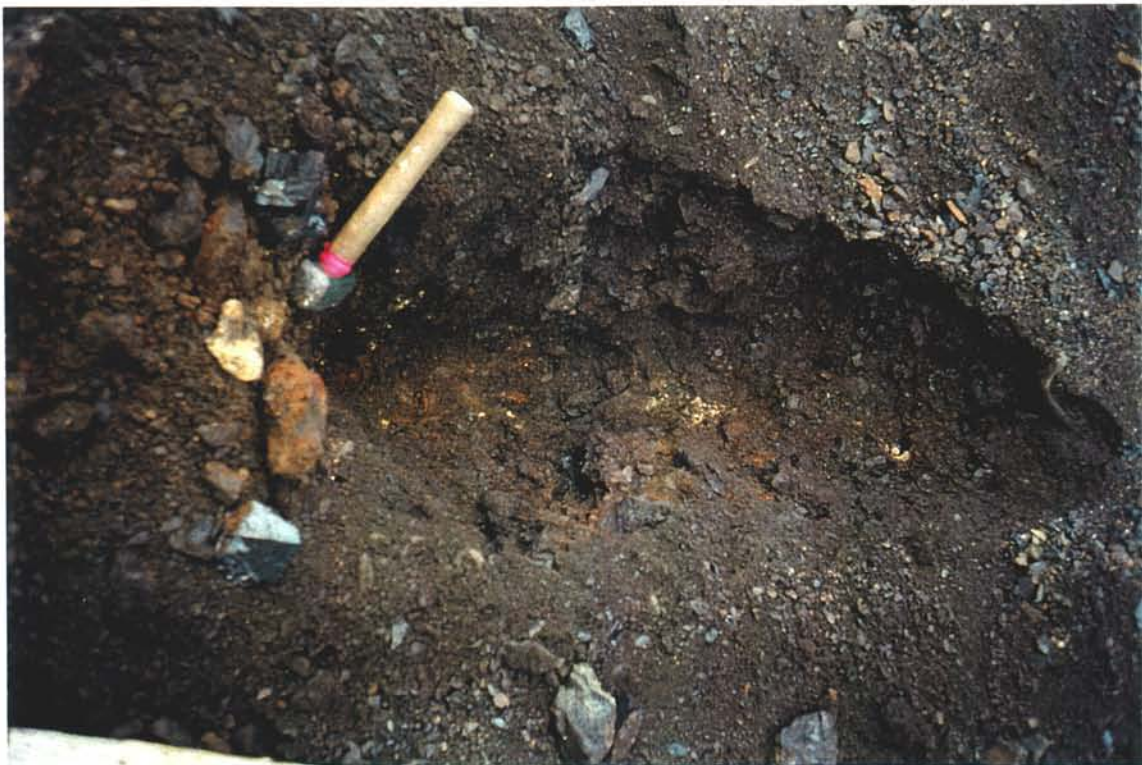
Photo 24-6: Waste rock dump WR-02 test pit (sample 24WR01-01) at Adit#2. Note strong oxidation at depth in pit and abundant siderite vein cobbles.

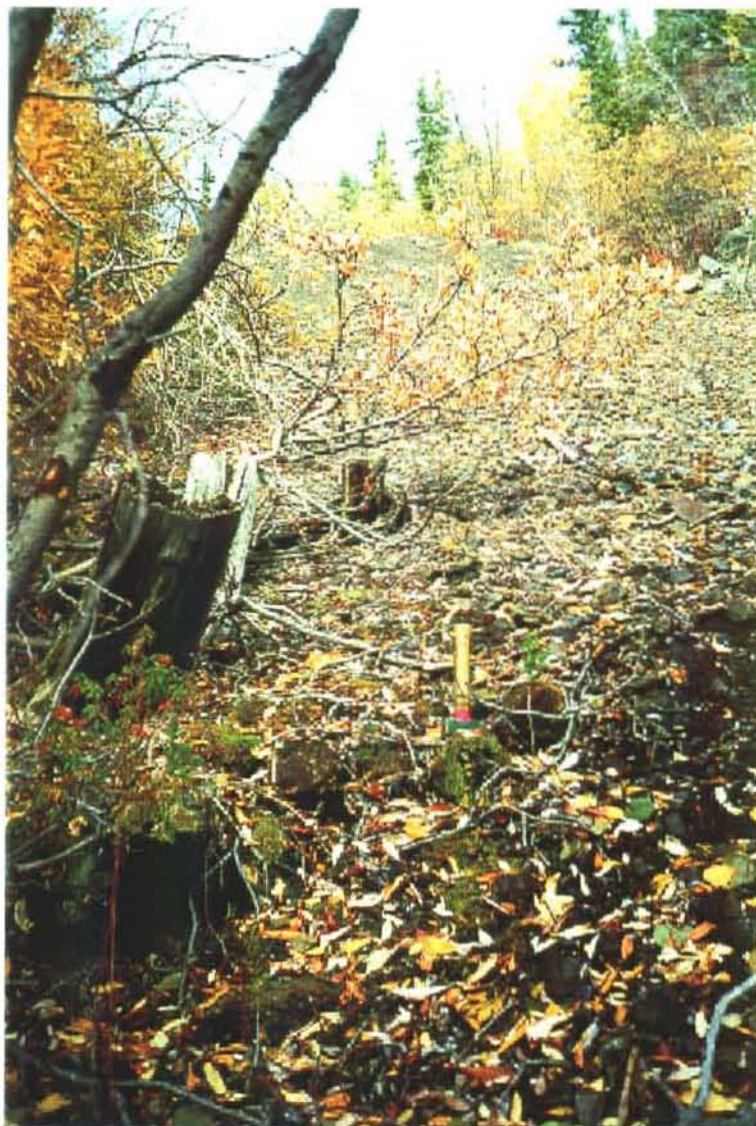
Photo 24-7: Adit #3 at base of rock dump WR-02. Note portal timbers to left of hammer. (Azimuth 000°)

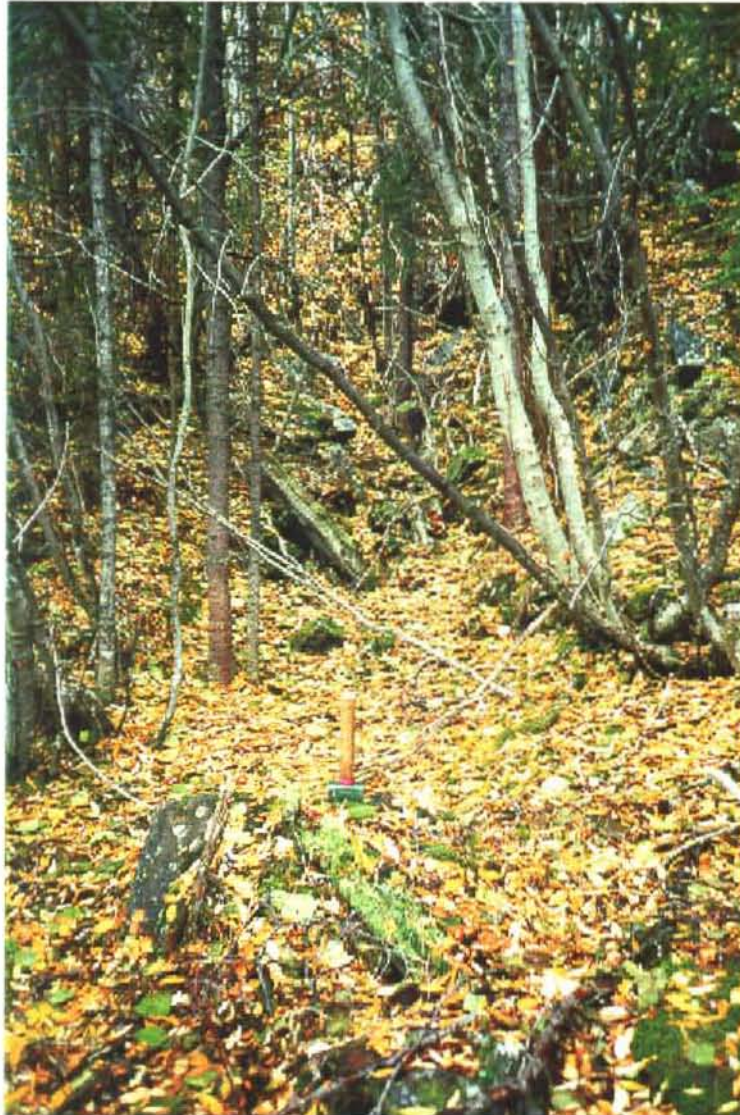
Photo 24-8: Collapsed portal at Adit #4. Note natural revegetation. (Azimuth 020°)

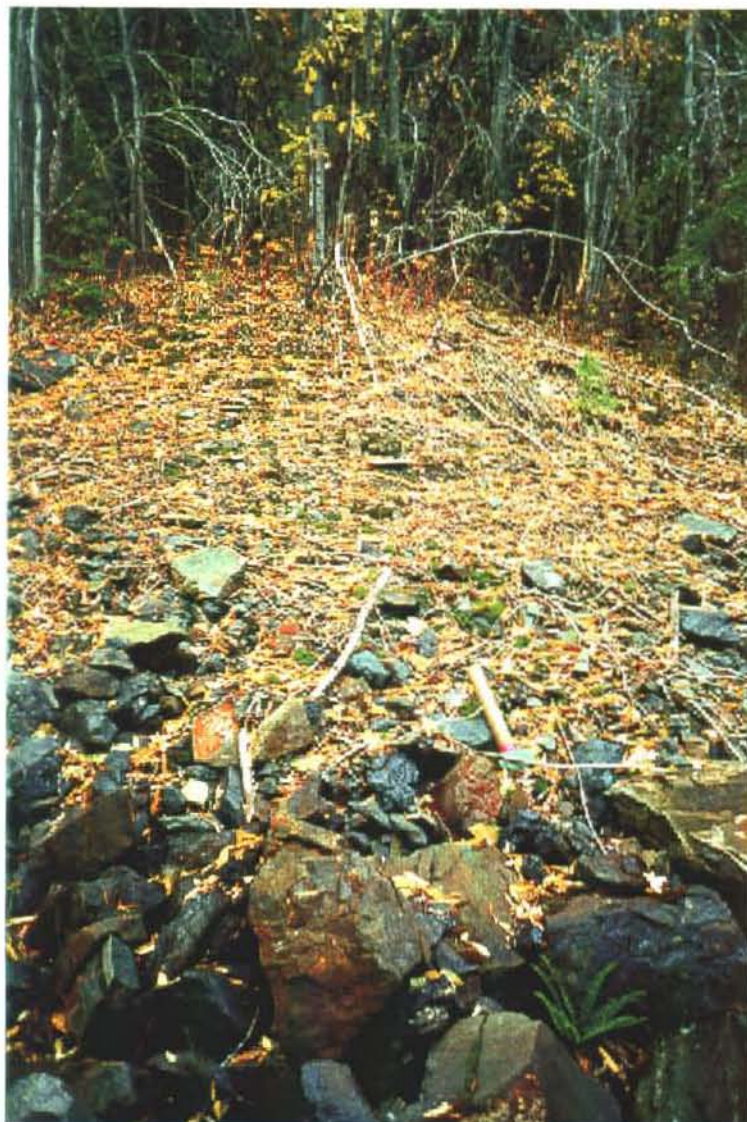
### **Waste Rock Pile WR-04 (Photo 24-9)**

This waste rock pile formed by end dumping out of Adit #4. It is composed of 60% blocky greenstone and 40% medium grained, crystalline siderite. Moderate oxidation was observed.

Photo 24-9: Rock dump WR-04. Note blocky greenstone and siderite vein material. (Azimuth 040°)

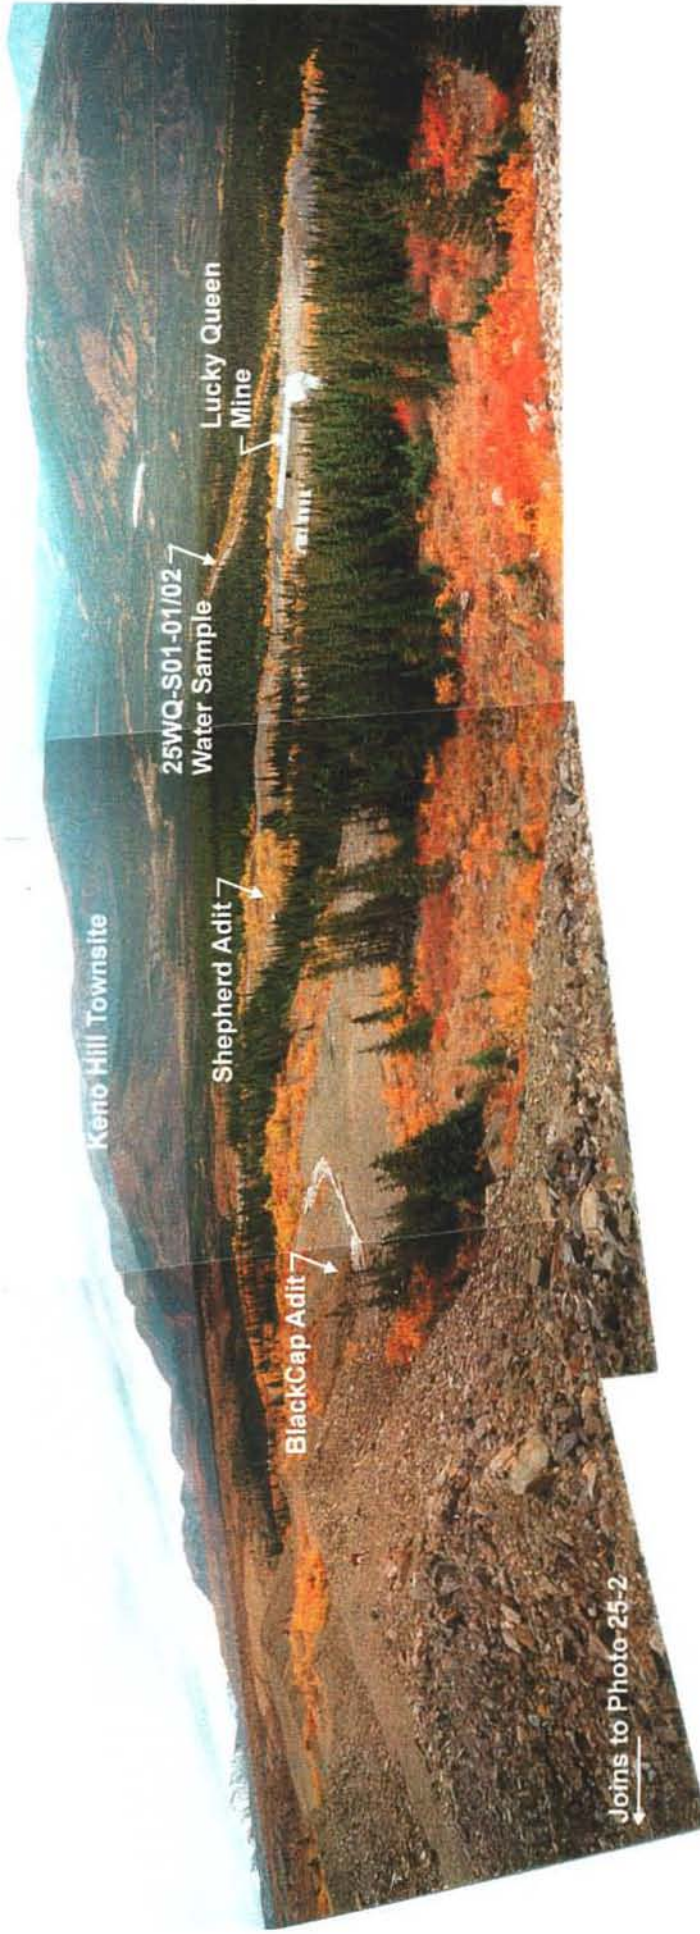
Photo 25-1: Panorama of the Shepherd and Lucky Queen mine sites.

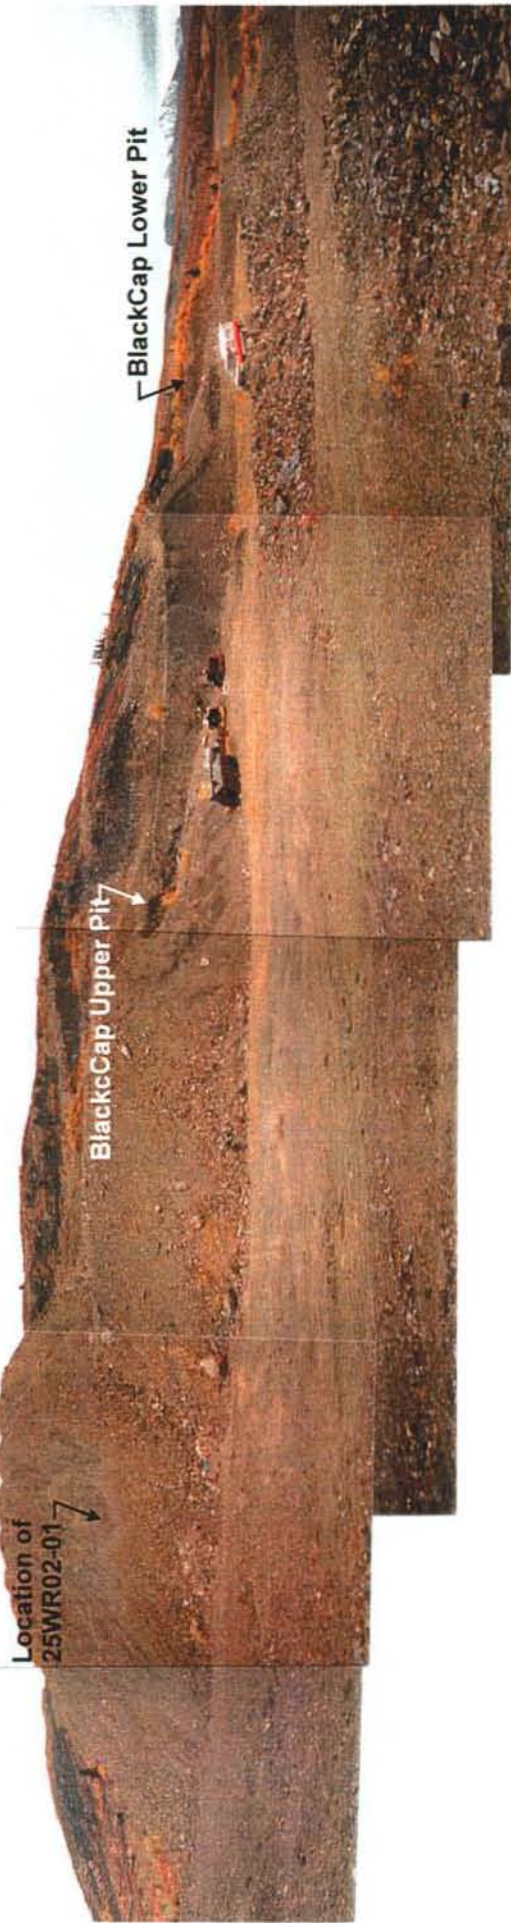
Photo 25-2 : Panorama of the BlackCap mine site. Note abandoned and burnt compressors.

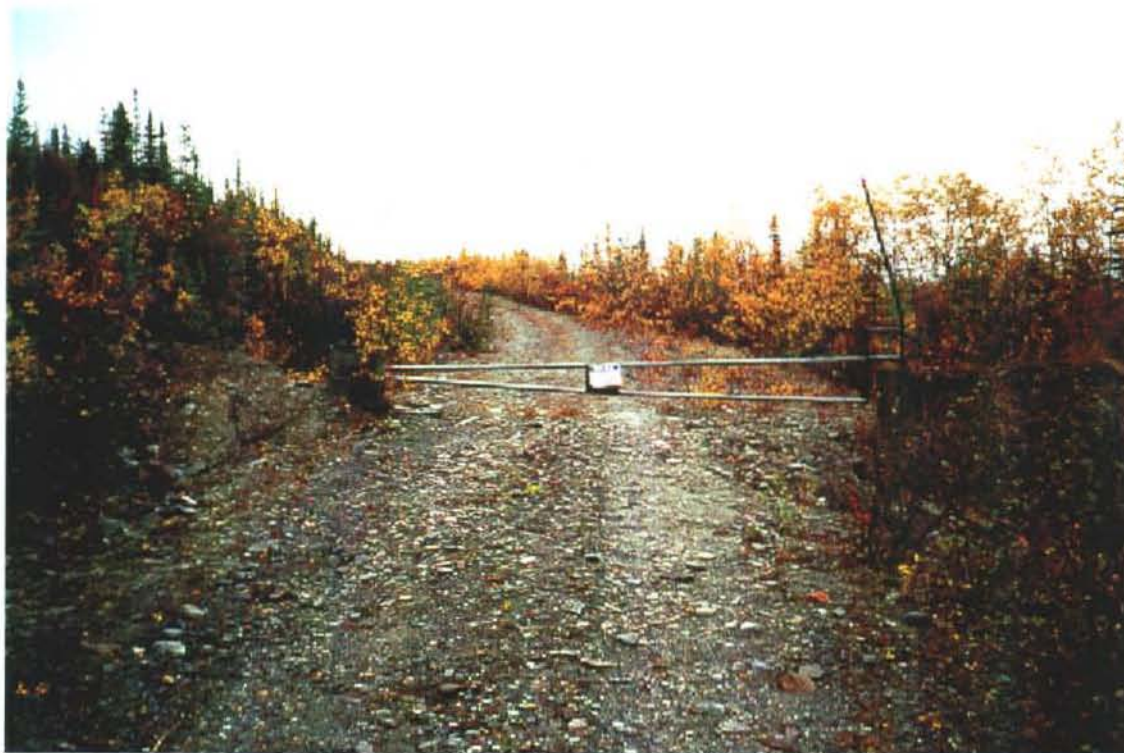
Photo 25-3: Locked gate at bottom of road limiting access to the Blackcap, Shepherd and Lucky Queen sites. (Azimuth 160°)

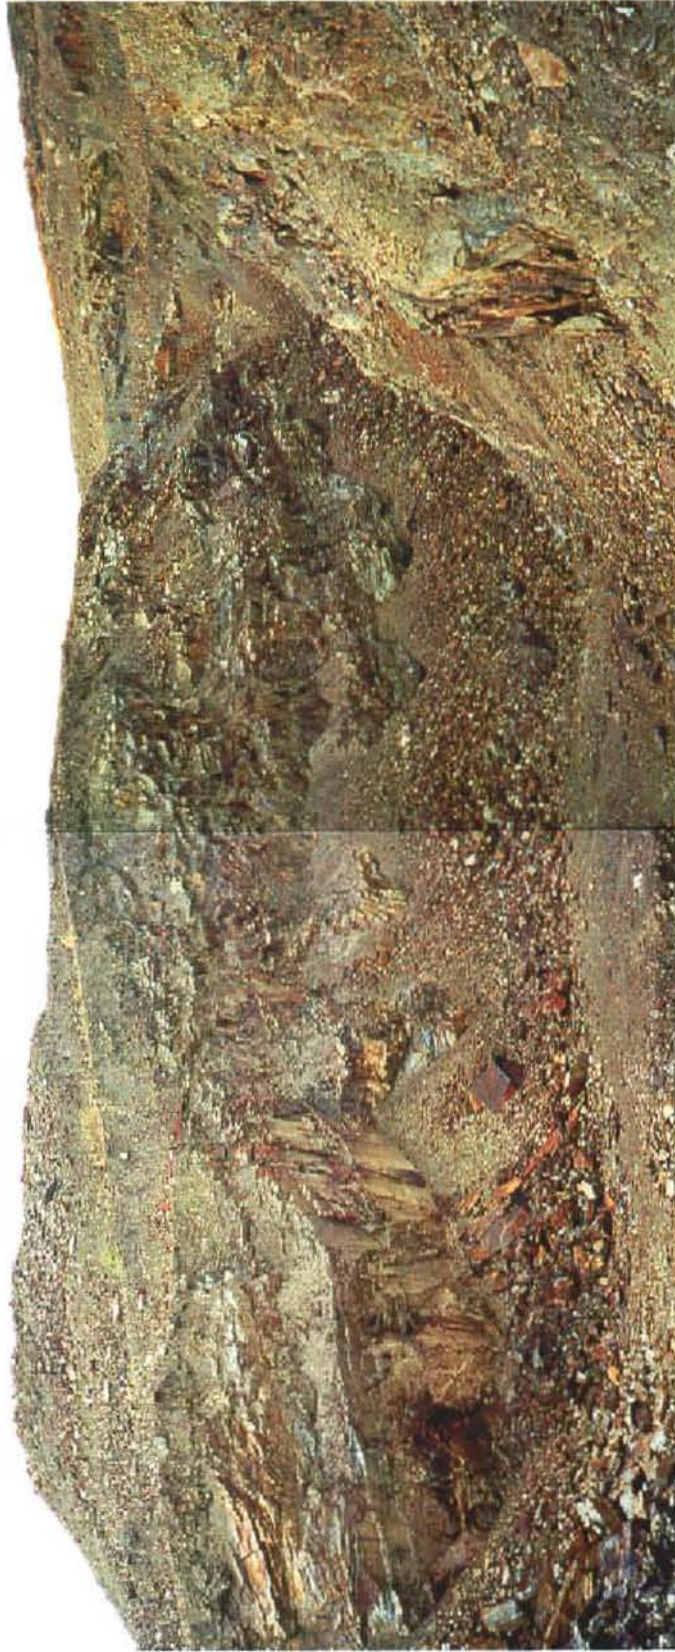
#### **North (Upper) Black Cap Pit (photo 25-4)**

The pit is located upslope of the Black Cap Adit. It measures roughly 130m long by 45m wide by 35m high. The steep-sided pit walls are comprised of predominantly quartzite containing some stacked quartz-siderite veins. A large volume of rock debris was observed at the base of the walls indicating a possible safety hazard. There was no vegetation observed in the pit.

Photo 25-4: Upper Blackcap pit. Note unstable pit walls and recent rock debris at base.(Azimuth 340°)

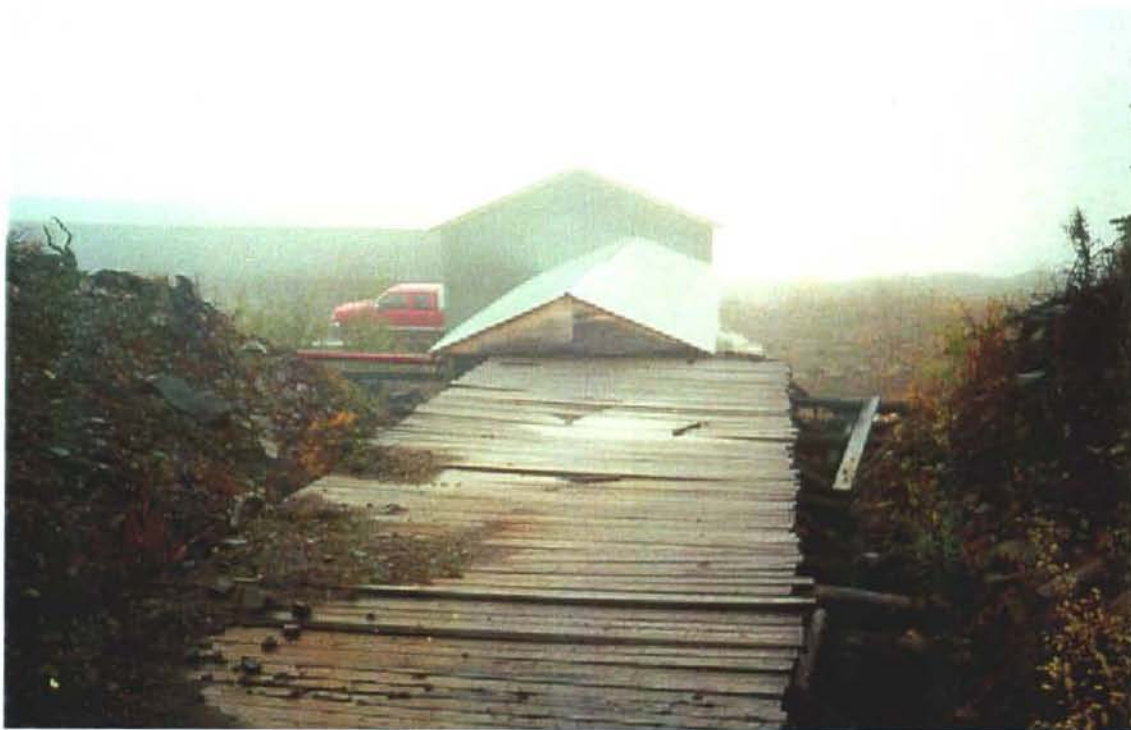
##### **Lucky Queen Adit (photo 25-7, 25-8, 25-9)**

Photo 25-7: Lucky Queen load out building and portal structure. Note cribbed portal in foreground and load-out in background. (Azimuth 200°)

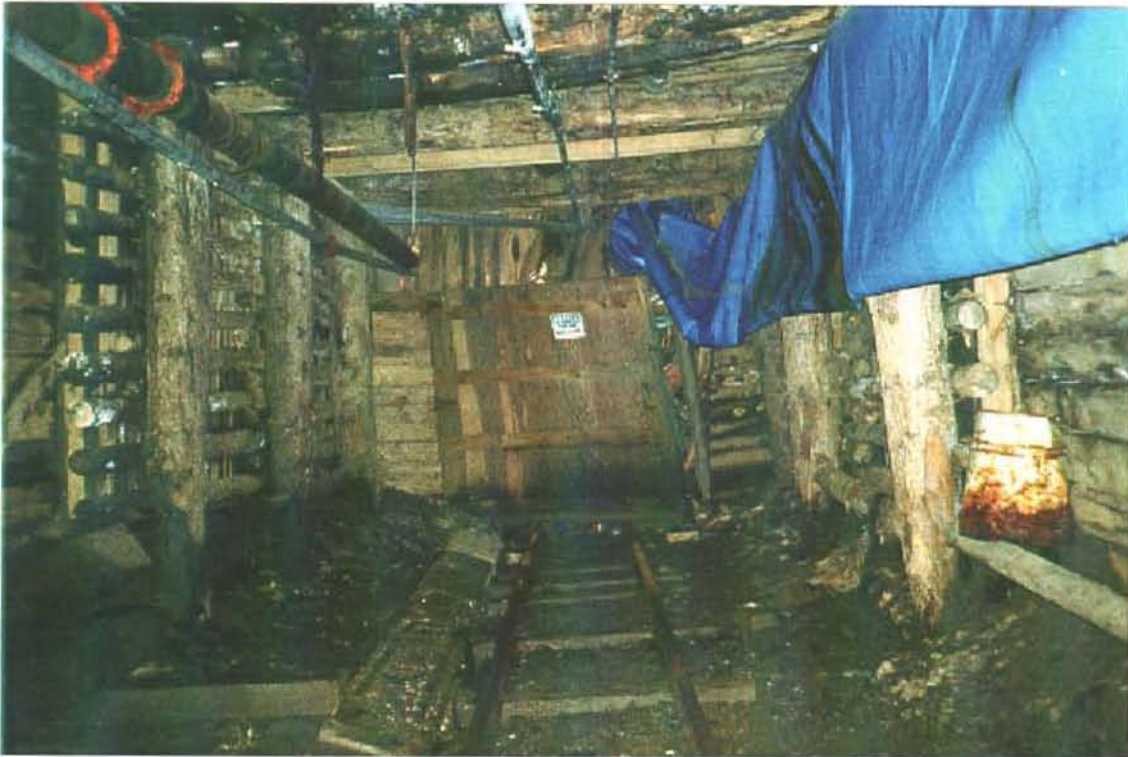
Photo 25-8: Interior of portal. Note drainage ditch to bottom left and partially collapsed door.  
(Azimuth 060°)
