# KENO VALLEY/DUBLIN GULCH ENVIRONMENTAL BASELINE ASSESSMENT

VOLUME III: Keno Valley Sites #21 to #40

Prepared for  
Waste Management Program  
Indian and Northern Affairs Canada

March, 2000

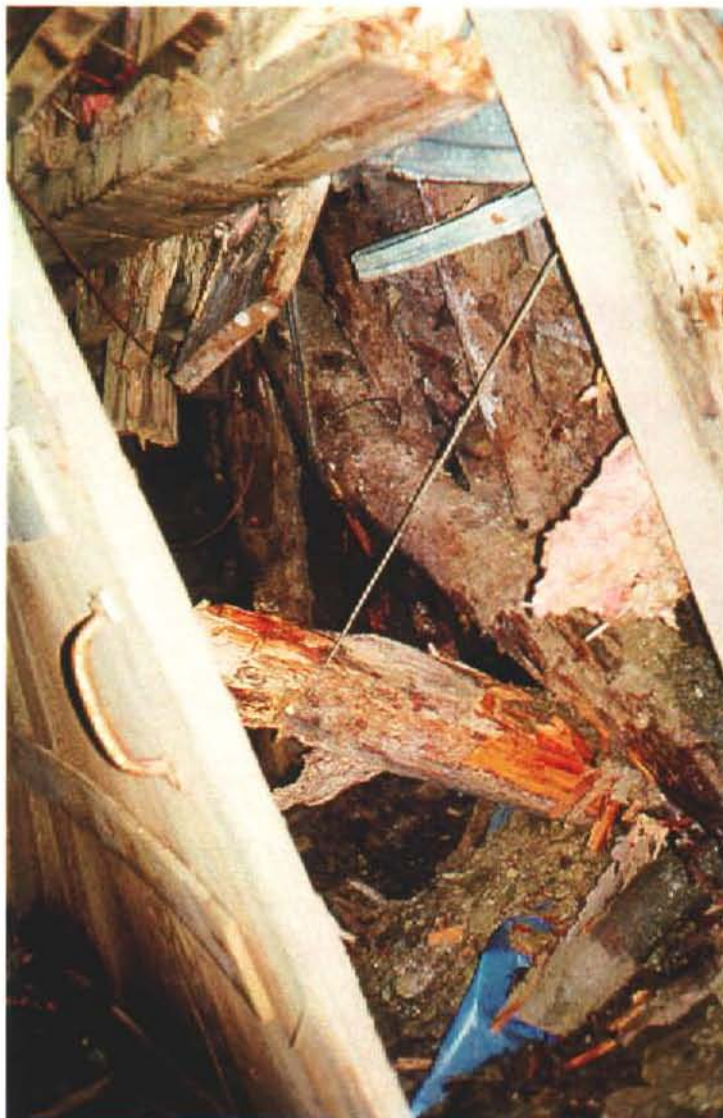
Photo 25-9: Collapsed portal timbers behind door.

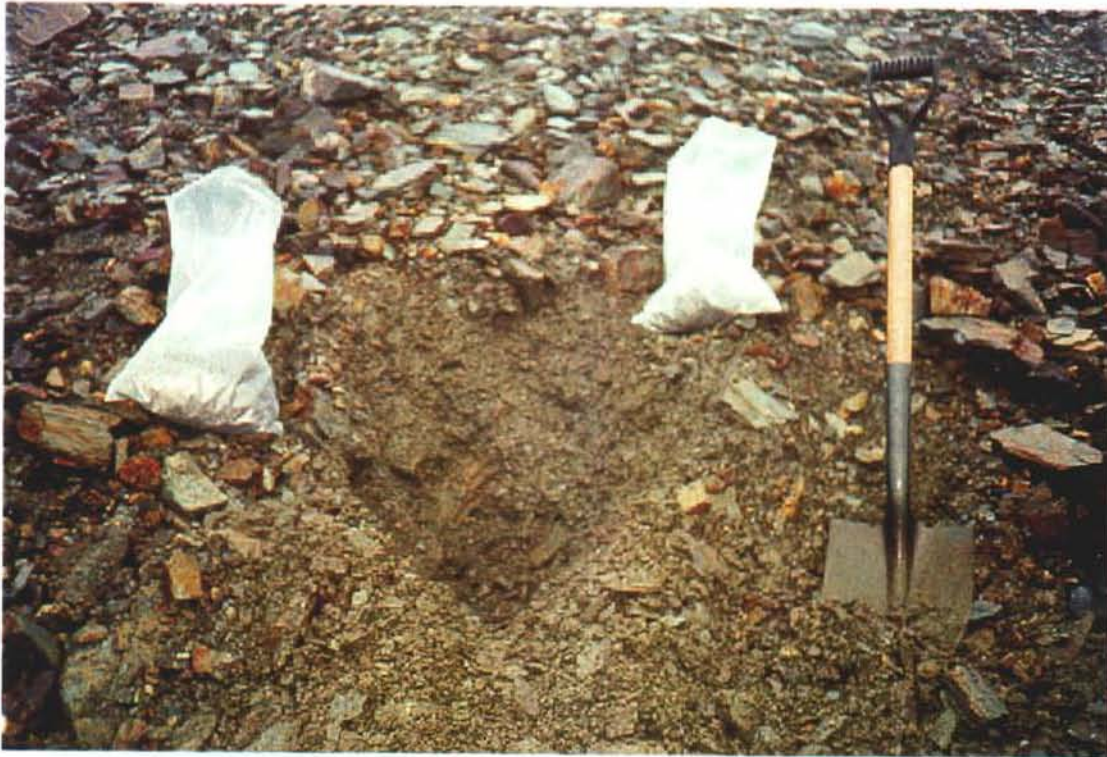
Photo 25-10: Waste rock pile WR03 sample (25WR03-01).

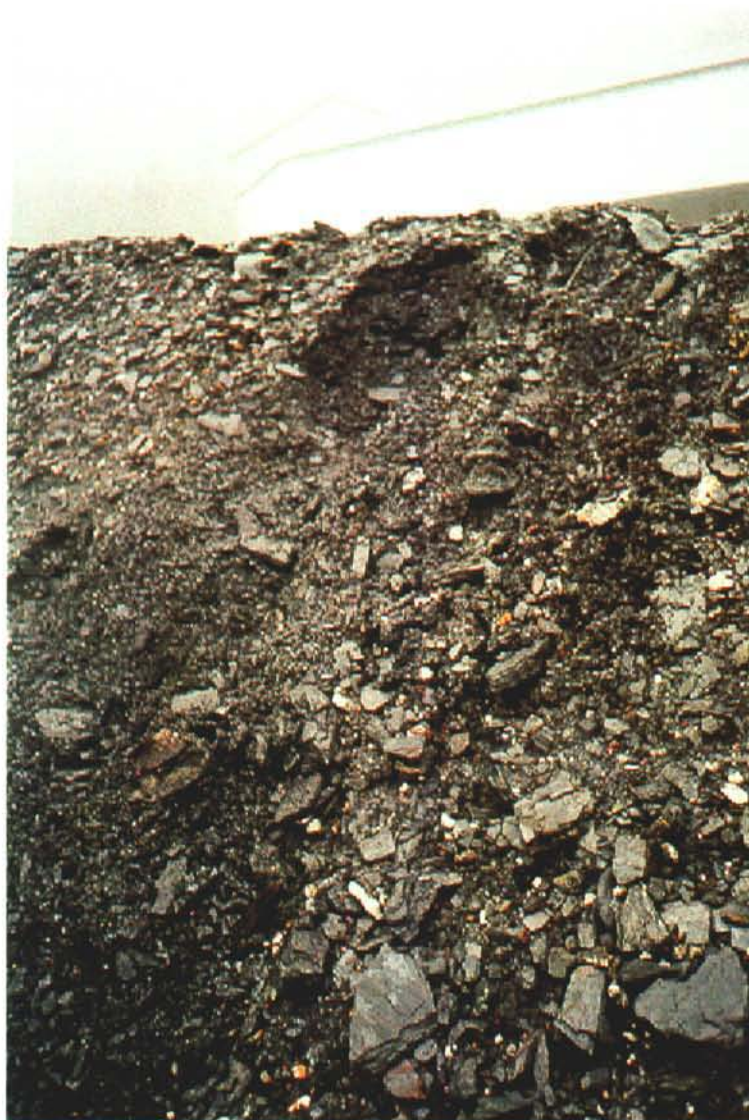
#### **Waste Rock Pile WR-05 (photo 25-11)**

Photo 25-11: Waste rock sample site (25WR05-01) at Lucky Queen waste rock pile WRO5.

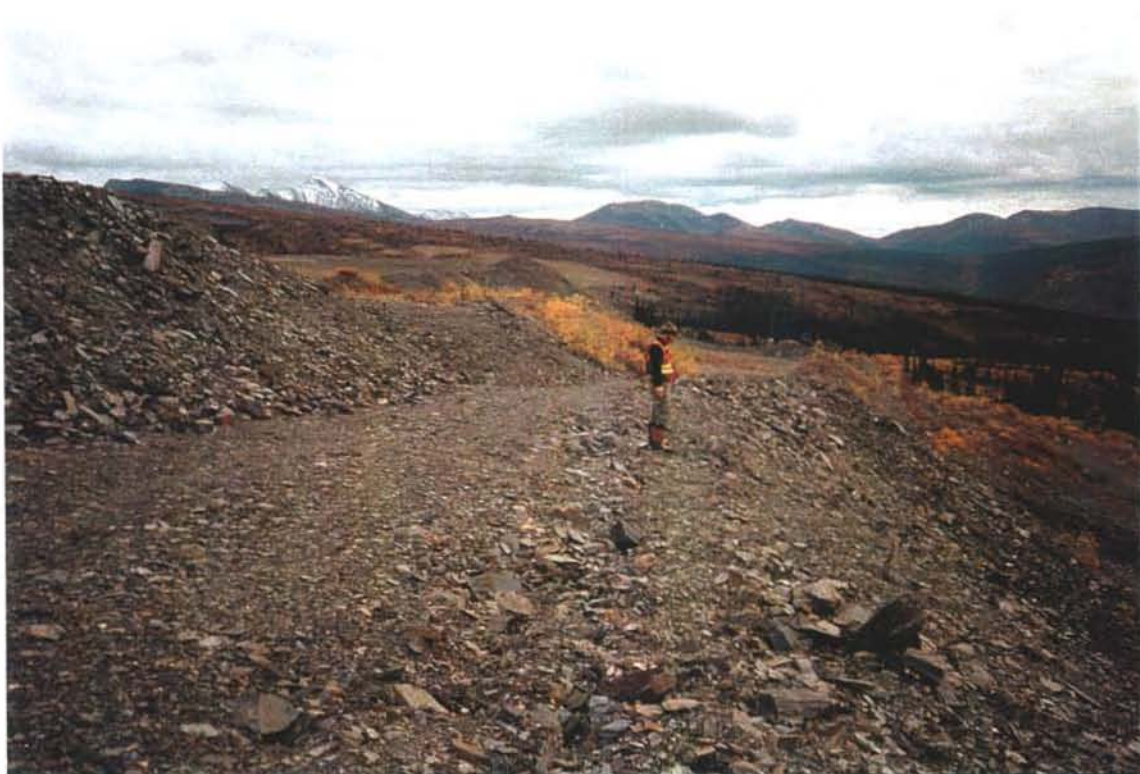
Photo 25-12: Tension cracks on edge of waste rock pile. Note slumped edge running along edge to mapper. (Azimuth 180°)

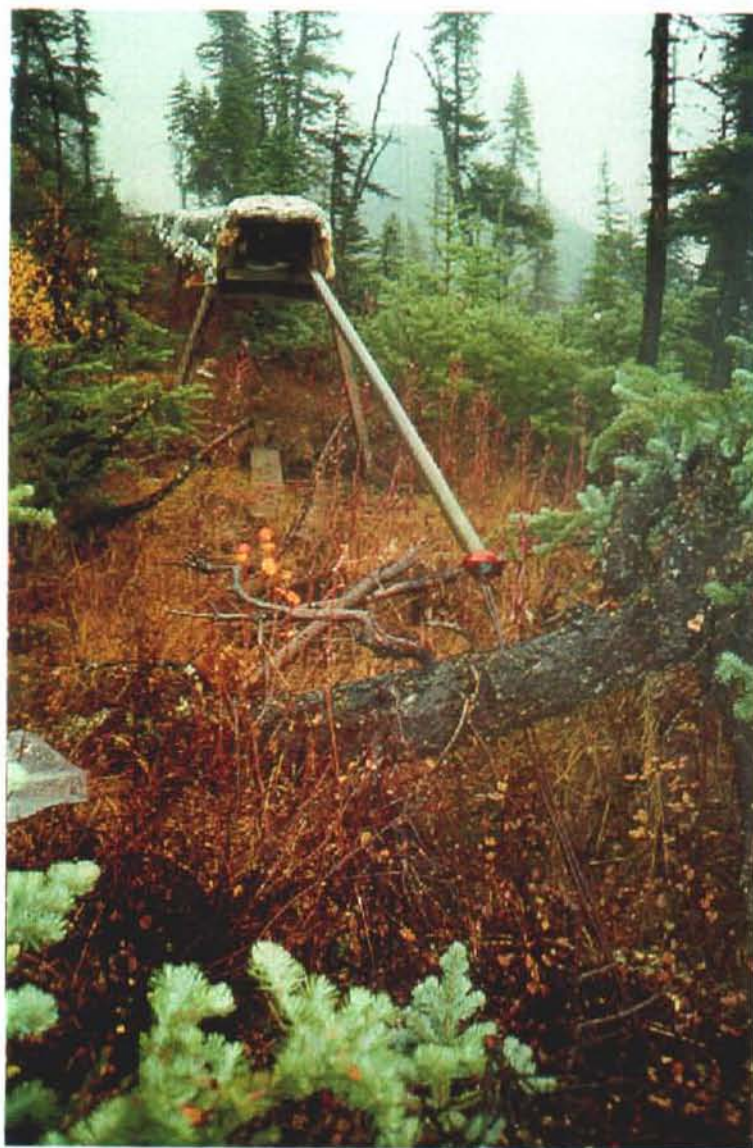
Photo 25-14: Mine drainage flume. Note copper heater coils extending out of pipe. (Azimuth 130°)

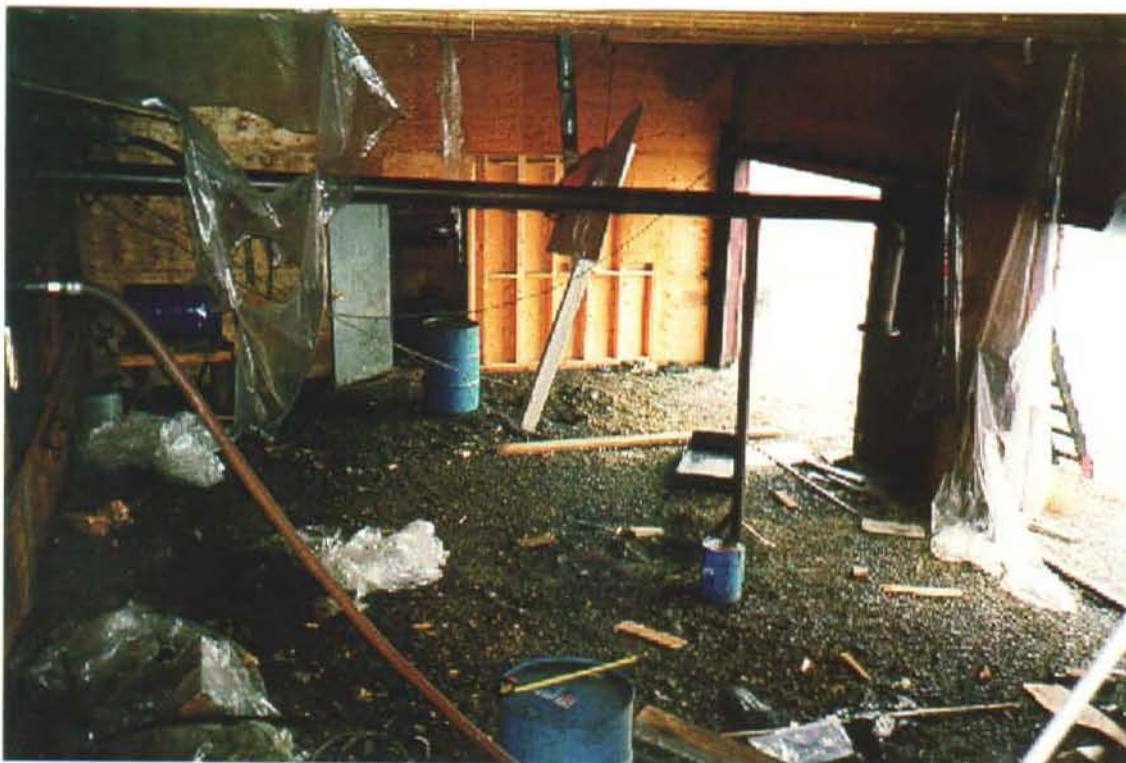
Photo 25-15: Interior of workshop bays. Note drum of transmission oil and pails of waste oil in left corner. Test pits located just right of far up-right drum (TP01) and blue pail of solvent near centre (Tp02). Workshop area through door on far wall. (Azimuth 180°)

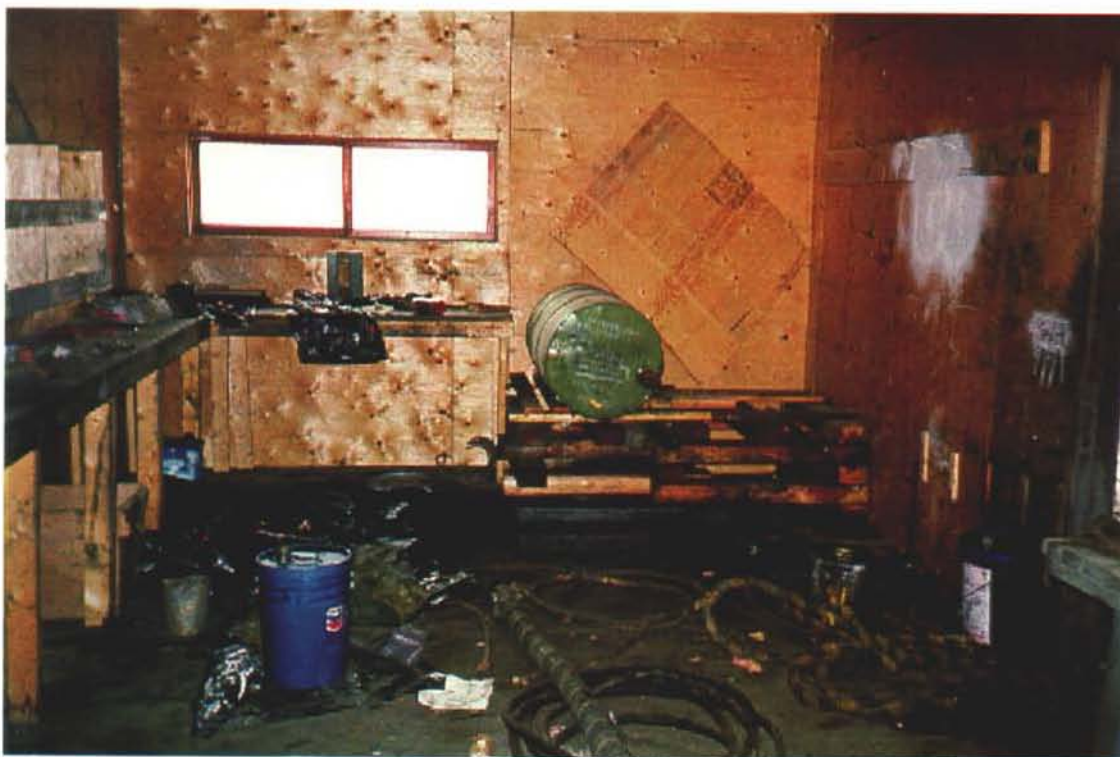
Photo 25-16: Interior of workshop area. Note leaking drum of hydraulic oil and full pan below. (Azimuth 250°)

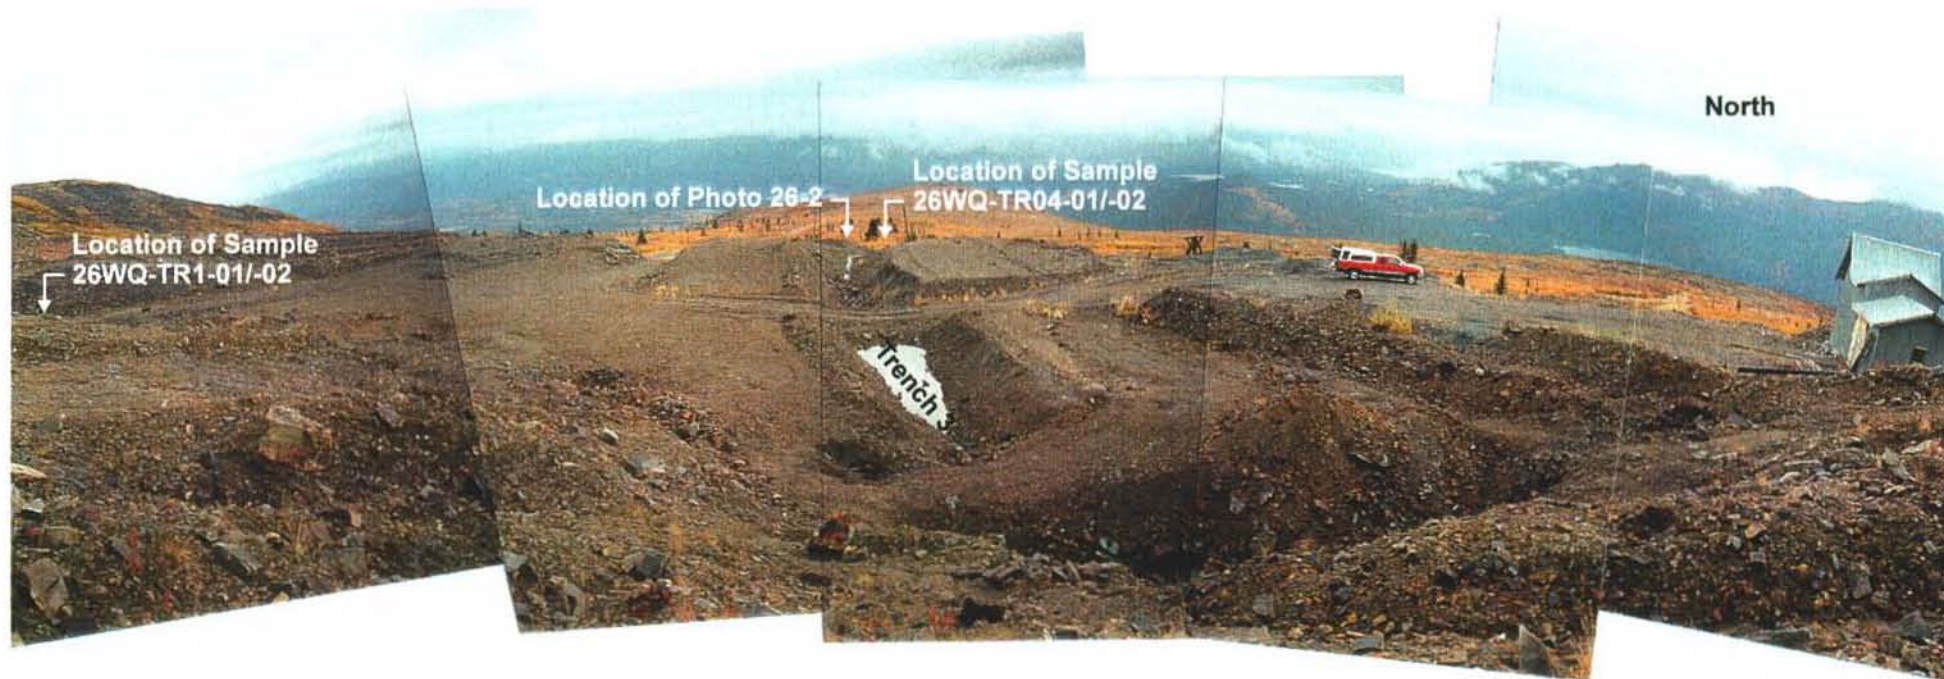
Photo 26-1: Panorama of site showing trenches, shaft building and overburden and waste rock dumps. Note old shaft just left of Trench 3 in foreground and powerline and haulage tram towers in background.

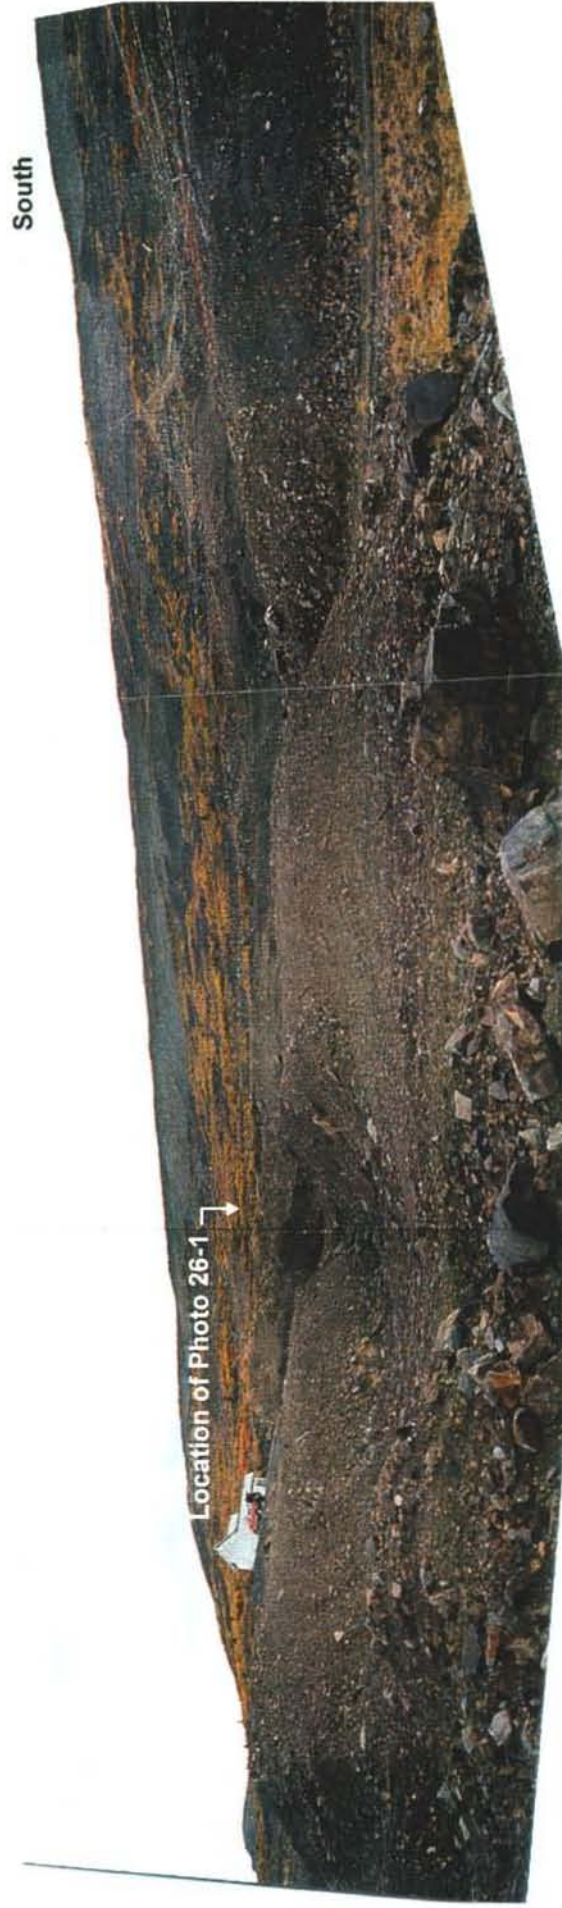
Photo 26-2: Panorama of Lucky Queen site. Note trench 4 drainage to left of centre and downed power pole to far right.

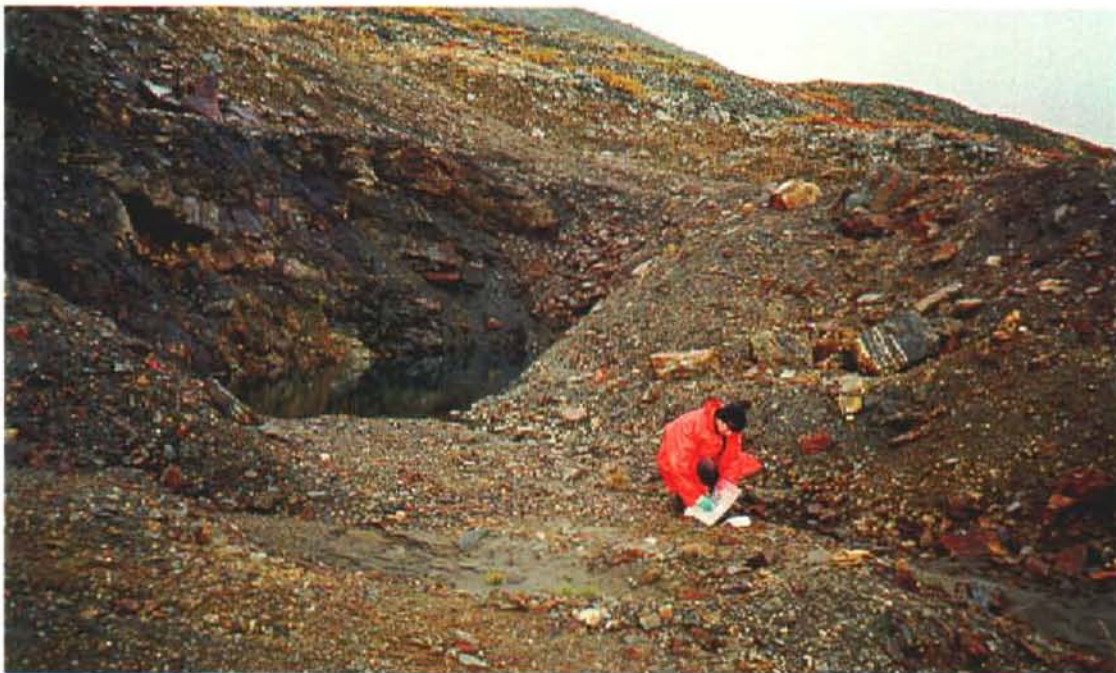
#### **Trench #1 (photo 26-3)**

Photo 26-3: Trench 1 sample site (26-WQ-TR01-01/02).  
Photo Direction (Azimuth 230°)

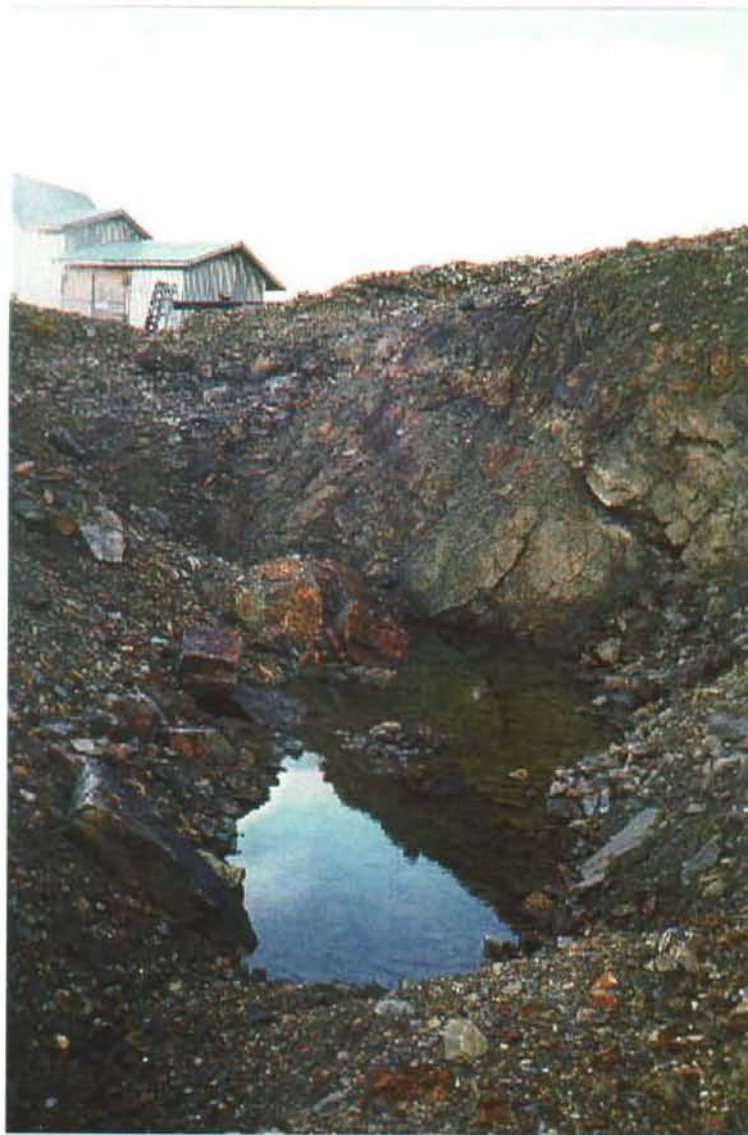
### **Trench #2 (photo 26-4)**

Photo 26-4: Trench 2 with shaft building behind.  
(Azimuth 065°)

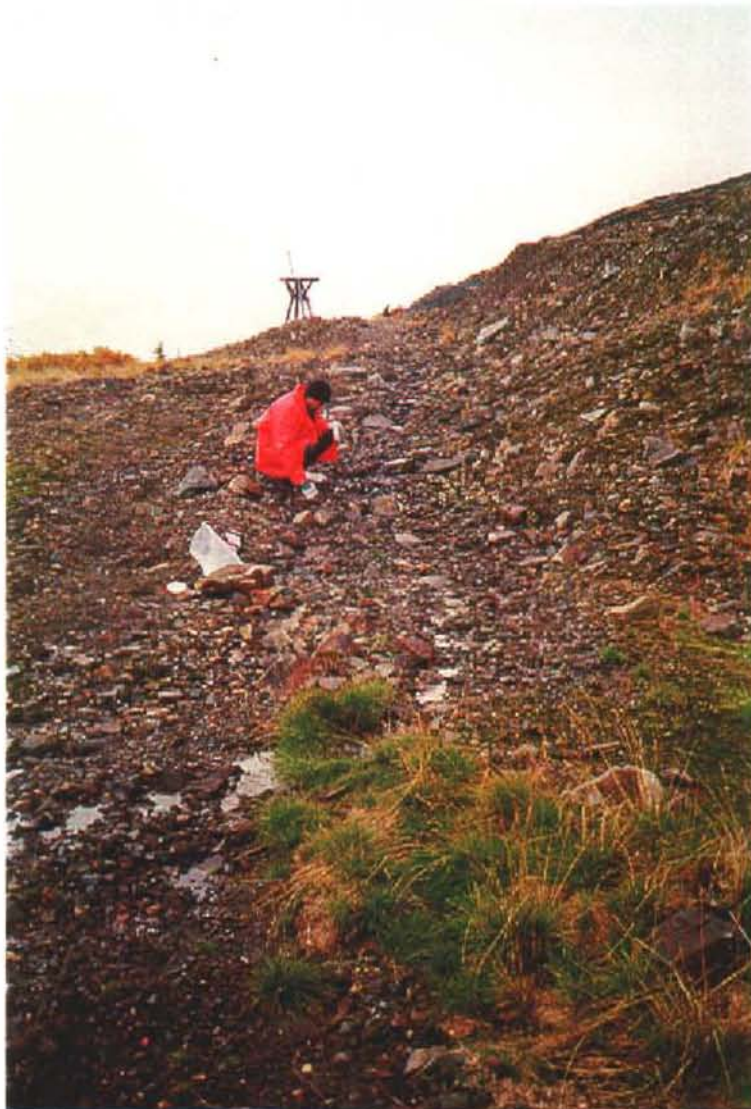
### **Trench #4 (photo 26-5)**

Photo 26-5: Trench 4 sample site (26-WQ-TR04-01/02).  
Note haulage tram tower. (Azimuth 090°)

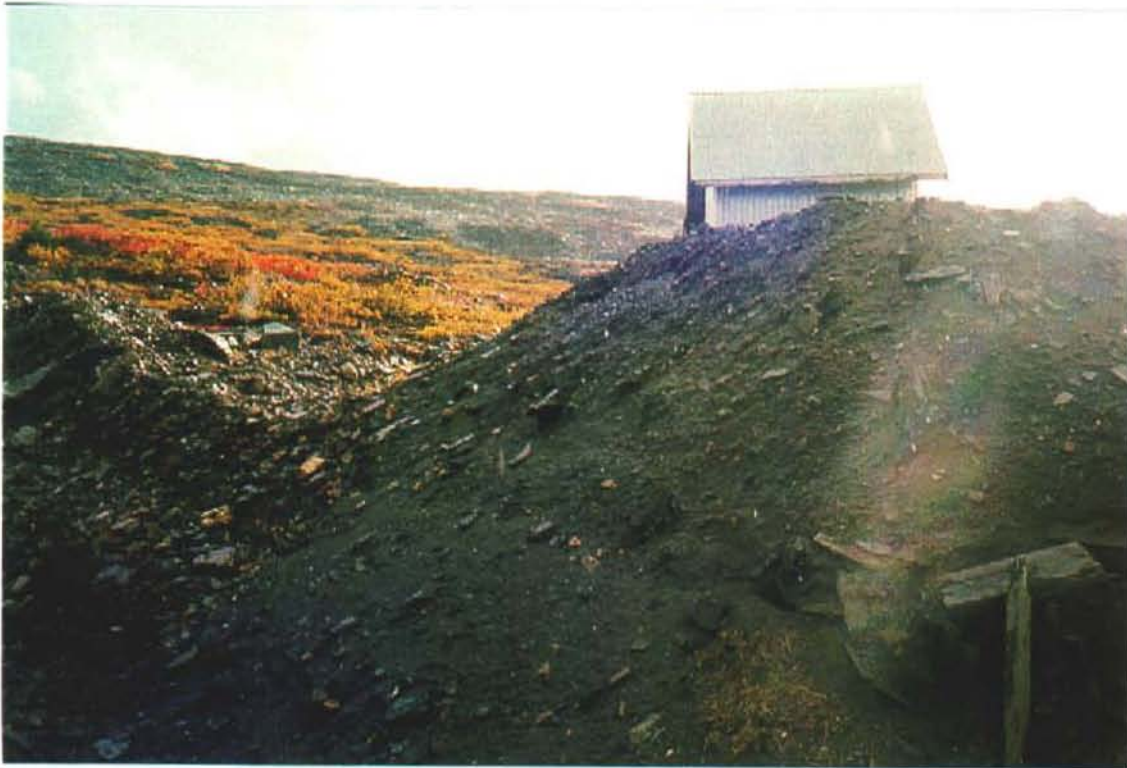
### **Trench #5 (photo 26-6)**

Photo 26-6: Trench east of shaft building. Note waste rock dump from underground development forming slope at right of photo. Photo Direction (Azimuth 130°)

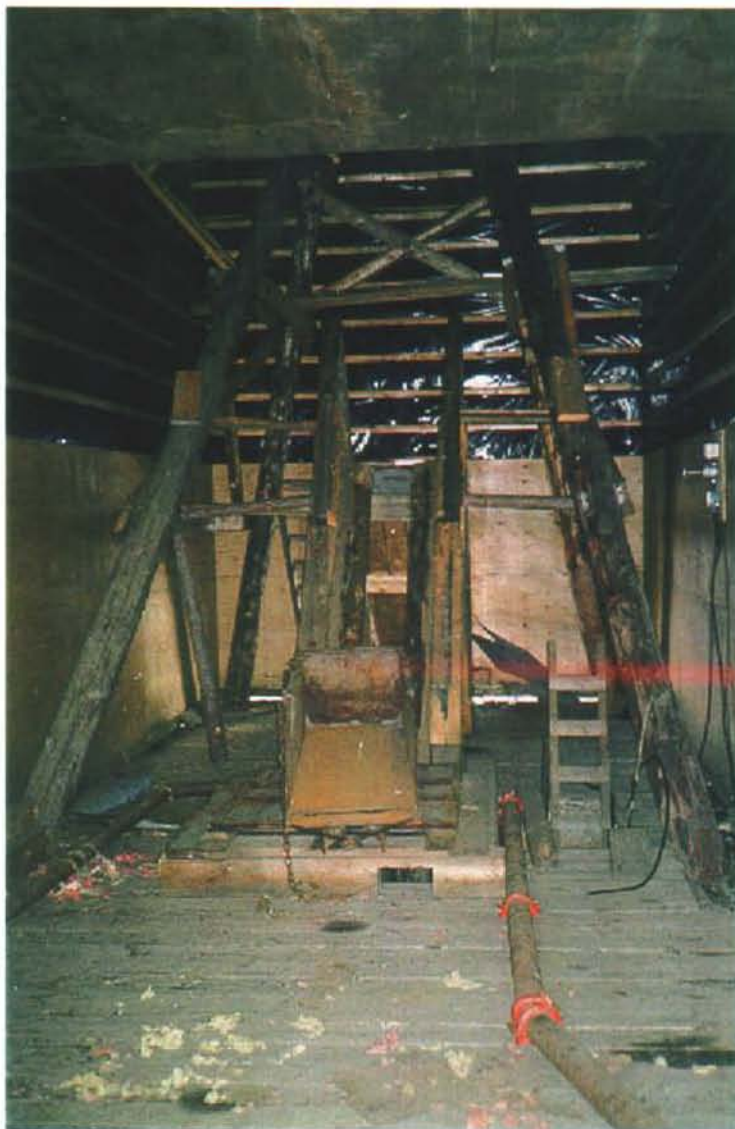
### **6.1 Building 26A (photo 26-7)**

Shaft #1 was rehabilitated in the 1970s and is still open. A wooden building (for description, see Section 6.1 below; also photo 26-7) has been built to cover the inclined shaft.

Photo 26-7: Interior of Lucky Queen headframe building (Bldg. 26-A) showing open manway and boarded shaft opening.

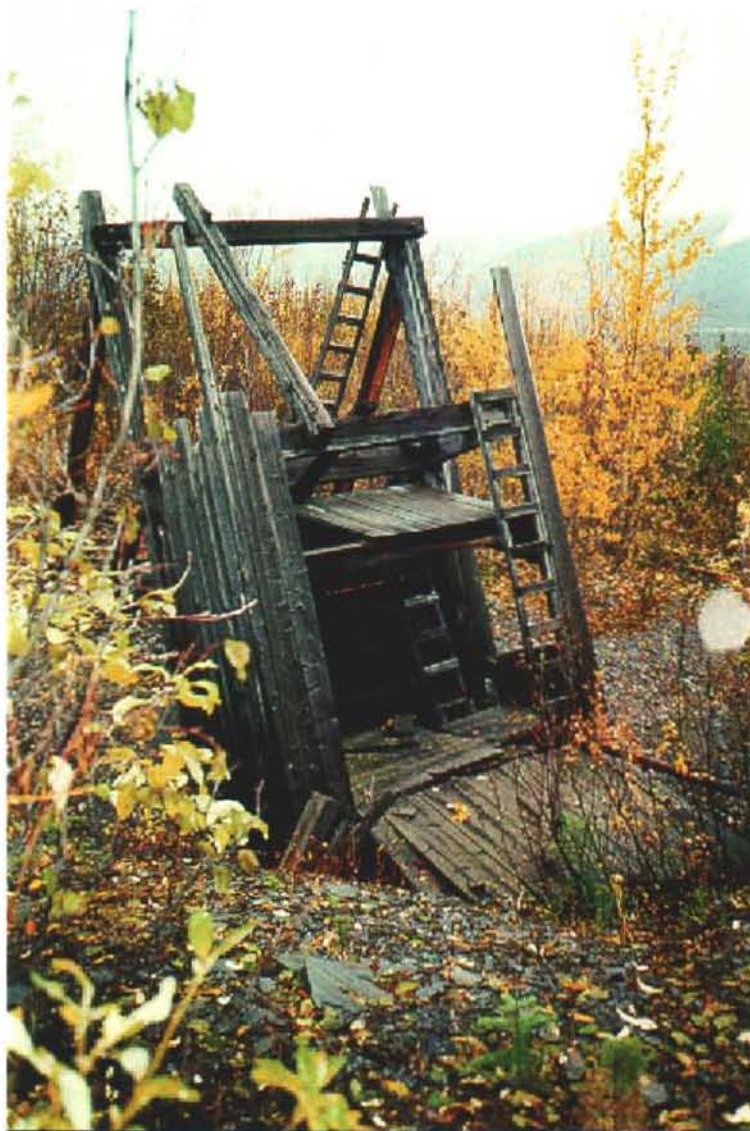
### Main Shaft (photos 27-1, 27-2)

Photo 27-1: Shaft headframe (Bldg. 27-1). (Azimuth 340°)

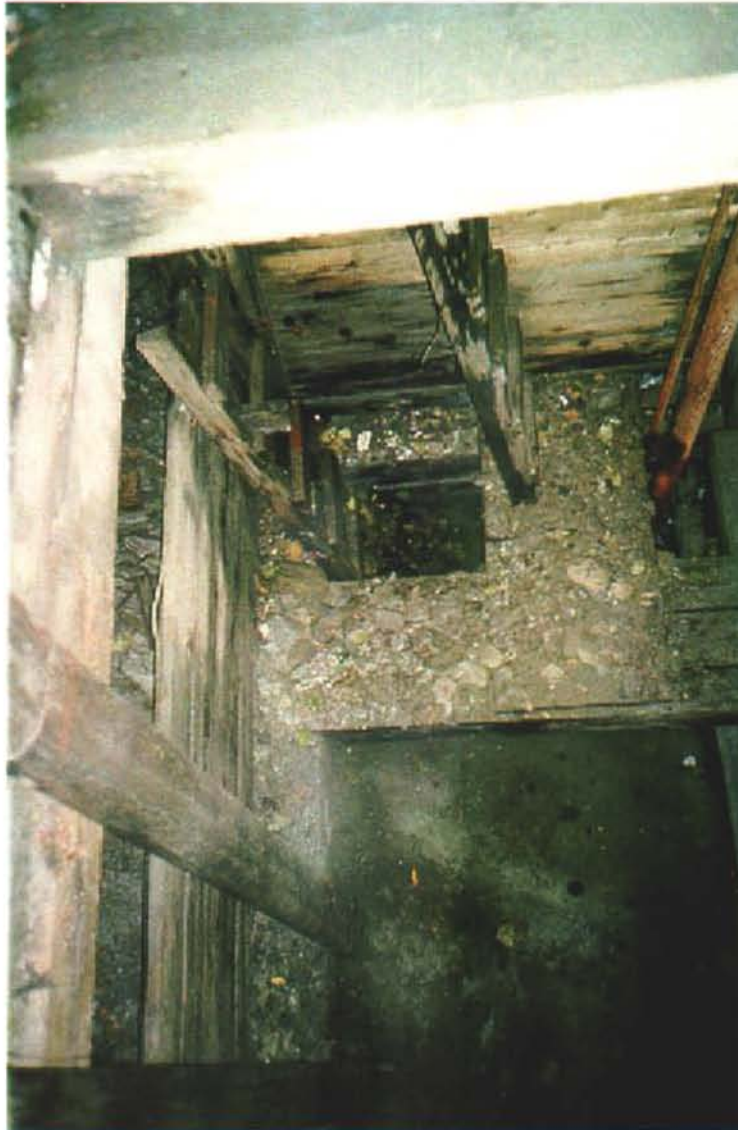
Photo 27-2: Interior of shaft A01 headframe (Bldg. 27-1).

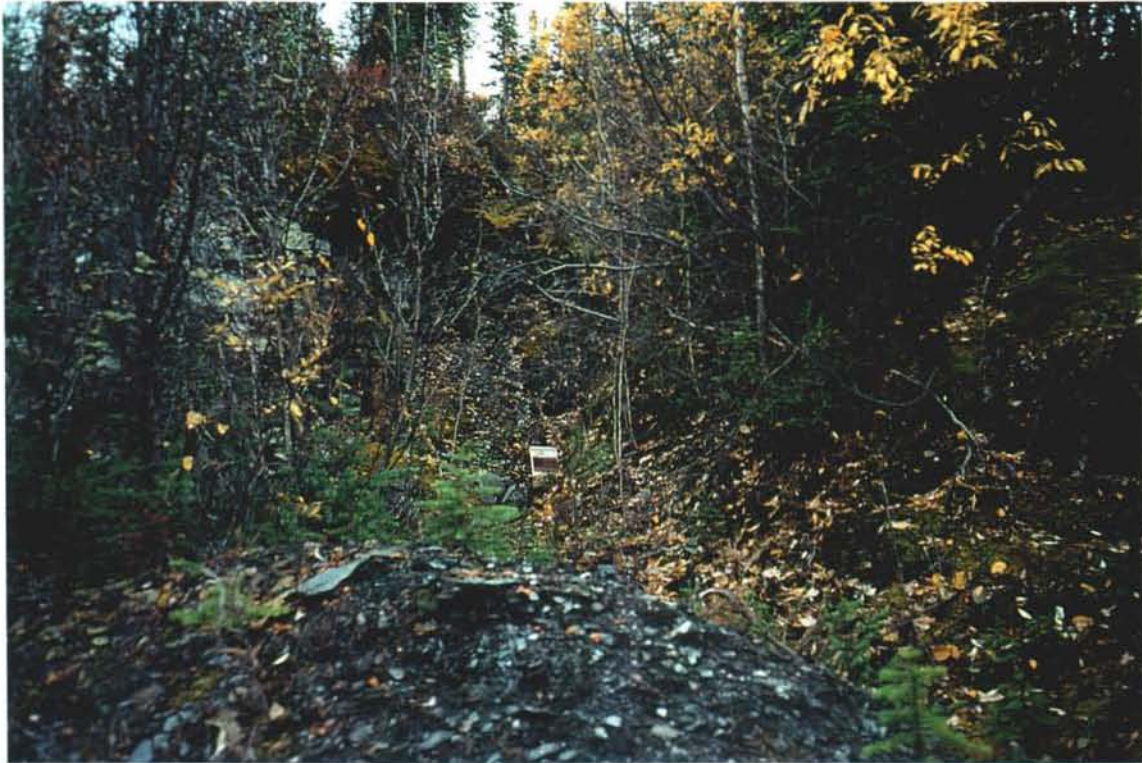
### **Lower Adit (photo 27-3)**

Photo 27-3: Collapsed adit portal (A02). (Azimuth 220°)

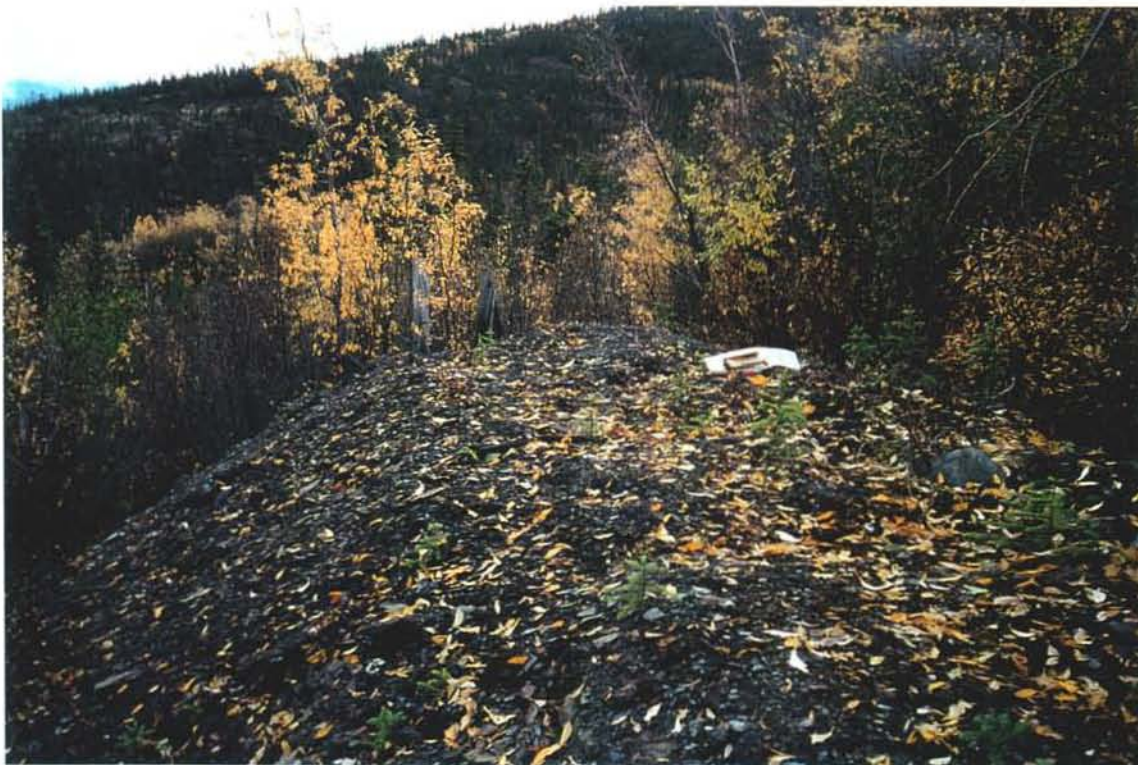
### Waste rock piles #2, #3 and #4 (photo 27-4)

Photo 27-4: Waste rock dump below shaft A01. (Azimuth 110°)

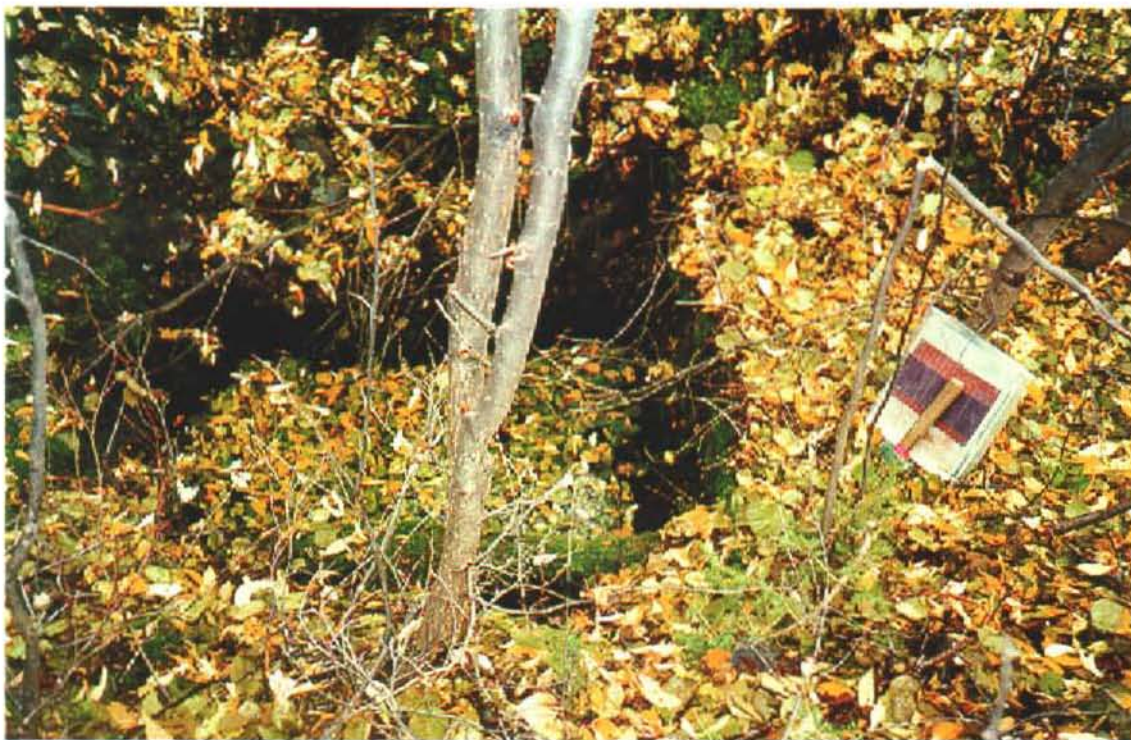
### Upper Shaft (photo 27-5)

Photo 27-5: Upper shaft hole to left of clipboard (A03). Note leaves covering the surface of standing water. (Azimuth 070°)

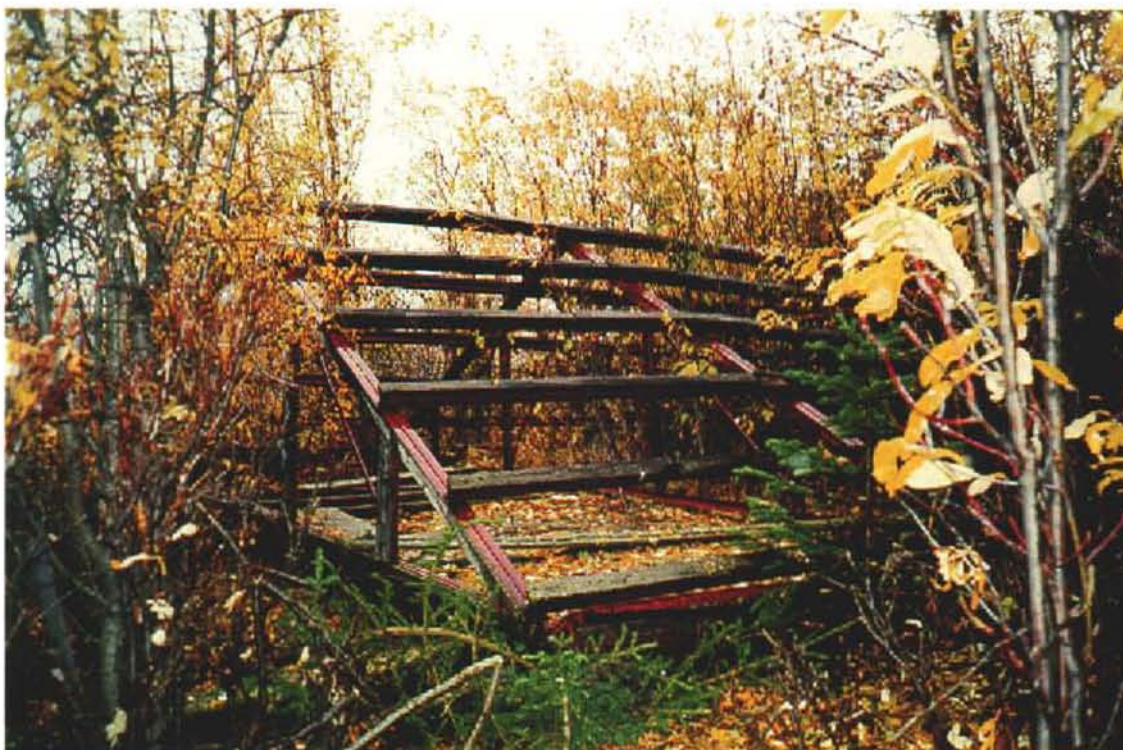
### **6.1 Building 27A (photo 27-6)**

Photo 27-6: Collapsed steel building frame (Bldg. 27-2). (Azimuth 120°)

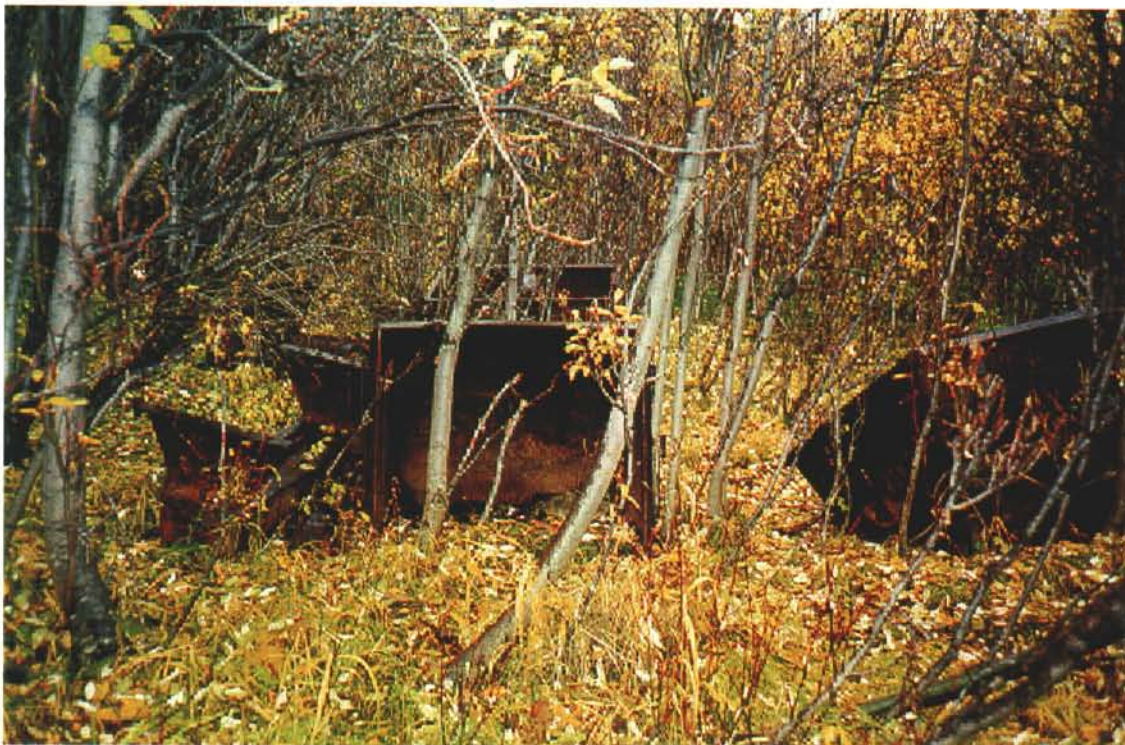
#### **7. SOLID WASTE DUMPS (photo 27-7)**

Photo 27-7: Abandoned ore cars. (Azimuth 240°)

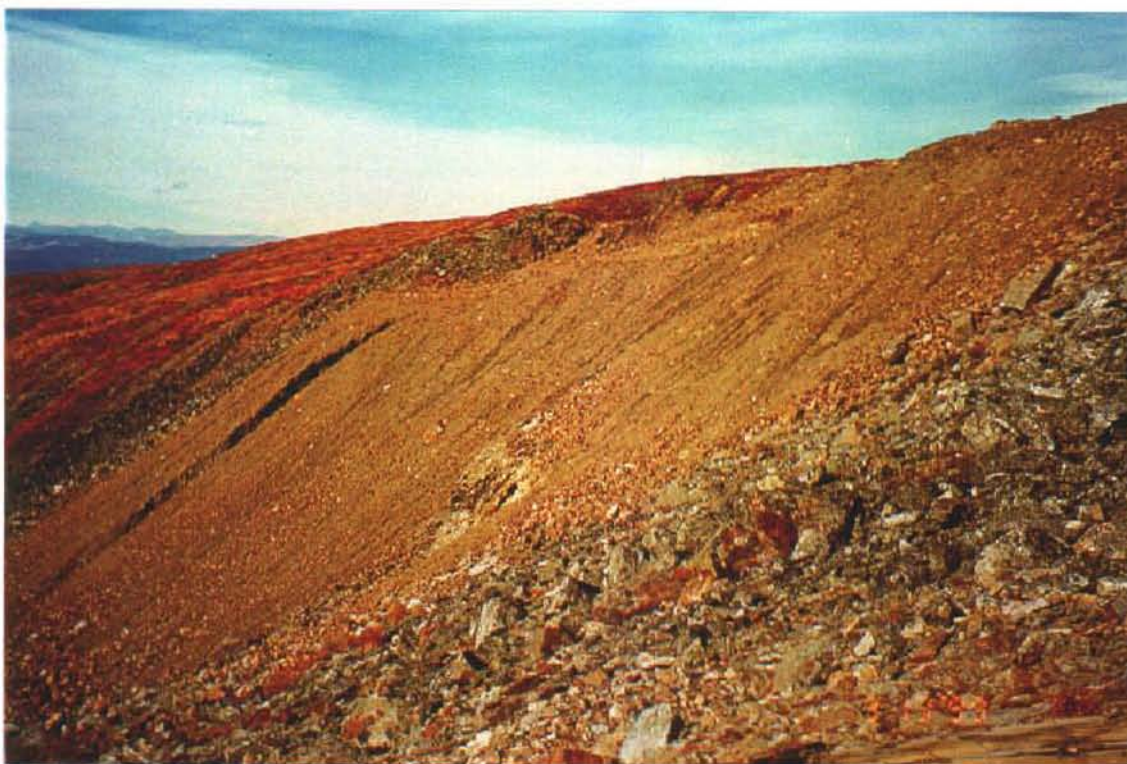
Waste rock pile - ORIGINAL SHAMROCK (photo 28-1)

Overburden and waste rock were pushed downslope from the open cut. The pit drains through the dump, and deep troughs are present on the dump slope. No significant vegetation was noted. The dump toe rests on an underground waste dump at the 200 level.

Photo 28-1: Waste rock below open cut at upper end of site. Note deep erosion path.

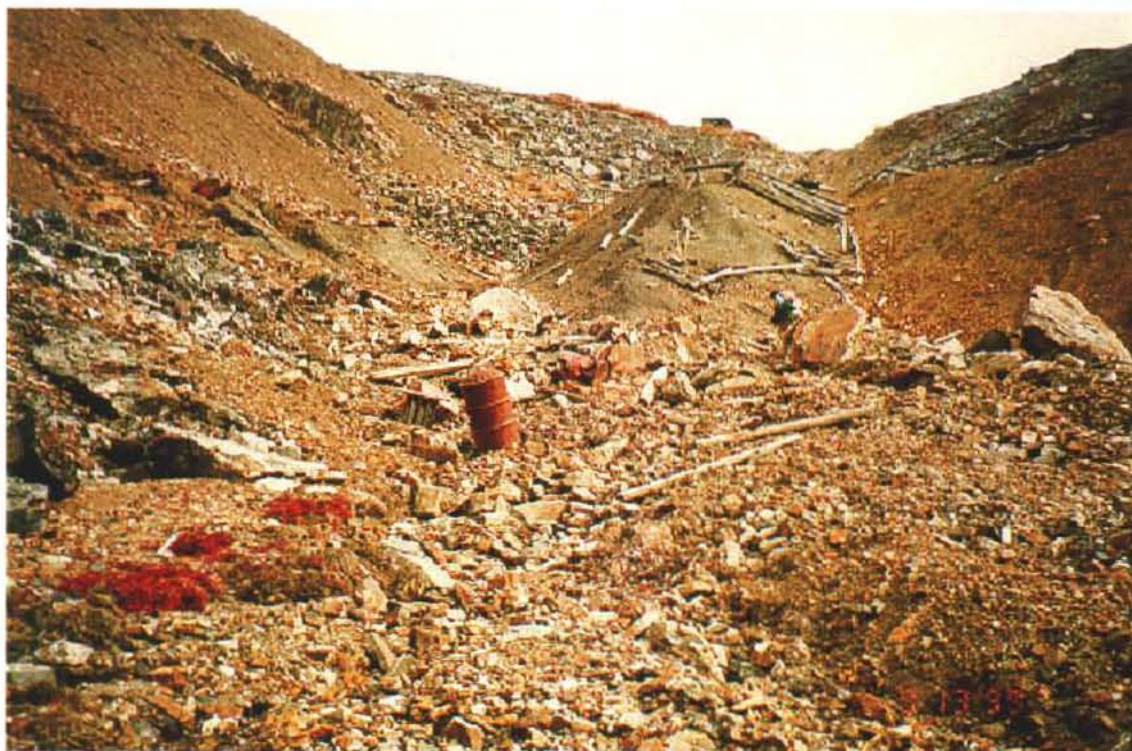
#### Waste rock pile - #200 level portal (photo 28-2)

Photo 28-2: Ravine below adit and associated waste rock piles.

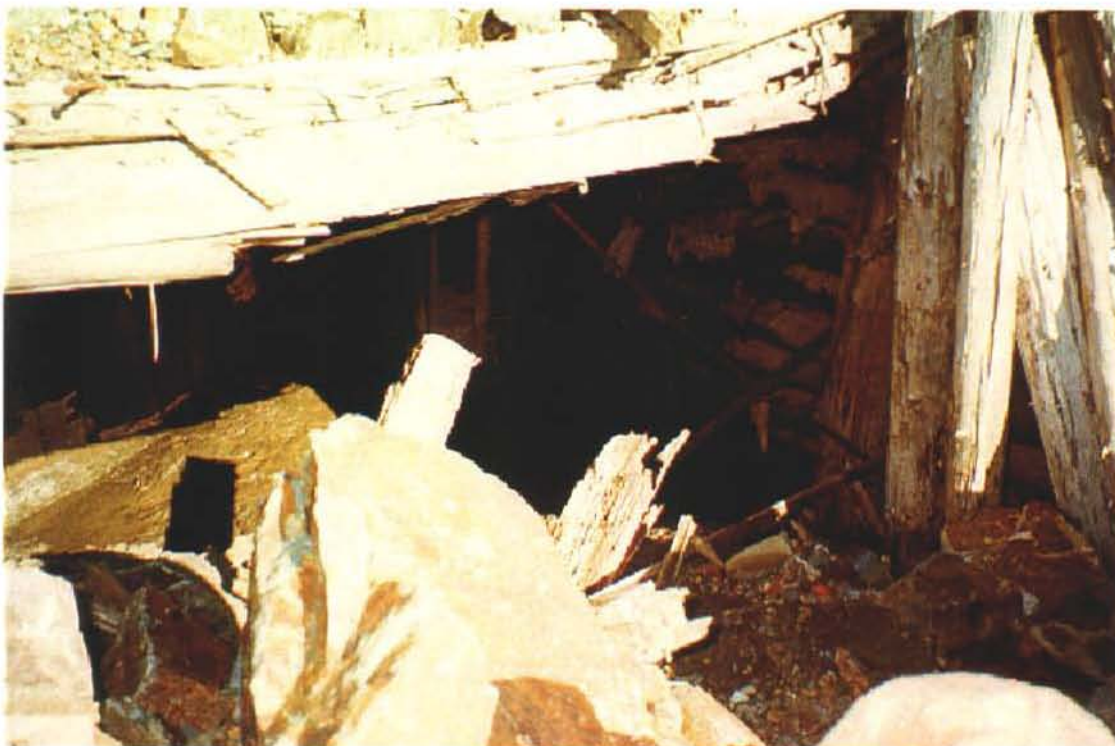
#### 200 Level Portal (photo 28-3)

Condition: Partially collapsed, mostly blocked by open pit waste and debris

Photo 28-3: Partially open adit entrance.

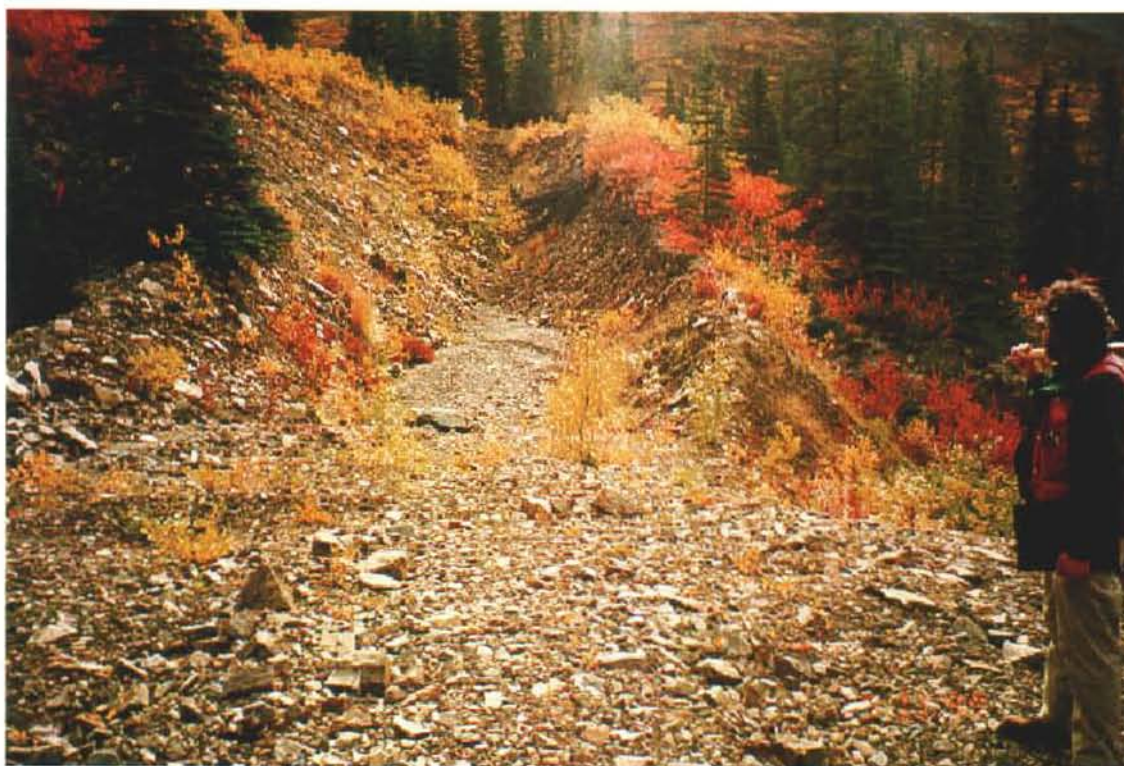
#### Six Trenches Southwest of Mine (photo 28-4)

Trenches cut across the mineralized structure that hosts the Original Shamrock mine to the northeast. Very little true outcrop is exposed, however subcrop indicates very strongly oxidized, rusty quartzite with minor schist. Veining and mineralization are weak. Manganese oxides are common. The trenches appear to be from the 1980's.

Condition: The trench sides are steep, with little revegetation. The adjacent, undisturbed gully area is similarly steep, with little vegetation.

Photo 28-4: Small test pit at lower end of site.
