# KENO VALLEY/DUBLIN GULCH ENVIRONMENTAL BASELINE ASSESSMENT

VOLUME III: Keno Valley Sites #21 to #40

Prepared for  
Waste Management Program  
Indian and Northern Affairs Canada

March, 2000

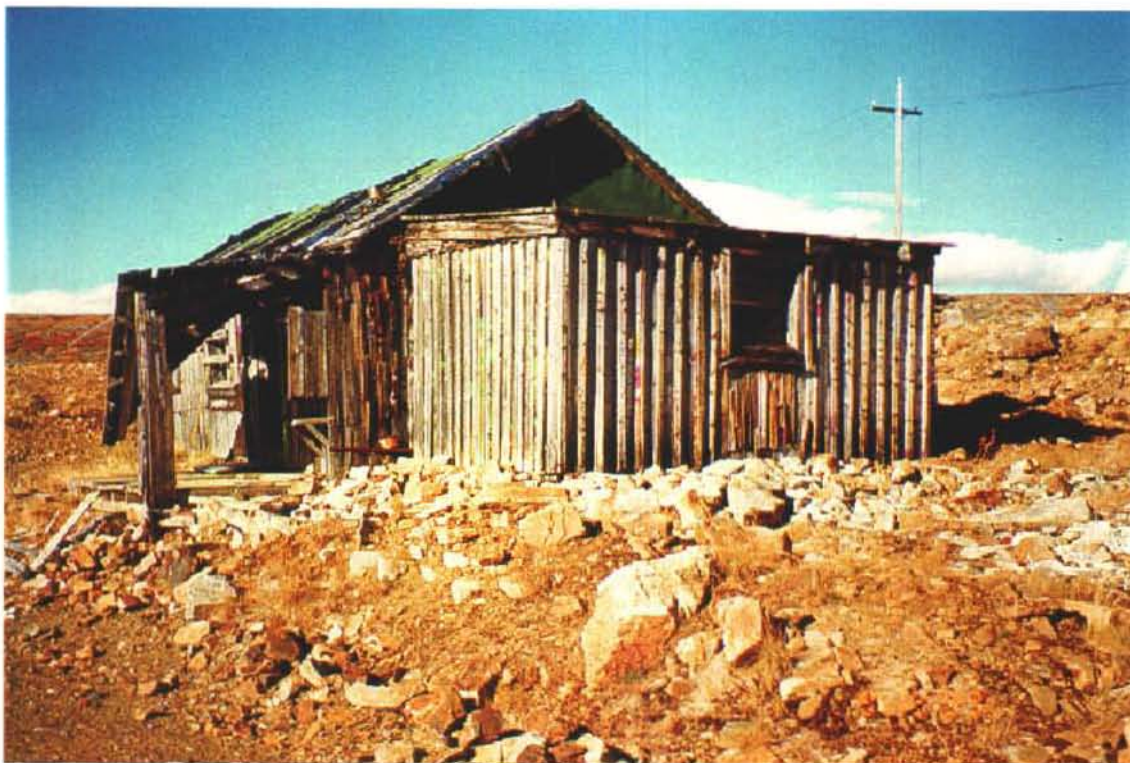
### Building 28A – Main Site Building (photo 28-5)

Two small petroleum hydrocarbon-based stains were noted to the east of the building, both with dimensions of 1 m<sup>2</sup> or less. A two-inch diameter pipe was noted extending from the building, however its former usage could not be determined. No staining was noted at the pipe end.

Photo 28-5: Main site living quarters (building 28A).

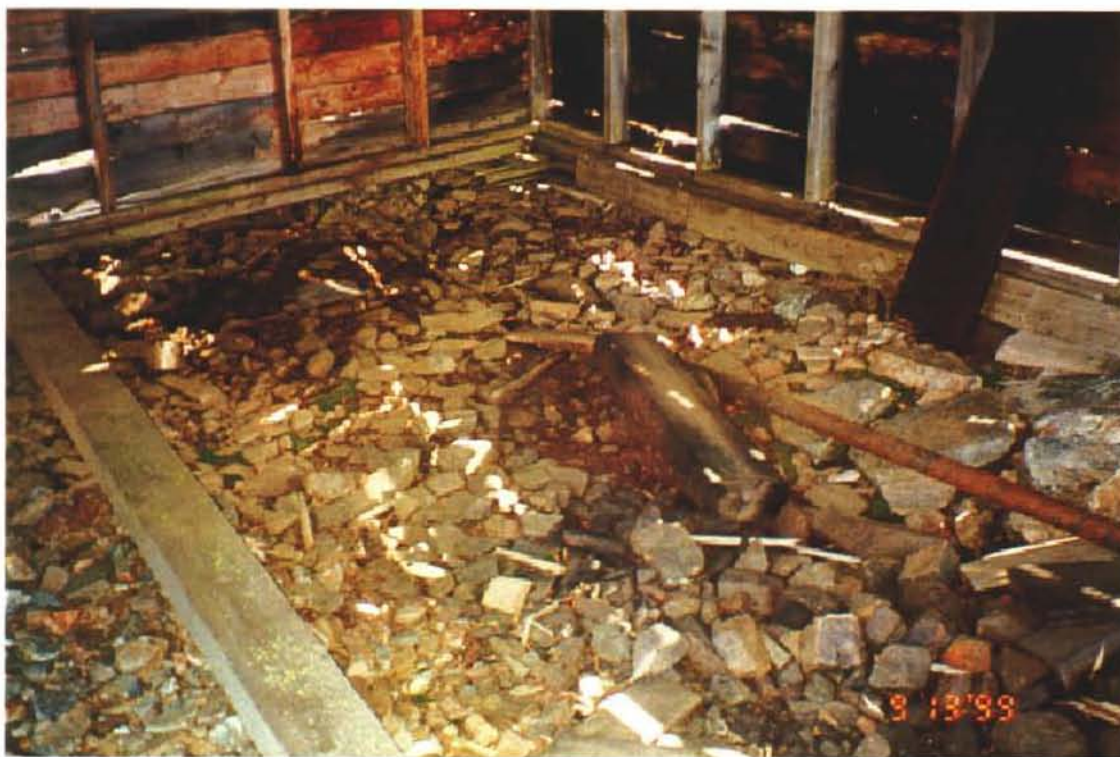
### Building 28B – Generator Shed (photo 28-6)

Photo 28-6: Interior of generator shed (building 28B). Note staining on rock.

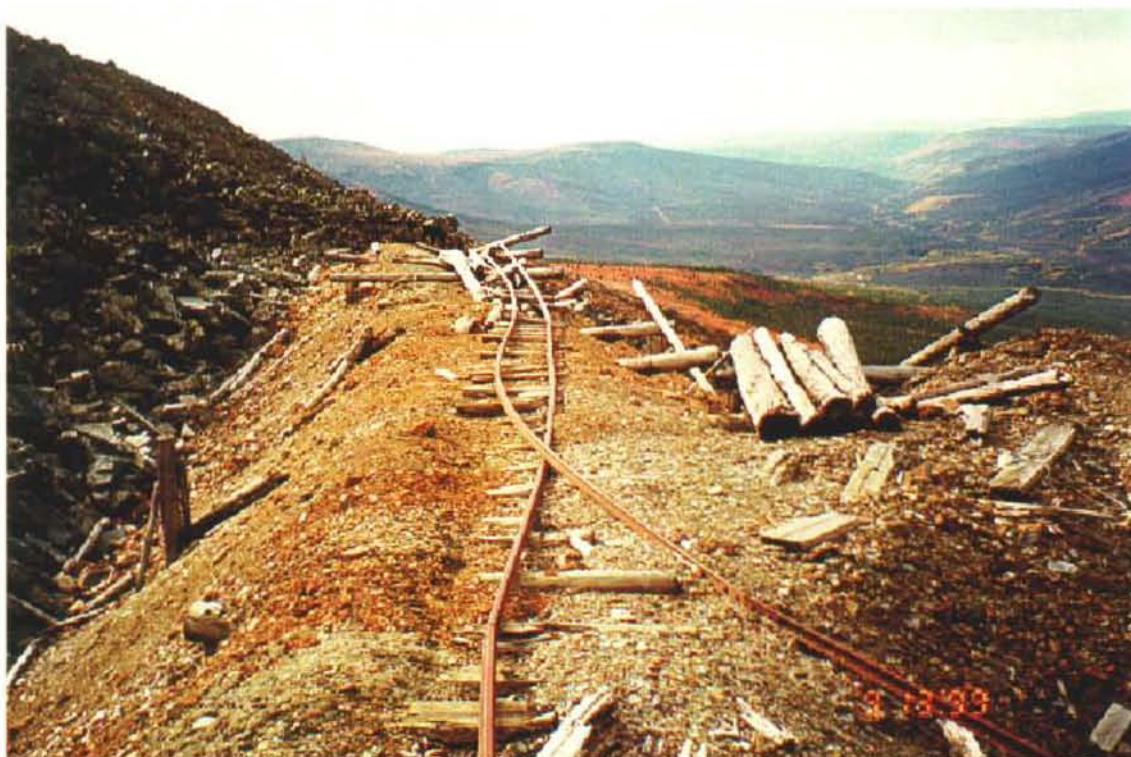
## 6.3 Rail and Trestle (photo 28-8)

Photo 28-8: Rail and trestle at main adit.

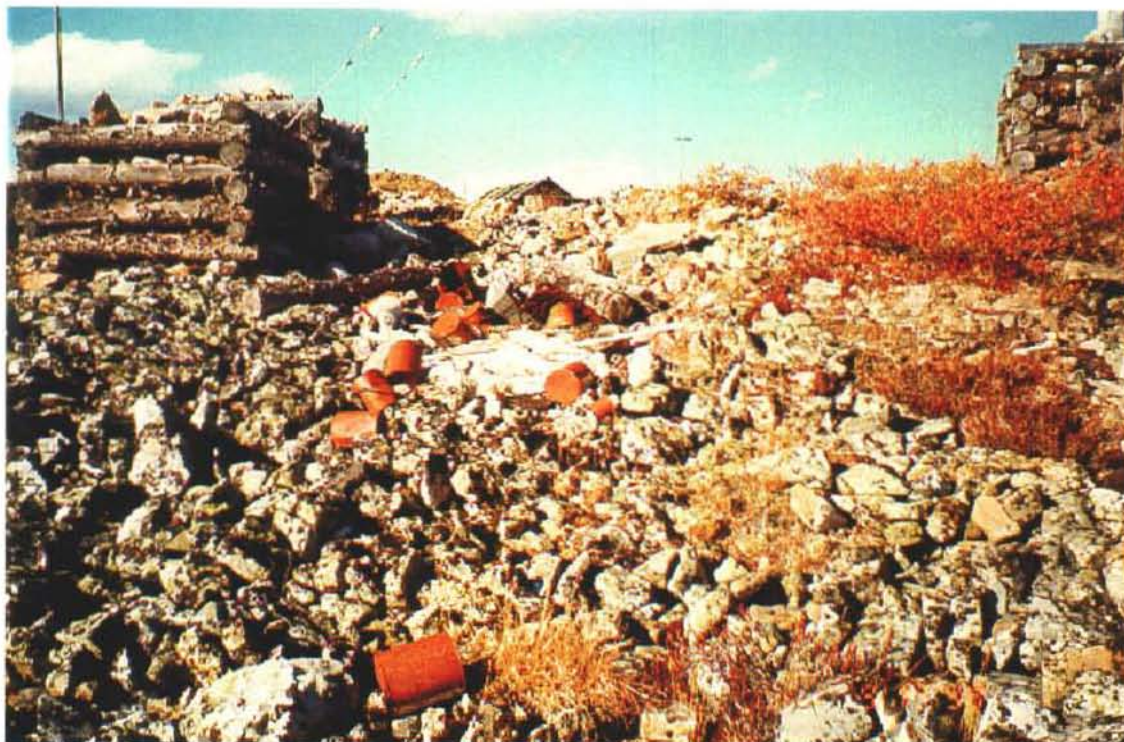
Location & access: approximately 50 m east of main building, near collapsed building and generator building and adjacent to power pole (photo 28-9).

Photo 28-9: Small solid waste dump adjacent to generator shed.

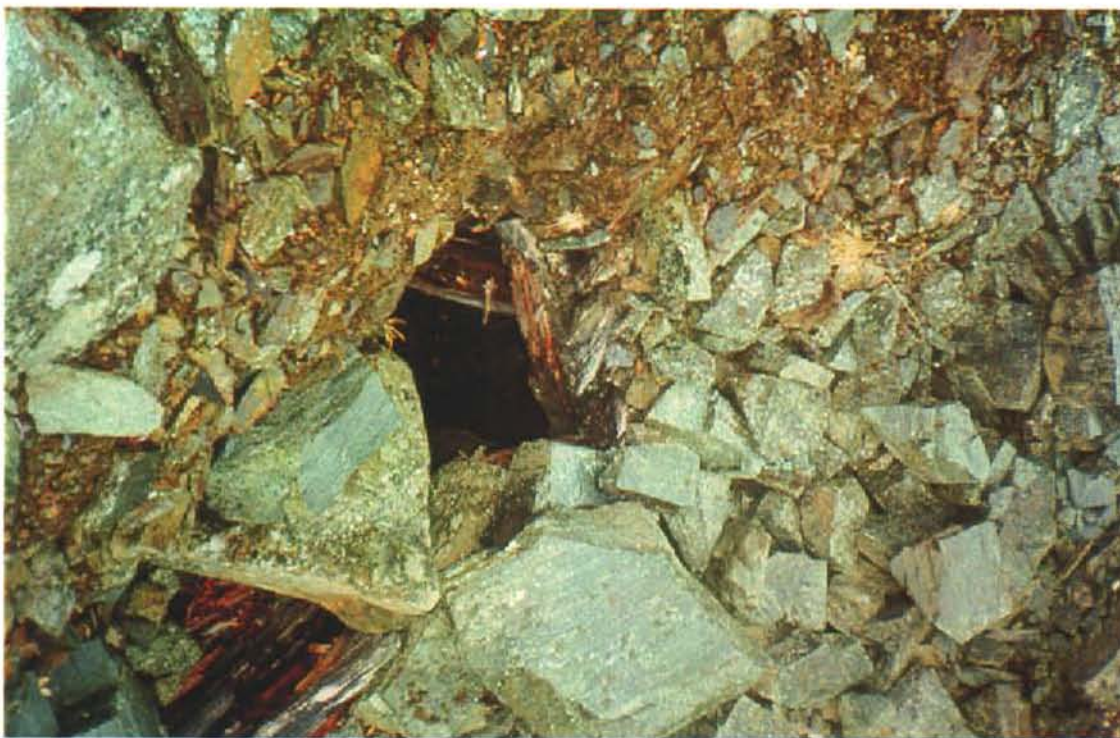
Upper Adits (photos 29-2,3)

Photo 29-2: Northern partly collapsed adit, upper workings.

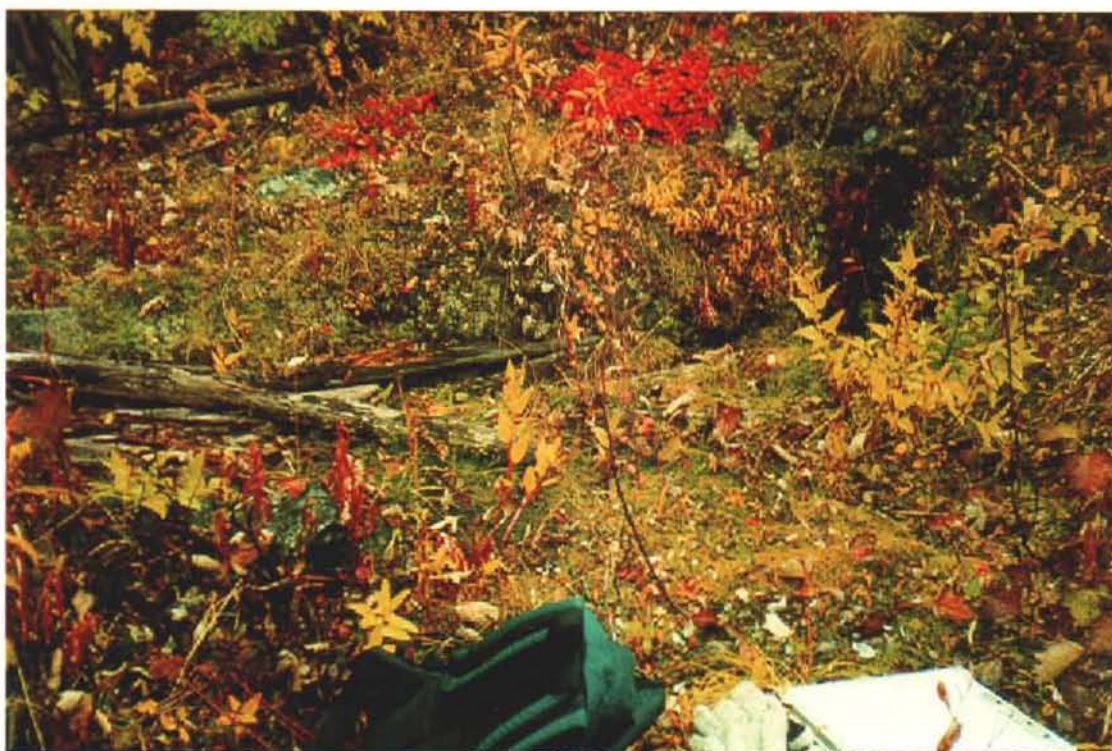
Photo 29-5: Collapsed adit, lower workings."

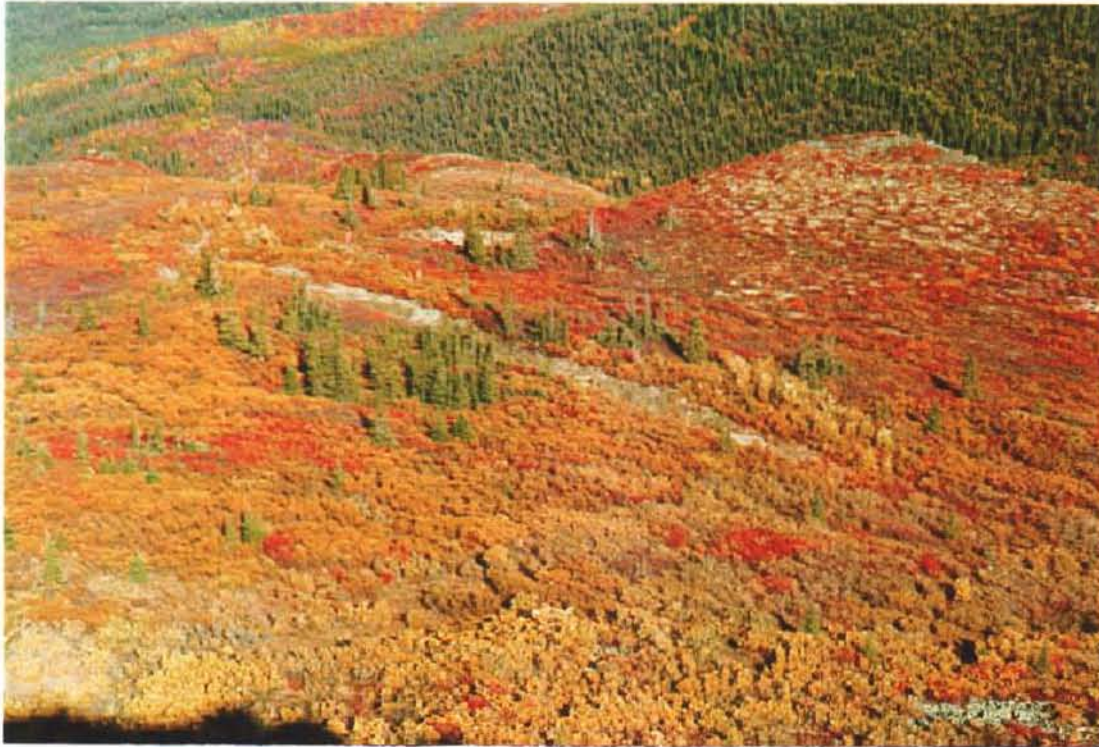
Photo 30-1: View of trench at Cub and Bunny site (Trench1) from above

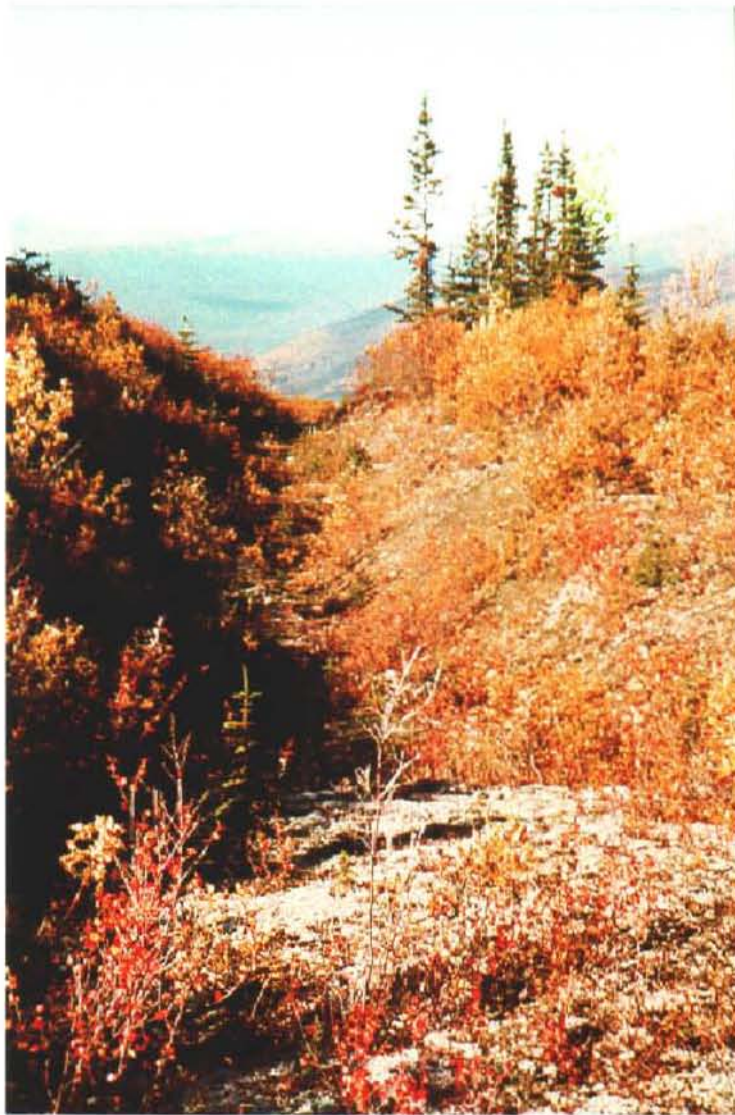
Trench 1 (photo 30-2)

Photo 30-2: View along length of Trench 1. (Azimuth 338°)

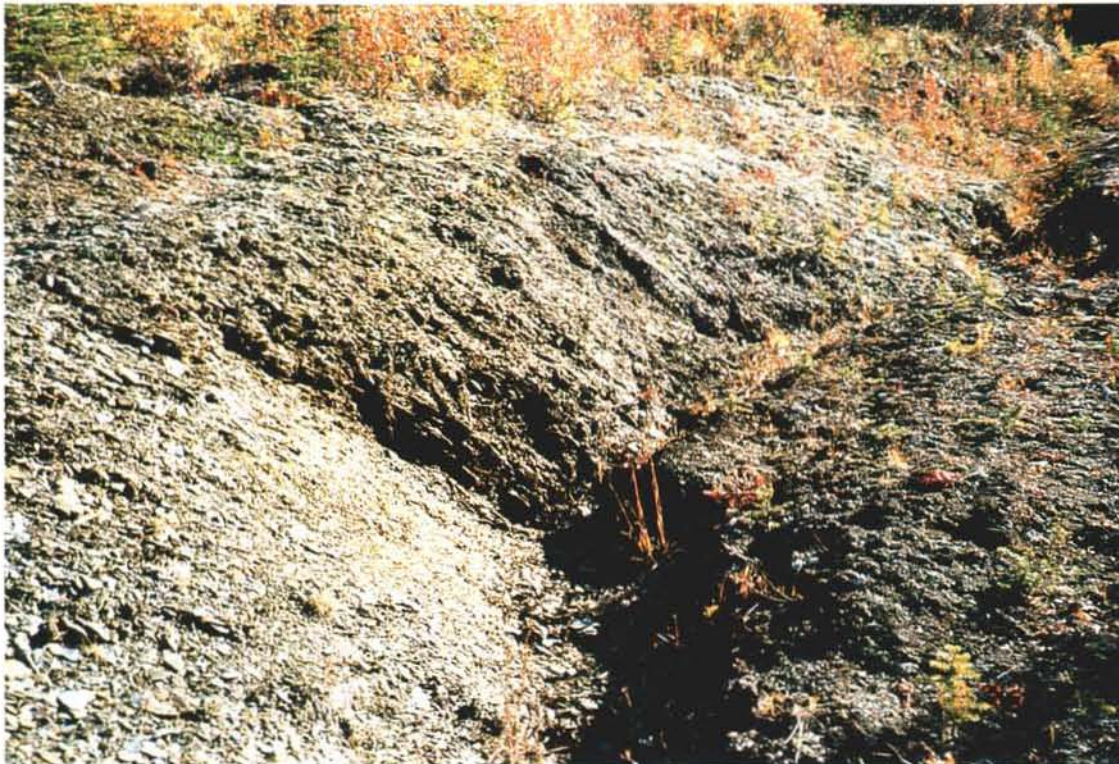
Photo 30-3: Exposed rock and soil inside of Trench1

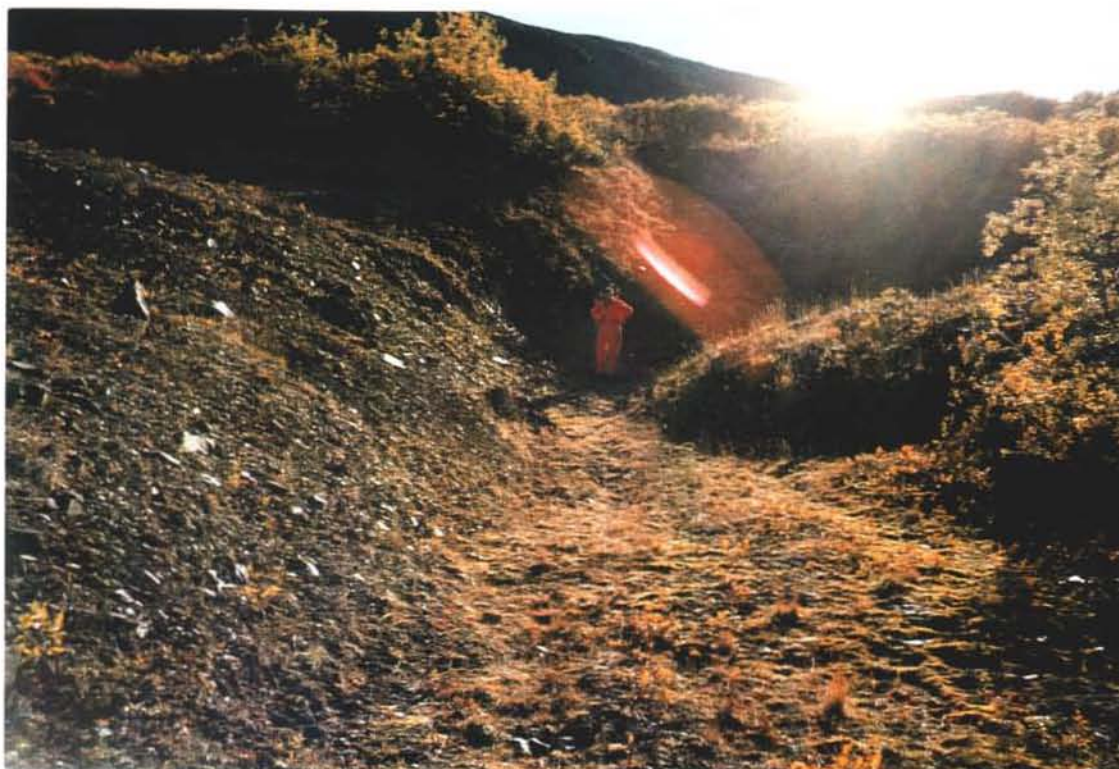
Pit 1 (photo 30-4)

Photo 30-4: View of Pit1 at Cub and Bunny site.

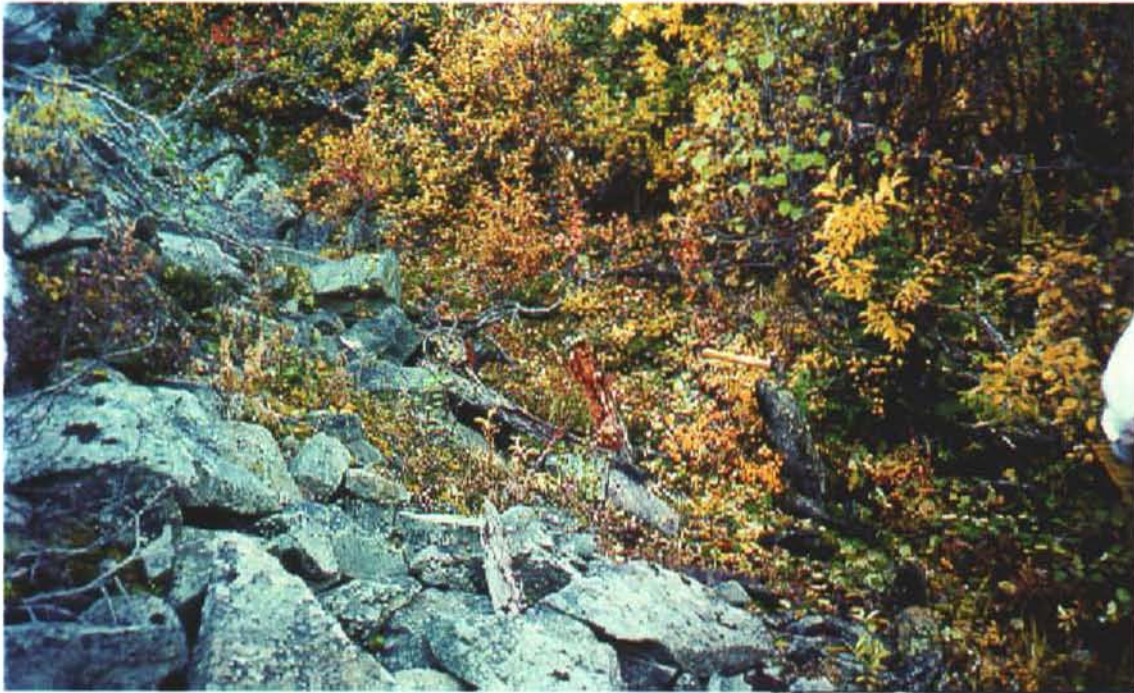
### **Upper Adit (photo 31-2)**

Photo 31-2: Collapsed upper adit portal. Note hammer in old portal timbers.  
Photo Direction (Azimuth 230°)

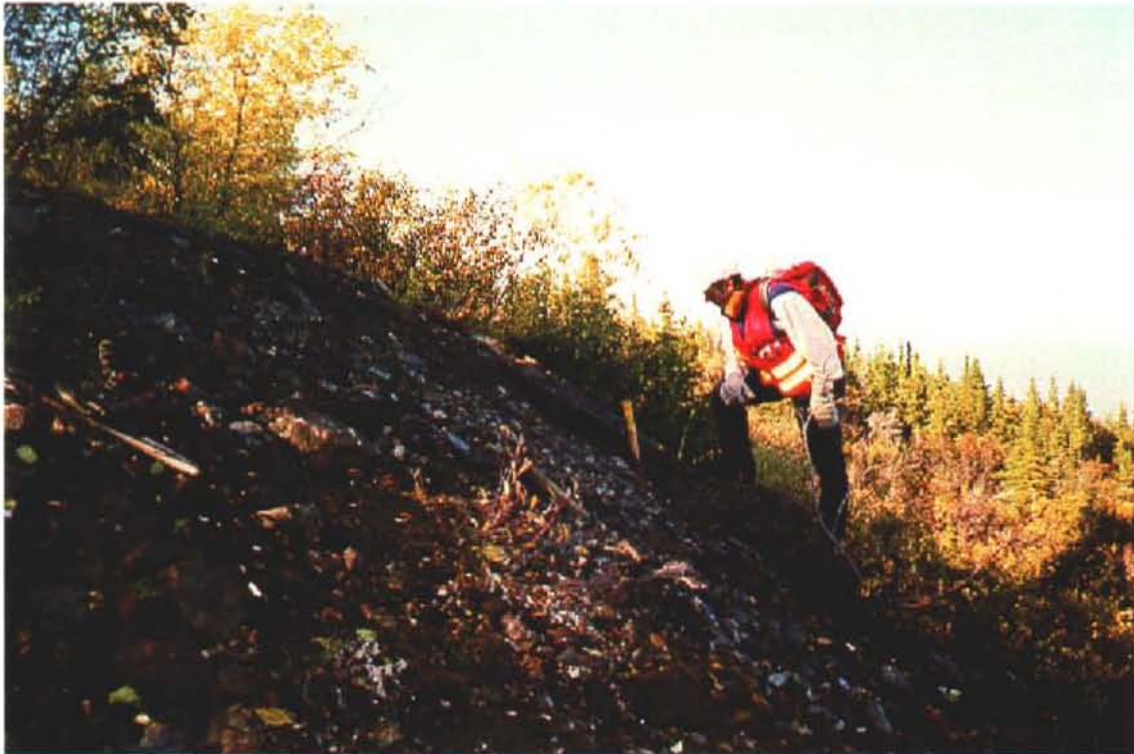
### **Waste rock pile #1 (photo 31-3)**

Photo 31-3: Upper adit level waste rock dump.  
Photo Direction (Azimuth 300°)

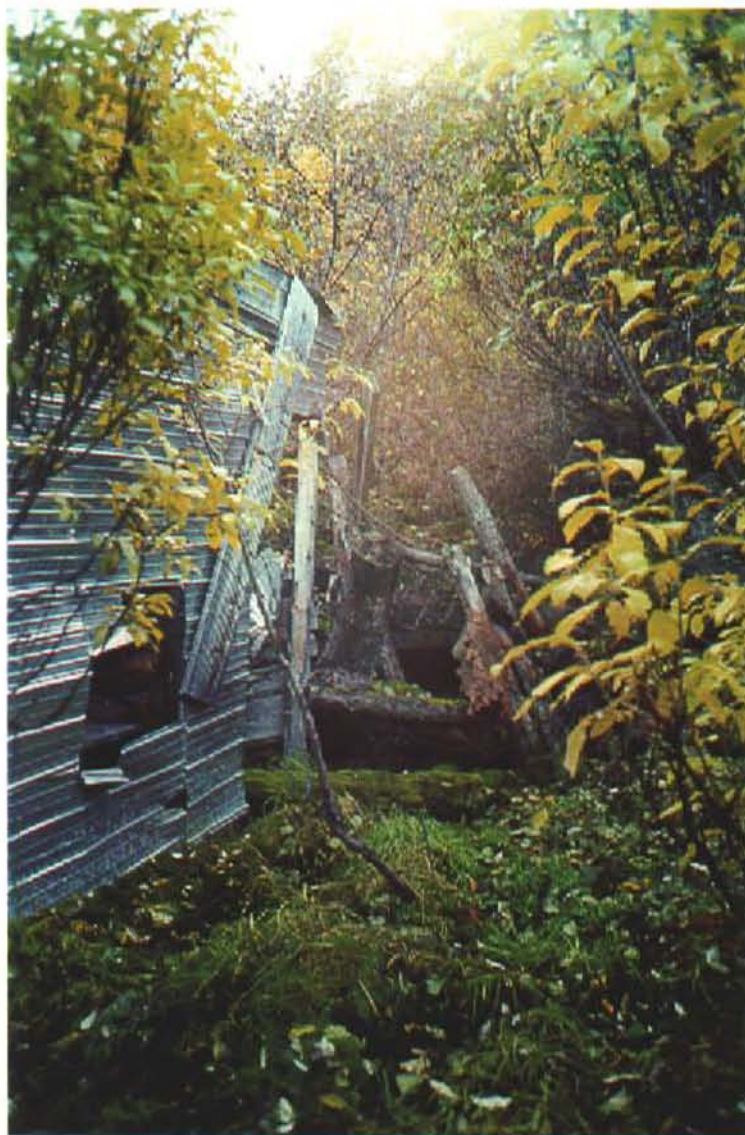
### **Middle Adit (photo 31-4)**

Photo 31-4: Collapsed middle adit portal and storage shed (Bldg. 31-B). Note damp ground from mine seepage.  
(Azimuth 160°)

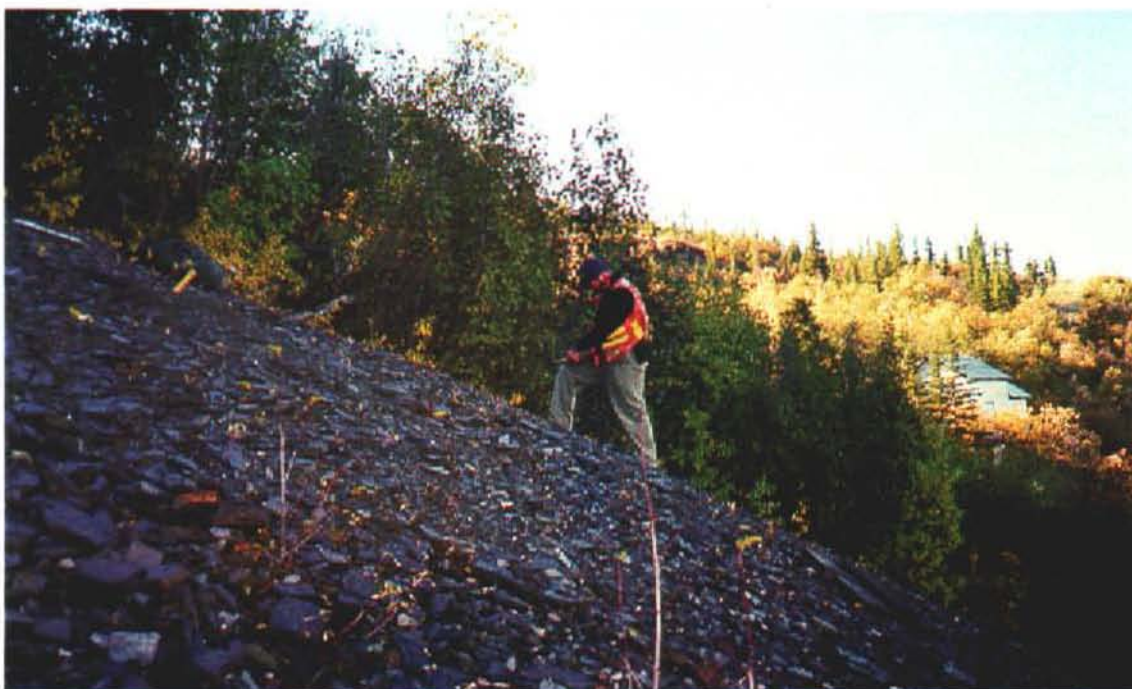
#### **Waste rock pile #2 (photo 31-5)**

Photo 31-5: Middle adit level waste rock dump with mine dry in background.  
Photo Direction (Azimuth 270°)

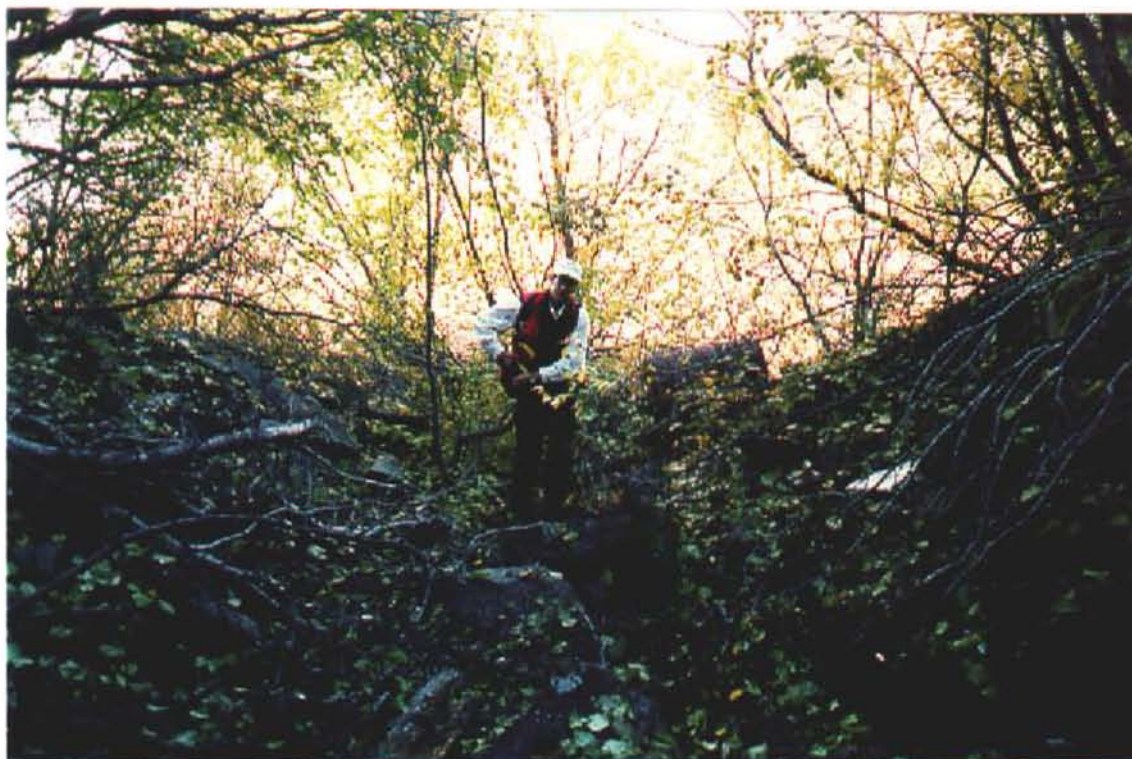
### **Lower Adit (photo 31-6)**

Photo 31-6: Collapsed lower adit portal.  
Photo Direction (Azimuth 032°)

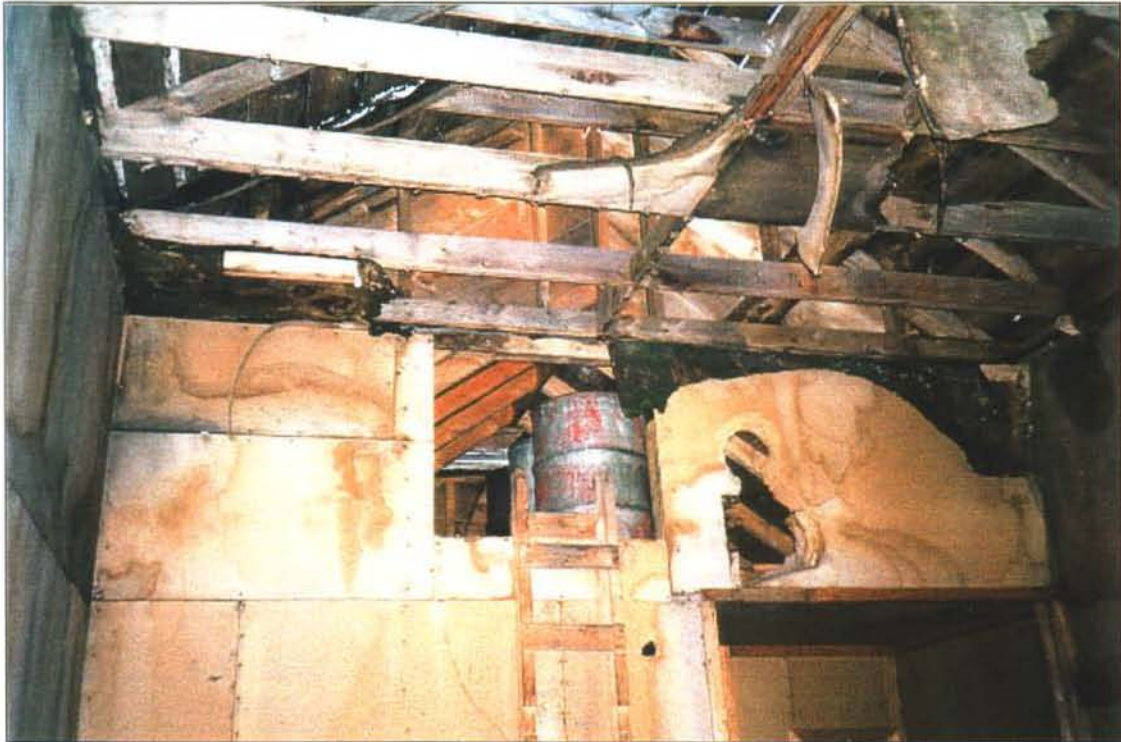
#### **Building 31-A: Dry Building (photo 31-7)**

Photo 31-7: Interior of dry (Bldg 31-A) showing rafters, wallboard and water tanks for shower and sauna.

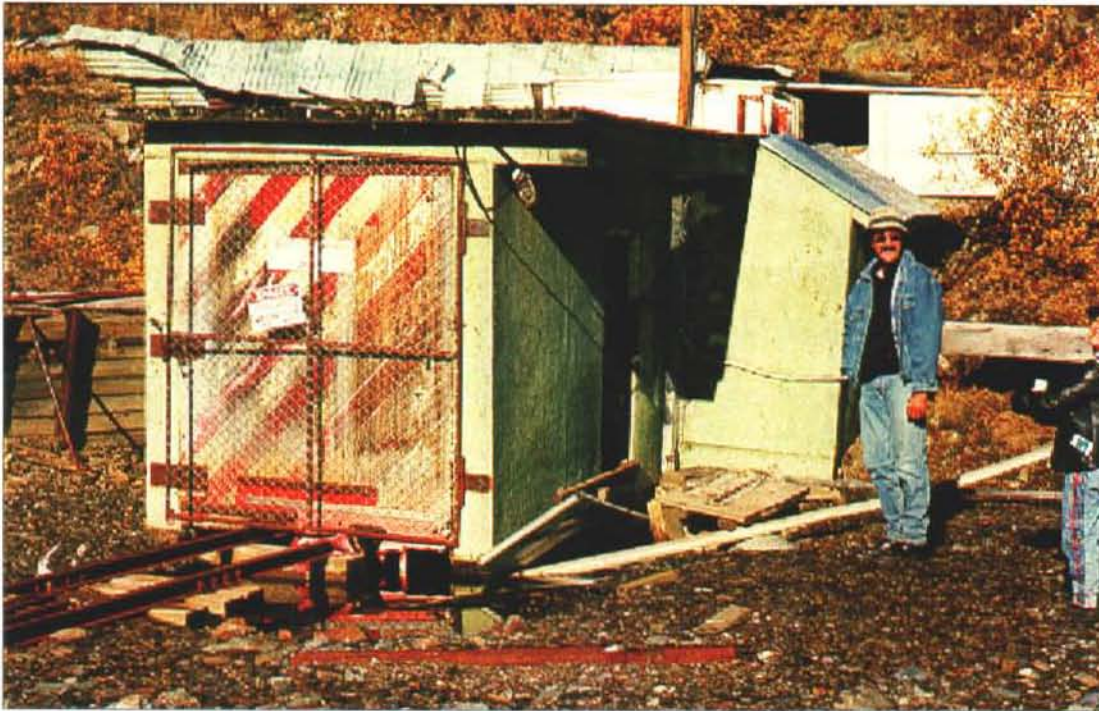
The Keno 700 adit drains an extremely large expanse of underground workings of which many are up to 70 years old (UKHM, 1996). Water samples were taken in seepage at the entrance to the Keno 700 adit (99-32-WQ-01, see Photo 32-2), below the end of the drainage culvert through the waste rock pile exposed and damaged by erosion (WQ-02, Photo 32-28) and in the receiving stream at the bottom of the outwash area a few hundred metres below the site (WQ-03, Photo 32-29). The results of the geochemical analyses for these samples are presented in Attachment 2.

Photo 32-2 : Keno 700. Mine adit shed (building 7) looking N.W.

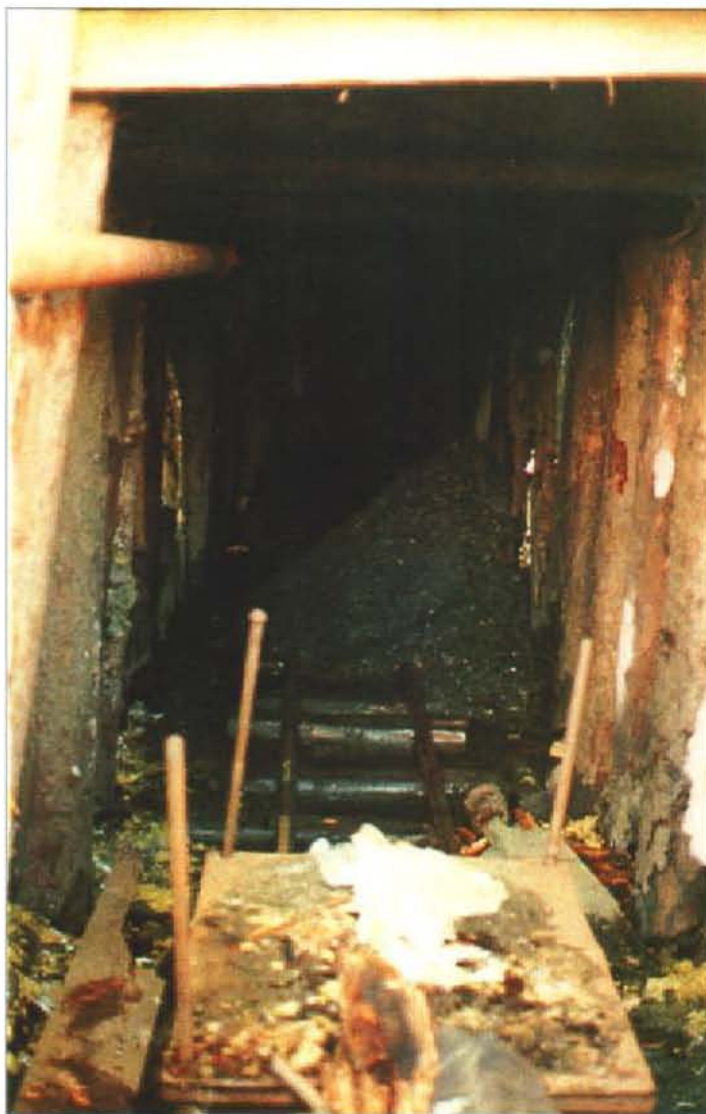
One water sample was taken in seepage at the entrance to the Keno 200 adit (99-32-WQ-04, see Photo 32-4); no additional samples were obtained due to the high and dry topography and lack of any apparent surface drainage. The results of the geochemical analyses for these samples are presented in Attachment 2.

Photo 32-4 : Keno 200. Mine adit water sample.

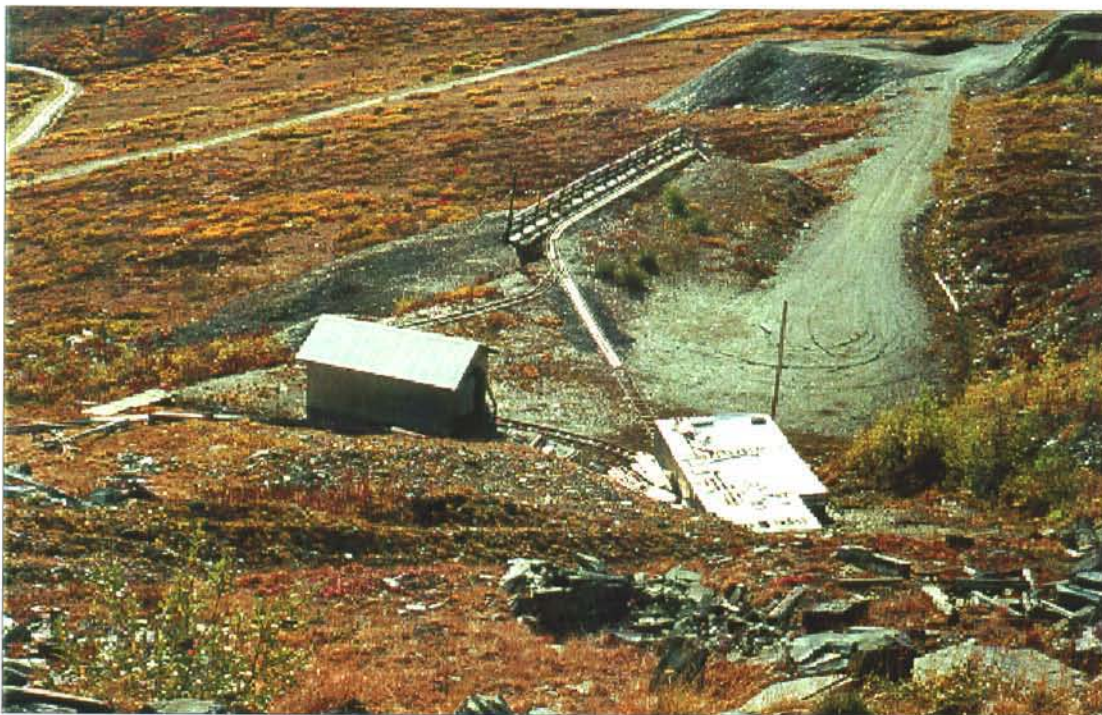
#### ***Comstock 150 Waste Rock*** (Photo 32-12)

General Description: Small mound, mixed with overburden upon which the Comstock 150 adit and loading infrastructure is located. The area is relatively high and dry; no evidence of surface adit seepage drainage was observed. The sides of the waste rock pile have been stabilized and reinforced by wood planks and logs (see Photo 32-23). A second, smaller pile (~ 15 m L x 4 m wide x 1.5 m high) was situated to the south of the site and the truck-loading trestle waste rock was composed of brown loose shale and overburden material. The waste pile appeared to contain a high percentage of sandy overburden. An inspection of the waste pile did not indicate any seepage faces or saturated conditions that would indicate saturated conditions at the site. The waste pile is located on a steep slope and is comprised of well-drained coarse granular material. No physical indications of acid rock drainage were documented at the subject site.

Photo 32-12 : Looking downslope (S) to Comstock-Keno 200 (from Comstock-Keno 150).

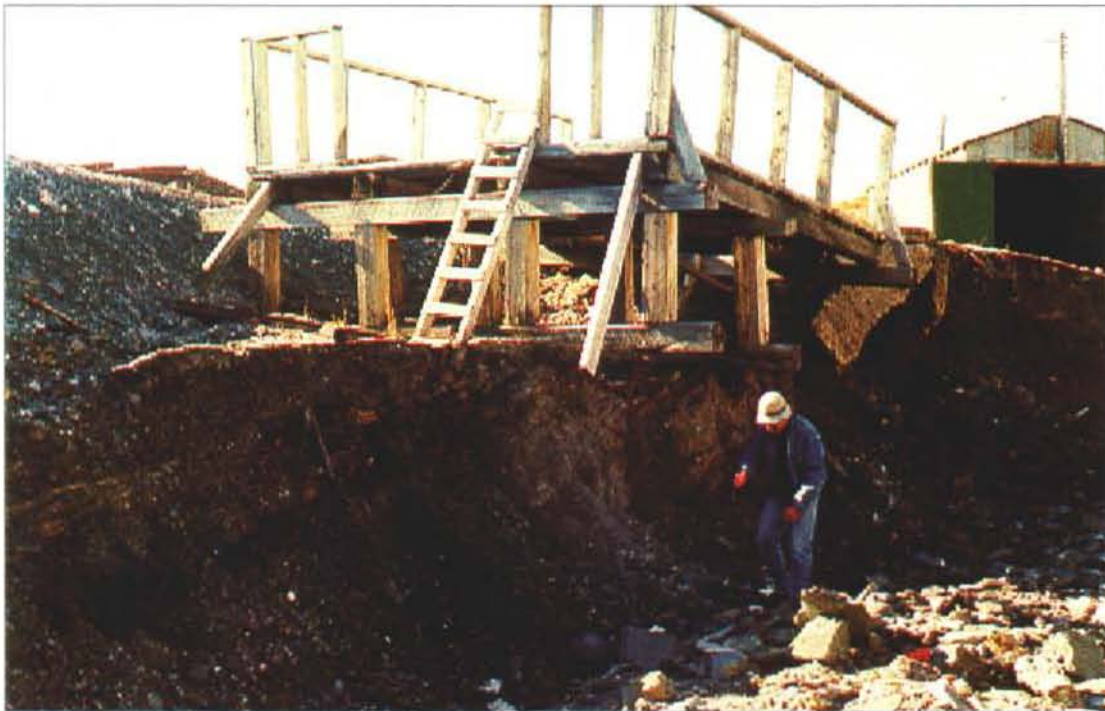
Photo 32-28 : Keno 700. Waste-rock pile outwash area looking W. Adit culvert at top.

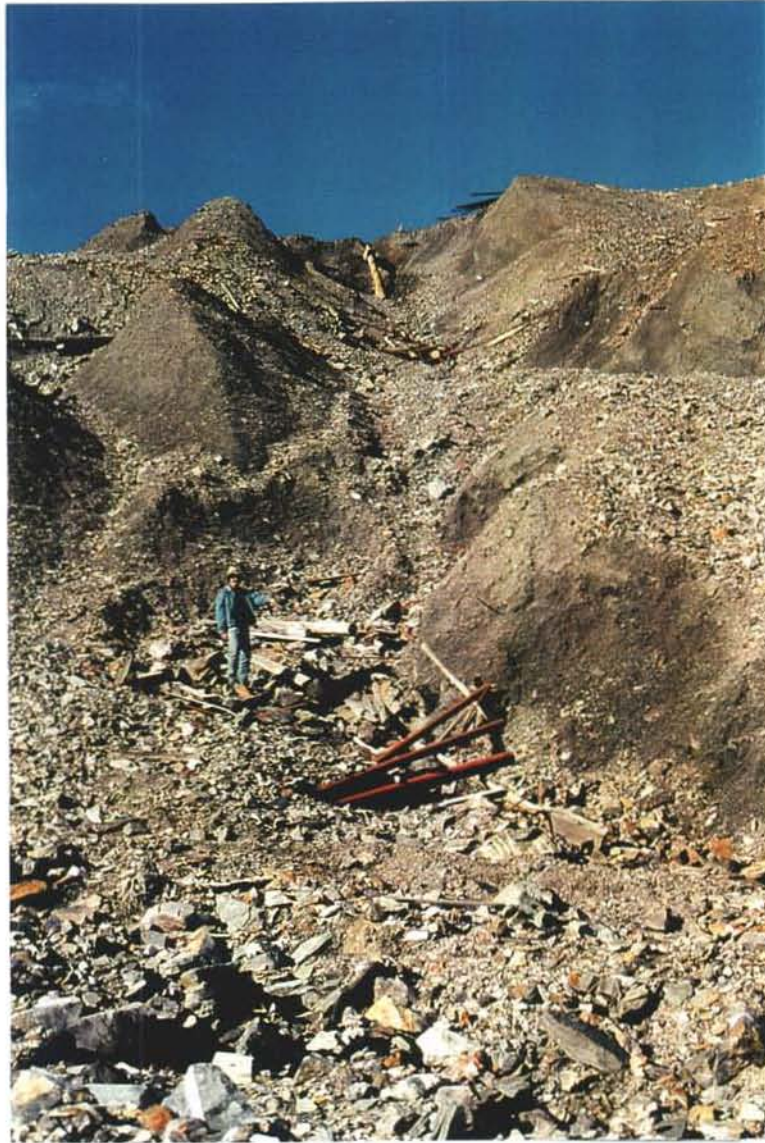
Photo 32-29 : Stream below outwash area.

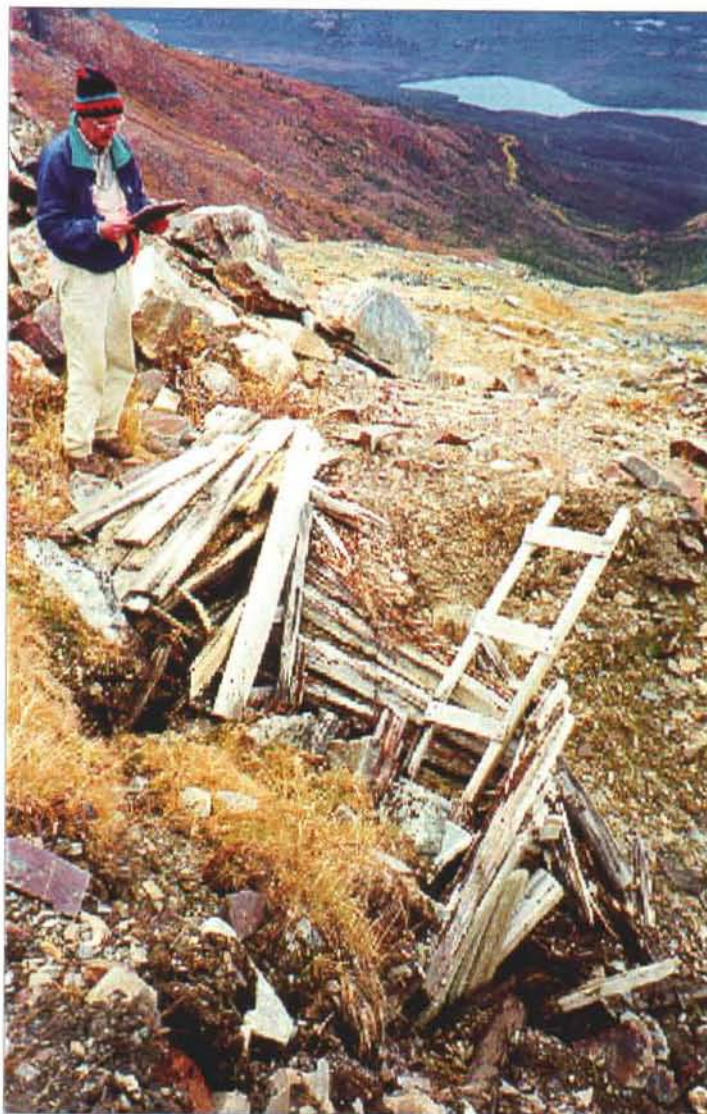
Condition: The shaft has collapsed at surface.

Photo 33-1 : Main Fault and Nabob. View of the Main Fault shaft, Gambler Lake is in the background. (Azimuth 330°)

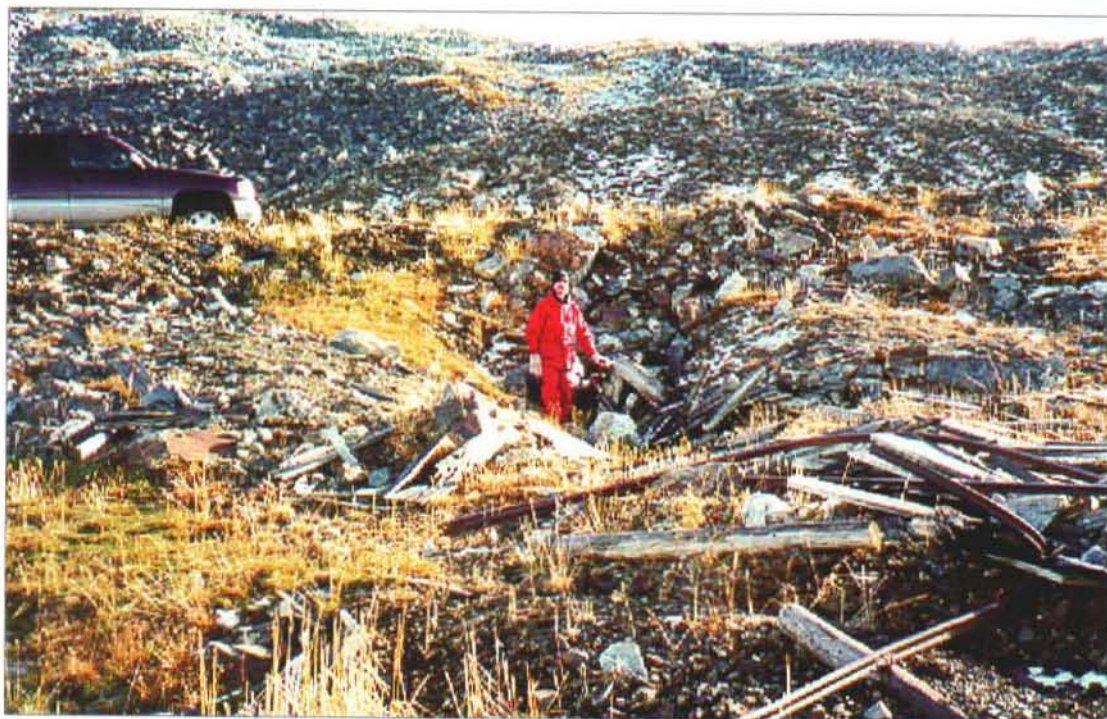
Condition: The portal and the first 5m (up to the road) of the adit have collapsed. The portal is filled with broken log cribbing and large boulders. No evidence of further stability problems was observed, the road above the adit did not appear to be slumping.

Photo 33-2 : Main Fault and Nabob. Collapsed Main Fault -Nabob Adit, truck is on Silver Basin Gulch Trail. (Azimuth150°)

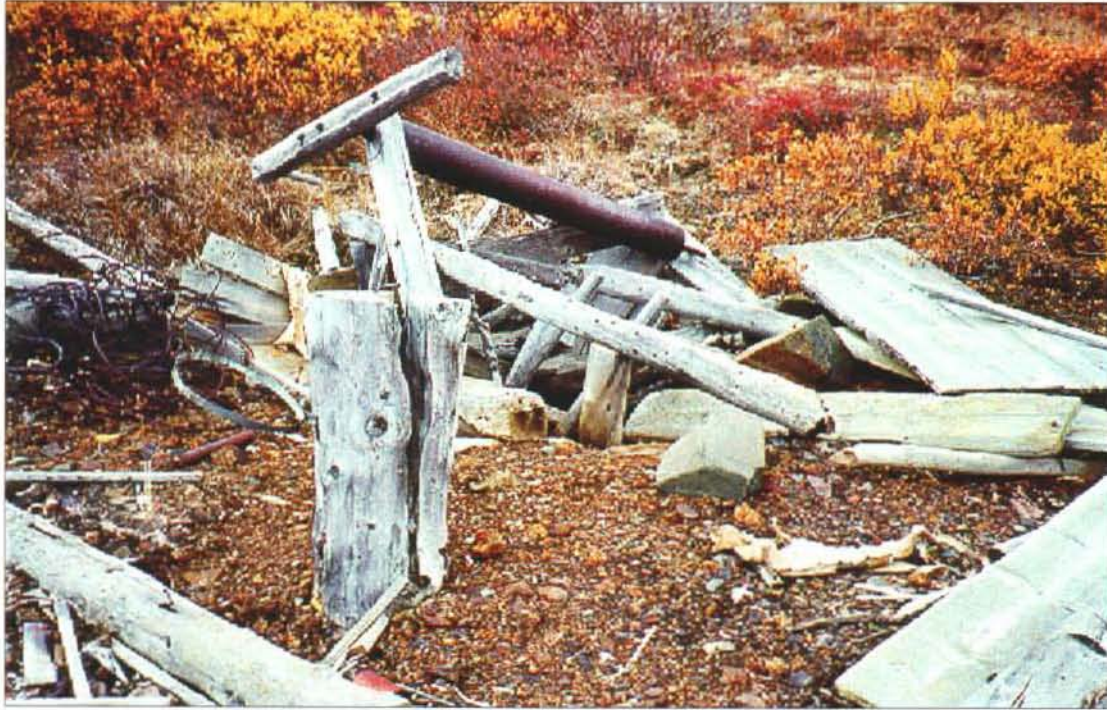
Photo 35-1 : Nabob #2. View of the collapsed Nabob #2 shaft. (Azimuth 050 °)

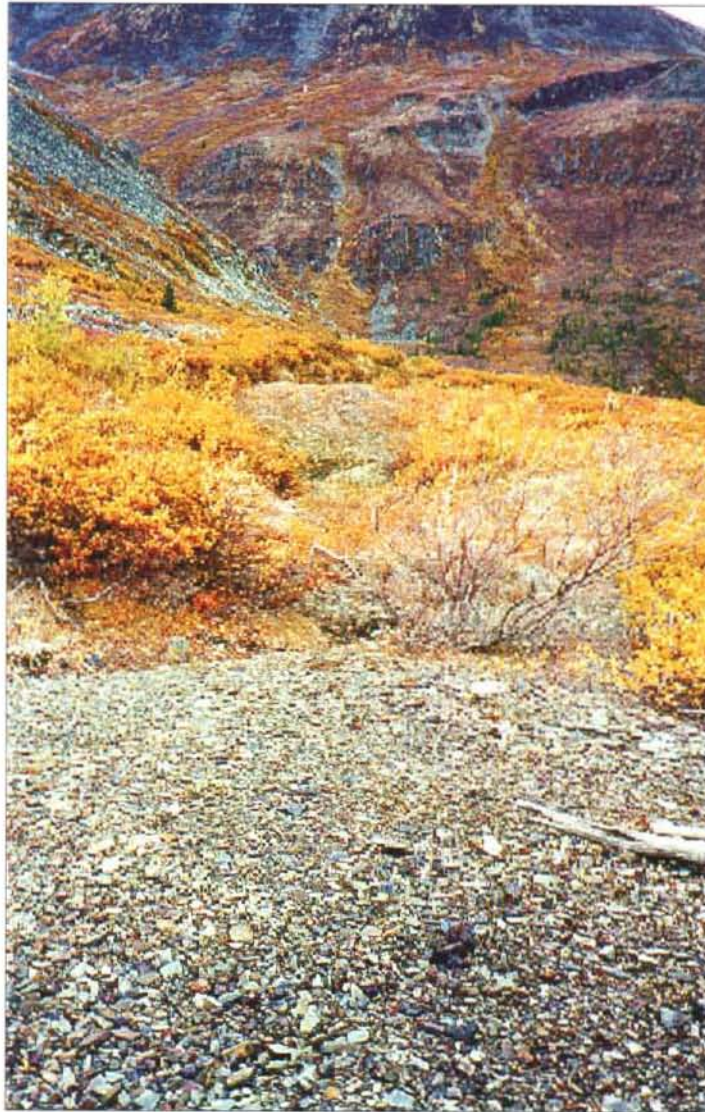
### **Trench #1 (photo 35-2)**

## **5.2 Waste Rock Disposal Areas (photo 35-2)**

Photo 35-2 : Nabob #2. The waste rock pile from the shaft is in the foreground and Trench #1 is in the background. (Azimuth  $230^{\circ}$ )

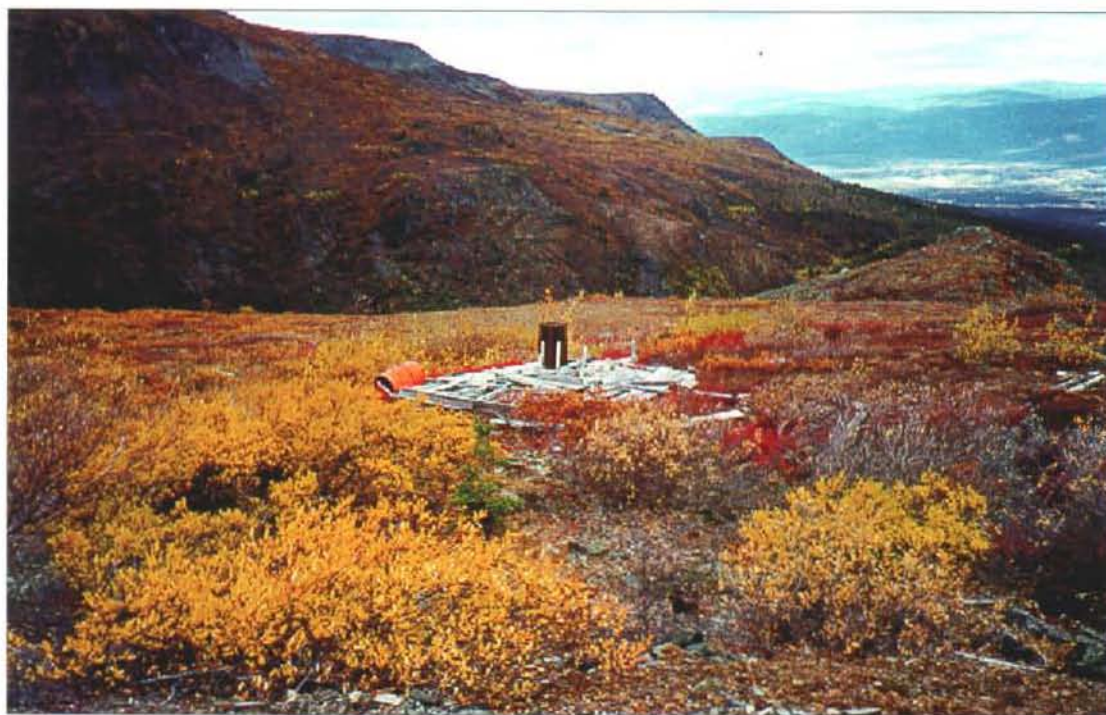
### **6.1 Building 35A (photo 35-3)**

Photo 35-3 : Nabob #2. Building 35A, an old cabin foundation. (Azimuth 235 °)
